Halberton Court Farm, Halberton, Devon

An Historic Building Assessment

COAS reference: C1/SBR/16/HFH

October 2016

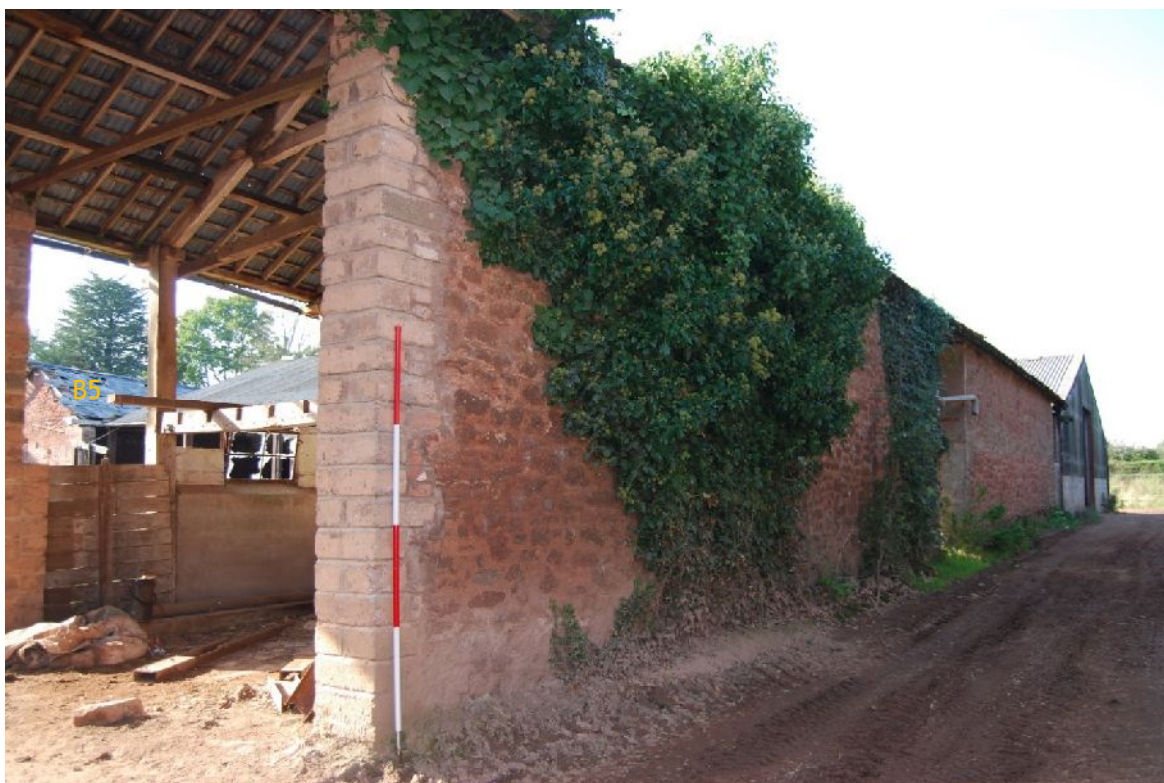
Plate 43. North-east exterior elevation of B6 (from SE; 2m scales)

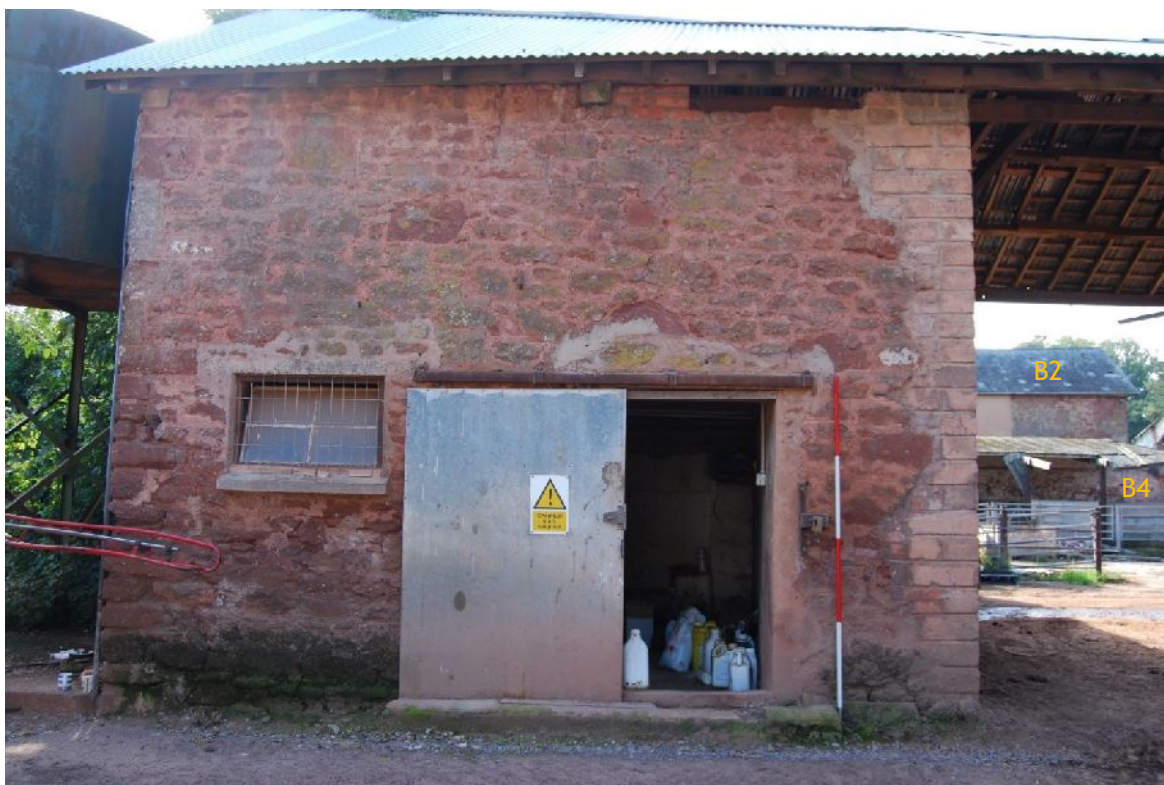
Plate 44. North-east exterior elevation of B6, S end (from NE; 2m scales)

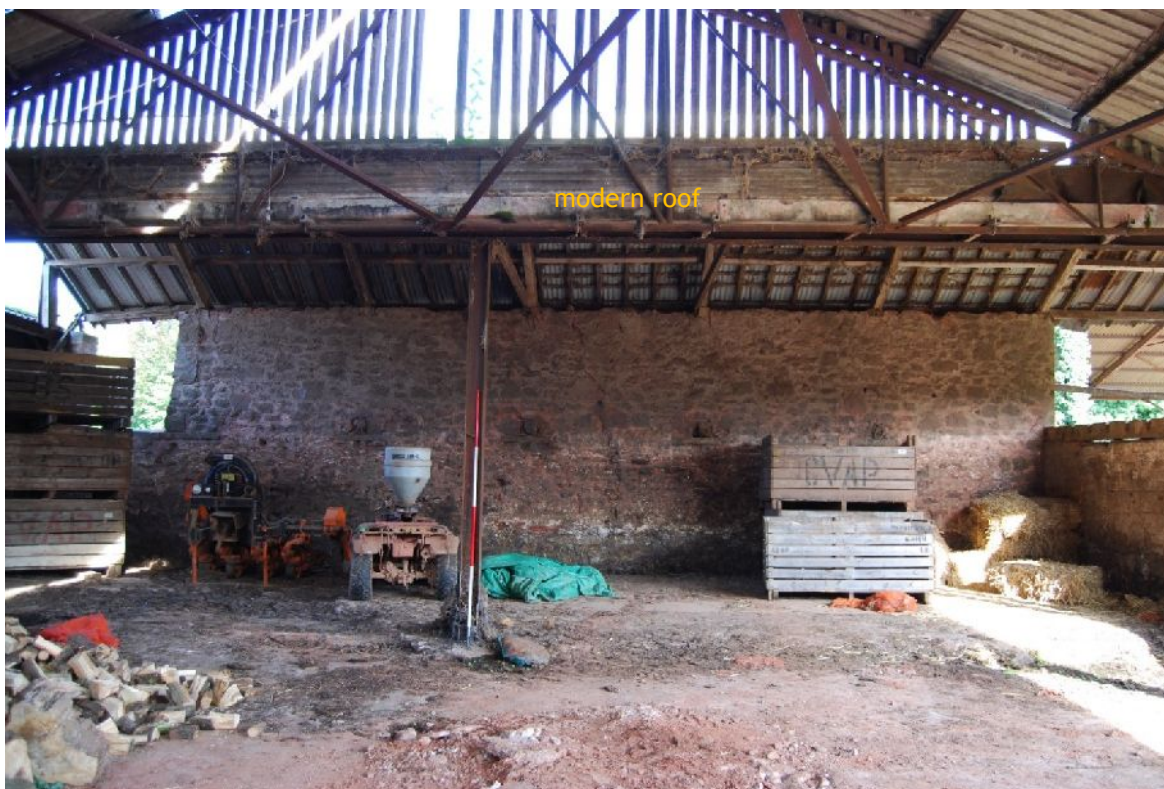
Plate 45. North-east interior elevation of B6, NE end (from SW; 2m scales)

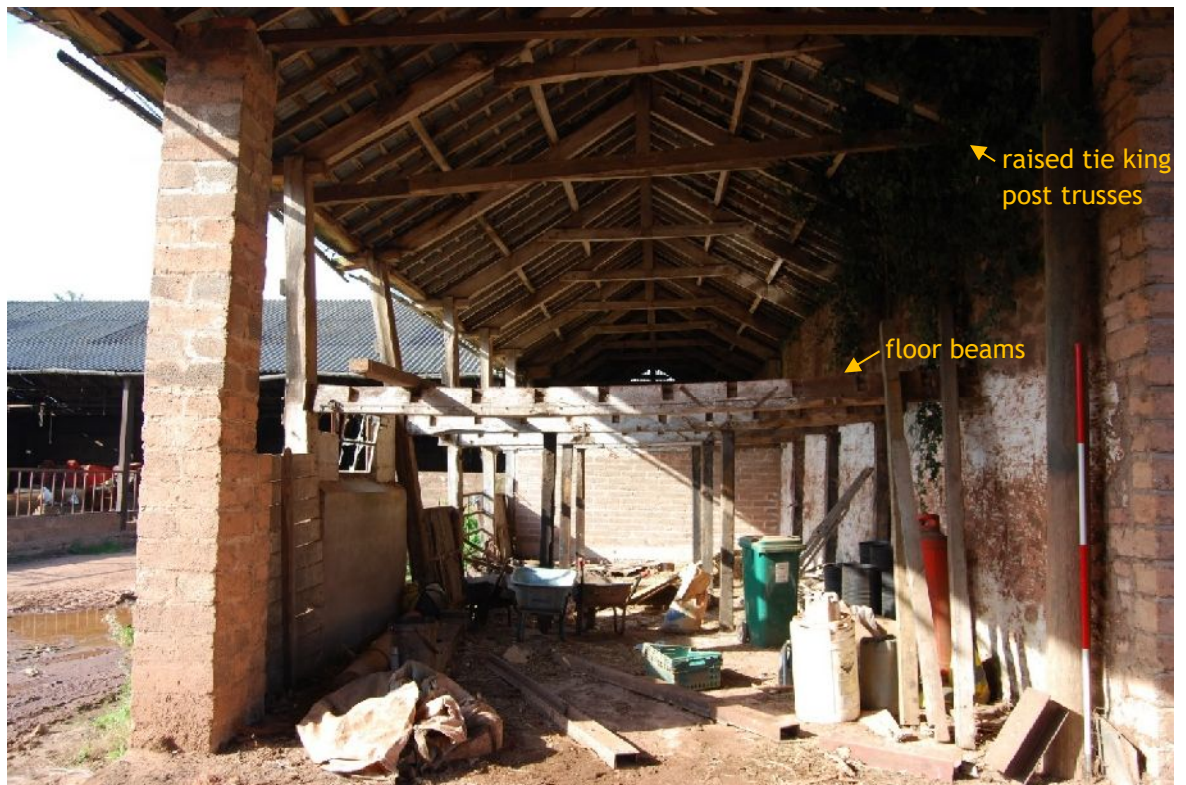
Plate 46. Interior of B6, central (from SE; 2m scales)

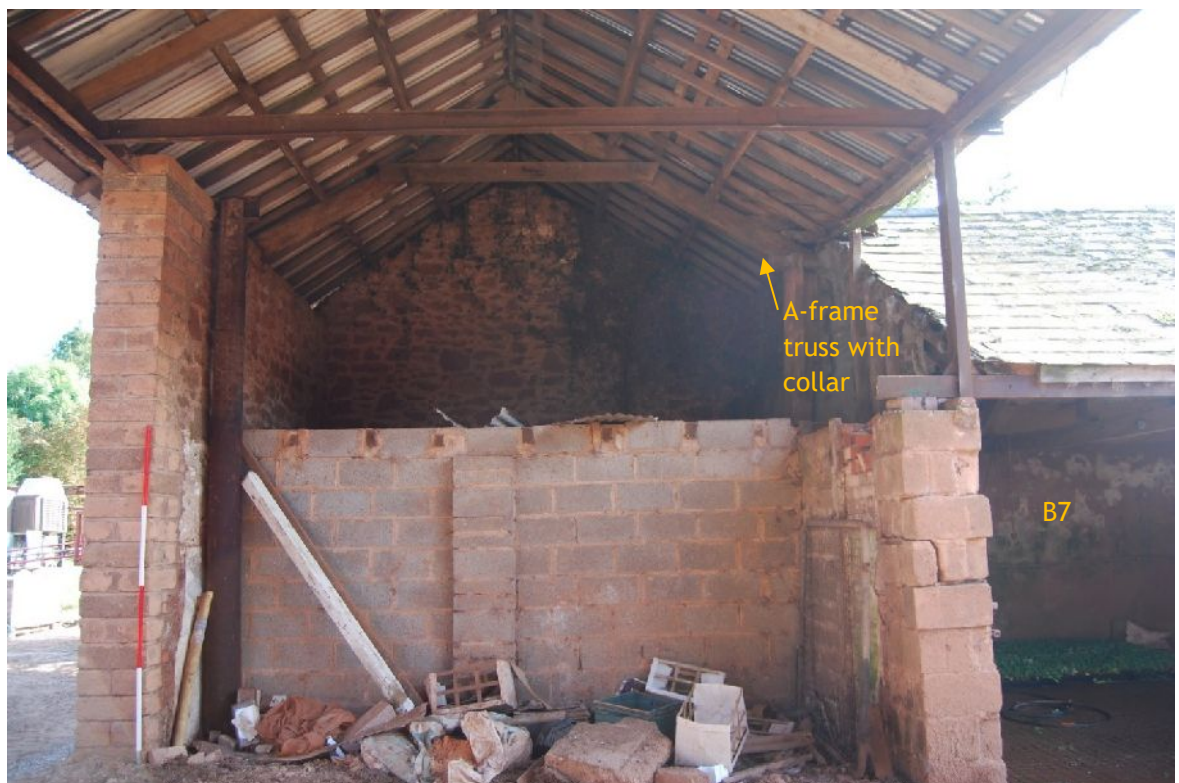
- 4.13 The eastern side of the farmyard is enclosed by a long, tall, open-sided barn with two access points from the east into the farmyard (Plates 42, 43 & 44). The original walls are constructed of random rubble, although alterations are apparent in the form of blocked openings and re-built concrete block and or brick quoins. The northern end is covered by a high modern roof (Plate 45), however throughout most of the building is a raised tie king post truss roof with substantial timber floor joists indicating the presence of a first floor presumably for storage (Plates 46). The truss at the southern end of the building (now blocked off and accessed from a door (see Plate 44) is a simple A-frame truss with collar (Plate 47). This suggests some modifications to the roof at this end.

Plate 47. Interior of B6, S end (from NW; 2m scales)

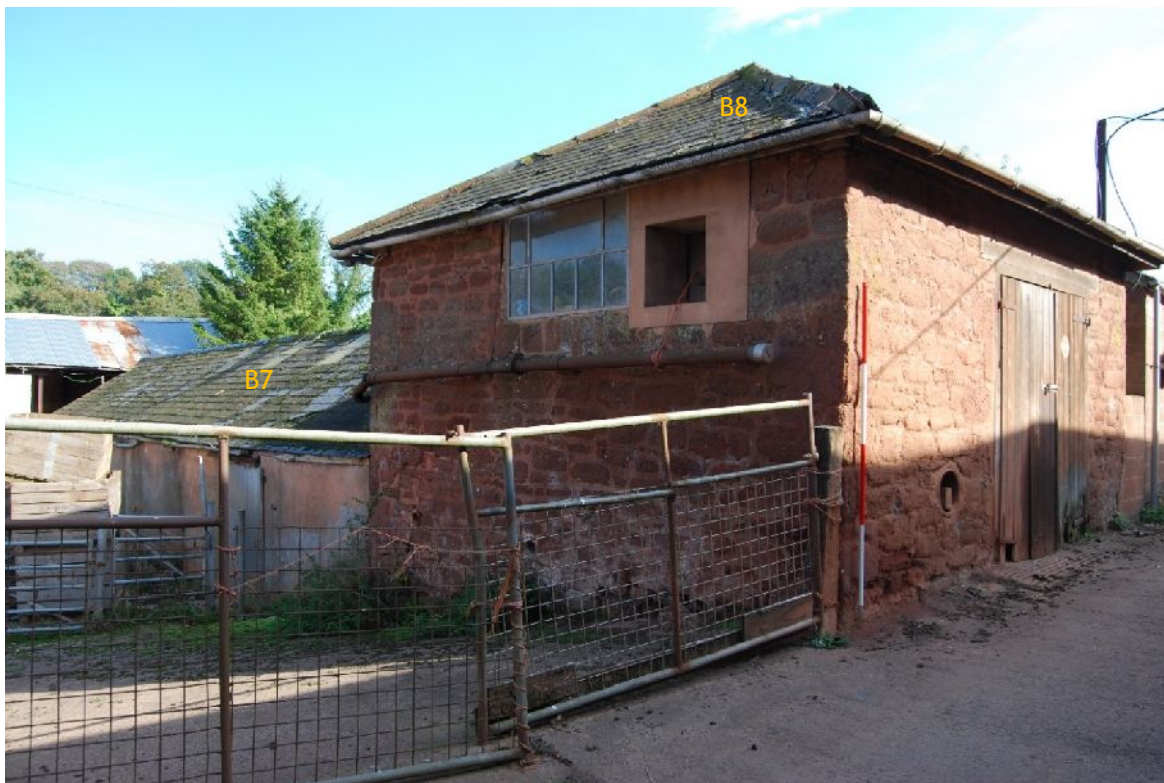
- 4.14 The southern side of the farmyard is enclosed by a long, low building (B7) between B6 to the east and B8 to the west (**Plate 48**). Probably associated with the structure shown on the 1814 map, B7 is rendered externally and internally, and has a slate roof with three modern roof lights (**Plate 49**) supported on king post roof trusses (**Plate 50 & 51**).

Plate 48. South-west elevation of B8 & north-east elevation of B7 & B8 (from NW; 2m scales)

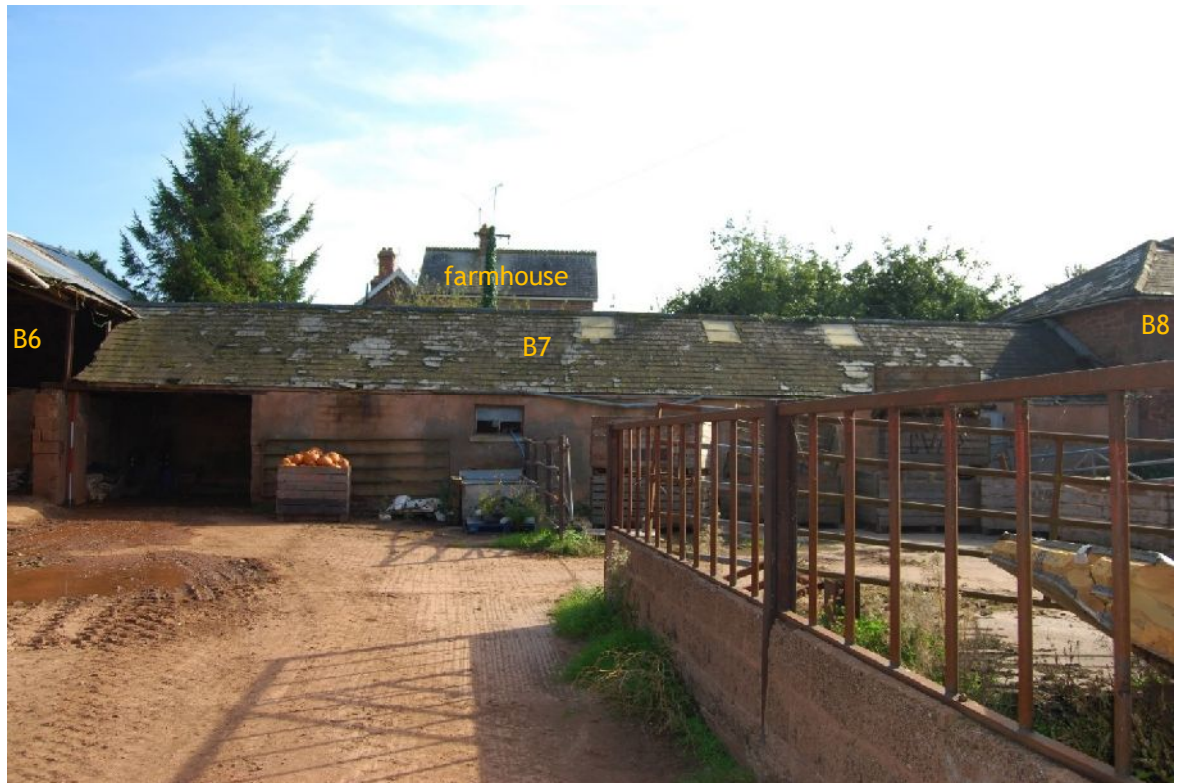
Plate 49. North-east exterior elevation of B7 (from NNW; 2m scales)

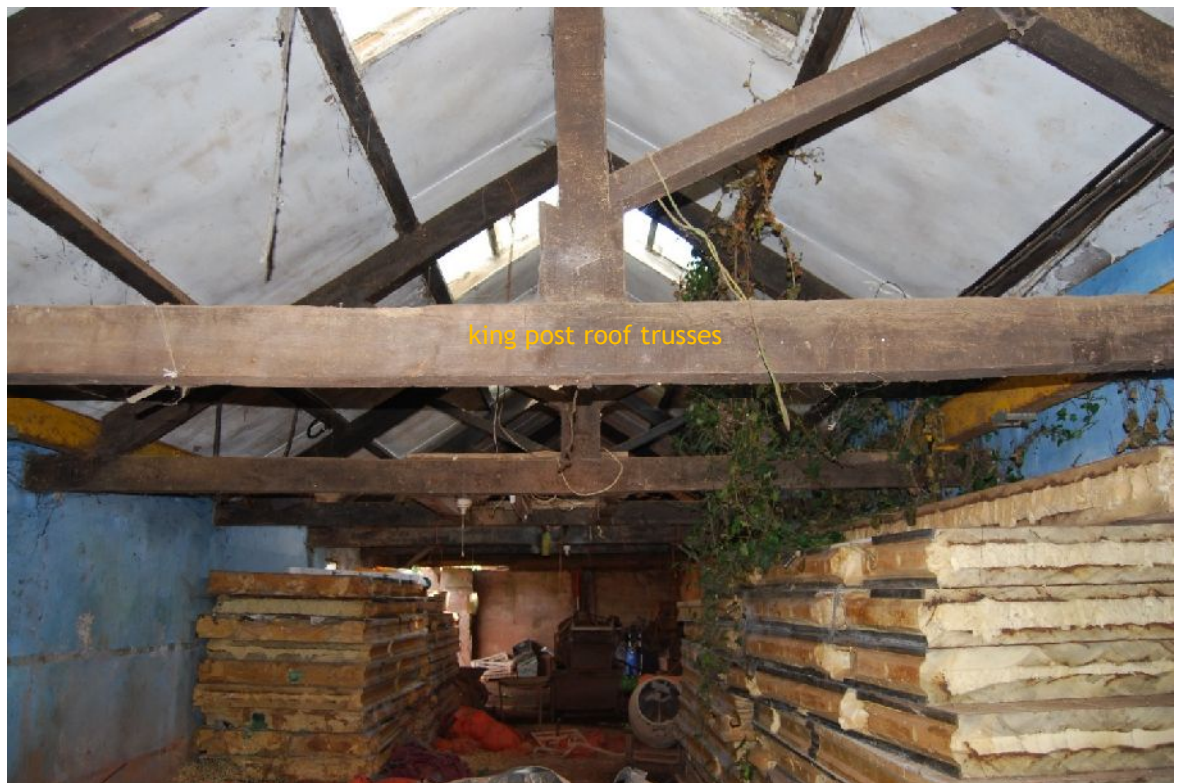
Plate 50. Interior of B7 (from SW; 2m scales)

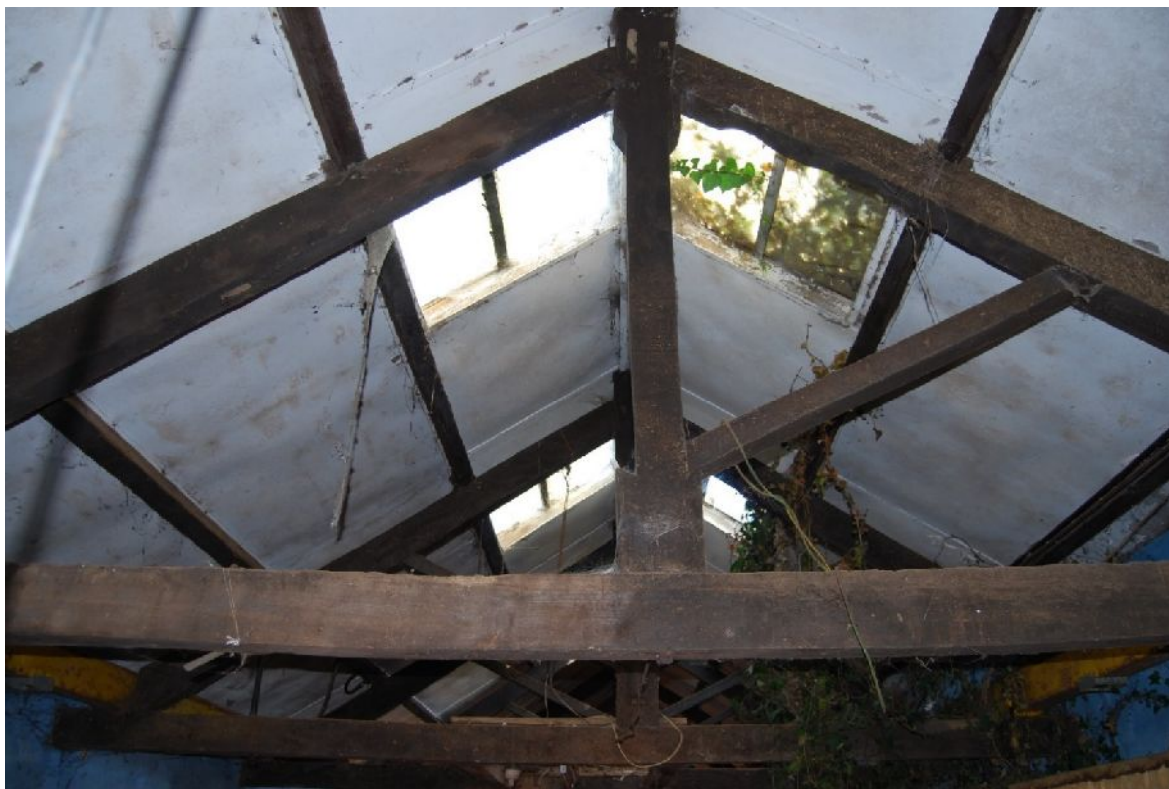
Plate 51. King post truss roof of B7 (from SW; 2m scales)

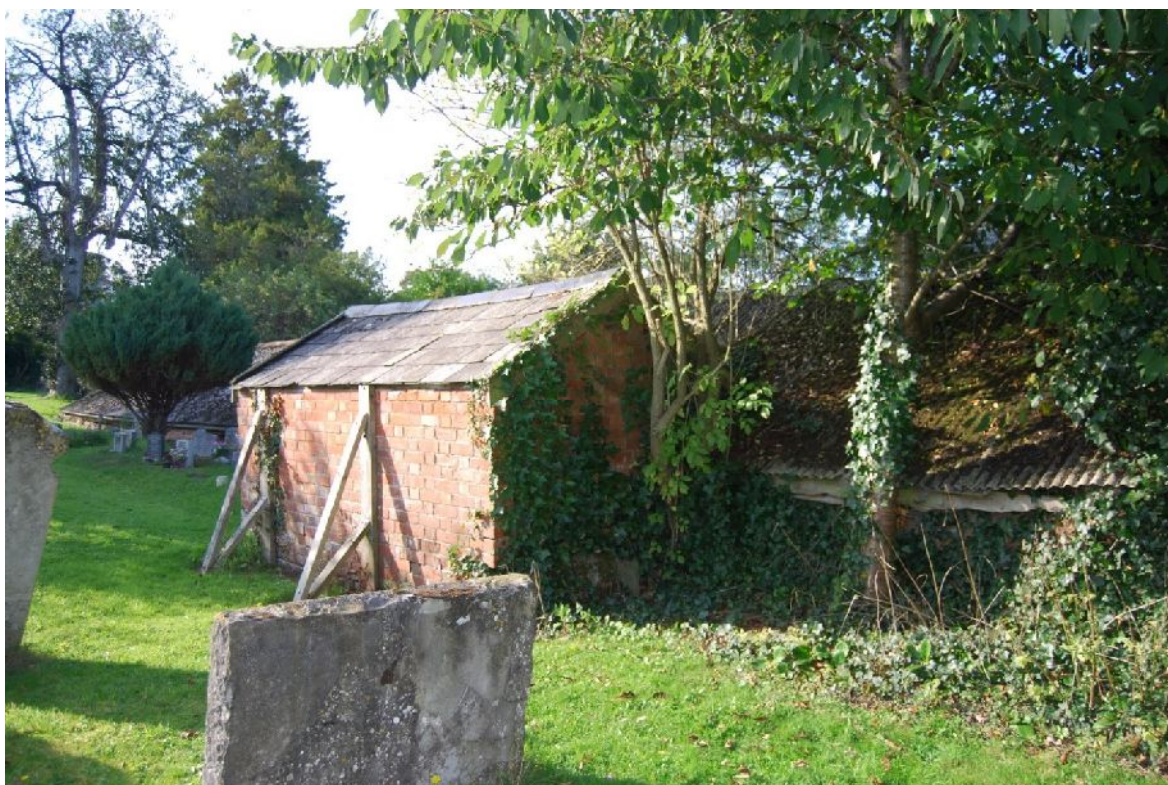
Plate 56. Graveyard outbuilding built on roof of B3 (from ESE)

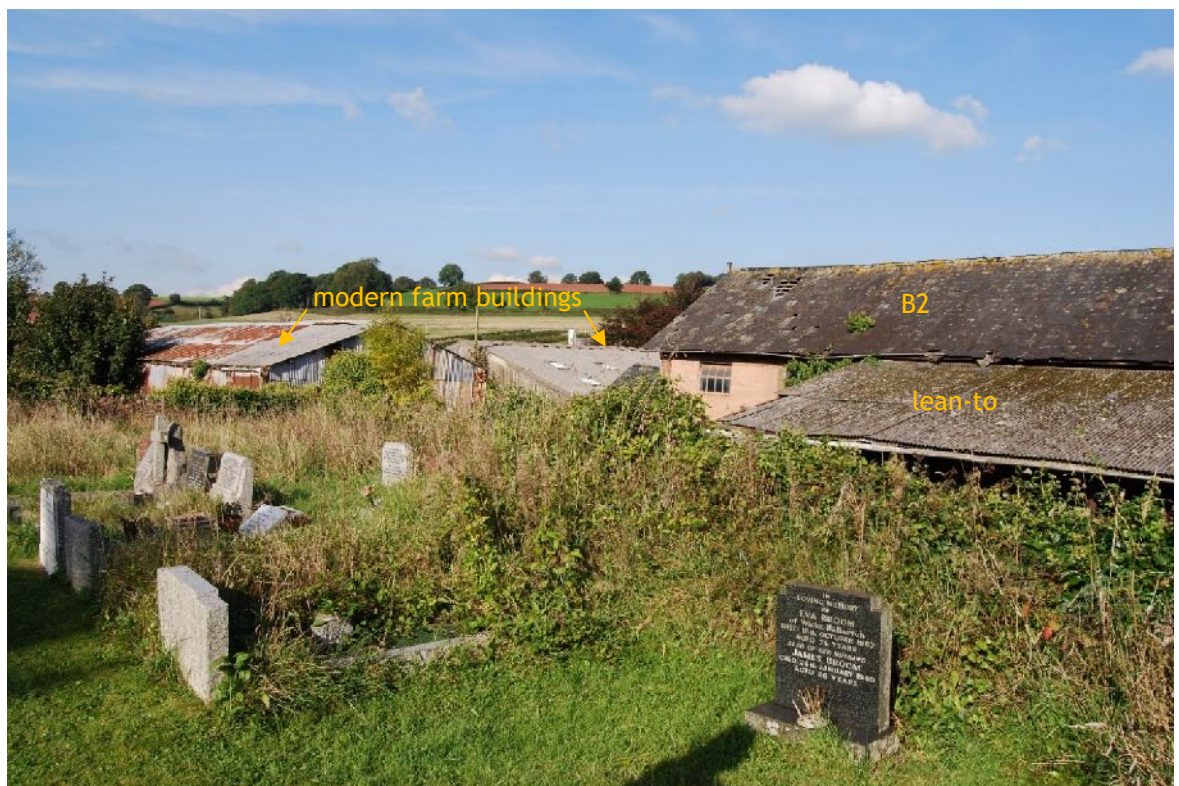
Plate 57. View from churchyard towards B2 (from SSW)

- 6.2 The removal of modern agricultural buildings would vastly improve the appearance and setting of the historic farm buildings. From St Andrew's graveyard the roofs of these structures would no longer create an eyesore and their removal would open up rural vistas to the north (**Plate 57**). Views from the graveyard would also be improved by the removal of the lean-to attached to the south-west elevation of the main barns. This would also restore the overall impression of a single very long barn overlooking the farmyard and forming a visual focus both within and outside of Halberton Court Farm. It is recommended that the ventilation structure which has been added to the roof of the southern part of the main barn (B1) is removed, together with the modern brick structures along the south-west elevation. This would restore the original roof line and south-west elevation so that the projecting porches regain their significance. The appearance of the barns would also be improved by rendering the modern brickwork at the northern end of B2 or re-building this section of the wall so it is more in-keeping with the rest of the building. Evidence of blocked openings should be retained and existing openings re-used. It is doubtful that roof lights will be permitted on the side of the roof looking towards the church. The scissor beam trusses are a key element in the appreciation of these buildings and if possible should be left visible.
