BARN, LAND EAST OF "ELLESMERE",
BACK WESTGATE, HORNSEA, EAST YORKSHIRE

ARCHAEOLOGICAL RECORDING

Report no: 2007/311.R03
Version: Final
Date: June 2009
Author: Shaun Richardson & Ed Dennison

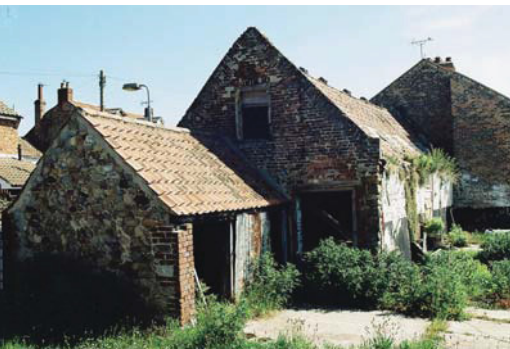
1-0.JPG

- 3.6 The barn is slightly sub-rectangular in plan, with the long walls running parallel to one another but set on a very slight curve, and the gables not quite meeting the long walls at right angles; this is probably a combination of poor original construction and subsequent instability which has resulted in some movement in the building (Gowers Bell Ltd 2006). The barn has maximum external dimensions of 14.85m east-west by 5.50m north-south. It is a tall single storey, with a steeply pitched pantiled roof, and there are six plastic tile skylights in the south roof slope, positioned to light cattle stalls in the interior (see below) (see plate 2). The roof ridge is punctuated by six salt-glazed ceramic vents. The only access to the interior of the barn at the time of the survey was through the doorway at the south end of the west gable. A small single storey structure adjoining the west end measures 4.90m east-west by 3.70m north-south, and this also has a pitched pantiled roof, although it is set much lower than the barn (1/00, 1/0, 4/03 and 4/04).

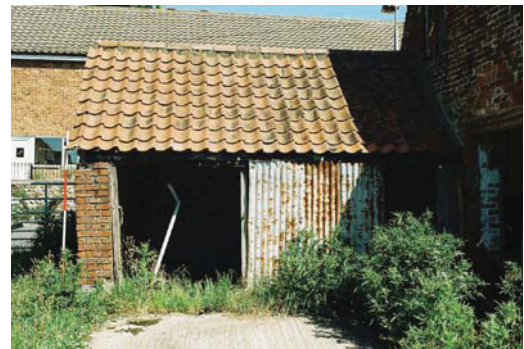
1-01.JPG

- 3.16 The interior of the small adjoining structure at the west end of the barn was largely empty at the time of the survey. There are doorways at the east and west ends of the south side, separated by a section of corrugated iron sheeting supported on timbers (1/01) (see plate 2); the corrugated sheeting blocks a six-barred gate, visible internally (2/07). On the west side of the west doorway, the south end of the west gable has been rebuilt in handmade red brick (4/06 and 4/07). The west doorway leads into the larger interior area, which is crossed by two common rafter roof trusses, of softwood and nailed construction throughout. These are of very similar form to those described within the barn, although the timbers are of smaller scantling and much more neatly sawn (2/09). The trusses are flanked by timbers laid across the wall tops. The east doorway leads into a small area separated from

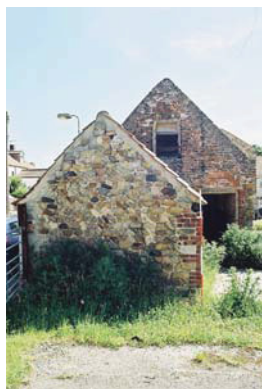
1-02.JPG

- 3.11 The west gable of the barn is largely obscured by the adjoining structure, although as has already been noted, the upper part is of tumbled-in brickwork, and contains a window opening fitted with a wooden frame (1/02 and 2/21). At its south end, a ground floor doorway provides the only access to the interior of the barn (see plate 2). This doorway is clearly a later insertion and is set within an area of brickwork comprising machine-made bricks very similar to those described above to the north elevation (4/05). It is fitted with a stable door of plank and batten construction (1/15 and 1/16). The west gable of the structure adjoining the west end of the barn is completely blank (2/21 and 2/22). The external face of the barn's east gable is completely hidden by the late 19th century house which is built up against it.

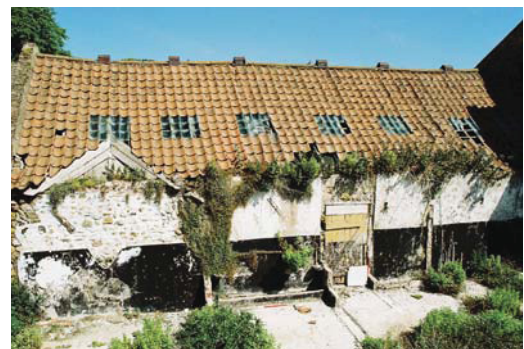
1-05.JPG

- 3.12 The original south external elevation of the barn was formerly covered by a lean-to beneath a catslide roof (1/05, 2/23 and 2/24); cartographic evidence suggests that this was built between 1854 and 1890. The roof shadow of the lean-to is still visible on the late 19th century house built up against the east end of the barn, showing that the lean-to itself post-dates the house (2/10). The interior of the lean-to was formerly plastered and painted the same as the interior of the barn (1/07). It measured c.9.80m east-west by 2.75m north-south externally but did not run parallel to the full length of the barn's south side, returning to the south at its west end to form a north-south range c.3.90m wide (east-west); the scar left by the removal of the north-south aligned roof ridge is still visible on the south roof slope of the barn (1/03 and 4/09). The lean-to also returned to the south at its east end, to run parallel to the east boundary wall of the farm (see below); both returns were also in place by 1892. The lean-to and both associated returns were floored with concrete, and contained concrete troughs (1/06 and 4/10) (see plate 3). They were arranged around a small yard to the south of the barn, covered over by 1911, and may well once have been open-sided to this yard. A cross passage through the lean-to led to the central doorway in the barn's south elevation, which is fitted with a plank and batten door; the lintel of the doorway is formed by a re-used timber from a building using pegged framed construction (2/03 and 2/04). The demolition of the lean-to has revealed a series of wall-tie plates along the south elevation, similar to those which survive on the barn's north elevation (1/08).

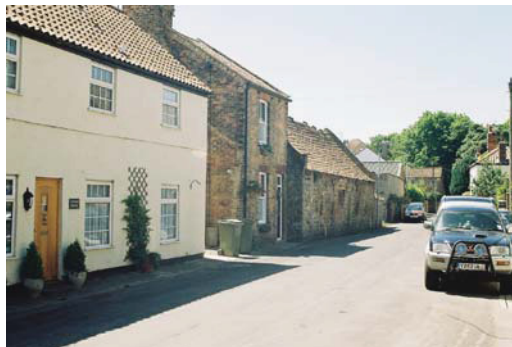
1-22.JPG

- 3.3 The single storey barn stands on the south side of Back Westgate, running parallel to the street frontage and fronting directly on to it (**1/22**, **1/23**, **2/25**, **4/21** and **4/22**) (see plate 1). Back Westgate is narrow and characterised by a relatively unspoilt mixture of 18th and 19th century properties, including single storey cobble cottages of early 18th century date placed parallel to the street frontage like the barn. Of these, Pevsner and Neave (1995, 479-480) highlight Sunset and Corner Cottages, formerly a single property, and note the rare survival of a single cruck blade to the north gable wall of Sunset Cottage, perhaps suggesting an origin pre-dating the early 18th century. Almost opposite the barn, the single storey brick and cobble Quaker Cottage also probably dates from the early 18th century (Pevsner & Neave 1995, 479-480).

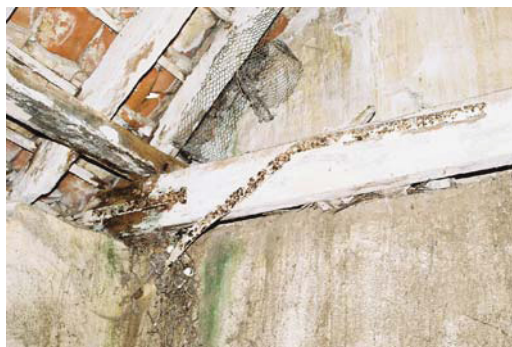
2-02.JPG

Plate 6: Brackets to later phase of roof timbers in barn, looking N (photo 2/02).
