ST GILES' CHURCH, BIELBY, EAST YORKSHIRE

ARCHITECTURAL AND ARCHAEOLOGICAL SURVEY

Report no: 2005/278.R01
Version: Final
Date: December 2009
Author: Ed Dennison & Shaun Richardson

St Giles' Church PCC
c/o Peter Gaze Pace Architects
The Old Rectory
Scrayingham
York YO41 1JD

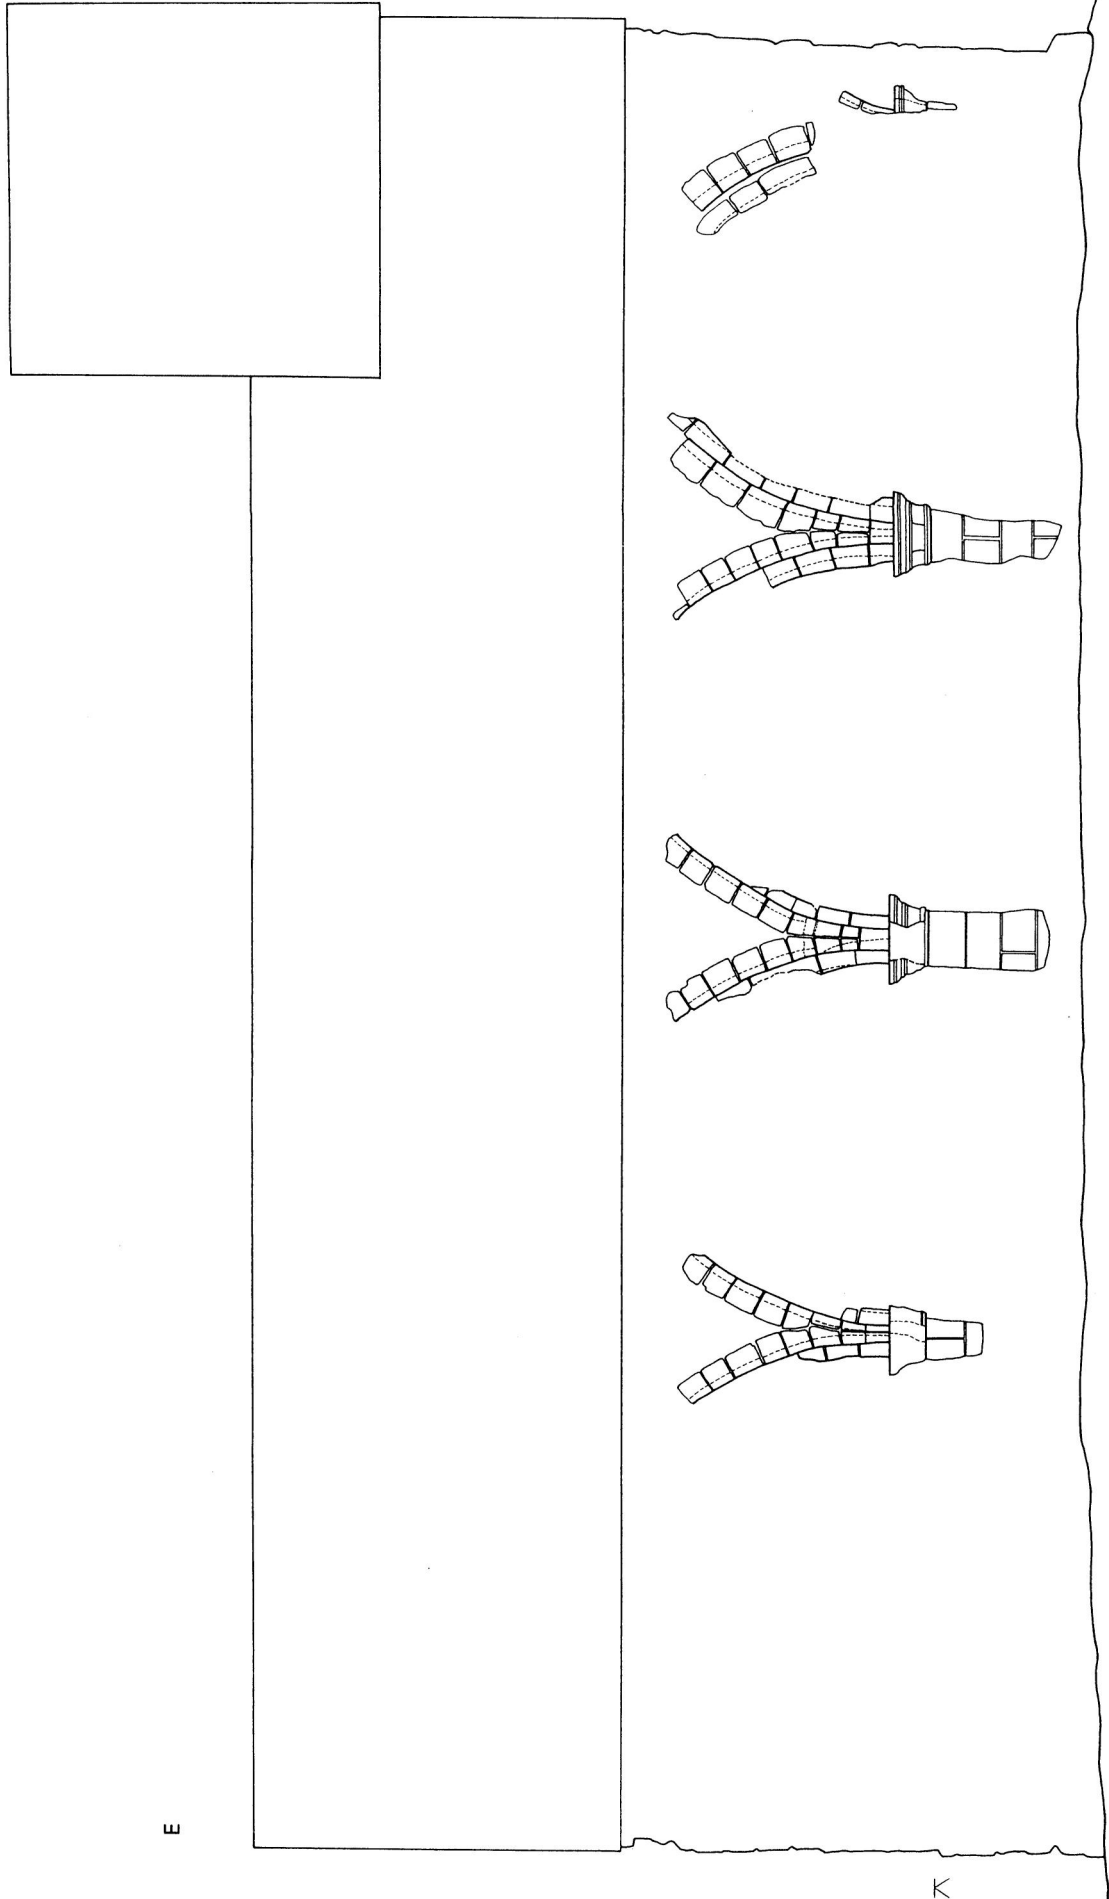
PROJECT	ST GILES' CHURCH, BIELBY		
TITLE	NORTH AISLE ARCADE FULLY EXPOSED		
SCALE	AS SHOWN	DATE	DEC 2009
EDAS		FIGURE	7

- 3.17 The principal feature of the elevation is the remains of the former north aisle arcade. Three full bays of the arcade survive, with the remains of a further bay at either end; the full bays have an average width of between 2.90m to 3.00m (from pier centre to centre). They once rose to pointed arches but have since been truncated; by extrapolating the curve of the surviving masonry, it might be estimated that the highest point of the arch's underside was set c.1.90m above the top of the capital. The double-chamfered arches spring from cylindrical piers (c.0.45m in diameter) of deep ashlar courses (see plate 7). Three of the piers are complete, and have moulded octagonal capitals; the fourth pier (at the very west end of the elevation and now largely concealed by a later buttress), is slightly taller than the other three, and the capital, while still octagonal, has both plainer moulding and a more deeply chamfered profile than the others (see figures 7 and 9). No pier bases were clearly exposed during the renovation works, although in Trench 2 (see below), a large sandstone slab was observed in the north wall beneath the second pier from the west end; the surface of the slab was set some 1.75m below the top of the capital, giving an approximate height for the piers. The 1967 Listed Building description notes that a "cylindrical respond to the west end" of the former north aisle was visible internally (see Appendix 2); this is presumably the westernmost pier noted externally, but it is no longer visible from the interior. The listing description also states that the remaining piers, by then hidden beneath plaster, were "painted". This presumably refers to a decorative scheme of historic interest, but no paint was observed on the remains of the arcade exposed externally. The stonework above the arcade is not markedly different to that used in the blockings below, although it is generally smaller.

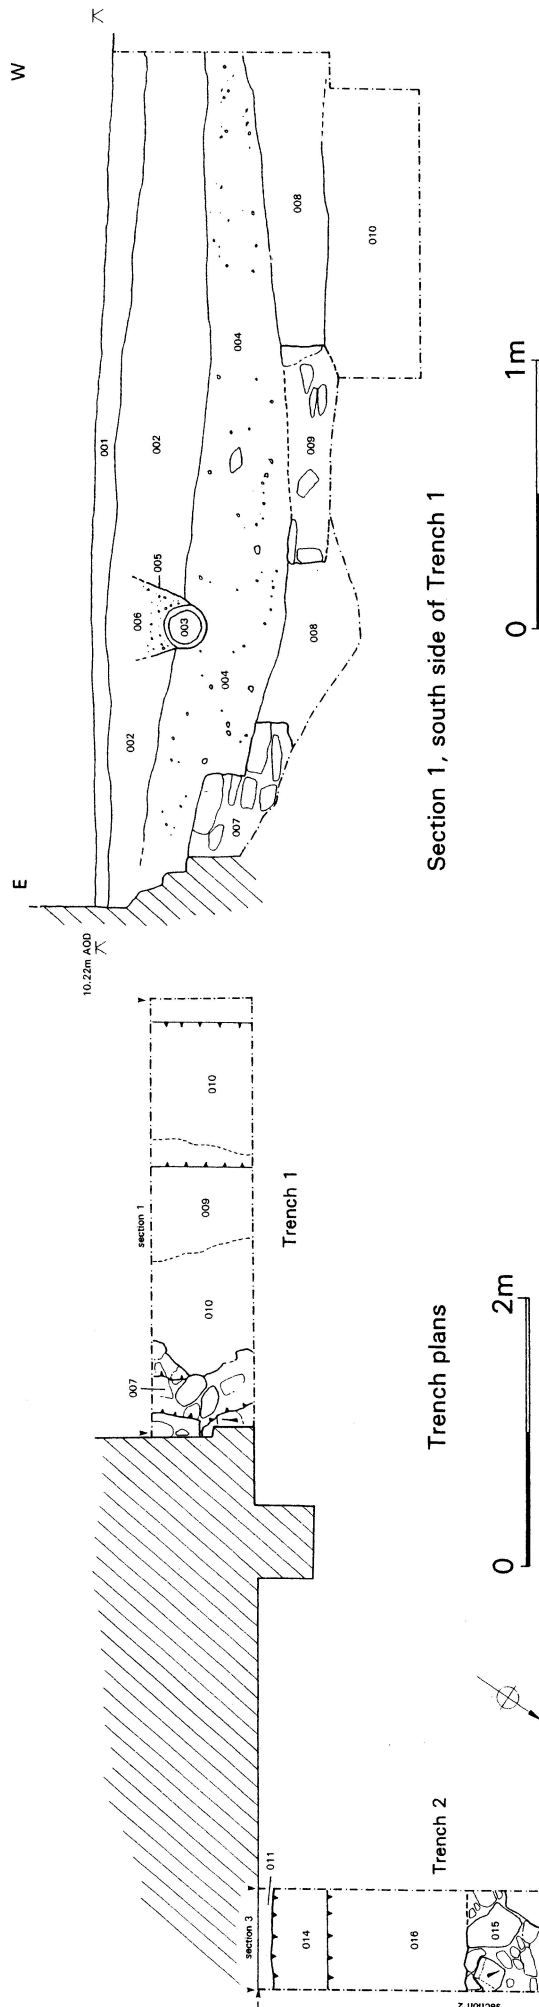
PROJECT	ST GILES' CHURCH, BIELBY		
TITLE	TRIAL TRENCHING RESULTS		
SCALE	AS SHOWN	DATE	DEC 2009
	EDAS	FIGURE	10

- 4.2 One trench (Trench 1) was dug west from the north-west corner of the church while another (Trench 2) was dug north from the north side of the church (see figure 10). Prior to the excavation, the ground level on the north side of the church lay at an average height of 10.34m AOD, sloping away at first gently and then more steeply towards the hedged boundary forming the north side of the churchyard. To the west of the church, the ground level lay at an average height of 10.22m AOD. A total of 18 archaeological contexts were recorded; these are all described in the following text as three digit numbers (e.g. 005) (see Appendix 1).

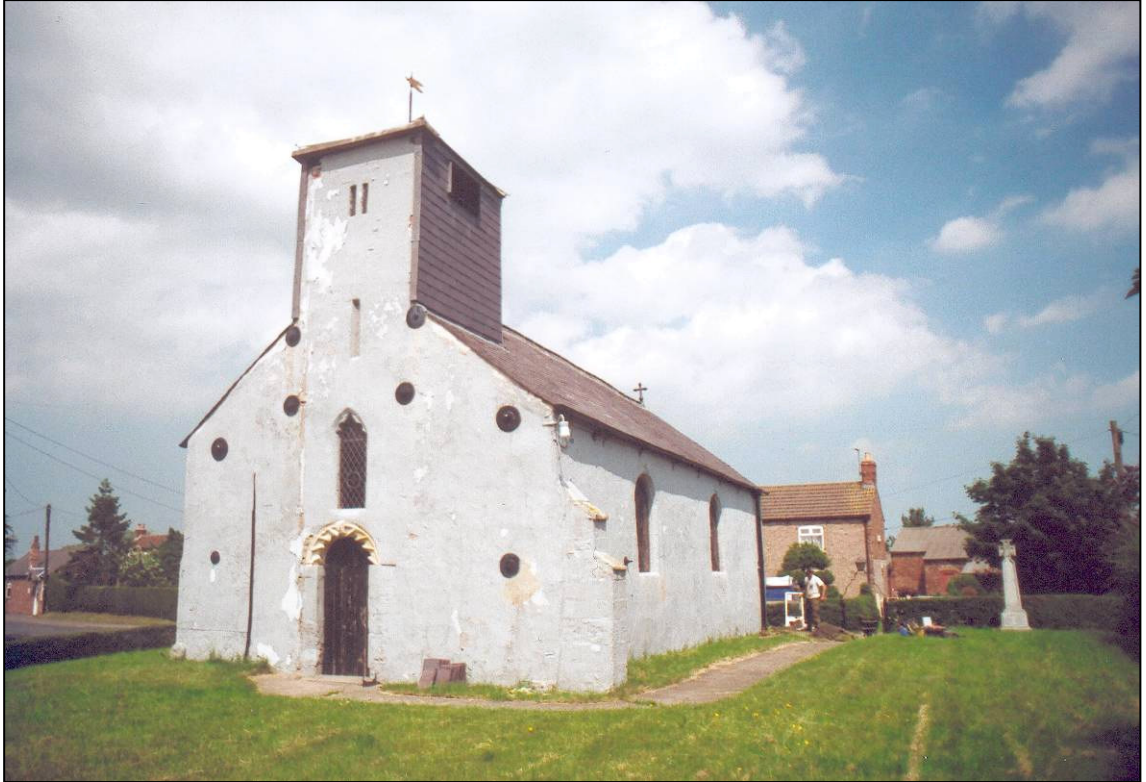
- 3.2 The church has a sub-rectangular single-cell plan, and comprises a five bay continuous nave and chancel, with bellcote over the west end (see plate 1); the long axis is orientated north-east/south-west, although for the purposes of the following description, it is considered to lie east-west. The existing church has neither aisles nor porches, although there was formerly at least one aisle (see below).

Plate 1: General view of church, prior to renovations, looking E.

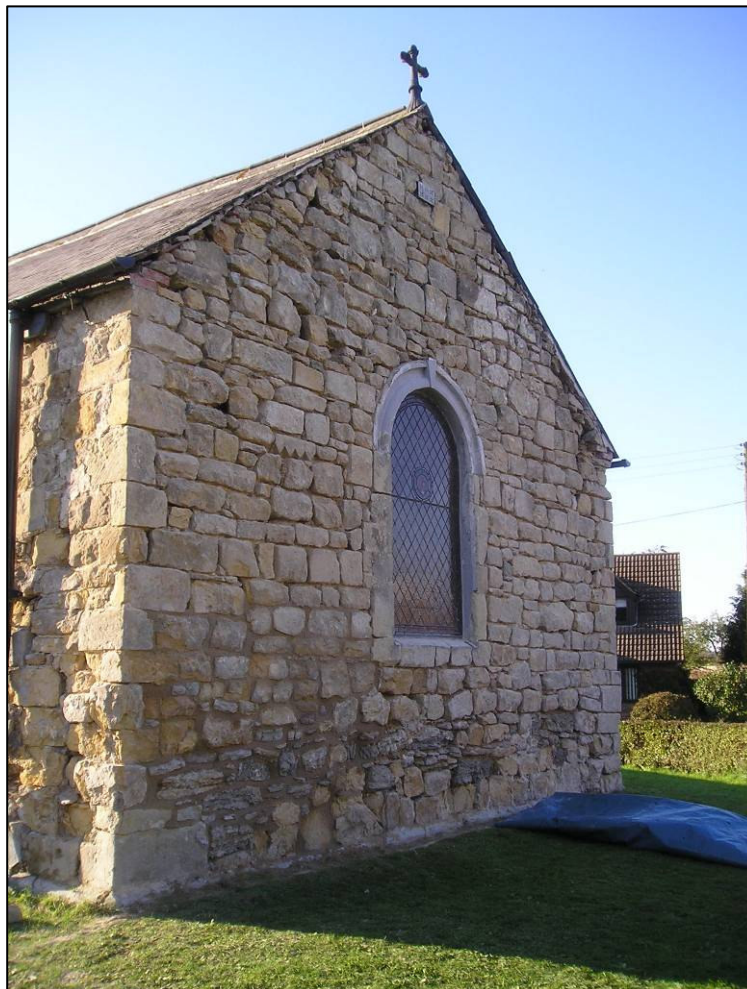
Plate 4: East elevation after removal of render and pointing, looking E.

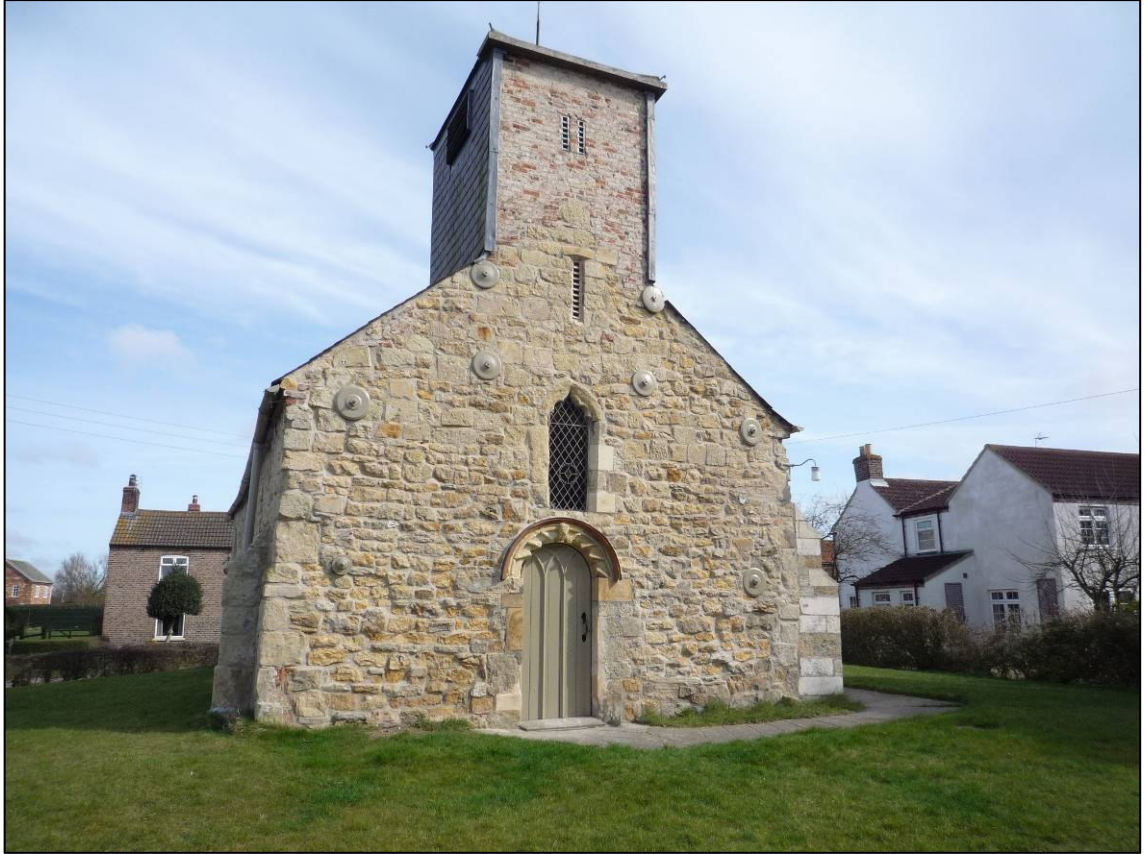
Plate 5: West elevation, renovations complete, looking NE.

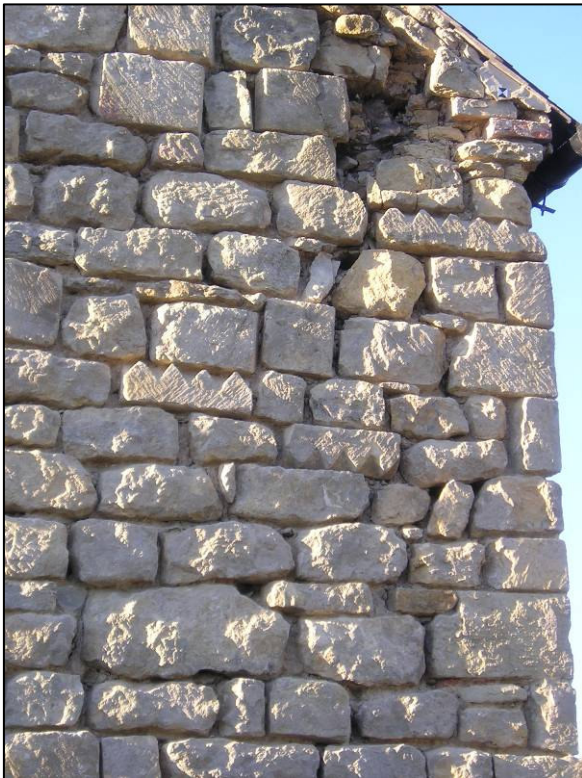
- 3.20 There are numerous re-used fragments incorporated into the east gable. To the south of the window, there is a piece of arcade stone, a chamfered jamb fragment, and the head/sill of a narrow window opening. To the north, there are three further chevron fragments and three chamfered jamb pieces (see plate 6). Three similar jamb pieces survive in the upper part of the gable, while immediately above the window, there is a small piece of stone with recessed ribbed triangular ornament. The gable is surmounted by a stone cross.

Plate 6: Detail of reused stonework in north side of east elevation, looking E.

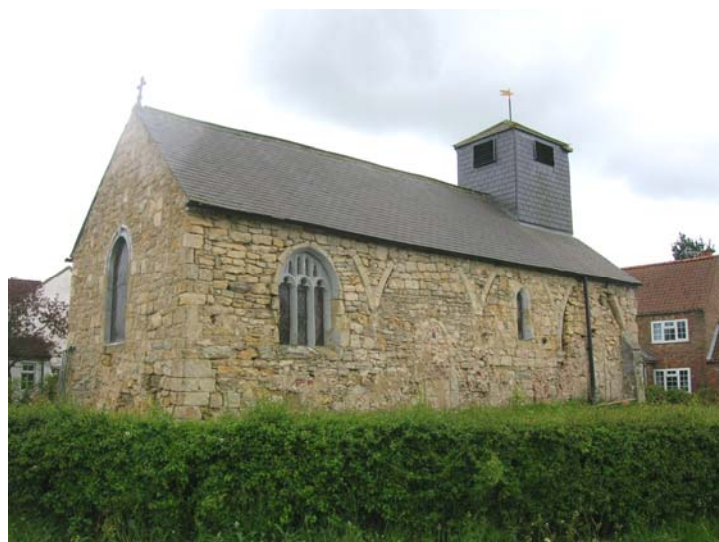
Figure 1:
St. Giles' church, North elevation,
showing evidence of alterations.

Features on the North elevation (see figure 1 above) make it clear that the configuration of the was different in the past and that it has since been down-scaled, for example the roof line appears to have been much higher and there is evidence of at least four large pointed arches, possibly leading to the North aisle which no longer exists. There are capitals and columns exposed to the North-West corner, however there is evidence that the other columns and capitals are also still in place, now blocked in to form the North external wall.
