AYTON CASTLE, WEST AYTON,  
NORTH YORKSHIRE:  
PHASE 1 REPAIRS

ARCHITECTURAL AND ARCHAEOLOGICAL RECORDING

Report no: 2005/263.R01  
Version: Final  
Date: October 2008  
Authors: Ed Dennison & Shaun Richardson

Scarborough Borough Council  
Property Services Department  
Town Hall  
St Nicholas Street  
Scarborough YO11 2HG

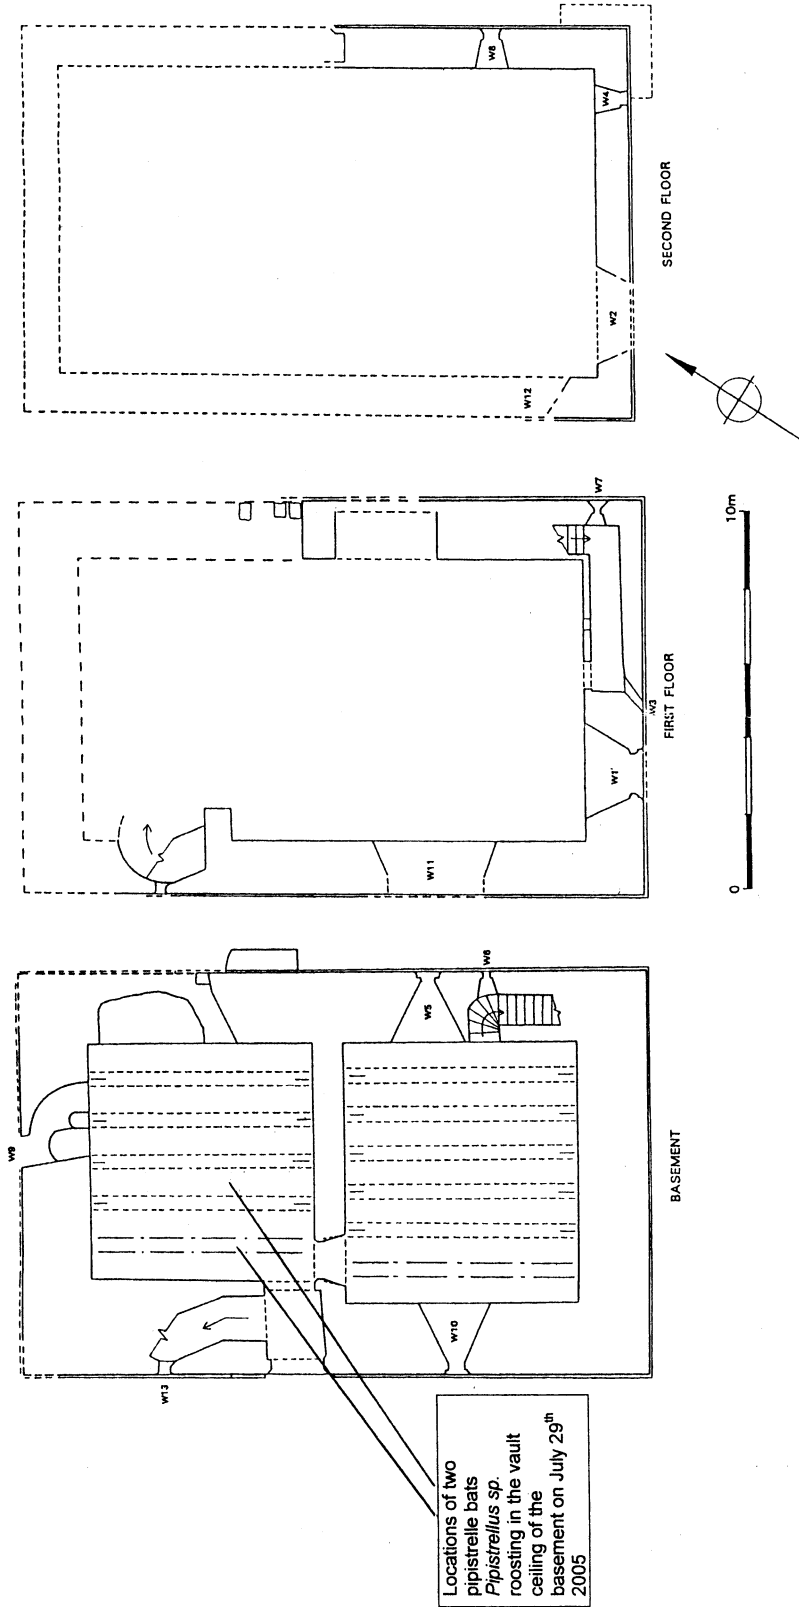
PROJECT		AYTON CASTLE	
TITLE		FLOOR PLANS	
DATE		NOV 95	
SCALE		AS SHOWN	
FIGURE		6

- 3.4.1 No signs of bats were recorded in any of the accessible external stonework of the castle. However, three pipistrelle bats *Pipistrellus sp.* were recorded roosting within the northern half of the basement (BHWB Figures 6 and 11). Two pipistrelles were located between the vault stones of the basement roof (BHWB Figure 6), whilst a third one was located between the vertical stones of the south elevation (BHWB Figure 11).

Locations of two pipistrelle bats *Pipistrellus sp.* roosting in the vault ceiling of the basement on July 29<sup>th</sup> 2005

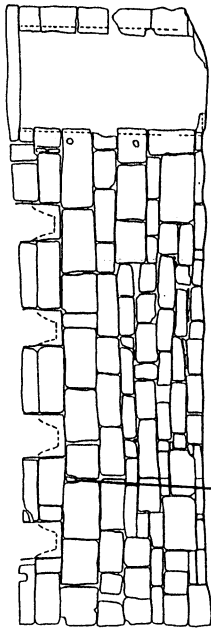
SOUTH ELEVATION

Location of a  
pipistrelle bat  
*Pipistrellus* sp.  
roosting in the wall of  
the south elevation on  
July 29<sup>th</sup> 2005

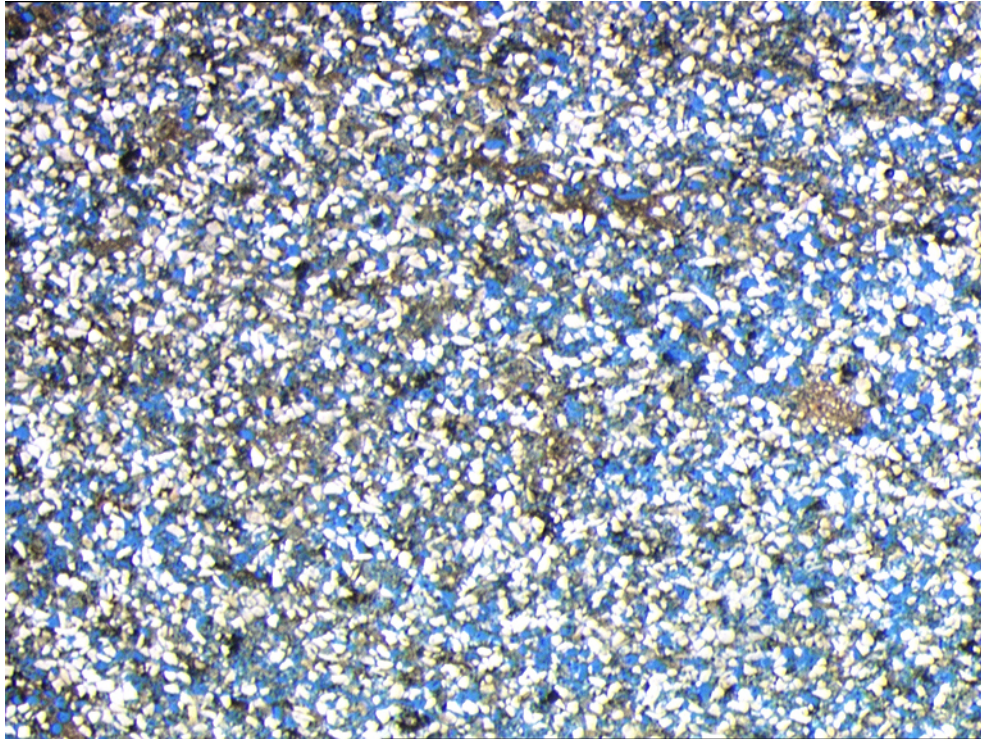
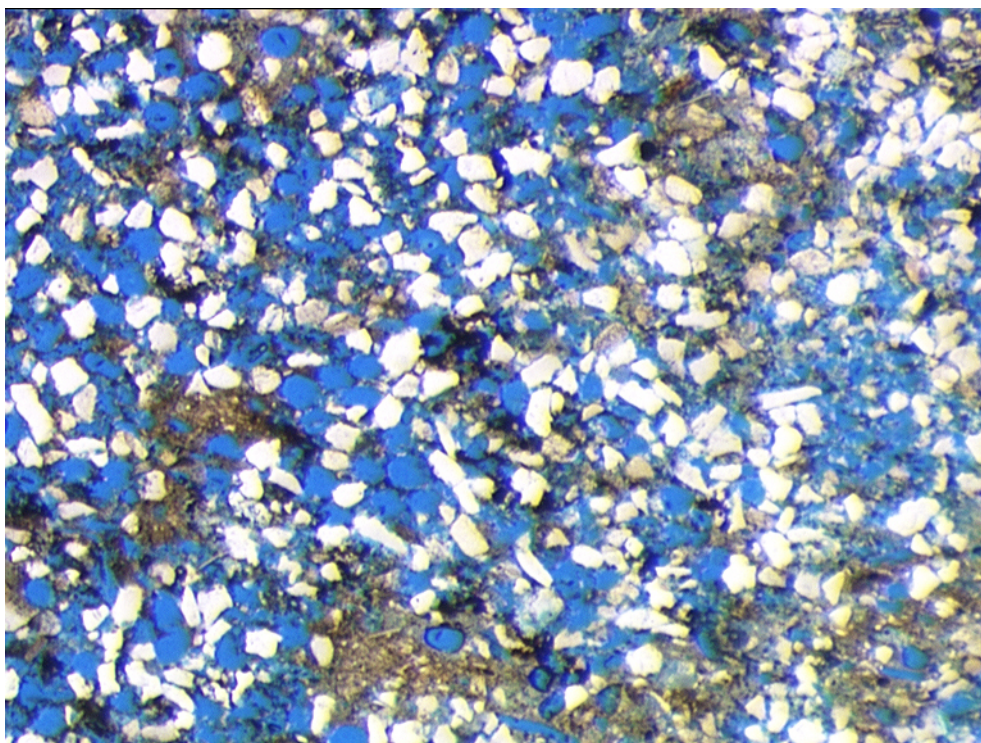
Photomicrograph Sample 1 (Field of view 8mm left to right)

Dominated by very fine sub-angular to sub-rounded detrital siliciclastic grains, with abundant evidence of bioclastic grains in a porous, muddy calcareous matrix. The siliciclastic grains (white in photomicrographs) dominantly comprise monocrystalline quartz, potassic and leached sodic / calcic feldspars and sparse muscovite mica grains. The bioclastic framework grains originally comprised siliceous spheres (spicules) derived from the decay of marine sponges. The weathering of the sandstone has, however, largely leached away these siliceous spicules leaving only open spheroidal pore spaces (*now infilled with blue resin*). The biogenic silica that formed the original skeletal material in these spicules is markedly more soluble than detrital silica and therefore more easily removed by weathering or during burial diagenesis.

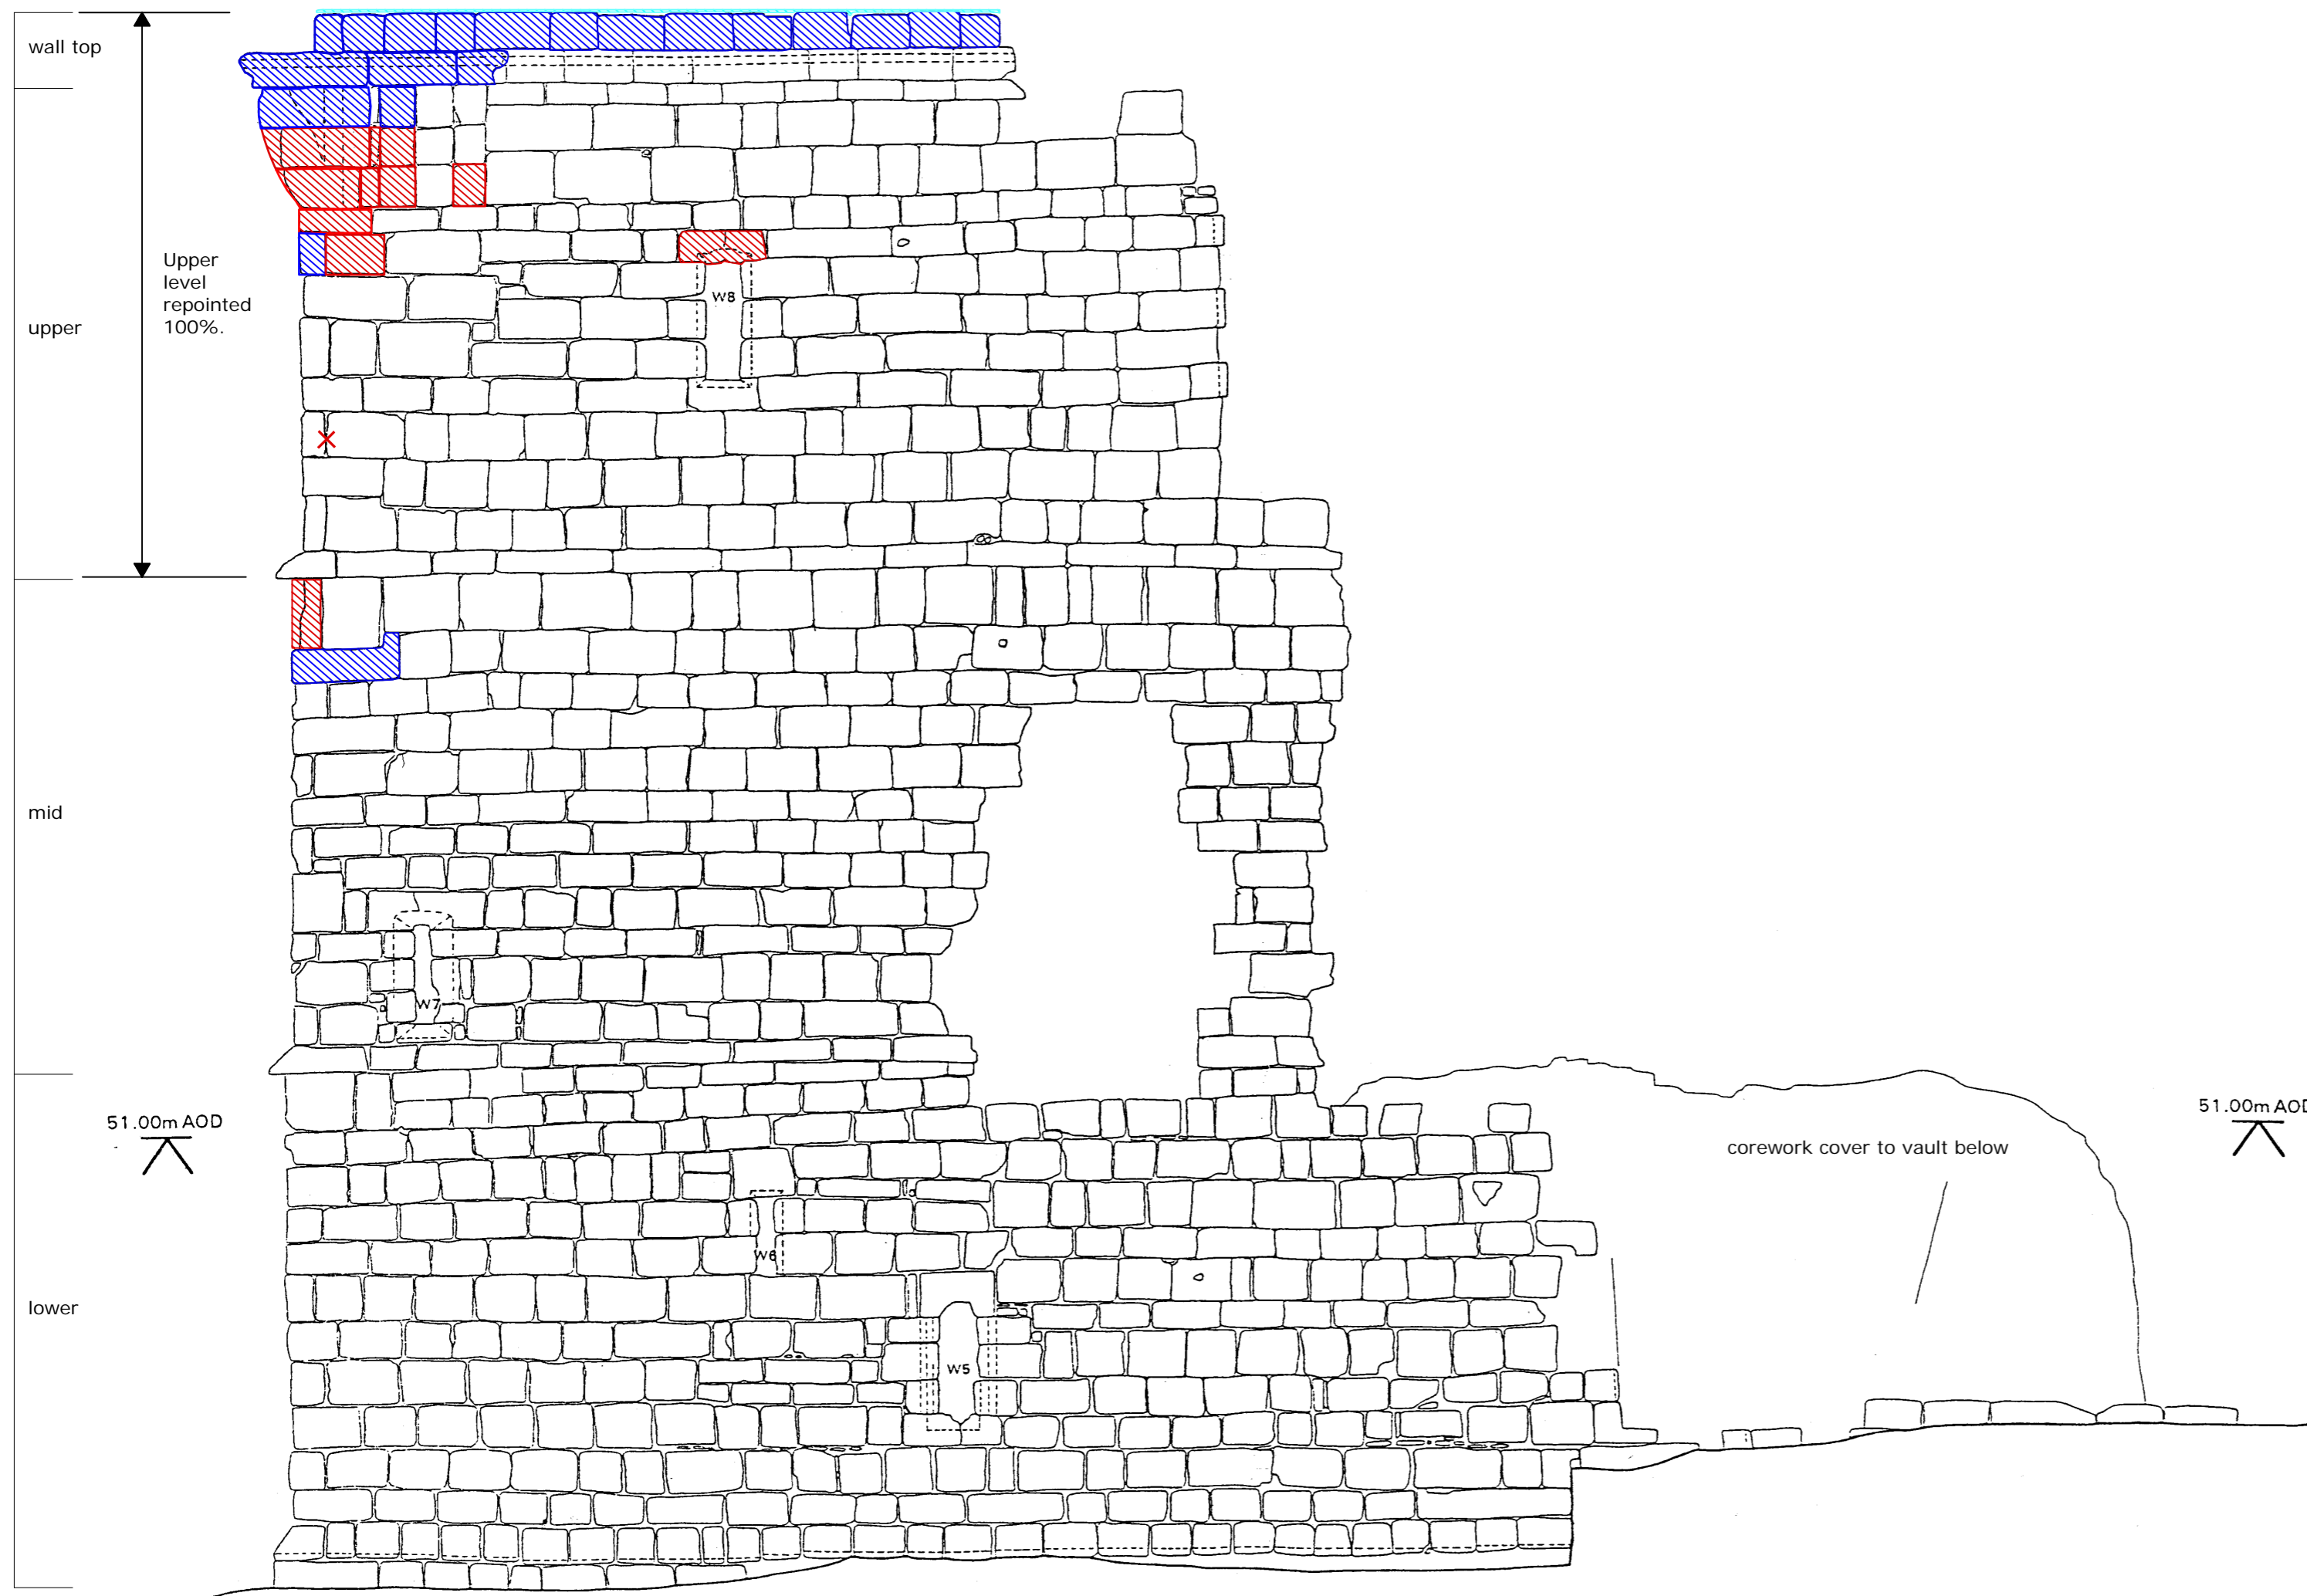
In general, the masonry of this elevation appeared to be in slightly better condition than the south and west sides.

- X Open joints retained for bats
- M Mason's mark
- - - Area of corework rebuilt
- [Red hatched box] Stone carefully cut out and renewed using stone from Lowther's Cragg Quarry, nr Whitby
- [Blue hatched box] Stone re-bedded to consolidate
- [Cyan hatched box] Wall top consolidated using reclaimed stone and 1:3 NHL3.5 sand mortar
- [Green hatched box] Re-built masonry - stones reclaimed from site
