CART SHED AND BARN, WHARRAM PERCY FARM,  
WHARRAM PERCY, NORTH YORKSHIRE

ARCHITECTURAL AND  
WILDLIFE SURVEY

Report no: 2009/354.R01  
Version: Final  
Date: March 2010  
Authors: Shaun Richardson & Ed Dennison

The Birdsall Estates Company Ltd  
Estate Office  
Birdsall  
Malton  
North Yorkshire YO17 9NU

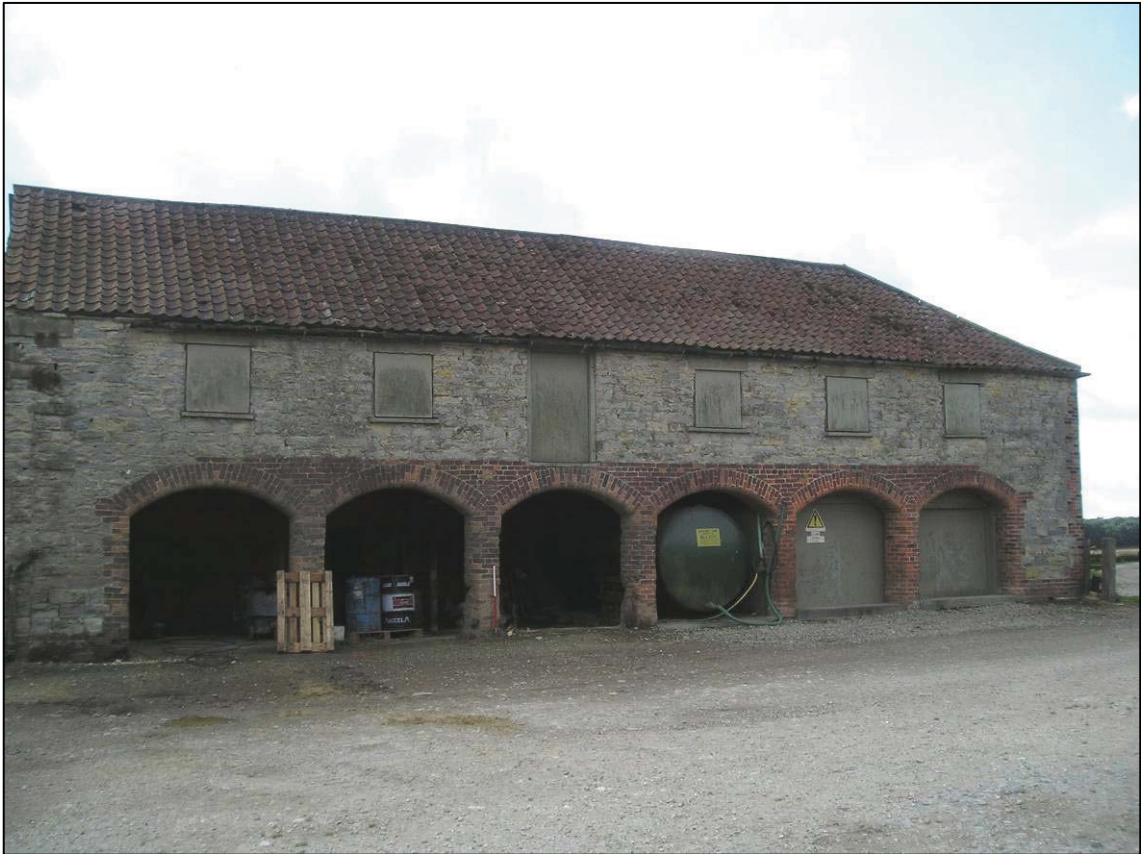
Plate 1: North elevation of cart shed, looking SW (photo 3/89).

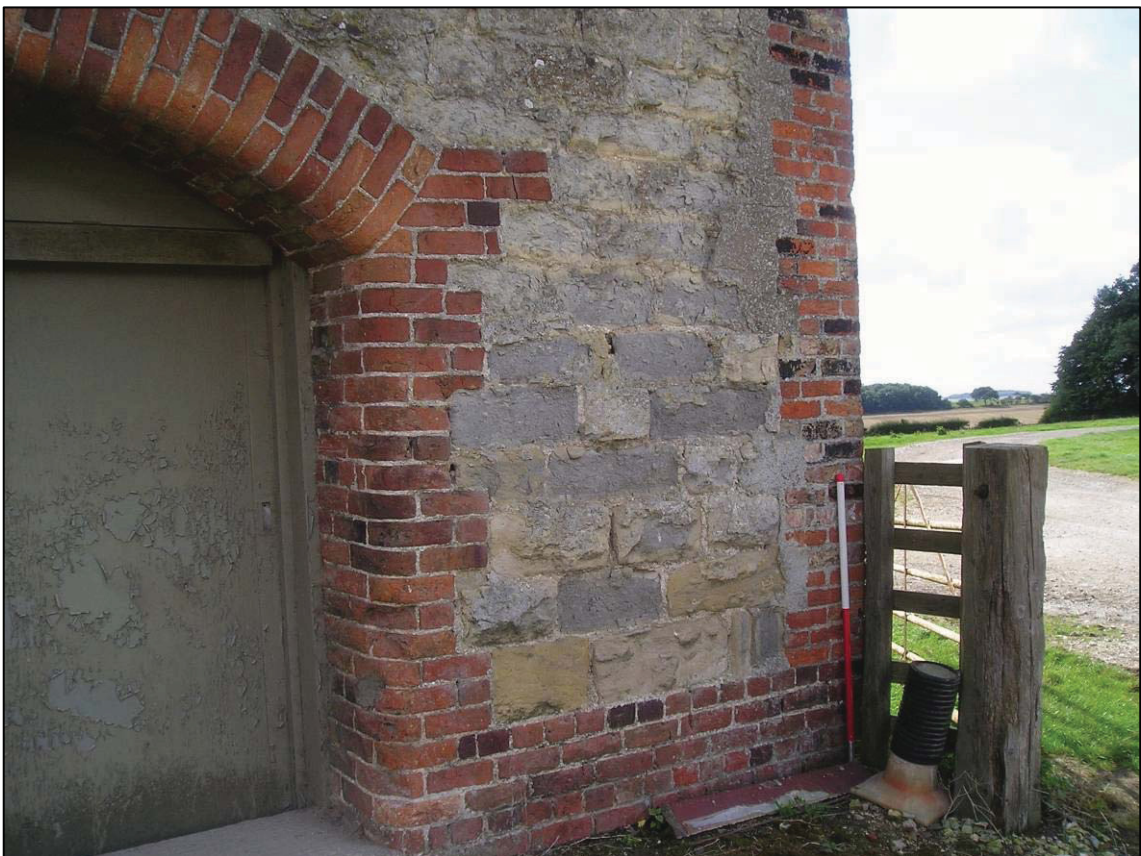
Plate 2: Brick quins and arch detail in north-west corner of cart shed, looking SW (photo 3/92).

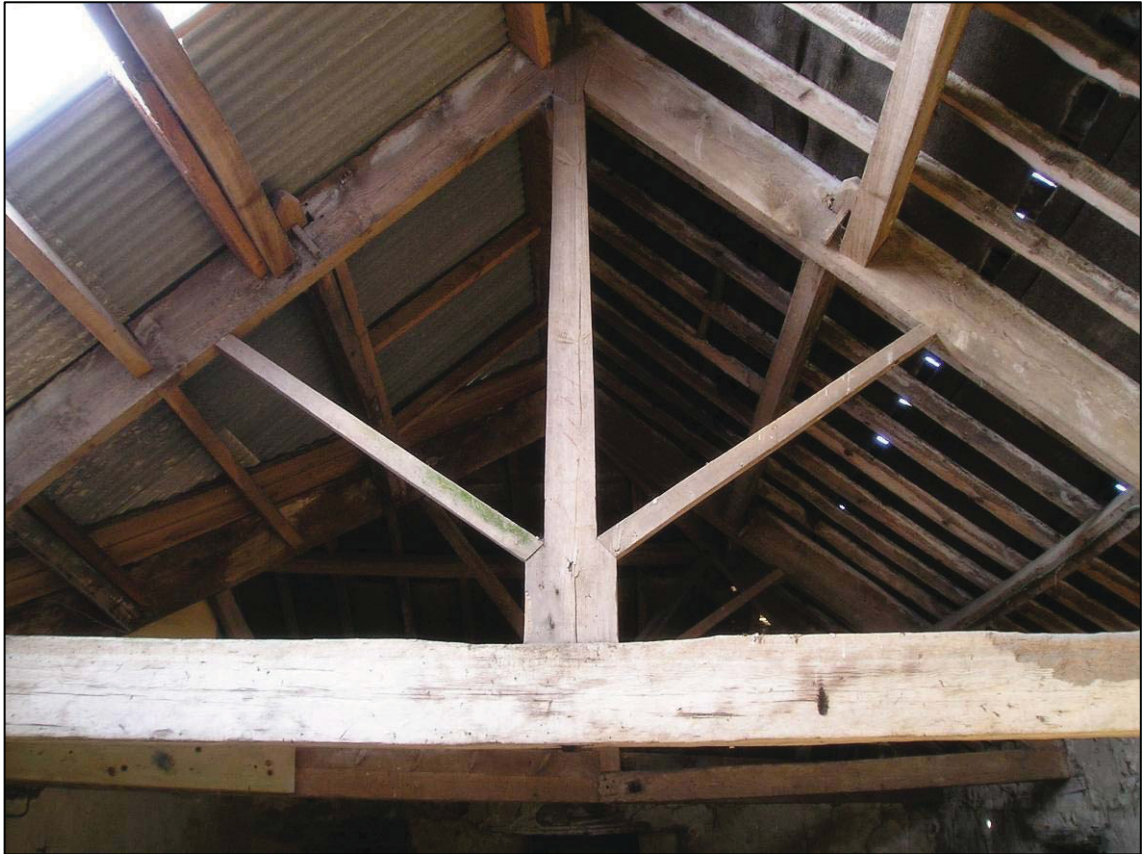
- 3.18 The first floor is crossed by six roof trusses, spaced at equal centres, and are virtually all of the same king-post form (see plate 3). The slightly tapered king-post has a symmetrically joggled foot, and is through-bolted to the tie-beam [3/56 and 3/57] (see figure 6). Raking braces rise from the foot of the king-post to the principal rafters; each principal supports a pair of staggered purlins with keyed through-tenons and there is a plank ridge-piece to the roof apex. The westernmost truss is slightly different in that it has to support the hipped west end of the roof. It is therefore set at a 45 degree angle to the north-west corner of the first floor, with subsidiary half tie-beams, principals and braces bolted to the main parts of the truss [3/50, 3/51 and 3/52].

Plate 3: Typical roof truss in cart shed, looking W (photo 3/57).

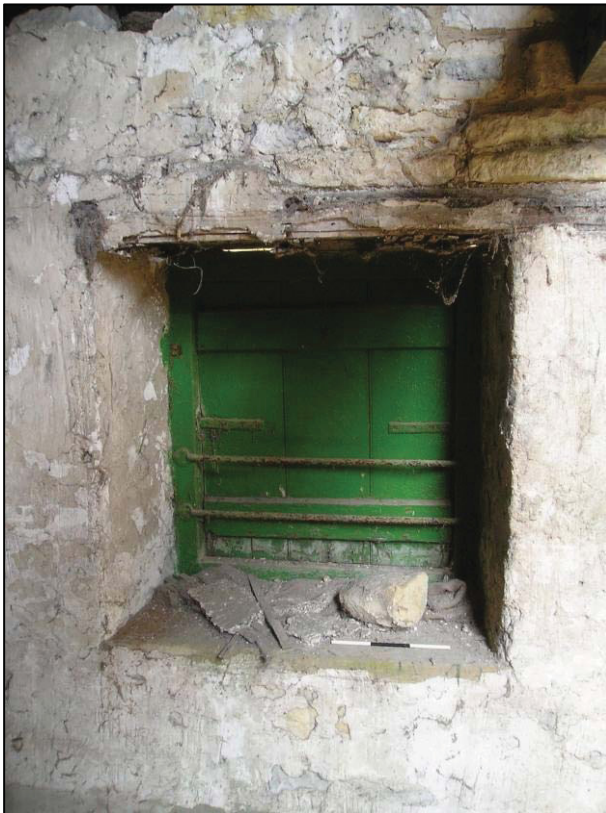
Plate 4: Internal detail of typical window, first floor of cart shed (photo 3/49).

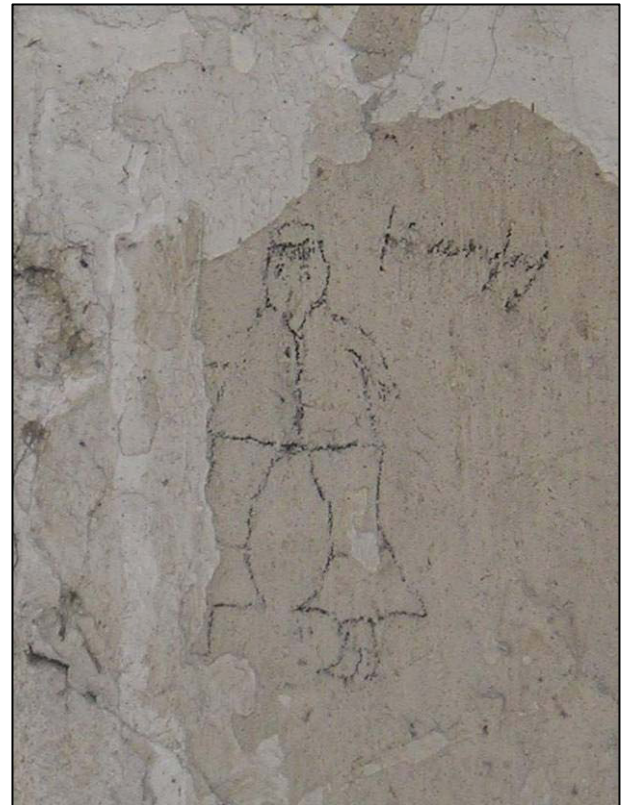
Plate 5: Horse lad sketch graffiti ("Humphrey") on north wall, first floor of cart shed (photo 3/67).

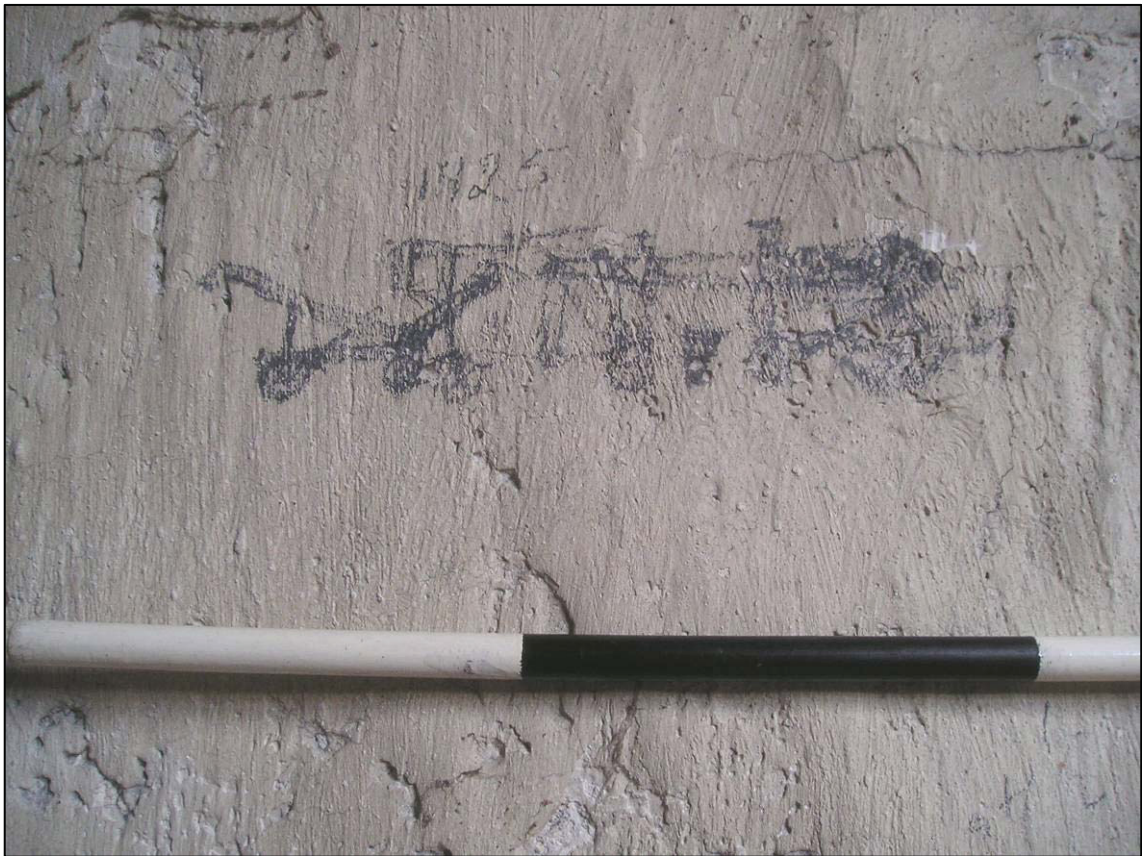
- 3.16 The written and sketched graffiti is listed below, commencing at the west end of the north wall. Between the first and second windows, there is a single column of figures together with a sketch of a traction engine driving a threshing machine and straw elevator, dated 1925 [3/64 and 3/65] (see plate 6). There are more column figures between the second and third windows, together with “Barley” and “Oats” and accompanying tally marks over the third window. The barley tally numbers ten, expressed as the traditional four vertical lines with a single diagonal line struck through them, but the oats tally numbers thirty, expressed as two vertical lines with a single diagonal struck through them [3/68]. Between the third and the fourth window, there are column figures, the name “Thos” and a sketched figure entitled “Humphrey” [3/66 and 3/67] (see plate 5); the form of his outfit, particularly the trousers, suggest that this a portrait of a horse lad, similar to that recorded elsewhere on the farm (Giles & Giles 2007, 341-342). There is no graffiti around the doorway, but between the fourth and fifth windows there is a small sketch of a heavily laden wagon and a foaming tankard entitled “The Pint”, as well as some illegible writing [3/69, 3/70 and 3/71]. There is a partially surviving sketch of another wagon to the east of these [3/72].

Plate 6: Sketch graffiti of threshing machine and elevator, dated 1925, on north wall, first floor of cart shed (photo 3/64).

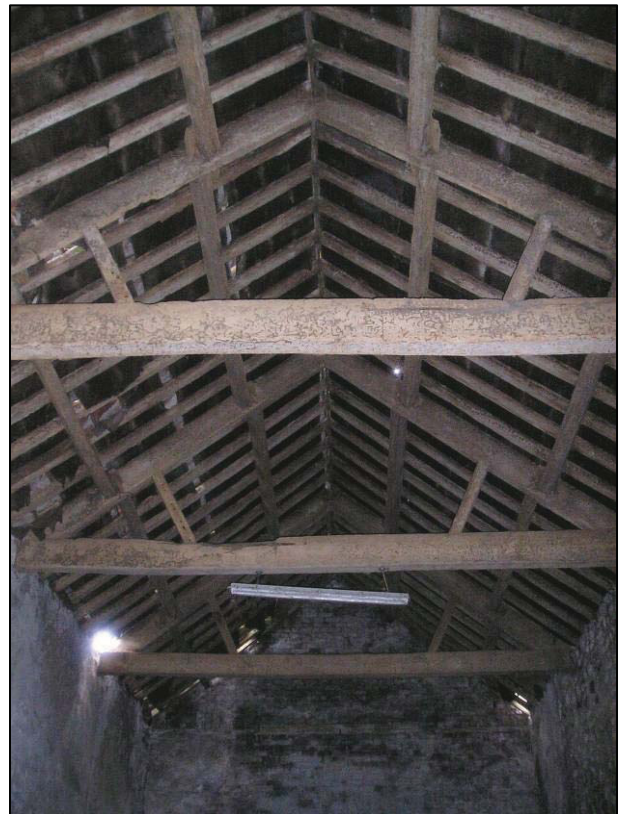
Plate 10: Roof trusses in barn, looking S (photo 3/25).

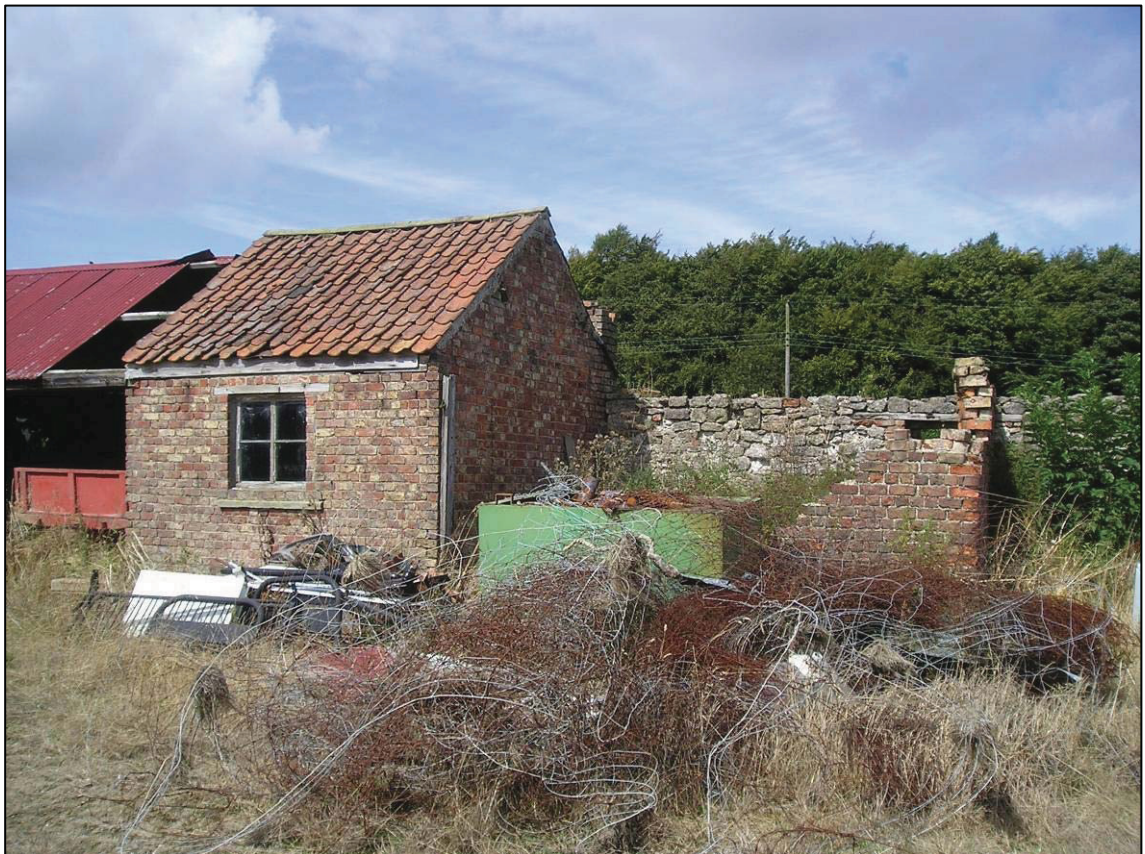
- 3.40 The principal elevation of the farmhouse faces south [3/107] and, as might be expected, has received the highest degree of architectural treatment. The north elevation facing onto the farm area is plainer and also somewhat longer with more fenestration [3/99]. There are a wash-house and outbuildings to the west, partly housed within a single storey lean-to shown in 1855. As previously noted, the farmhouse is a Grade II Listed Building (see Appendix 3).
- 3.41 A small square structure used until the late 1990s as a home by the Wold Ranger stands at the north-east corner of the large open yard to the north of the farm complex. It is a single storey brick structure with a pitched pantiled roof and a doorway in the west gable, and is lit by a window in the south wall [3/116 and 3/117] (see plate 12). It is built onto or partly incorporates a now ruinous structure,

Plate 12: Wold Ranger's house (roofed), looking N (photo 3/117).
