BARN, NORTH-EAST OF HALL FARM COTTAGE,
MAIN STREET, HORKSTOW, NORTH LINCOLNSHIRE

ARCHITECTURAL AND
WILDLIFE SURVEY

Report no: 2009/362.R01
Version: Final
Date: April 2010
Authors: Shaun Richardson & Ed Dennison

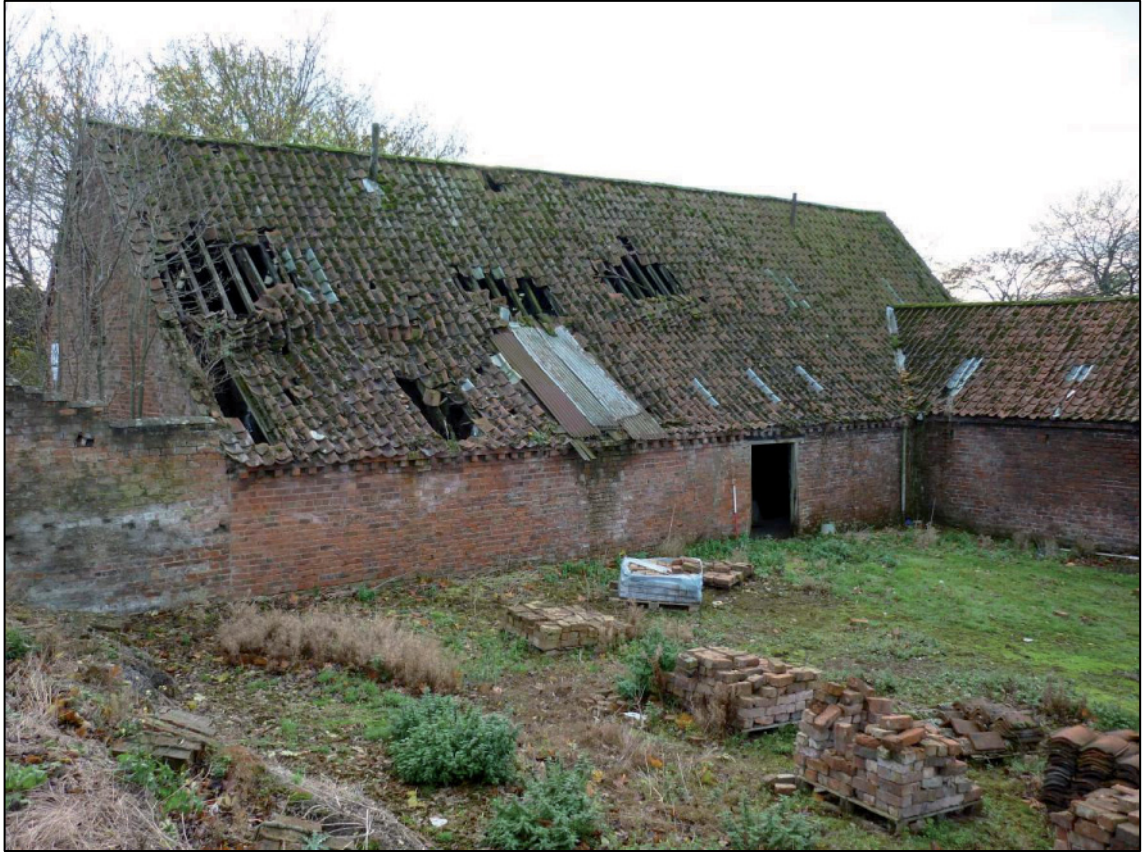
Plate 1: North elevation of barn, looking SW (photo 1/328).

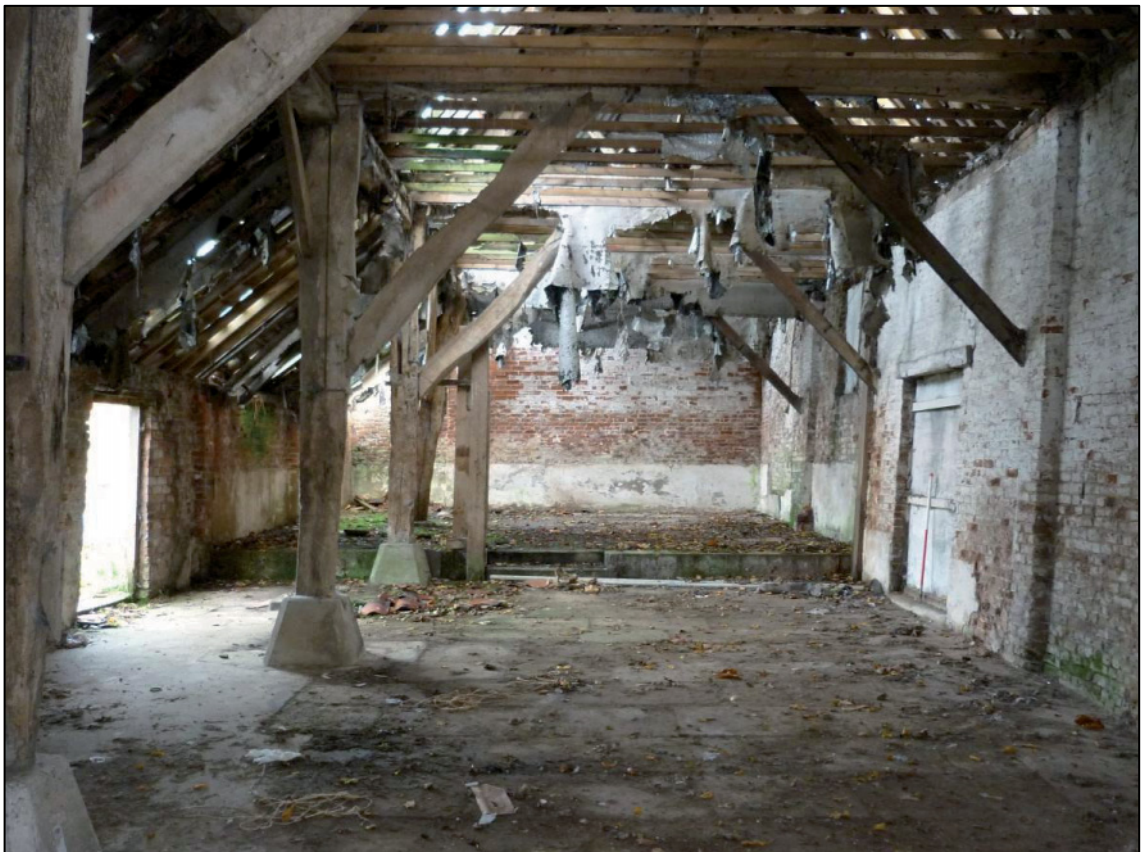
- 3.12 The interior of the barn retains a substantial frame [1/422 to 1/425] with a north aisle [1/420], comprising four trusses dividing the building into five bays of approximately equal length (c.4.20m east-west), although the central bay is slightly narrower (see plate 4). All the bays are of a similar width (c.4.70m north-south) while the aisle is 2.20m wide. The trusses are numbered 'I' to 'IIII' from west to east, using incised marks usually located at the joint of the post and brace to the

Plate 4: Interior of barn, looking E (photo 1/422).

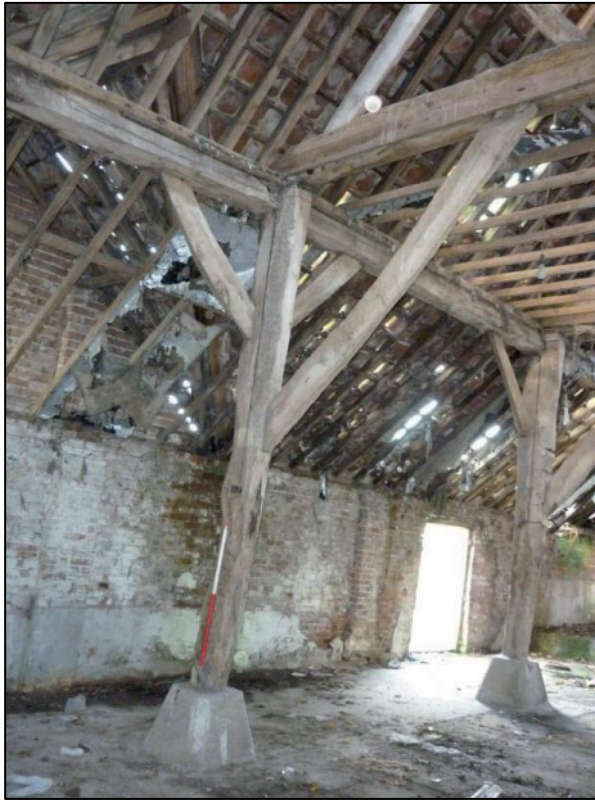
- 3.13 All trusses are of similar form, using 'normal assembly' (Alcock *et al* 1996; Grenville 1997, 36), and are of pegged construction throughout, using round-section pegs driven from the fair or upper face as defined by the incised numbering [1/386]. All older parts of the trusses are of hardwood, probably oak, with some later softwood alterations/additions (see below). The north arcade post only survives to each truss; the arcade posts may originally have been placed on stone stylobates but the feet are now encased in chamfered concrete bases (see plate 5). At their feet, the posts have average measurements of 0.20m east-west by 0.35m north-south, but they increase in scantling towards their slightly splayed heads. There is a long, gently curvilinear brace rising from the post to the cambered tie-beam, with shorter, more steeply-angled braces from the post to the arcade plate; the arcade braces are absent from the central bay to formerly allow cart access and there is no structural evidence to suggest that they were ever present. The south end of each tie-beam is supported by a straight softwood brace rising from the south wall.

Plate 5: Brace, post and tie-beam of truss I, looking NE (photo 1/386).

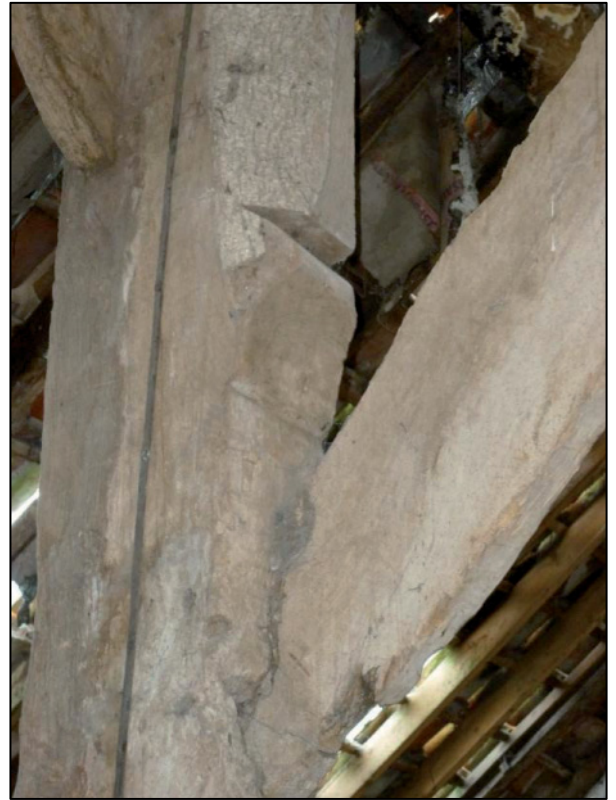
Plate 6: Moulding to south face of post of truss II, looking NE (photo 1/397).

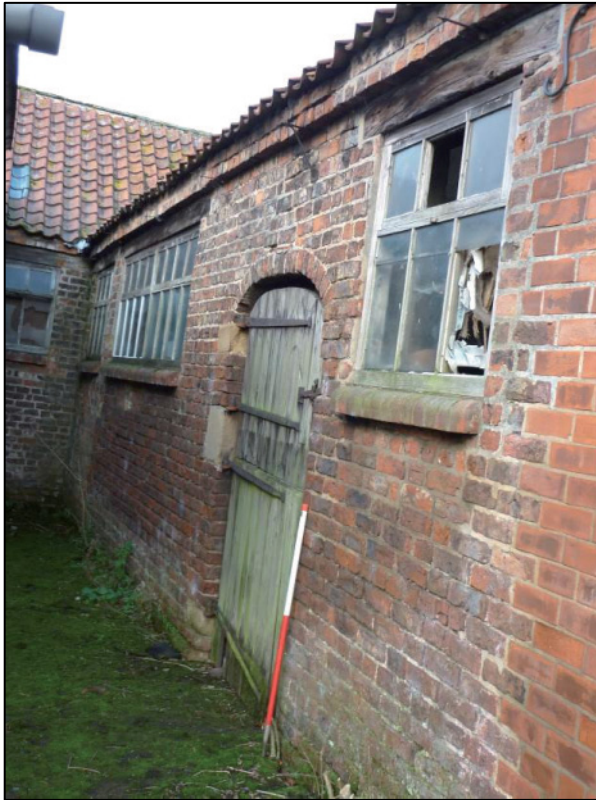
Plate 8: West elevation of stable, looking N (photo 1/362).

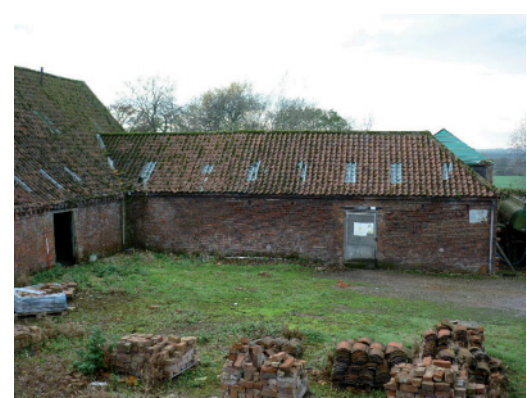
1-329.JPG

- 3.23 The east elevation of the stable is largely blank, broken only by a doorway towards the north end giving access to the north cell [1/329] (see plate 7). The brickwork within this elevation is laid in a distinctive bonding pattern, with three stretcher courses to a course of alternating paired headers and paired stretchers, rising to slightly projecting eaves. The eaves are carried around to the north elevation [1/337] but the bonding pattern is not; despite being built from the same bricks, the north elevation is laid in a variation of English garden-wall bond (two or three stretcher courses to each header course). Projecting bricks at the north-east corner of the stable mark where a modern wall formerly ran to the north. The north elevation has a ventilated window opening to the centre with a depressed arched head [1/338] while at the west end is the passage which marks the limit of the structures recorded during the current survey [1/339]. The doorway forming the

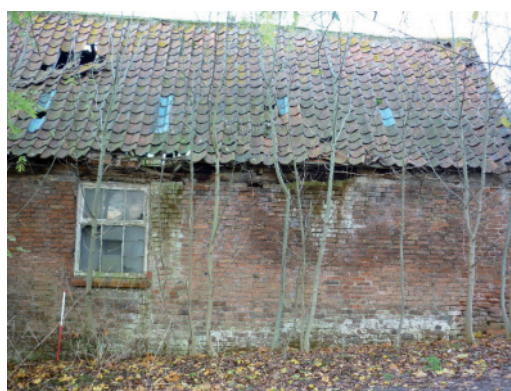
1-350.JPG

- 3.9 The south elevation is divided into three parts by two 20th century brick buttresses which have been placed opposite two of the trusses of the internal timber-frame (see plate 2). To the east of the east buttress [1/350], the brickwork has the same irregular bonding as seen to the east gable, although the bricks are smaller and more closely resemble those used in the north elevation to the west of the doorway. There is a window with a cambered head and projecting brick sill, fitted with a 6-pane casement frame, while above the wall-plate is exposed, particularly at this western end [1/352 and 1/357]. The appearance and dimensions of the wall-plate indicate that it is likely to comprise at least part of the former south arcade plate, re-used here, and a stop-splayed scarf joint is visible in this part [1/356]. The scarf joint has the number 'IIII' scored across it, the same number as used on the truss nearest to it in the interior, although the scarf cannot be seen internally (see plate 3); in addition, the timber either side of the scarf appears different, suggesting that at least two separate timbers have been joined together. There are also likely to be other scarf joints in the wall plate which cannot at present be seen. Between the two buttresses [1/353 and 1/354], the elevation is built of similar brickwork with the same irregular bonding pattern. Within this part, there is a doorway with a depressed arched head, retaining a plank and batten stable door mounted on long strap hinges. To the west, a blocked diamond-shaped breather is visible, and above this a small hatch doorway fitted with a plank and batten door. At the west end of the elevation, beyond the western buttress, there is a second blocked diamond-shaped breather [1/358 and 1/359]. However, the brickwork within which the breather is set (occupying approximately the entire area between the western buttress and the end of the elevation) is quite different to the rest of the elevation - the bricks are similar but they are neatly laid in a distinctive Flemish bond variant of three stretchers/one header/three stretchers to each course, with the headers in alternate courses being vertically aligned. The brickwork is apparently similar to that used in the adjacent farm house to the south, and may be either a contemporary repair or an 'enhancement' of that part of the barn that was close to the house.

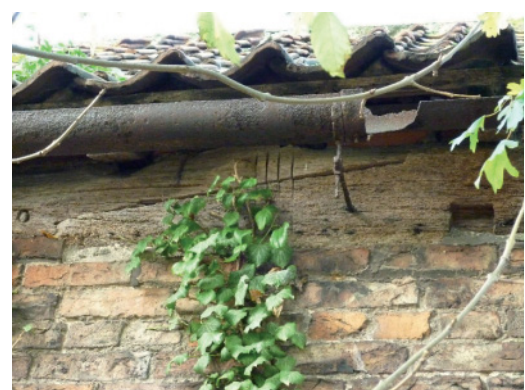
1-356.JPG

Plate 3: Exposed scarf joint to wall plate, south elevation of barn (east end), looking N (photo 1/356).

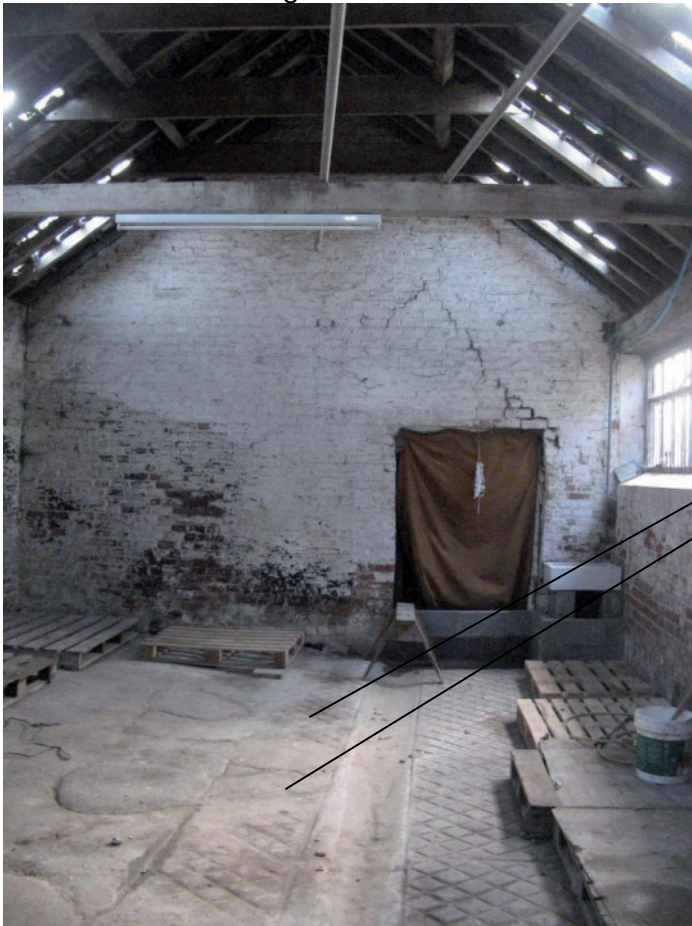
Plate 4 Stable B – main room looking from north to south - location of three bat droppings on the floor below the ridge beam

2.5.21 Nevertheless, three relatively old bat droppings were recorded on the floor below the central ridge beam in the southern half of the main room. The indication was that bats had temporarily roosted during the summer months between the ridge beam and red pantiles of Stable B at the locations shown in Drawing No. 1 and Plate 4. In addition, occasional butterfly wings of both tortoiseshell *Aglais urticae* and peacock *Inachis io* (which are eaten by Brown long-eared bats *Plecotus auritus*) were also noted on the stone floor.

Location of three
bat droppings on
the floor below
the ridge beam

3. Caution should be applied to all dismantling procedures with any cavities beneath the roof coverings, timbers and walls of the buildings checked for bats as the work proceeded. In particular, the contractor should be made aware of the possibility of bats roosting between the ridge beam and red pantiles of Stable B at the locations shown in Drawing No. 1 and Plate 4. It is essential that the contractor is also aware of what action to take should roosting bats be found i.e. that a Licensed Bat Worker should be immediately notified and all work stopped. However, if works are timed to take place when bats are at their least vulnerable (refer to No. 2) then any bats temporarily roosting within the ridge beam of Stable B (if any) should be able to disperse 'naturally' without any interference. If this is not the case, the torpid bats should be carefully transferred, by the Licensed Bat Worker, from the roost into one of the Schwegler bat boxes in the nearby vicinity.
