GRIMWITH HOUSE, GRIMWITH RESERVOIR,  
APPLETREEWICK, NORTH YORKSHIRE

ARCHITECTURAL ASSESSMENT

Report no: 2010/371.R01  
Version: Final  
Date: January 2011  
Author: Shaun Richardson & Ed Dennison

Yorkshire Dales National Park Authority  
Yoredale  
Bainbridge  
Leyburn  
North Yorkshire DL8 3EL

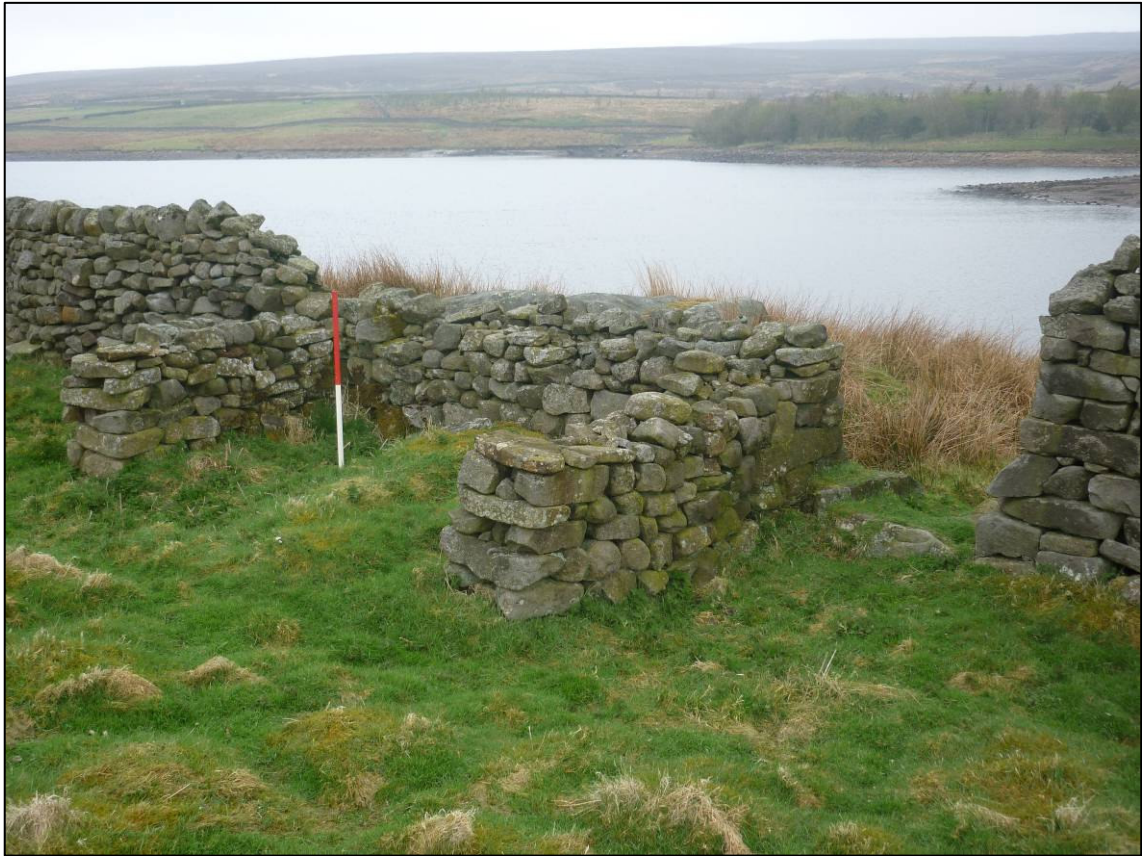
Plate 3: Structure in north enclosure wall, looking NW (photo 1/317).

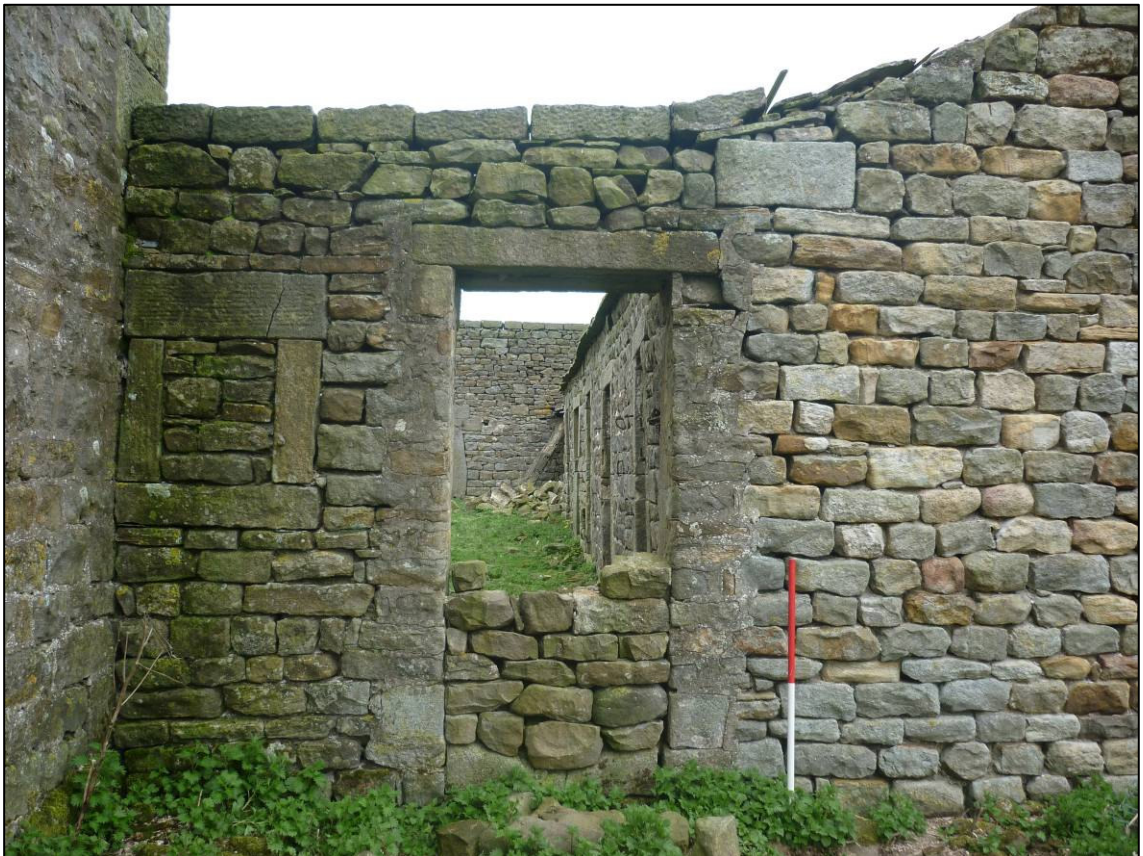
Plate 6: Doorway and blocked window in yard wall between east range and barn, looking N (photo 1/346).

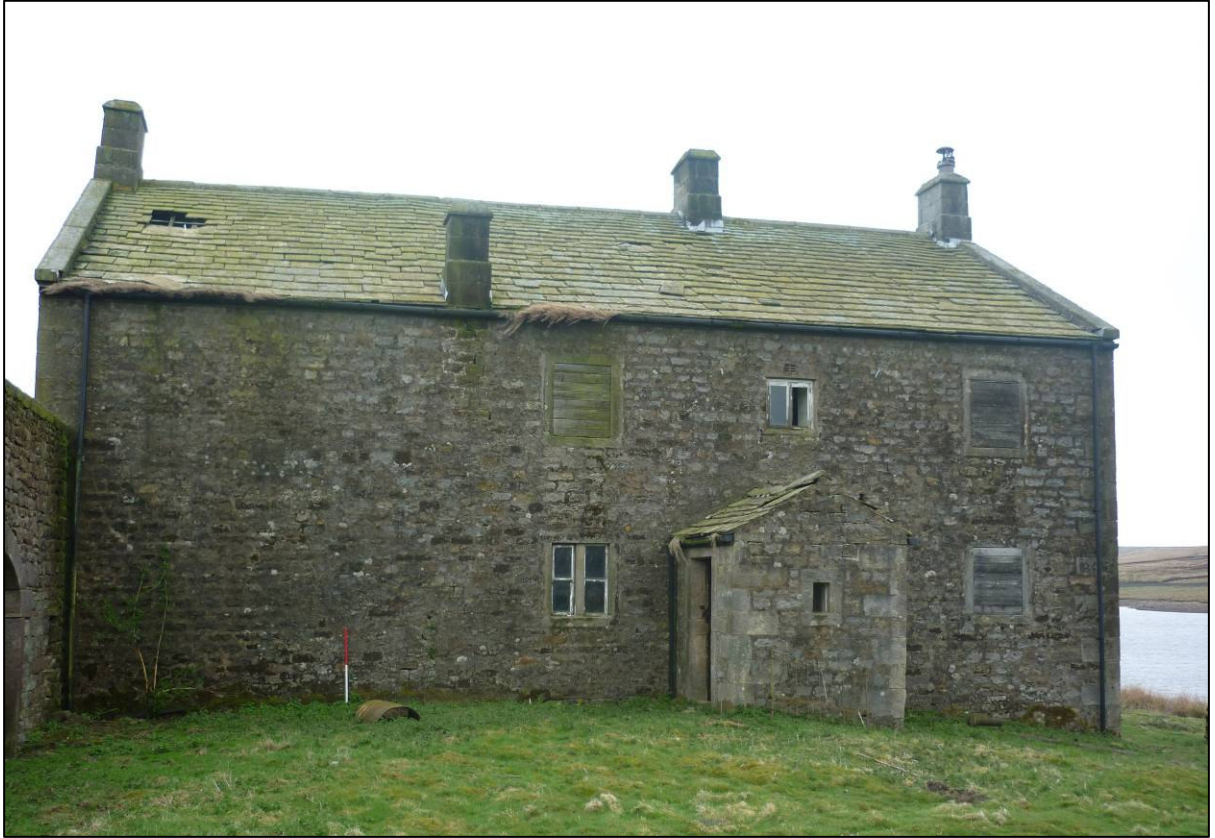
Plate 7: East elevation of house, looking W (photo 1/357).

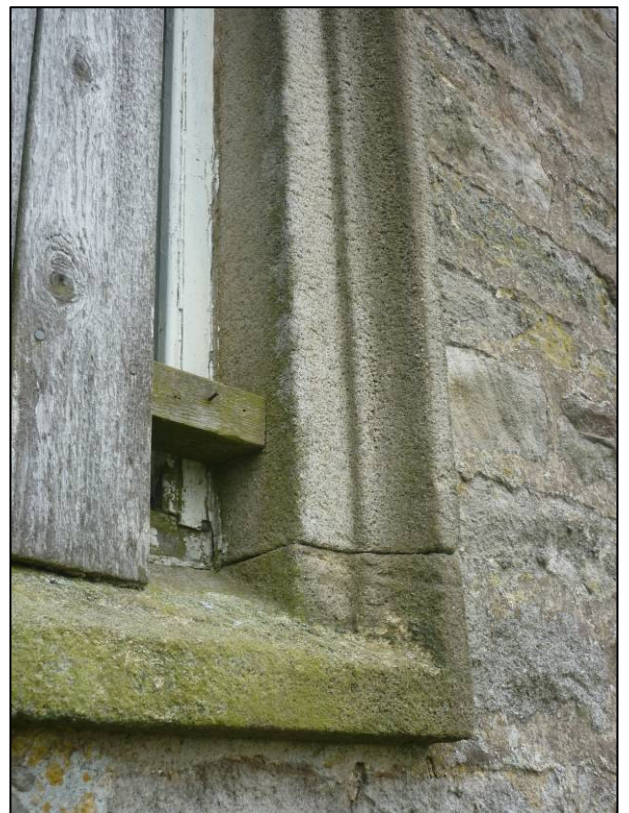
- 3.14 The north gable has a single ground floor window to the west side, and two windows above to the first floor, placed symmetrically within the gable [1/365]. All three windows are of the same size and almost certainly of the same form, although only the east first floor window remained unboarded at the time of the survey. Each window has a slightly projecting moulded architrave [1/366] (see plate 9) and the east first floor window retains a four-pane (2 over 2) horned sash. The quoins rise to slightly projecting plain kneelers which support the gable coping. There is a drain, carved out of a solid piece of stone [1/367], at the base of the gable's north-west corner.

Plate 9: Detail of ground floor window to north gable of house, looking S (photo 1/366).

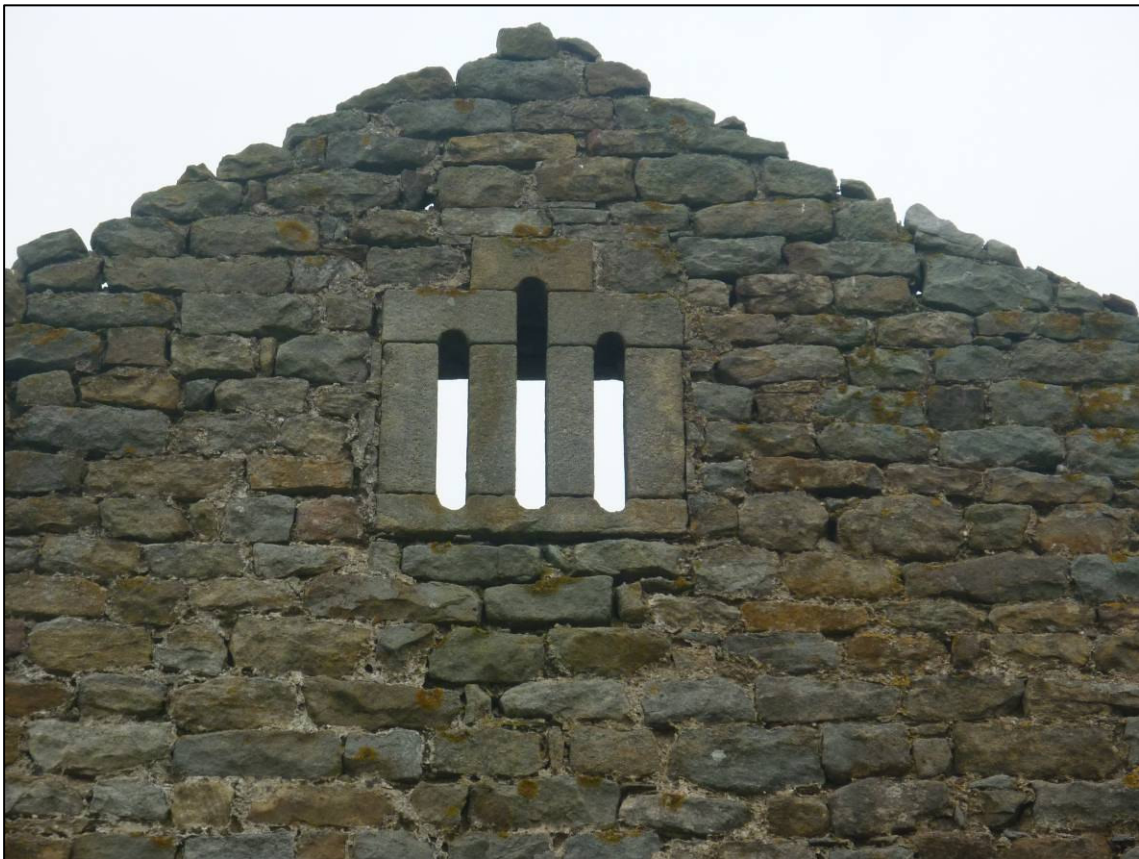
those flanking it [1/342] and, given the internal layout of the shippon (see below), perhaps forming a mucking-out hole; all three openings are boarded up. The doorway itself [1/343] retains the remnants of a board and batten door. The southern part of the elevation is blank. The south gable is also largely blank [1/373]. The quoins to either end rise to slightly projecting plain kneelers, like those surviving on the house, which once supported the gable coping. In the apex of the gable, there is a very well constructed tripartite opening [1/374], each narrow light having a curved head and foot; the central light is taller than the two either side (see plate 13).

Plate 13: Detail of opening in apex of south gable of barn, looking N (photo 1/374).

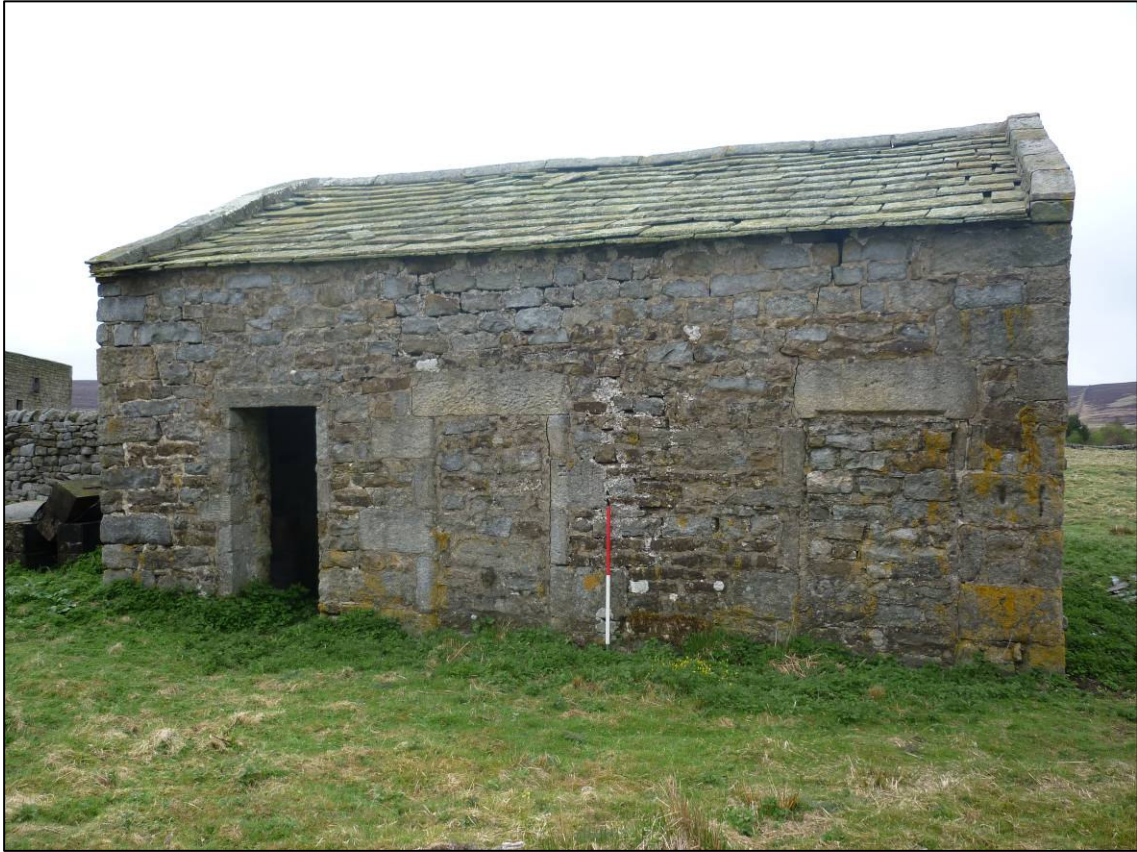
- 3.39 The south elevation [1/324] contains three doorways (see plate 14). Only the west doorway remains open; this appears to be a later insertion, and there is a great deal of modern repointing around it, perhaps indicating more extensive rebuilding. The central and east doorways [1/325] are both blocked. The central doorway has a substantial hammer-dressed lintel and chamfered quoined jambs; one of the quoins to the east jamb bears the inscription 'E.S 181(?)' with an 'X' carved beneath it. The east doorway also has chamfered quoined jambs but in contrast to the central doorway, the chamfering is carried around the soffit of the substantial lintel [1/326]. The soffit chamfering does not line up exactly with that of the jambs, suggesting that, if the lintel is not re-used, the door head was of slightly shouldered form.

Plate 14: South elevation of garage building, looking N (photo 1/324).

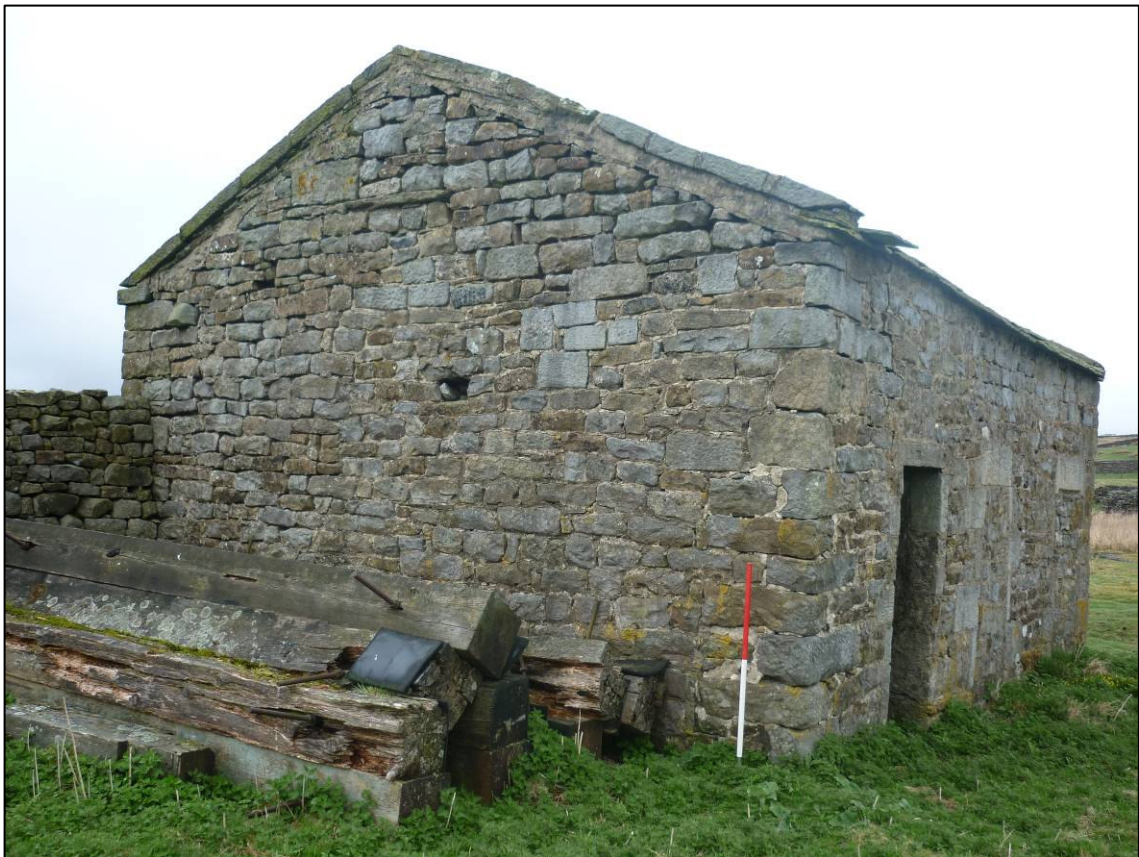
Plate 15: West gable of garage building, looking NE (photo 1/327).

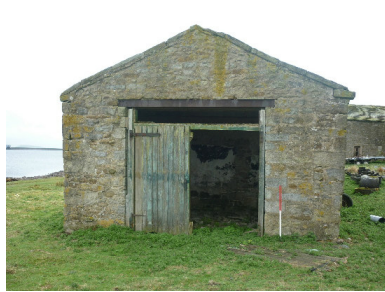
1-329.JPG

- 3.40 The east gable [1/329] is largely formed by the wide inserted garage opening, which has a steel lintel. However, the way in which the walled boundary angles to the south-east corner of the building in 1891 suggests that there was an entrance into the building here prior to the insertion of the garage doors. At the north-east corner, the quoins rise to a plain flat projecting kneeler not unlike those to the house and barn. The north elevation [1/330] is largely blank, with the exception of a small blocked opening [1/331] towards the east end and two possible sockets set c.1.40m above ground level. The west gable [1/327] may preserve a partial trace of the south slope of a more steeply pitched roof line, but this is not certain (see plate 15). There is a small blocked opening at the apex of the gable, and to the north end, a plain flat projecting kneeler as noted to the east gable.
