RETAINING WALL, OLD GANG SMELT MILL,
SWALEDALE, NORTH YORKSHIRE

ARCHAEOLOGICAL RECORDING

Report no: 2011/401.R01
Version: Final
Date: July 2011
Author: Shaun Richardson & Ed Dennison

Yorkshire Dales National Park Authority
Yoredale
Bainbridge
Leyburn
North Yorkshire DL8 3EL

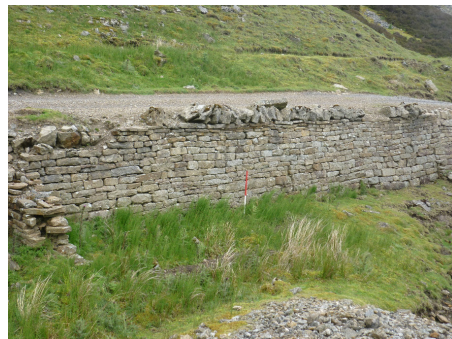
1-392.JPG

- 4.4 The easternmost stub wall of the bouse teams is butted by the section of retaining wall to its immediate east. This section of wall is c.12m long and stands to a maximum height of 2.20m [1/392] (see plate 1). It is built to a battered profile from coursed squared stone with upright coping. At the end of this section, low level projecting stubs suggest that there may once have been a small structure set against the wall, measuring c.3m long, perhaps a former bouse bin. To the east of this possible structure, the wall face steps back 0.30m to the north and butts the retaining wall to the west [1/394] (see plate 2). This recessed section forms a discrete length of wall 2.60m long, of similar form to that to the west but standing only 1.70m high [1/395]. This section of retaining wall is in turn butted by the wall to the east, where the wall face again steps back to the north by 0.30m. This creates a separate section of wall 1.40m long [1/396], perhaps connected to a wheelpit to the south (see below). At the east end of this section there is another small step to the north, after which the wall continues east for c.4.8m before terminating at a 4m long area of collapse [1/397] (see plate 3). On the east side of the gap, there may possibly be a butt joint, but this is not certain. The retaining wall can then be traced east for a further 7.00m, before encountering another c.6m wide area of collapse. Within this section of collapse, there is a 1m wide strip of level ground at the base of the wall before the ground surface falls off very steeply to the south, and the remains of a small attached structure may be visible here. Beyond the second area of

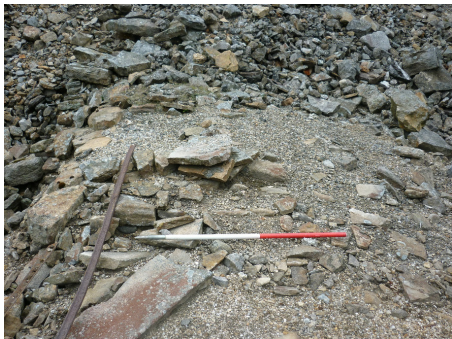
1-406.JPG

- 4.5 As has been noted above, there is a narrow strip of level ground adjacent to the base of some parts of the retaining wall. However, for much of its length, the wall stands at the top of a very steep south-facing scarp of spoil, over 2m in height. At the base of this spoil, the remains of another retaining wall are visible, standing up to 0.30m high at the eastern end, rising to 1.00m at the western end. This lower retaining wall effectively forms the northern limit of the dressing floor, and is pierced by a water wheel pit. The stone pit is aligned north-east/south-west and has a total length of 6.60m [1/404 and 1/405] (see plate 5). It measures 1.60m wide at the south end, but narrows slightly towards the north end. The long side walls remain visible as does a step at the southern end. At the north end of the wheelpit, the long side walls can be traced slightly further up the slope amongst the spoil here. They appear to be aligned on the 1.40m long recessed section of the trackway retaining wall described above, presumably to hold a launder. It may also be significant that a previous watching brief undertaken in 2007 recorded a small culvert, perhaps controlled by a sluice, which was aligned on the same area (Richardson & Dennison 2008). The interior of the wheelpit is choked with rubble and one large piece of timber, and there are two further pieces of timber to the west. To the south of the latter, the NAA survey identified a post. This is no longer visible, although the fragmentary remains of an apparent stone flag and timber structure can be seen here. On the east side of the wheelpit, stone footings define a structure c.2m square [1/406] (see plate 6) - comparison with other recorded dressing floors within the Yorkshire Dales strongly suggests that these footings form the remnants of a crusher base, the crushing machinery being driven by the adjacent waterwheel.
