GUNNERSIDE GILL, MELBECKS,  
NORTH YORKSHIRE  
ARCHAEOLOGICAL EROSION SURVEY

ARCHAEOLOGICAL EROSION SURVEY

Report no: 2009/363.R01  
Version: Final  
Date: July 2011  
Author: Ed Dennison & Shaun Richardson

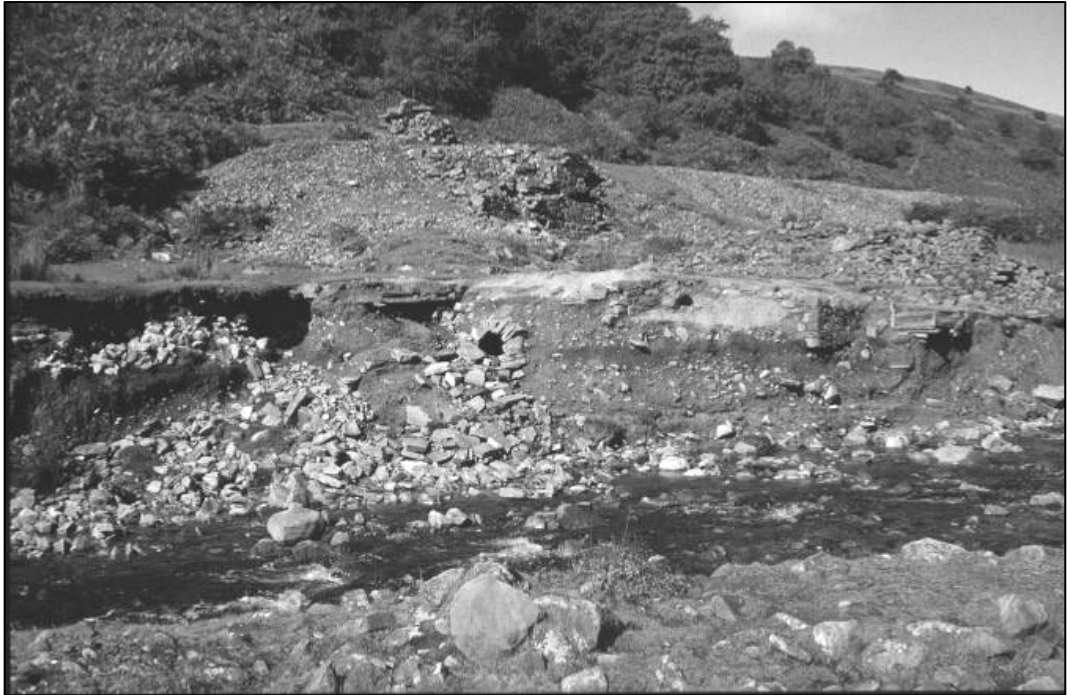
Plate 1: General view of eroding structures on Sir Francis Mine dressing floor, looking NW, September 1993 (YDNPA GG143).

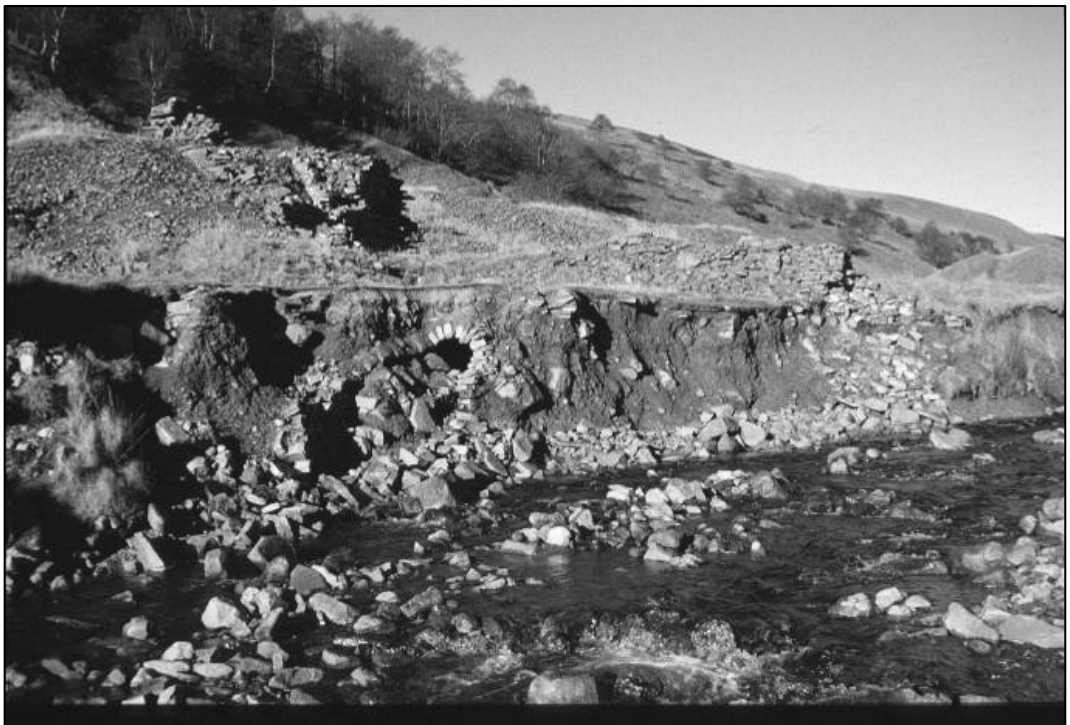
Plate 2: General view of eroding structures on Sir Francis Mine dressing floor, looking NW, January 2000 (YDNPA GG554).

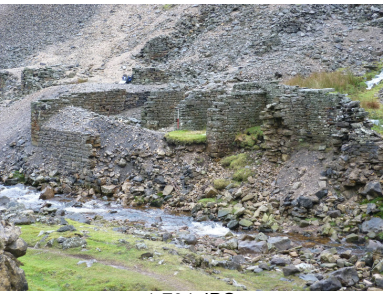
1-704.JPG

Plate 10: Sir George Level bouse teams, looking NE, December 2009 (photo 1/704).

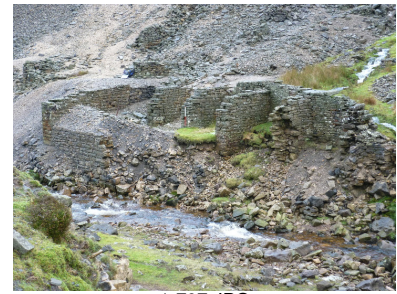
1-707.JPG

- 4.17 The eastward movement of the beck has removed c.5m of the southern end of the Sir George Level bouse teams (Site B86) since May 1994 [1/707 and 1/708] (see plates 9 and 10). Although it was not commented on by the Phase 2 survey, the spacing of the former walls here suggests that they may have represented the remains of an additional pair of bins, making a total of seven once serving the Sir George Level. As a result of the erosion, the stream (Water Sikes) which formerly ran around the southern end of the bouse teams in May 1994 has now found a new route down the steeply sloping ground here, some 6m to the north of its earlier position [1/721 and 1/725]. The timber floor of the southernmost surviving bin (Site B86/5) [1/718] has been completely destroyed, as has a 2m length of the dividing wall between it and the bin to the immediate north (Site B86/4) (see plate 11); this

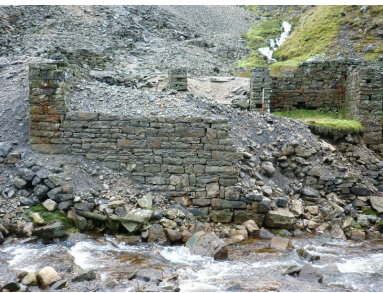
1-712.JPG

Plate 12: Revetment wall B85, Sir George Level bouse teams, looking E, December 2009 (photo 1/712).

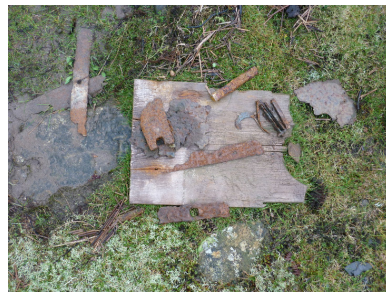
1-714.JPG

- 4.19 During the course of the December 2009 survey work, a number of features were noted on the west bank of the beck which had not been previously recorded, as they lay outside the 1994 Phase 2 survey area. Two vertical wrought-iron spikes or very large nails, standing up to 0.30m in height, can be seen adjacent to a large stone, approximately opposite bin 86/2 of the Sir George Level bouse teams [1/715 to 1/717]. In this same area, a collection of ferramenta, including wrought-iron straps and the remnants of a screen or grid similar to those described above, had been placed on a piece of timber by persons unknown [1/714].

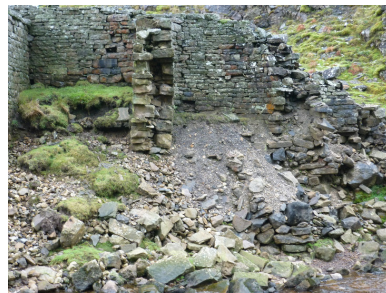
1-718.JPG

Plate 11: Eroding wall between bins B86/4 and B86/5, Sir George Level Bouse teams, looking E, December 2009 (photo 1/718).

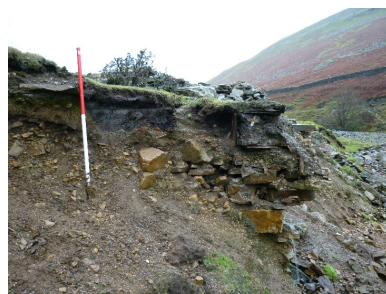
2-775.JPG

Plate 4: East end of eroding section, revealing timber launder, looking NW, December 2009 (photo 2/775).

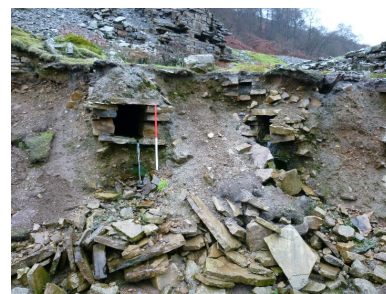
2-776.JPG

- 4.8 This culvert is one of three such features to emerge from the scarp at this point [2/776]. To the north, there is a smaller culvert, set at approximately the same level and of similar construction [1/780], but on an almost north-south orientation (see plate 5). It is on the same general alignment as culvert 94 described in the Phase 1 survey and in the 1995 erosion survey (but now set c.7m back due to the erosion), although this had an arched head (Cranstone & Instone 1994, 55; BHWB 1995, 3) (see plate 2). It is however possible that the two culverts are the same feature, with the arched section originally nearer the beck perhaps being a later addition as an earlier flag-topped length was encroached on by dressing waste. The third culvert is set immediately above and immediately to the south of the second, and much closer to ground level. At 0.20m square, it is smaller than the other two, although of similar construction, and appears to be on a north-west/south-east orientation.

Plate 5: Culverts exposed in eroding bank of Sir Francis Mine dressing floor, looking NW, December 2009 (photo 2/776).

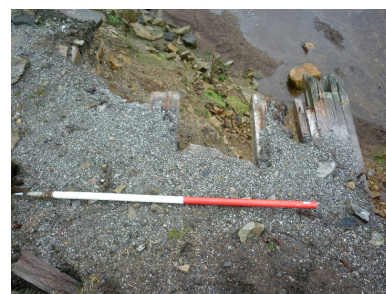
2-785.JPG

Plate 6: Eroding timber structure, Sir Francis Mine dressing floor, looking E, December 2009 (photo 2/785).

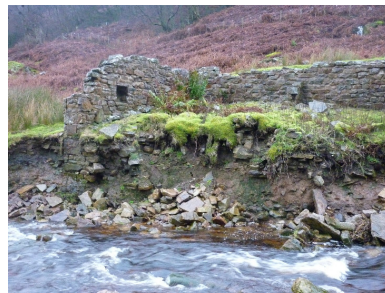
2-799.JPG

2	799	Mineshop, failing repointing at SW corner	-
2	803	Mineshop, looking W	-
2	804	Mineshop, looking W	-
