ELLERTON PRIORY, SWALEDALE,
NORTH YORKSHIRE

ARCHAEOLOGICAL SURVEY

Report no: 1996/19.R01
Version: Final
Date: September 2011
Author: Ed Dennison

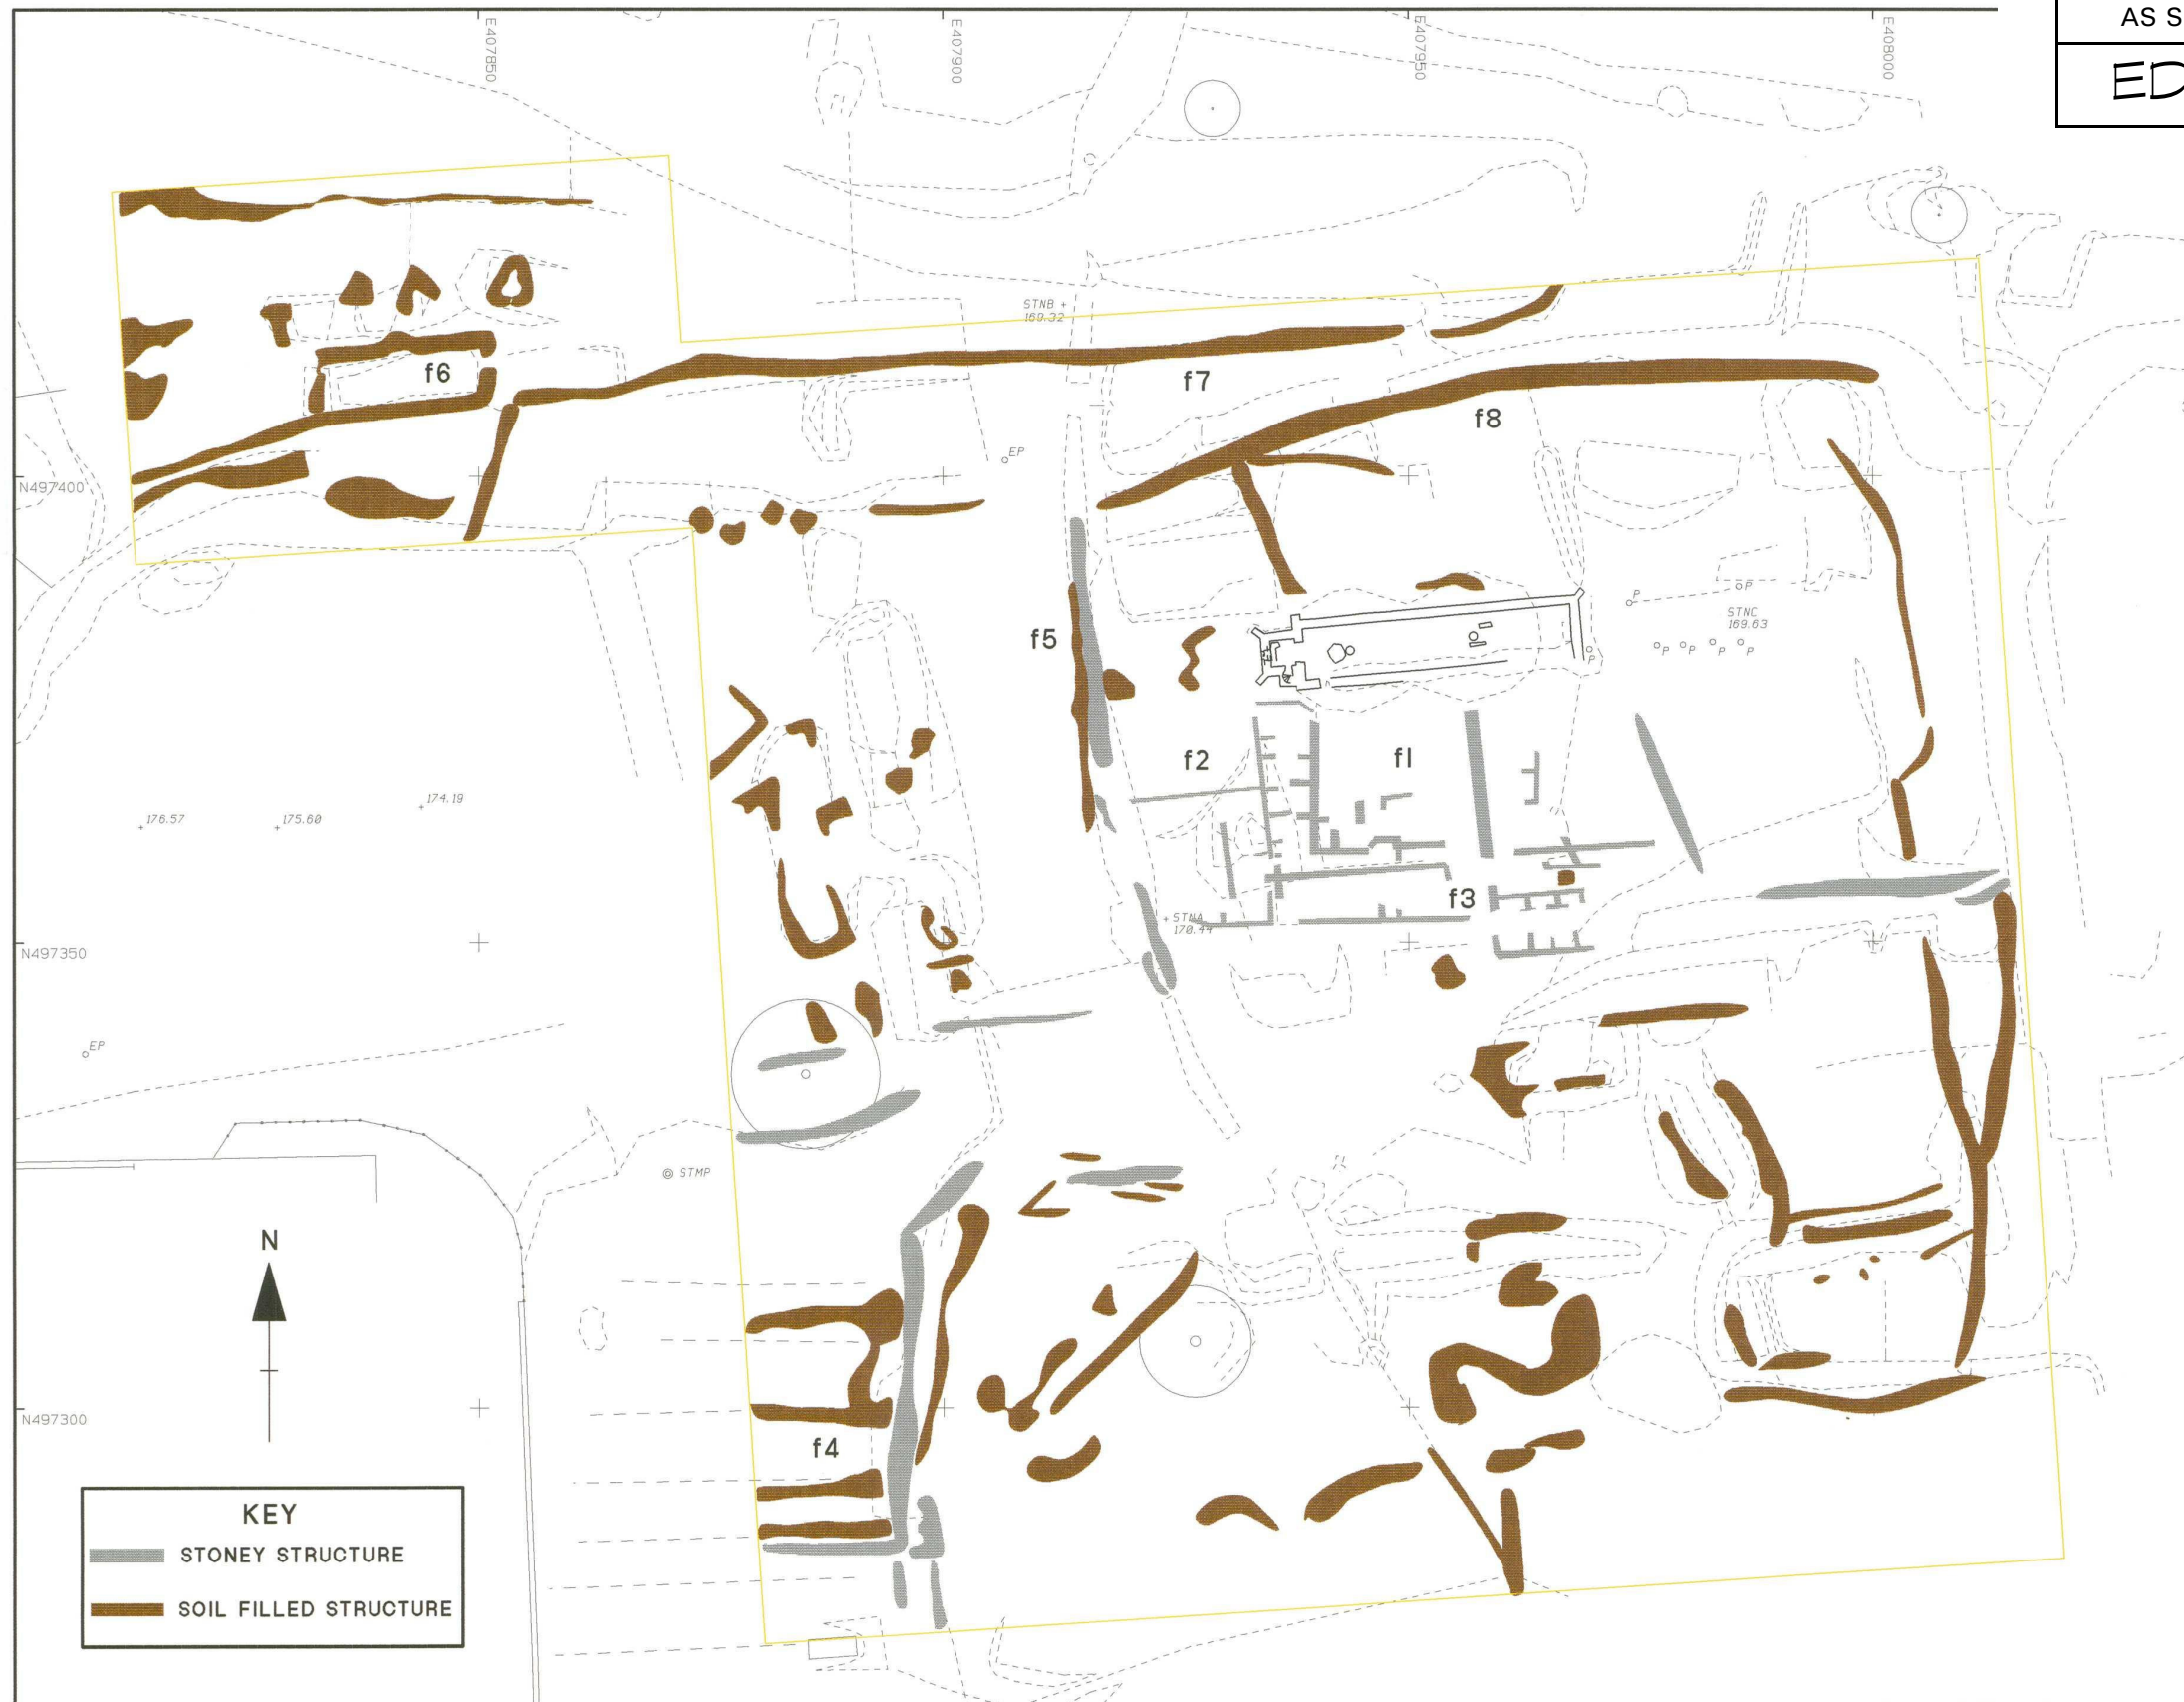
PROJECT	ELLERTON PRIORY		
TITLE	PLAN OF CHURCH		
SCALE	AS SHOWN	DATE	SEPT 2011
	EDAS	FIGURE	9

- 3.27 The survey area is characterised by a high concentration of small dipolar magnetic anomalies which almost certainly reflect the presence of ferrous litter in the soil. Four other large, intense anomalies have been detected which correspond to the footings for a telegraph pole ('f10' on figure 8), a rubble-filled hollow associated with a probable spring and drain ('f11'), an area of modern dumping and ground disturbance ('f12'), and a reinforced concrete slab associated with a septic tank ('f13'). A high concentration of dipolar magnetic anomalies ('f9') was also detected immediately to the east of the church, reflecting the presence of ferrous and/or fired materials such as metalwork, bricks and tiles in the ground; this corresponds to an area of disturbed ground containing debris from the previous removed timber and corrugated iron hen house (see above).

- 3.34 The earthwork survey was not able to positively establish whether the cloisters were attached to the north or south side of the church, but the geophysical survey was able to confirm a southern location. Indeed, the geophysical data is remarkably clear, and several short stub walls suggestive of internal divisions are evident in the west range which appears to be some 5m wide (see figure 8). A double parallel alignment of foundations in the south range may represent part of the internal covered walk which traditionally surrounded the cloister garth. The east range is not so obvious, but it is likely to be represented by a short section of buried wall running at a slight angle towards the south-east corner of the chancel. Overall, the cloisters measure c.25m east-west by 20m north-south, and the internal area contains relatively few features; the cloister garth was traditionally kept clear of buildings, and may have been used as a garden or a place of burial. No obvious features were seen in the geophysical data, although the 15m long north-south anomaly might represent a drain or path within the cloister garth.

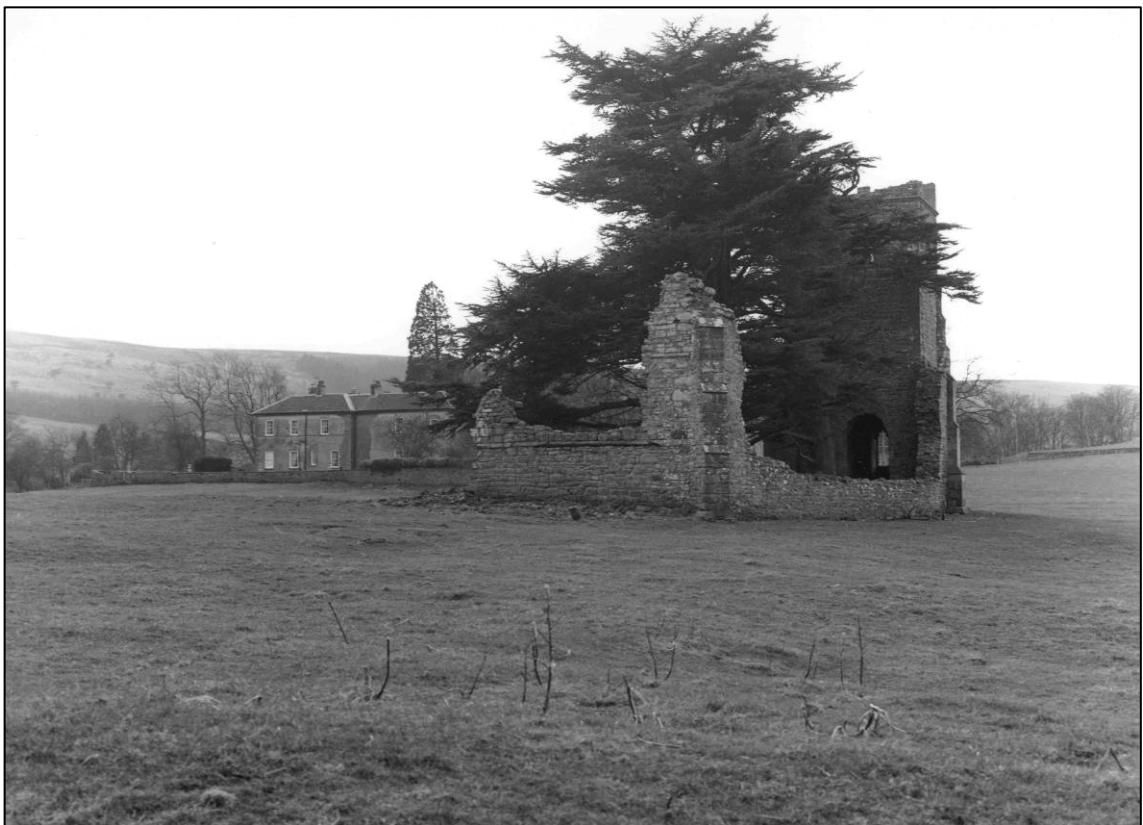
Plate 2: Ellerton Priory church, looking SW towards Ellerton Abbey (house) (February 1999).

- 4.1 The standing remains of the church at Ellerton Priory comprise the western tower, and an aisleless, undivided, nave and chancel or presbytery (see plate 2). The earliest elements of these standing remains have been dated on stylistic grounds to the 13th century, but the majority of them, including the present tower, appear to result from a major building phase in the 15th century. Subsequent phases of intervention can be ascribed to the 19th century, and to the late 20th century (1987 and 1990), when the building was consolidated by the Yorkshire Dales National Park. The ground floor of the church was open to livestock at the time of the survey, and two mature Cedar trees are growing within the nave. The tower is roofed however, and its interior is largely weatherproof.

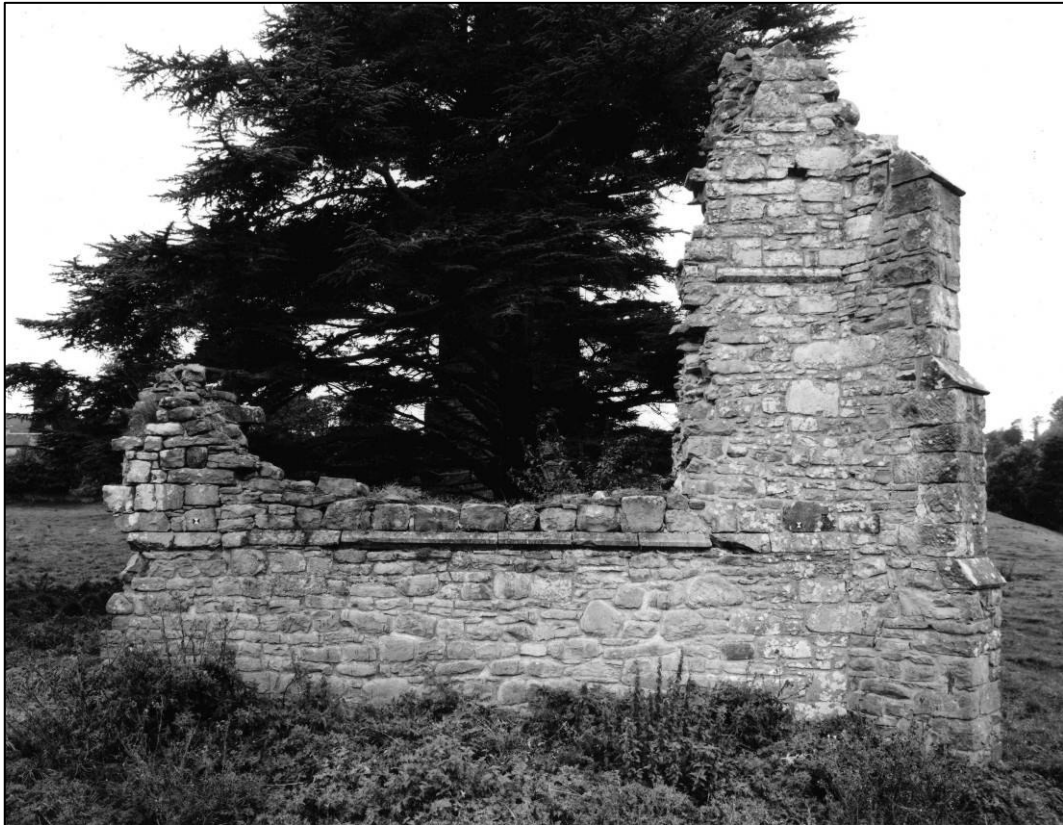
Plate 5: East external elevation of chancel, looking W
(photo 2/7 September 1996).

- 4.10 The present outline of the east wall indicates that there may have been a large window in this elevation, as might be expected for a church, but nothing of this survives. It is possible that the removal of the window dressings was accompanied by the replacement of some of the off-set dressings, and possibly by the rebuilding of part of the north end of this wall. Some alterations to this wall may also have been made when the adjoining post-built agricultural structure was constructed, as shown on the OS 1975 1:2500 map (see figure 2).

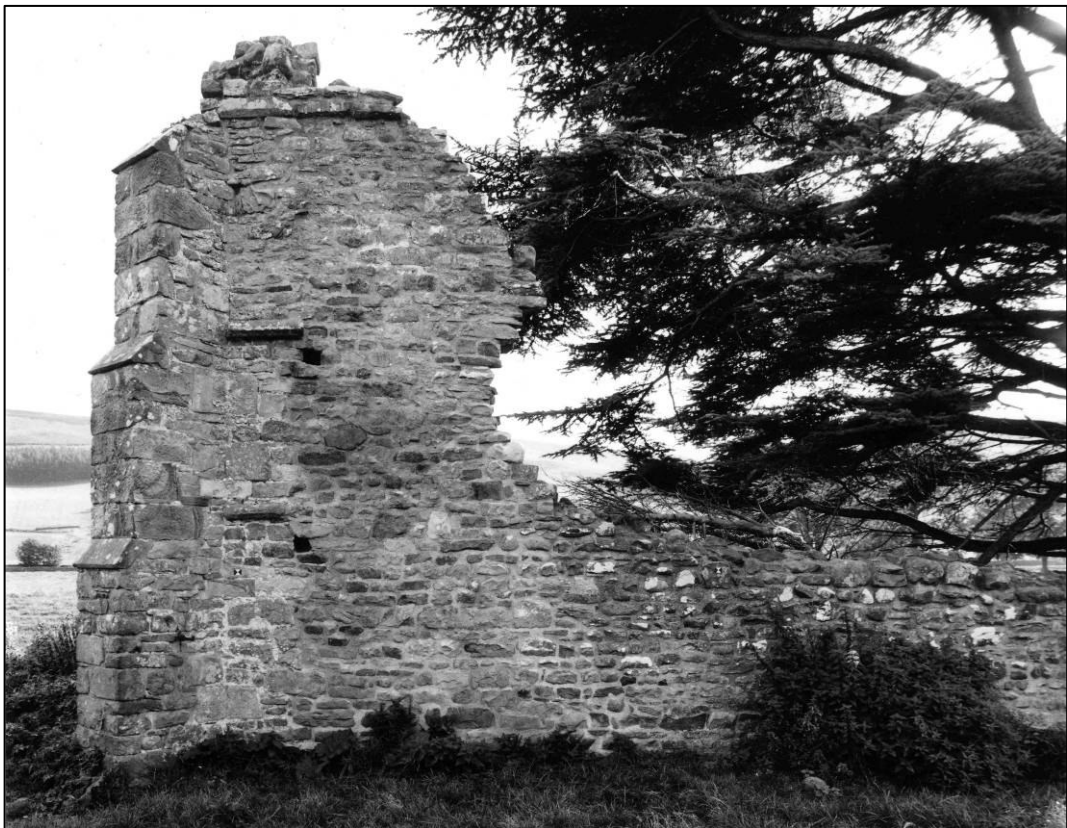
Plate 6: East end of north external wall of chancel, looking S
(photo 3/2 September 1996).

- 4.11 The north-east angle buttress adjacent to this elevation runs to a height of 5.0m above ground level, but it may have continued further upwards, as its top is presently corework (see plate 6). There are three chamfered off-sets on the buttress, and a chamfered plinth. The buttress is clearly contemporary with the adjoining east and north walls of the chancel as a number of the stones are continuous between them. The dressings of the buttress are of sandstone and some display rather rough punch dressing, and are heavily weathered.

- 4.12 The east end of the north chancel wall is of a similar height to the adjoining east wall, some 5.6m maximum (elevation 2) (see plate 6). However, only a length of some 0.6m of the wall is believed to be original, with the remainder being secondary. The form of the wall is unusual, being interrupted by two string courses, at heights of 2.0m and 3.5m above ground level, and these do not
