MIDGE HALL FARM POND,
ROSEDALE EAST, NORTH YORKSHIRE

ARCHAEOLOGICAL INVESTIGATIONS

Report no: 2012/423.R01
Version: Final
Date: September 2012
Author: Shaun Richardson & Ed Dennison

Mr Paul Metcalf
Kiln View, Midge Hall Farm
Daleside Road
Rosedale Abbey
North Yorkshire YO18 8RL

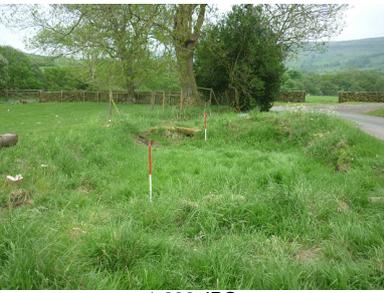
1-232.JPG

- 4.6 Prior to excavation, the pond was formed by a sub-rectangular depression, measuring c.6.0m north-south by 5.5m east-west, heavily vegetated and up to a maximum of 0.7m in depth [1/232, 1/233 and 1/235] (see figure 4 and plate 1). Coursed sandstone lining was visible close to the south-east corner [1/237] (see plate 2) and along the west side [1/236], but otherwise the sides comprised steep vegetated scarps. Modern ceramic and plastic pipes entered the pond at both the north-east and north-west corners respectively.

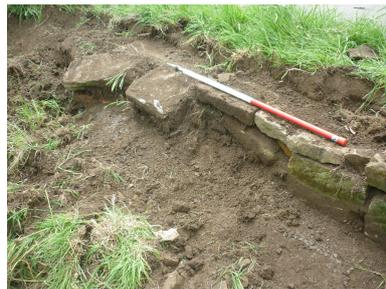
1-242.JPG

- 4.12 The west side of the pond retained the remains of its stone lining for much of its length [1/240 to 1/243], comprising two courses of squared unmortared sandstone, with a total height of 0.50m; a deeper base course, resting directly on the shale (003), below a single shallower upper course (see plate 3). Towards the southern end, the uppermost course may have included a pair of slipped capping stones. There was a slight step in the shale base of the pond to the immediate east of the stone lining of the west side.
