RIEVAULX ABBEY PRECINCT BOUNDARY
(NORTH-WEST SECTION),
RIEVAULX, NORTH YORKSHIRE

ARCHAEOLOGICAL WALKOVER SURVEY
AND MANAGEMENT RECOMMENDATIONS

Report no: 2013/444.R01
Version: Final
Date: March 2013
Author: Ed Dennison & Shaun Richardson

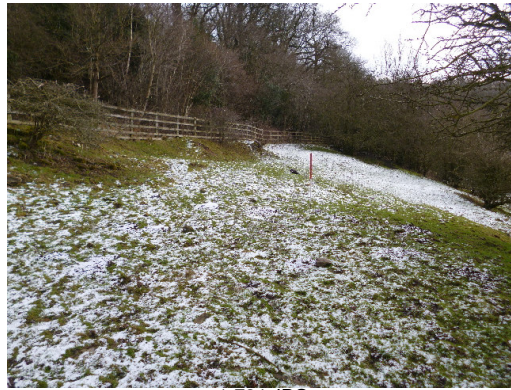
1-734.JPG

- 3.17 After a distance of c.10m, the precinct boundary appears to turn through a near right-angle to run to the north-east (**J2**). Here, a very shallow, very spread bank can be followed for c.12m along this return [1/734; 1/735], until it reaches the base of a south-facing scarp, 3.8m to the south of the modern post-and-rail fence on the south side of Arden Lane. This scarp contains a high proportion of stone rubble, and a single low hawthorn bush [1/730; 1/731]. Just to the north of the bush, at the top of the scarp, a wall can again be seen in plan, running east, albeit only for a short length of 0.70m; here, it has a face to face width of c.1.30m [1/733]. The form of the wall footings at their southern end suggest that they have been cut away or dug out, and may once have continued south at a higher level. The published plans of the precinct boundary (Fergusson *et al* 2006, 30; Fergusson & Harrison 1999, 176; see figures 3 and 4) does not include this c.12m long north-east return, but instead shows the alignment continuing for a short distance along the main course to the east before meeting with the south side of Arden Lane. A gate through the precinct boundary is suggested to have been present in this general area (Caroe & Partners 2000 vol 2, 23), and is presumably the origin of the name 'Arden Lane Gate', and so the c.12m long return and the adjacent short eastern wall line may be connected with this, rather than the actual precinct boundary wall (see discussion below). The c.12m long return is depicted as a field boundary on an 1806 estate plan (Caroe & Partners 2000 vol 2, fig. 5).
