GUNNERSIDE GILL, MELBECKS,  
NORTH YORKSHIRE  
FURTHER ARCHAEOLOGICAL EROSION SURVEY

FURTHER ARCHAEOLOGICAL EROSION SURVEY

Report no: 2012/442.R01  
Version: Final  
Date: January 2013  
Author: Shaun Richardson & Ed Dennison

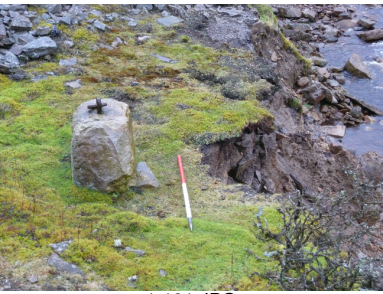
1-191.JPG

Film	Frame	Subject	Scale
1	191	Area 1, Sir Francis, crusher weight, looking NE	1m
1	192	Area 1, Sir Francis, crusher weight and erosion scarp, looking NE	1m
1	193	Area 1, Sir Francis, structure to SW of crusher weight, looking NE	1m
1	197	Area 1, Sir Francis, mineshop, looking NE	1m
1	198	Area 1, Sir Francis, mineshop, looking NE	1m
1	199	Area 1, Sir Francis, mineshop, looking S	1m
1	200	Area 1, Sir Francis, erosion scarp, looking SW	-
1	201	Area 1, Sir Francis, erosion scarp, looking SW	-
1	203	Area 1, Sir Francis, erosion scarp, looking SW	-
1	204	Area 1, Sir Francis, mineshop, looking W	1m
1	205	Area 1, Sir Francis, mineshop, looking W	1m
1	206	Area 1, Sir Francis, mineshop, looking W	1m
1	207	Area 1, Sir Francis, mineshop, looking SW	1m
1	208	Area 1, Sir Francis, erosion scarp, looking NW	-
1	209	Area 1, Sir Francis, erosion scarp, looking NW	-
1	210	Area 1, Sir Francis, erosion scarp, looking NW	-
1	211	Area 1, Sir Francis, erosion scarp, looking W	-

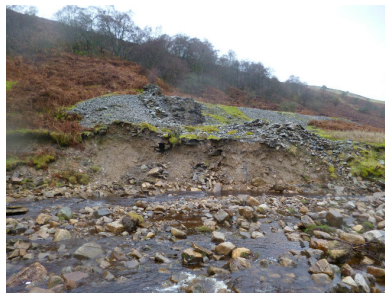
1-208.JPG

Plate 1: General view of eroding structures on Sir Francis Mine dressing floor, looking NW, November 2012 (photo 1/208).

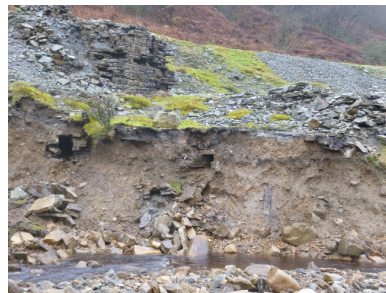
1-209.JPG

Plate 2: Detailed of eroding structures on Sir Francis Mine dressing floor, looking NW, November 2012 (photo 1/209).

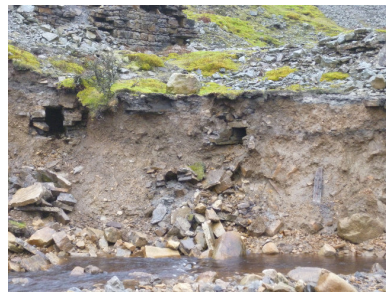
1-213.JPG

1	212	Area 1, Sir Francis, erosion scarp, looking W	-
1	213	Area 1, Sir Francis, erosion scarp, looking NW	-
1	215	Area 1, Sir Francis, erosion scarp, looking NW	-
1	216	Area 2, Sir George bouse teams, looking NE	-
1	217	Area 2, Sir George bouse teams, looking NE	-
1	218	Area 2, Sir George bouse teams, looking E	-
1	220	Area 2, Sir George bouse teams, looking E	-
1	221	Area 2, Sir George bouse teams, looking NE	-
1	222	Area 2, Sir George bouse teams, looking NE	-
1	226	Area 2, wall to S of Sir George bouse teams, looking NE	-
1	228	Area 2, wall to S of Sir George bouse teams, looking S	-
1	230	Area 2, Sir George bouse teams, looking NE	-
1	233	Area 1, Sir Francis and beck, looking SW	-
1	235	Area 1, Sir Francis and beck, looking SW	-
