BENT RIGG RADAR STATION,
SOUTH-EAST OF RAVENSCAR, STANTON DALE,
NORTH YORKSHIRE

ARCHAEOLOGICAL MONITORING OF
2013 REPAIR WORKS

Report no: 2011/410.R02
Version: Final
Date: September 2014
Author: Ed Dennison

National Trust (Yorkshire Region)
Goddards
27 Tadcaster Road
York
YO24 1GG

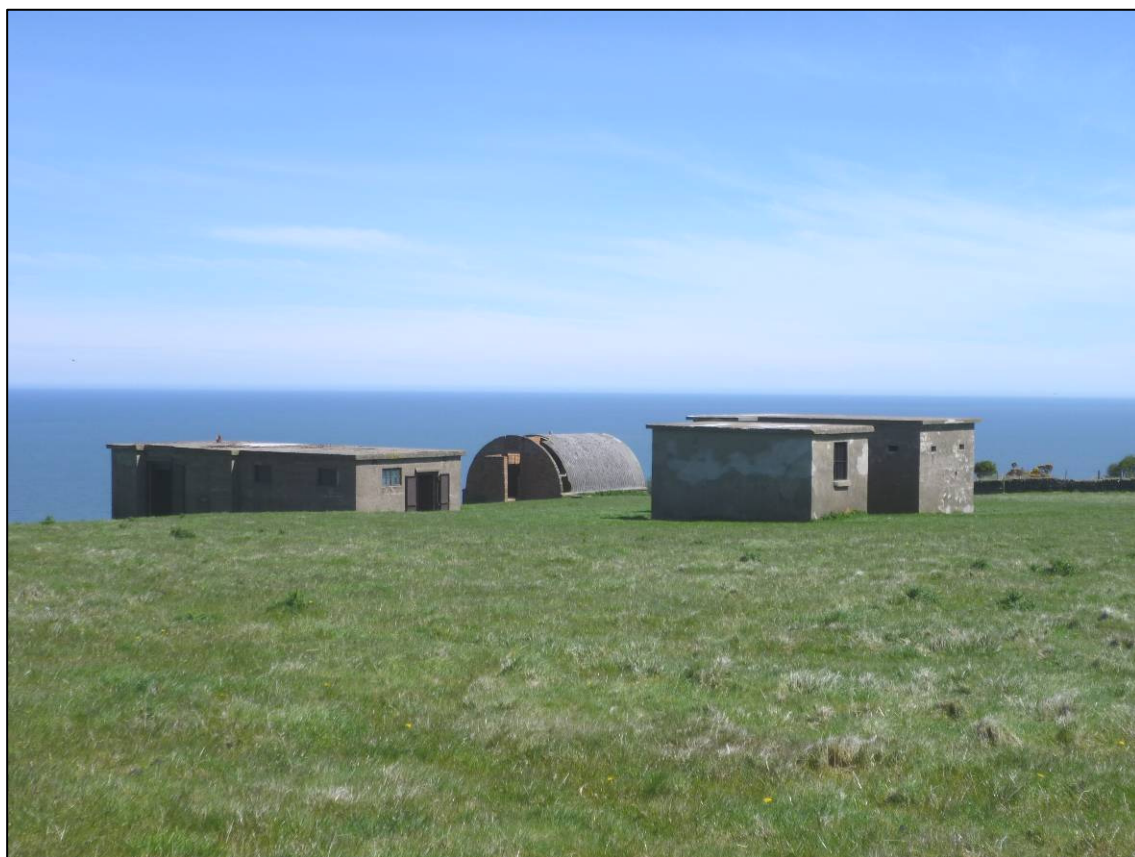
Plate 16: General view of repaired buildings, looking SE (photo 2/709).

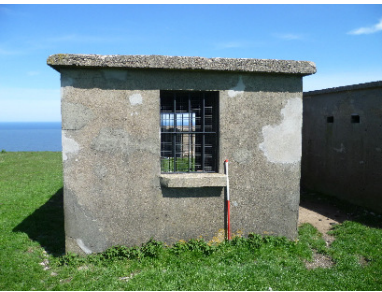
2-658.JPG

- 5.3 The repair works comprised the treating of all exposed metalwork, including the steel rods visible on the eroded roof edges, the patching of several areas of eroded/spalled concrete render (c.0.25m thick) to the external wall faces [1/919, 1/920; 2/656, 2/658, 2/660, 2/706] (see plate 1, the repair of eroded roof edges [2/657], the removal of the rotted frame and glass to the window in the west elevation, and the repainting of the door frame in the east elevation [2/654]. New steel grilles were also added to the window and door openings to prevent unauthorised access [2/655, 2/659] (see plates 1 and 2).

Plate 1: Repairs to render and inserted window screen, W side of Building R1, looking NE (photo 2/658).

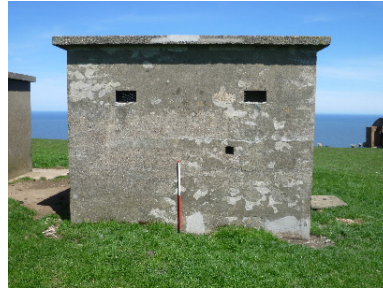
2-665.JPG

- 5.5 As with Building R1, the repair works involved the treating of all exposed metalwork, including the steel rods visible on the eroded roof edges, the patching of several areas of eroded/spalled concrete render to the external wall faces [2/665, 2/667, 2/668], the repair of eroded roof edges, and the repainting of the internal door frame in the east elevation. The mesh grilles to the wall vents were treated with a rust inhibitor and repainted [2/664, 2/666, 2/669] (see plate 4), and a new steel grille was added to the internal door opening to prevent unauthorised access [2/661, 2/662] (see plate 3). Once repairs were complete, the building's appearance was much improved [2/670, 2/697, 2/705] (see plate 5).

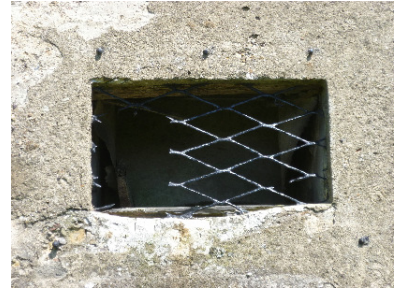
2-666.JPG

Plate 4: Repairs to vent grill on W side of Building R2, looking NE (photo 2/666).

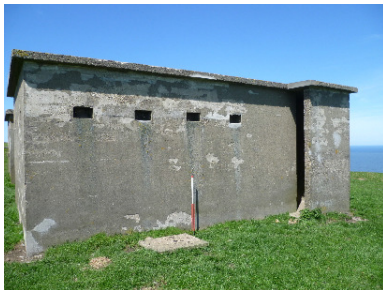
2-668.JPG

Plate 5: Repairs complete to S side of Building R2, looking NW (photo 2/668).

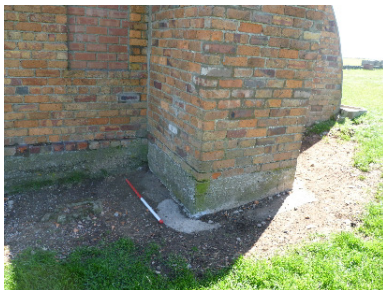
2-673.JPG

- 5.8 As noted above, the amount of actual ground disturbance work was limited to a small trench dug around the north-east corner of the north porch. The small brick-built porch is founded on a concrete base and measures 1.15m east-west by 1.37m north-south, with a doorway in the west side; the porch was possibly built at a later date than the rest of the building as there is a straight joint between the two. The L-shaped excavated trench measured 0.75m along the long sides, 0.30m along the short sides and was a maximum of 0.30m deep, slightly undercutting the corner of the porch [1/901-1/906] (see figure 5 and plate 6). A 0.30m depth of dark brown clay topsoil with no inclusions was revealed, with occasional small stones in the base of the trench; it is unlikely that these formed any sort of foundation, and it was clear that the 0.40m thick concrete slab at the bottom of the porch had been founded directly onto the topsoil. Once recorded, the trench was filled with concrete to form a firm foundation [2/673] (see plate 7).

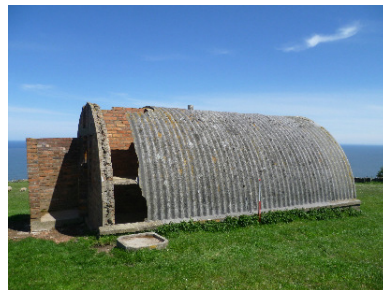
2-674.JPG

- 5.10 Once repairs were complete, the building was much improved, although the unrepaired asbestos roof still detracted from its overall appearance [2/674, 2/678, 2/698] (see plates 7 and 8).

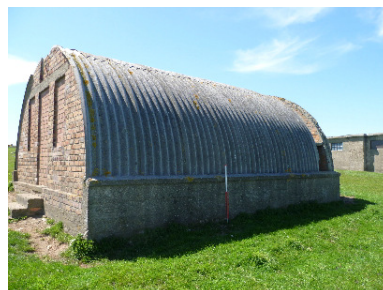
2-677.JPG

2	677	Repairs complete to S gable of Building R3, looking NW	1m
2	678	Repairs complete to Building R3, looking NW	1m
2	679	Inserted door screen to Building R3, looking SE	1m
2	680	Repairs complete to W end of Building R4, looking NE	1m
2	681	Repairs complete to door D2 in Building R4, looking NE	1m
2	682	Repairs complete to Building R4, looking N	1m
2	683	Repairs complete to window W1 in Building R4, looking NW	-

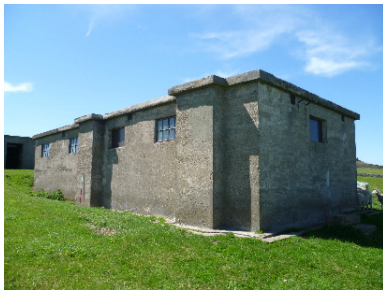
2-684.JPG

2	684	Repairs to roof edge on S side of Building R4, looking N	-
2	685	Repairs complete to Building R4, looking NW	1m
2	686	Repairs complete to E end of Building R4, looking NW	1m
2	687	Repairs complete to N side of Building R4, looking SW	1m
2	688	Repairs to door D1 with inserted screen in N side of Building R4, looking SE	1m
2	689	Repairs to door D1 with inserted screen in N side of Building R4, looking SE	1m
2	690	Repairs to N side of Building R4, looking SE	1m
2	691	Repairs to window W7 on N side of Building R4, looking SE	-
2	692	Inserted screen to door D1 in Building R4, looking NE	-
2	693	Repairs complete to door D2 in Building R4, looking E	-
2	694	Repairs complete to roof of Building R4, looking E	1m
2	695	Repairs complete to roof of Building R4, looking E	-
2	696	Repairs complete to roof of Building R4, looking NE	1m
2	697	Repairs complete to Buildings R1 & R2, looking SW	-
2	698	Repairs complete to Building R3, looking SE	-

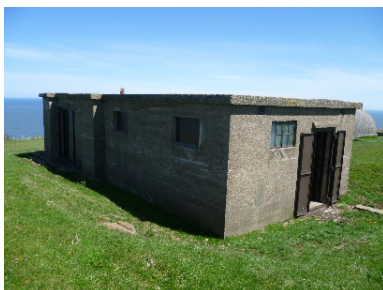
2-703.JPG

2	699	Repairs complete to roof of Building R4, looking NE	1m
2	703	Repairs to roof edge of Building R4, looking NE	-
2	704	Repairs complete to Building R4, looking E	-
2	705	Repairs complete to Building R2, looking NW	-
2	706	Repairs complete to N side of Building R1, looking SE	-
2	707	General view of repaired Buildings R3 & R4, looking SE	-
2	708	General view of repaired Buildings R1 & R2, looking SE	-
2	709	General view of repaired buildings, looking SE	-
