REPAIRS AND ALTERATIONS TO THE  
PRIEST'S HOUSE AND CHAPEL,  
BARDEN TOWER, BARDEN, NORTH YORKSHIRE

ARCHITECTURAL AND ARCHAEOLOGICAL  
OBSERVATION, INVESTIGATION AND RECORDING

Report no: 2015/510.R01  
Version: Final  
Date: December 2016  
Author: Ed Dennison & Shaun Richardson

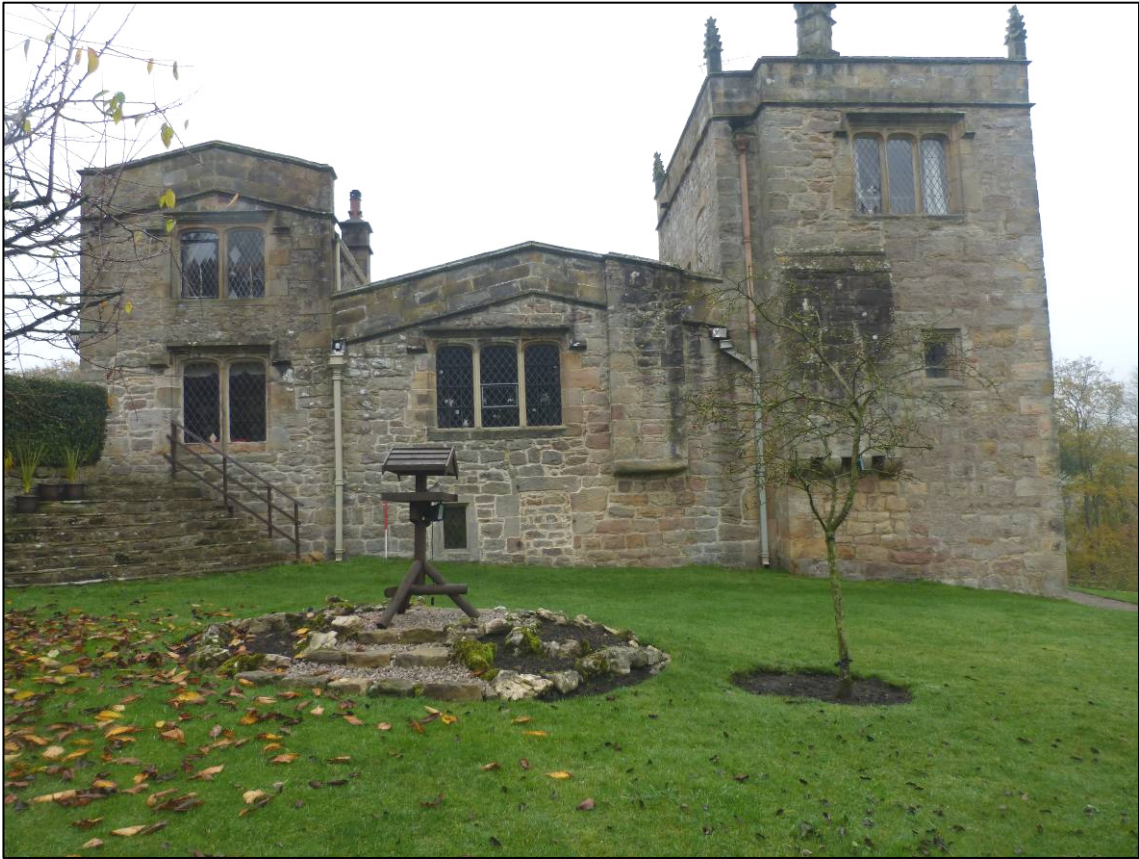
- 3.14 The west elevation of the building comprises (from north to south) the west gable of the domestic block, the west gable of the chapel and the west side of the tower [1/123, 1/125, 1/127] (see plate 3). Starting with the domestic block, at the base of the west gable, at lower ground floor level, there is a small, flat-headed, chamfered window partly obscured by a flight of stone steps which are a recent addition. To the ground floor, there is a two-light moulded chamfered mullioned window with elliptical headed lights and a hoodmould; the mullion has a cavetto section, whilst the hoodmould is dropped and returned at either end, but is without stops. Each light is glazed with fixed diamond-paned leaded glass. There is a very similar window, but slightly less tall, to the first floor [1/128, 1/130] (see plate 4), and above, an angled sandstone ashlar parapet following the pitch of the roof, with mouldings to the base and top.

Plate 3: West elevation of domestic block (left), chapel (centre) and tower (right), looking NE (photo 1/125).

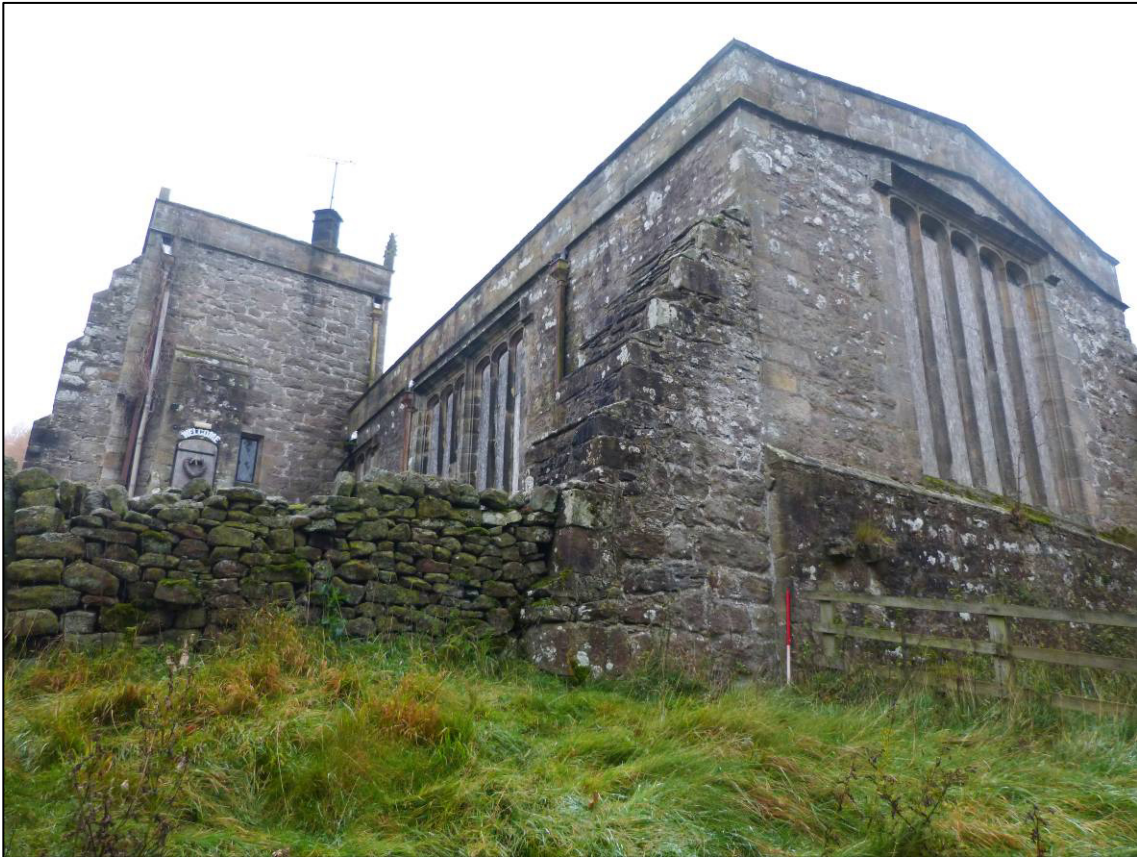
- 3.22 The east elevation of the building comprises the east gable of the chapel. This rises from crude projecting stone footings, above which there is a chamfered plinth [1/191, 1/194] (see figure 9 and plate 40). The gable itself has a central, tall, five-light moulded chamfered mullioned window with elliptical headed lights and a hoodmould; the mullions have cavetto sections, whilst the hoodmould is dropped and returned at either end, but is without stops. The glazing is of diamond-paned leaded glass. The gable is surmounted by an angled ashlar parapet, similar to that on the west gable of the chapel [1/187] (see plate 12).

Plate 12: Chapel, east gable and buttress, looking W (photo 1/187).

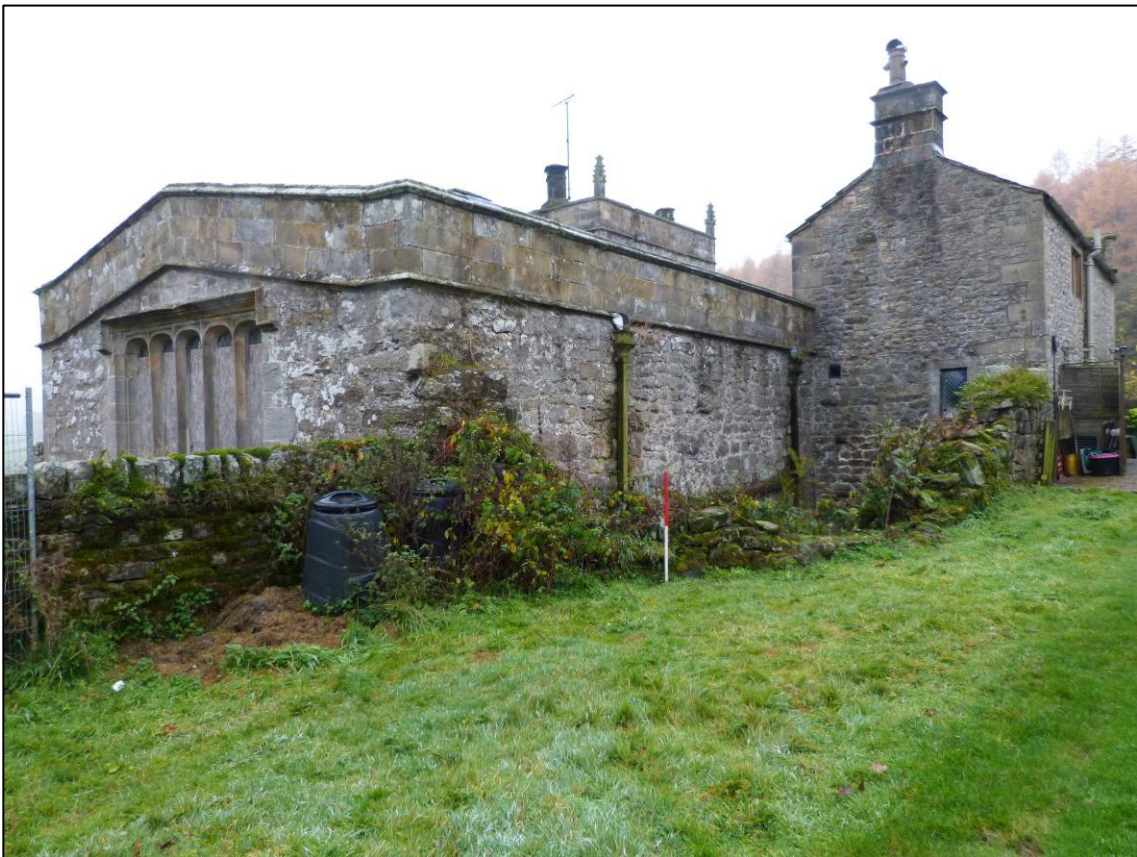
- 3.23 The north elevation of the building comprises the north elevation of the chapel, the east gable of the domestic block, and the north elevation of the domestic block [1/101] (see plate 13). There is also a retaining wall extending east from the north-east corner of the domestic block, initially parallel to the north elevation of the chapel and then curving south-east to the north-east corner buttress of the chapel, which partly defines a sunken area or light well [1/106]; this space was cleared out

Plate 13: Chapel and domestic block, looking SW (photo 1/101).

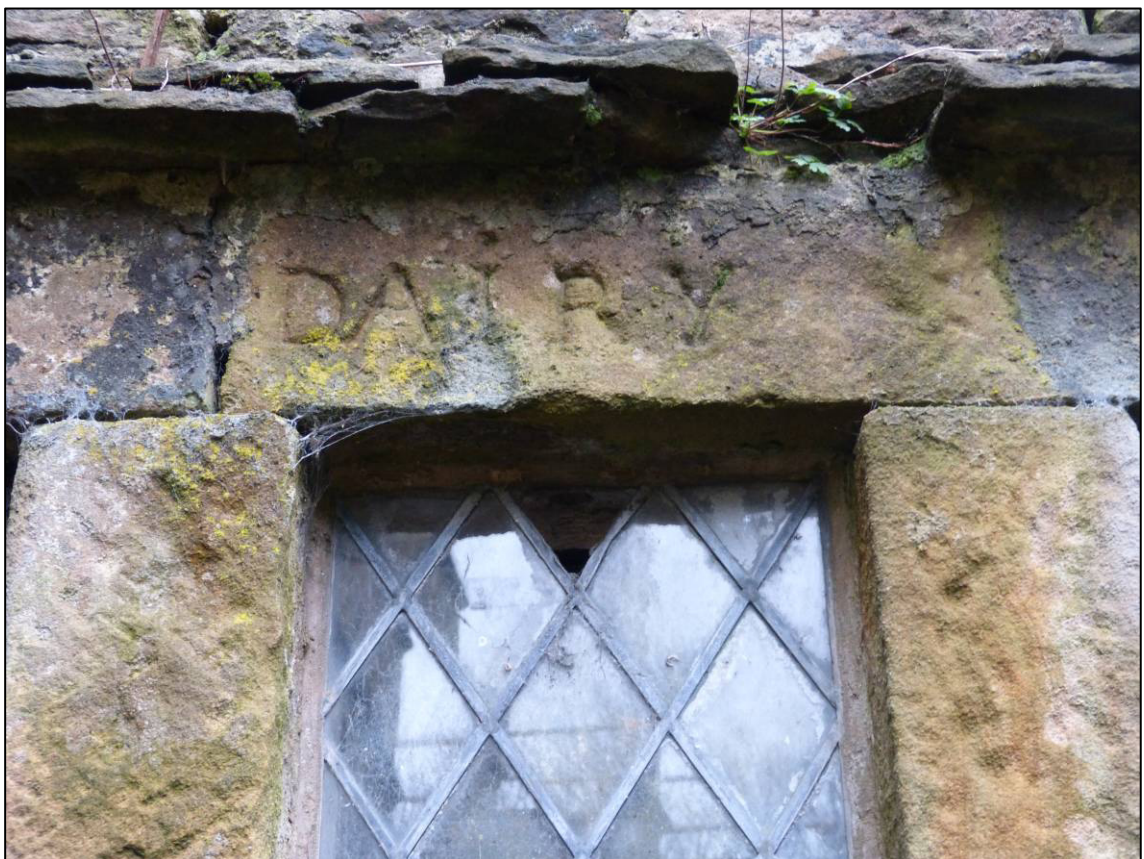
Plate 16: Domestic block, lower ground floor, east gable, window inscription, looking SW (photo 3/398).

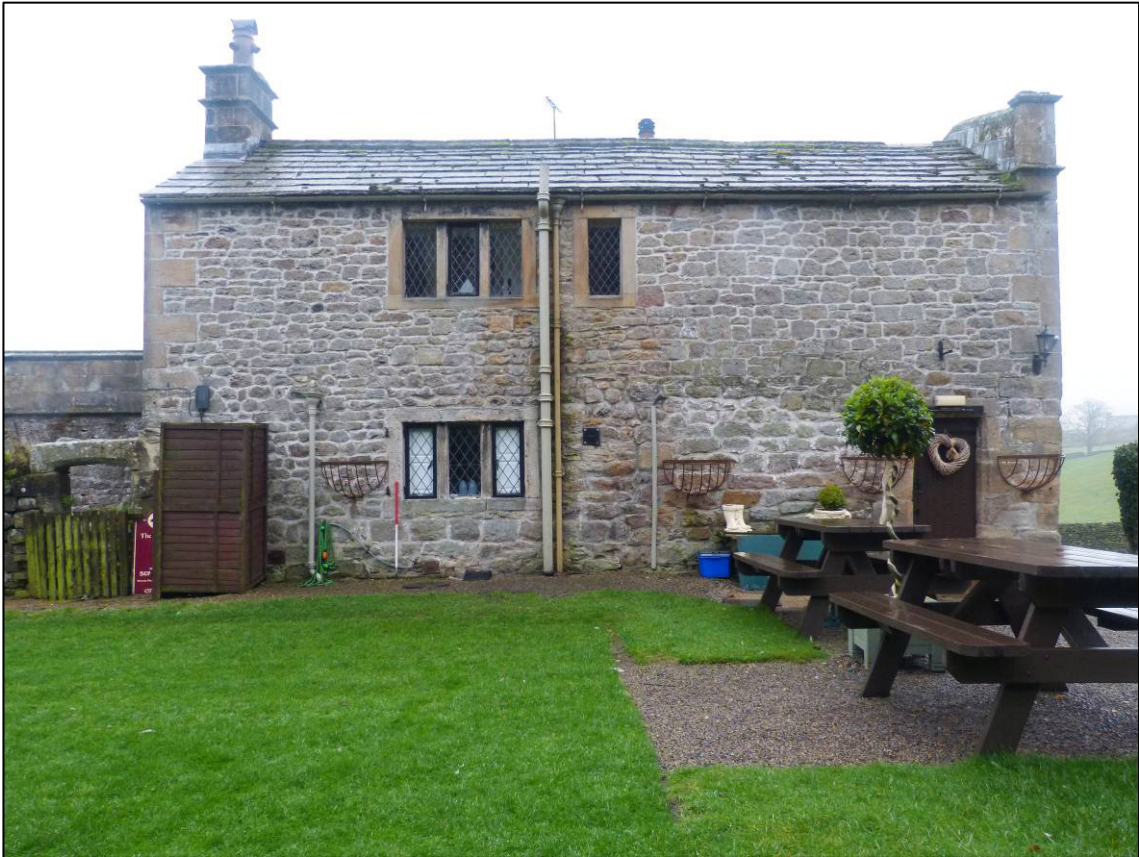
Plate 17: Domestic block, north elevation, looking SE (photo 1/118).

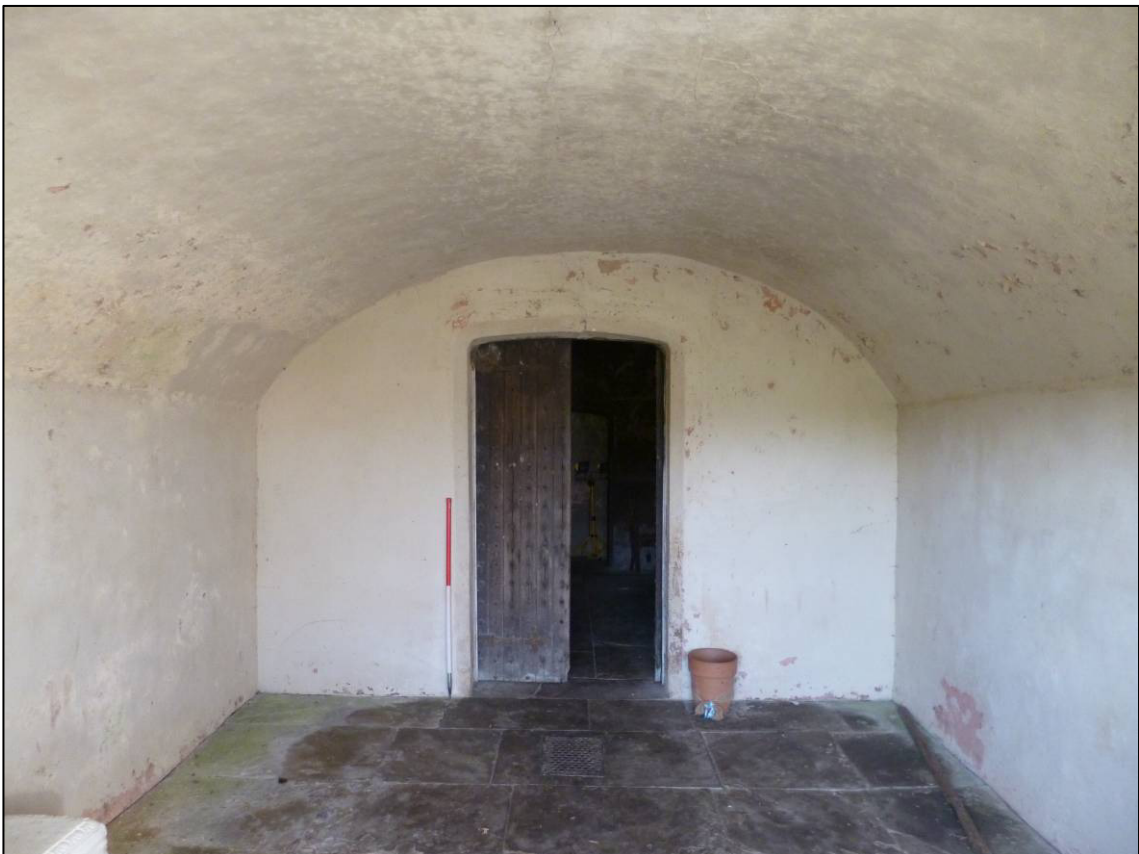
Plate 18: Tower, lower ground floor entrance chamber interior, looking NW (photo 2/648).

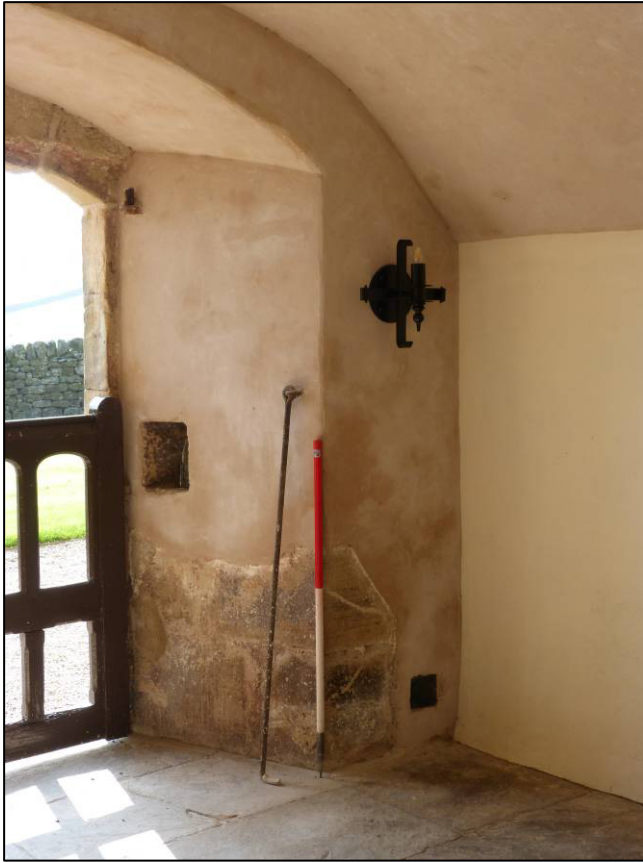
Plate 19: Tower, lower ground floor entrance chamber interior, works complete, looking S (photo 7/602).

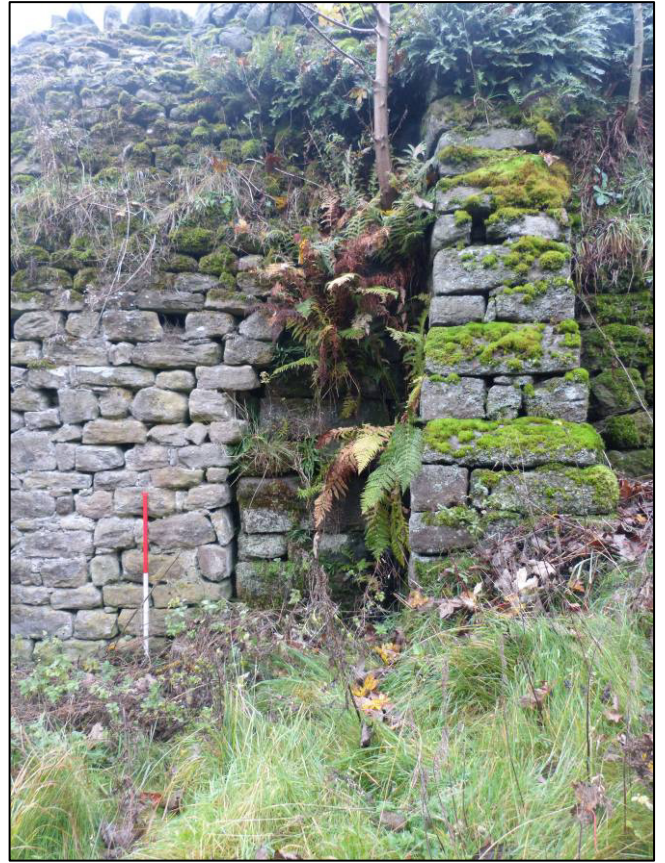
Plate 20: Retaining wall, north-east of chapel, east elevation, looking SW (photo 1/201).

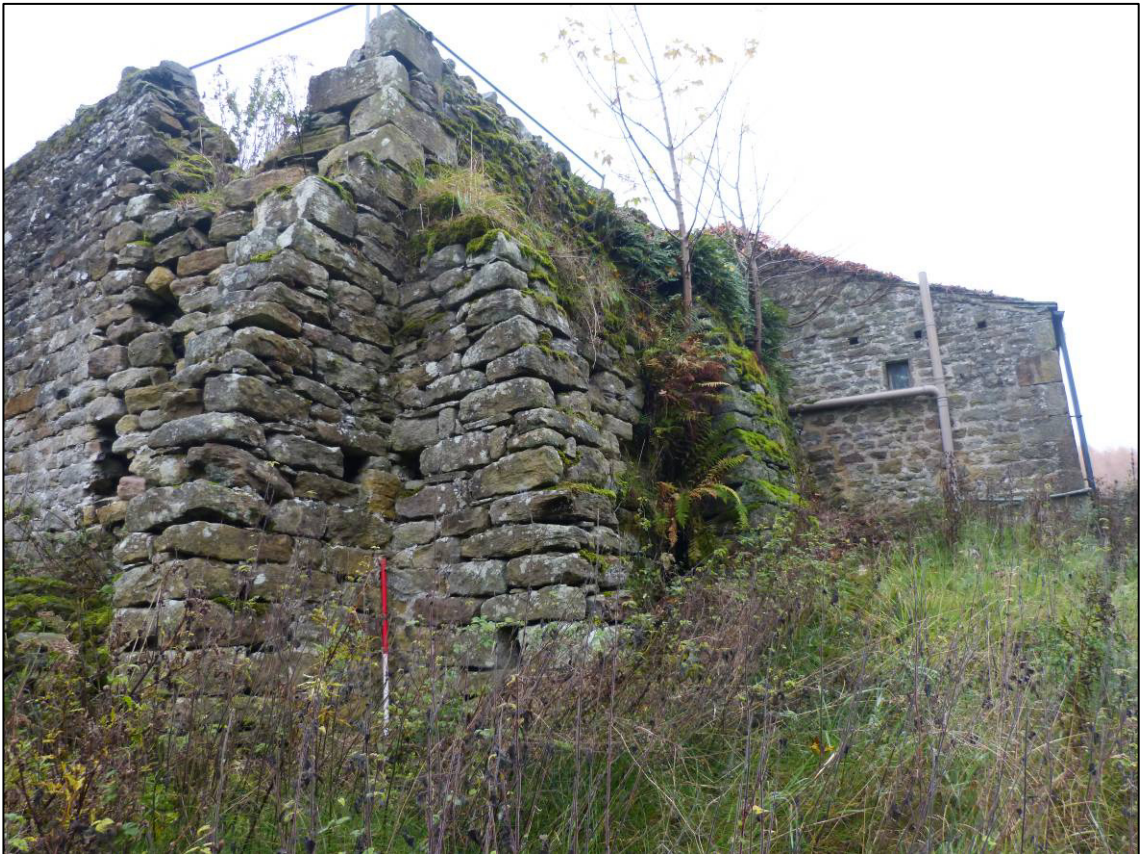
Plate 24: Retaining wall, north-east of chapel, corner buttress, looking NW (photo 1/198).

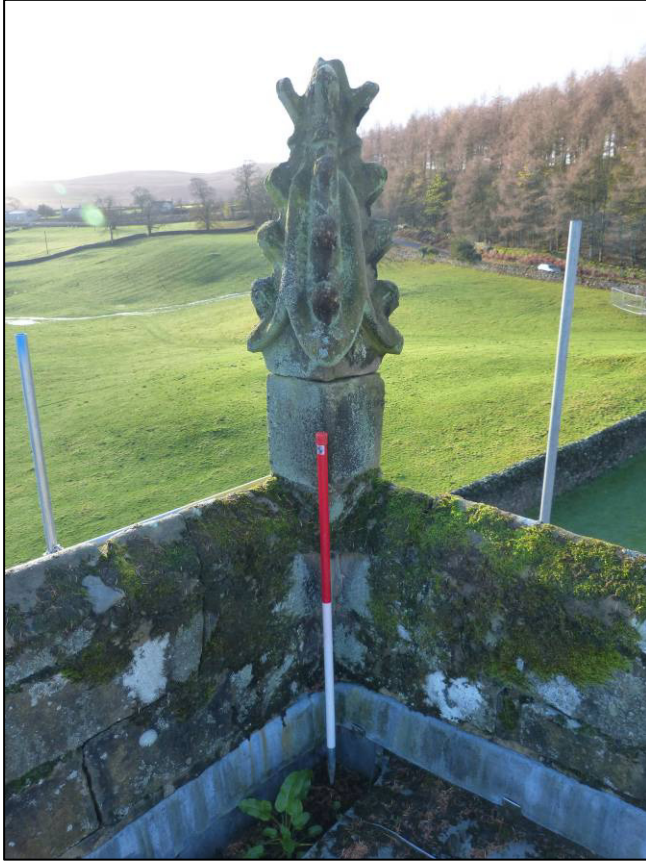
Plate 26: Tower, south-west corner pinnacle, looking S (photo 2/316).

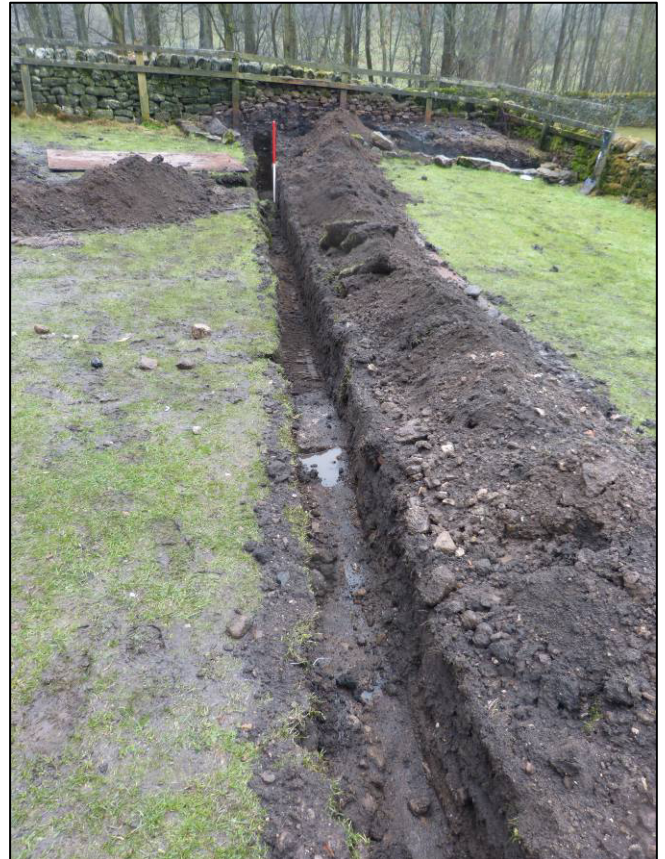
Plate 32: Drainage trench T2, east end,  
looking E (photo 6/929).

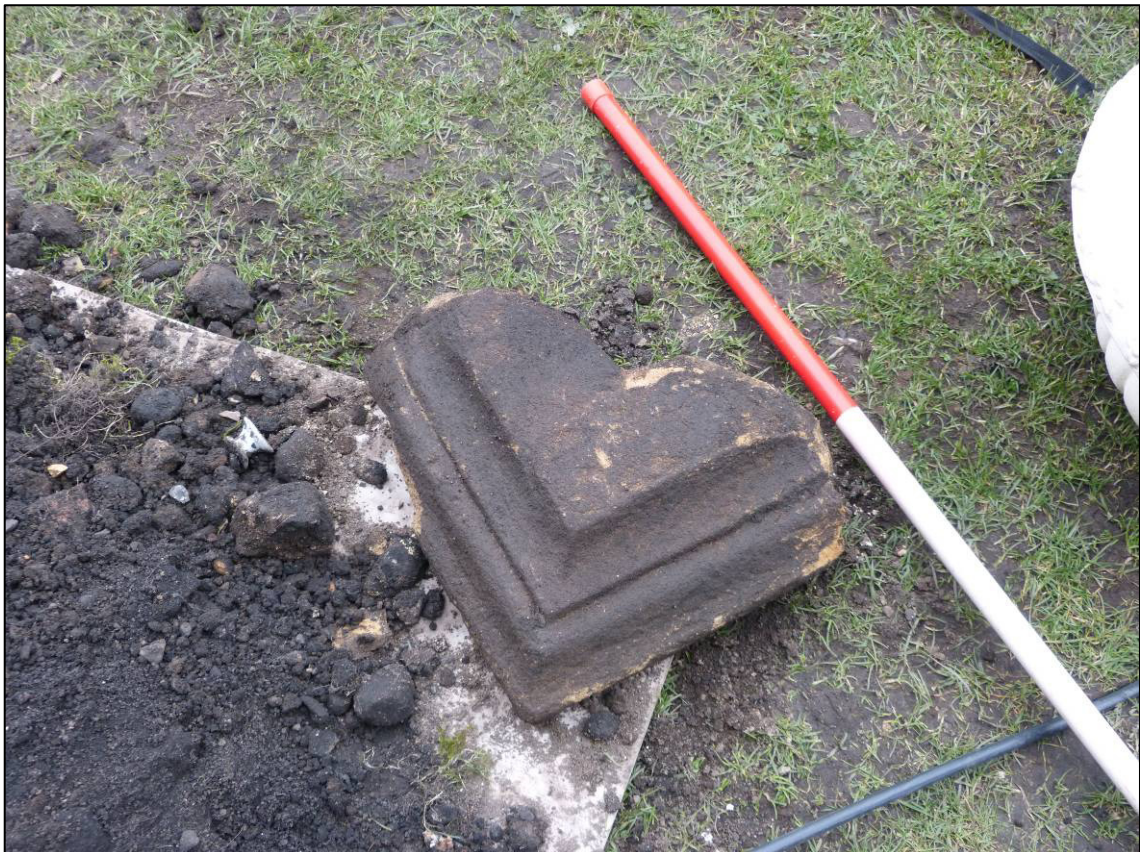
Plate 33: Drainage trench T1, ex situ moulded stone (photo 5/914).

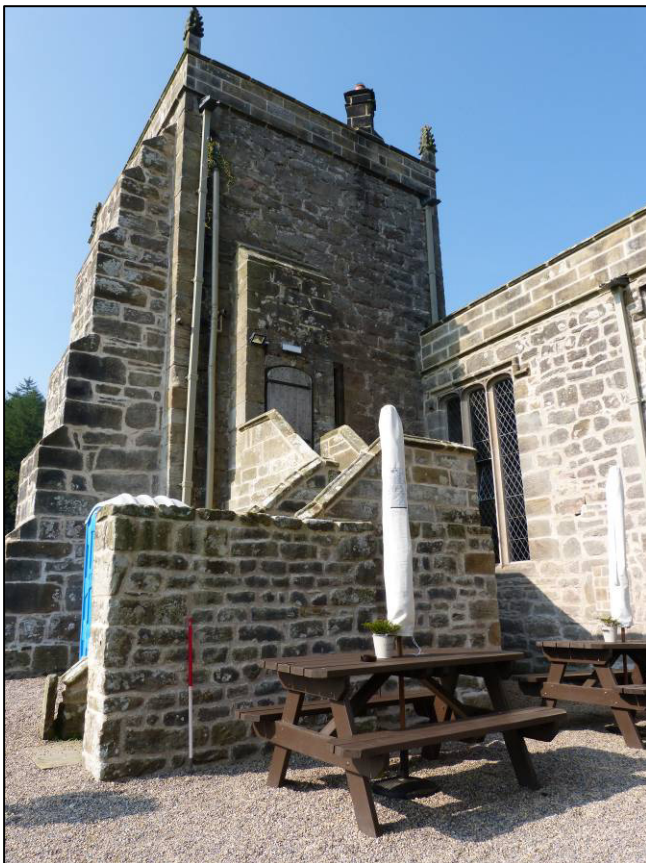
Plate 38: Tower, east elevation and steps, works complete, looking W (photo 7/581).

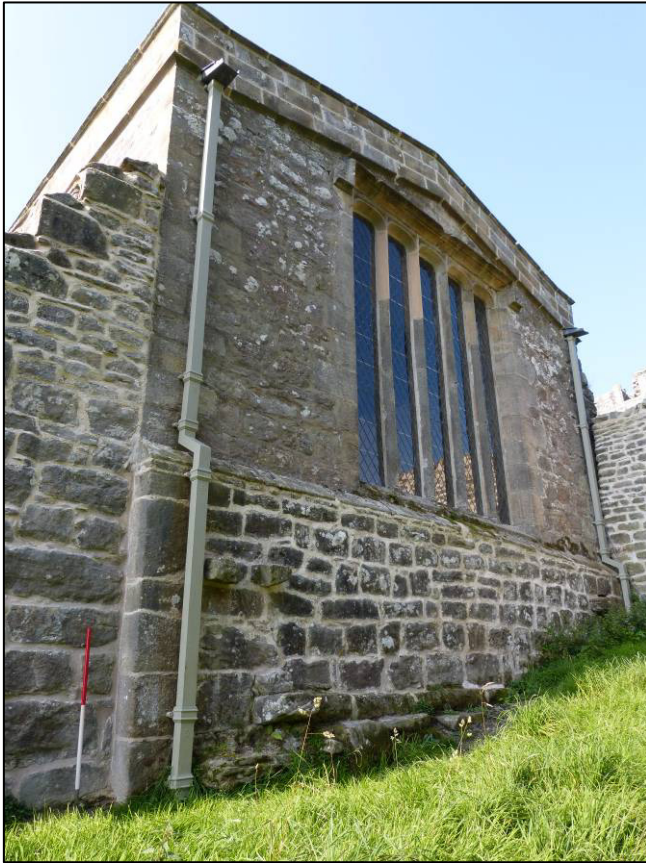
Plate 40: Chapel, east gable, works complete, looking NW (photo 7/590).
