FYLING DEER PARK WALL,  
FYLINGDALES, NORTH YORKSHIRE

ARCHAEOLOGICAL RECORDING  
AND MONITORING OF 2016-17 REPAIRS

Report no: 2016/527.R01  
Version: Final  
Date: February 2018  
Author: Ed Dennison

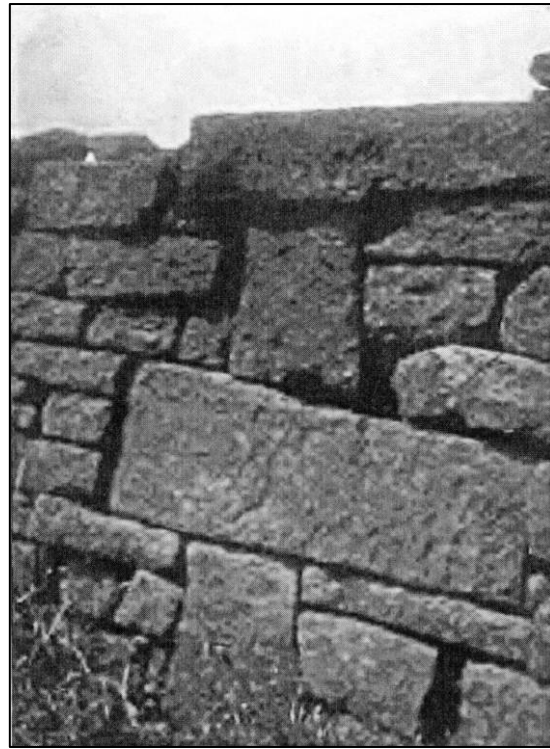
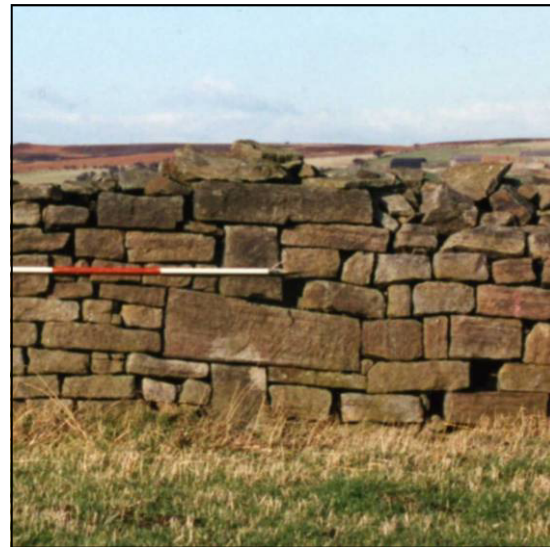
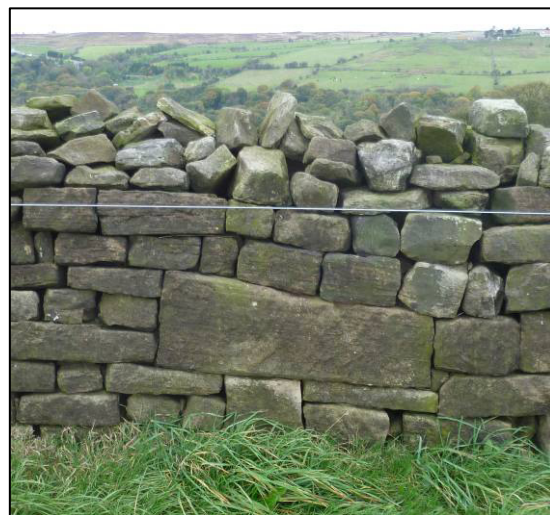
Cross 28 south

Top: Atkinson, J C 1898 'An Ancient Wall at Fylingdales, near Whitby'. *The Reliquary and Illustrated Archaeologist*, July 1898, p197.  
 Centre: 1991 photograph 23/S40.  
 Bottom: 27th October 2016 (photo 1/297).

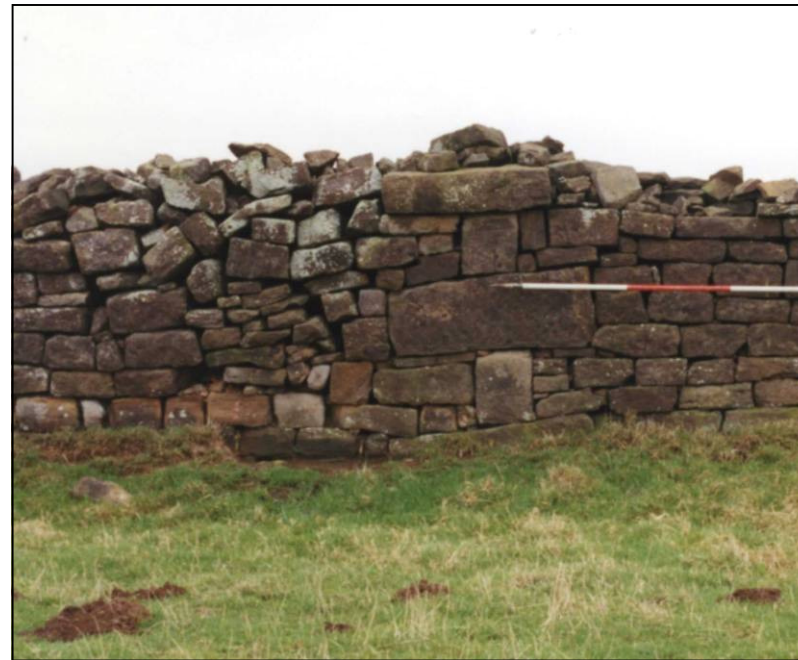
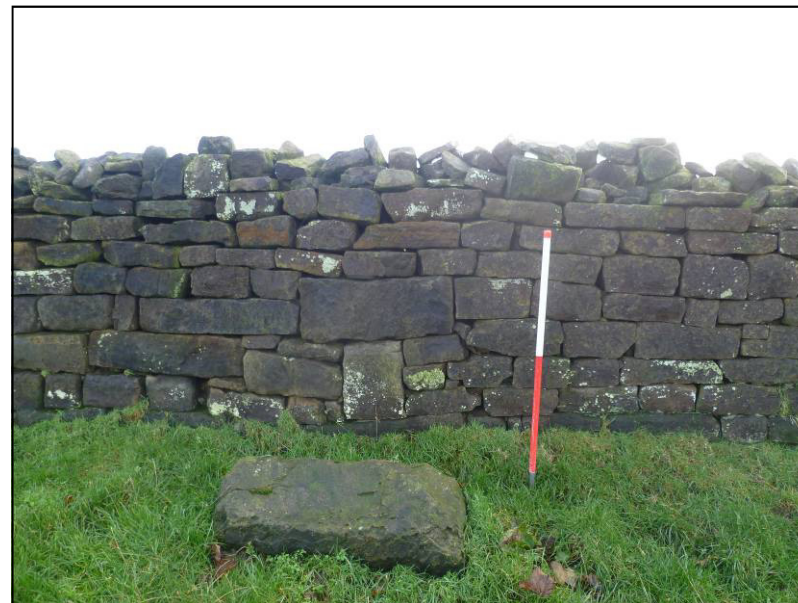
Cross 28 north  
 Top: 1991 photograph 23/S40.  
 Bottom: 8th November 2016 (photo 2/470).

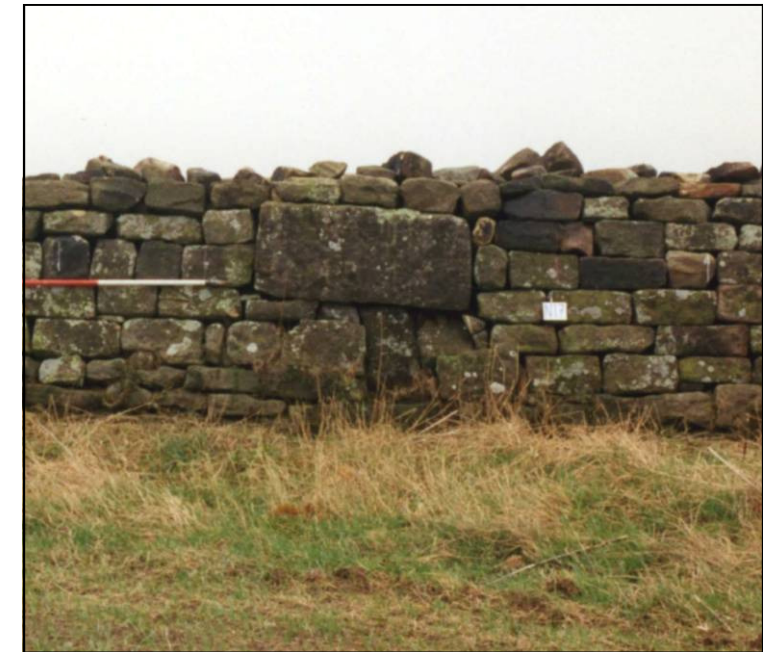
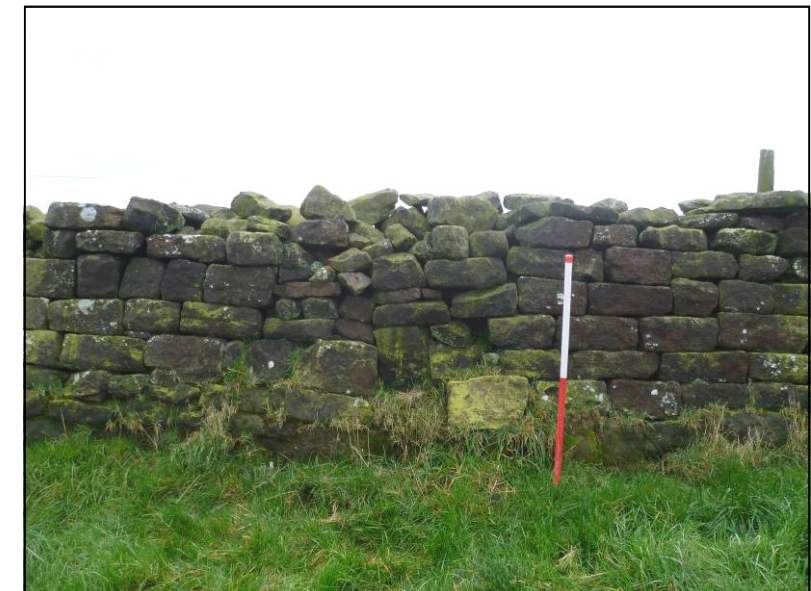
Cross 13 north  
 Top: 1991 photograph 3/N17.  
 Bottom: 27th October 2016 (photo 1/271).

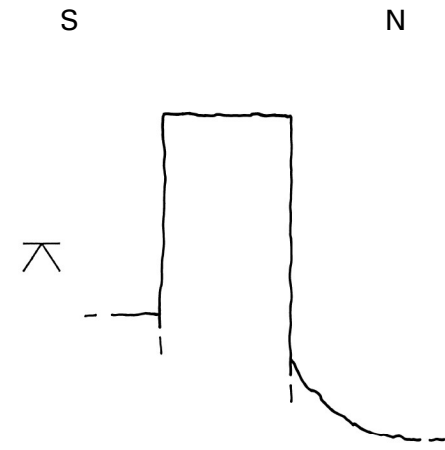
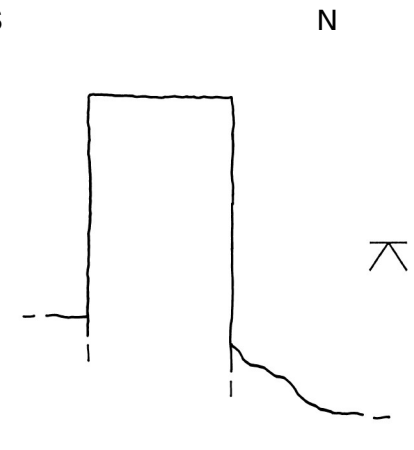
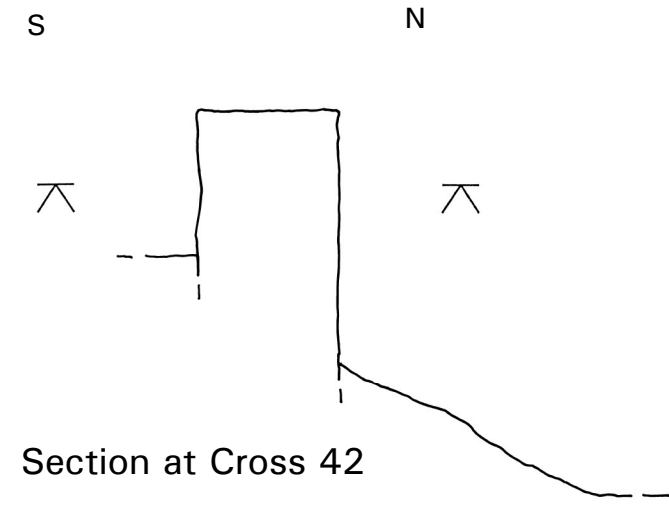
PROJECT FYLING DEER PARK WALL	
TITLE SECTIONS OF CROSSES	
SCALE AS SHOWN	DATE FEB 2018
EDAS	FIGURE 6

- 5.9 The presence of the bank on the north side of the wall serves to emphasize the difference in ground levels either side of the wall, and also to raise the height of the north face of the wall. Along virtually the whole alignment, the ground on the south side of the wall is significantly higher than that on the north. At cross 4, towards the west end of the wall, there is a difference of 0.9m between ground levels, at cross 8 it is 0.7m, at cross 22 it is 0.7m, and at cross 42 towards the east end of the wall, it is 1.4m (see figure 6).

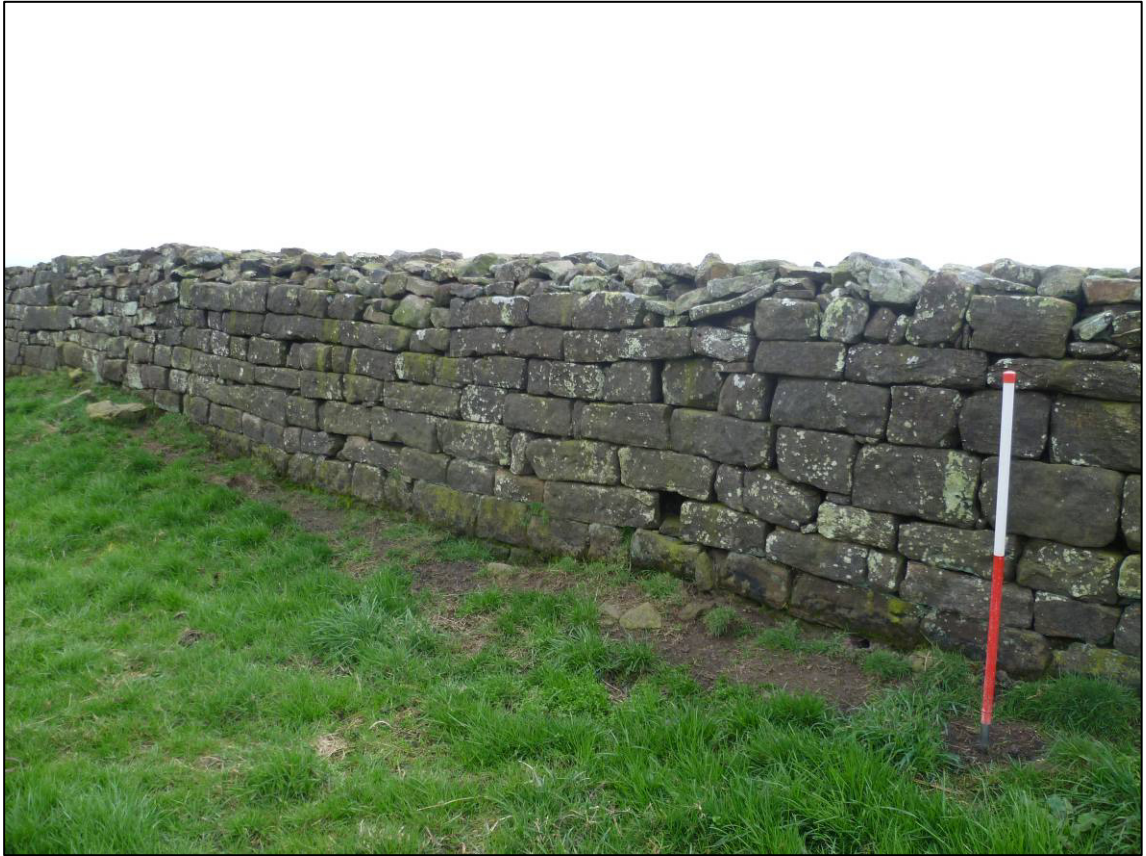
Plate 3: Possible section of original walling between crosses 24 and 25, north side, looking E (photo 4/046).

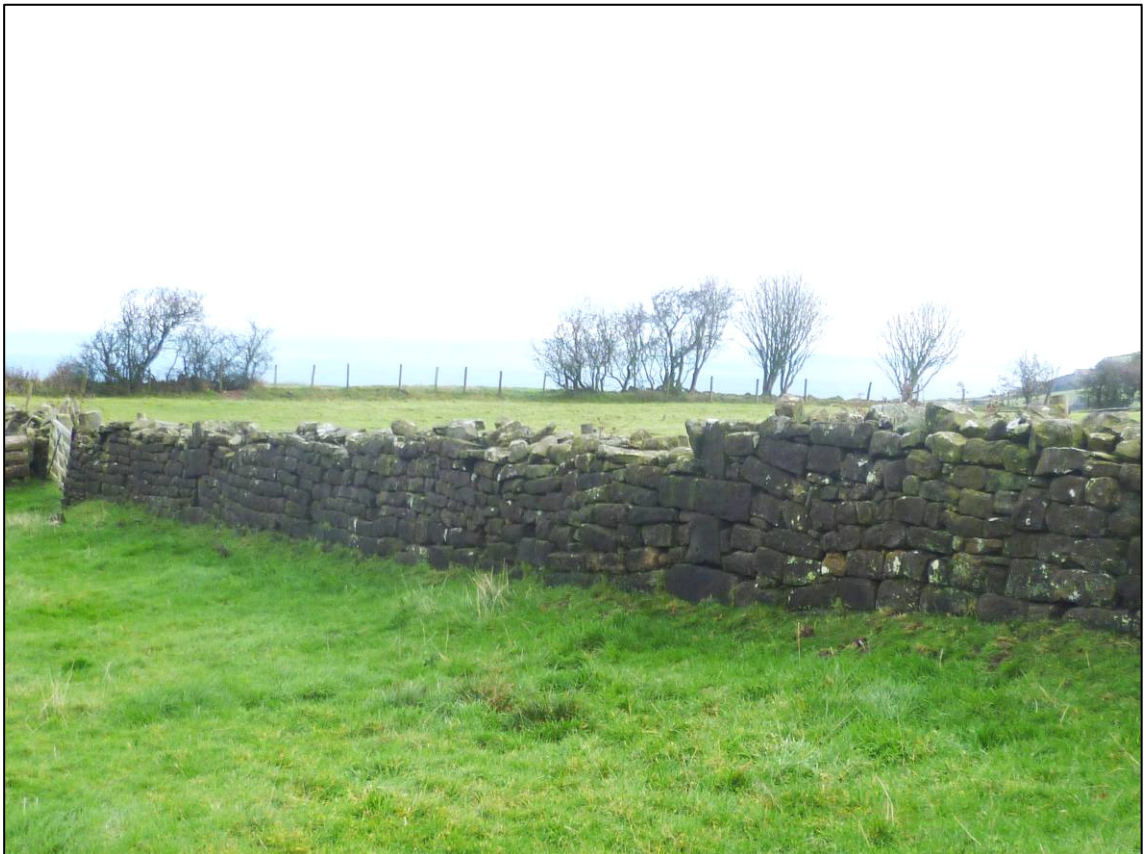
- 5.4 The wall is of drystone construction, and is built of large square blocks of local gritstone with a rubble core. The blocks are generally well coursed, except where there has been previous repair or rebuilding, and indeed this provides evidence for earlier interventions. It has previously been suggested that significant portions of this section of wall appear to be undisturbed medieval fabric, retaining the original courses and many of the stone crosses (Proctor 2016). However, the waller undertaking the repair work thought that about 60%-70% of the alignment had been altered or rebuilt (Donald Gunn, *pers. comm.*), and a comparison with the 1991 photographic record and the survey results suggests that this percentage may have been even higher. Nevertheless, some potentially original or earlier sections were identified, for example to the east of cross 7N [1/254] (but perhaps this was pre-1991 repair), between crosses 24 and 25 [4/046, 4/047] (see plate 3) (although this section does not appear so regular in the 1991 photographs), around crosses 30N and 37N [5/195; 2/461] (although the latter appears to be a later rebuild according to the 1991 photographs), west of cross 39N [2/456], and between crosses 47N and 48N [2/447] (see plate 4).

Plate 4: Possible section of original walling between crosses 47 and 48, north side, looking E (photo 2/447).

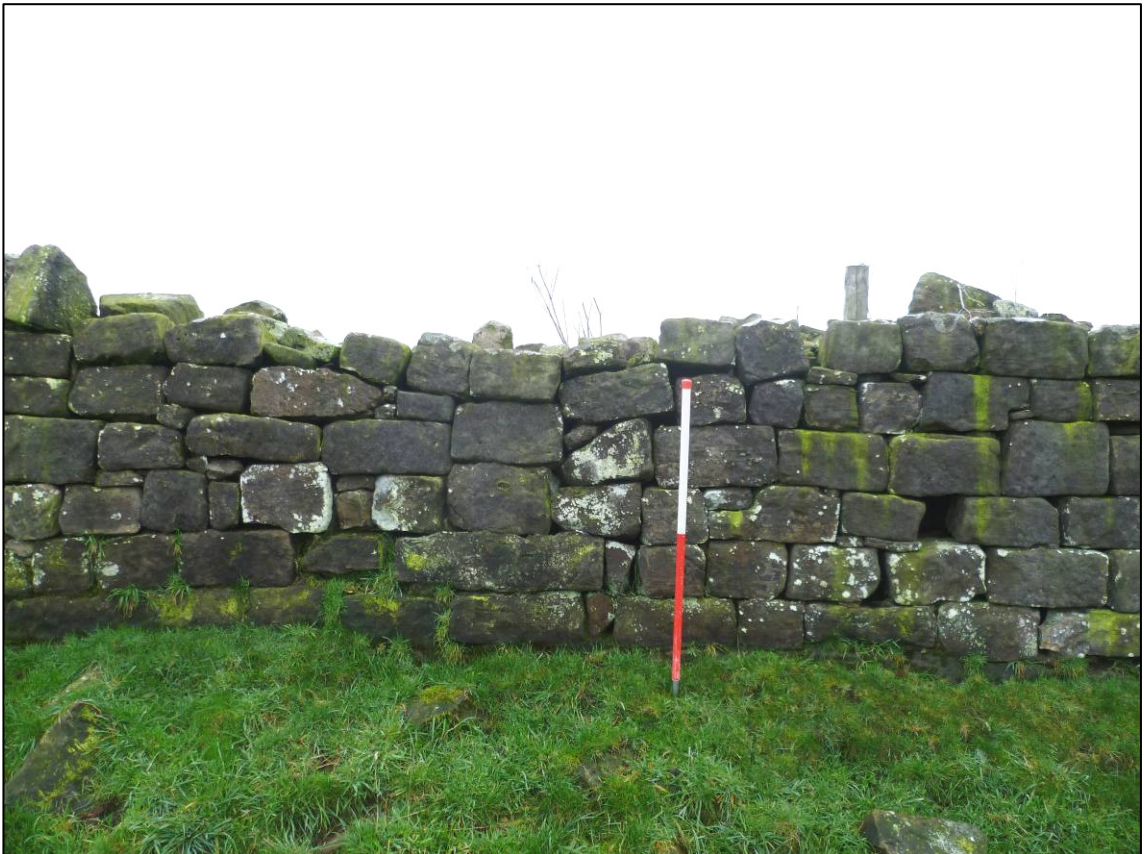
Plate 8: Possible blocked stile, east of cross 2, north side (photo 1/246).

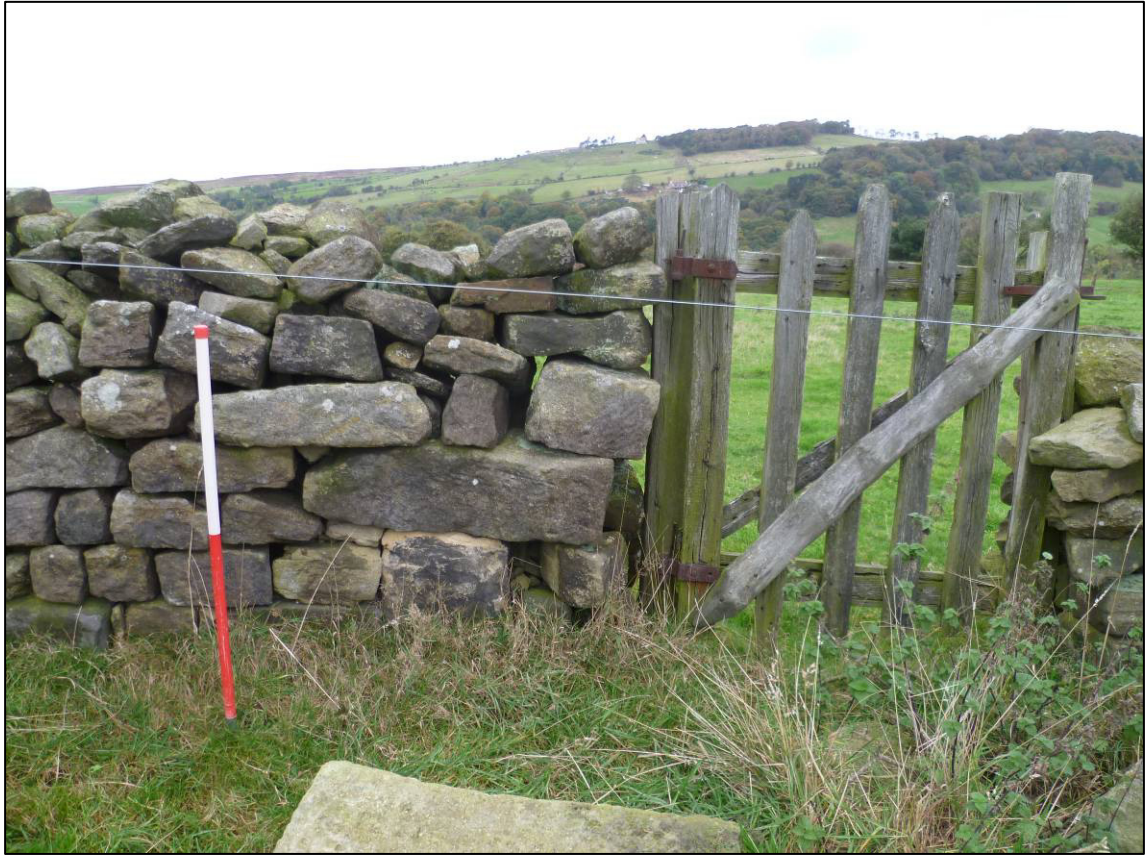
Plate 9: Cross 46 and wooden gate, south side (photo 1/306).

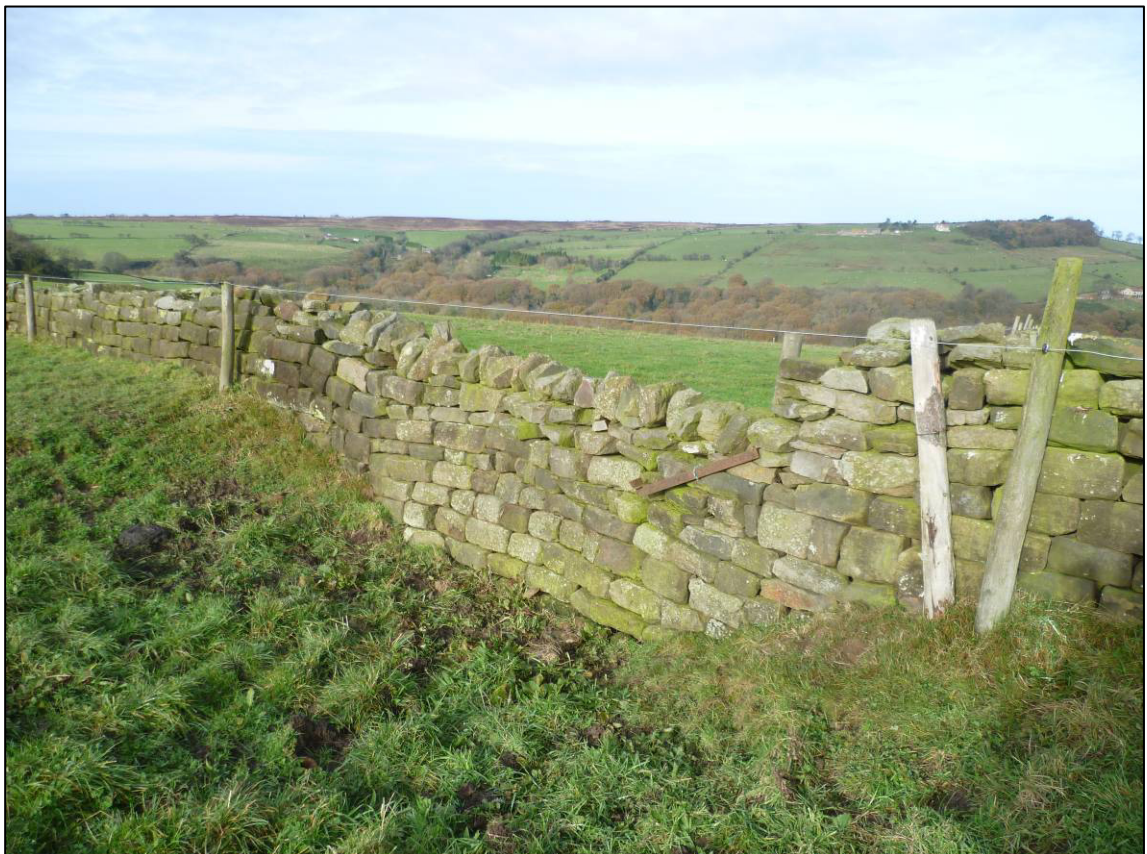
Plate 10: Recently blocked gate between crosses 12 and 13, S side, looking NW (photo 5/222).

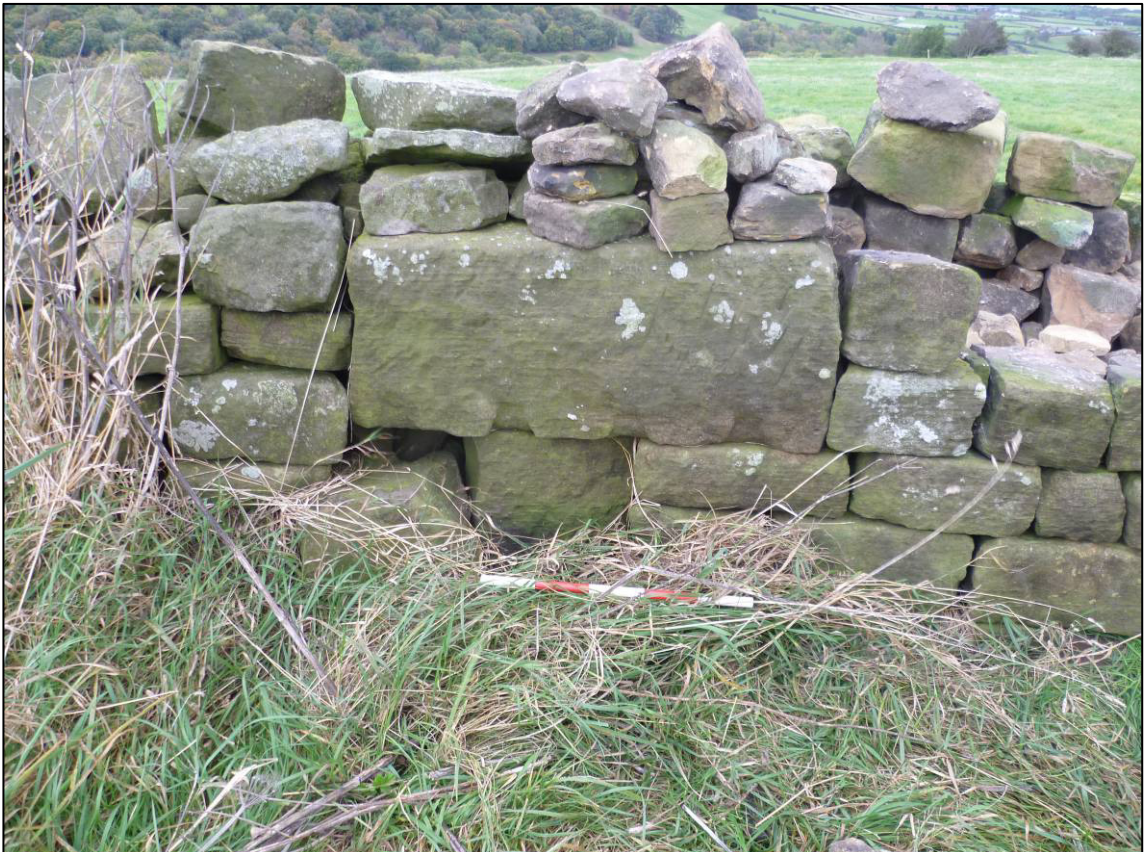
Plate 14: Cross 5, south side, showing plug and feather marks to upper lintel (photo 1/267).

<b>Cross</b>	<b>Description</b>	<b>Photo</b>	<b>Photo before</b>	<b>Photo after</b>	<b>Other photo</b>
<b>5S</b>	To left of gate. Lower lintel not visible, no upper through in collapsed wall top. Plug and feather marks to lower side of upper lintel. No repairs to cross in 2016-17 but wall top courses reset.	1/244 (S) before* 1/267 (S) before 1/268 (S) plug marks* 3/603 (S) after*

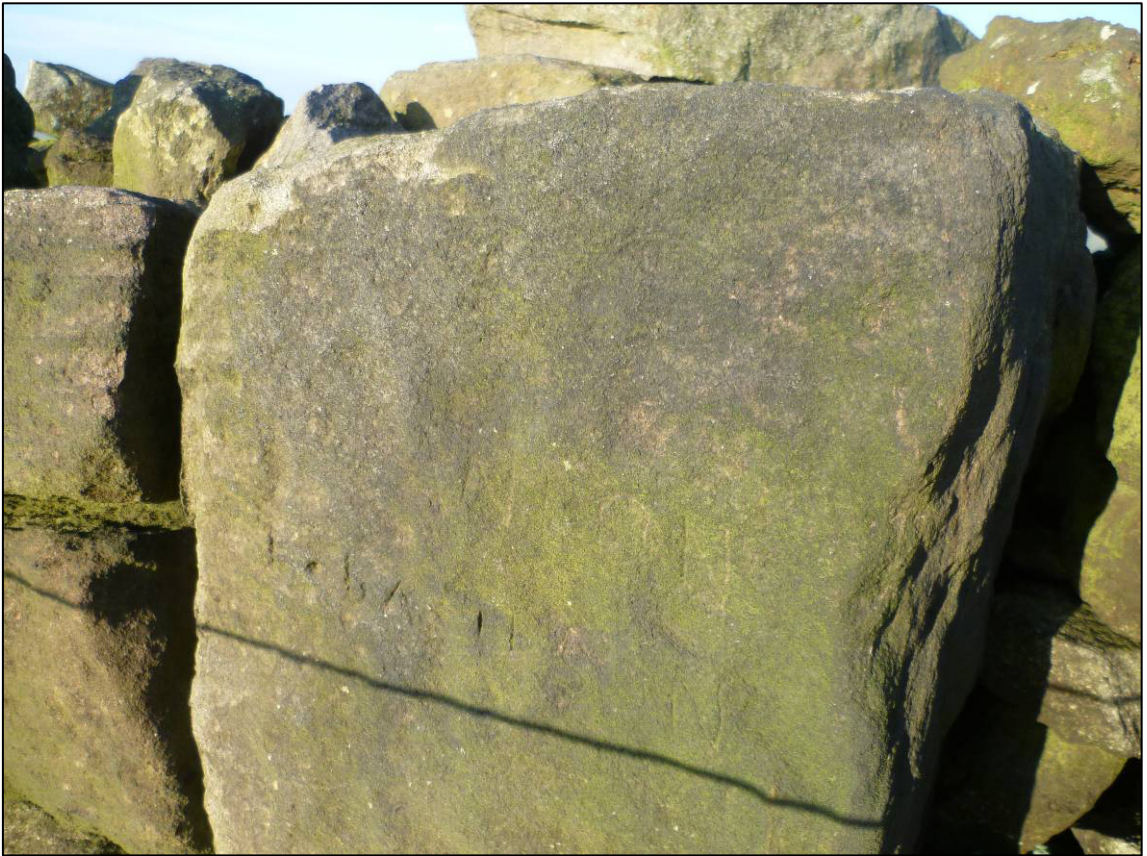
Plate 15: Cross 22, south side, inscription (photo 3/627).

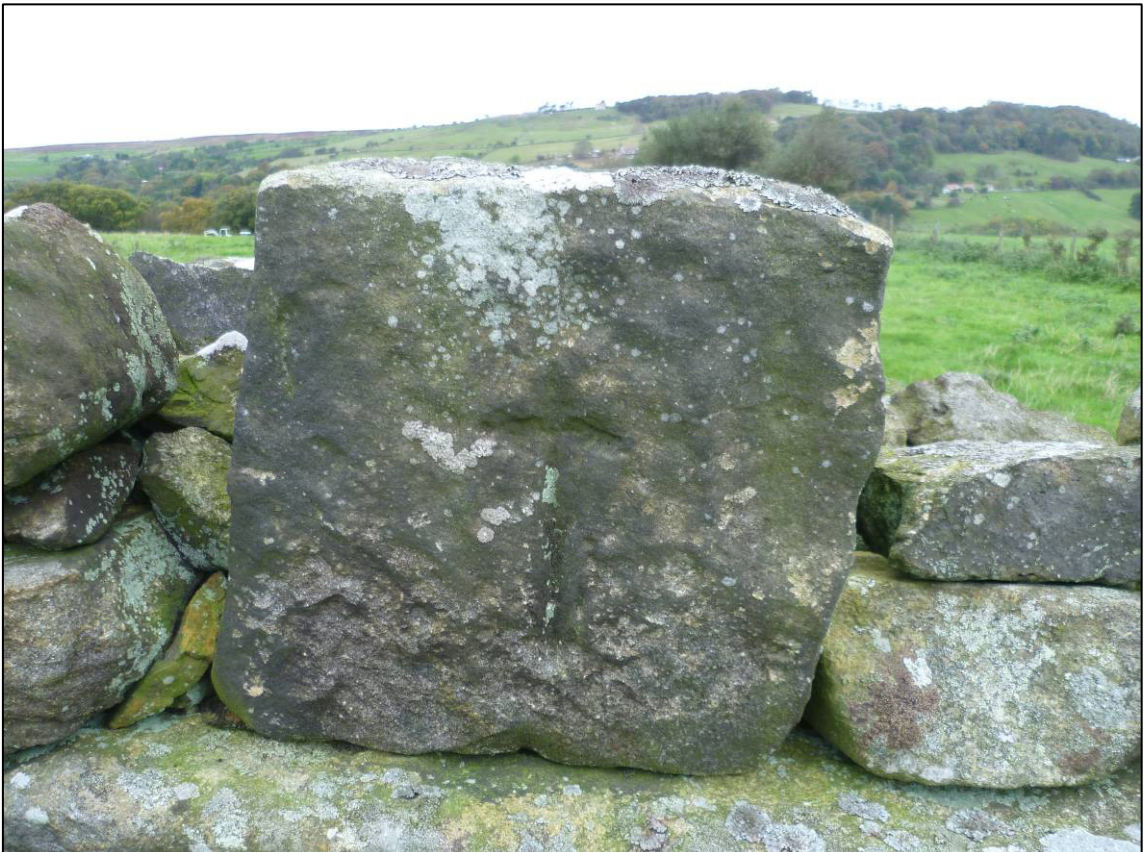
Plate 16: Cross 48, south side, carved cross on upper through (photo 1/311).

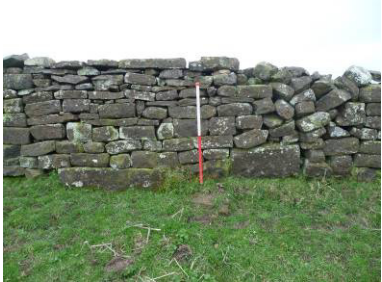
<b>Cross</b>	<b>Description</b>	<b>Photo</b>	<b>Photo before</b>	<b>Photo after</b>	<b>Other photo</b>
<b>7N</b>	15m between Crosses 6 & 8 in area of rebuild, large lintel in place at base of wall may be remains of a cross, with displaced possible through two courses above, but most elements missing. Wall 1.2m high. No repairs done in 2016-17. Possible blocked opening W of cross (1/253). Possible section of original walling E of cross (1/254*).	3/608 (N) after 4/013 (N) after*

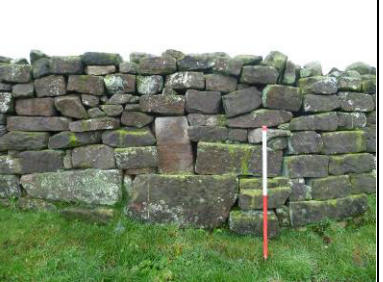
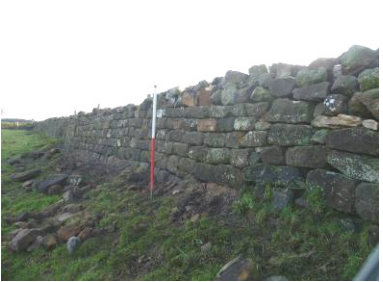
<b>7S</b>	Not really visible. Lower lintel almost completely buried, but hole above where lower through has been removed. Remainder lost in rebuild. No repairs done in 2016-17. Hole under lower through also visible in 1991, repairs to E in 1991.	3/607 (S) after 4/014 (S) after*		 	
<b>8N</b>	Short lower lintel and lower through visible, rest lost in wall rebuild. Lower through slightly leaning. No repairs to cross in 2016-17 but some rebuilding of wall to E (3/610*; 5/229).	1/252 (N) before*

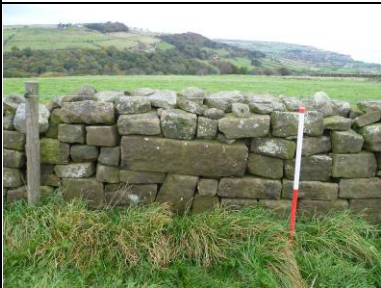
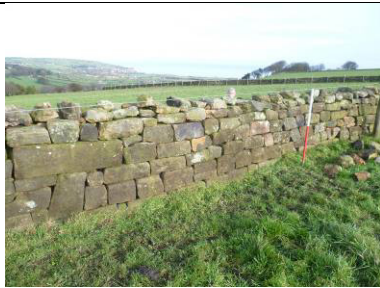
<b>Cross</b>	<b>Description</b>	<b>Photo</b>	<b>Photo before</b>	<b>Photo after</b>	<b>Other photo</b>
<b>8S</b>	Wall 0.9m high. Lower lintel not visible. Lower through leaning with upper lintel above. No upper through, lost in old wall rebuild. No repairs done to cross in 2016-17, but some rebuilding of wall to E (3/606, 3/609; 5/228*).	1/260 (S) before*

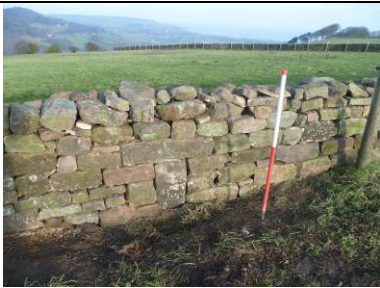
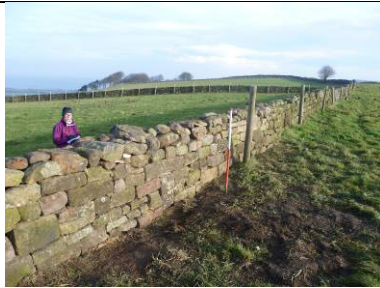
<b>9S</b>	Lower lintel not visible, lower through visible in area of old wall repair. Upper elements not visible. Repaired 2016-17 with thin upper lintel (possibly not original) added. Courses to E rebuilt (3/613*). Repairs done in 1991 either side of cross up to cross 10S.	3/611 (S) after*

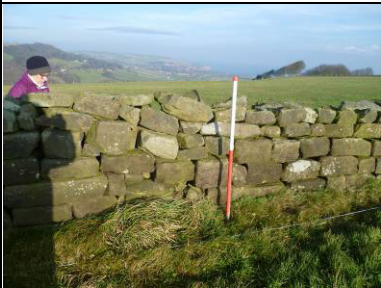
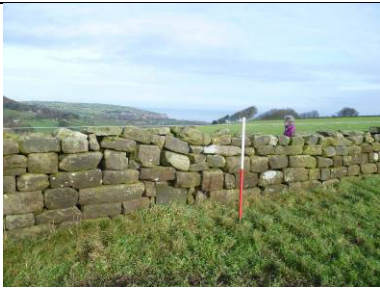
<b>Cross</b>	<b>Description</b>	<b>Photo</b>	<b>Photo before</b>	<b>Photo after</b>	<b>Other photo</b>
<b>13S</b>	Possible displaced lower through visible, but not convincing. No other elements. In area of localised old rebuild. Wall typically 0.8m high. No repairs done in 2016-17, but some apparent in 1991.	3/616 (S) before* 3/617 (S) before 5/221 (S) after*

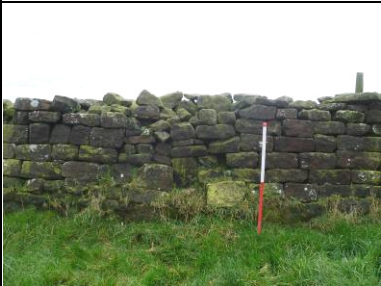
<b>13N</b>	Possible lower through visible, although difficult to see lower lintel. No upper elements. Coincides with localised area of old rebuild. Wall typically 1.2m high. No repairs done in 2016-17. Complete cross visible in 1991.	1/271 (N) before*

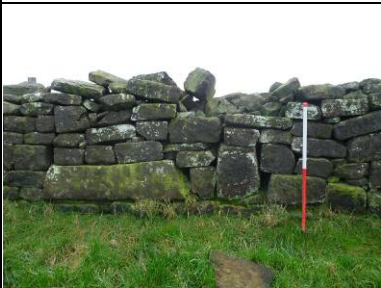
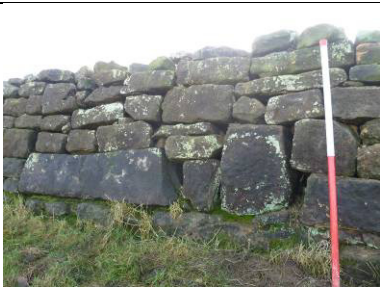
<b>14N</b>	Lower through sitting on part buried lower lintel, upper lintel displaced to east in area of old rebuild. No obvious upper through. Wall top rebuilt 2016-17.	1/272 (N) before* 3/619 (N) after*

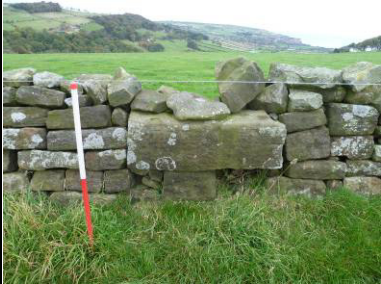
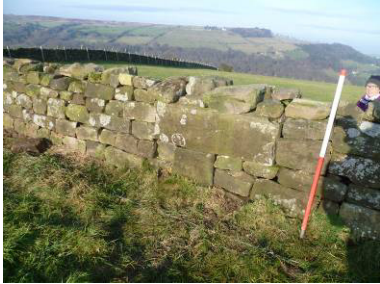
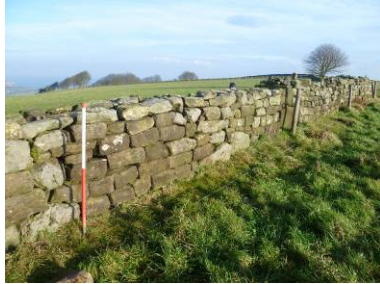
<b>Cross</b>	<b>Description</b>	<b>Photo</b>	<b>Photo before</b>	<b>Photo after</b>	<b>Other photo</b>
<b>14S</b>	Off centre lower through and upper lintel visible. Top of upper lintel at wall top. Hole under E side of lintel. No upper through. Limited works done, but hole infilled and wall top replaced. Adjacent courses rebuilt 2016-17 (3/620*).	1/285 (S) before* 3/618 (S) after*

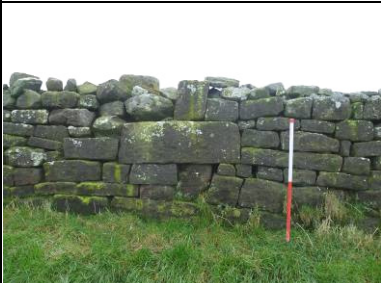
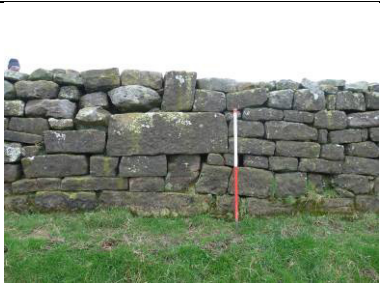
<b>15N</b>	Relatively well preserved, with all elements surviving. Upper lintel slightly off centre, 1.12m long, 0.40m high & 0.26m deep. Lower through slanting and upper through not square, on wall top. No repairs done to cross in 2016-17 but top course of adjacent wall replaced.	1/273 (N) before* 4/020 (N) after*

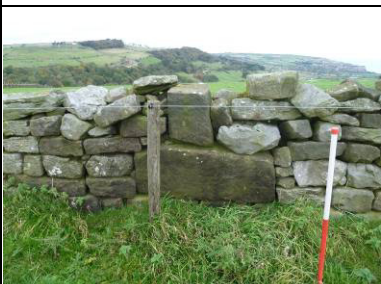
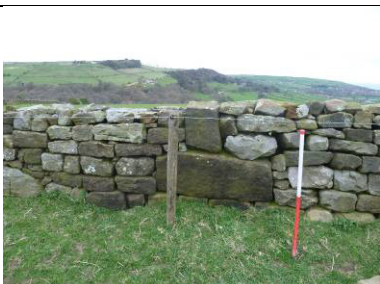
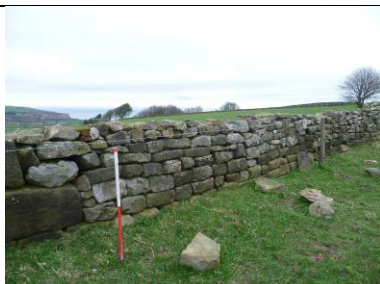
<b>15S</b>	Height of wall 0.95m. Lower lintel and through not visible. Massive upper lintel with diagonal tool marks. Upper through forms wall top and also has diagonal tooling marks. Adjacent wall tops reset and some courses rebuilt in 2016-17 (4/018-019*).	1/286 (S) before * 4/017 (S) after*

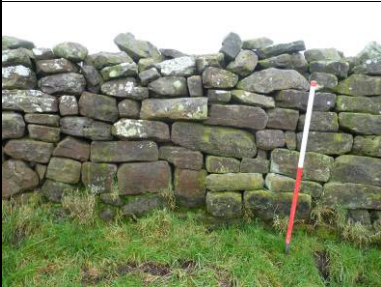
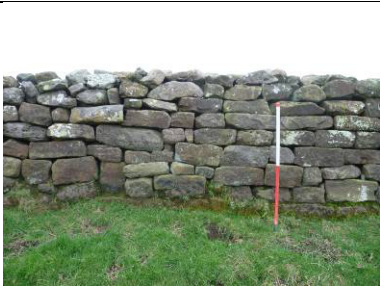
<b>Cross</b>	<b>Description</b>	<b>Photo</b>	<b>Photo before</b>	<b>Photo after</b>	<b>Other photo</b>
<b>16N</b>	Probable mostly buried very long lower lintel 15m from cross 15 in base of wall. Displaced lower through 1.0m long at E end, slightly set back from wall face. No upper elements. In area of former localised rebuild. Random wall tops, wall 1.2m high. No repairs done to cross in 2016-17 but wall top reset.	1/274 (N) before* 3/621 (N) before 3/622 (N) before 4/021 (N) after*

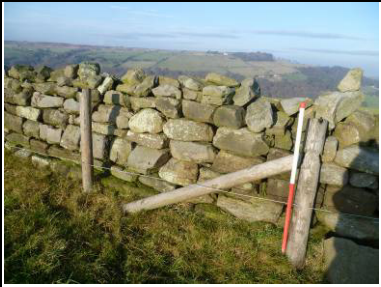
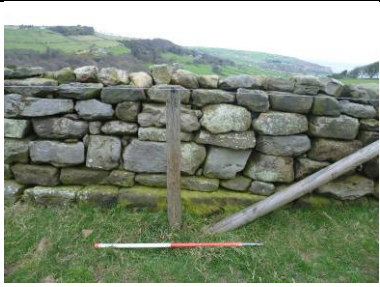
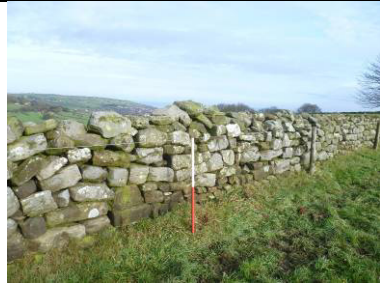
<b>16S</b>	Behind fence post. Just lower through visible in bottom of wall, mostly hidden by vegetation, seemingly further to W than on other side. Probable lower lintel below, 1.0m long. Upper elements missing. No repairs to cross in 2016-17, but wall top reset. Area of old rebuilt between crosses 16 and 17 (5/220*).	3/623 (S) before* 4/022 (S) after*

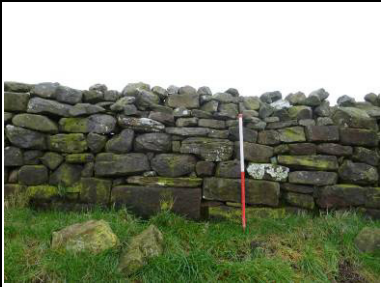
<b>17N</b>	Difficult to see, but 15m from cross 16. Possible lower lintel in place with lower through displaced to left. No upper elements. Area of old rebuild above. No repairs proposed or evident in 2016-17.	1/275 (N) before*

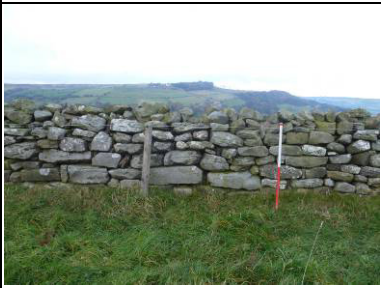
<b>Cross</b>	<b>Description</b>	<b>Photo</b>	<b>Photo before</b>	<b>Photo after</b>	<b>Other photo</b>
<b>17S</b>	No obvious sign of any elements, in area of old rebuild down to ground level. No repairs proposed or evident in 2016-17.	2/488 (S) before*

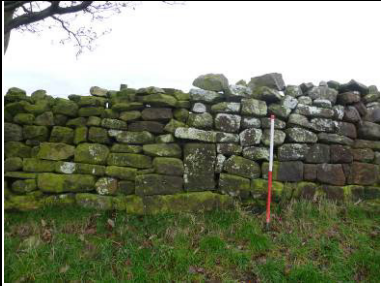
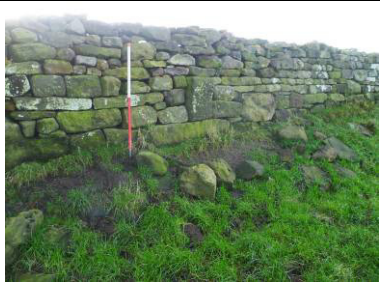
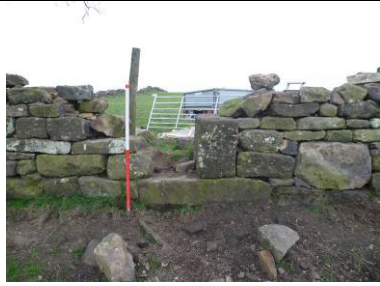
<b>18N</b>	Just to right hand side of tree, 15m from Cross 17. Lower lintel visible, with off centre lower through above. Top of lintel not level, and through sits on highest part. Upper lintel and through missing. Coincides with area of lichen covered old rebuild. 2016-17 repairs in progress 4/4/17 (4/026*). Rebuilding to courses above lower through and wall tops reset. End of lower through is proud of wall face. Some rebuilding to W and E (4/027-028; 5/219).	1/276 (N) before* 5/218 (N) after*

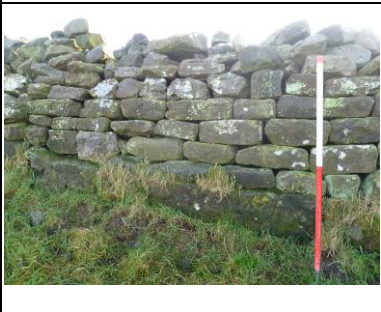
<b>Cross</b>	<i>Description</i>	<i>Photo</i>	<i>Photo before</i>	<i>Photo after</i>	<i>Other photo</i>
<b>19N</b>	Only large lower lintel visible, with notched stone displaced to W. Wall typically 1.0m high. No repairs proposed or evident in 2016-17.	3/624 (N) before* 3/625 (N) before

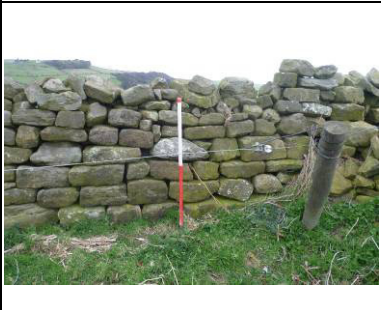
<b>19S</b>	Only lower lintel visible in base of wall, no obviously throughs and no upper lintel. Wall typically 1.0m high, same as N side. No repairs proposed or evident in 2016-17.	4/029 (S) before*

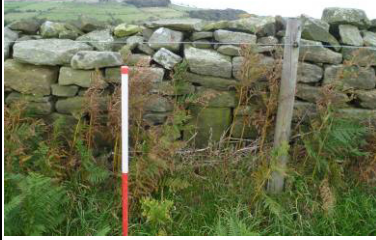
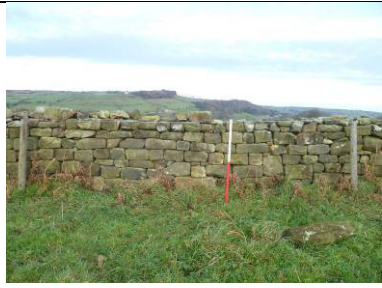
<b>Cross</b>	<b>Description</b>	<b>Photo</b>	<b>Photo before</b>	<b>Photo after</b>	<b>Other photo</b>
<b>23S</b>	Only lower through visible, some vegetation. In area of old rebuild, including wall tops. Lower through fully exposed after resetting of wall tops, possible through or lintel in wall to W. 2016-17 minor repairs to wall tops, in section between crosses 22 and 23 (5/213*).	1/291 (S) before* 4/037 (S) after* 5/212 (S) after

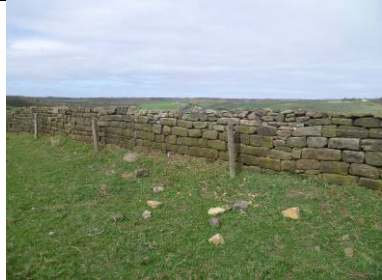
<b>24S</b>	Large upper through central on upper lintel, with lower through displaced to the left. No obvious lower lintel but lower through may be displaced to W. Smaller stones all round, suggesting old repair. Wall typically 1.2m high. No repairs proposed in 2016-17. Possible area of original build between crosses 24 and 25 (4/047*).	1/292 (S) before*

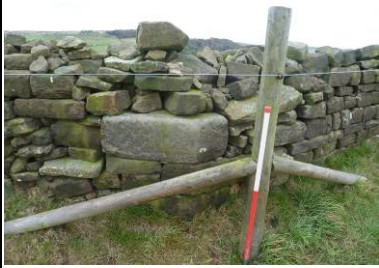
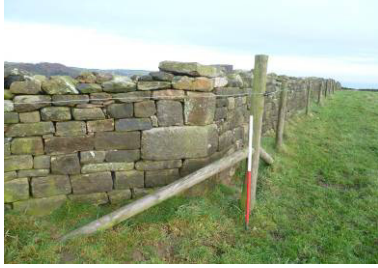
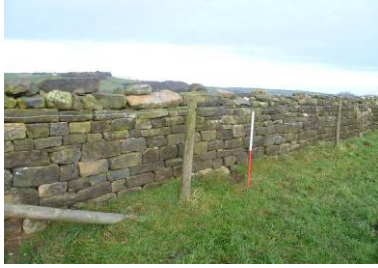
<b>S</b>	Not a cross - angle of wall. No obvious cross elements but quoins have chamfered angles to three visible courses below area of rebuild. Repairs to wall to E and W in 2016-17, including rebuilding of upper courses around angle itself, raising height of wall (5/204*). Area of recent repair to E in 1991.	1/295 (S) before* 1/296 (S) before 5/205 (N) after*

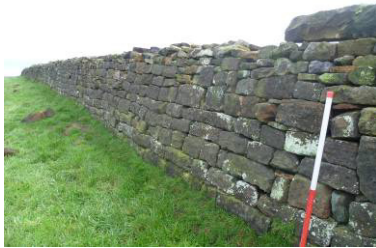
<b>29N</b>	All elements visible, although off centre throughs misaligned and with sloping sides. Rough walling on top and around cross elements. No repairs to cross in 2016-17 but some rebuilding to E and W with resetting of wall tops (5/202*-203). Substantial build to this part of the wall, 1.3m high, with batter. Large lintel to immediate W, not apparently connected with cross. Hole adjacent to lower through also present in 1991, with some rebuilding to E.	2/469 (N) before* 5/201 (N) after*

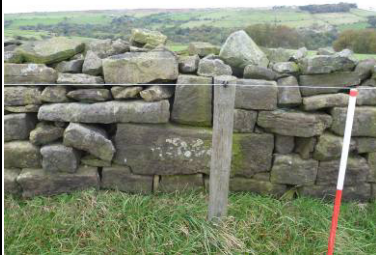
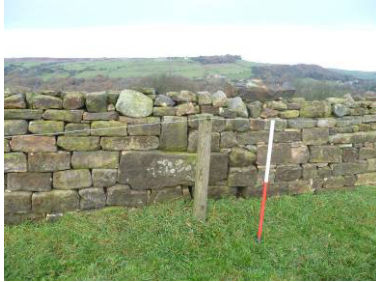
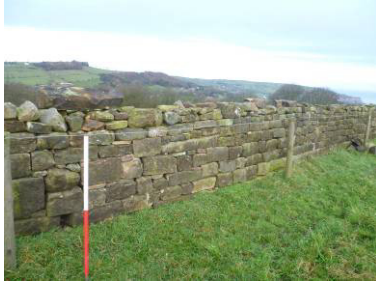
<b>29S</b>	Top half of lower through and upper lintel and upper through visible. Throughs slightly off centre. Bottom of lintel has notches cut from both corners. No repairs to cross in 2016-17, but wall rebuilding to E and W (5/199*-200).	1/298 (S) before* 1/299 (S) before 5/198 (S) after*

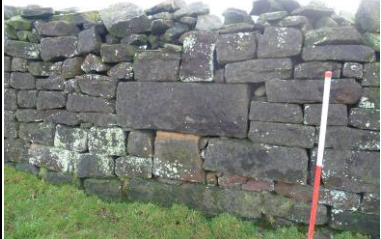
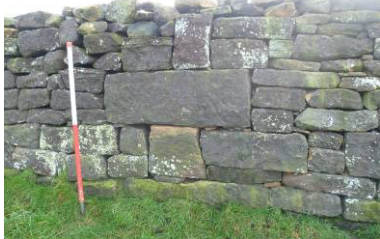
<b>Cross</b>	<b>Description</b>	<b>Photo</b>	<b>Photo before</b>	<b>Photo after</b>	<b>Other photo</b>
<b>30N</b>	Relatively well preserved, with all elements visible, only lowest part of lower lintel buried. Throughs slightly off centre and with sloping sides. Upper through has smaller section to lower one. Random wall top, but otherwise well-built section of wall. No repairs to cross in 2016-17, minor resetting of wall tops to E and W (5/196*-197).	2/468 (N) before* 5/195 (N) after*

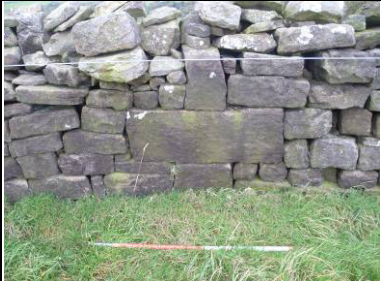
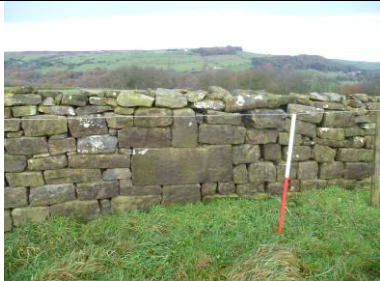
<b>30S</b>	Lower part of lower through buried, but upper elements visible. Upper through has angled section. Cross is 0.90m high, wall is 1.12m high. Minor repairs, resetting wall tops, in 2016-17. Resetting of courses both E and W, as far as Cross 29 (5/193-194*).	1/300 (S) before* 5/192 (S) after*

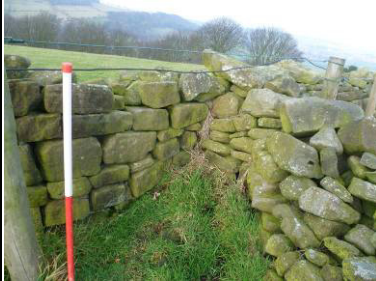
A photograph showing a section of a stone wall with a red and white marker post. The wall is made of large, roughly-hewn stones. The top left corner shows a slight downward slope in the courses above the lintel.		
<b>32S</b>	Not visible, hidden in angle of wall by wall from S. No repairs done in 2016-17. Field wall from S butts park wall and hides cross, therefore presumably later.	3/629 (S) before*

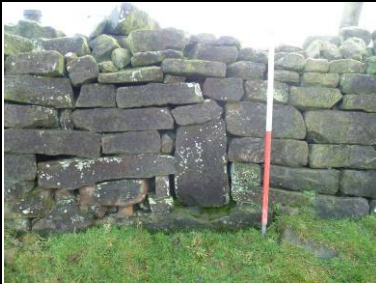
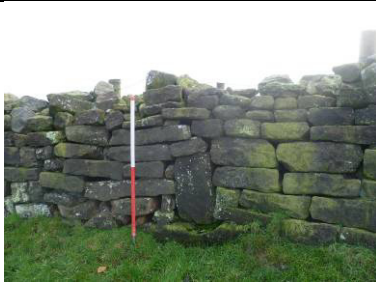
<b>32N</b>	13m from Cross 33. Only lower lintel and lower through visible, old rebuild above. Top surface of lintel is dished, so through is set back onto better surface. No repairs evident in 2016-17 and no change to cross. Much collapse to W in 1991.	2/466 (N) before* 5/191 (N) after*

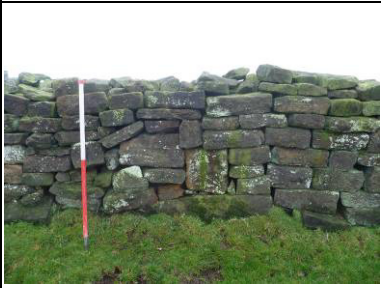
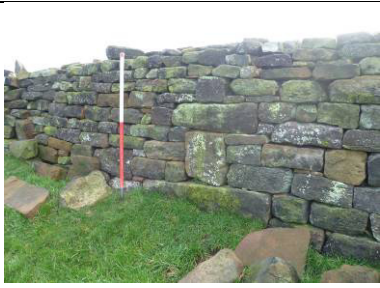
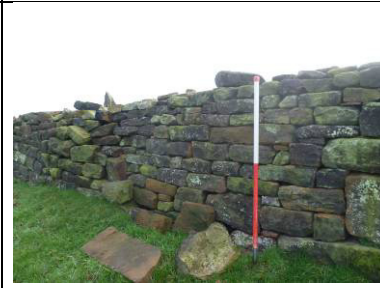
<b>Cross</b>	<b>Description</b>	<b>Photo</b>	<b>Photo before</b>	<b>Photo after</b>	<b>Other photo</b>
<b>33N</b>	Upper part of lower lintel and lower through only visible. Small packing stones under lower through. Area of old rebuild above and around. Wall 1.2m high. Repairs done 2016-17. Upper lintel and through added to cross, and adjacent courses rebuilt (5/190*). Packing stones also evident in 1991.	2/465 (N) before* 5/189 (N) after*

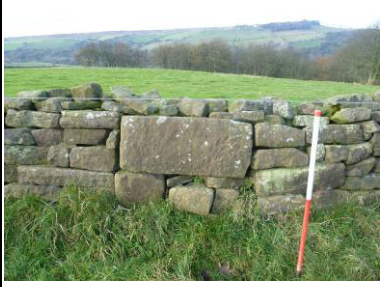
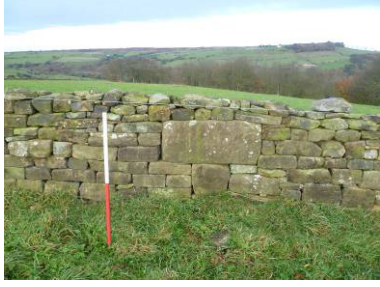
<b>33S</b>	Low section of wall. Lower lintel mostly buried, lower through off centre at west end of upper lintel, large squared upper lintel (0.90m long x 0.42m high), upper through missing. Random packing under lintel and on wall top. Obvious earlier rebuild. Repairs done 2016-17. Lower through repositioned centrally, and adjacent courses reset. Wall top heightened. Area of collapse to E in 1991.	2/483 (S) before* 5/187*-188 (S) after

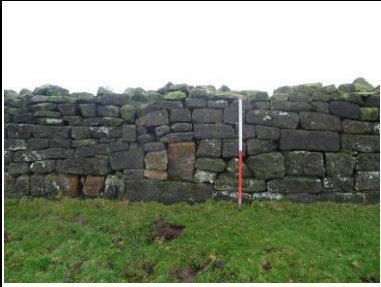
<b>34N</b>	Lower lintel and lower off centre through only visible. Plug and feather marks on top face of lintel - well preserved. Old rebuilding above and around. No repairs proposed or evident to cross or wall tops in 2016-17.	2/464 (N) before*

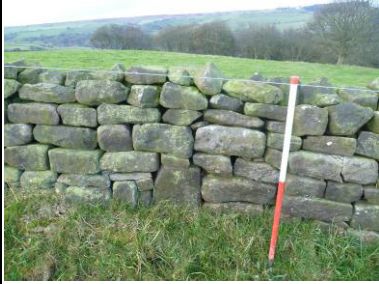
<b>Cross</b>	<i>Description</i>	<i>Photo</i>	<i>Photo before</i>	<i>Photo after</i>	<i>Other photo</i>
<b>34S</b>	Only top half of lower through visible. Old rebuilding above and around. Wall typically 1.0m high. No repairs proposed or evident to cross or wall tops in 2016-17.	2/481 (S) before*

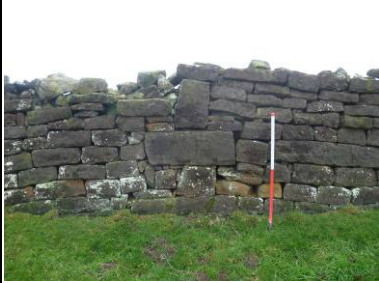
A photograph showing a stone wall made of large, roughly-hewn blocks. A red and white surveying pole is placed vertically against the wall for scale. The wall is situated in a grassy field with hills in the background.		
<b>35N</b>	Well preserved with all elements in place. Lower lintel partly buried, longer than one above. Very thick upper lintel. Lower through shorter than one above, both slightly slanting. No repairs proposed or evident to cross or wall tops in 2016-17.	2/463 (N) before*

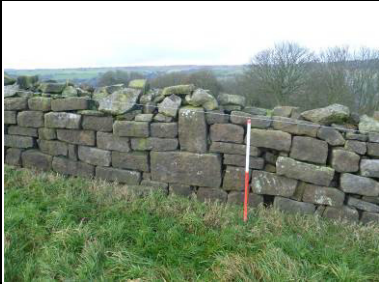
<b>35S</b>	Lower part of lower through buried, lower lintel not visible, presumably fully buried. Upper lintel similarly sized to N side. Upper through slightly off centre. No repairs proposed or evident to cross or wall tops in 2016-17.	2/480 (S) before*

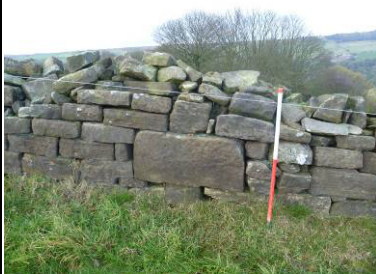
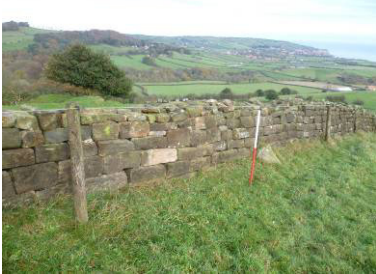
<b>36S</b>	Lower lintel not visible, presumably buried, bottom of lower through at ground level. Upper through slightly displaced. Substantial upper lintel. Random stones on wall top. No repairs proposed to cross in 2016-17 but area of rebuild to E and wall tops reset (5/185*).	2/479 (S) before*

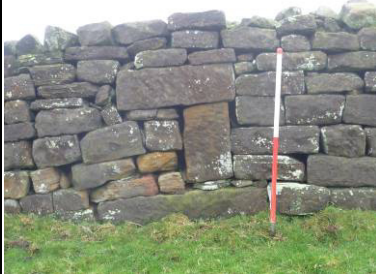
<b>37N</b>	Lower lintel partly buried, lower through supported on small stones. Upper lintel off centre and area of old rebuild below. No upper through. Well built section of wall, 1.2m high, but with some localised slippage, on substantial bank, 1.0m high and 1.5m wide (2/461*). Repairs proposed but none evident in 2016-17.	2/460 (N) before*

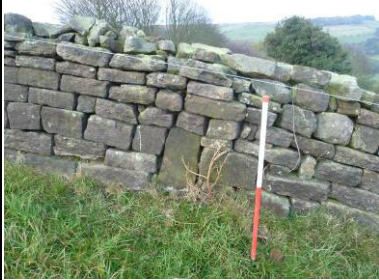
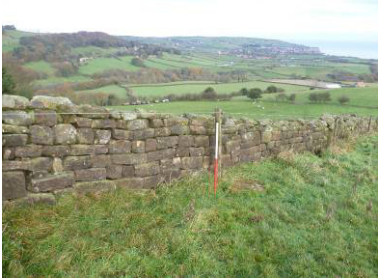
<b>Cross</b>	<i>Description</i>	<i>Photo</i>	<i>Photo before</i>	<i>Photo after</i>	<i>Other photo</i>
<b>37S</b>	15m from Cross 38, small bramble to left. Only lower through visible, on sloping ground. Lower lintel buried, no upper lintel or through, area of old rebuilding above. Wall 1.2m high and courses follow slope of the ground. 2016-17 repairs done with some limited rebuilding to the E (5/184*). No repairs to actual cross. Collapse to E in 1991.	2/478 (S) before*
