FYLING DEER PARK WALL,  
FYLINGDALES, NORTH YORKSHIRE

ARCHAEOLOGICAL RECORDING  
AND MONITORING OF 2016-17 REPAIRS

Report no: 2016/527.R01  
Version: Final  
Date: February 2018  
Author: Ed Dennison

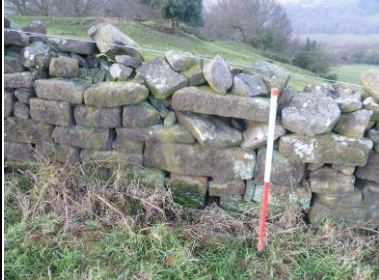
<b>38S</b>	15m from Cross 39. Only lower through visible, lower lintel buried. Upper lintel seems too small to be original - old rebuild? Collapsing wall top above. Repairs to be done but none evident in 2016-17.	2/477 (S) before 3/631 (S) before*

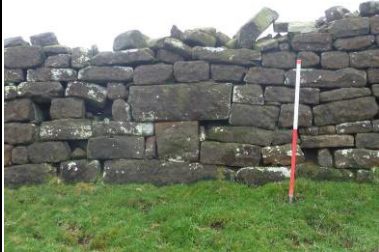
<b>38N</b>	All elements visible. Lower lintel part buried, narrower upper lintel with lower through intact. Rebuild to left and random walling on top. Repairs to be done but none evident in 2016-17.	2/459 (N) before*

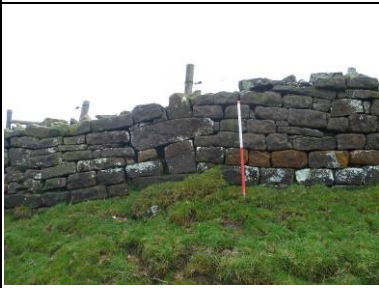
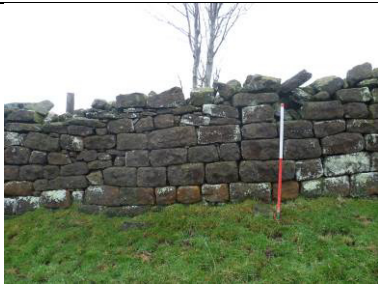
<b>Cross</b>	<b>Description</b>	<b>Photo</b>	<b>Photo before</b>	<b>Photo after</b>	<b>Other photo</b>
<b>39N</b>	In front of angled fence post and joint of wall to left side. Lower lintel party buried, with upper lintel and two off centre throughs present. Falling away to the E due to sloping ground. No repairs proposed or evident in 2016-17. Possible small area of original walling to W (2/457*).	2/456 (N) before*

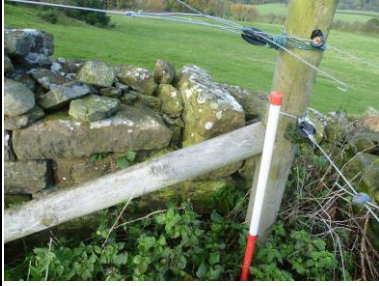
<b>39S</b>	Behind angled fence post, difficult to see. Lower lintel, lower through and upper lintel in place, top through displaced. No repairs proposed or evident in 2016-17.	2/476 (S) before*

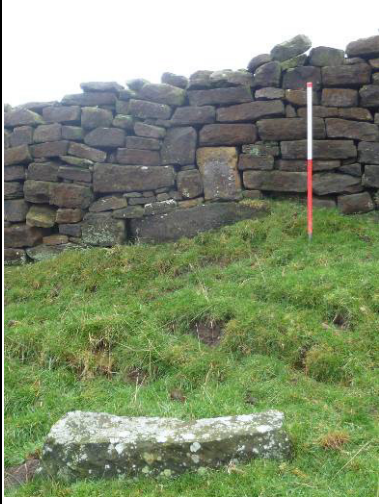
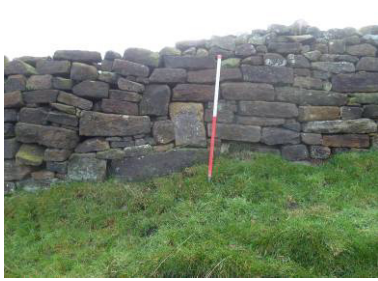
<b>40N</b>	Lower lintel and lower off centre through in place, leaning slightly. Area of old rebuilding to W (5/182*). No upper elements although possible upper lintel lying in front of wall. Wall stands on 0.75m wide bank. Repairs to be done 2016-17 but no obvious repair to actual cross although wall tops reset.	2/455 (N) before* 5/181 (N) after*

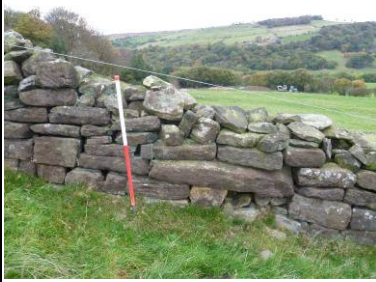
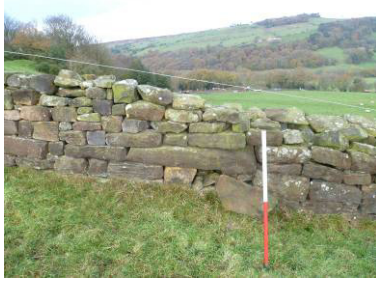
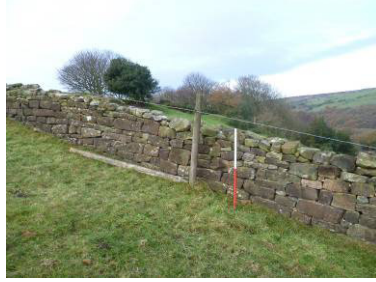
<b>Cross</b>	<b>Description</b>	<b>Photo</b>	<b>Photo before</b>	<b>Photo after</b>	<b>Other photo</b>
<b>40S</b>	Lower through in place with possible upper lintel above, although rather thin. No upper through. Area of old rebuild above and around. Repairs done 2016-17 - cross not touched but top of wall reset/rebuilt to W as far as field boundary (5/180*) and also to E (5/183).	1/302 (S) before* 5/179 (S) after*

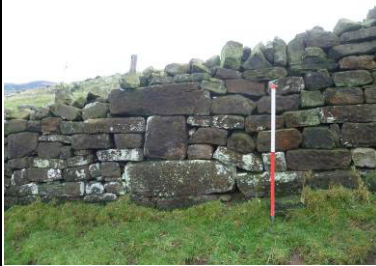
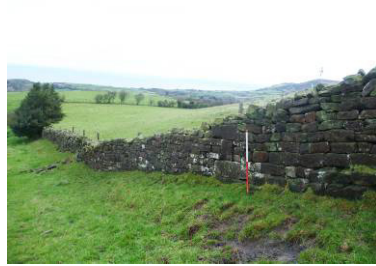
<b>41N</b>	Lower lintel fully exposed, on another footing. Massive lower through, slightly off centre, and upper lintel above, again slightly off centre. No upper through. Area of old rebuild to right, random stones on wall top. Wall typically 1.3m high on bank (2/454*). No repairs proposed or evident in 2016-17. Upper through lost since 1991.	2/453 (N) before*

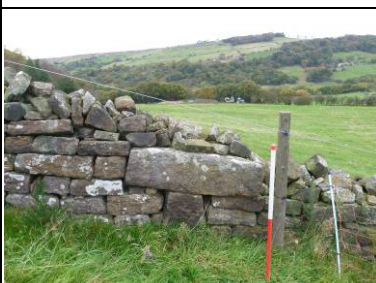
<b>41S</b>	Lower through partly buried, off centre upper lintel above. No upper through. Random stones on top forming collapsing wall top. Wall to E collapsing. No repairs proposed or evident in 2016-17. Wall to E not quite so collapsed in 1991.	1/303 (S) before*

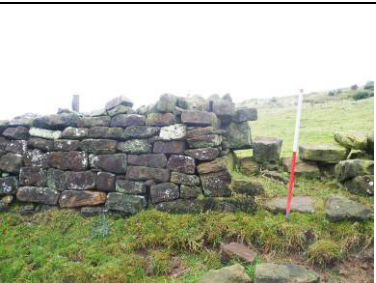
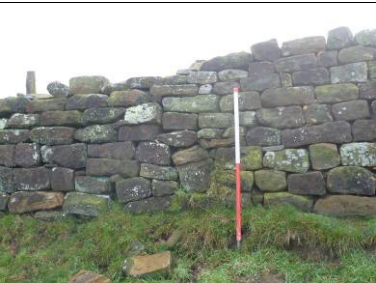
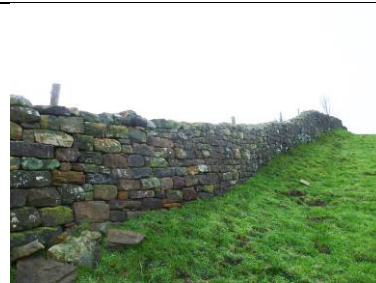
<b>Cross</b>	<b>Description</b>	<b>Photo</b>	<b>Photo before</b>	<b>Photo after</b>	<b>Other photo</b>
<b>42N</b>	Immediately adjacent to collapsed section of wall to right. Lower lintel at ground level cracked, lower through intact but exposed through wall thickness by collapse. Rough, collapsing old rebuild above - no upper elements visible. Repairs done 2016-17. Major rebuild to W and on top of lower through. Cross not repaired - no stones available? Cross not now visible on this side of wall. Wall to W rebuilt (5/177-178*). Wall not collapsed in 1991.	2/452 (N) before* 4/054-055 (N) before 5/176* (N) after

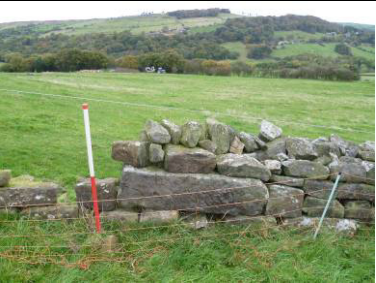
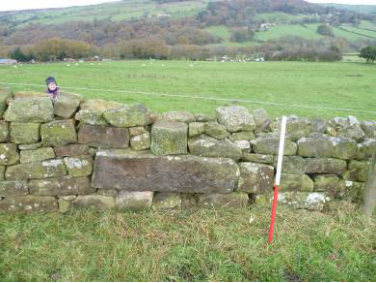
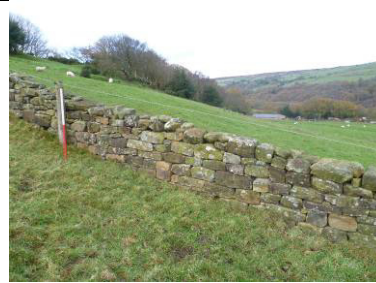
<b>42S</b>	Collapsed section of wall to immediate left. Lower through just visible but exposed in wall thickness. Upper lintel displaced to E and partly overhanging gap. No upper through. Rough old rebuilding above, collapsing. Repairs done 2016-17 - upper through replaced but not with original stone and not as a through and adjacent upper courses rebuilt, raising height of wall slightly. Wall to W rebuilt (5/174-175*). Wall to W less collapsed in 1991.	1/304 (S) before* 5/173 (S) after*

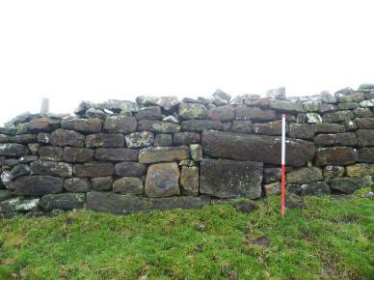
<b>43N</b>	Wall on substantial bank 0.75m high x 1.0m wide. Long lower lintel with off centre lower through in place. Upper lintel displayed to W in area of old rebuild. No upper through. No repairs proposed or evident in 2016-17.	2/451 (N) before*

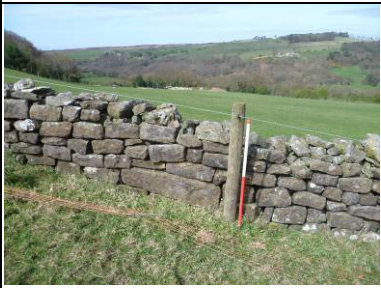
<b>Cross</b>	<b>Description</b>	<b>Photo</b>	<b>Photo before</b>	<b>Photo after</b>	<b>Other photo</b>
<b>43S</b>	Only lower lintel visible at base of wall, no throughs or upper lintel, to left of holly tree. No repairs proposed or evident in 2016-17.	1/308 (S) before 4/051 (S) before*

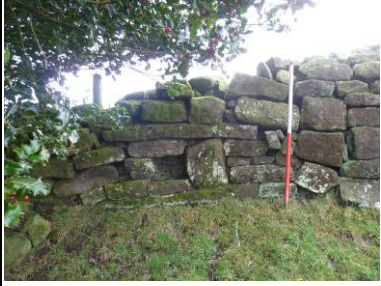
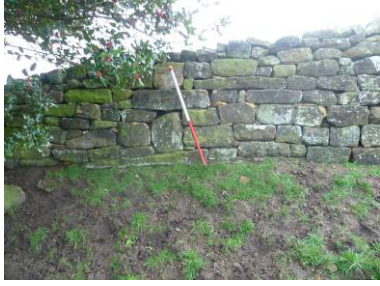
<b>44N</b>	Adjacent to holly tree (left). Long lower lintel and lower off centre through in place. Hole in wall face to right of through. Upper lintel removed and lying by holly tree. Area of old rebuild above lower through with possible upper through incorporated, although many other stones lying around holly tree. Repairs done 2016-17. Adjacent courses either side rebbed and stabilised, upper lintel renewed, old upper through replaced. Wall tops repaired.	2/449 (N) before 2/450 (N) before* 5/171 (N) after*

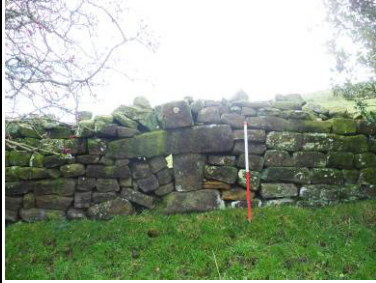
<b>Cross</b>	<b>Description</b>	<b>Photo</b>	<b>Photo before</b>	<b>Photo after</b>	<b>Other photo</b>
<b>45N</b>	Between holly tree (W) and hawthorn (E). Well preserved but wall collapsed around, especially to E. All elements visible, short lower lintel at ground level. Long upper lintel (1.33m long) off centre with left (E) end falling due to poor rebuild below. Upper through forms wall top. Wall 1.2m high on slight bank 0.5m high. No repairs evident in 2016-17.	2/448 (N) before*

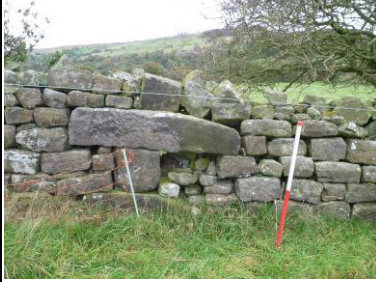
<b>45S</b>	Between holly tree and hawthorn. Well preserved but wall collapsed around, especially to E. Lower lintel partly buried. As on N side, long upper lintel off centre with right (E) end falling due to poor rebuild and holes below. Upper through forms wall top. No repairs evident in 2016-17.	1/307 (S) before*

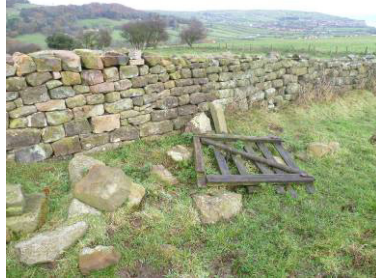
<b>46S</b>	Immediately left (W) of small wooden gate, opening 1.5m wide. Large lower through and upper lintel visible, old rebuild above this, including smaller stone where upper through would have been. Repairs to wall ends to be done 2016-17. Gate actually removed and cross repaired - right hand courses rebuilt and small through replaced on top of upper lintel. Gate opening infilled (5/166*, 5/169). Two large stones adjacent to wall, including a possible through. Less collapse in 1991.	1/306 (S) before* 5/165 (S) after*

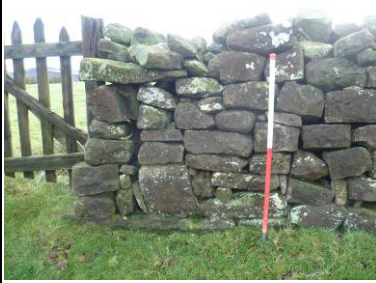
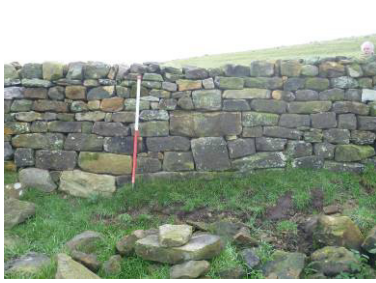
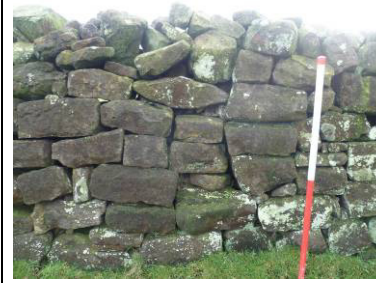
<b>Cross</b>	<b>Description</b>	<b>Photo</b>	<b>Photo before</b>	<b>Photo after</b>	<b>Other photo</b>
<b>46N</b>	Immediately right (W) of small wooden gate. Probable lower lintel part buried, slanting lower through visible. No upper elements. Area of old rebuild, also presumably when gateway was inserted. Wall on bank 0.5m high. Repairs to wall ends to be done 2016-17 - gate actually removed and opening infilled. Cross rebuilt - lower through still in place but upper stones inserted. Pile of stones lying around. Possible blocked step stile to W (2/446*).	2/444 (N) before 2/445 (N) before* 5/167 (N) after* 5/168 (N) after

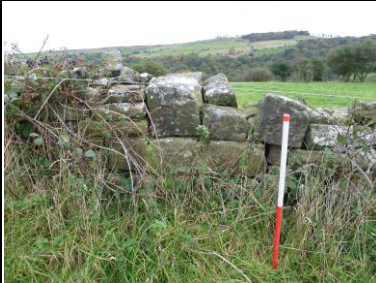
<b>47S</b>	Base of cross hidden by vegetation, but lower through, upper lintel and upper through (slightly off centre) visible. Lower through mostly buried. Wall top has old rebuild, including probably the upper through which is at wall top level. No repairs evident in 2016-17.	1/309 (S) before*

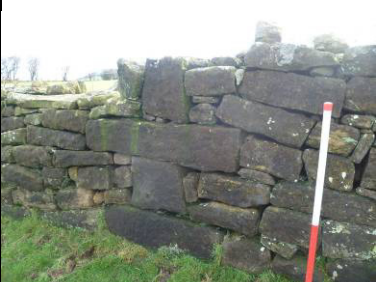
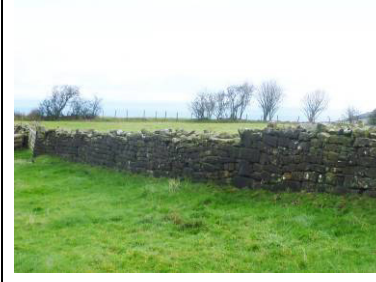
A photograph of a stone wall section partially obscured by tall grass and other vegetation. A red and white surveying pole is placed vertically against the wall. The background shows a rural landscape with hills.		
<b>47N</b>	Well preserved with all elements visible. Lower through at ground level, lower through large section. Thinner longer upper lintel and upper through resting on small stones, also slightly chamfered on E side. Top of upper through at wall top and random stones around suggesting old rebuild. No repairs evident in 2016-17. Possible area of original walling between crosses 47 and 48 (2/447*) but 1991 photos show uneven courses.	2/442 (N) before 2/443 (N) before*

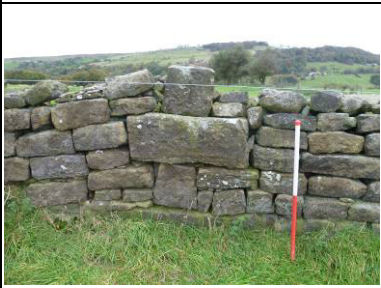
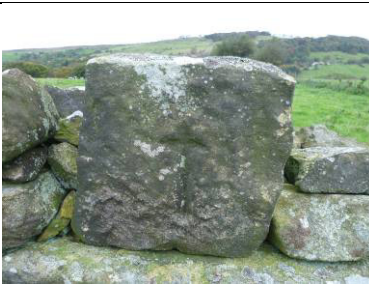
<b>Cross</b>	<b>Description</b>	<b>Photo</b>	<b>Photo before</b>	<b>Photo after</b>	<b>Other photo</b>
<b>48S</b>	Well preserved with all elements visible. Disproportionately long lower lintel, partly buried and has angled plug and feather marks. Upper lintel slightly off set to throughs. Upper through has a carved cross on outward face (1/311*), and top protrudes above wall top. Wall typically 1.2m high. No repairs evident in 2016-17.	1/310 (S) before*

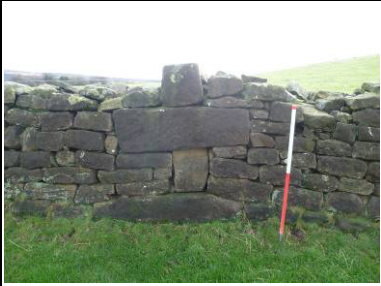
<b>48N</b>	See drawing. Well preserved, all elements visible. Lower lintel has sloping upper surface to both ends, with lower through off centre but on the higher part. Upper lintel slightly off centre to lower through but central to upper one. Top of upper through protrudes above wall top. No repairs evident in 2016-17.	2/441 (N) before*

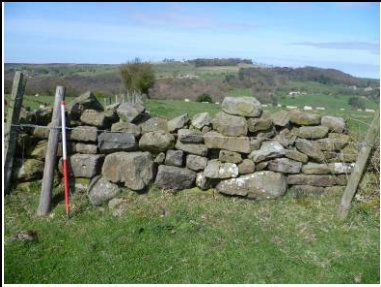
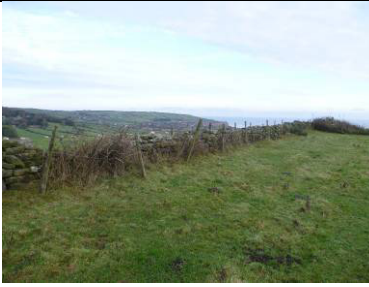
<b>49S</b>	Possible lower through in bottom of wall, but roughly rebuilt all around. No other elements visible. No repairs evident in 2016-17. Wall to E much denuded (5/164*). Wall mostly standing in 1991.	4/052 (S) before*

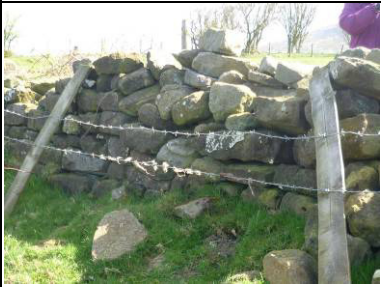
<b>Cross</b>	<i>Description</i>	<i>Photo</i>	<i>Photo before</i>	<i>Photo after</i>	<i>Other photo</i>
<b>49N</b>	Nothing really visible this side. No repairs evident in 2016-17.	4/053 (N) before*

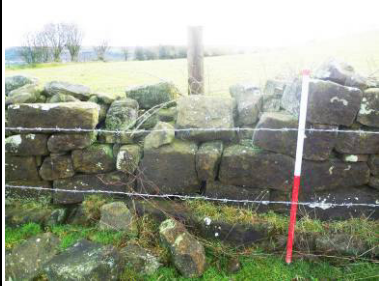
<b>50N</b>	Only lower lintel and lower through visible, with plug and feather marks on bottom surface of through. Remainder above old rebuild. Wall averages 0.8m high, but areas of collapses. Repairs to be done 2016-17, but none evident.	2/439 (N) before*

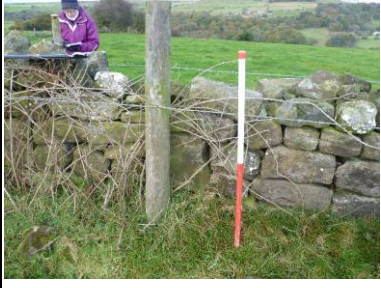
<b>50S</b>	Directly behind fence post. Lower lintel mostly buried, large through above. Upper lintel and through gone in old rebuild. Wall averages 0.8m high, but areas of collapses. Repairs to be done 2016-17 but none evident. Courses above in 1991 but no obvious upper through. Collapse between crosses 50 and 51 in 1991.	2/440 (S) before* 3/632 (S) before

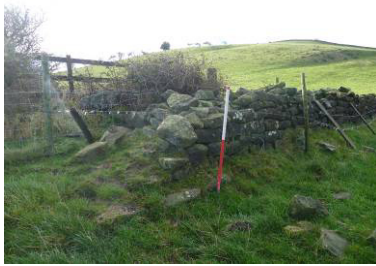
<b>Cross</b>	<i>Description</i>	<i>Photo</i>	<i>Photo before</i>	<i>Photo after</i>	<i>Other photo</i>
<b>51S</b>	12m from wall end. Partly hidden by vegetation. Possible lower through visible, but lower lintel may not be original. Upper elements lost in old rebuild and random stones along wall top. No repairs evident in 2016-17.	1/313 (S) before*	 		
<b>51N</b>	12m from E end of wall. Lower lintel with central lower through above which has sloping sides. Upper elements lost in old rebuild and random stones along wall top. Wall 1.00m high, with slightly wider footings. No repairs evident in 2016-17. Wall collapsing to E (2/436*).	2/437 (N) before 2/438 (N) before*
