FLAMBOROUGH CASTLE, TOWER STREET,  
FLAMBOROUGH, EAST YORKSHIRE

ARCHAEOLOGICAL SURVEY  
AND MONITORING OF 2017-18 REPAIRS

Report no: 2017/538.R01  
Version: Final  
Date: December 2018  
Author: Ed Dennison & Shaun Richardson

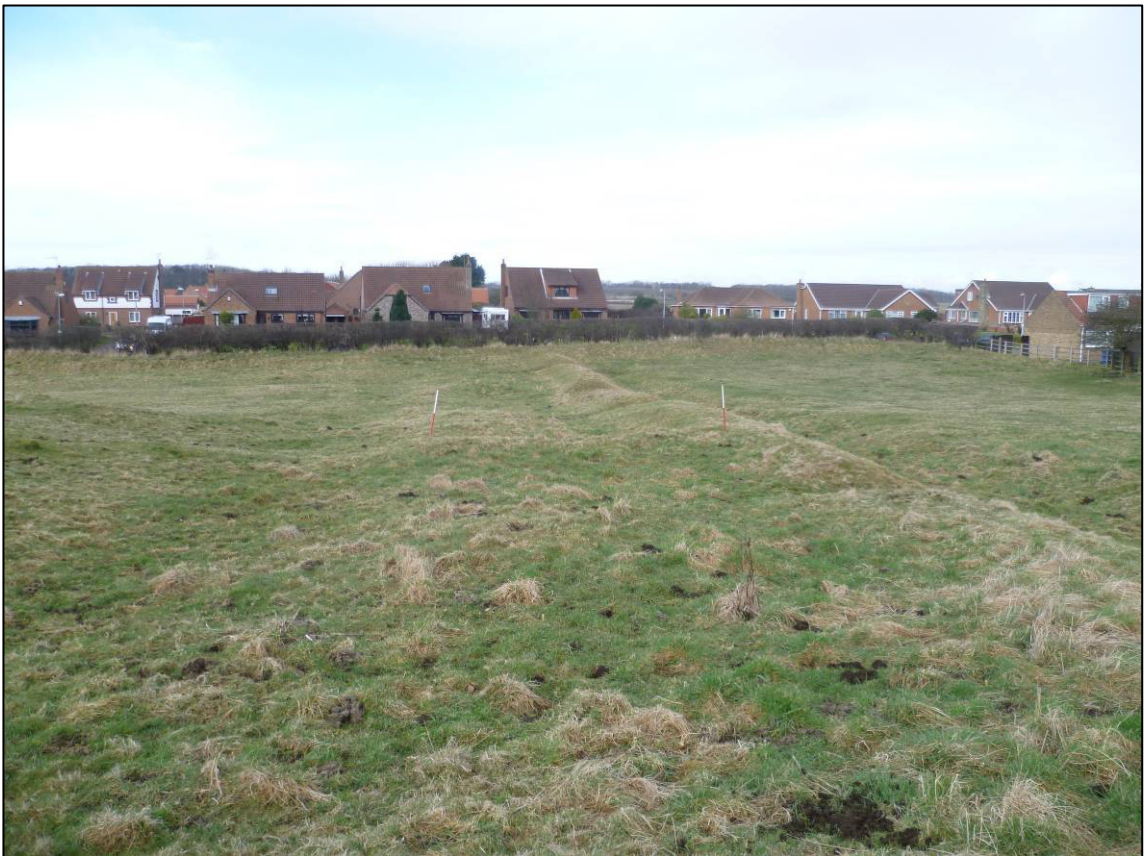
Plate 4: Bank (Site 2), with building platform (Site 3A) in foreground, looking E (photo 5/851).

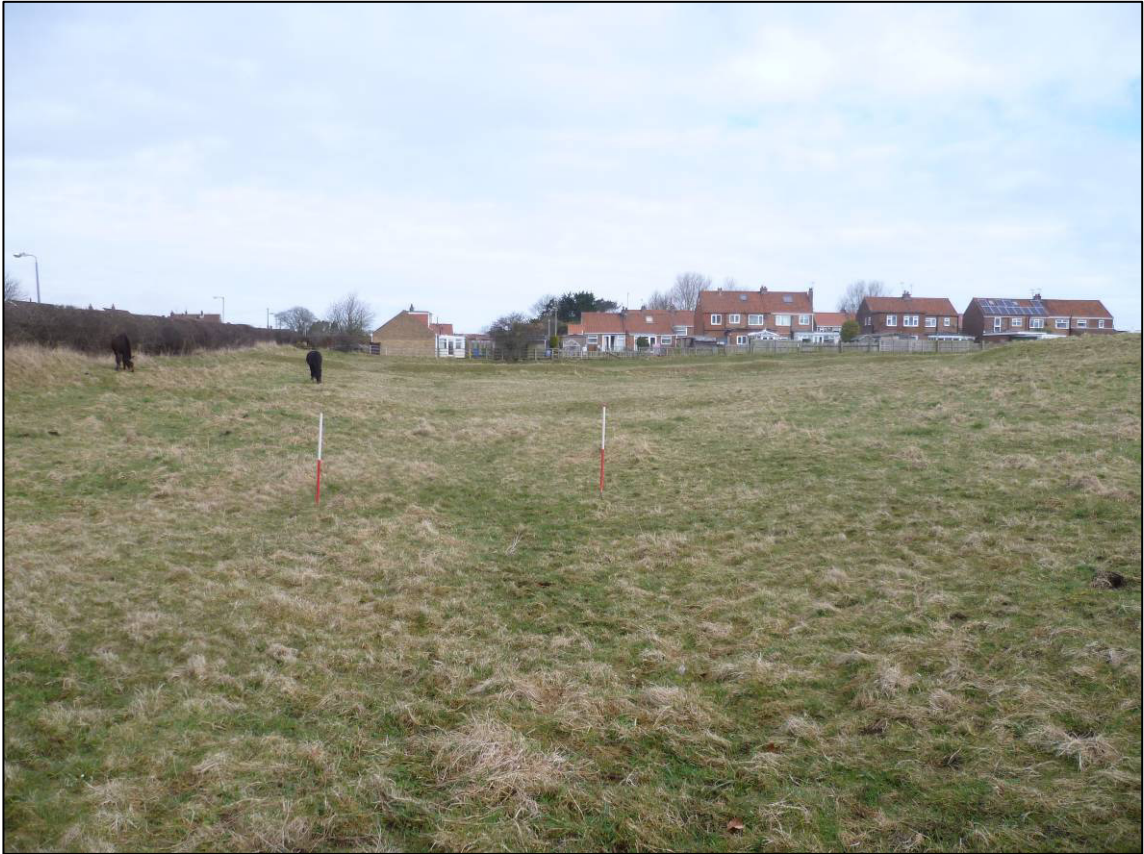
Plate 5: Former moat (Site 3C), central part, looking N (photo 5/865).

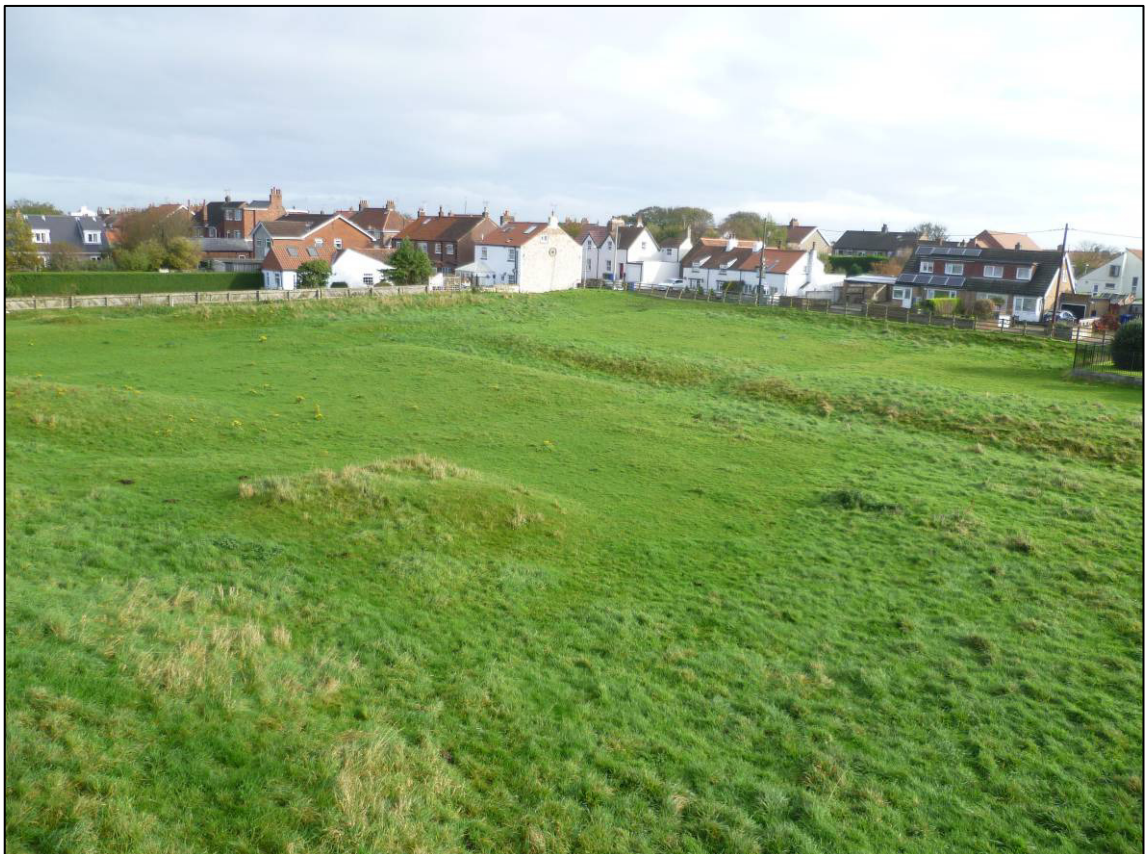
- 3.19 The area defined by the features described above is c.70m square, excluding the smaller south-eastern enclosure [2/969; 5/875] (see plate 8). On its eastern side,

Plate 8: View of gardens area (Site 5) from top of castle, looking NE (photo 2/969).

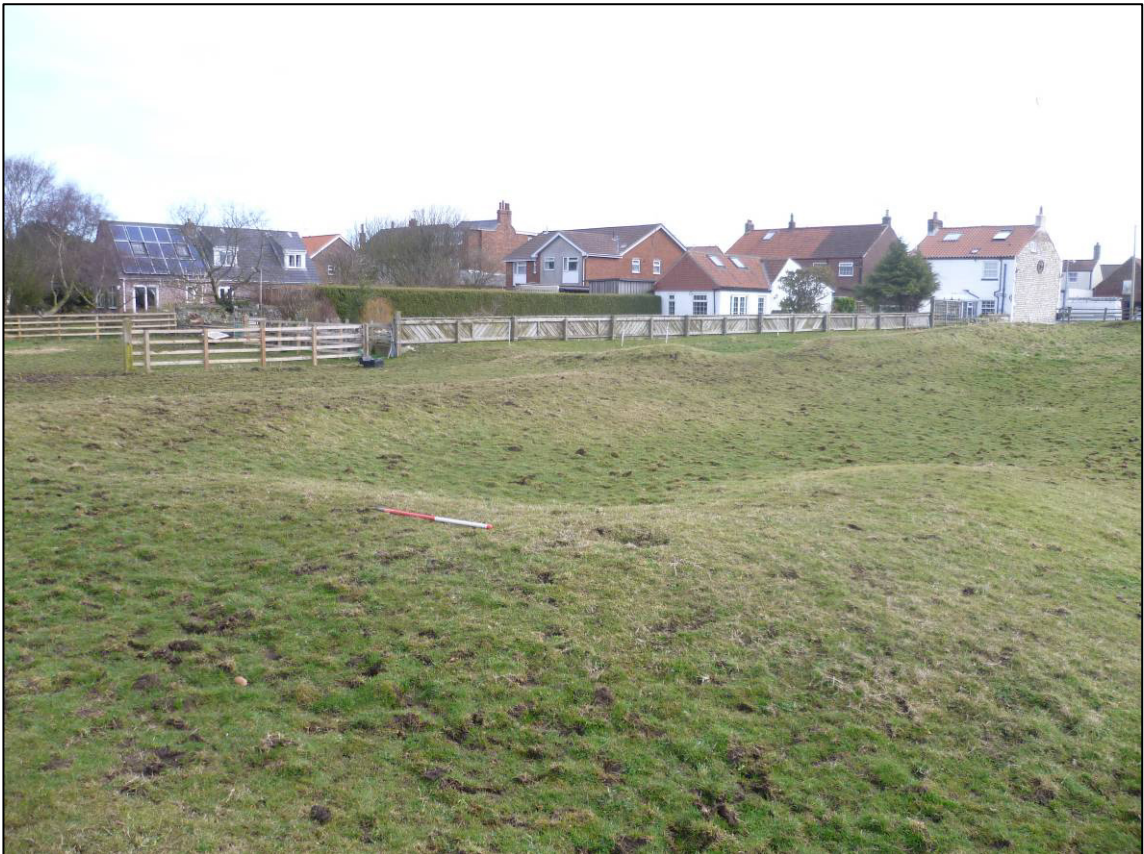
Plate 10: Building platform (Site 5C) and bank (Site 5A) on edge of gardens area, looking NE (photo 5/844).

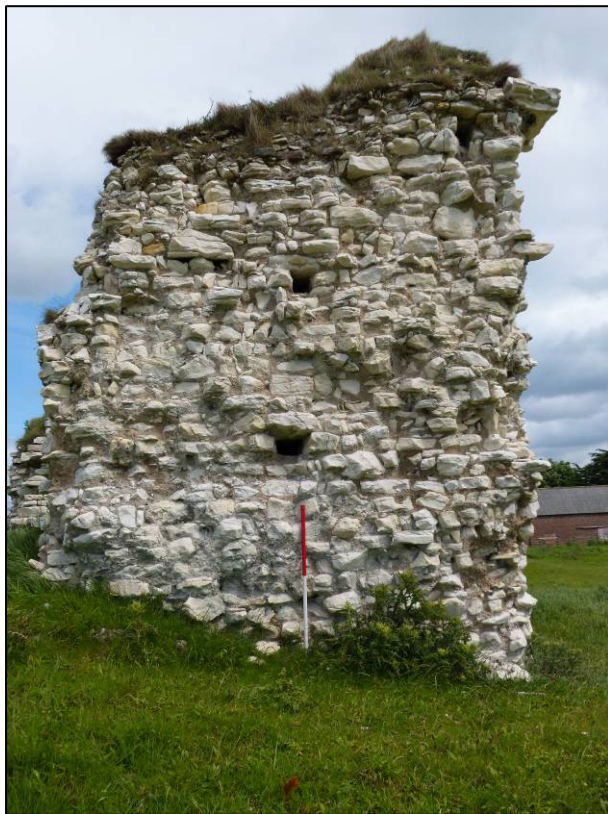
- 3.41 At the base of the south wall, the wall face steps out by 0.14m, the step being visible across the whole elevation. Three chamfered sandstone springers for the vault ribs survive *in situ* at the eastern end of the step, possibly with a fourth truncated example to the west [1/808; 4/797] (see plate 35). There are two damaged areas to the west end of the step at the same spacing as the surviving springers, and it appears that there were eight transverse ribs in all, set at 1.10m centres. The ribs supported a chalk vault over; a chamfered chalk springer course for the vault sat directly on top of the step, although the only remnants are a block to either end. It is curious that, above the step, there is no clear evidence for any damage left by the removal of the floor supported by the vault. The wall face is very clean, with no indication that there was ever corework over the vault which was tied into the wall, or even evidence for a timber floor laid above the vault. There are three lines of putlog holes visible, five to the lowest line, five to the middle line, and two to the upper line [1/801; 3/278] (see figure 12E) (see plate 25).

Plate 25: Castle (Site 6G), internal elevations, looking SE (photo 1/815).

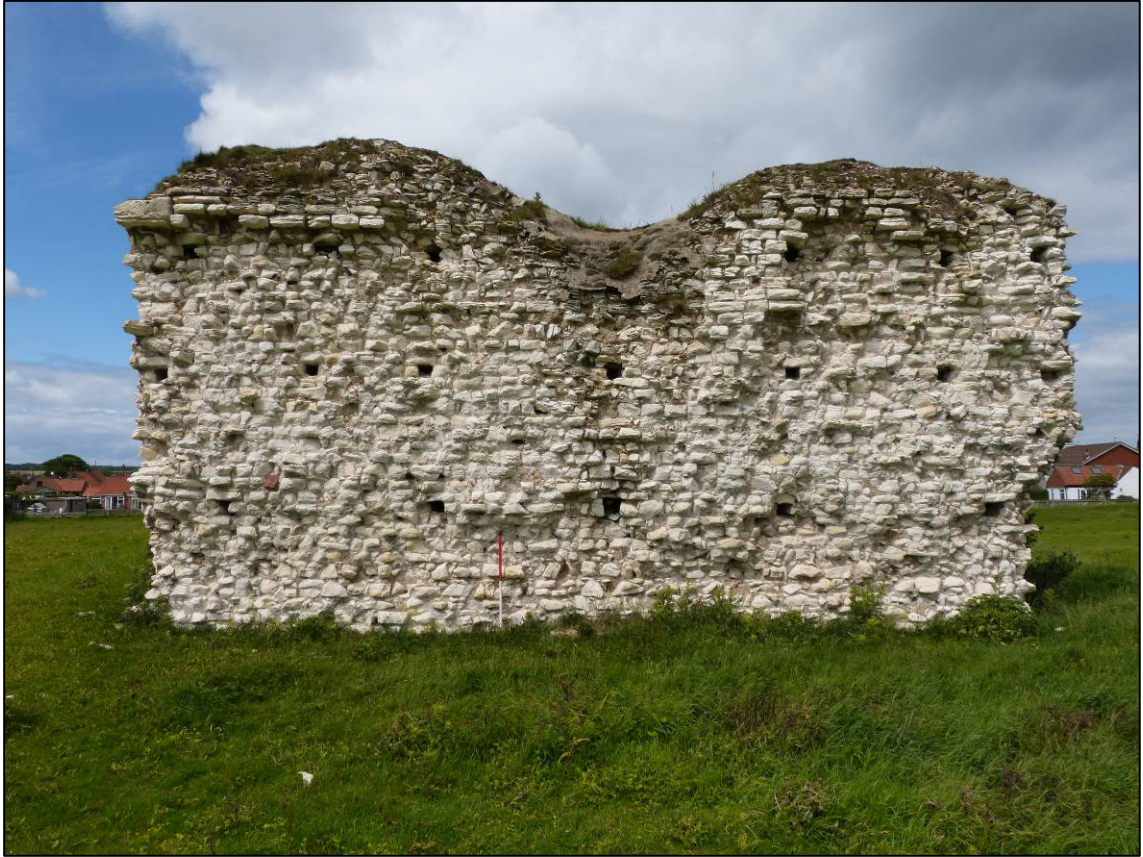
Plate 30: Castle (Site 6G), east external elevation, detail of chute, looking W (photo 1/806).
