YEDINGHAM PRIORY,
YEDINGHAM, NORTH YORKSHIRE

ARCHAEOLOGICAL AND ARCHITECTURAL
OBSERVATION, INVESTIGATION AND RECORDING

Report no: 2017/535.R01
Version: Final
Date: January 2018
Author: Ed Dennison & Shaun Richardson

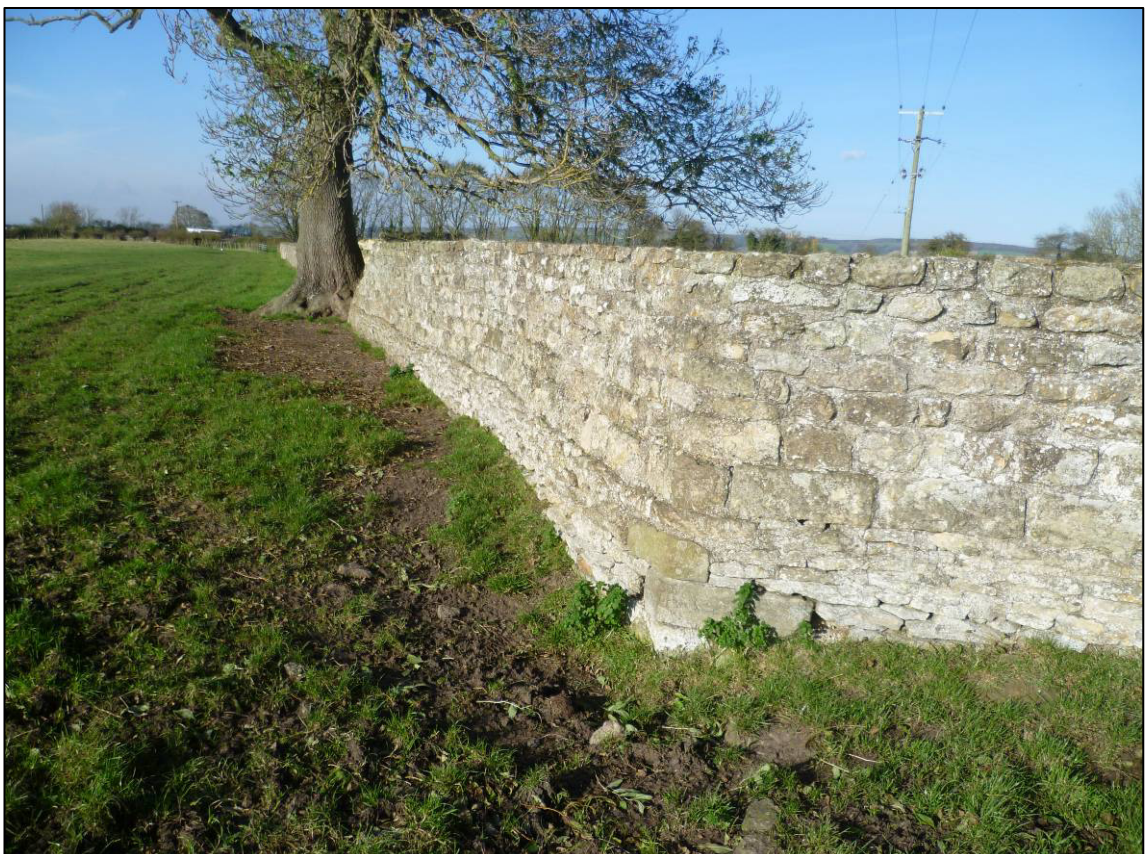
Plate 4: Angled field wall to west of priory buildings, showing thinner courses and angled quoins to wider footings compared to rebuilt section above, looking NW (photo 4/152).

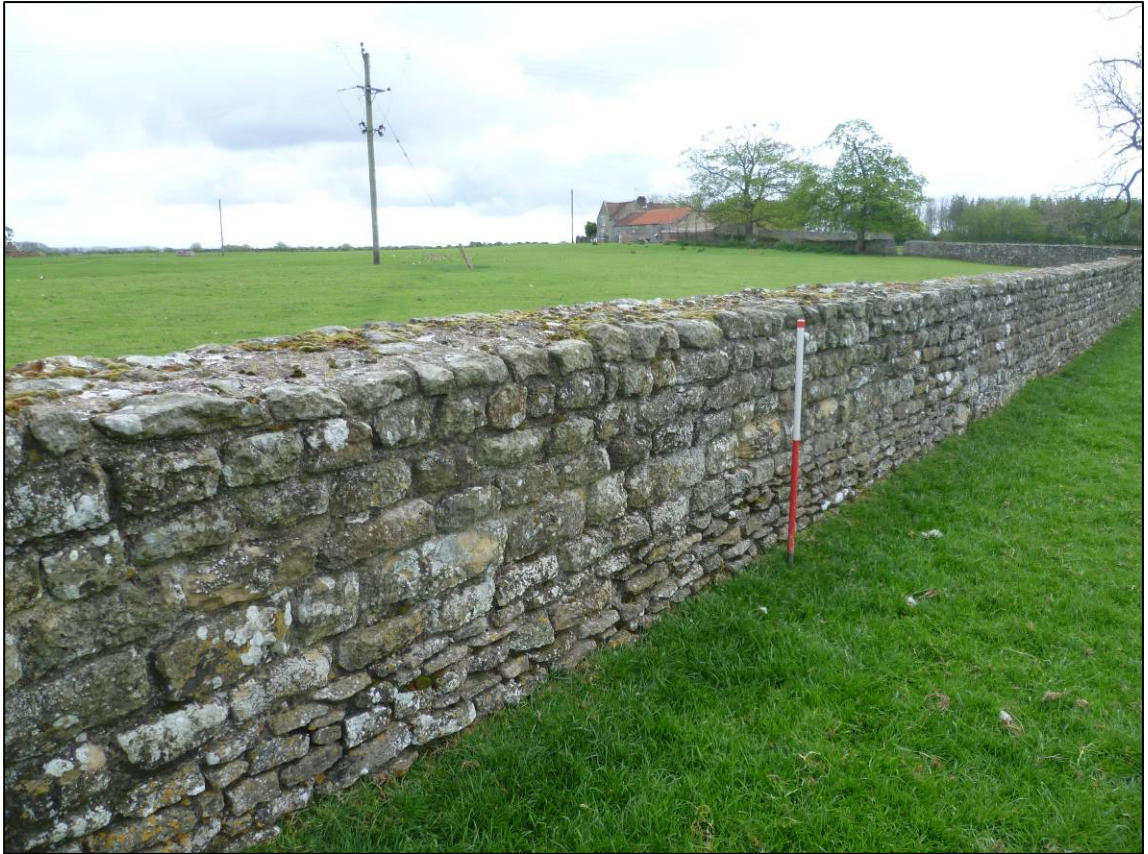
Plate 5: Field wall to north-west of priory buildings, showing different phases, looking SE (photo 2/268).

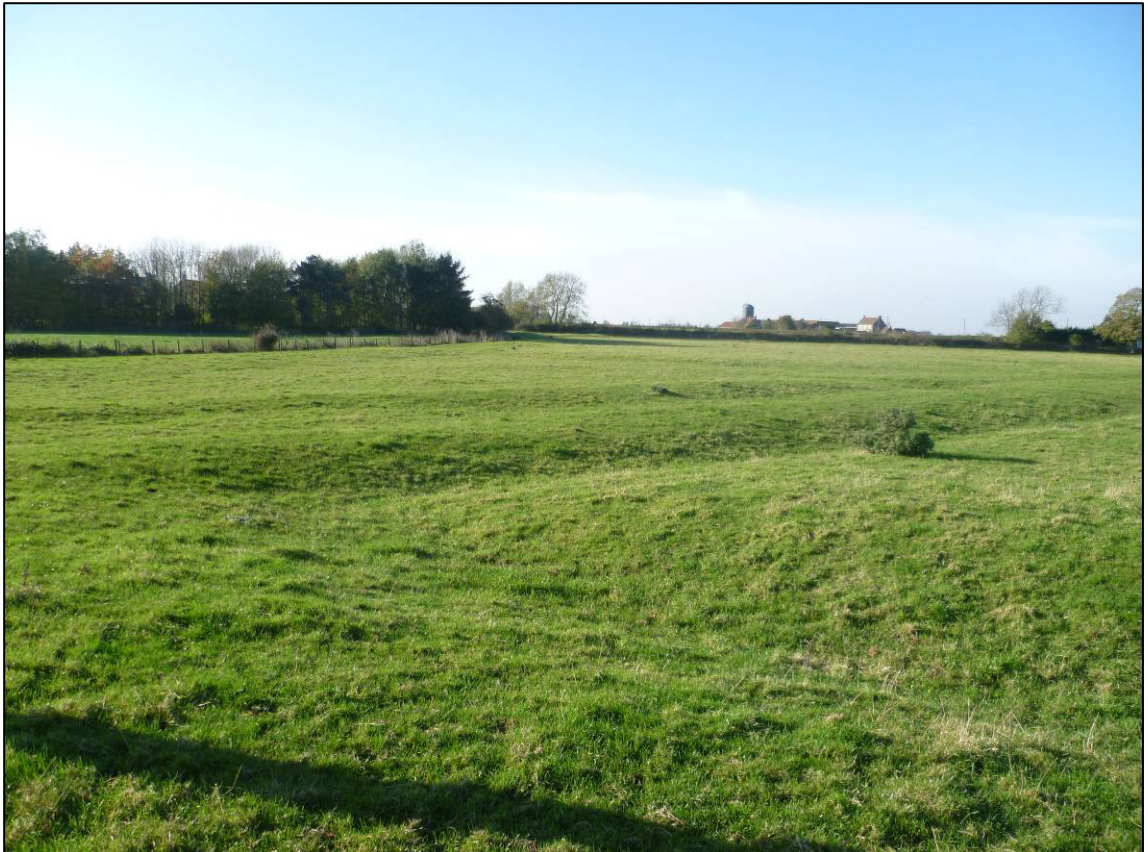
depressions adjacent to the artificial cut of the river (see below) [2/262-2/265; 4/150, 4/151] (see plate 6). The large enclosure is especially clear on aerial photographs of the priory complex taken in August 1981 (see figure 8). Quite what the large enclosure represents is presently unknown, but it could be a fishpond, garden or orchard.

Plate 6: Earthworks to south-west of priory buildings, corner of large enclosure, looking NW (photo 4/151).

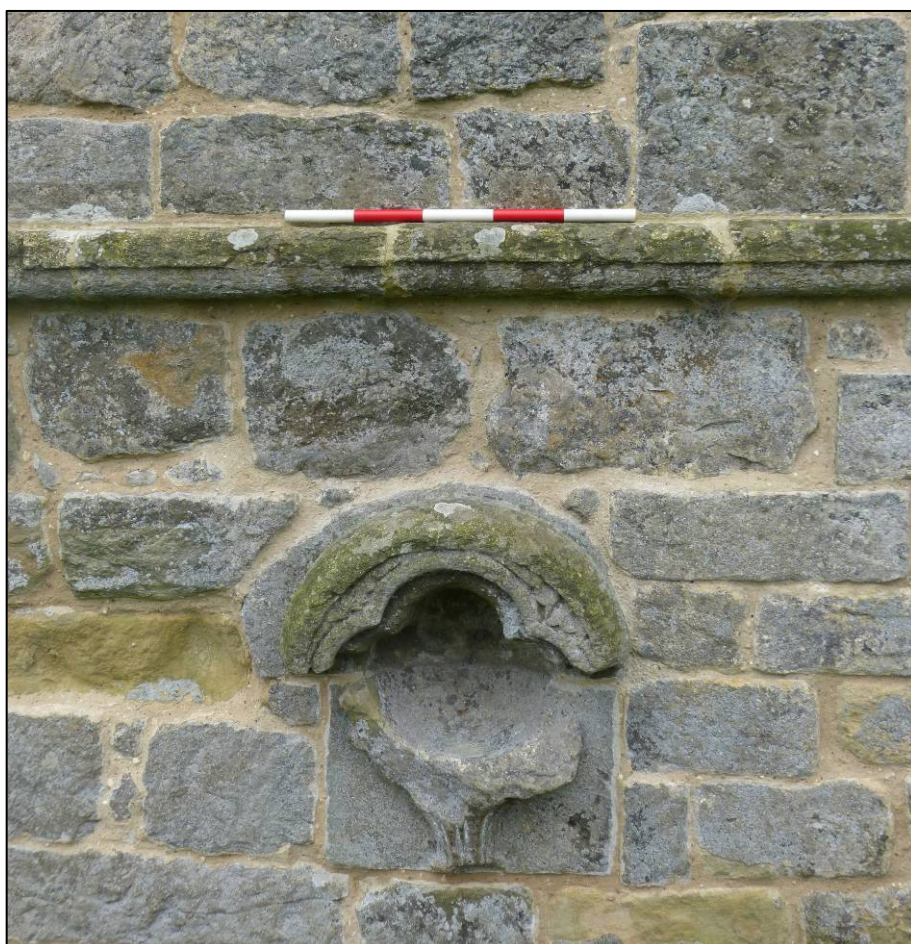
Plate 10: Stoup and roll-moulded stringcourse, north elevation of barn, looking S (photo 3/908).

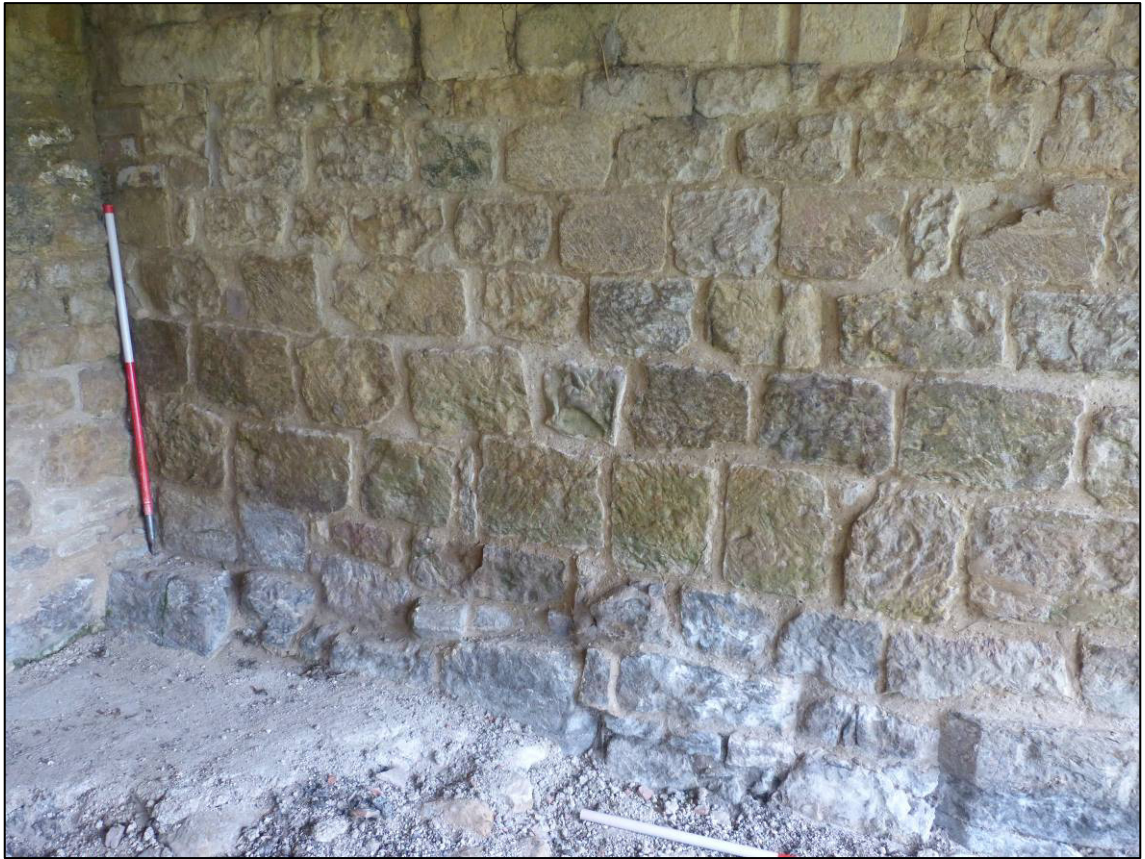
Plate 17: Blocked doorway at base of west gable of barn, with buttress base to left, visible after ground reduction works, looking E (photo 3/956).

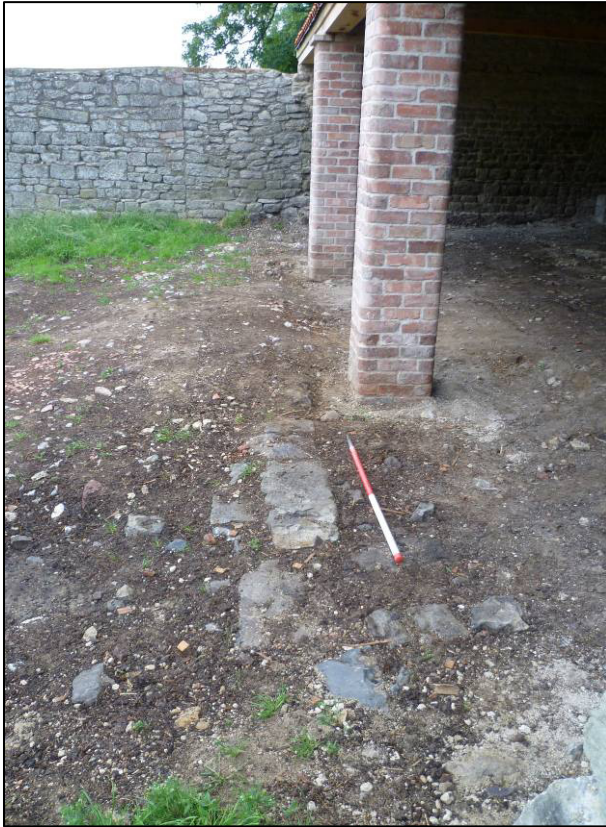
Plate 19: Exposed wall alignment in front of cart shed, looking W.

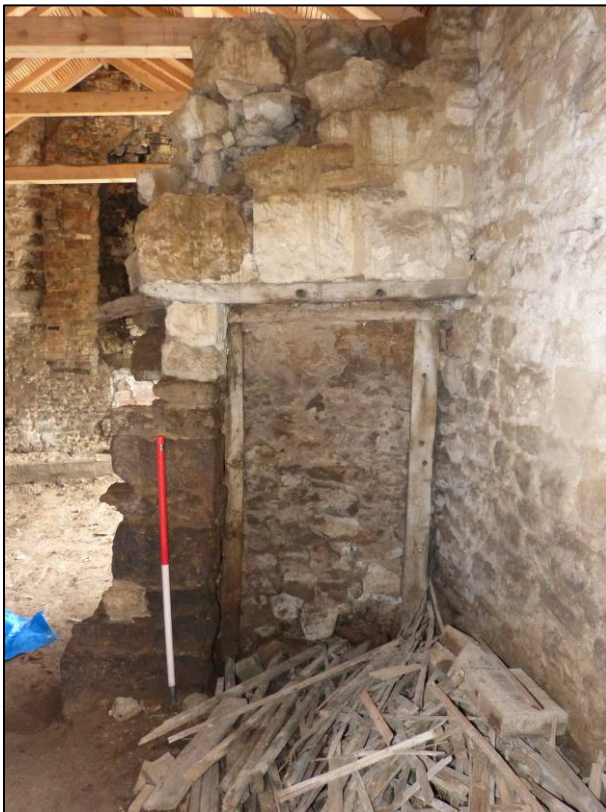
Plate 25: West side of internal stub wall in barn, looking E (photo 1/300).

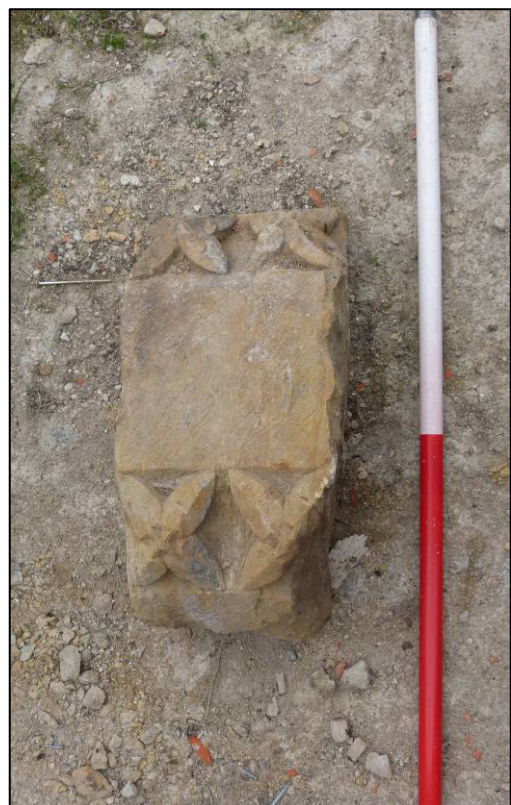
Plate 26: Recovered ex-situ stone with dogtooth moulding (photo 1/334).

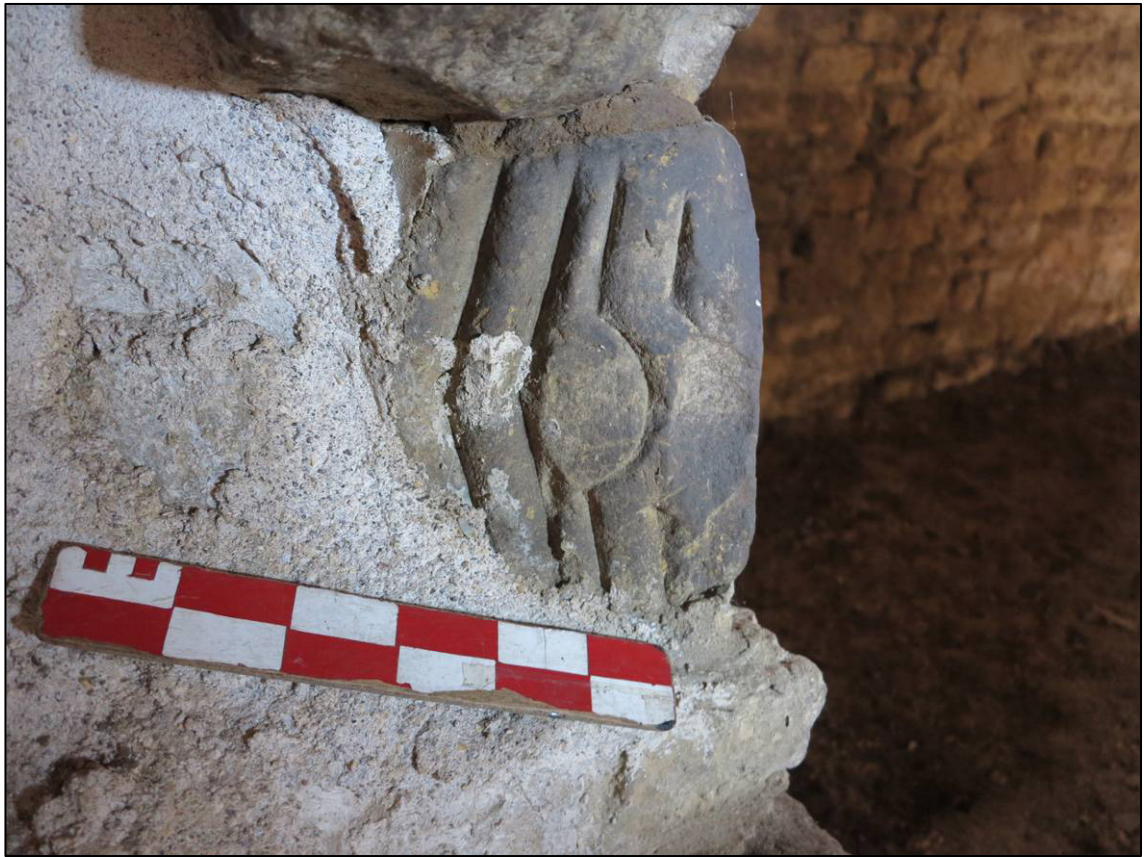
Plate 27: Re-used late 12th century carved stone in end of internal stub wall in barn
(photo courtesy Stuart Harrison).

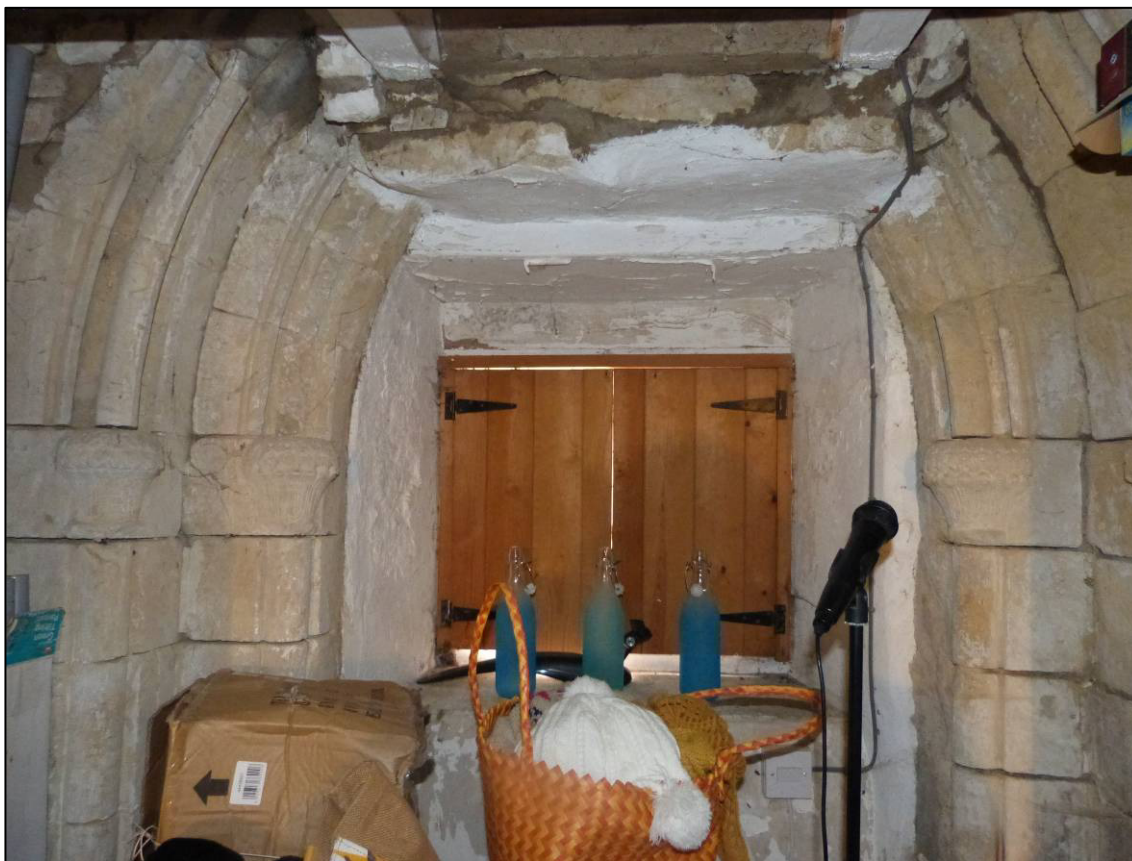
Plate 29: Medieval doorway in north wall of house's service range (internal view), looking N (photo 1/288).

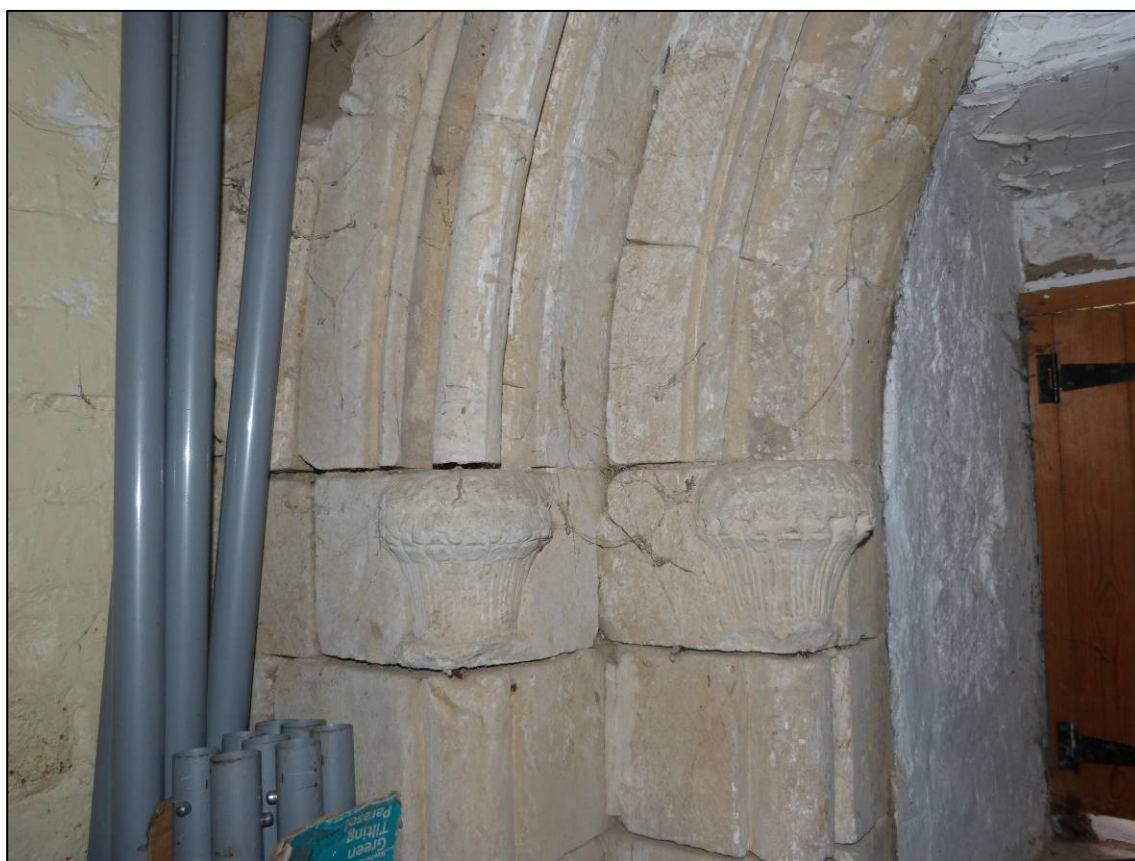
Plate 30: West side of medieval doorway in north wall of house's service range (internal view), looking NW (photo 1/289).

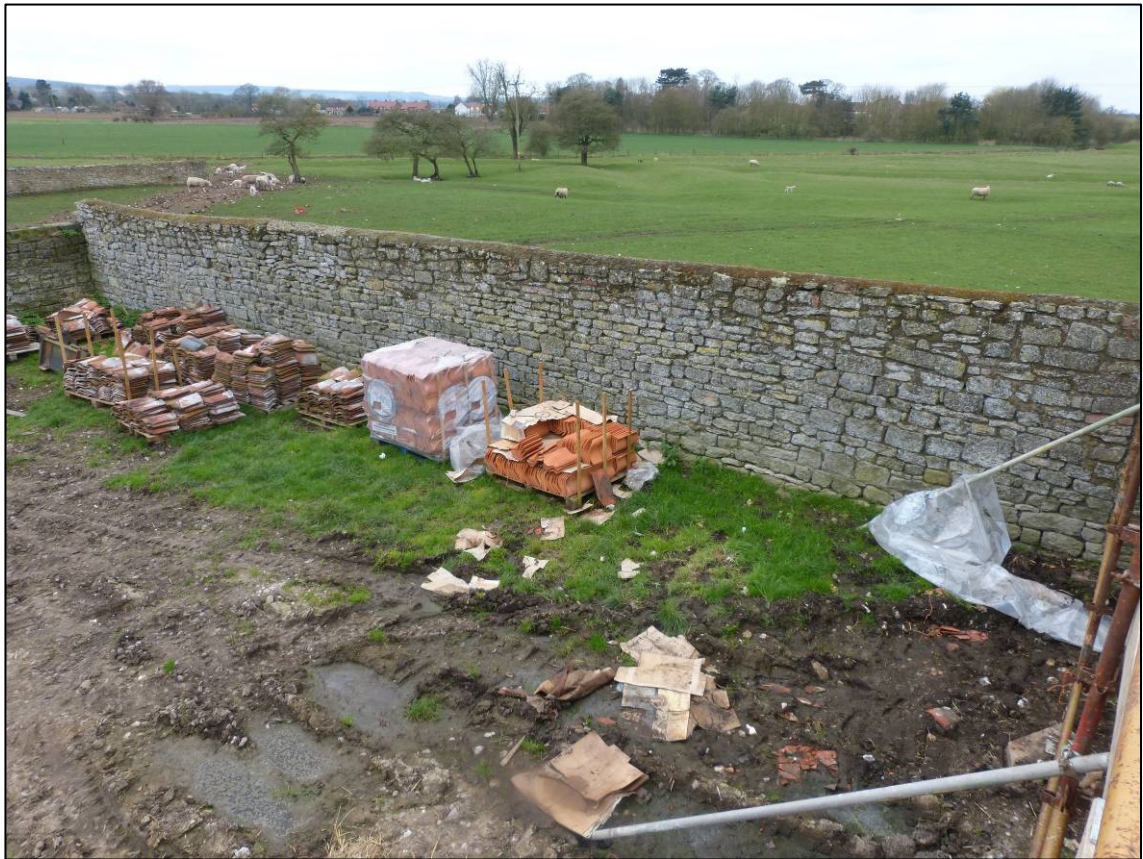
Plate 31: West wall of yard (internal face), looking SW (photo 1/337).

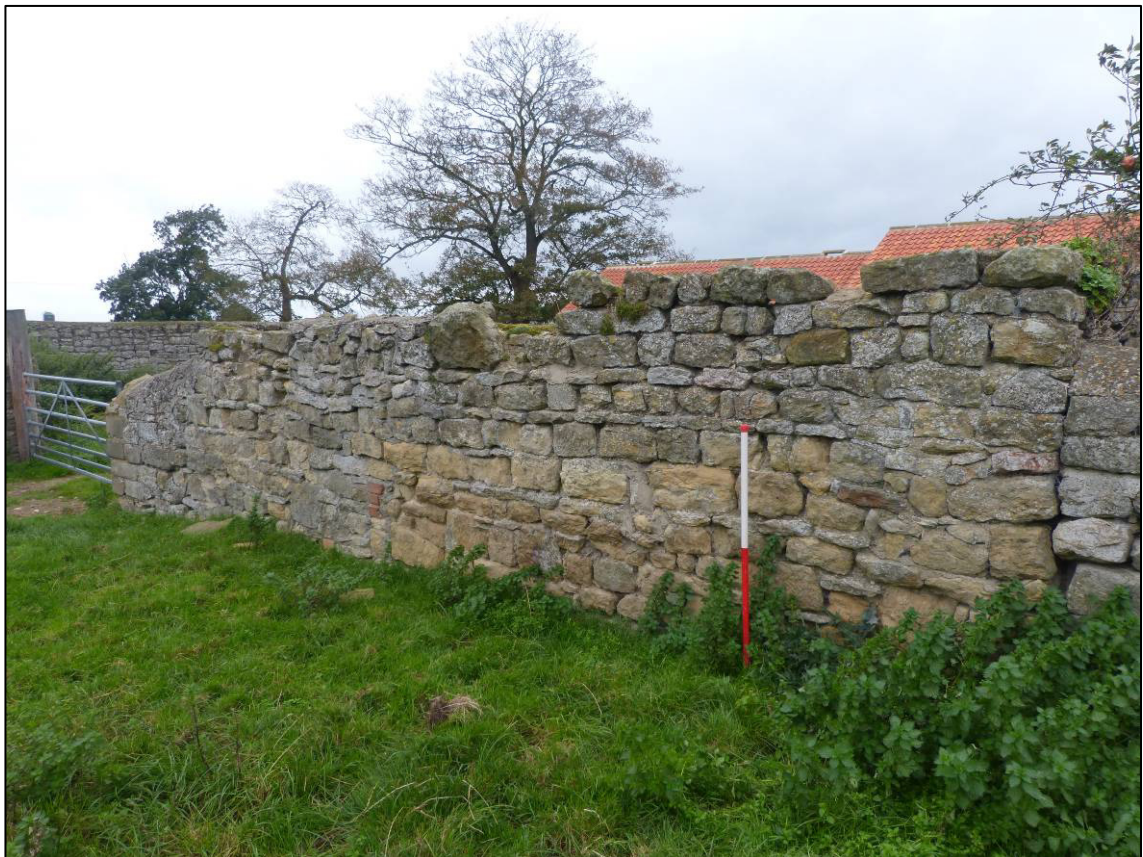
Plate 32: East part of south yard wall (external face), looking NW (photo 3/917).

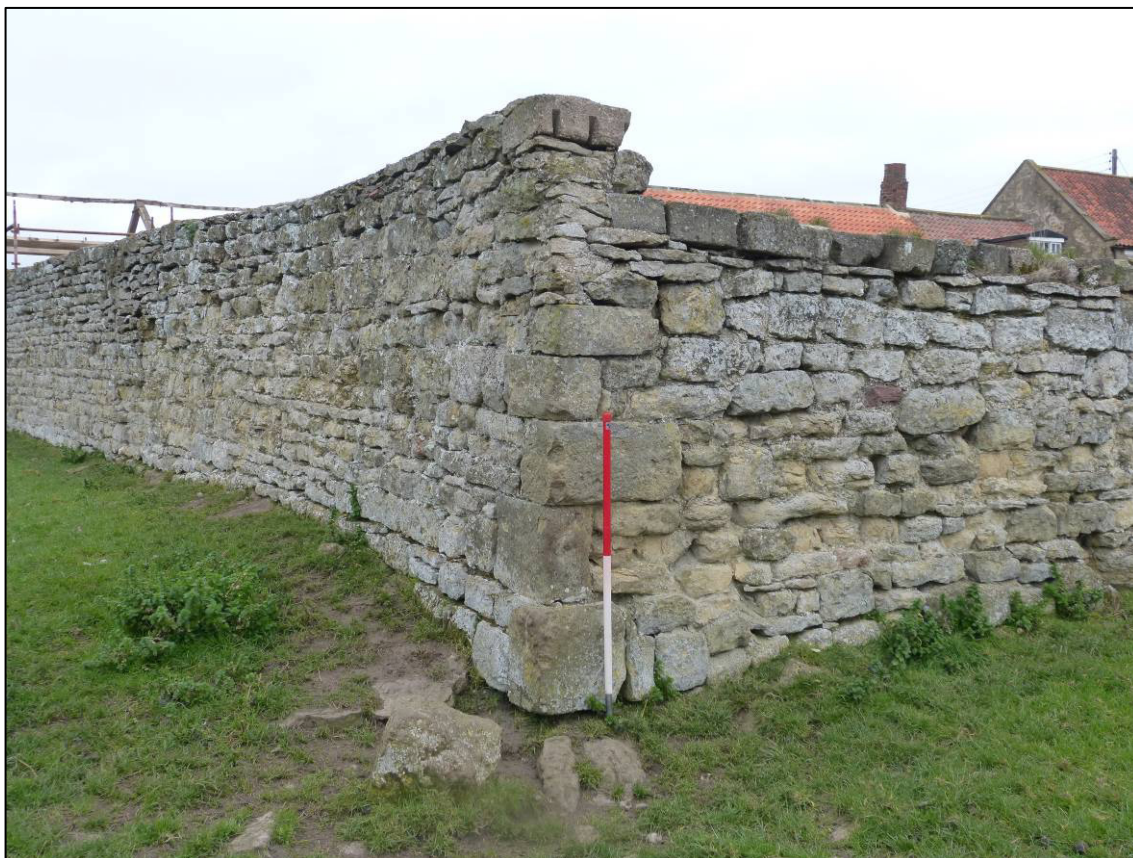
Plate 33: Quoins at south-west corner of yard wall, looking NE (photo 1/347).

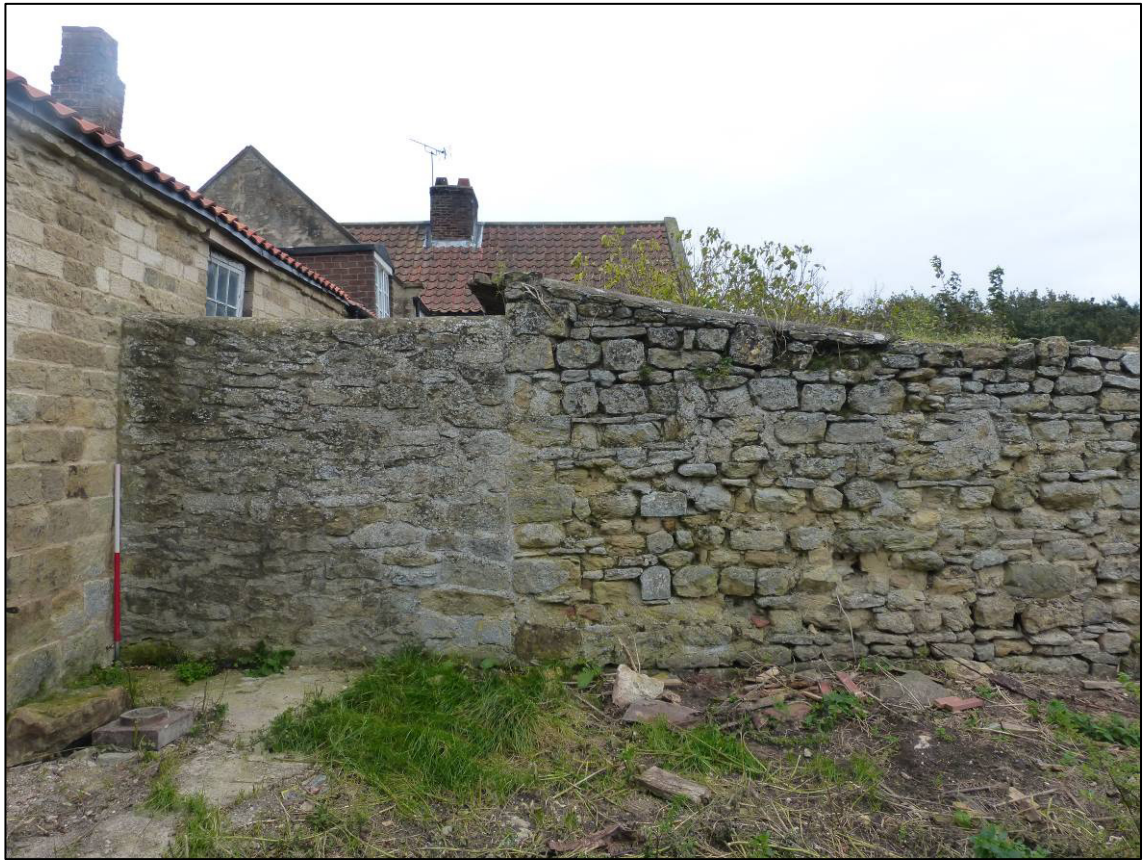
Plate 35: North end of east yard wall (internal face), showing differential coursing pattern, quoins of lean-to structure and blocked opening, looking E (photo 3/946).

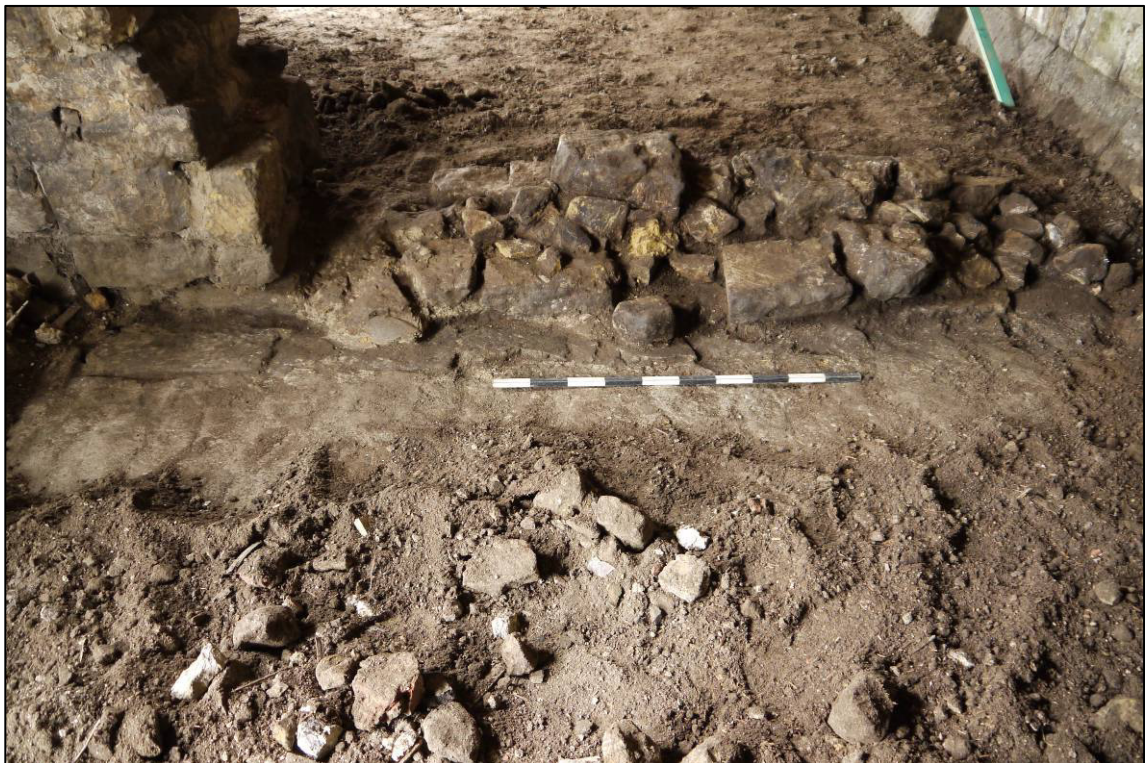
- 4.3 The foundations of the former north-south aligned cross-wall, now represented by the stub wall extending for 1.60m from the south wall of the barn, were revealed [2/304-2/308] (see plates 36 and 37). Only the top of the foundation (104) was exposed, but it measured 2.50m long (north-south), and was composed of roughly dressed sandstone blocks, typically up to 0.50m long and over 0.30m wide. The foundation was only seen on the east side of the wall but extrapolation suggests that it was at least 1.00m wide, slightly wider than the 0.60m wide wall (102) above, and it continued under the upstanding section of stub wall; the foundation was slightly offset from the wall line above. The foundation did not continue across the full width of the barn, terminating c.1.00m to the south of the north wall, suggesting the north end may have been robbed. No bonding material was evident within the foundation.

- 4.5 The hard-packed ground on the east side of the cross-wall foundation (102) was cleaned back for a distance of 0.60m, to reveal a hard compacted lime mortar surface (103) of uncertain depth (see plate 36). No ground-reduction work was undertaken in this area, the ground level being built up with material from the west side of the barn.

Plate 36: Excavated footings of cross-wall (102), with underlying foundations (104) and compacted surface (103) to east, looking W.

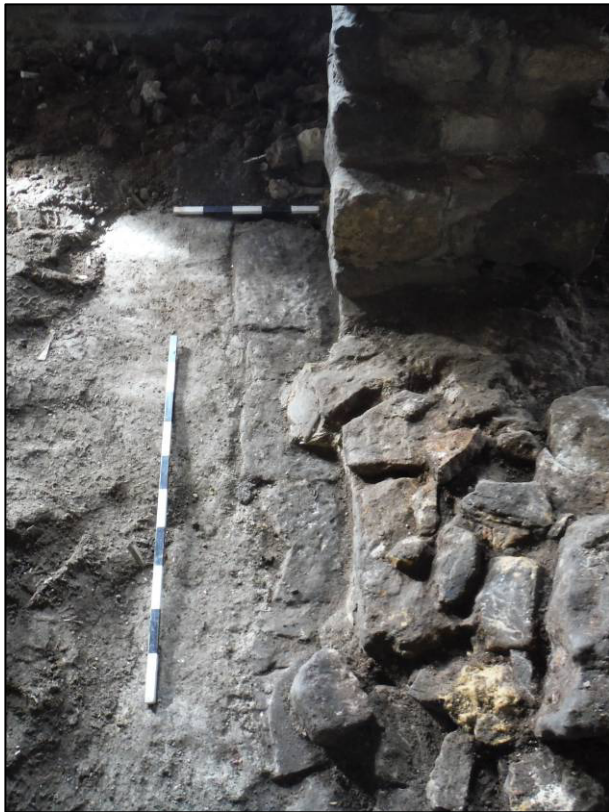
Plate 37: Excavated footings of cross-wall (102), with underlying foundations (104) running under stub wall, and compacted surface (103) to E, looking S (photo 2/308).

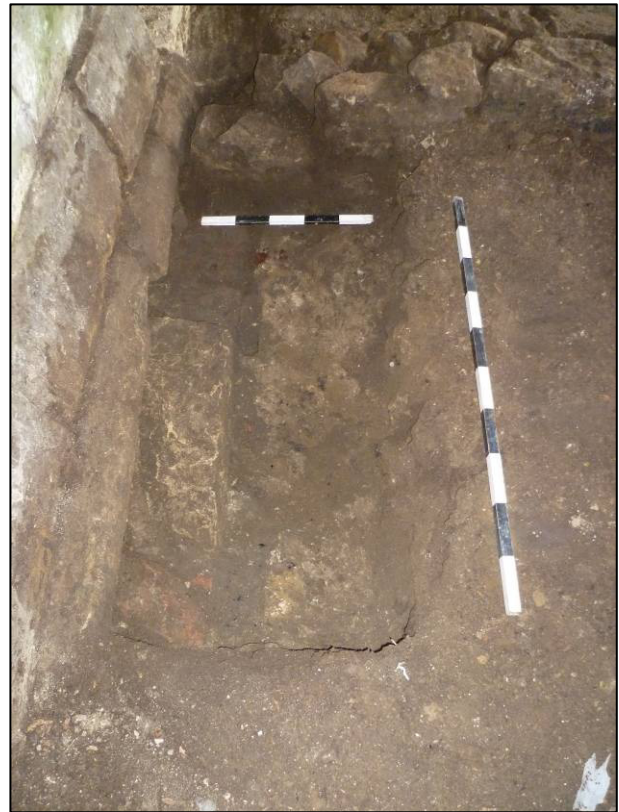
- 4.10 Cut into the earlier construction/demolition deposit (107) rubble was an east-west aligned construction cut [108] over 0.32m wide for the foundation (109) of the north wall of the barn (113) (see plate 38). The foundation (109) varied from one to two visible courses (typically 0.23m high) of unbonded roughly hewn sandstone blocks, up to 0.60m long by 0.35m wide by over 0.11m thick, some of which may have been re-used as at least two pieces were heavily burnt; the foundations stepped out 0.18m beyond the wall face (111) above but the full depth of the foundations was not revealed. The construction cut had been backfilled with a dark grey sandy silt (110). Above the foundation, the lowest two courses of the north wall of the barn (113) were formed by two separate moulded chamfered plinths of dressed sandstone (111), the upper set back by 0.07m from the lower; the lower course was 0.20m high while the upper, previously exposed, course was 0.30m high [2/287] (see figure 11).

Plate 38: Excavated Test Pit 1, showing foundations (109) under double chamfer of barn wall (111), with cut for foundation trench [108], looking E (photo 2/285).

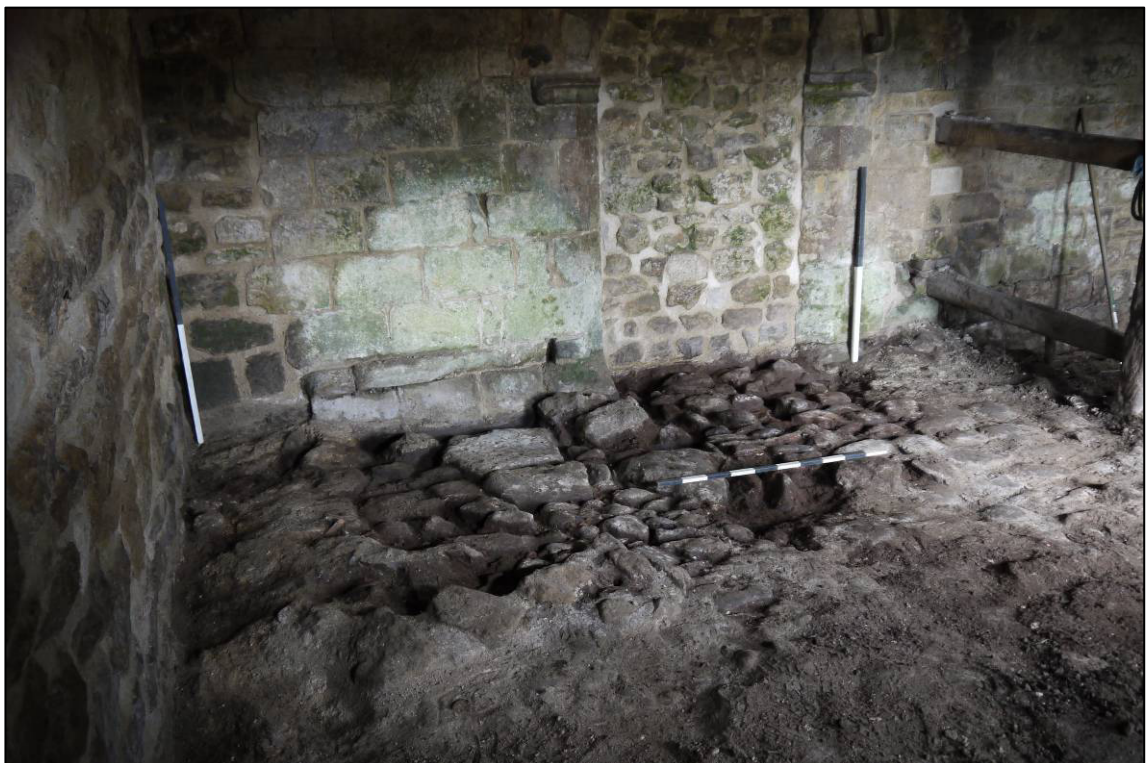
- 4.6 The hard-packed floor in the north-west corner of the barn was also cleaned back prior to its removal, over an area measuring c.1.50m north-south by 3.00m east-west. This revealed a rough hard-standing surface (101) made up of rounded cobbles and pieces of worked squared and rubble sandstone of various sizes, bound in a firm mid-brown clay, straw and animal dung mixture; the larger pieces of stone lay to the west of the blocked doorway here [2/303] (see plate 39). This surface was obviously an area of hard standing for cattle, and it was bedded on a 0.30m thick layer of loose mid-dark brown clay (106). A small assemblage of animal and bird bone, and two shards of 20th century glass, were recovered from the ground-raising deposit (106) (see Appendix 5).

Plate 39: Cleared ground surface in north-west corner of barn, showing hard standing (101), looking N (photo 2/303).

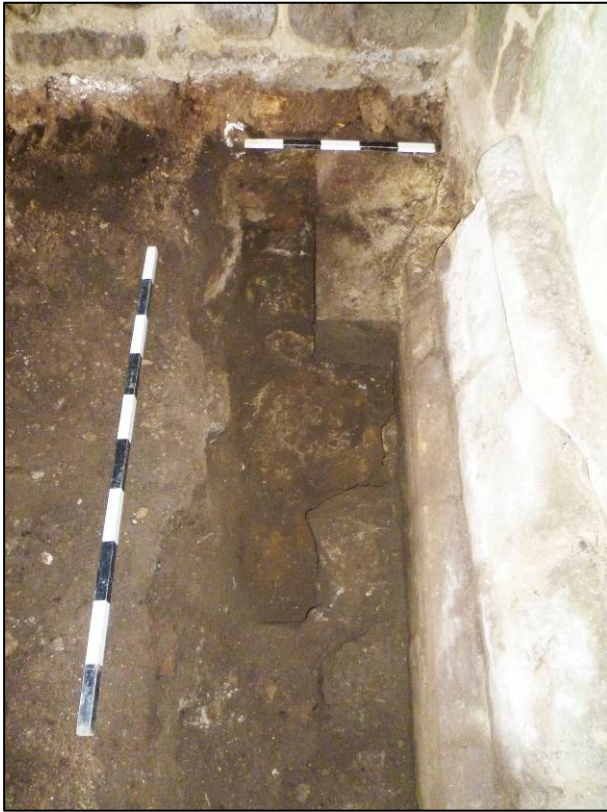
- 4.13 The earliest feature encountered was the east-west aligned foundation (112) of the north wall of the barn (113) (see plate 40). The foundation comprised at least two courses of unbonded, roughly hewn, sandstone blocks, ranging in size from 0.30m by 0.10m by 0.10m thick to 0.20m by 0.20m by 0.36m thick, which stepped out 0.20m from the wall face (111) above. As in Test Pit 1, the full depth of the foundation was not revealed.

- 4.15 The base for a buttress (114) was exposed in the north-west corner of the test pit [2/294, 2/295] (see plate 40). This lay on top of the foundation course (112), which stepped out further to the south and east to accommodate it. It measured 0.50m east-west, the west end running under the west wall of the barn, and it was stepped out 0.30m from the north wall, although the plinths and roll-moulding had been chopped out. Two courses of the buttress base (114) were exposed, the lower course being unbonded and of squared stones measuring 0.18m square and over 0.20m thick. Only one block of the second course survived in the western corner, measuring 0.18m long by 0.30m wide and 0.15m high. The east-west measurement of the buttress coincided with the straight joints in the north wall face above (113). A short length of the foundation of the west wall of the barn (115) was also exposed, lying on top of the north wall foundation (112) and abutting the buttress base (114).

Plate 40: Excavated Test Pit 2, showing foundations (112) of barn wall (111), with buttress base (114) in corner, looking W (photo 2/291).

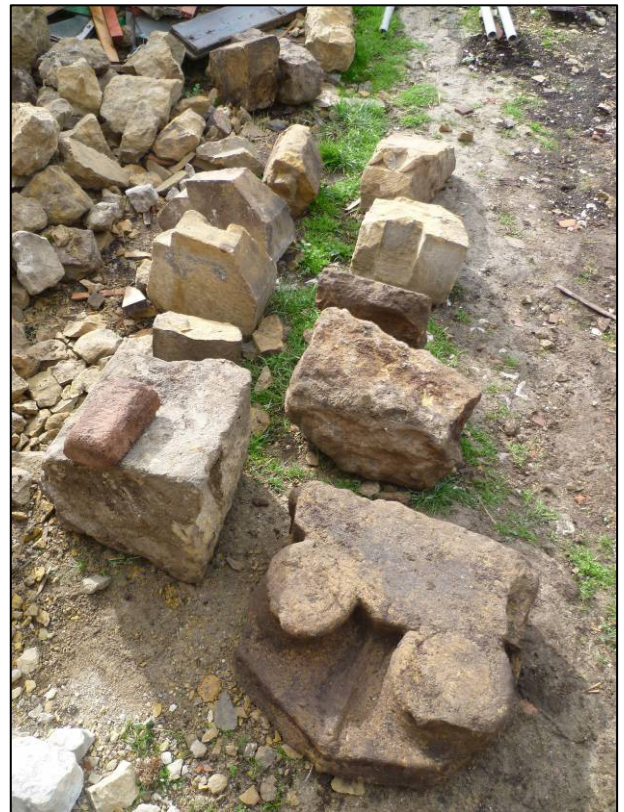
- 4.7 A number of architectural fragments were recovered from the hard-standing surface (see plate 41). These are predominately of late 12th-early 13th century date, and include two window voussoirs, an ashlar block with an angled socket for a timber, a short length of detached nook shaft, an incomplete jambstone with dogtooth decoration (see plate 43), and a chamfered block perhaps part of a vault rib or the soffit order from an arch [2/244, 2/247-2/249, 2/280] (see Appendix 3). Of particular note is a double section of capital, each for a single detached shaft, attached to an octagonal block showing that it represents part of a much larger pier; there are setting out marks visible on the underside suggesting the mason had several failed attempts before completing the piece [2/245, 2/246] (see plate 44). It may have formed part of an arcade of some sophistication (perhaps for the north aisle) or a support for a vault in one of the claustral buildings such as the chapter house or undercroft (Stuart Harrison, *pers. comm.*).

Plate 41: Ex-situ carved stonework recovered from excavations and internal floor clearance (photo 2/249).

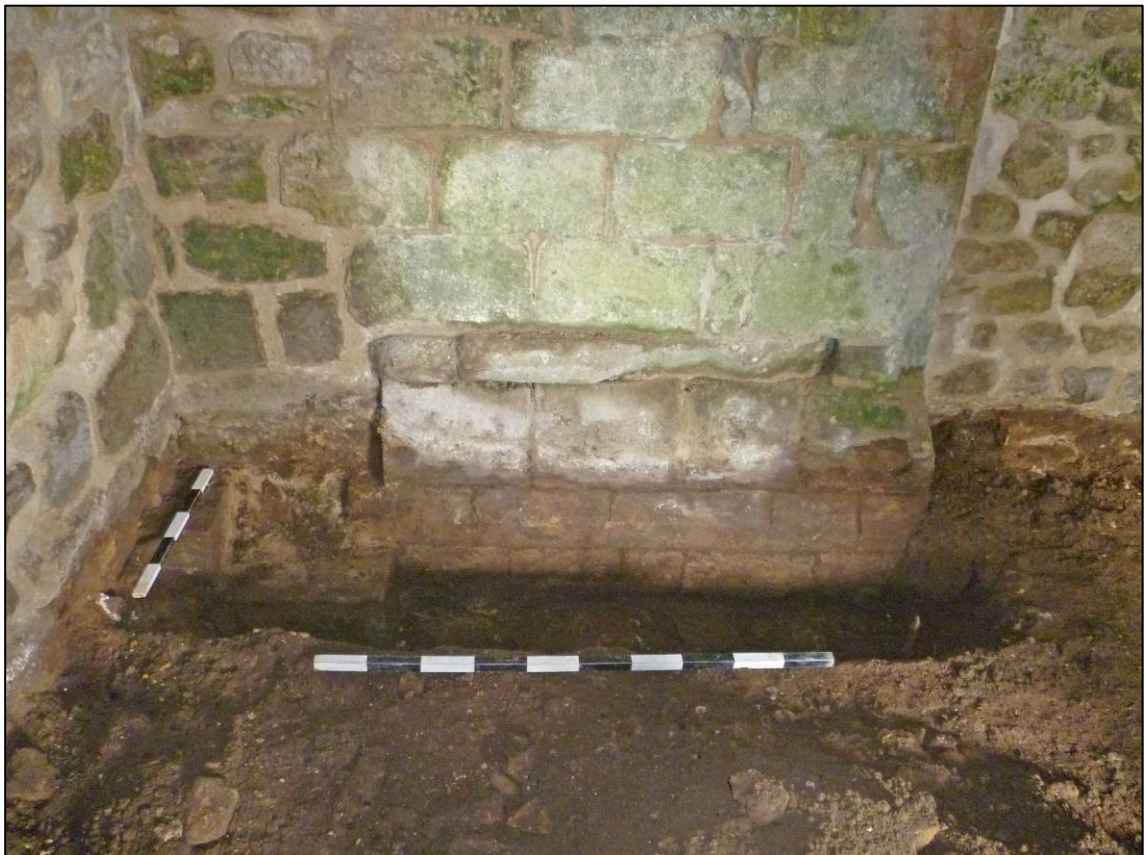
Plate 42: Excavated Test Pit 2, showing chamfered plinth to base of barn wall (111), with buttress base (114) to left, looking N (photo 2/297).

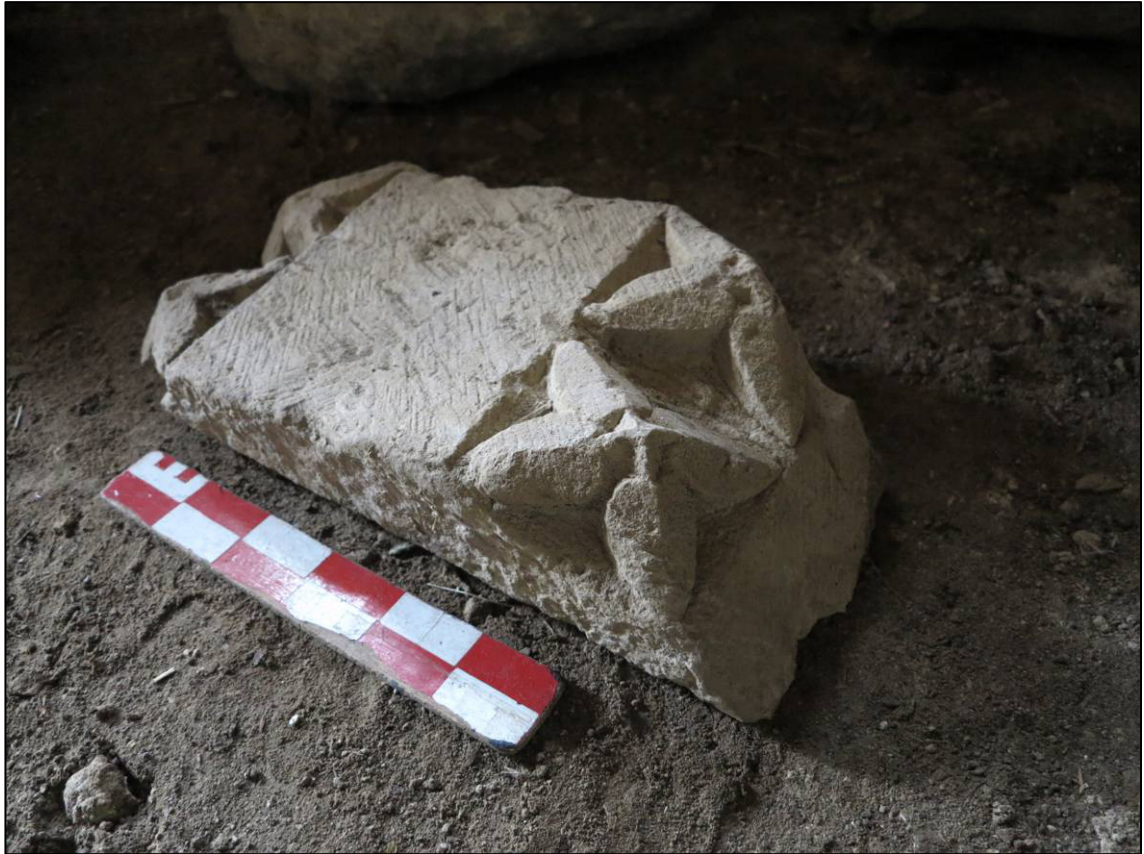
Plate 43: Ex situ incomplete jamb stone with dogtooth decoration, late 12th or early 13th century date (photo courtesy Stuart Harrison).

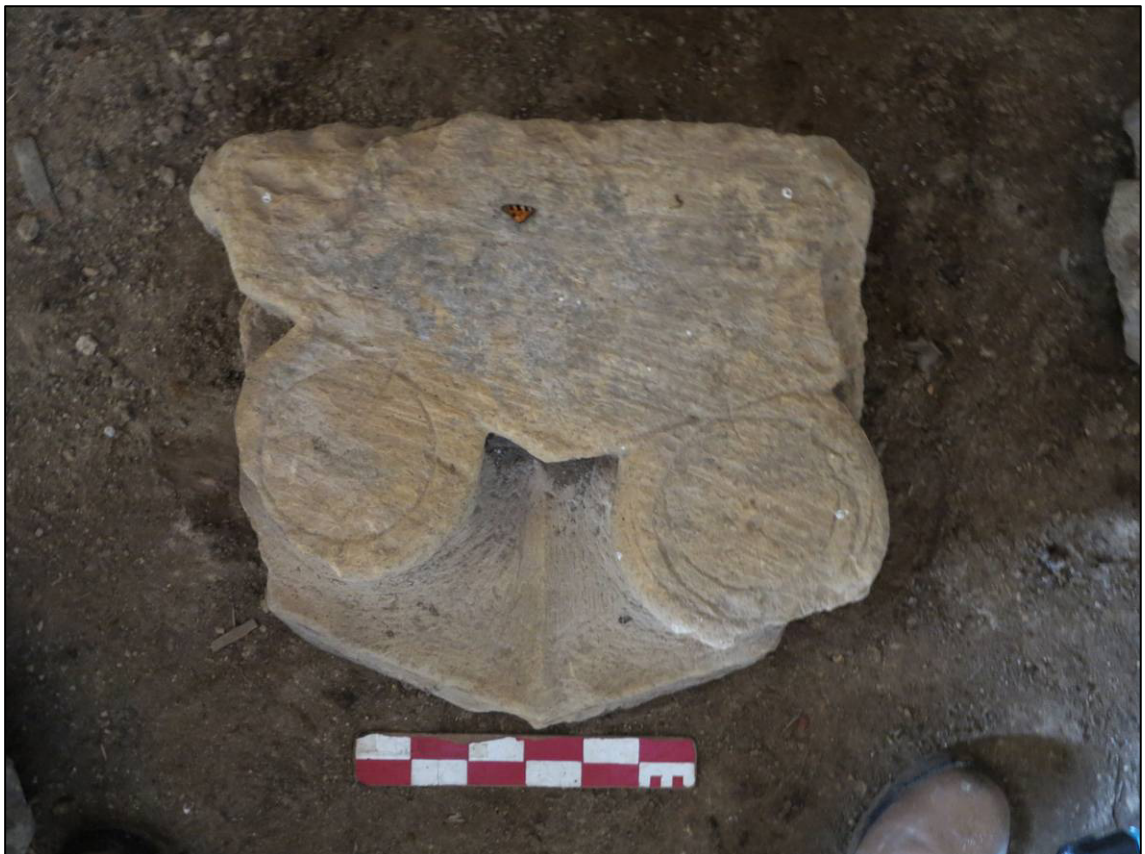
Plate 44: Double section of capital each for a single detached shaft, part of former pier, showing setting out marks, late 12th or early 13th century (photo courtesy Stuart Harrison).
