CONSTRUCTION OF WC EXTENSION,
PRIEST'S HOUSE AND CHAPEL,
BARDEN TOWER, BARDEN, NORTH YORKSHIRE

ARCHITECTURAL AND ARCHAEOLOGICAL
OBSERVATION, INVESTIGATION AND RECORDING

Report no: 2018/582.R01
Version: Final
Date: June 2019
Author: Ed Dennison & Shaun Richardson

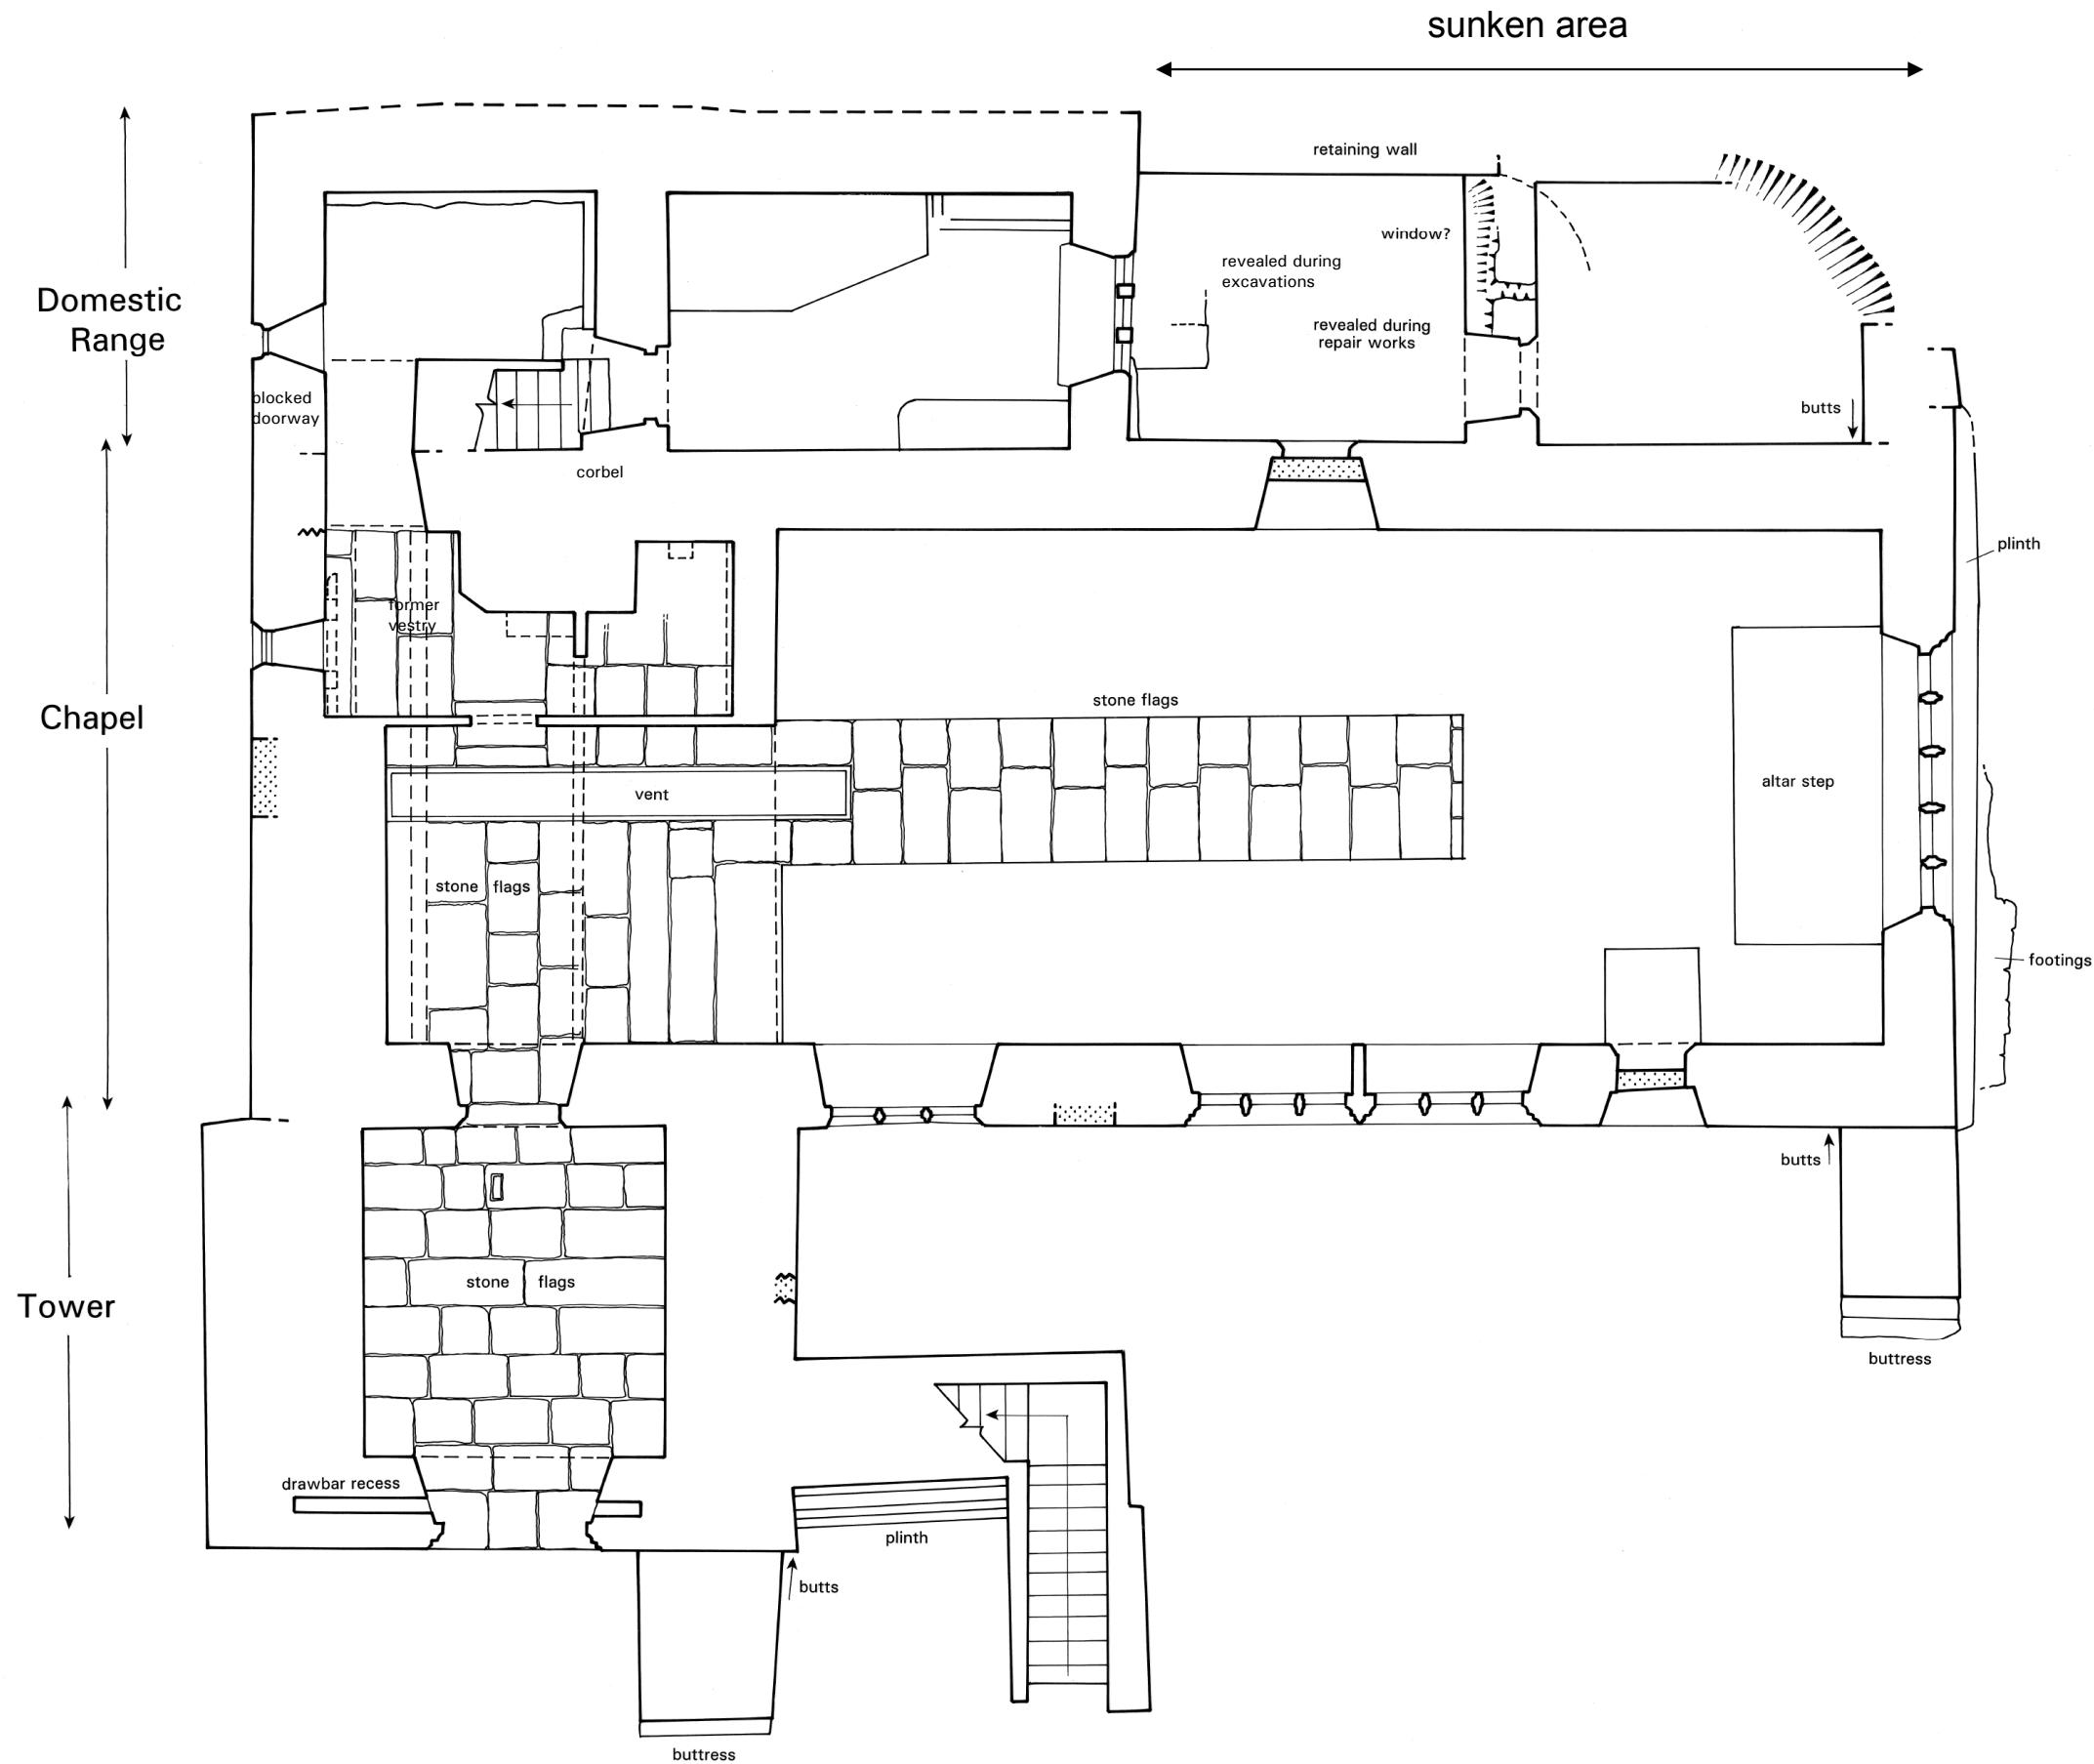
PROJECT	
BARDEN PRIEST'S HOUSE AND CHAPEL	
TITLE	
LOWER GROUND FLOOR PLAN	
SCALE	DATE
AS SHOWN	JUN 2019
EDAS	FIGURE
	7

- 3.5 The sunken area on the north side of the chapel is bounded by the north elevation of the chapel, and the east gable and north elevation of the domestic range (see figure 7). There is also a retaining wall extending east from the north-east corner of the domestic range, initially parallel to the north elevation of the chapel and then formerly curving to the south-east to the north-east corner buttress of the chapel. This retaining wall was rebuilt as part of the 2015-16 works, and is described below.

- 3.8 Prior to the 2015-16 works, the retaining wall defining the north side of the sunken area was collapsing, with a curving alignment, particularly marked towards the eastern end (see figure 7). The uppermost part of the retaining wall formed a freestanding element, built of relatively large coursed squared stone, and with a chamfered doorway with an elliptical head at the west end. This doorway was rebated to the inner (south) face and appeared to be an *in situ* feature, rather than a 19th or 20th century creation re-using pieces taken from elsewhere on the site. The doorway is set at ground floor level on this side of the building. To the east of the doorway, there was what appeared to be the jambs of a blocked fireplace, with a few projecting stones perhaps representing a former hearth; these features had previously been noted and recorded by an unknown architect in November 1994 (see figure 5). Further to the east, the upper part of the retaining wall curved around to the south. Much of this curving part is a later rebuild and is rather crude, but in part could form the splayed jamb of a window or other opening. There was no clear surviving evidence in the retaining wall for sockets relating to floor joists at ground floor level, but it was noticeable that the lower half of the wall (i.e. at lower

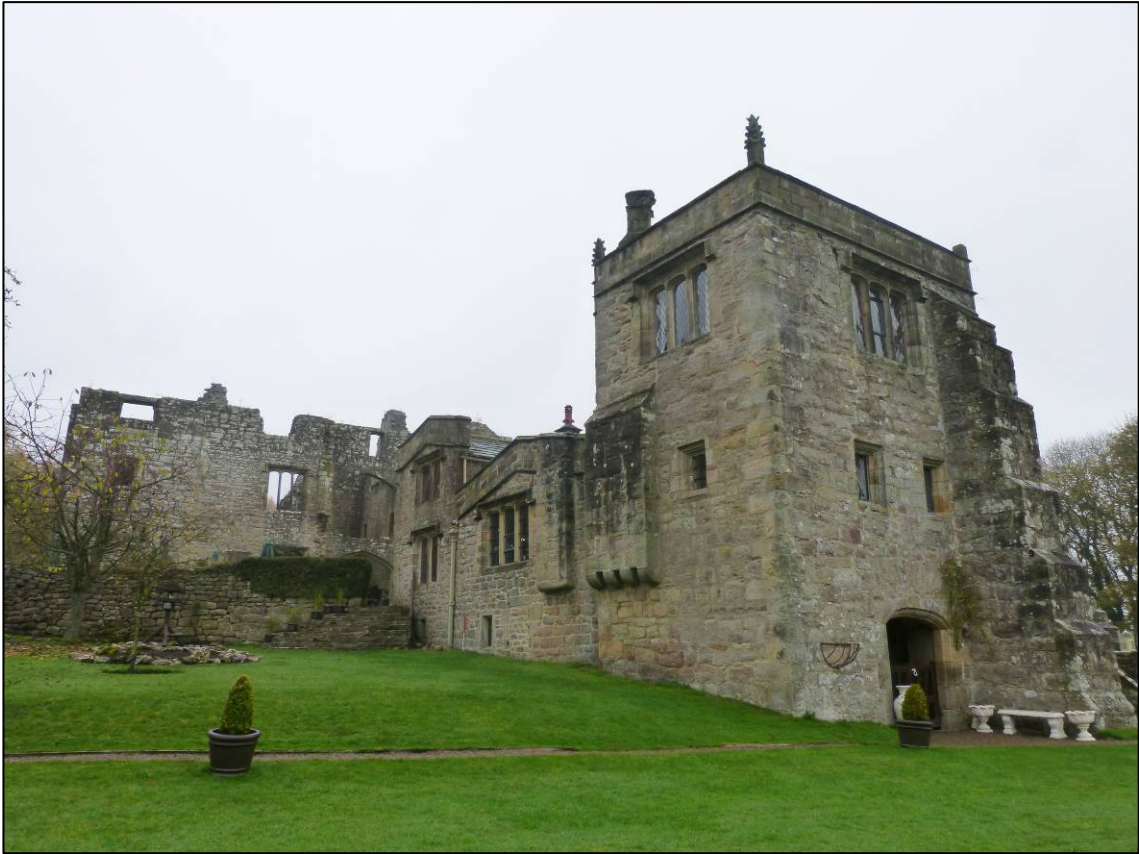
- 1.4 The early 16th century Priest's House and Chapel building lies on the east side of the B6160 road, with a series of steep banks which descend to the River Wharfe to the east (see figure 2 and plate 1). To the immediate north of the buildings are the ruins of Barden Tower, a late 15th century tower house built by Sir Henry Clifford which was later remodelled in 1658-59 by Lady Anne Clifford (see plate 2). The site is bounded on the west, south and east by dry stone walls, some up to 2.0m in height, while to the north it is enclosed by post and wire fencing. The buildings are currently used as a restaurant and wedding venue, and are surrounded by well tended gardens and lawns.

Plate 1: Priest's House and Chapel complex, with Barden Tower to rear, looking NE (November 2015).

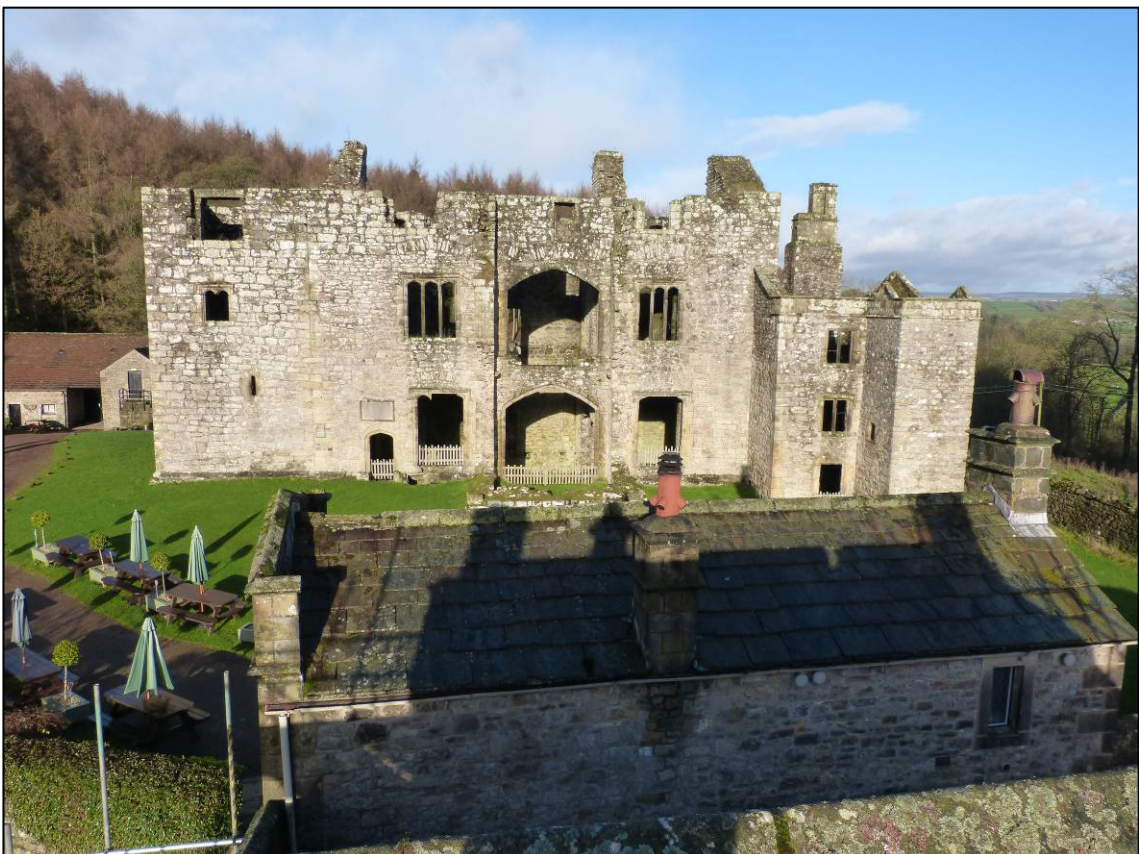
Plate 2: Barden Tower, from the roof of the Priest's House tower, looking NW (November 2015).

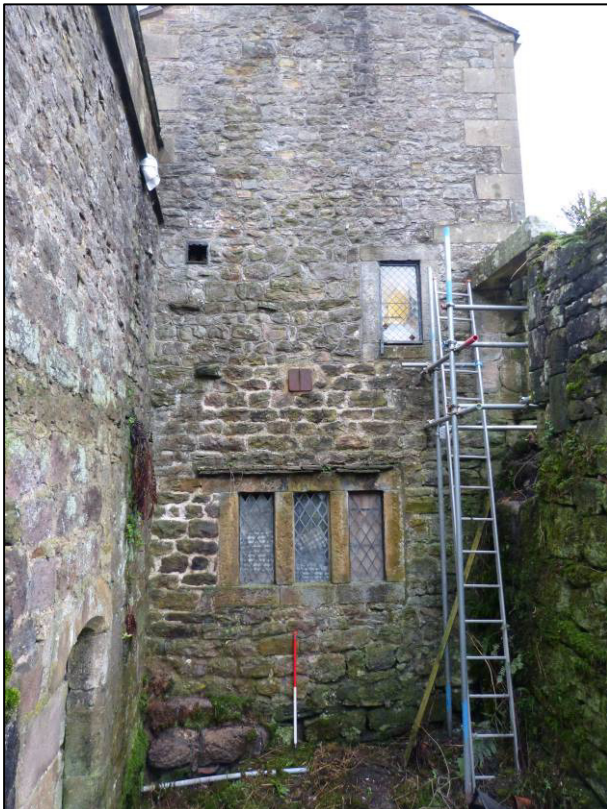
- 3.7 The east gable of the domestic range has a three-light, flat-headed, mullioned window to the lower ground floor; the mullions are flat-faced and each light is glazed with diamond-paned leaded glass (see plate 4). The centre part of the lintel bears the incised letter 'DAIRY' and there is a crude drip mould of thin stones over the lintel. Above, to the ground floor, towards its northern end, there is a flat-headed window fitted with diamond-paned leaded glass of modern appearance. The first floor is blank.

Plate 4: East gable of domestic block from within sunken area (December 2015).
