REPAIRS TO GATEWAY,
FYLING DEER PARK WALL, FYLINGDALE,
NORTH YORKSHIRE

ARCHAEOLOGICAL RECORDING

Report no: 2019/581.R01
Version: Final
Date: May 2019
Author: Ed Dennison

North York Moors National Park Authority
The Old Vicarage
Bondgate
Helmsley
York YO62 5BP

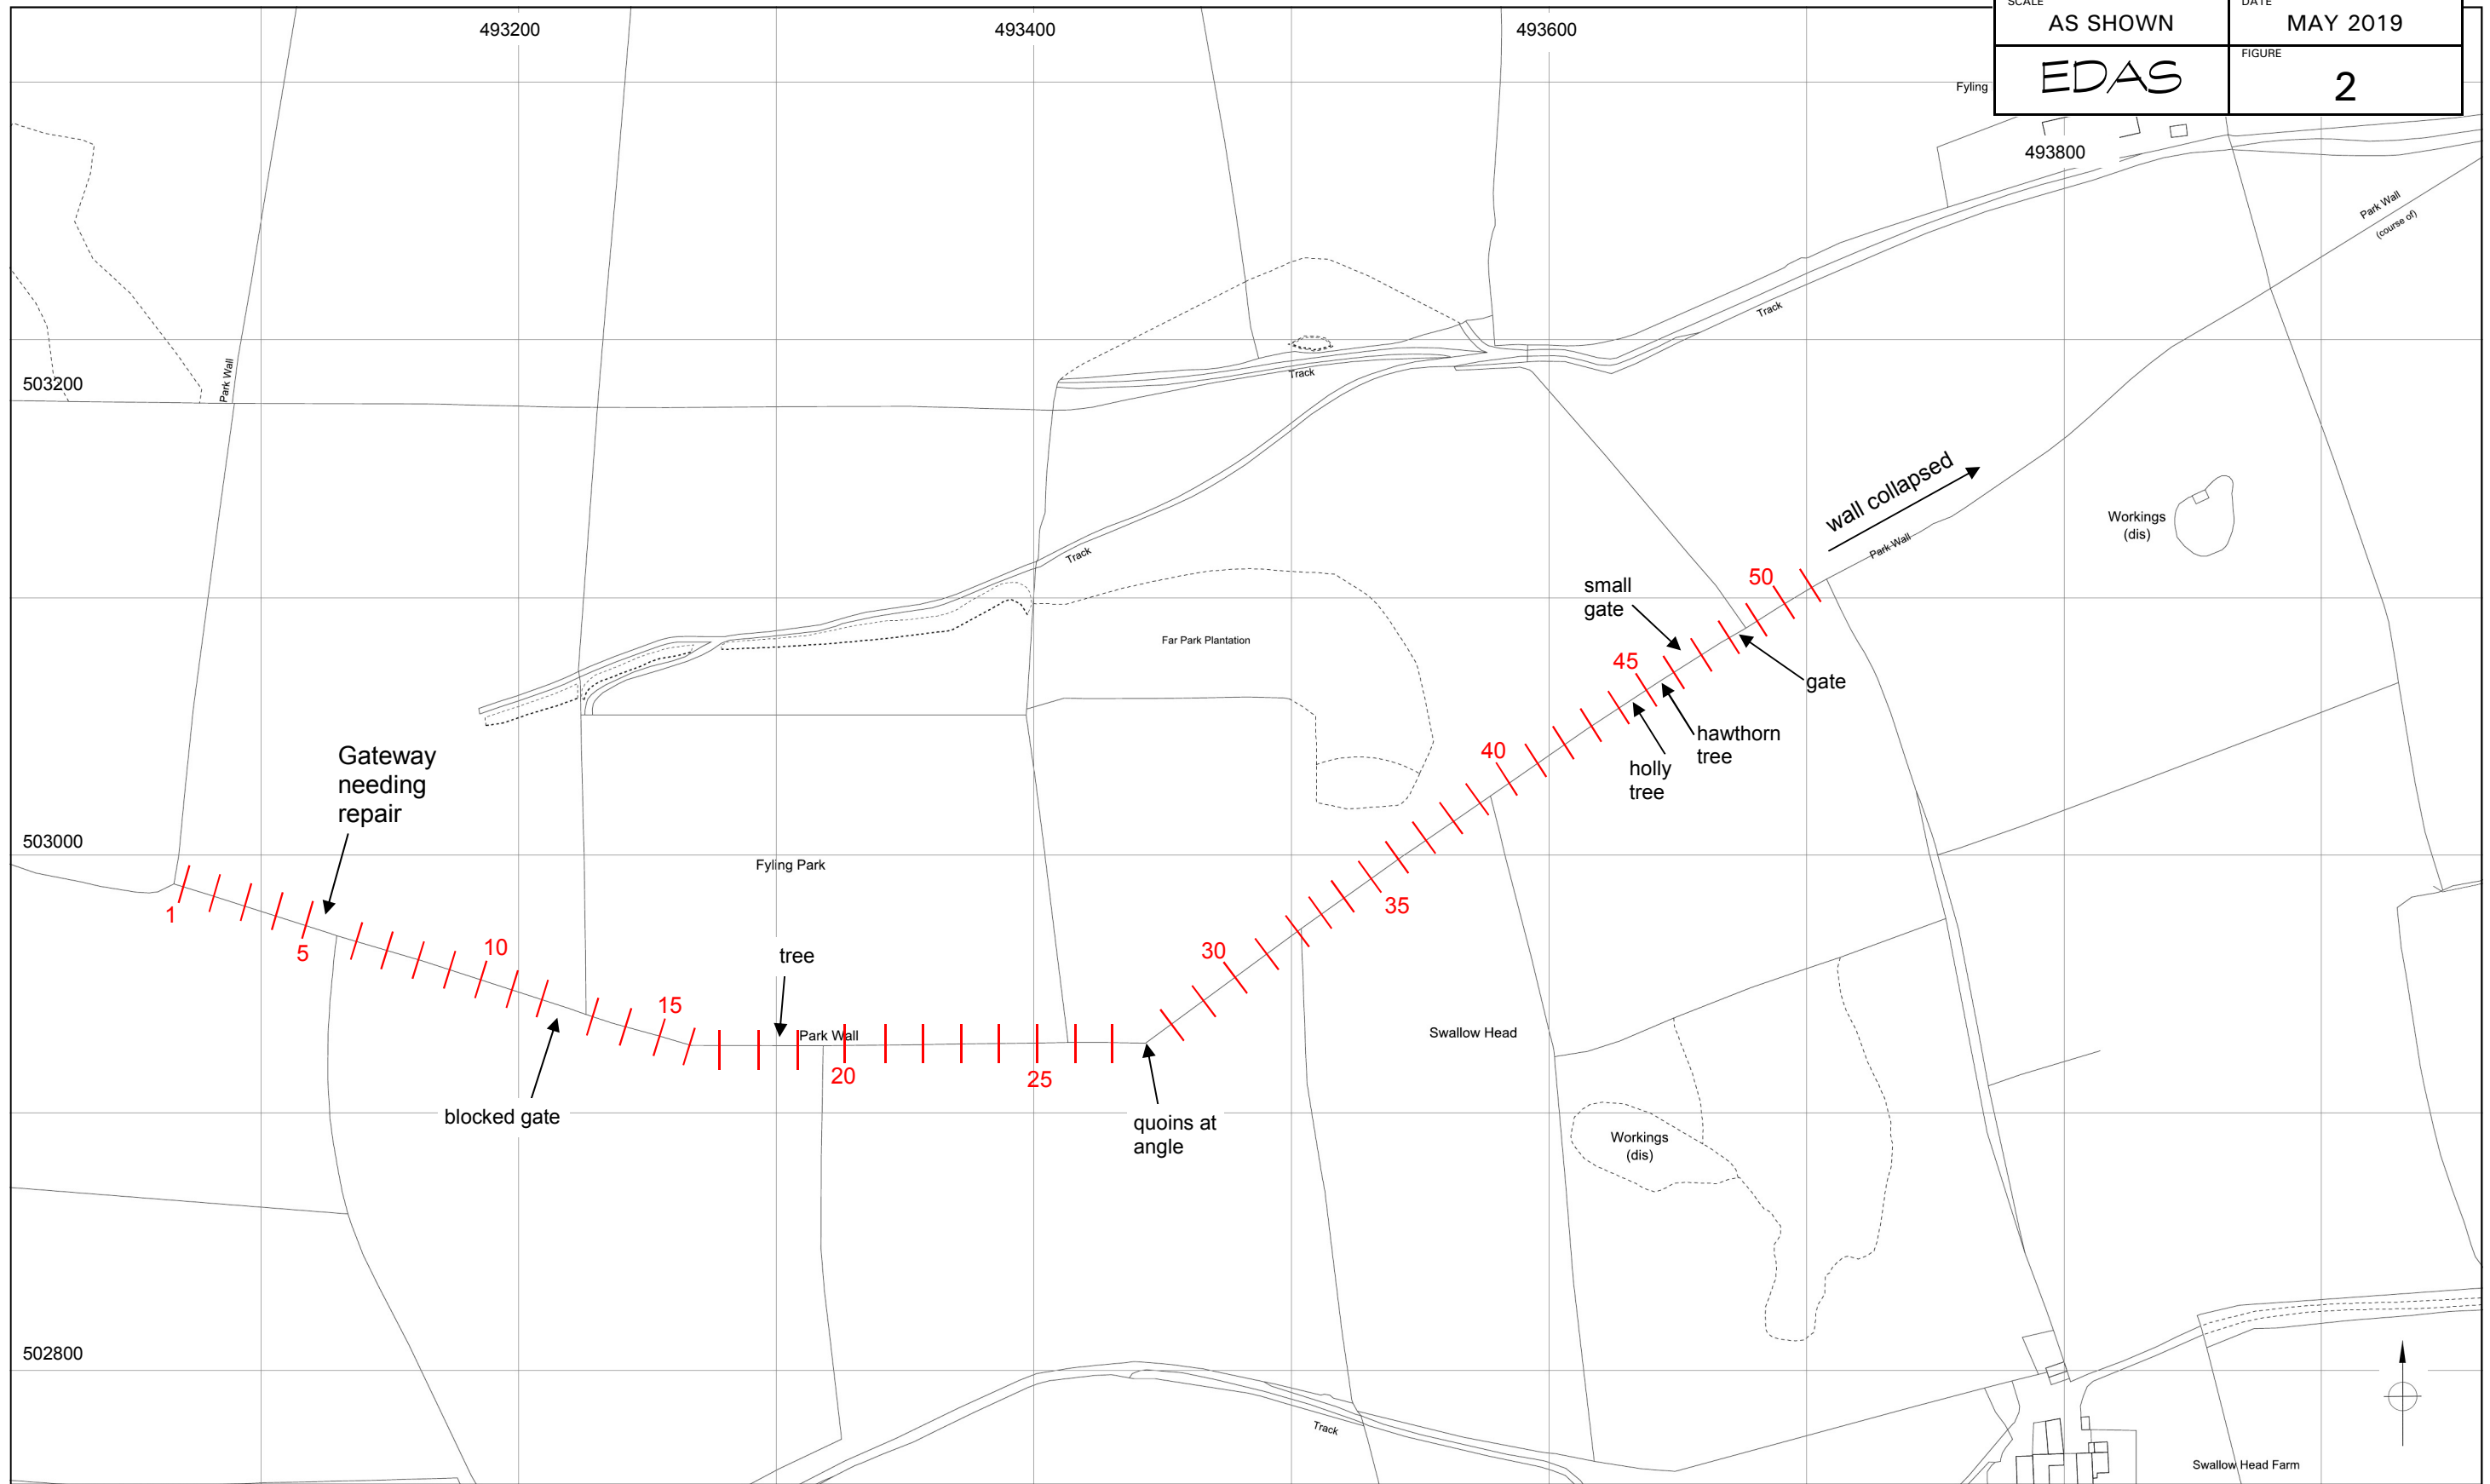
PROJECT		FYLING DEER PARK WALL	
TITLE		LOCATIONS OF CROSSES	
SCALE	AS SHOWN	DATE	MAY 2019
EDAS		FIGURE	2

- 2.5 The defining characteristic of the surviving section of deer park wall is the presence of stone crosses, placed every c.15m along the alignment (see figure 2). These are constructed of six large worked stones, placed in a combination of 'lintels' and 'throughs', with two parallel lower lintels forming the base of the wall. Previous authors have suggested that these crosses reflect the former monastic ownership of the park and, while this may well be true, they also serve to provide

- 4.2 The gateway needing repair lies towards the western end of the southern section of the deer park wall, at NGR NZ 93123 02973. It provides an access through the wall for a north-south aligned public footpath and bridleway, which is shown on the 1853 6" Ordnance Survey map (sheet 46, surveyed 1848-49) and the 1893 25" Ordnance Survey map (sheet 46/12, surveyed 1891) (Dennison 2018, figure 2). Both these maps show a square "sheepfold" in the angle of walls on the east side of the gateway, but nothing of this now remains. In terms of the identified stone crosses along the wall alignment, the gateway lies between no 5 and no 6 (see figure 2).
