ESTATE SHOOTING TRACK,
NORTH-EAST OF NORTH INGS PLANTATION,
SKELDERSKEW MOOR,
NEAR COMMONDALE, NORTH YORKSHIRE

ARCHAEOLOGICAL MONITORING
OF EROSION REPAIRS

Report no: 2020/621.R01
Version: Final
Date: August 2020
Author: Ed Dennison

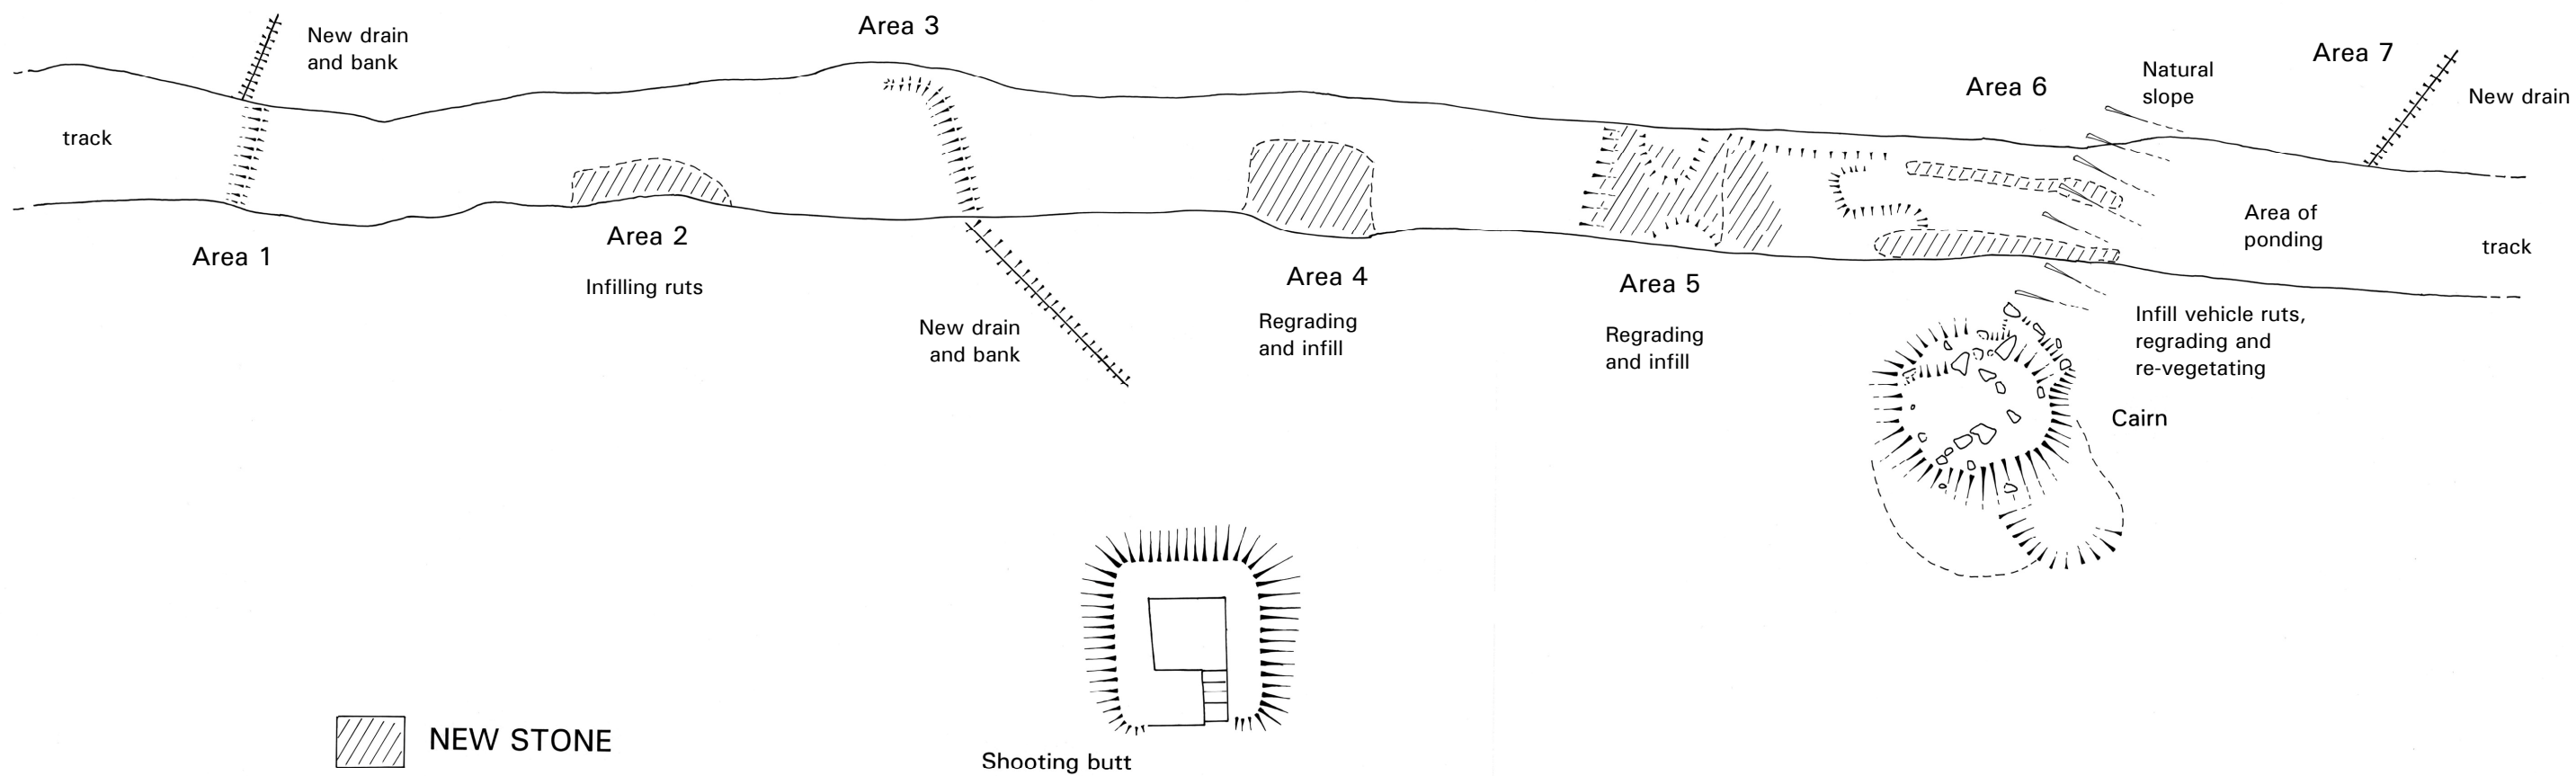
PROJECT		NORTH INGS SHOOTING TRACK	
TITLE		SITE PLAN	
SCALE	AS SHOWN	DATE	AUG 2020
EDAS		FIGURE	3

- 3.1 Several pieces of work were undertaken to alleviate the problems of erosion and run-off water ponding along this section of the shooting track, as set out below. In all, the extent of the works covered a length of 50m along the track, ending at a point 7.00m to the south of the cairn (see figure 3). The work was undertaken using a Kubota mini-digger with a 0.90m wide ditching bucket, with some additional hand excavation as required.
