WESTMORLAND DALES HIDDEN LANDSCAPE
PARTNERSHIP
MONUMENTS AT RISK SURVEY

ARCHAEOLOGICAL SURVEYS OF
SMARDALE KILNS AND QUARRY,
PENDRAGON CASTLE,
RAVENS' GILL BARROWS AND
CROSBY LODGE SHIELING

Report no: 2017/548.R01
Version: Final
Date: July 2018
Author: Ed Dennison & Shaun Richardson

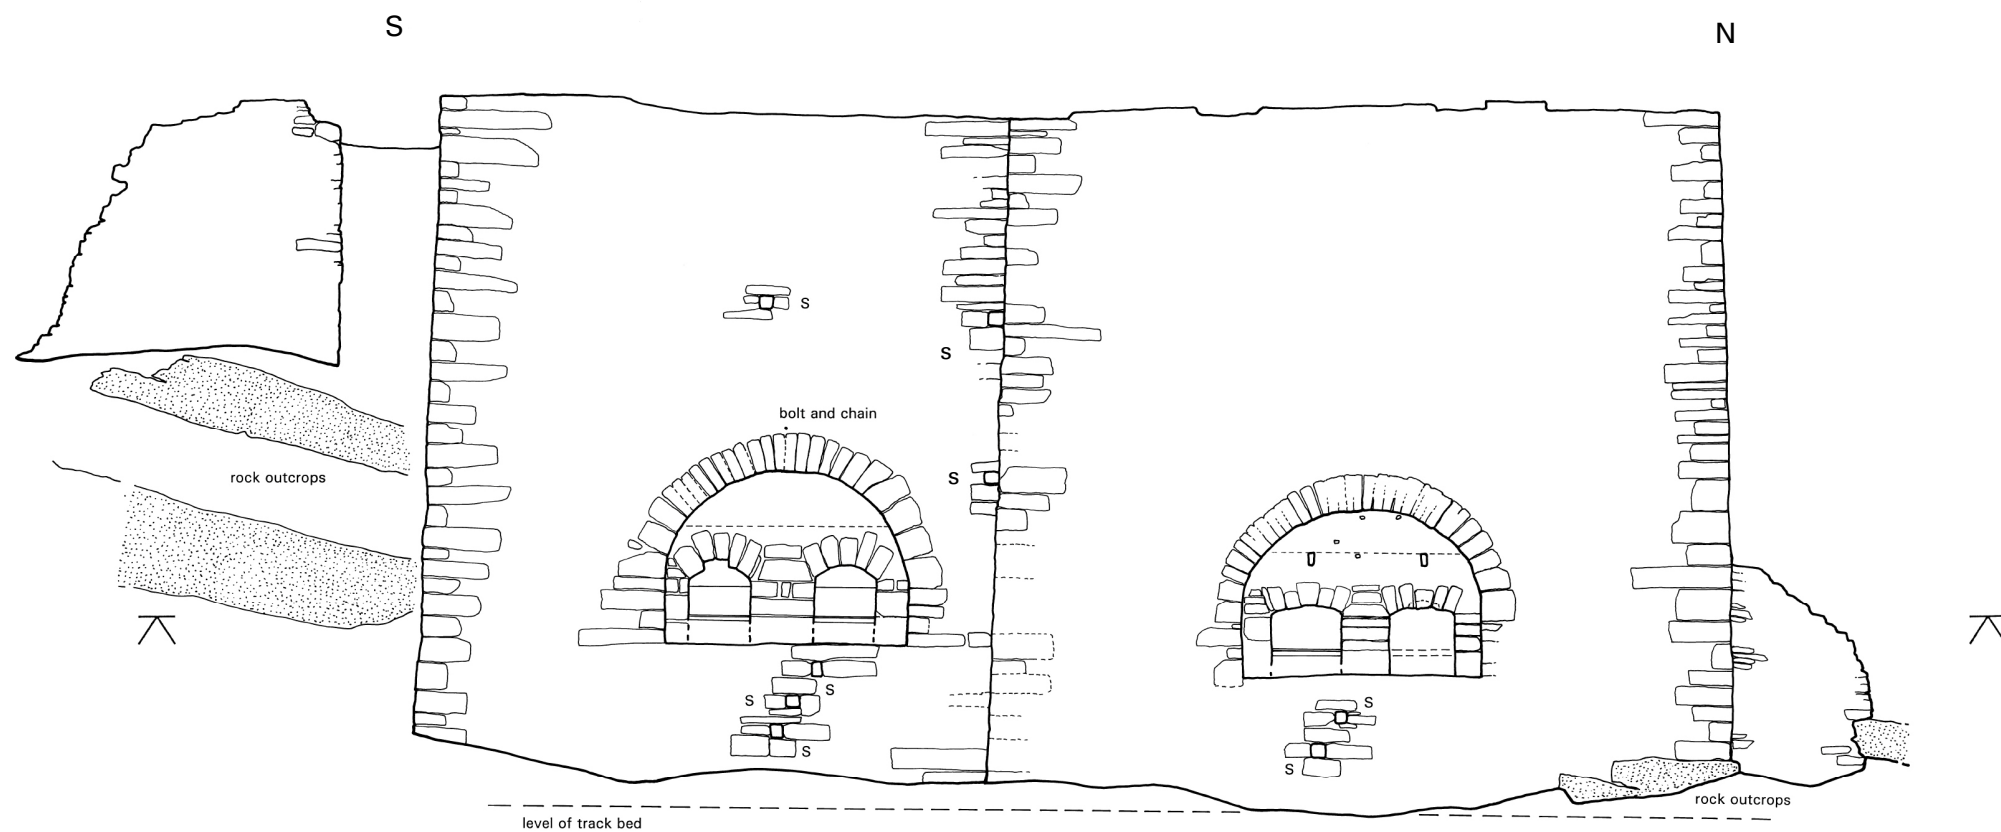
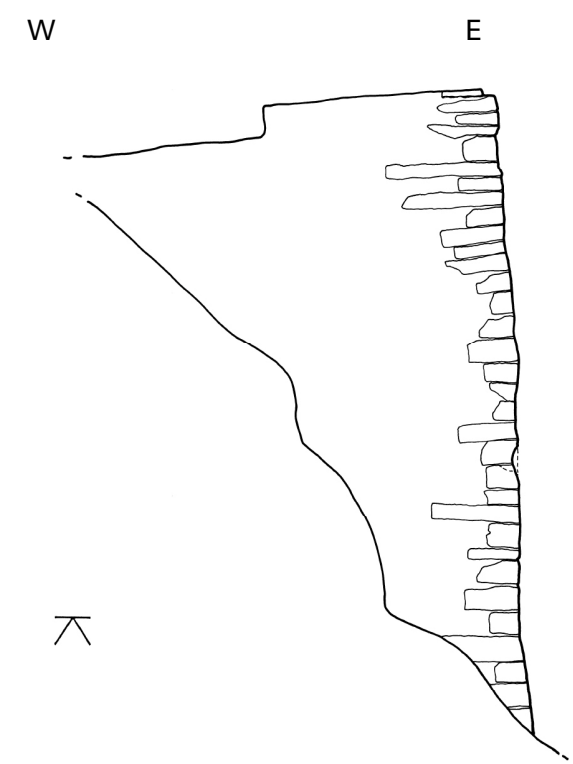
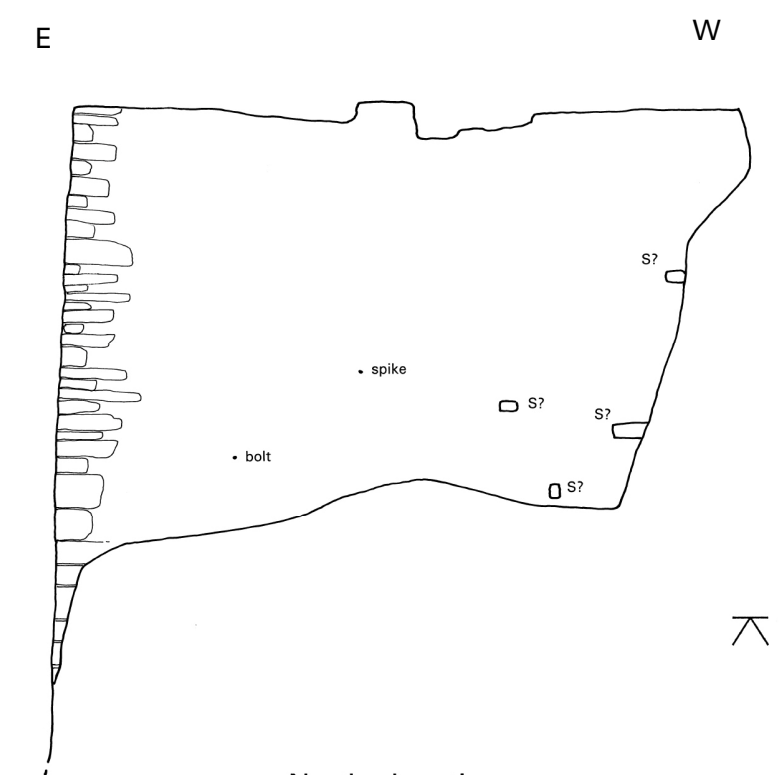
PROJECT		WESTMORLAND MARS	
TITLE			
SMARDALE KILNS - ELEVATIONS			
SCALE	AS SHOWN	DATE	JUL 2018
EDAS		FIGURE	6

- 2.20 The south elevation of the south kiln is a maximum of 9.20m in height, and at an upper level runs west for c.6.00m [1/010] (see plate 4). There is then a break of c.1.50m, and the line of the elevation is carried on in plan for a further 1.30m (see plate 1). This south elevation contains no sockets, recesses, ironwork or other features. There is considerable erosion on the south-east corner, where many joints are open, and several stones are split due to water penetration with frost damage [1/053]. Some movement is also evident higher up with a bulge indicating some thrust from behind.

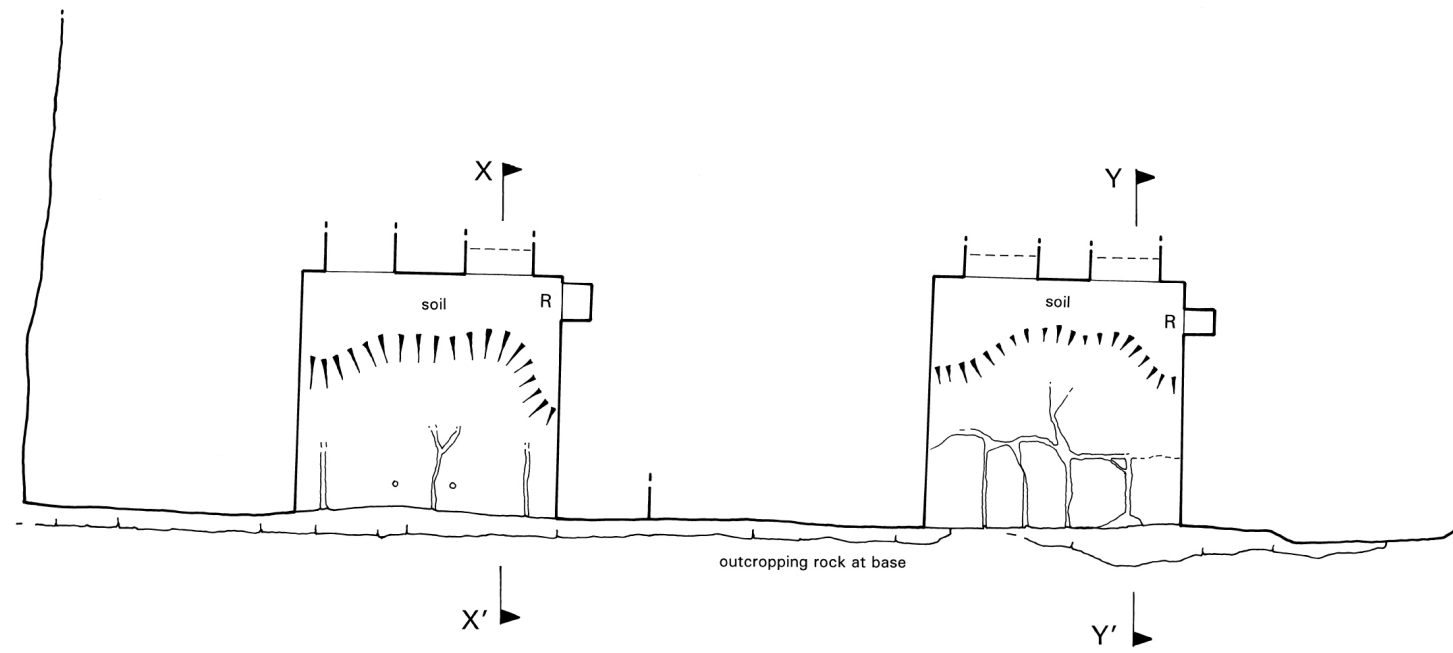
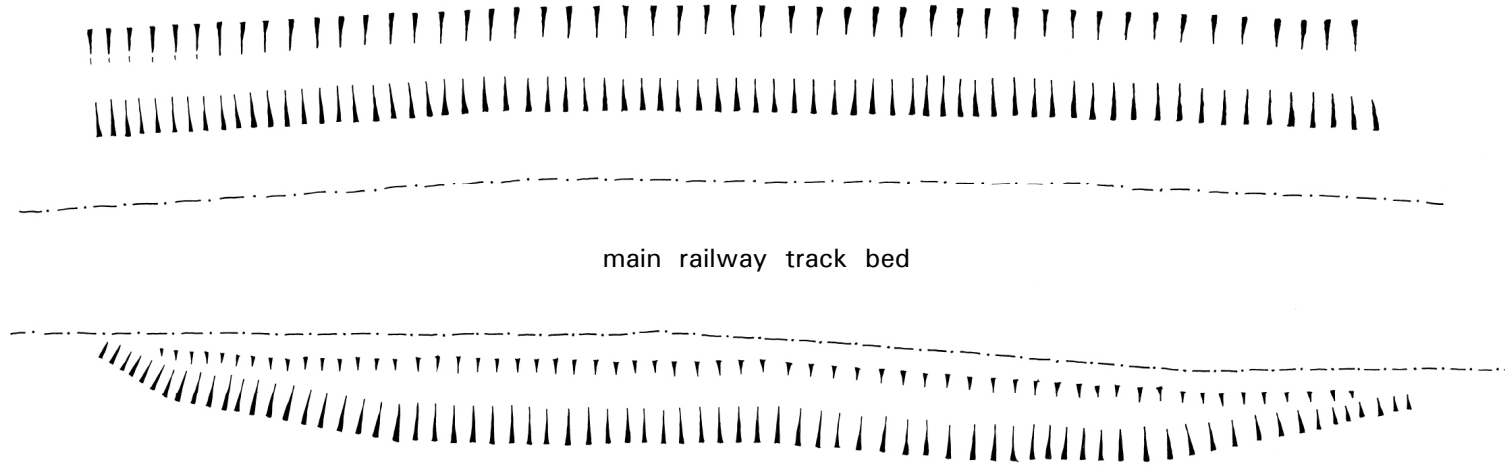
PROJECT		WESTMORLAND MARS	
TITLE		SMARDALE KILNS - BASE LEVEL	
SCALE	AS SHOWN	DATE	JUL 2018
EDAS		FIGURE	7

set at a low level towards the west end [1/034, 1/035]. There are two draw openings in the west wall, each with a segmental arched head of rubble voussoirs. To the interior of the draw openings, a section of north-south aligned rail (assumed to be either wrought- or cast-iron), measuring 120mm wide by 65mm deep in section supports shorter sections of similar rails running east-west. The rails do not appear to conform to the profile or dimensions of any 'normal' railway rail (Richard Lamb, *pers. comm.*), and so are probably not re-used here from the adjacent railway main line or siding, for example. Together, these support the base of the pot or charge hole over the draw opening; there are firebricks above the rails to the south draw opening. Below the rails, each opening is also fitted with a cast-iron grate of composite form. A north-south aligned bar, 0.07m deep, has a ledge cast into the rear face. The grate pieces rest on this bar, containing closely spaced gaps set at 30mm centres; the grate extends back at least 0.95m from the face of the draw openings. To the north draw opening, the grate must have begun to deform or collapse during use, and so a firebrick wall was built beneath to support the south side. Above the arched heads of the draw openings, the face of the west wall is corbelled out slightly [1/027-1/031] (see plate 6).

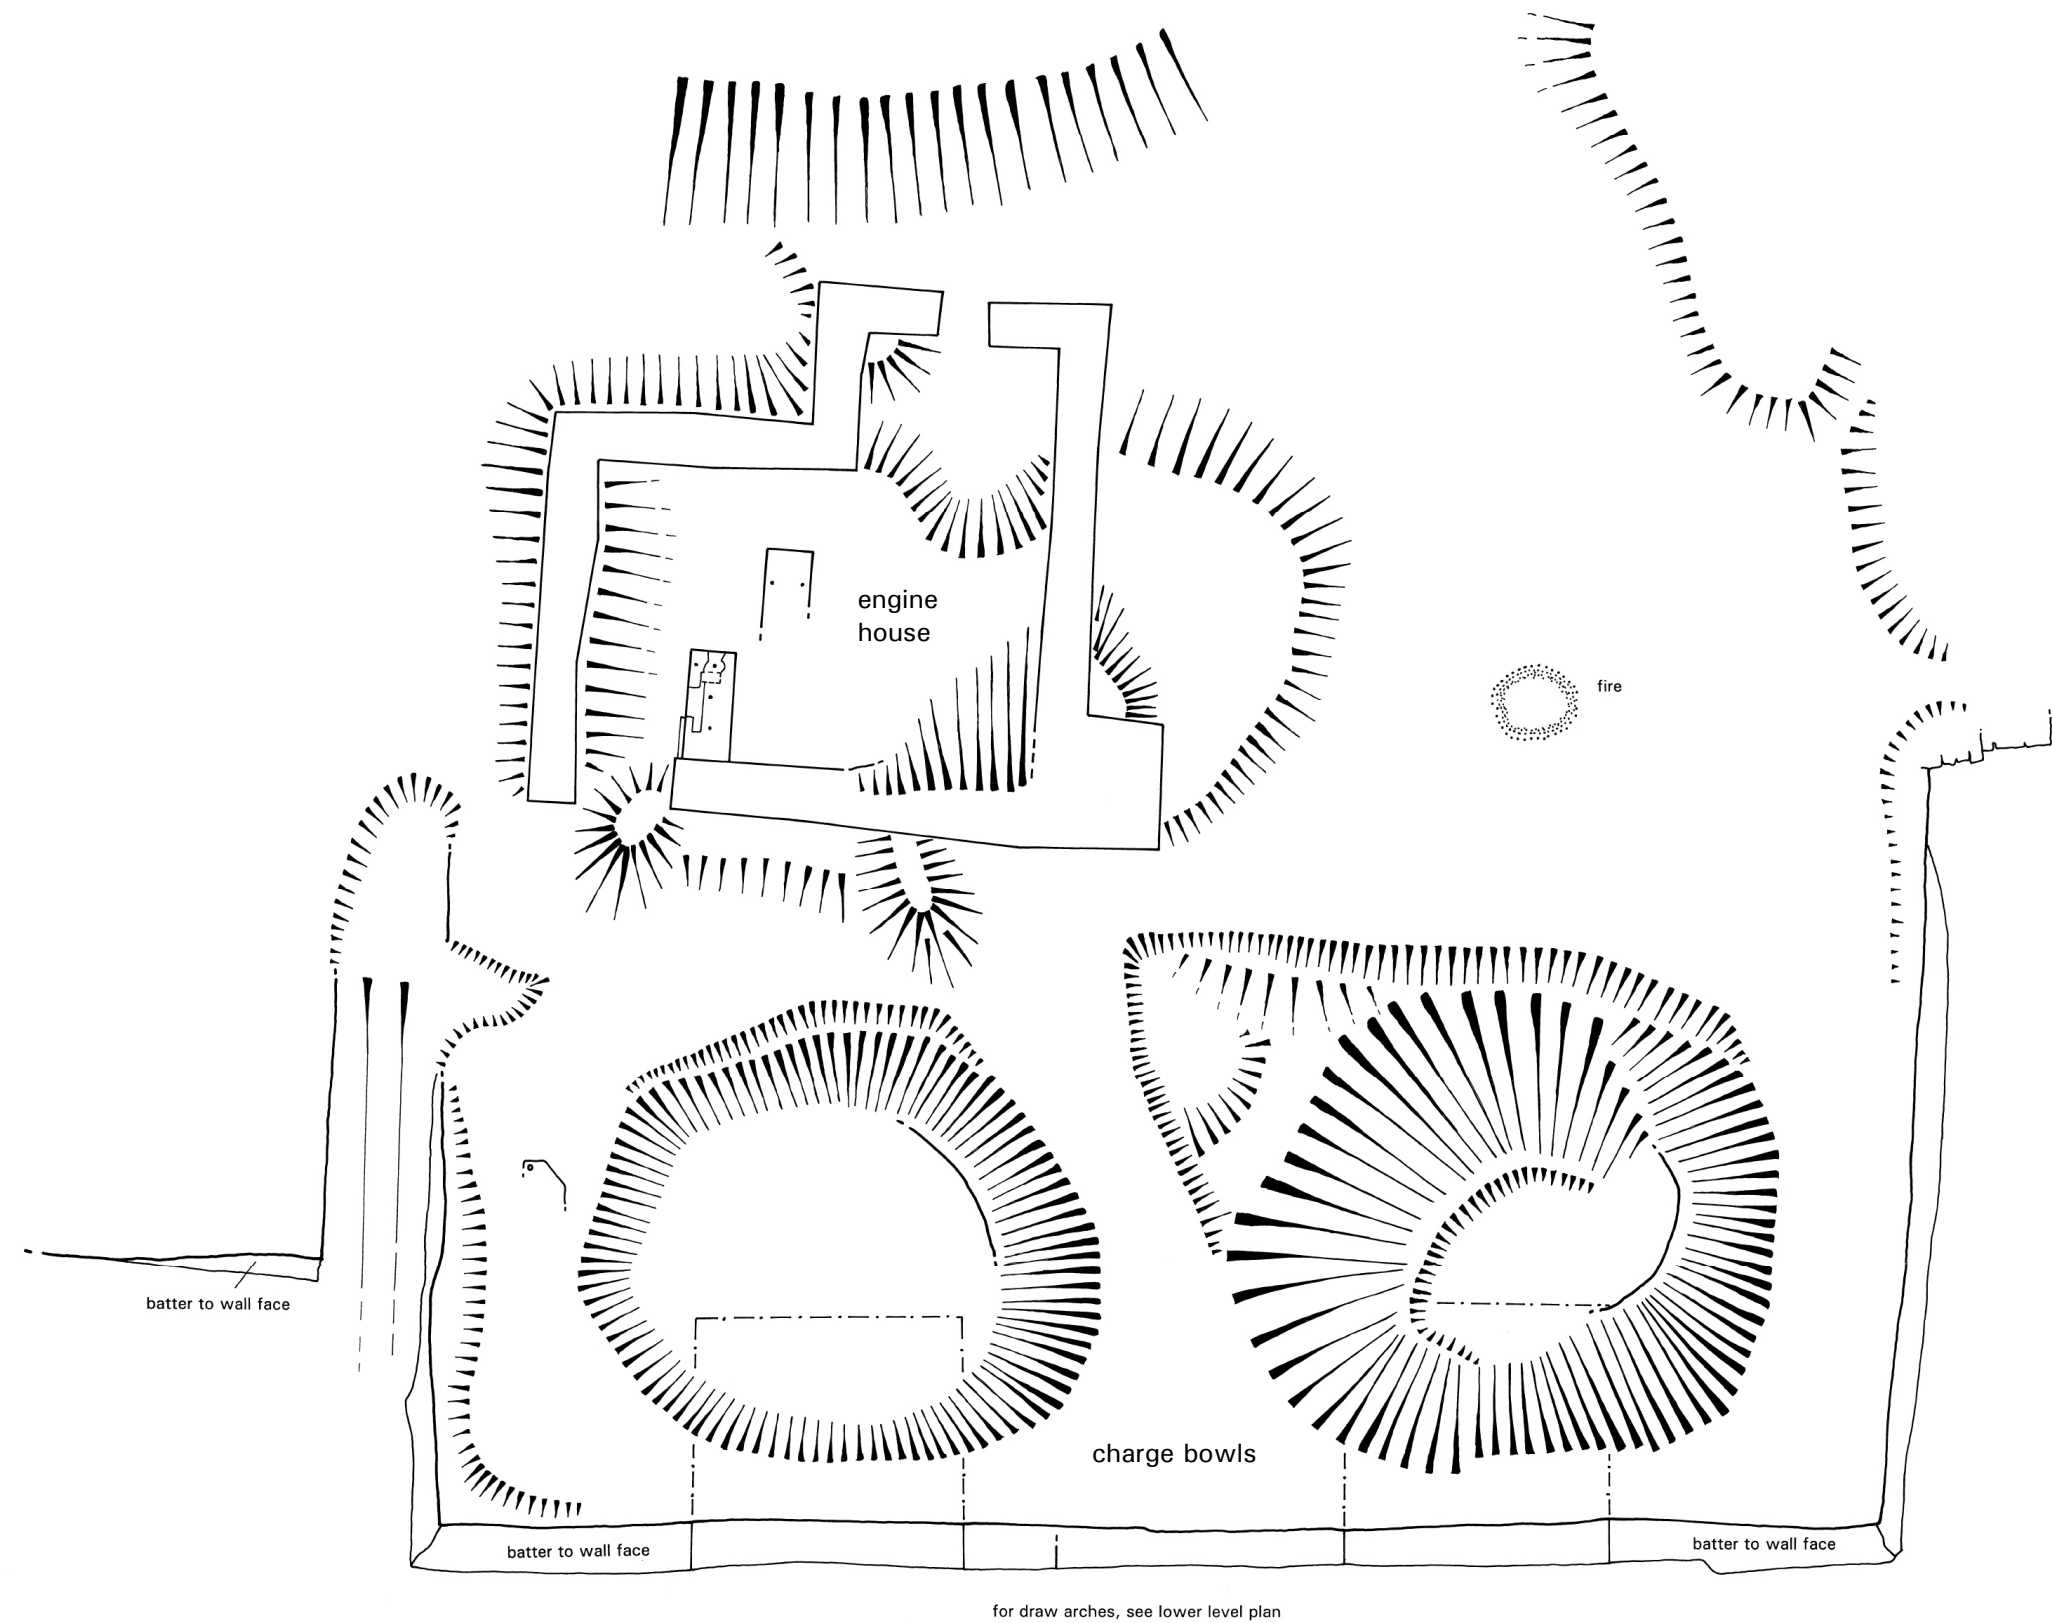
PROJECT		WESTMORLAND MARS	
TITLE		SMARDALE KILNS - UPPER LEVEL	
SCALE	AS SHOWN	DATE	JUL 2018
EDAS		FIGURE	8

- 2.26 The interior of the engine house appears to have been divided into two distinct spaces. The small projection at the north-west corner appears to have formed a separate internal space [1/047], whilst the engine stood in the main part of the interior, and was reached via the doorway in the east wall. Two large rectangular limestone blocks, forming part of the engine bed, survive to the interior of the building; they are both partly obscured by fallen rubble, and it is likely that clearance and perhaps limited excavation would reveal further details of the engine and driving arrangement. The block nearest the door once must have had a bearing mounted on the centre of the south side, secured by two threaded bolts which remain visible. There was evidently once a plate bolted to the upper surface of the south end of the block, with another fitting of unknown purpose adjacent to it [1/049-1/052] (see plate 11). The second block is of similar size, and has two threaded bolts to the north end [1/048].

- 2.27 The mouths of the charge bowls are both badly collapsed. The northern bowl is now formed by a sub-circular depression, c.6.00m across and up to 1.70m deep. The fragmentary remains of burnt stone lining are visible to the north side only, but these are now so distorted that it is difficult to estimate its original diameter [1/040, 1/041] (see plate 12). The top of the southern bowl is also formed by a sub-circular depression, c.6.50m across and up to 1.50m deep. There is a tree growing out of the north-west side, and some undercutting on the east side, close to the top. The fragmentary remains of its firebrick lining are visible to the north-west quadrant. These suggest that the bowl was originally between 4.00m-4.50m in diameter towards the top, and that the draw openings in the draw arch were placed beneath the approximate centre of the bowl [1/043, 1/054] (see plate 13). To the south of the southern charge bowl, there is large *in situ* stone with a circular hole cut into the south-west corner.

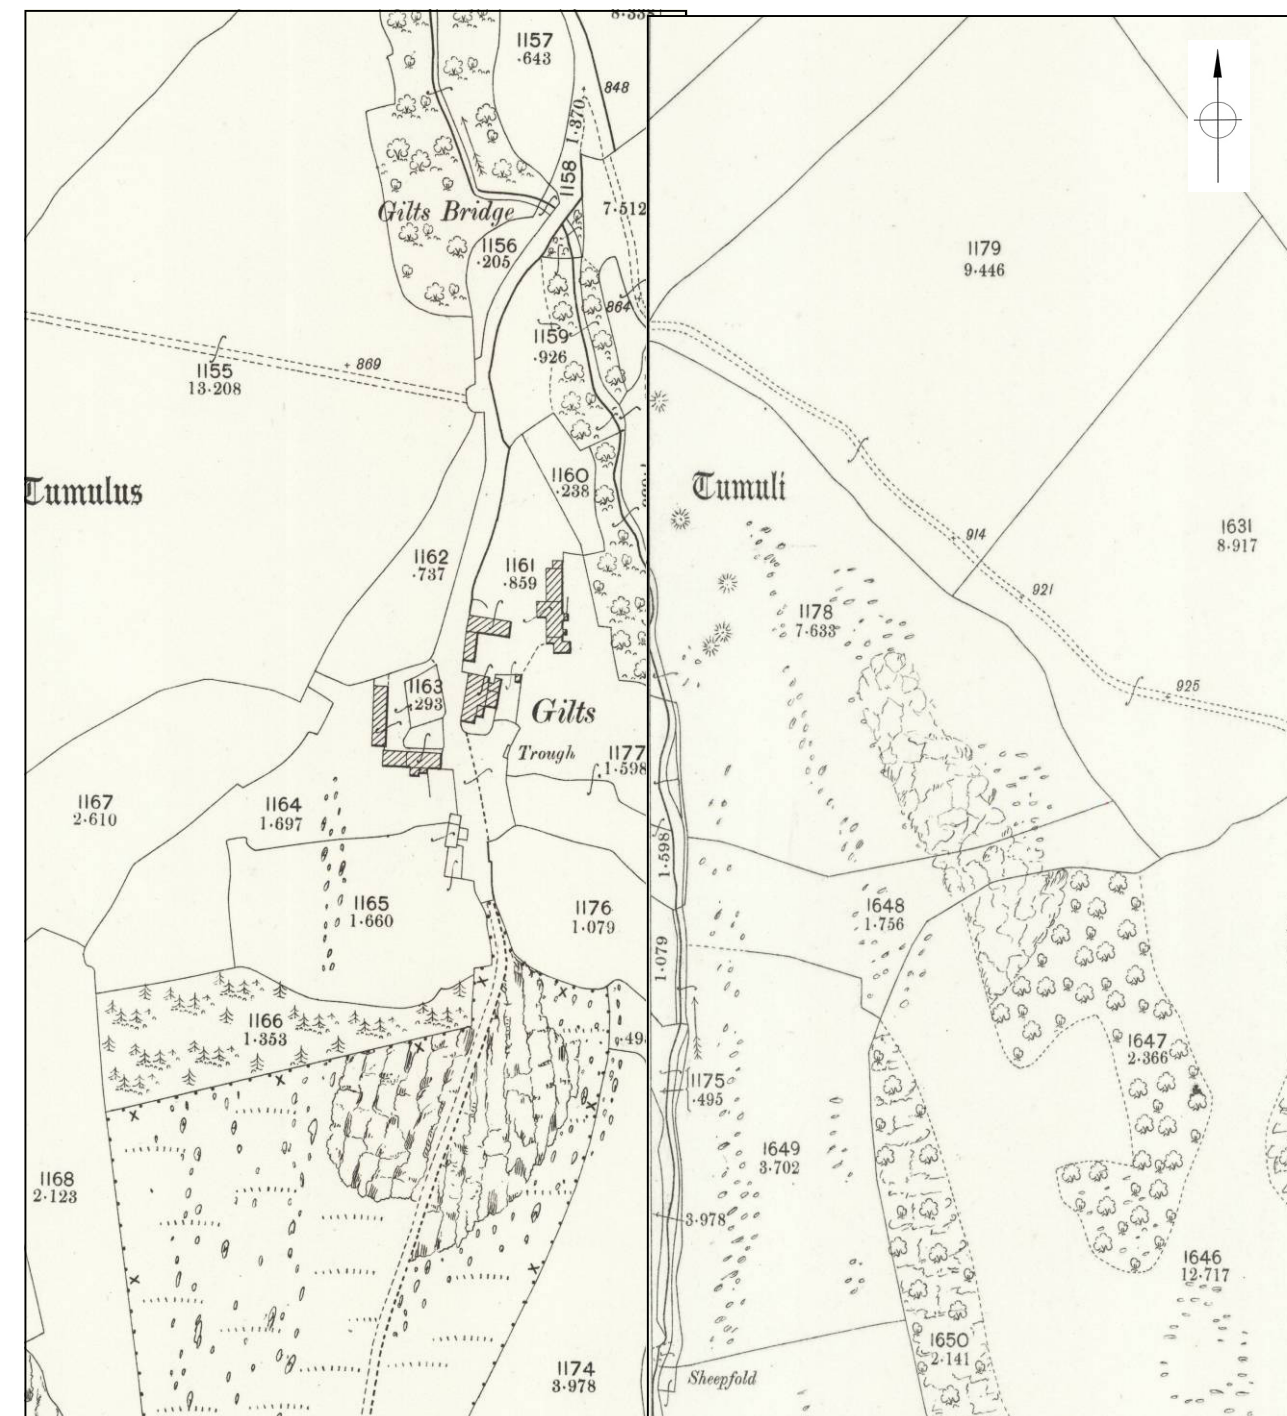
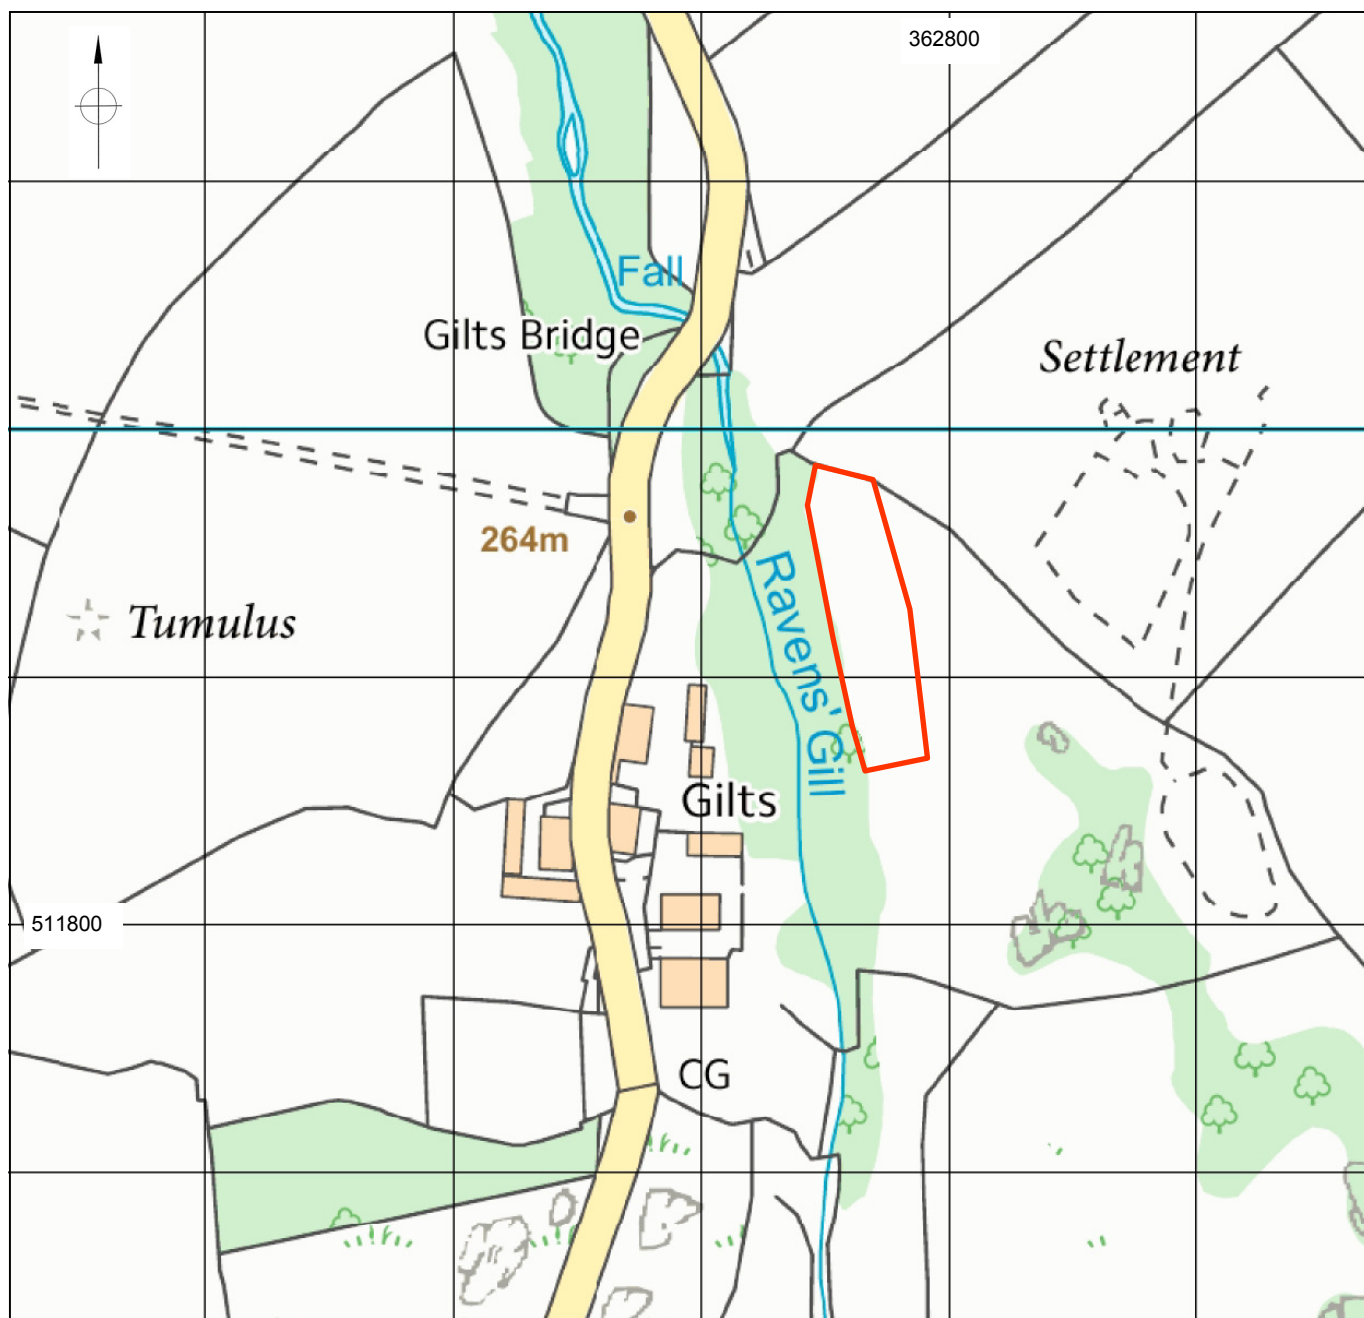
PROJECT		WESTMORLAND MARS	
TITLE			
RAVENS' GILL BARROWS DEPICTIONS		DATE	
SCALE	NTS	JUL 2018	
EDAS		FIGURE	21

- 4.11 Four of the five barrows were also noted by the RCHME as part of their 1936 inventory of historical monuments in Westmorland (RCHME 1936, 89-90, Site 49) (see figure 21A). The northern mound was recorded as being oval in form and 34ft by 27 ft and 4½ft high, the central mound was oval in form and 21ft by 24ft and 2½ft high, the northern of the group of three was oval in form and 32ft by 27ft and 3½ft high, and the southern of the group of three was circular, 24ft in diameter and 2½ ft high.

- 5.10 The shieling and another adjacent were also noted by the RCHME as part of their 1936 inventory of historical monuments in Westmorland (RCHME 1936, 89, Sites 36c and 36d), as remains of similar buildings, (c) 140 yards S of (b), and (d) 110 yards WSW of (c) (see figure 21A).

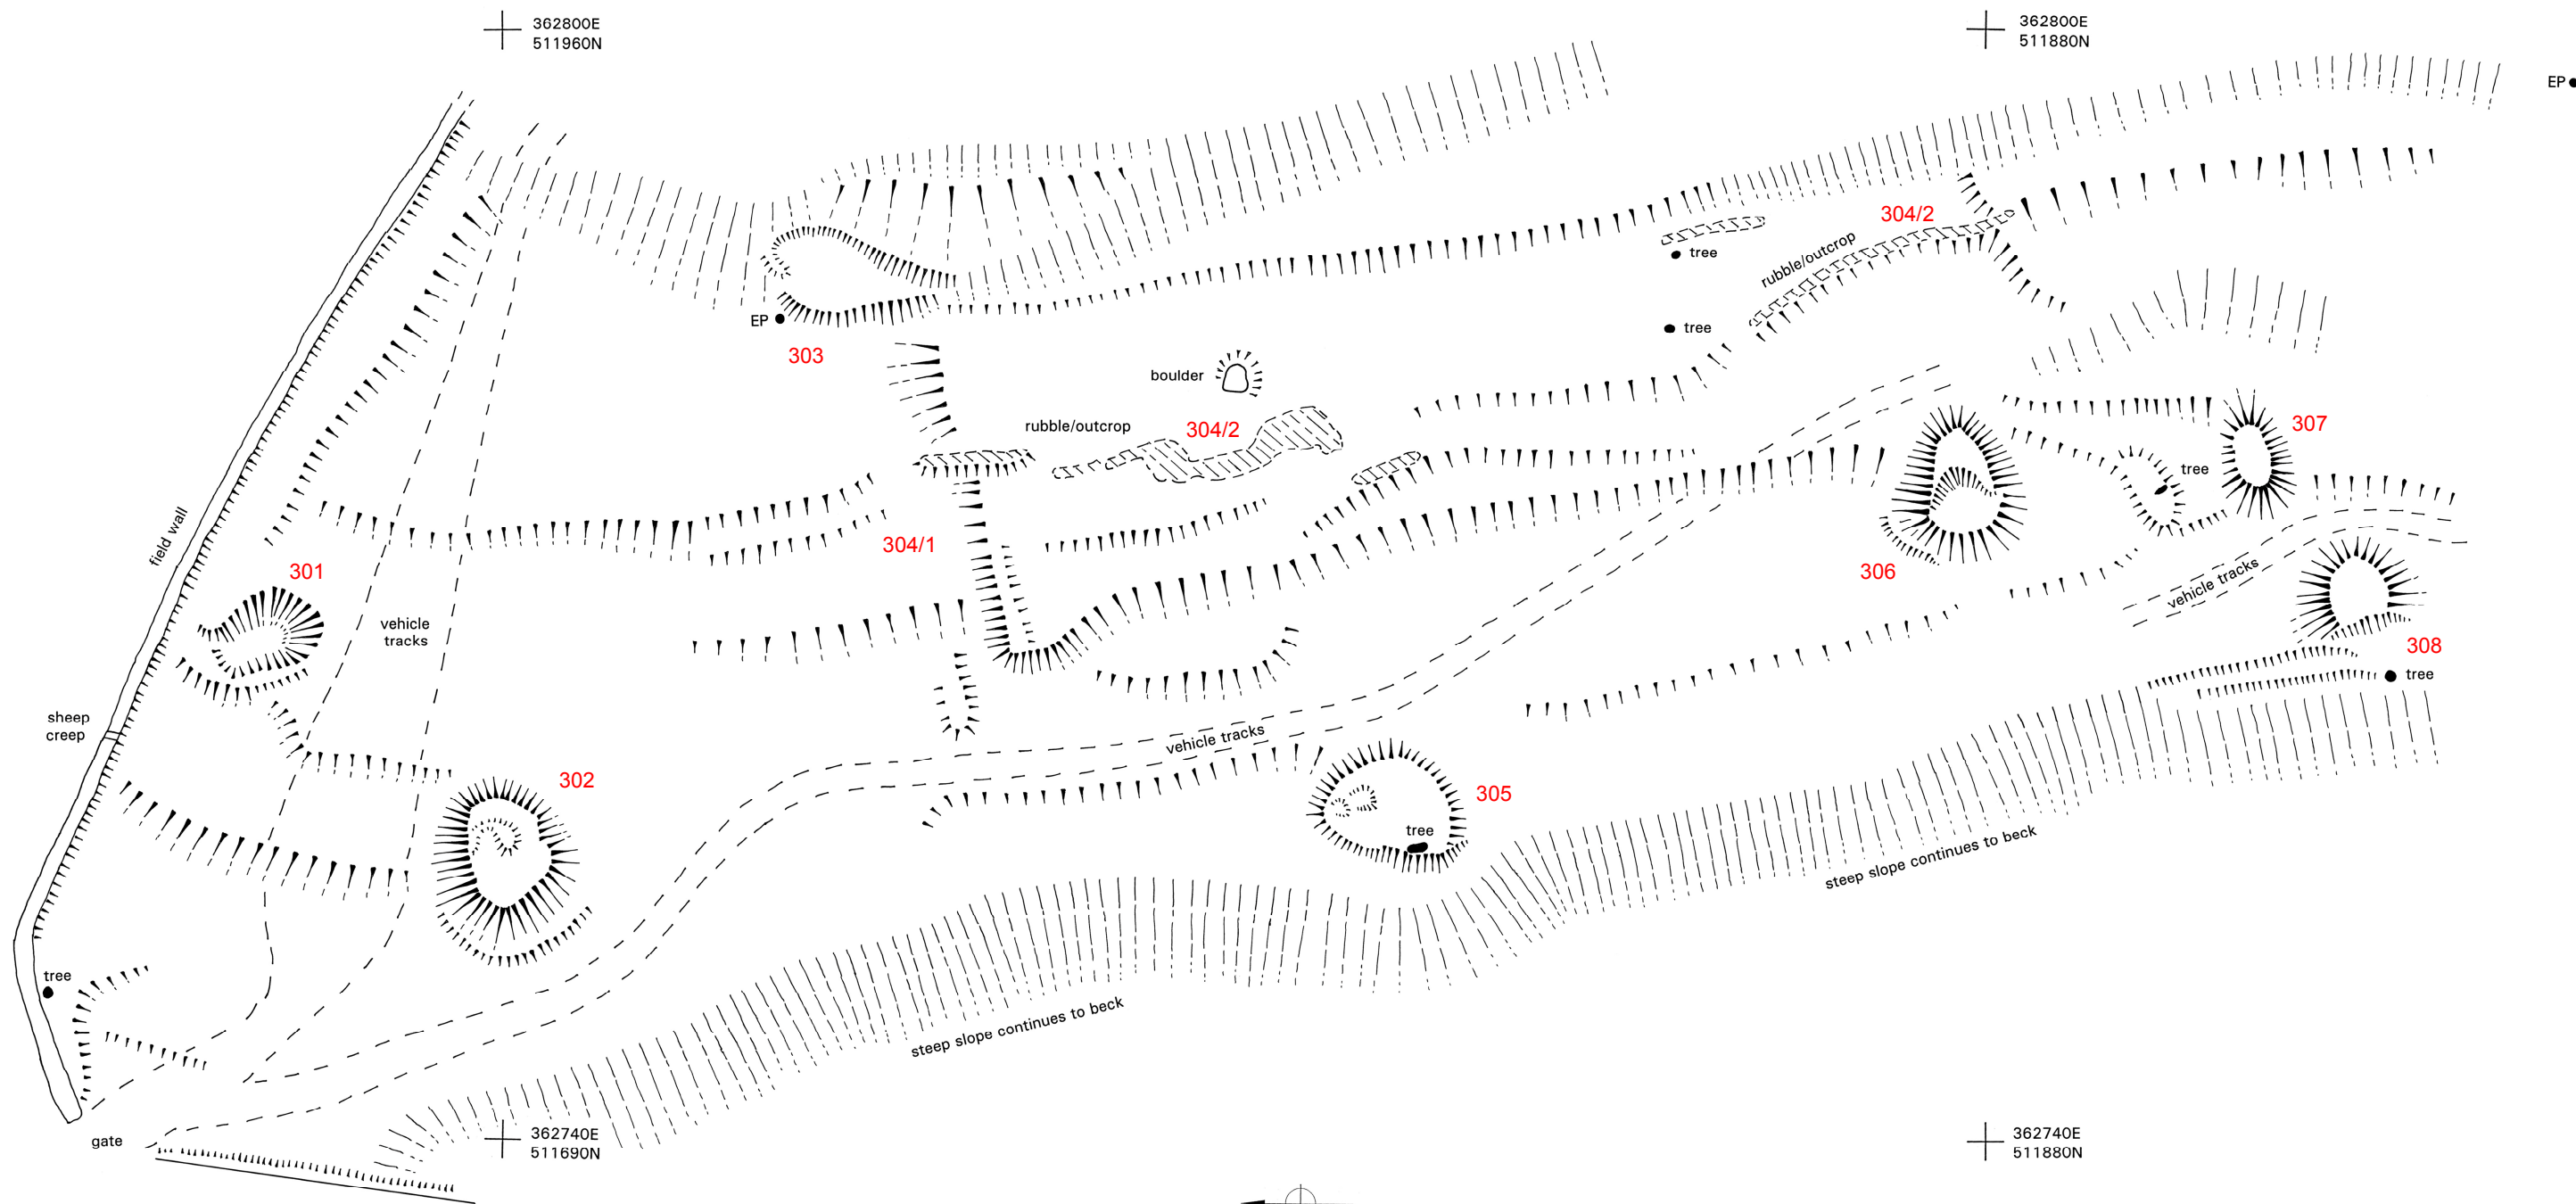
PROJECT		WESTMORLAND MARS	
TITLE		RAVENS' GILL BARROWS AREA OF SURVEY	
SCALE	AS SHOWN	DATE	JUL 2018
EDAS		FIGURE	22

- 4.13 The survey area measured a maximum of 130m north-south by 55m east-west (see figure 22 and plate 86). Within this area, the ground surface is set at an average height of 251m AOD, but the ground slopes fairly evenly from 274m AOD in the south to 265m AOD in the north, and in a series of steps from 274m AOD in the east to 267m AOD in the west. The stepped nature of the ground surface reflects the underlying geology of the survey area. There is an extensive area of denuded limestone pavement to the east; the eastern limit of the survey area effectively forms the western edge of the pavement. From this point, the surface steps down to the west across a series of west-facing scarps, up to 1.0m in height. These scarps are set on a very shallow north-west/south-east alignment, and represent terraces within limestone pavement which have become covered in soil; in several places, outcropping limestone remains visible along the line of the scarps. The survey area is bounded by a drystone wall to the north, by limestone pavement to the east, and by Ravens' Gill to the west [5/244]. At the time of the field survey, the area was used as rough pasture for a small number of sheep [5/239, 5/272-5/274, 5/276, 5/277]. At the time of the erosion visit, the area was well vegetated with a preponderance of wildflowers including orchids.

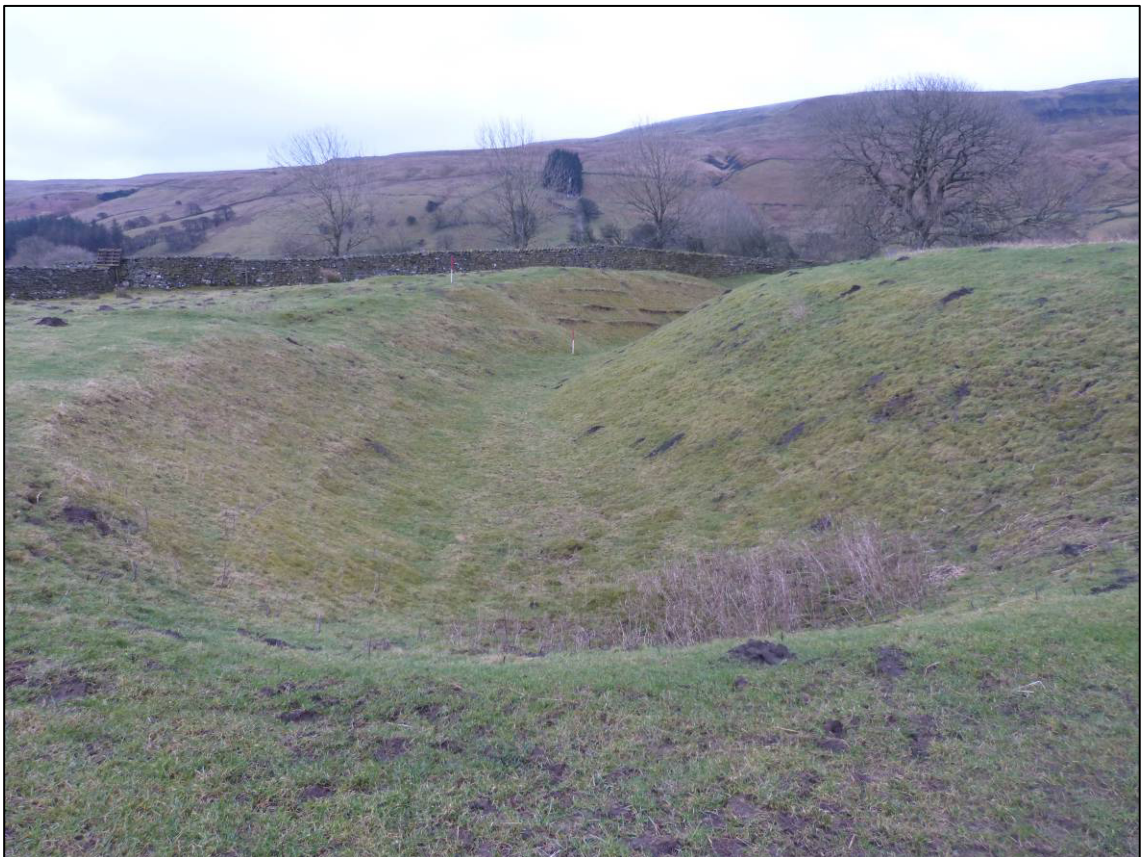
- 3.136 The areas of sheep tracks are shown on figure 19, and they lie on all sides of the castle mound (Areas 5, 13, 14, 15, 16, 17 and 19). As might be expected, these tracks are more visible in winter, when vegetation is short [7/449, 7/460] (see plates 32 and 36), but they can still be seen in the summer months, although in some cases they become completely grassed over [10/126, 10/152-154, 10/170]. Areas 16 and 17 lie on the south facing slope of the north ditch (200/1), between the potential bridge site (200/3) and the eastern causeway (200/4); Area 16 covers an area measuring 20m long by 7m wide extending to the full extent of the slope [6/312; 10/156-10/158] (see plates 71 and 72), while Area 17 lies to the south-east and covers an area of some 20m by 3m near the top of the slope [10/164]. In these cases, no remedial action is considered necessary as the summer growth of vegetation seems to stabilise the tracks. However, there are a number of more prominent sheep tracks on the south and south-west sides of the mound (Areas 4, 9, 10 and 12) which are more severe where some intervention is needed; these are discussed under 'specific areas' below.

Plate 32: Pendragon Castle, possible bridge site to north ditch (Site 200/3), looking NW (photo 7/460).

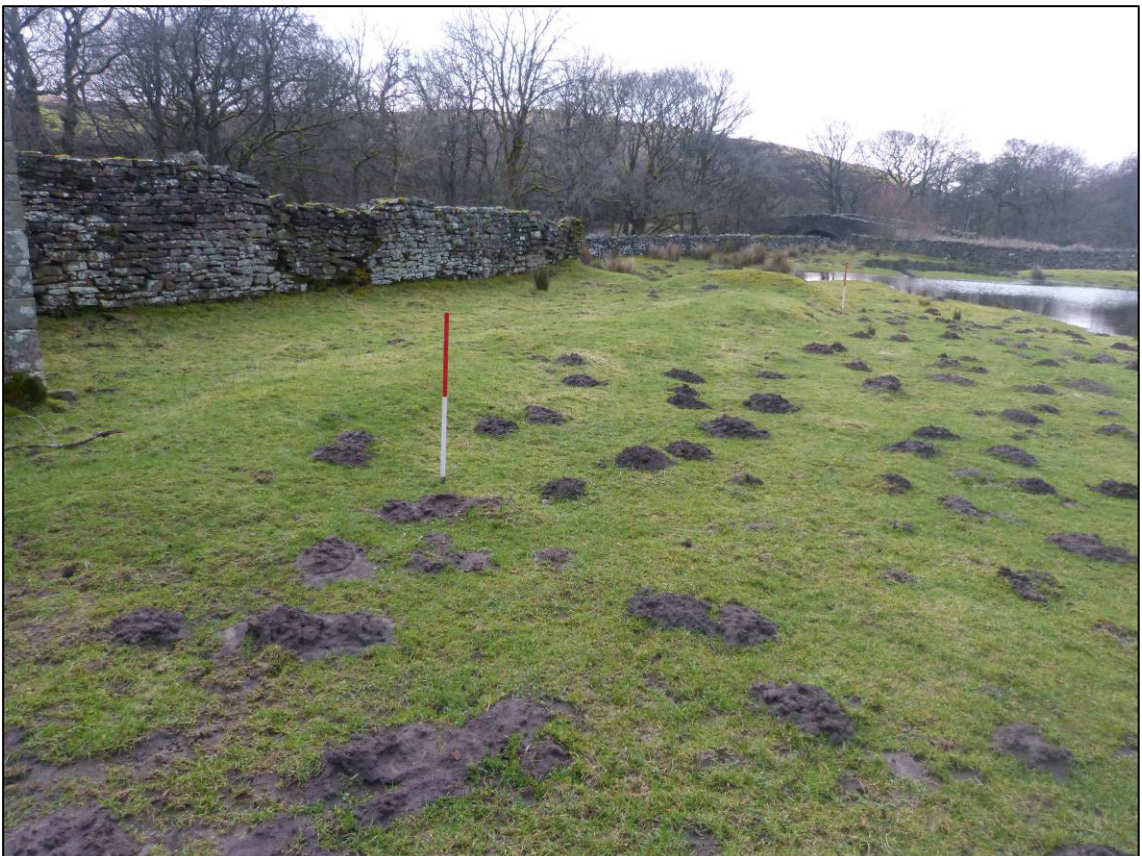
- 3.67 The earthworks representing the buildings shown in 1739 are aligned north-south, and have total measurements of 56.0m long by 8.0m wide [7/473] (see plate 40);

Plate 40: Pendragon Castle, south part of building range (Site 204/2), looking NW (photo 7/473).

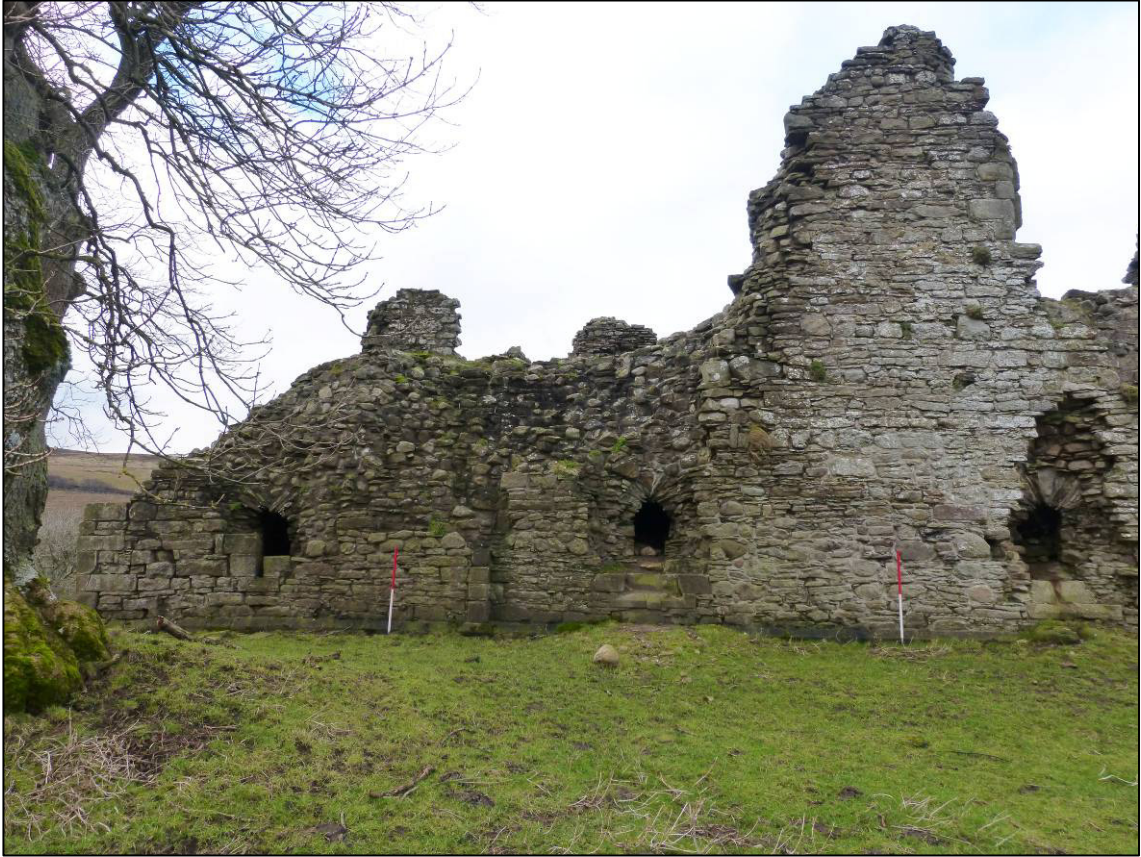
Plate 47: Pendragon Castle, propped masonry at north-west corner of castle, looking SW (photo 9/574).

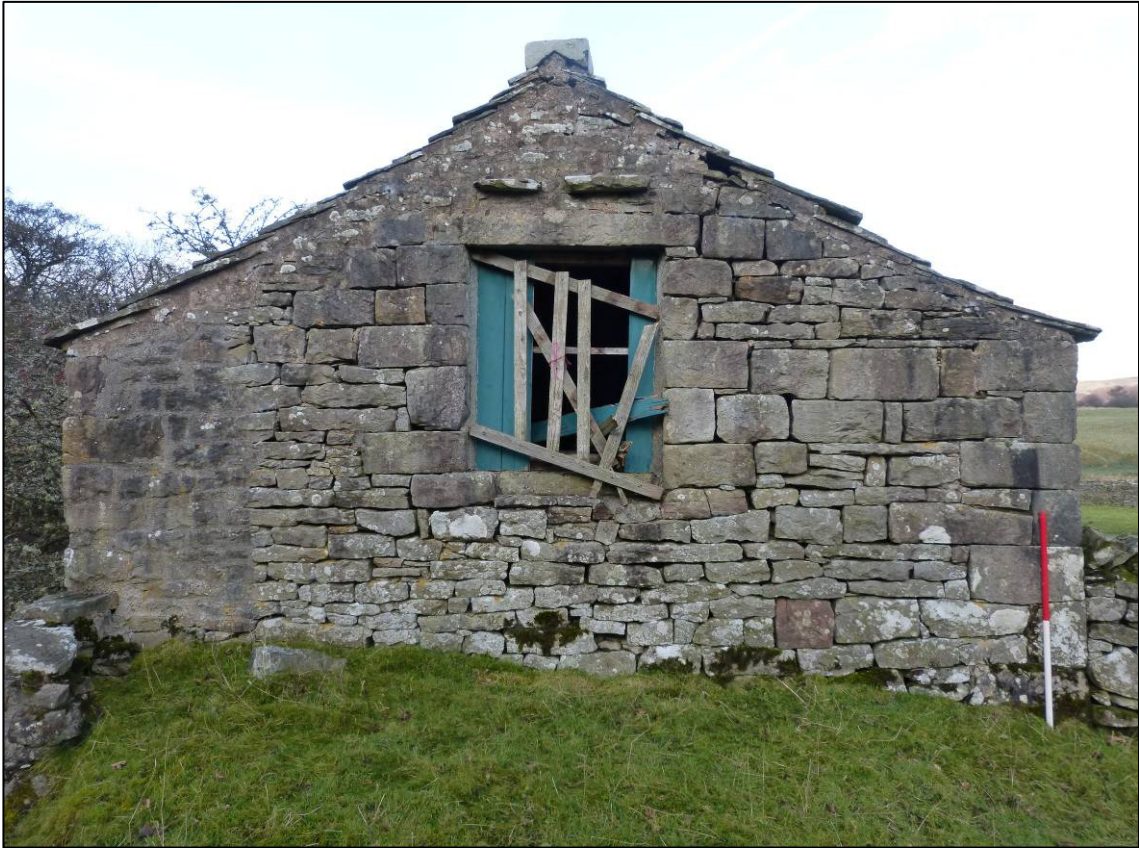
- 3.105 The barn is of a single storey, having a pitched stone slated roof with stone ridge coping; the coping piece to either end of the ridge has an short, integral, slightly raised square end, resembling a finial base [3/206] (see plate 64). It is built of a mixture of roughly squared and thinly coursed stone rubble, interspersed with short bands of re-used squared ashlar, presumably taken either from the castle or the earlier stable block. The west elevation is generally better coursed, and uses longer, shallower stone rubble. There are dressed quoins to the north-east and south-east corners, with rubble quoins to the south-west corner. All stone was originally set with a lime mortar, although there is also much modern repointing to the east elevation.

Plate 64: Pendragon Castle barn, south and west elevations, looking NE (photo 3/205).

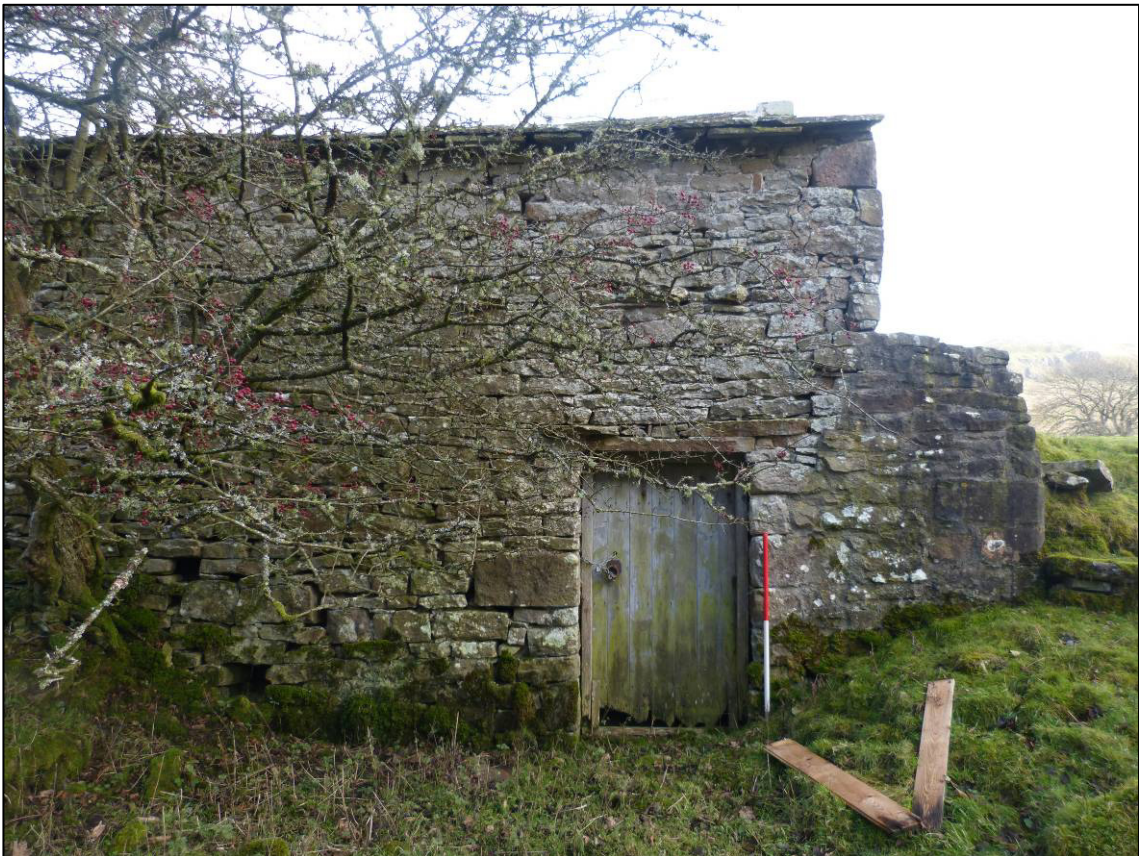
- 3.107 Regarding the external elevations, as already noted above, rising ground level means that only the upper part of the south gable remains visible [3/187] (see plate 65). There is an opening to the centre of this gable, with quoined jambs and a flat head formed by a stone lintel [3/189]. The sill is re-used, perhaps from the 17th century buildings. There is an area of re-used stone to the east of the opening, with some modern repointing to the west; above, there are two through stones. The west elevation has a doorway at the south end, with a thin stone lintel which barely overlaps the jambs [3/198]. There is a single intermittent course of through stones, set c.2.60m above ground level [3/196, 3/197] (see plate 66). To the south of the doorway, the elevation is continued as a wall stub, containing the north jamb of a chamfered doorway opening; this has been heavily repointed, so that its relationship to the main body of the elevation is now unclear [3/194, 3/195]. The ruinous back wall of the 17th century range (see Site 204/2 above) continues to the south [3/193, 3/207, 3/208] (see plate 67). To the north of the doorway in the west elevation, there is a drain at a low level [3/199], and further east, three possible sockets, although they are more likely to mark where stones have fallen from the elevation [3/201]. The north end of the elevation appears to be continuous with the wall running to the north [3/202]. This stands 1.50m high on average and also contains what appear to be former sockets to the west face, although again they may mark where stones have fallen or been removed [3/203, 3/204].

Plate 65: Pendragon Castle barn, south gable, looking N (photo 3/187).
