WESTMORLAND DALES HIDDEN LANDSCAPE
PARTNERSHIP
MONUMENTS AT RISK SURVEY

ARCHAEOLOGICAL SURVEYS OF
SMARDALE KILNS AND QUARRY,
PENDRAGON CASTLE,
RAVENS' GILL BARROWS AND
CROSBY LODGE SHIELING

Report no: 2017/548.R01
Version: Final
Date: July 2018
Author: Ed Dennison & Shaun Richardson

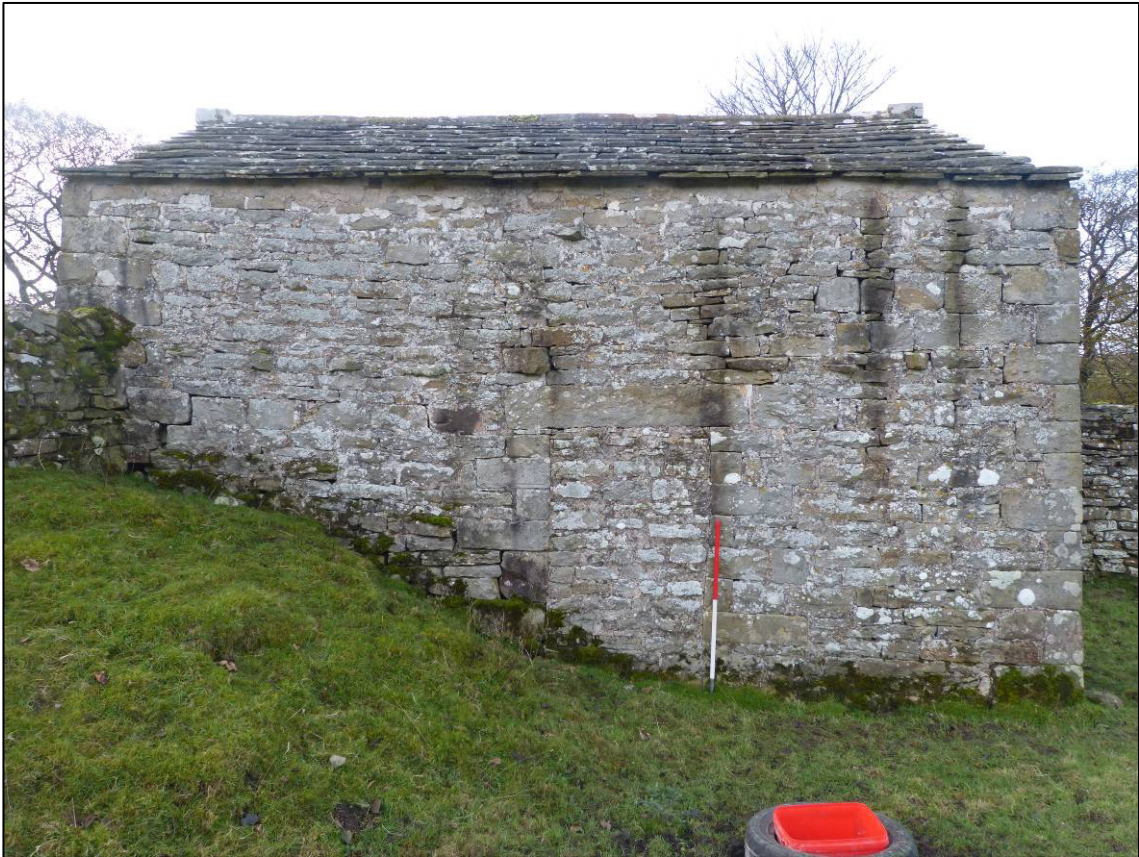
- 3.108 The north gable contains three courses of through stones, set at 1.0m, 2.2m and 3.3m above ground level [3/193] (see plate 68). The gable is heavily repointed or rebuilt above the level of the uppermost through stone course. Between the second and third courses of through stones, there are two sockets which pass through the full thickness of the wall. The east elevation has a blocked ground floor doorway placed just to the north of centre [3/191] (see plate 69). This doorway has neatly dressed quoined jambs and a deep, monolithic lintel [3/192]. There is a single course of through stones placed at c.2m above ground level, with a single through stone at a higher level over the doorway.

Plate 68: Pendragon Castle barn, north gable, looking S (photo 3/193).

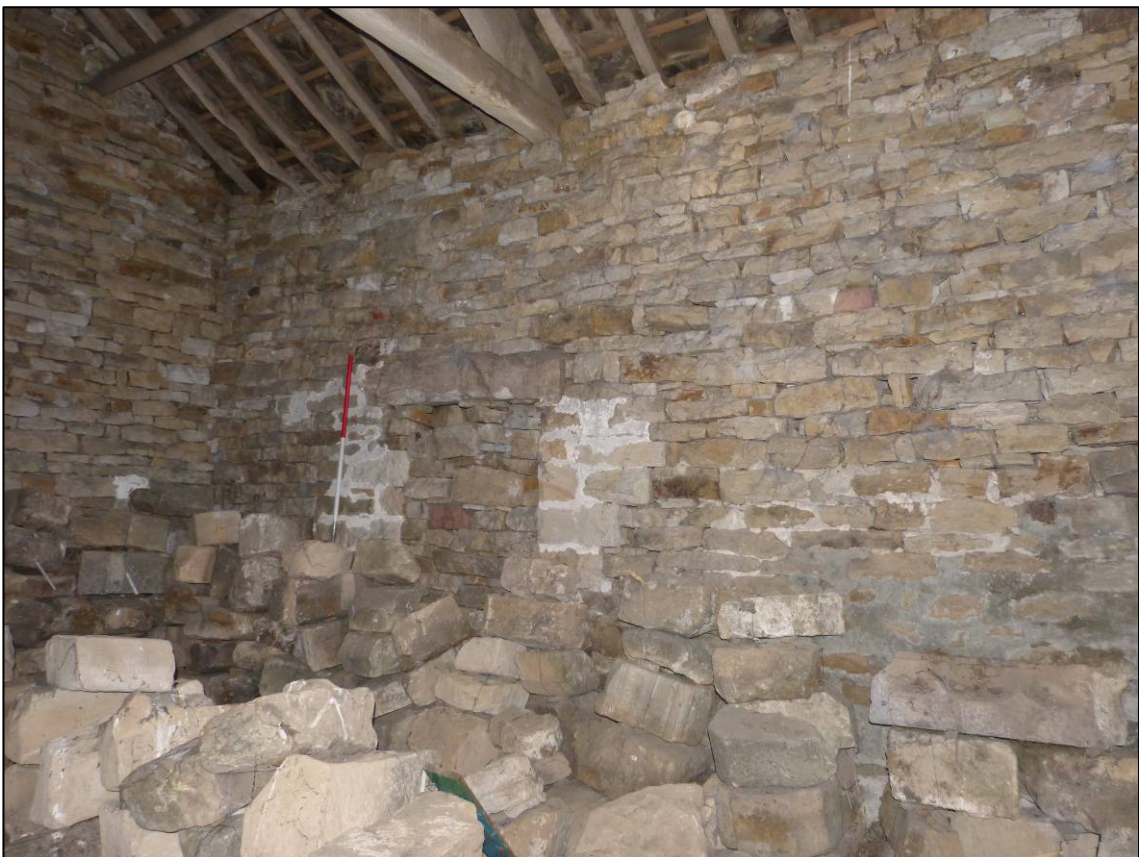
Plate 70: Pendragon Castle barn, interior showing east wall and stored stonework, looking NE (photo 4/228).

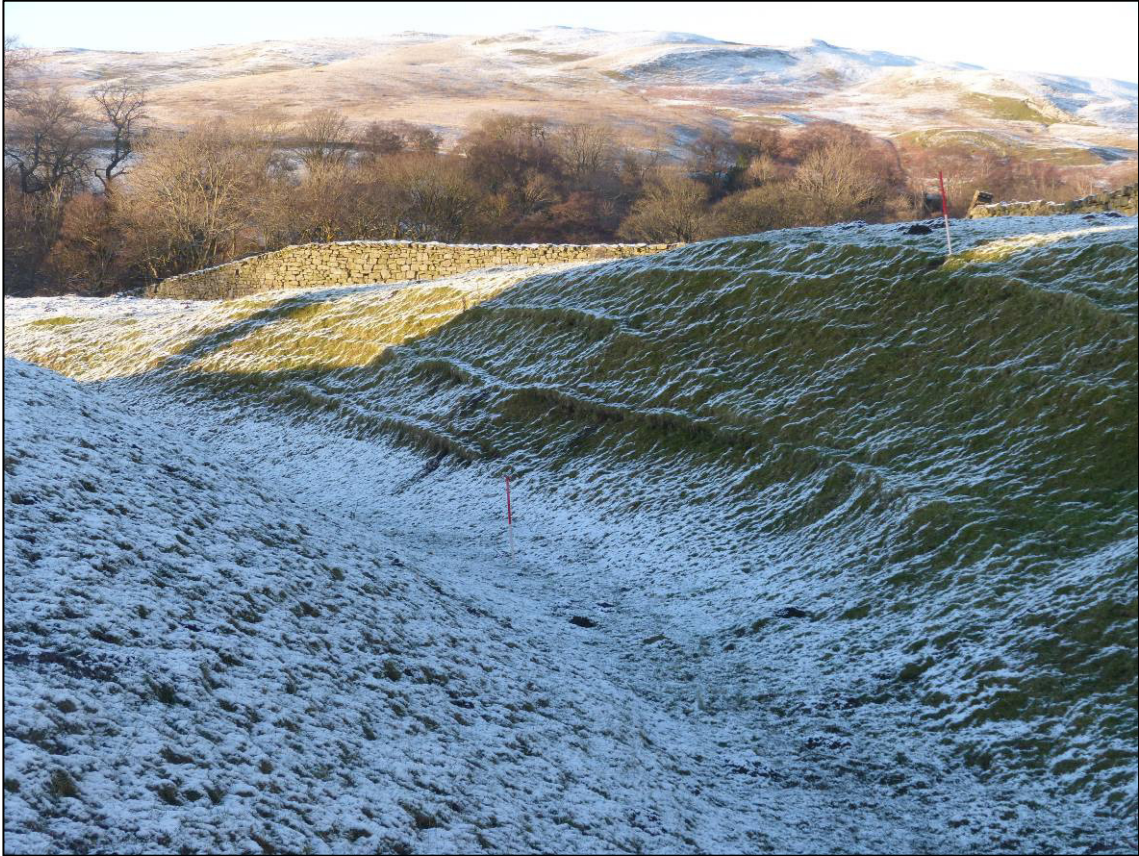
Plate 71: Pendragon Castle, sheep tracks on north slope of north ditch (200/1) (Area 16), looking N (December 2017) (photo 6/312).

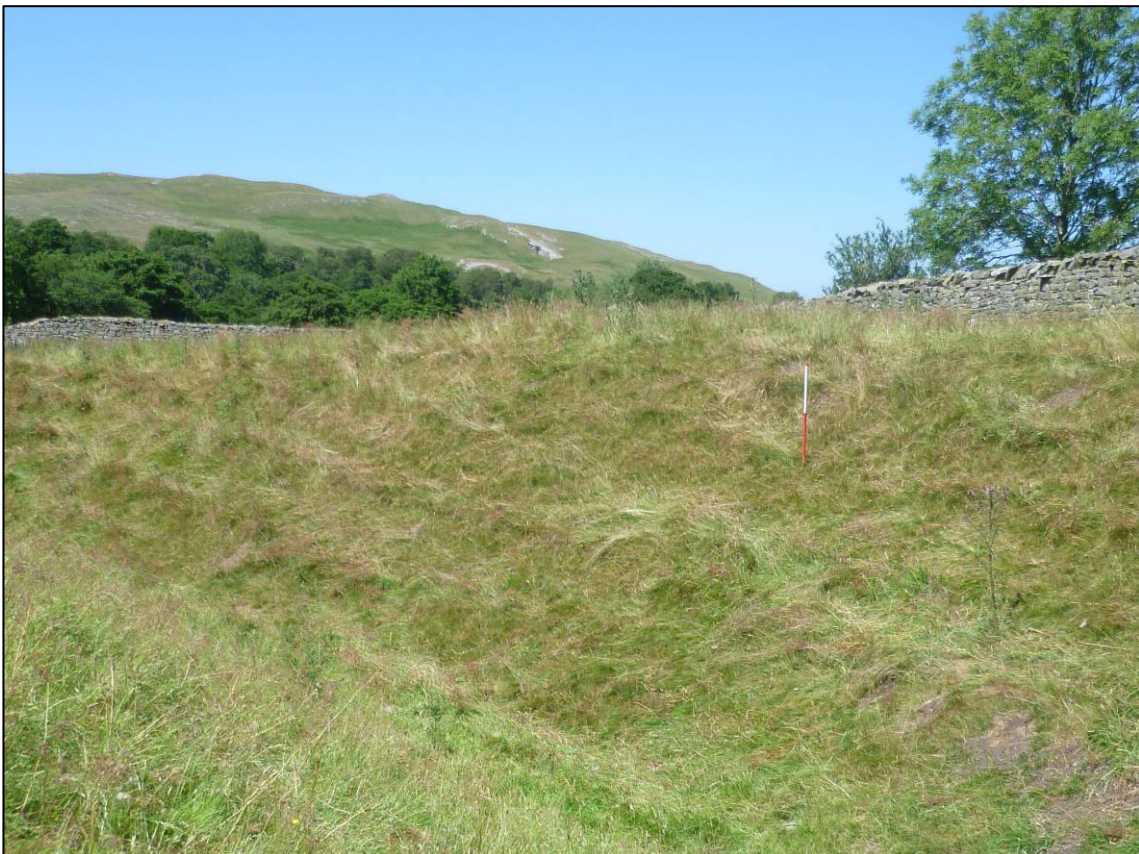
Plate 72: Pendragon Castle, sheep tracks on north slope of north ditch (200/1) (Area 16), looking N (June 2018) (photo 10/158).

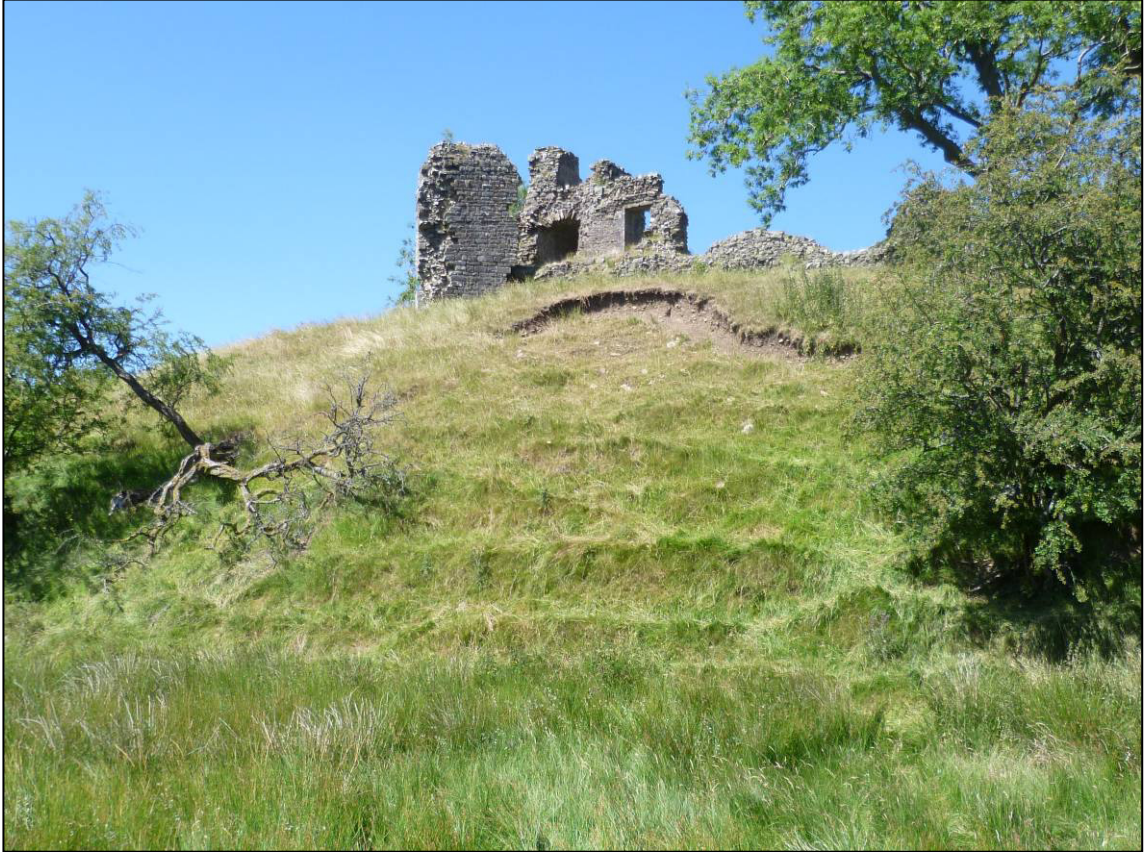
Plate 75: Pendragon Castle, slumping scar and slippage below (Areas 7 and 9) on south side of castle mound (201), looking NW (photo 10/174).

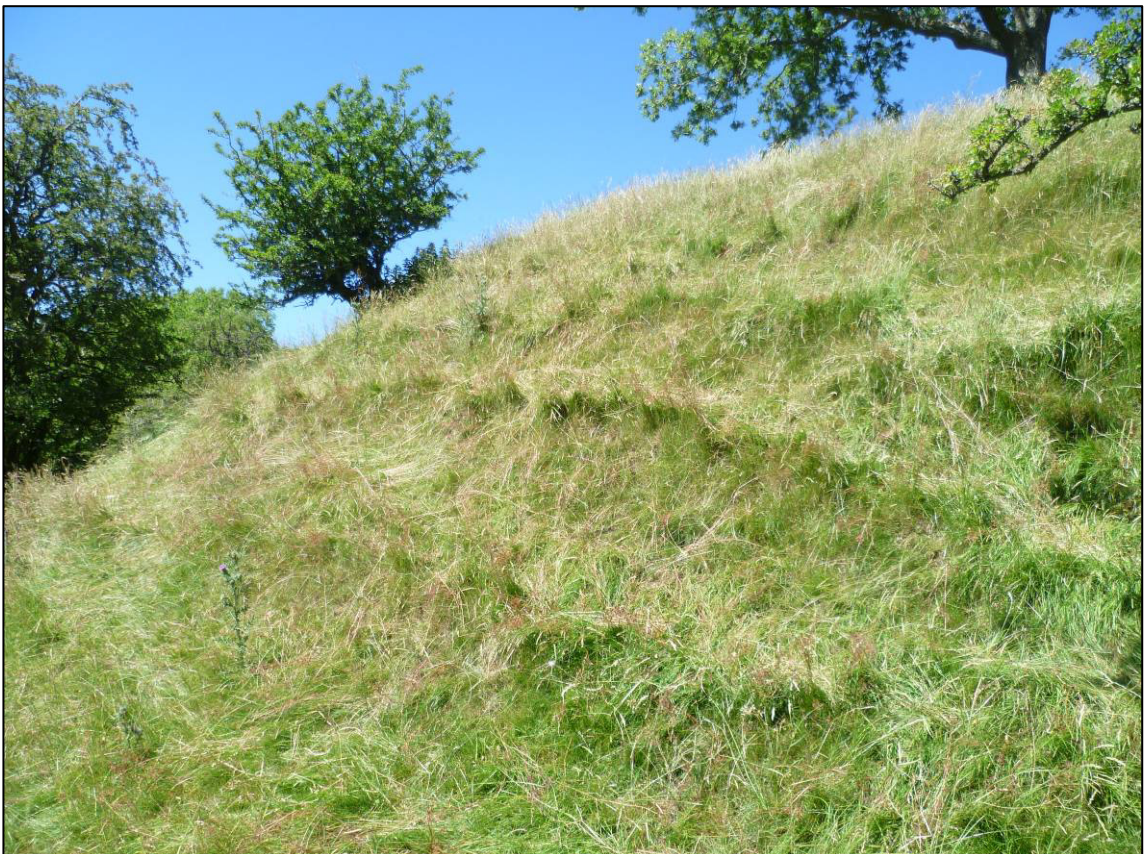
Plate 76: Pendragon Castle, slumping/sheep tracks (Area 4) on south side of castle mound (201), looking W (photo 10/124).

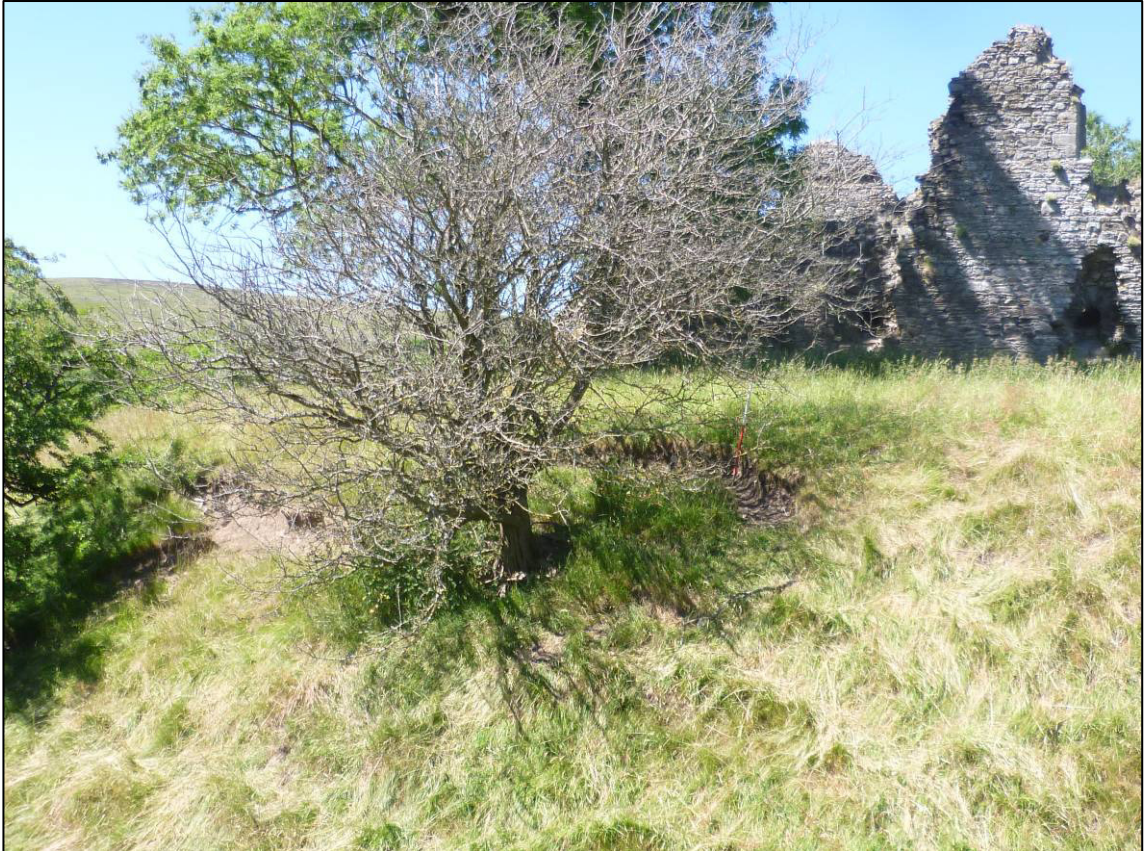
Plate 77: Pendragon Castle, slumping scars (Areas 1 and 2) on south-east side of castle mound (201), looking NW (photo 10/114).

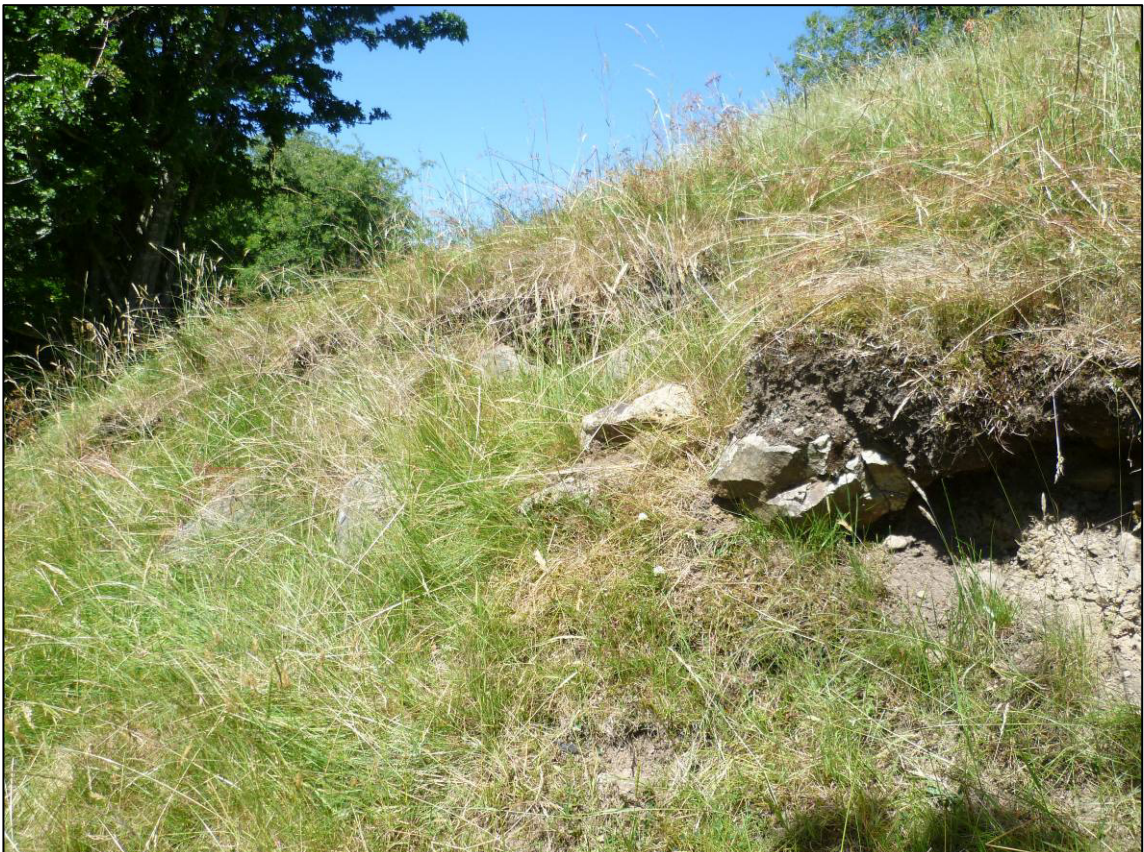
Plate 78: Pendragon Castle, slumping scar with exposed stone (Area 11) on south-west side of castle mound (201), looking NW (photo 10/143).

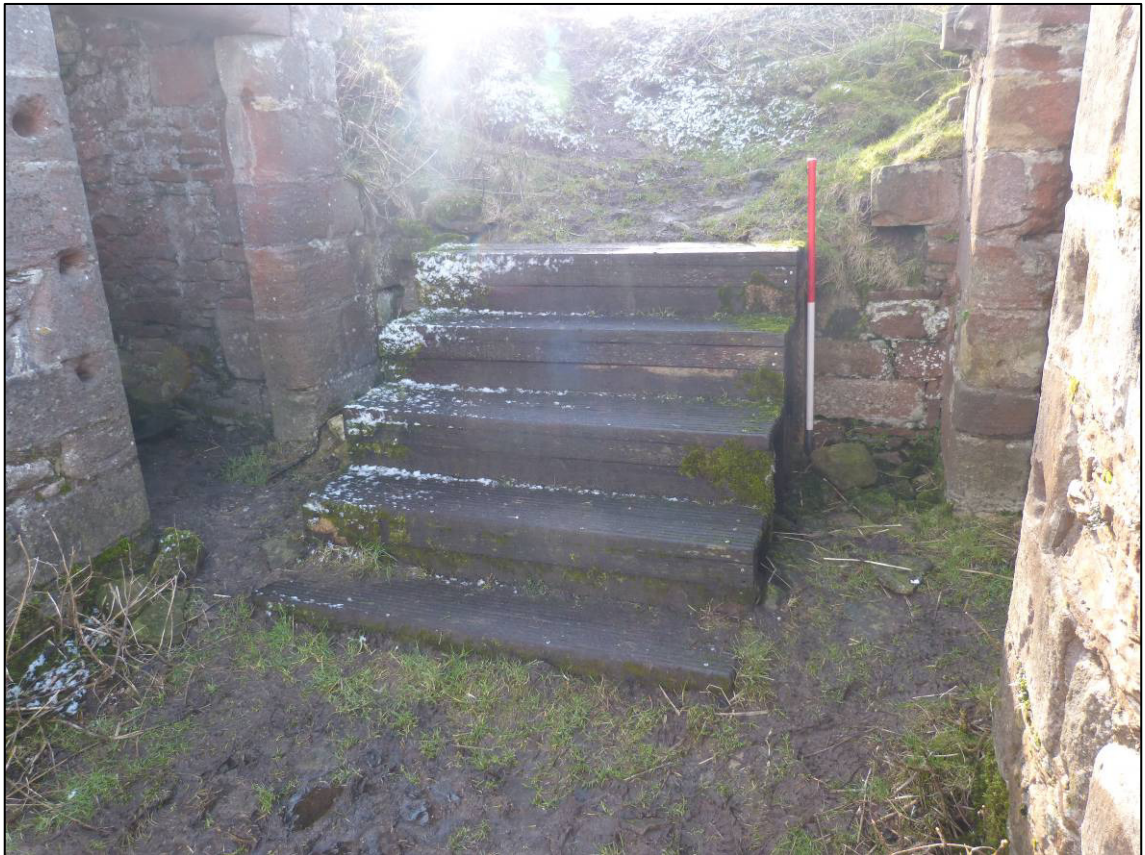
Plate 80: Pendragon Castle, entrance passage, modern wooden steps, looking S (photo 9/546).

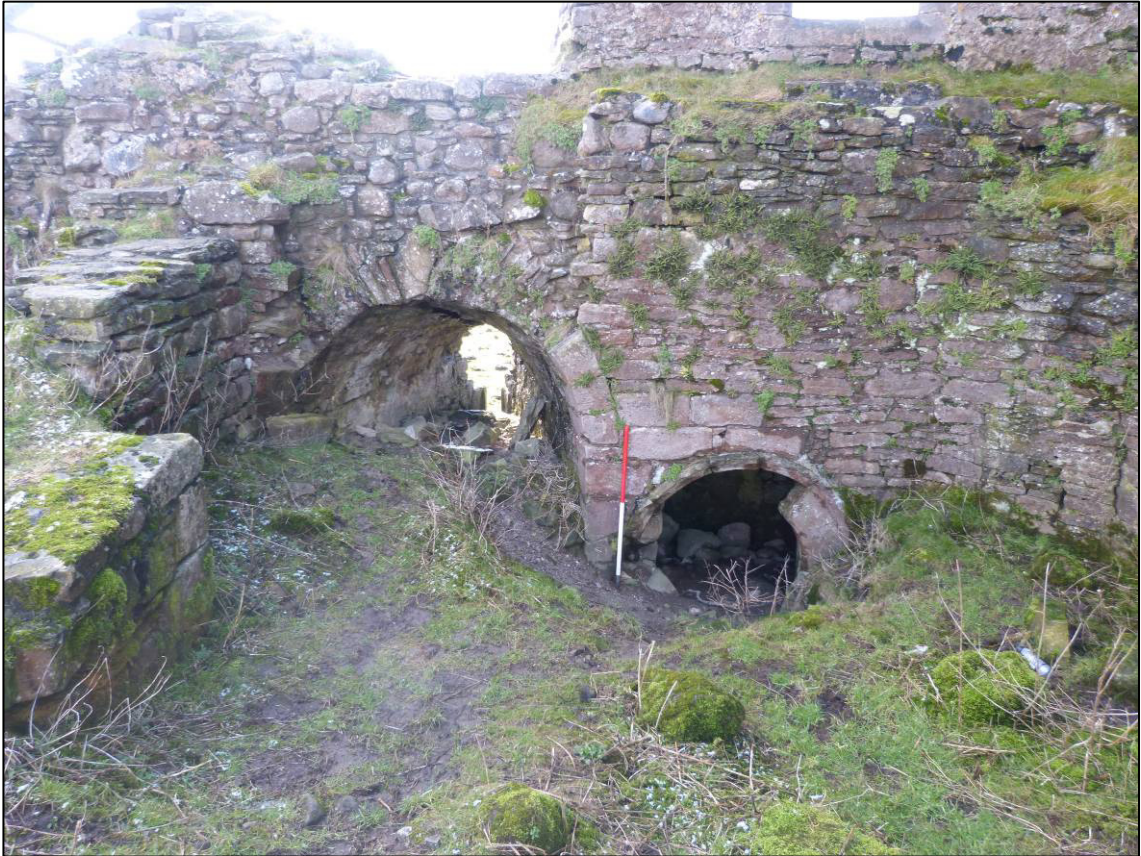
Plate 84: Pendragon Castle, west end of south internal wall, looking S (photo 9/553).

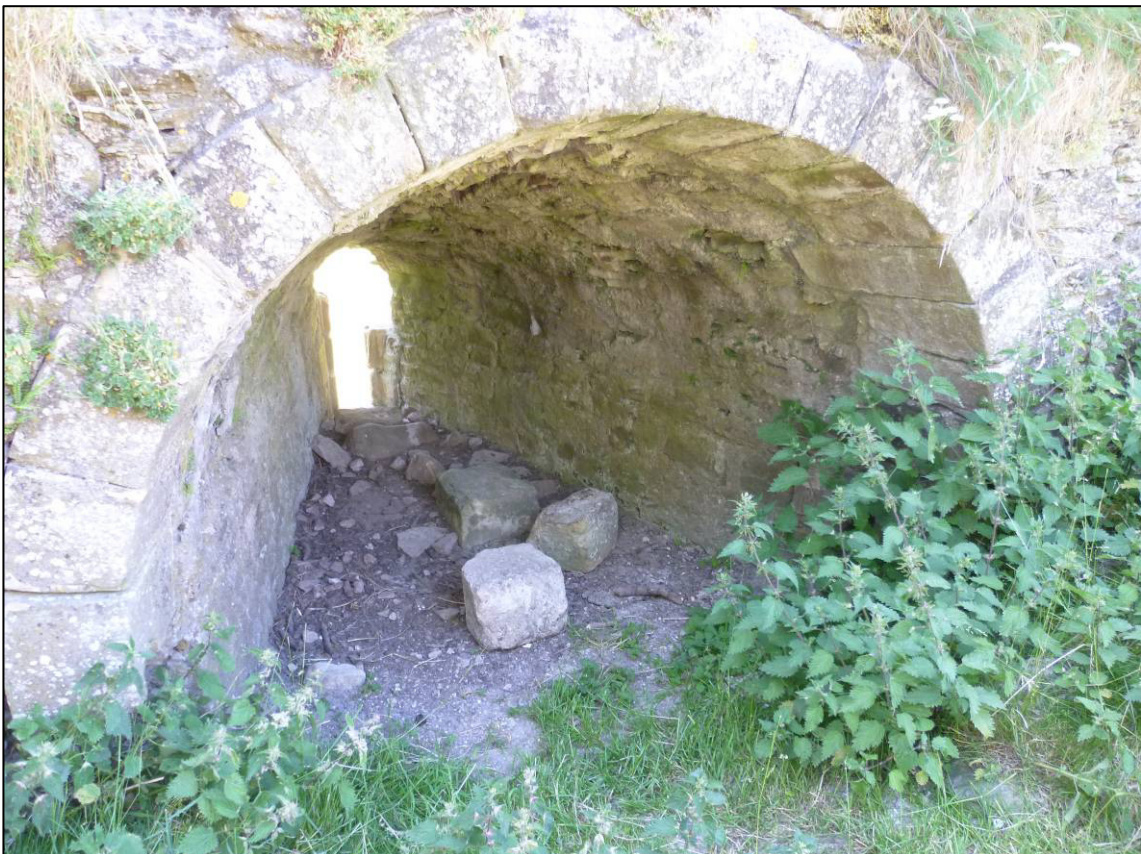
Plate 85: Pendragon Castle, interior, rubble in south window of west wall, looking W (photo 10/180).

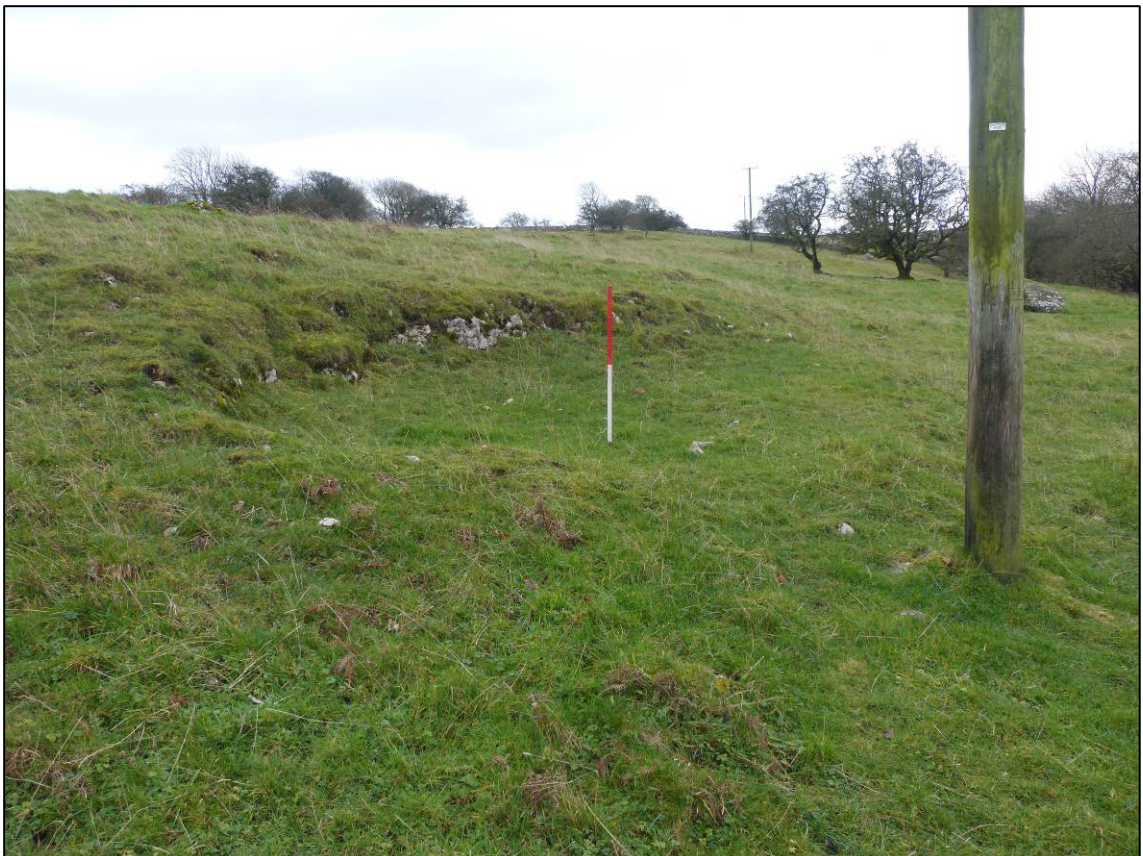
Plate 89: Ravens' Gill barrows, scooped platform (Site 303), looking S (photo 5/278).

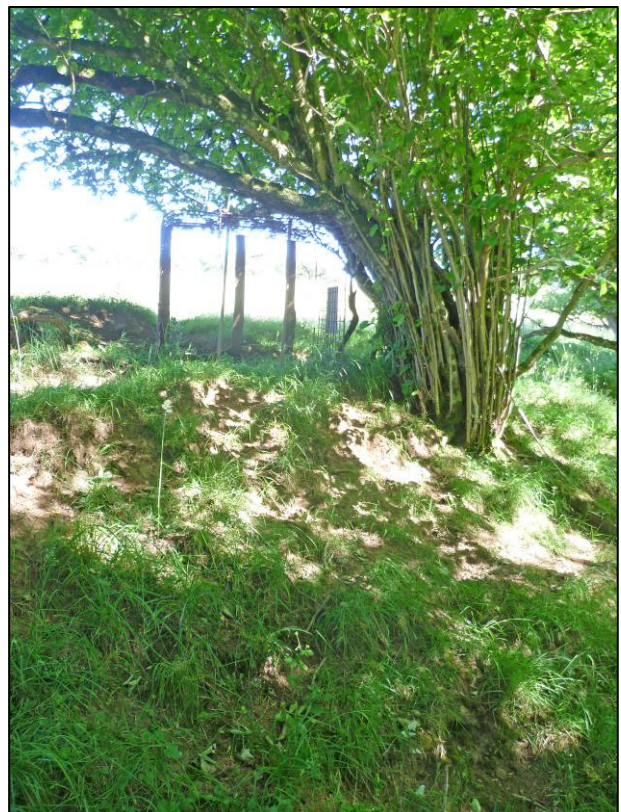
- 4.35 There is a similar lying-in hollow or scrape truncating the west side of barrow 308, on the east side of the hawthorn tree which lies at the top of the steep slope down to the beck; a large patch of bare earth is visible [10/203, 10/204]. As with barrow 305, there are several active rabbit burrows amongst the exposed roots of the tree, especially on the west side, and this erosion has been exacerbated by the movement of stock along the top of the steep slope which has created terraces [10/205] (see plate 92). Overall, this western area of erosion measures some 10m long (north-south), mostly to the north of the tree. The long vegetation at the time of the erosion site visit meant that the adjacent vehicle tracks noted during the survey work were no longer evident.

Plate 92: Ravens' Gill barrows: erosion on west side of barrow (308), looking S (photo 10/205).

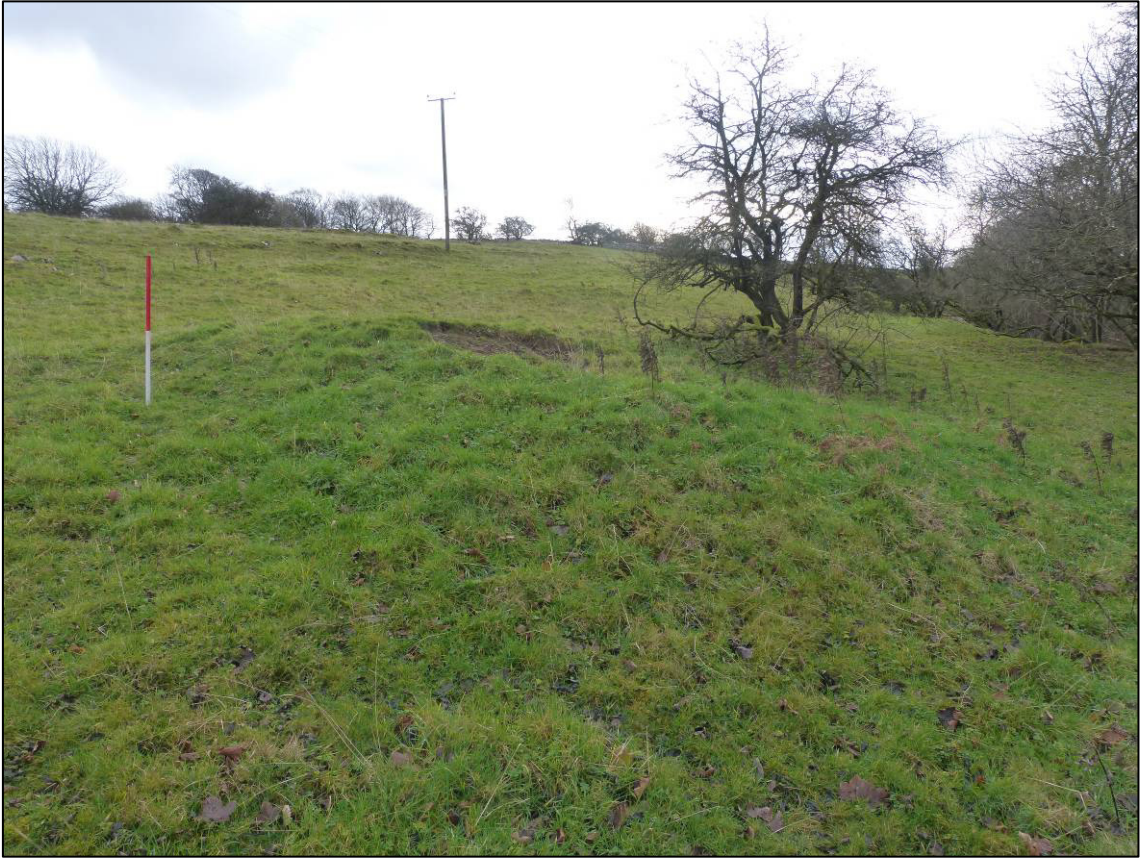
Plate 95: Ravens' Gill barrows, barrow (Site 306), looking S (photo 5/262).

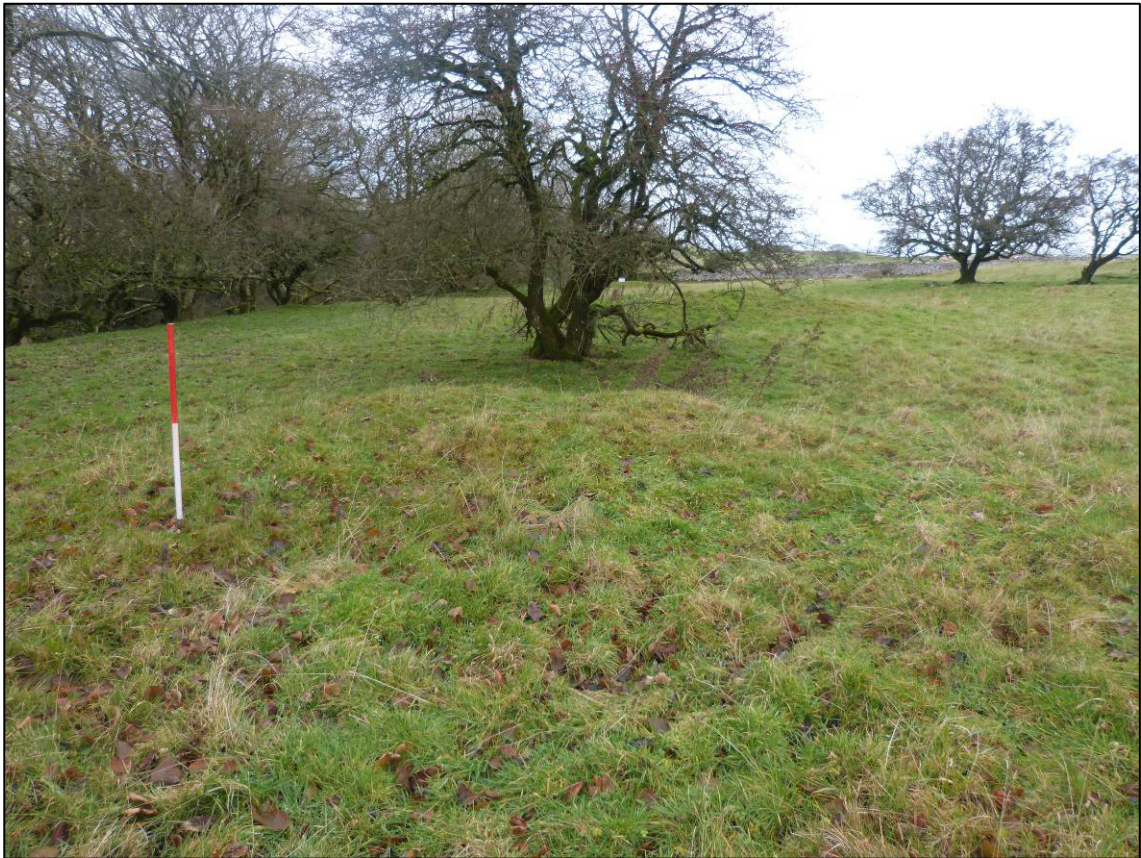
Plate 97: Ravens' Gill barrows, southern part of barrow (Site 307), looking N (photo 5/270).

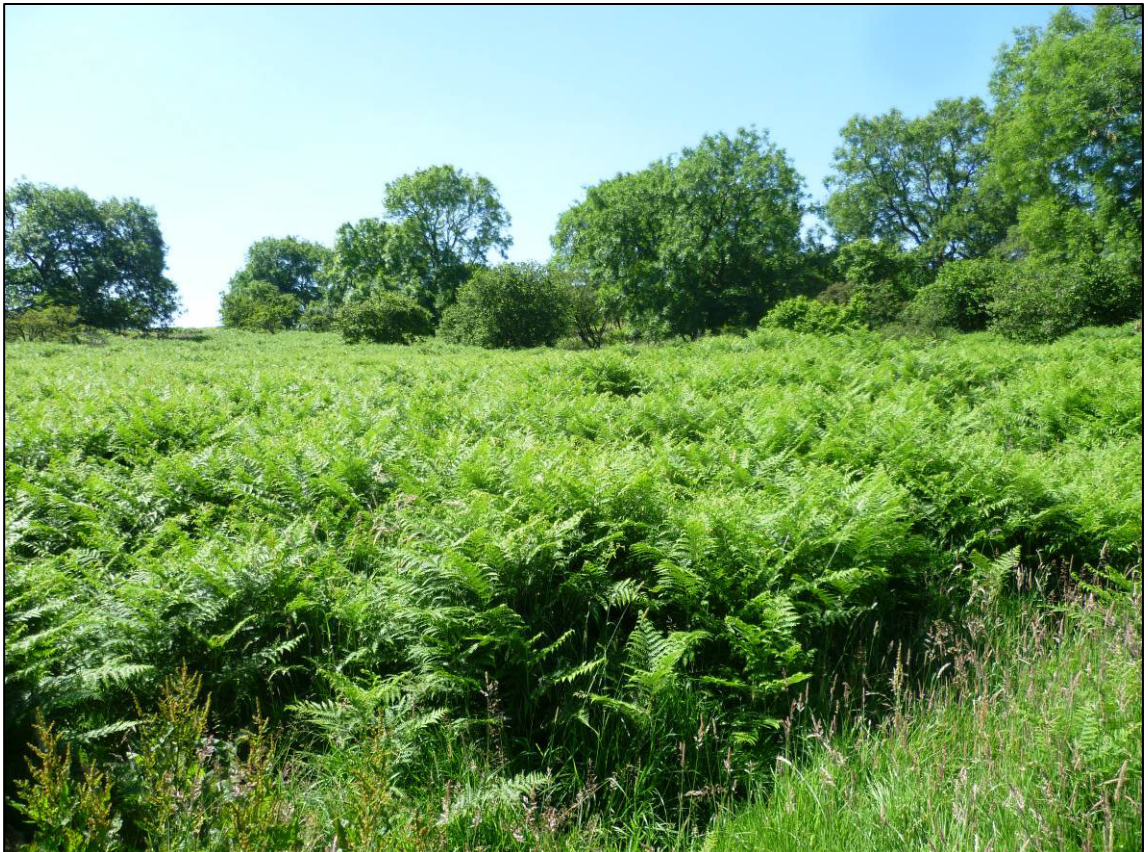
- 5.18 The entry in the current 'Heritage at Risk' register notes that the condition of the shieling (Site 400/1) is generally unsatisfactory with major localised problems, with the principal vulnerability being extensive vehicular damage and erosion (Historic England 2017, 1). However, although the site was severely affected by, and completely covered with dead bracken at the time of the field survey (February 2018), no evidence for any vehicular damage or other erosion was noted. By the time of the erosion survey visit (June 2018), the site and its surroundings were completely covered with a dense cover of bracken, and no earthworks could be identified [11/216] (see plate 100).

Plate 100: Crosby Lodge shieling (Site 400/1), general area in dense bracken (July 2018), looking SW (photo 11/216).

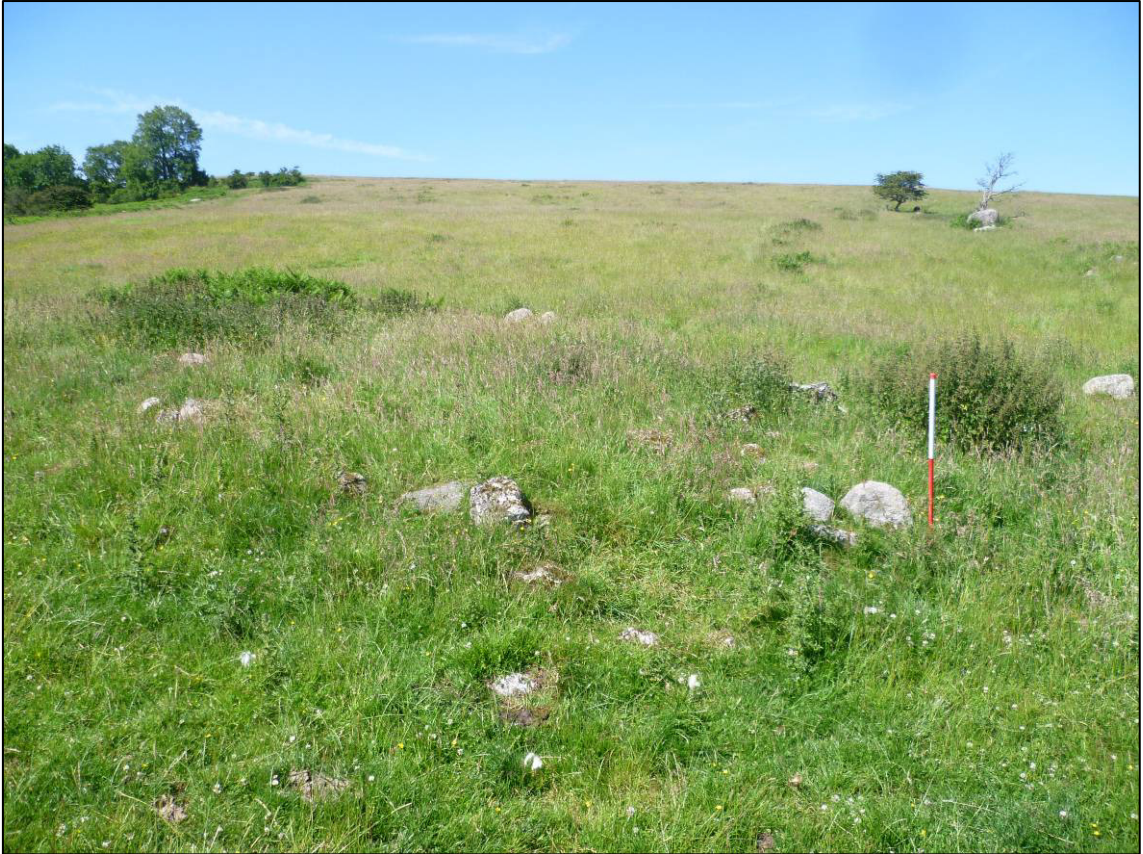
- 5.19 The second surveyed shieling (Site 400/2) lay in pasture and was overgrown, although was still identifiable [11/211] (see plate 102). There was an isolated clump of bracken starting to cover the south-west corner of the monument, and nettles on the east side and in the interior [11/212, 11/214]. Parts of the long walls were also completely covered with long grass [11/213, 11/216].

Plate 102: Crosby Lodge shieling (Site 400/2), looking SW July 2018) (photo 11/211).
