EXPOSED CULVERT, OLD GANG SMELT MILL,
SWALEDALE, NORTH YORKSHIRE

ARCHAEOLOGICAL WATCHING BRIEF

Report no: 2007/317.R01
Version: Final
Date: February 2008
Author: Shaun Richardson & Ed Dennison

Yorkshire Dales National Park Authority
Yorebridge House
Bainbridge
Leyburn
North Yorkshire DL8 3EE

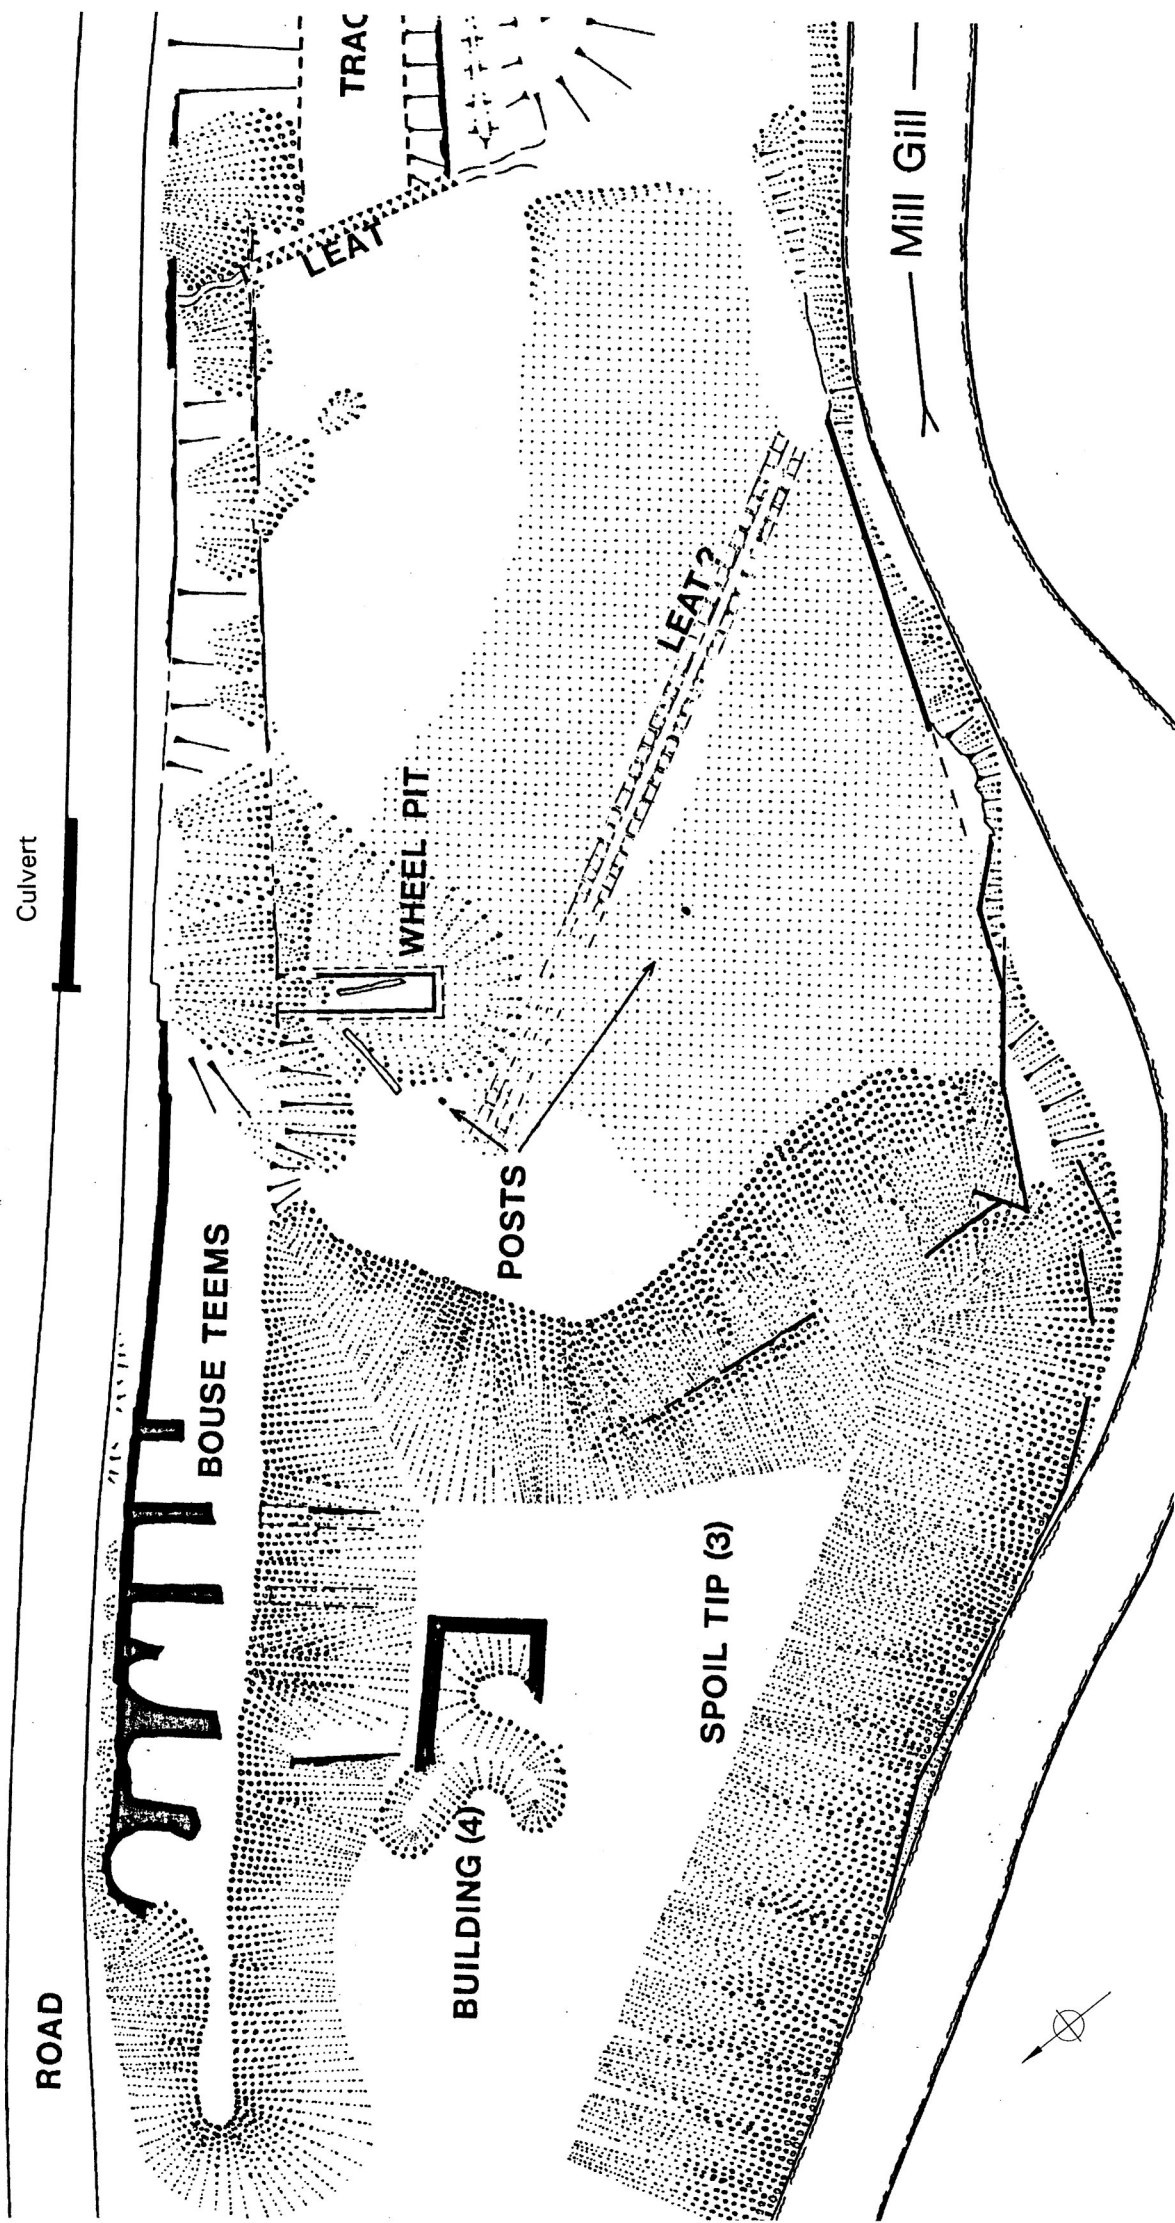
PROJECT EXPOSED CULVERT, OLD GANG MILL	
TITLE LOCATION OF CULVERT	
SCALE AS SHOWN	DATE FEB 2008
EDAS	FIGURE 3

- 4.2 Once clearance was complete, a c.1.70m section of culvert was exposed (see plate 1). The culvert was aligned north-west/south-east along the north side of the track; its line could be traced for a further 4.60m to the east, where it was blocked by a fall. The culvert was also choked to the immediate west of the exposed section by stones, soil and fallen material. Beneath the flagstone capping, the sides of the culvert were c.0.80m deep and built of roughly coursed and squared unmortared stone. The culvert had an average width of 0.50m and was floored with neatly-cut flagstones (see plate 2), although these were missing at the western end of the exposed section. Also at the west end, a smaller culvert (0.18m wide) appeared to enter the main culvert from the north, whilst opposite, a similar feature appeared to leave the south side to run to the south; the latter was in line with the remains of a wheelpit positioned on the dressing floor to the south.

- 4.3 Whilst the overburden was being cleared, it was observed that the flagstone roof of the culvert was supported in a number of places by re-used rails laid across its width. Furthermore, other short sections of rail had been placed vertically against the sides to prop up the flagstones. The rails had two distinct profiles (see figure 4). A high proportion of rotten wood was also present in the overburden above the smaller culverts seen in the north and south sides of the main feature, together with a 0.80m long piece of wrought-iron or steel with a U-section and pierced by several neat circular holes along one side and the base.

- 4.4 As stated above, all loose metal items or those disturbed during the course of the works were replaced within the culvert, which was then re-roofed using the fallen flagstones or other stones obtained from the base of Mill Gill. The overburden was subsequently replaced.
