CHURCH OF ST MARY,
STRENSALL, YORK

ARCHAEOLOGICAL WATCHING BRIEF

Report no: 2004/227.R01
Version: Final
Date: October 2006
Author: Ed Dennison

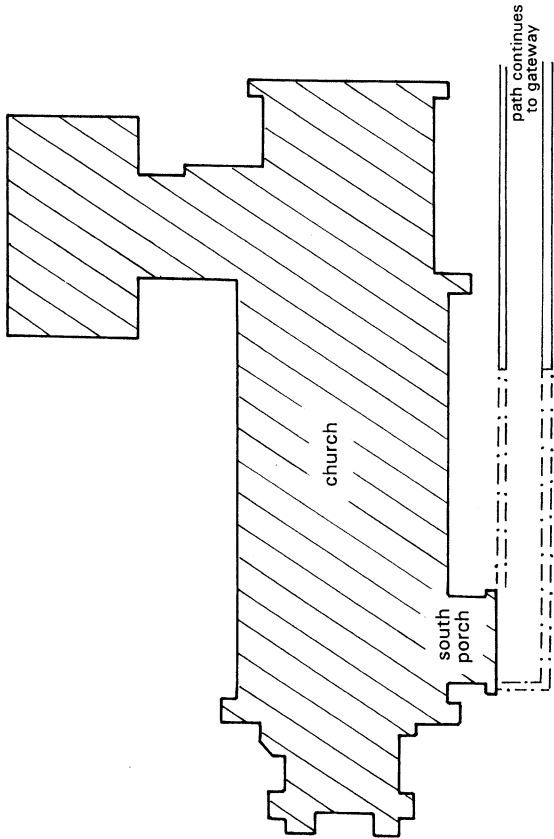
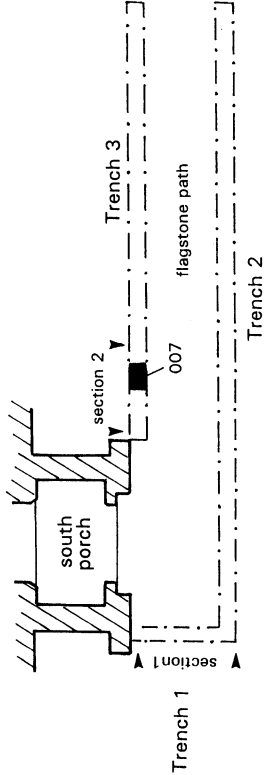
PROJECT	ST MARY'S CHURCH, STRENSALL		
TITLE	WATCHING BRIEF RESULTS		
SCALE	AS SHOWN	DATE	OCT 2006
EDAS		FIGURE	2

- 4.1 Trench 1, excavated immediately to the south of the porch, revealed a thin layer of brown loamy soil with gravel (001) less than 0.14m thick underneath the flagstones, and overlying a c.0.18m depth of fine sandstone rubble hardcore (002). This in turn overlay a fine, orange-brown sand (003) of unknown depth. All these three deposits had been cut by a recent trench (004) which had been excavated for a gas pipe which ran approximately north-south, and then east-west along the line of the southern kerb; the fill of the trench was a loose brown loam containing small stones, gravel and brick fragments (005). The excavation at the north end of the trench, adjacent to the south-west corner of the porch, revealed a brick plinth (008) under the main sandstone foundation (010); the bricks measured 78mm thick and 102mm wide but only one course was exposed.

- 4.3 Trench 3 was excavated eastwards from the south-east corner of the porch for a distance of c.8.0m. At a point c.1.0m from the west end of the trench, a north-south wall footing (007) was visible, 0.50m wide and 0.25m below the turf surface. The footings comprised at least two courses of re-used brick and floor tiles heavily bonded with a lime mortar, and they appeared to run north towards the wall of the nave; the full depth of the footings was not revealed in the shallow trench (see plate 2). Although OD levels were not taken, the footings appeared to be at approximately the same level as the brick plinth (008) beneath the porch. The footings were overlain by a disturbed deposit of dirty brown loam containing much brick, tile and sandstone rubble (006) with the turf and topsoil (009) averaging 0.27m thick above. There was no evidence of any continuation of the footings in the adjacent trench (Trench 2), although they may have been removed when the path was first laid.

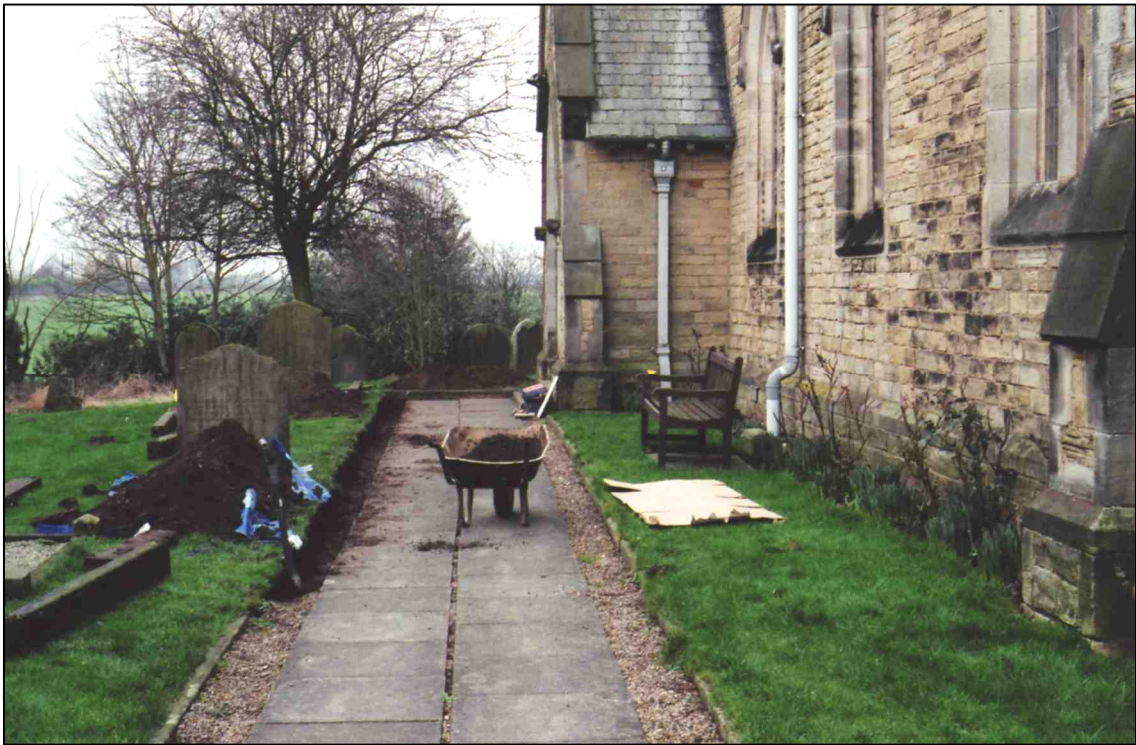
Plate 1: General view of work in progress, looking west.
