ST PETER AND ST PAUL'S CHURCH,  
PICKERING, NORTH YORKSHIRE  
ARCHAEOLOGICAL WATCHING BRIEF

ARCHAEOLOGICAL WATCHING BRIEF

Report no: 2006/292.R01  
Version: Final  
Date: July 2007  
Author: Ed Dennison

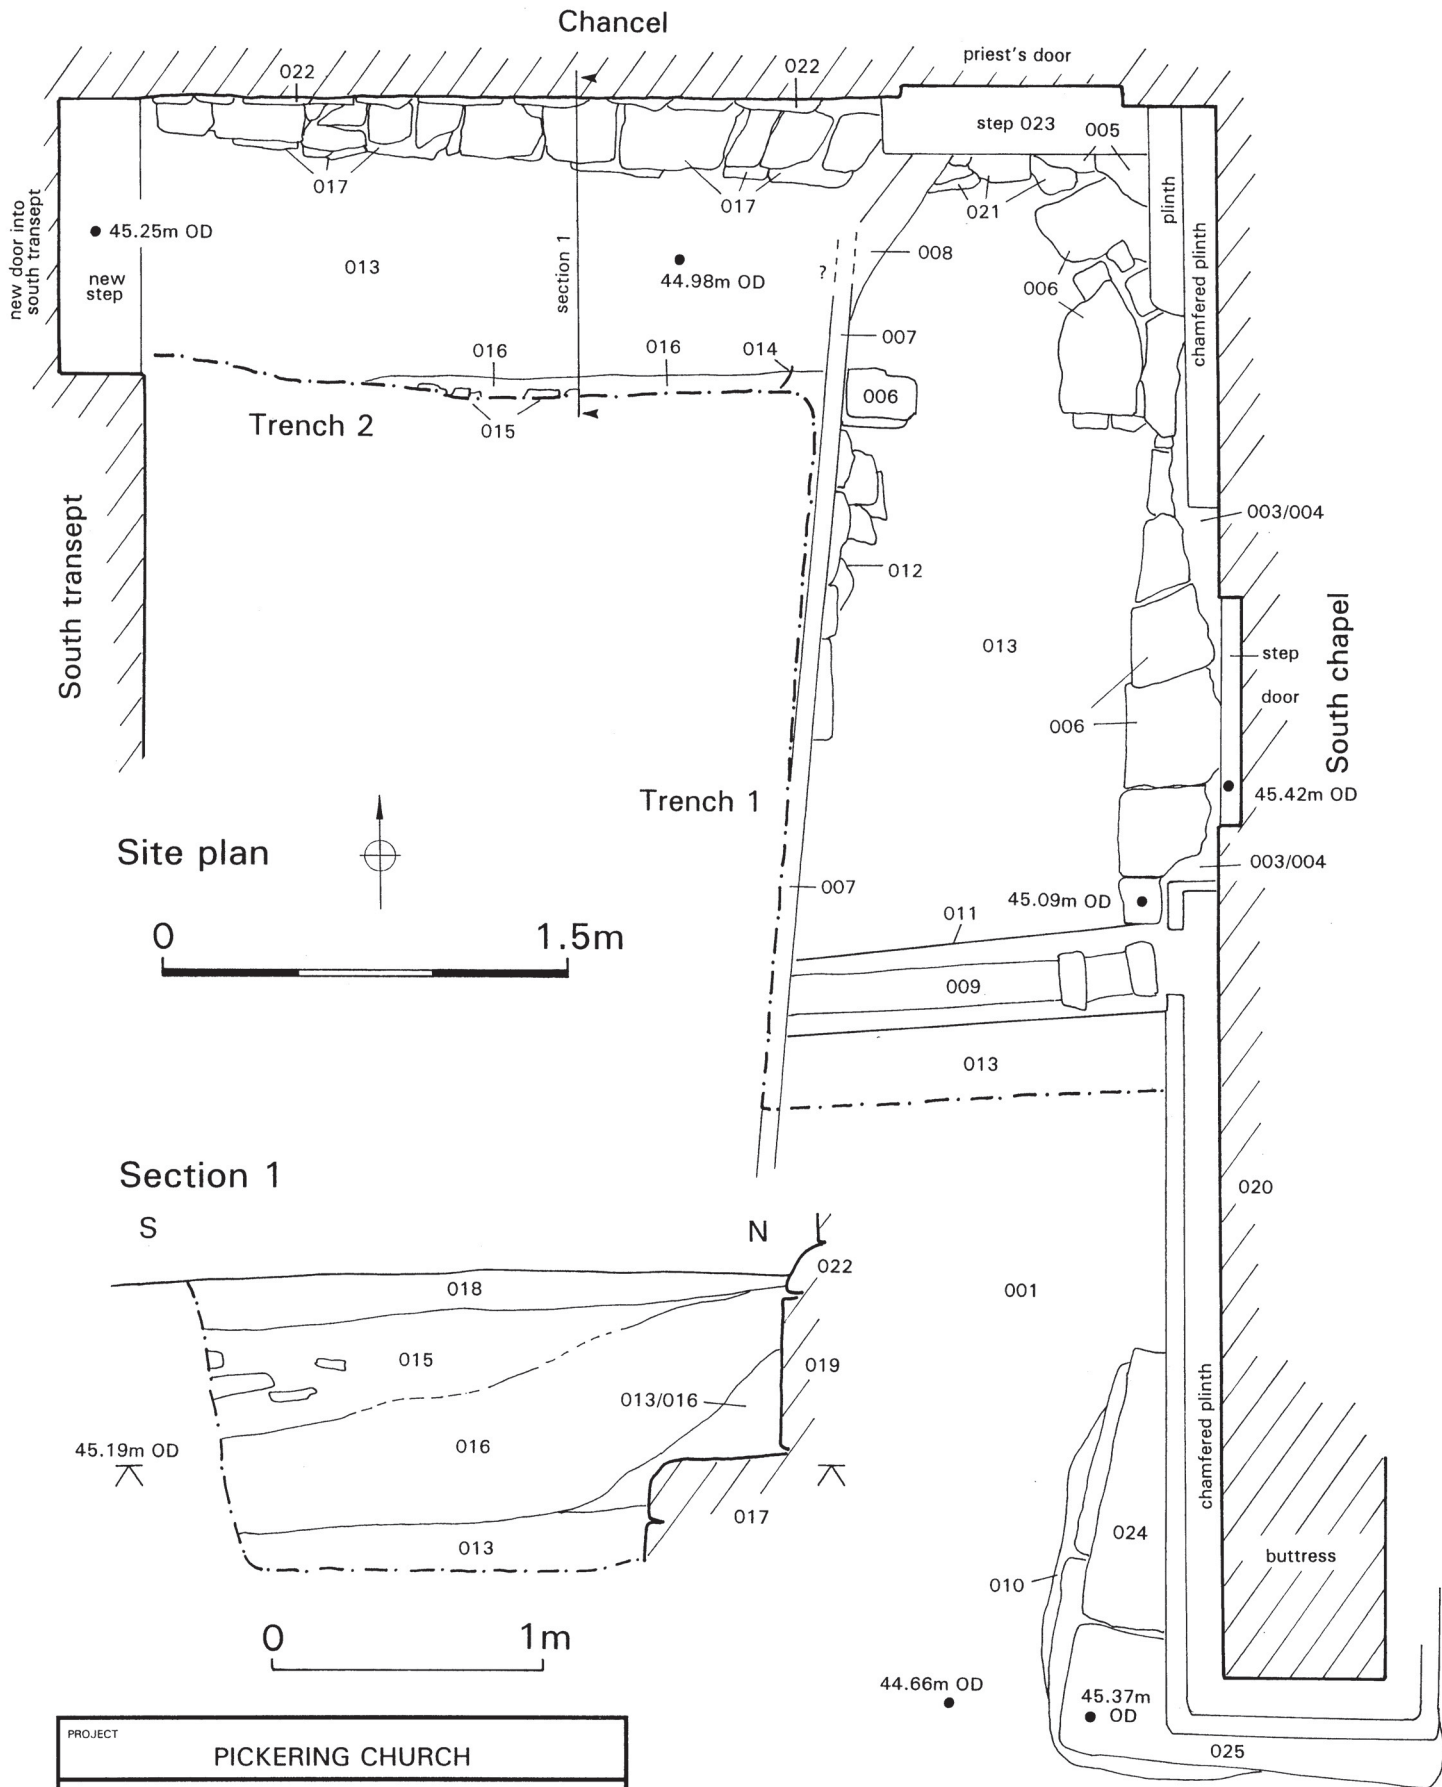
- 4.6 The foundations of the west wall of the south chapel and the south wall of the chancel (006 and 017 respectively) were exposed by the groundworks, and were both seen to be composed of soft yellow semi-dressed sandstone rubble of a generally uniform character (see plates 1 and 2). These foundations stepped out from, and appeared to be on a slightly different alignment to, the chamfered plinths and walls of the south side of the chancel (022 and 019) and the west wall of the south chapel (020), which have a more east-west alignment but which rest on these foundations. It appears that the foundations might well be those of an earlier structure, and this is reinforced by the curious relationship between the upper and lower parts of the buttress located at the south-west corner of the south chapel.
