EROSION REPAIRS,  
OLD GANG LEAD SMELTING MILL,  
MILL GILL, SWALEDALE, NORTH YORKSHIRE

ARCHAEOLOGICAL MONITORING AND RECORDING

Report no: 2022/665.R01  
Version: Final  
Date: May 2022  
Author: Shaun Richardson & Ed Dennison

Yorkshire Dales National Park Authority  
Yoredale  
Bainbridge  
Leyburn  
North Yorkshire DL8 3EL

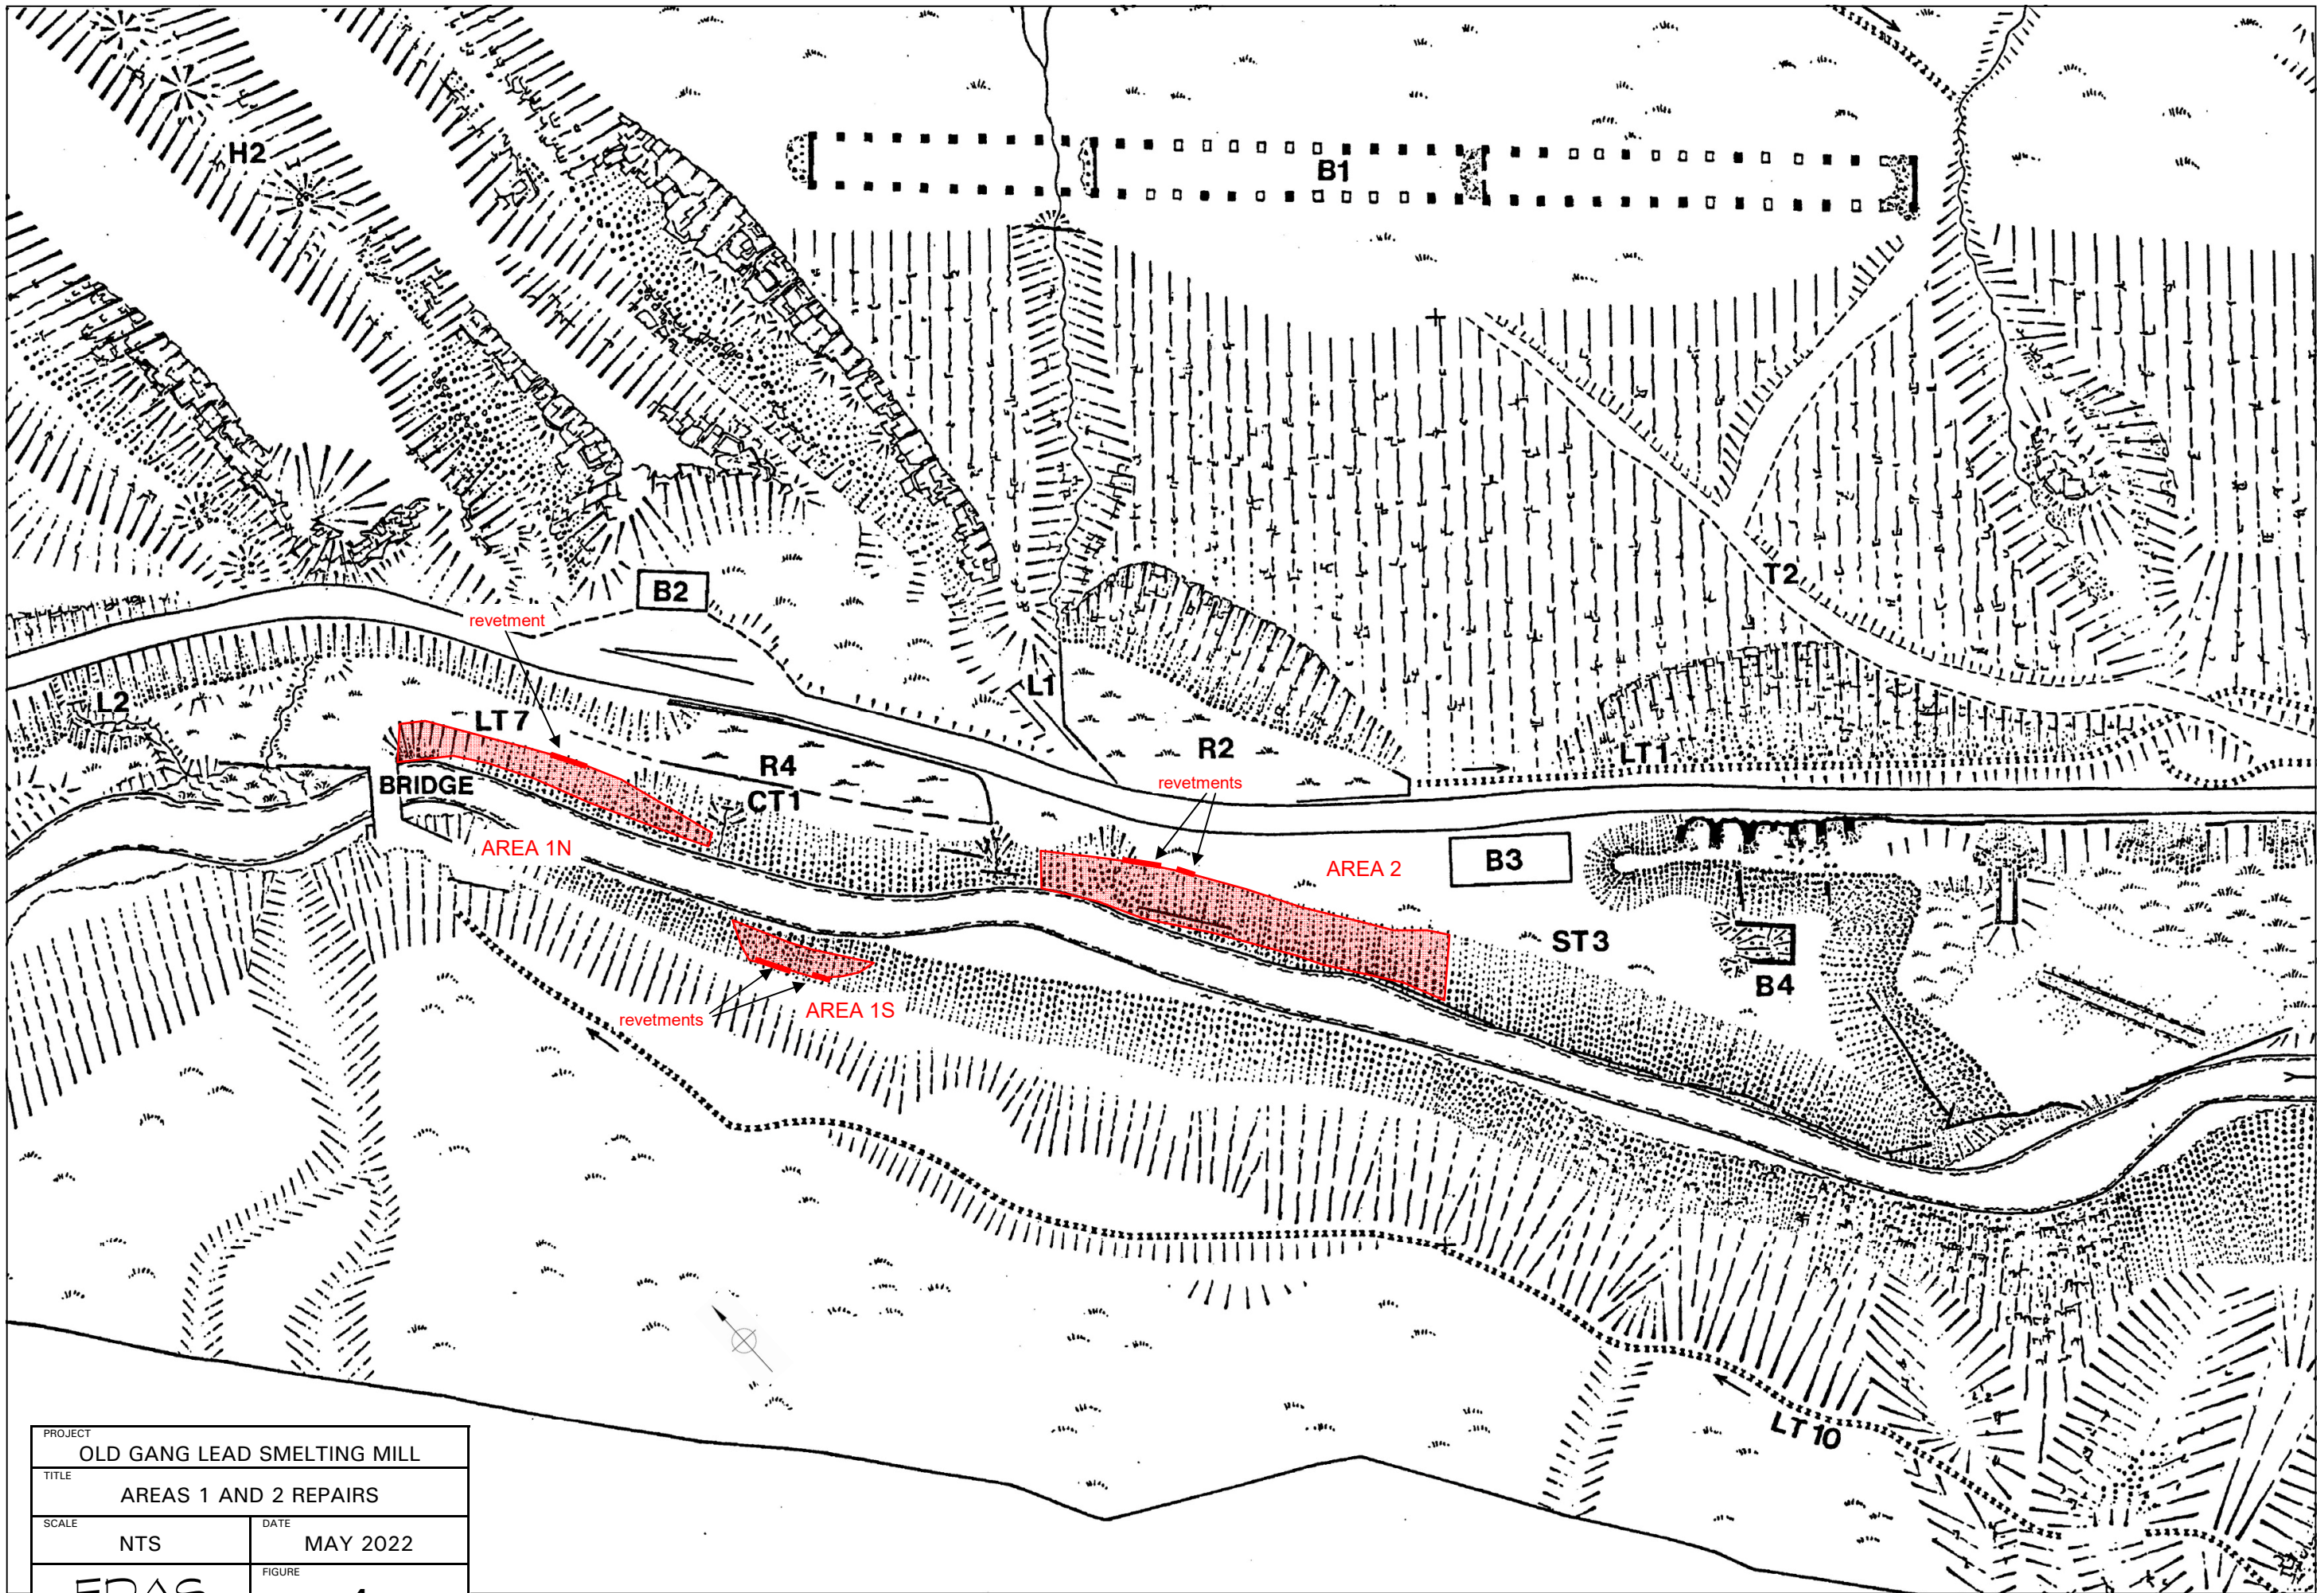
PROJECT		OLD GANG LEAD SMELTING MILL	
TITLE		AREAS 1 AND 2 REPAIRS	
SCALE	DATE	NTS	MAY 2022
EDAS	FIGURE	4

- 7.4 The July 2019 flooding had cut into the looser deposits forming the long linear spoil heap (ST3) (see plates 1 and 2). In 1992, the base of the south scarp of the spoil heap (i.e. where it met the flattened bottom of Mill Gill) was set c.14m to the south of the south side of the main track through the mine complex; by 2022, this measurement had been reduced to c.12.50m [1/839, 1/840]. The top of the spoil heap's south scarp appeared largely unchanged since 1992, although the cutting back of the lower deposits had caused a slump, revealing a section of retaining wall not visible in 1992. The exposed part of the retaining wall was set within the western part of Area 1, and had a total visible length of c.7m; it was placed broadly in line with the top of the spoil heap's south scarp [1/834, 1/835] (see plate 3). It may have supported a tramway shown here on the Ordnance Survey map of 1895, and also depicted in historic photographs (Gill 2004, 76); the latter suggests the presence of a retaining wall to the beck (see figure 3). The wall stood c.2m in height, and was of drystone construction, using pieces of roughly squared rubble; these were roughly graduated in size from bottom to top, with some of the lower stones measuring c.0.70m by 0.50m [1/832] (see plate 4). The wall had a slightly battered profile, whilst in plan, it was slightly angled, with both ends angling away to the north from the centre [1/833].

- 7.5 In order to repair this area of erosion, the required total length of rock armouring was c.36m. Machine access was gained from the east side of the bridge [1/836, 1/837] (see plate 5). The rocks were laid mostly in two courses, standing up to c.1m in height, although towards the eastern part there were three courses to take account of the falling levels, making the armoured wall up to 1.5m in height [2/877, 2/881, 2/884, 2/896] (see plate 6). The outer face of the armoured wall was set between c.3m and 5.5m south of the top of the south scarp of the spoil heap (ST3), with between c.2m and 5m of loose material from the bed of the beck meeting the scarp [1/871, 1/872]. The newly exposed revetment wall referred to above was retained, with the armoured wall being built in front of it [2/882; 3/244] (see plate 7). The east end of the new section of wall stopped just short of the central culvert of the reservoir (R4) [3/250], while the west end butted up against northern bridge abutment [2/880; 3/247]. By May 2022, the new armoured wall was well bedded-in, although the exposed revetment wall is perhaps in danger of collapse without some consolidation [3/277, 3/280] (see plate 8).
