FORMER CLAYTON HOSPITAL,
NORTHGATE, WAKEFIELD WF1 3JS

ADDITIONAL ARCHITECTURAL RECORDING

Report no: 2021/649.R01
Version: Final
Date: December 2021
Author: Shaun Richardson & Ed Dennison

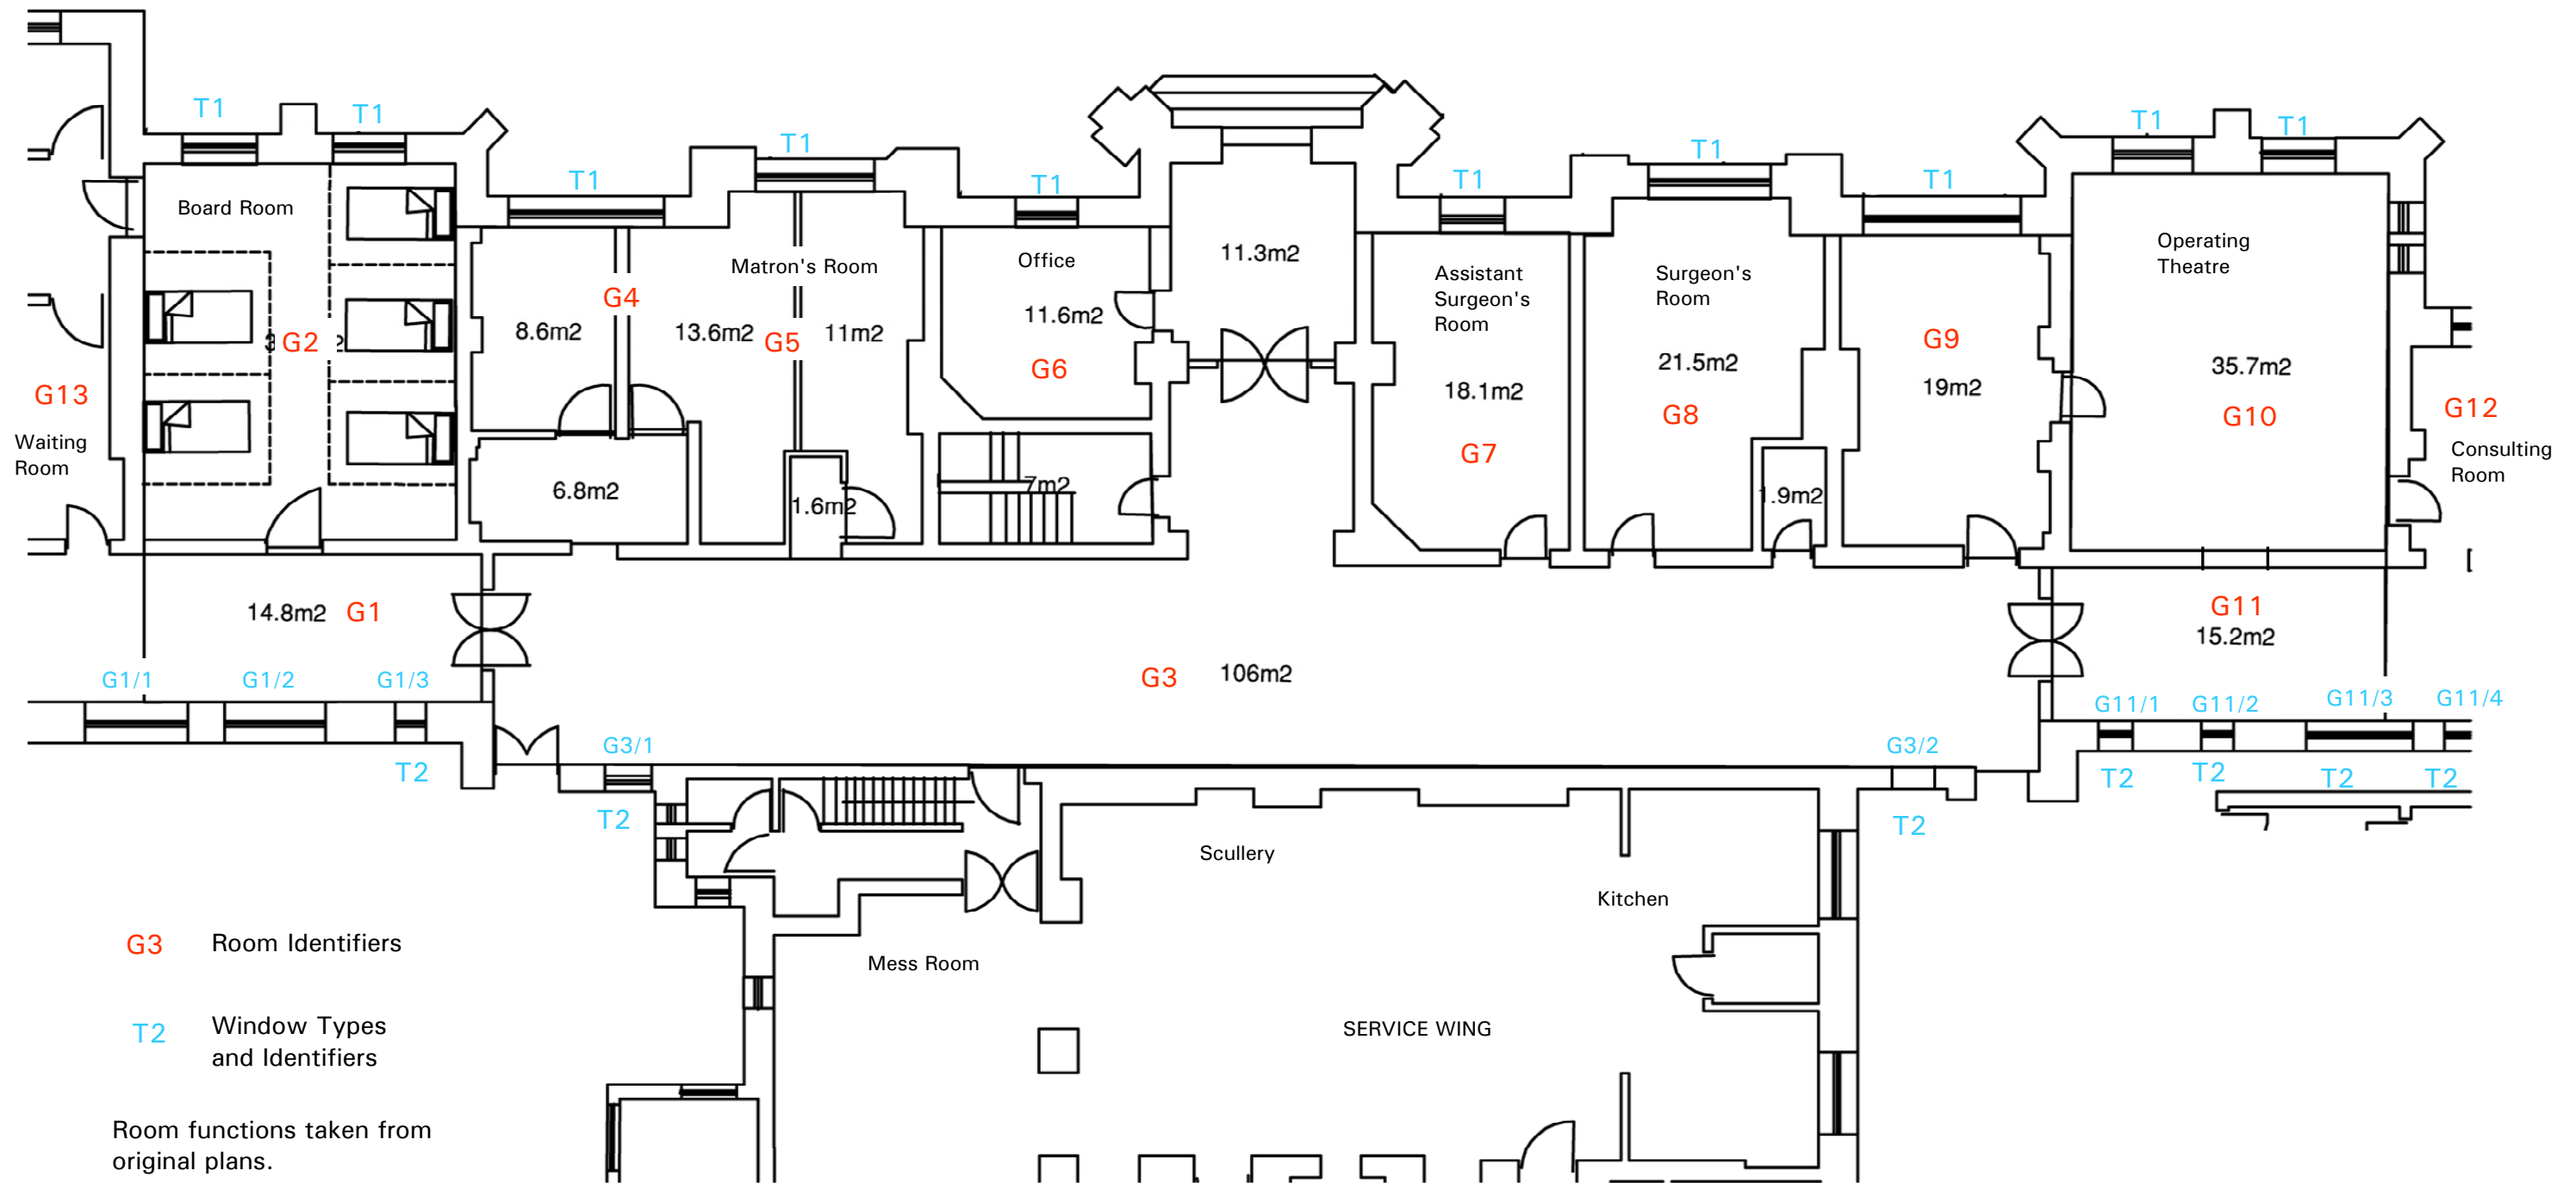
PROJECT CLAYTON HOSPITAL, WAKEFIELD	
TITLE WINDOW SURVEY GROUND FLOOR	
SCALE NTS	DATE DEC 2021
EDAS	FIGURE 3

The Ground Floor (see figure 3)

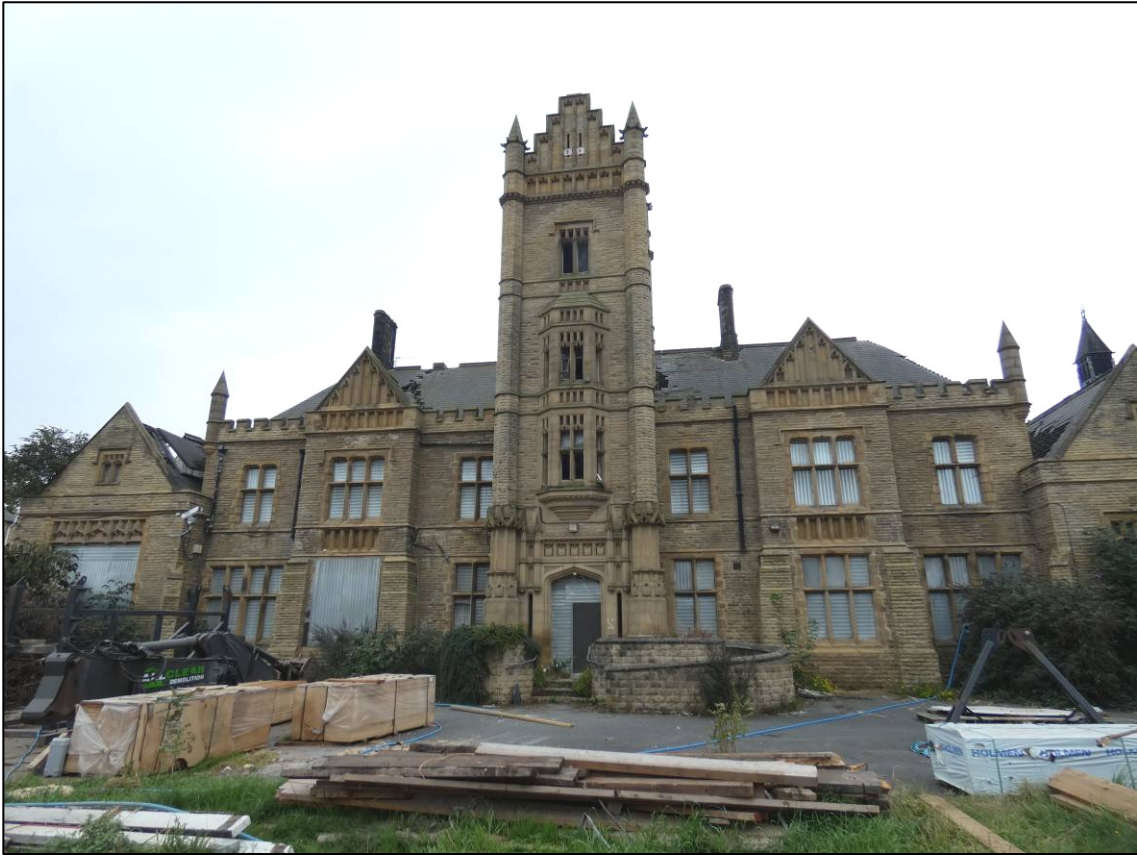
Plate 1: Front (north) elevation of retained building, looking SE.

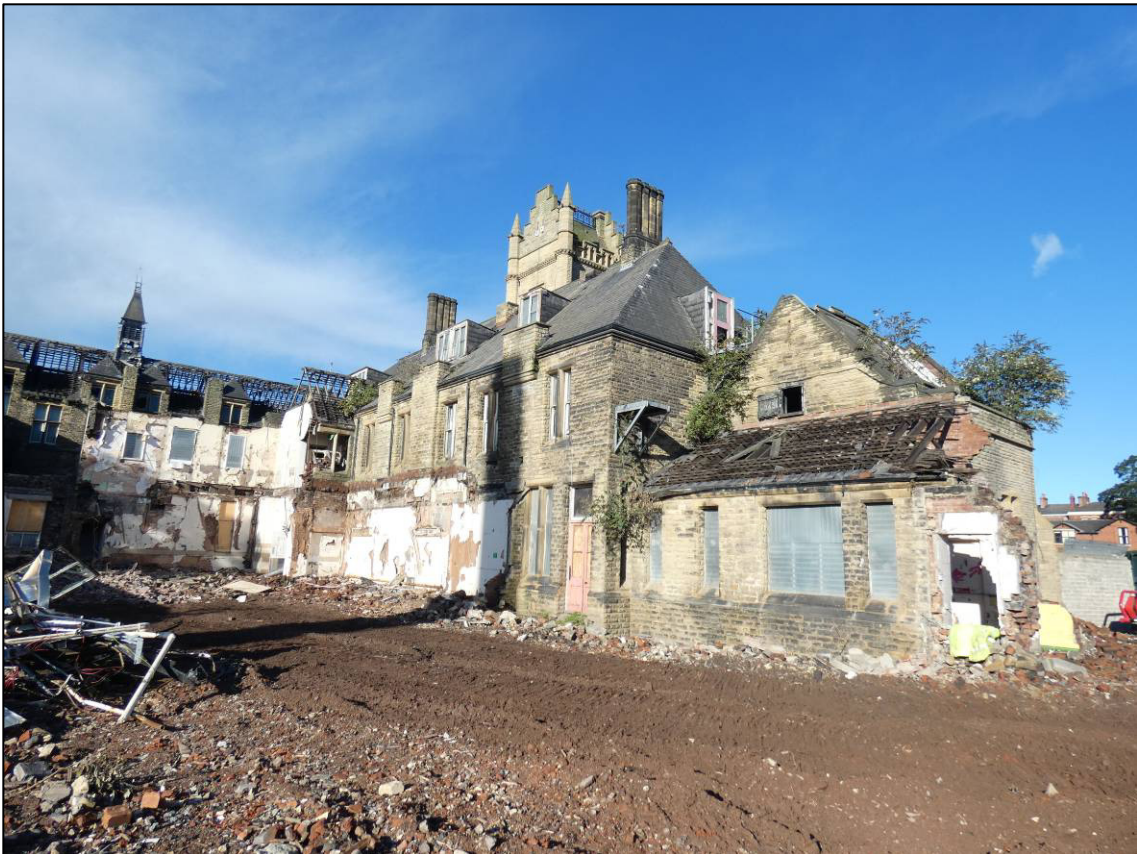
Plate 2: Rear (south) elevation of retained building, with demolition of adjacent structures on going, looking NW (photo 1/758).

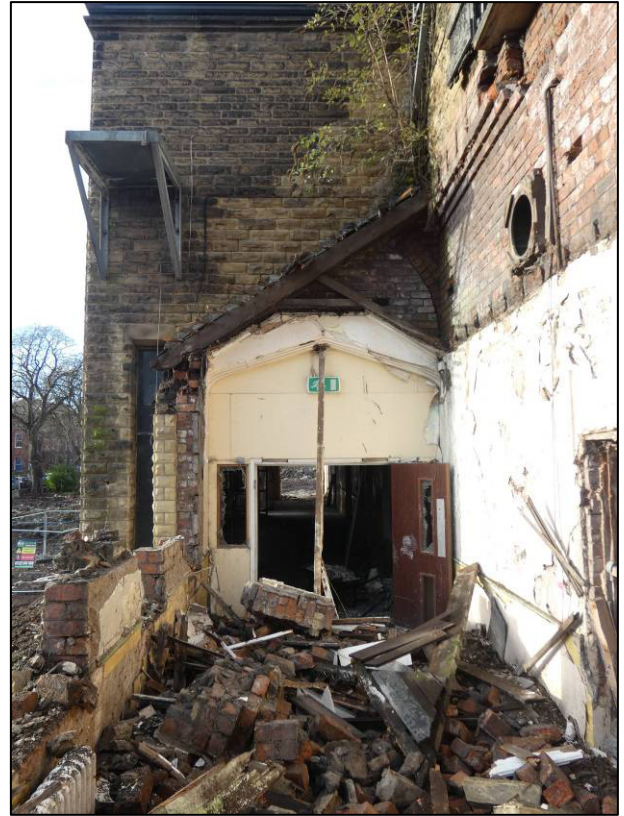
- 5.6 The west wall of the corridor (G11), forming a return to the south elevation, is dominated at ground floor level by the tall Tudor-arched doorway opening leading into the main circulation corridor (G3). This doorway has a moulded arch and jambs, with modern partition infilling [2/168, 2/169] (see plate 16). Above the corridor arch, there is a low area of brickwork and a brick relieving arch, beneath the only surviving element of the single-pitch roof. The remainder of the wall/elevation is faced with neatly (and rather shallowly) coursed and squared rock-faced sandstone set with a lime mortar. It is largely blank, with the exception of a tall, narrow single-light window to the immediate south of the corridor.

Plate 16: East elevation after demolition, former west wall of corridor (G11), looking W (photo 2/168).

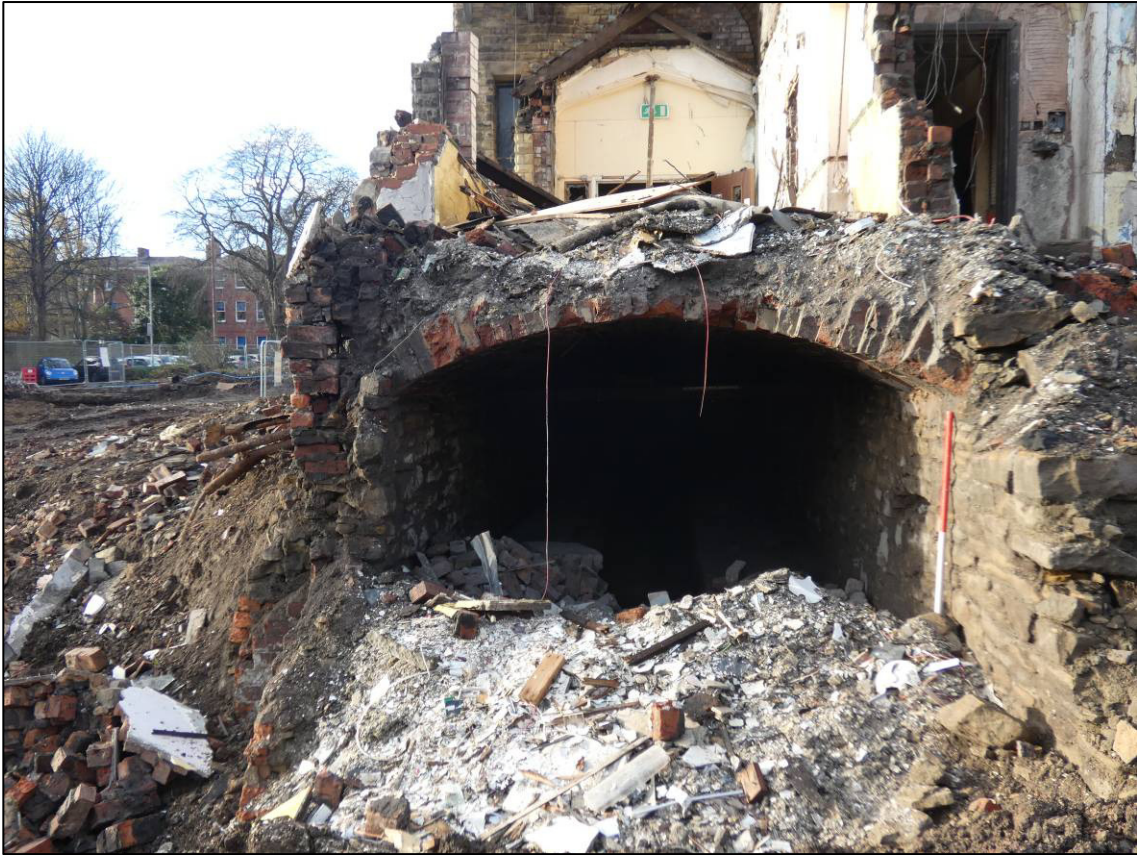
- 5.7 Demolition work also exposed the east end of a vaulted east-west aligned cellar passage which formerly ran the full length of the building beneath the main circulation corridor (G3) and ancillary corridors (G1 and G11) on the ground floor. It should be noted that this is not the east-west cellar corridor which is shown on the original plans (Kerr 2016, 38); this lay to the south of the passage, and its remains were exposed further to the west (see below). This cellar passage has roughly coursed and squared stone walls, with a wide brick barrel vault over [2/161-2/164] (see plate 18). It was too dangerous to enter, but when viewed from the outside, it has a concrete floor with what appears to be inserted raised areas running parallel to the walls [2/166] (see plate 19). The passage does not appear on the original plans of the cellar, but must surely be part of the building's original construction; its purpose is unclear.

Plate 18: Vaulted cellar passage, east end, looking W (photo 2/163).

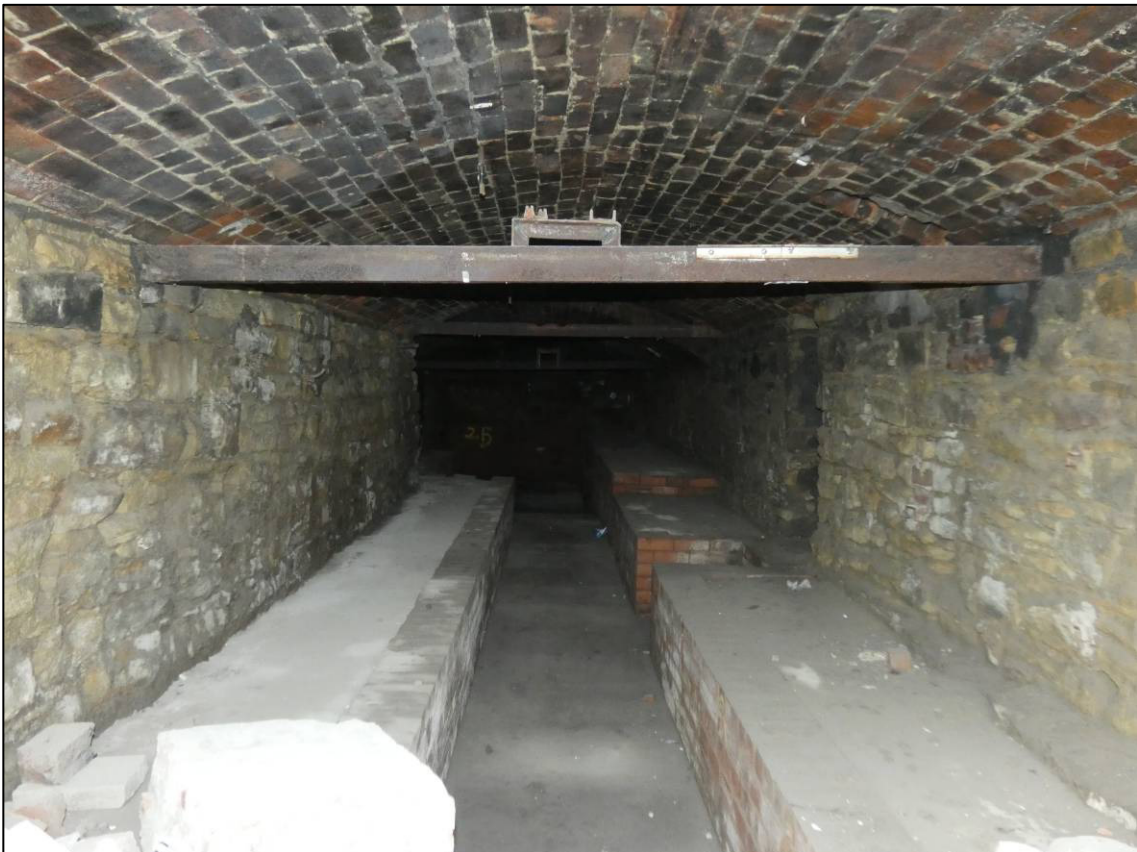
Plate 19: Vaulted cellar passage, east end, interior, looking W (photo 2/166).

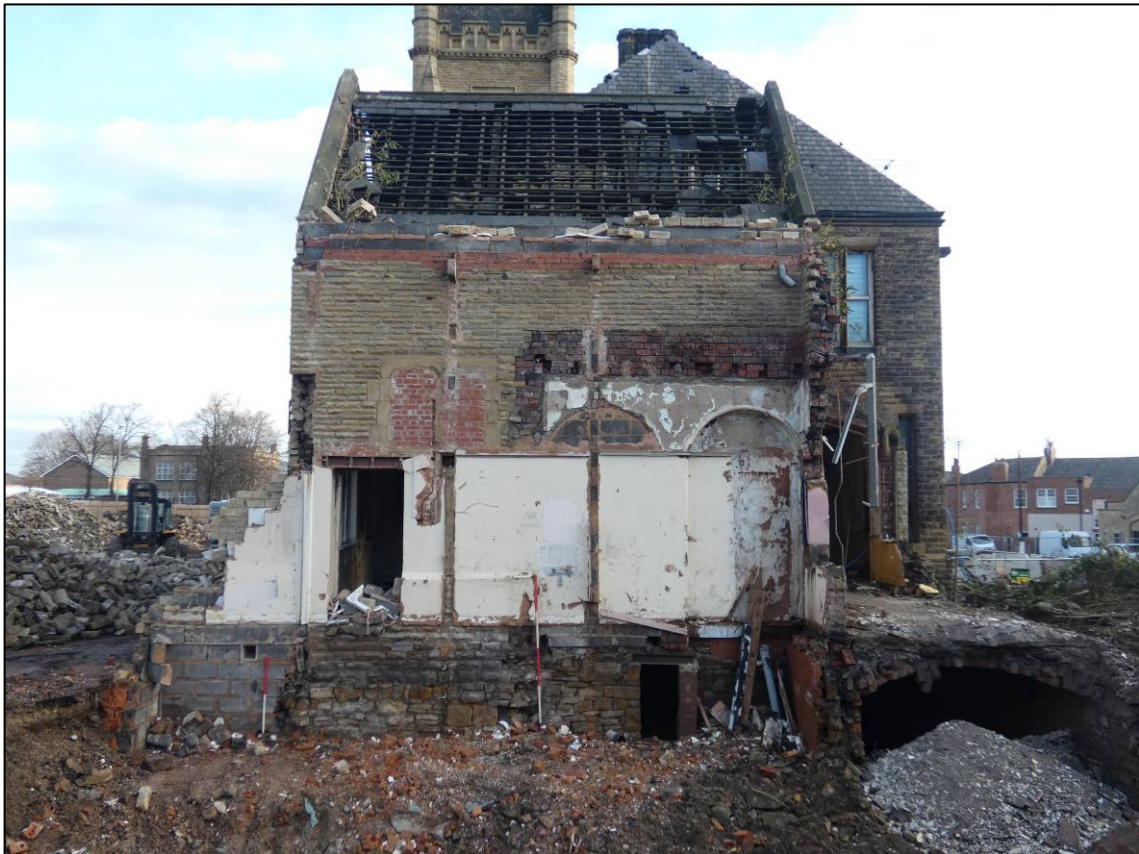
- 5.13 Following demolition of the structures to the west, the remaining elevation comprised principally a corridor (G1) on the south side and what had been a Waiting Room (G13) to the immediate west of the Board Room (G2). The elevation is a mixture of a single and two storeys and, as would be expected given the original plan form of the building, essentially similar to what has already been described for the east elevation [2/139-2/144] (see plate 24).
- 5.14 Described from north to south, the north end of the elevation comprises what was once the external west wall of the Board Room (G2). This had an angle buttress at the corner (demolished to make way for a 20th century addition), and is faced with neatly (and rather shallowly) coursed and squared rock-faced sandstone set with a

Plate 24: West elevation after demolition, looking E (photo 2/141).

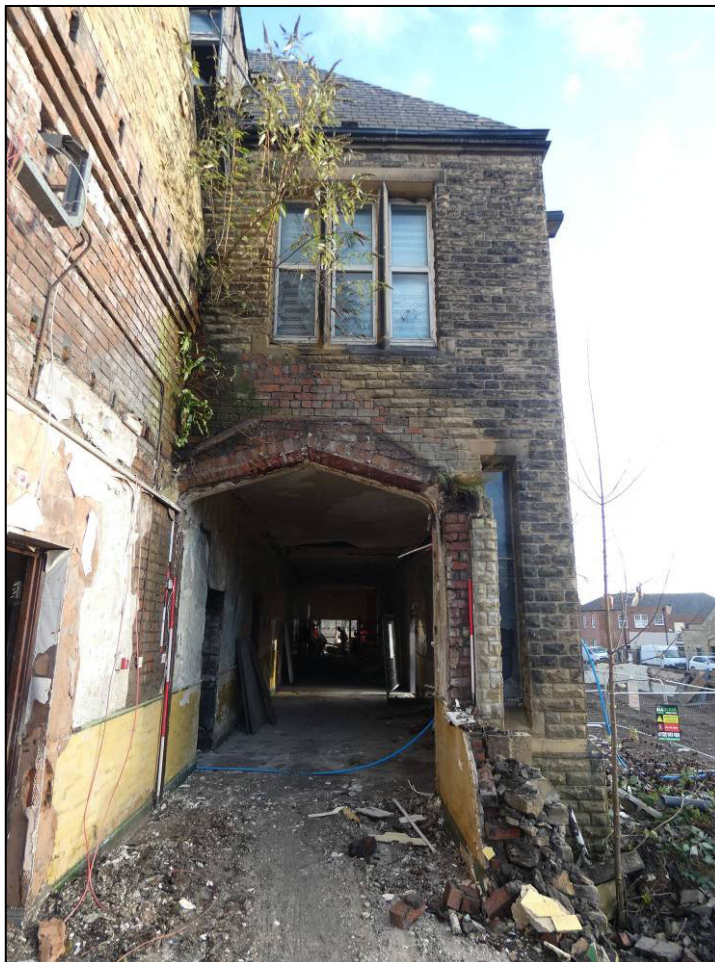
Plate 26: West elevation after demolition, former east wall of corridor (G1), looking E (photo 2/156).
