CONSERVATION FABRIC REPAIRS,
BUTTERTON BRIDGE, PICKING GILL,
SAWLEY, NORTH YORKSHIRE

ARCHAEOLOGICAL AND ARCHITECTURAL
OBSERVATION, INVESTIGATION AND RECORDING

Report no: 2020/620.R01
Version: Final
Date: May 2021
Author: Shaun Richardson & Ed Dennison

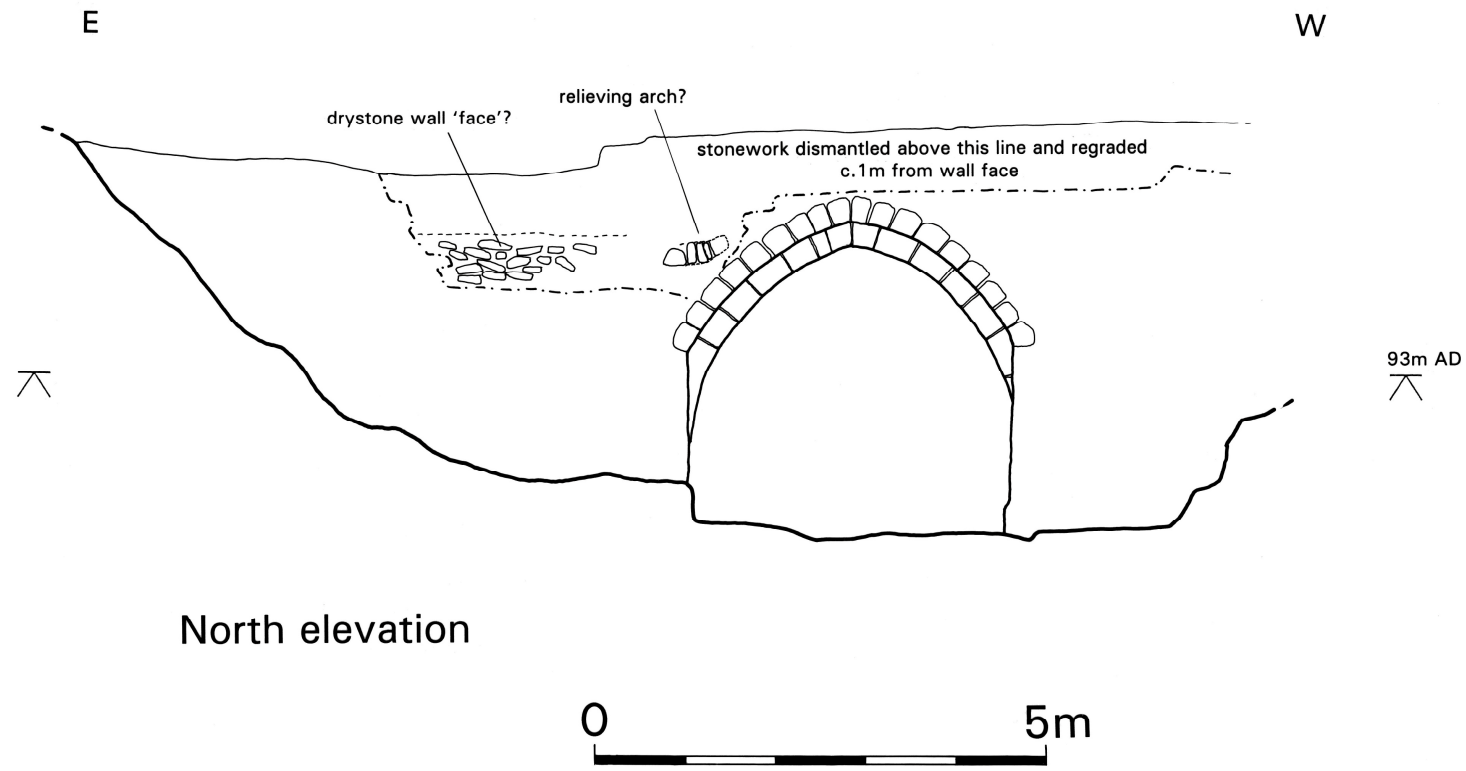
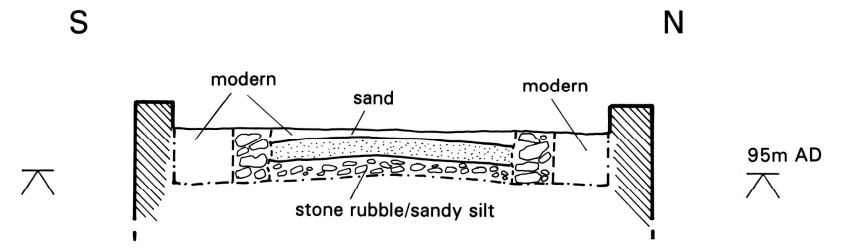
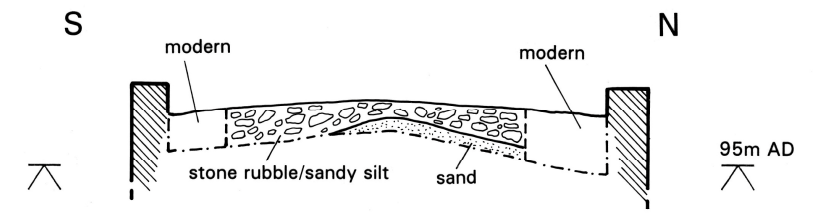
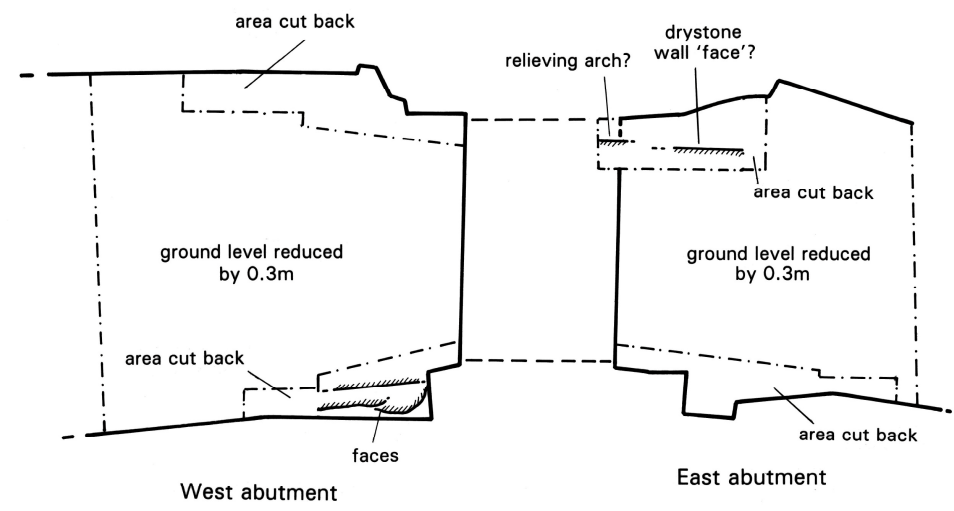
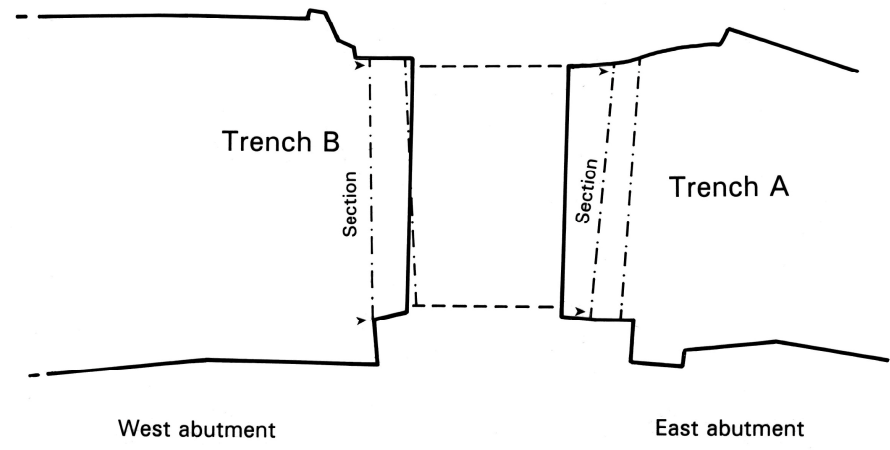
PROJECT		BUTTERTON BRIDGE, SAWLEY	
TITLE		WATCHING BRIEF RESULTS	
SCALE	AS SHOWN	DATE	MAY 2021
EDAS		FIGURE	8

Areas of ground reduction

Section locations

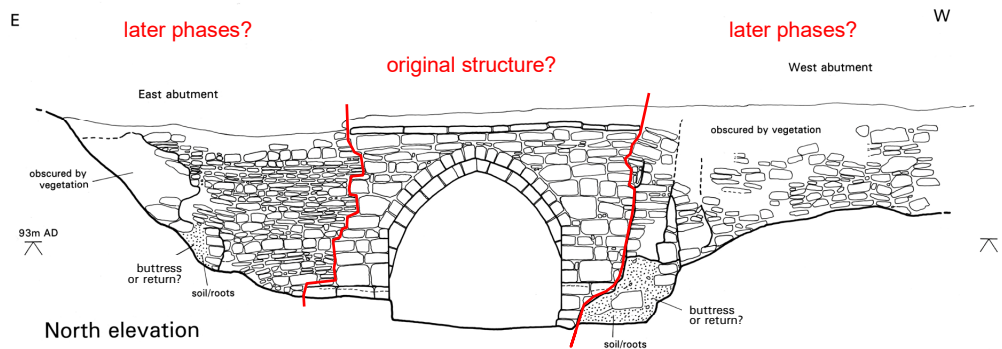
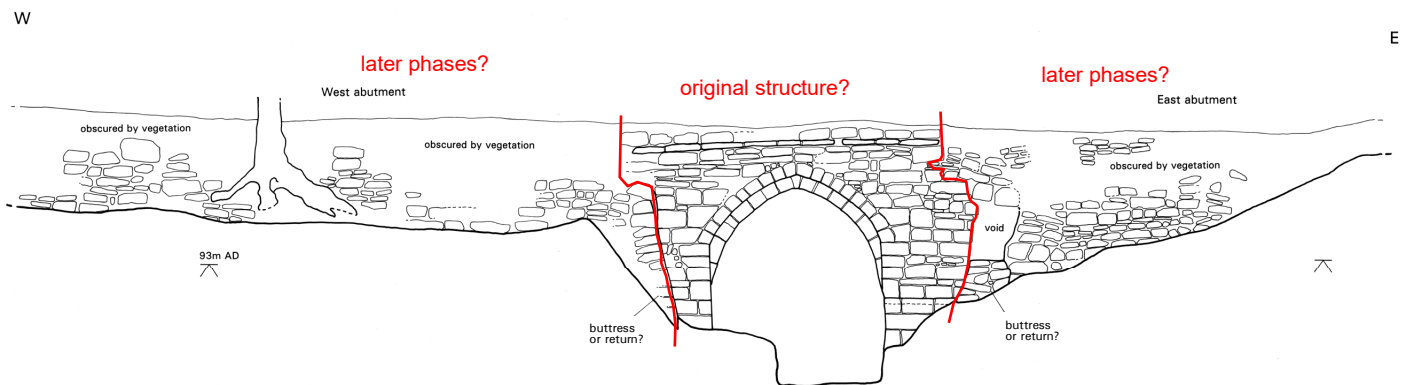
PROJECT		BUTTERTON BRIDGE, SAWLEY	
TITLE		SUGGESTED PHASING	
SCALE	AS SHOWN	DATE	MAY 2021
EDAS		FIGURE	9

- 6.1 The structural information recorded during the repair and consolidation work at Butterton Bridge can be summarised as follows. There is a clear difference in the quality of the masonry between the central part of the bridge and that of the abutments to either side, the junction between the two being staggered and rather crude (see figure 9). The central part (essentially the arch and facing stone of the arch) appears to have remained relatively unaltered throughout its history, with the abutments seemingly going through several different phases of repair and rebuilding. This is particularly noticeable to the east part of the north elevation, where a distinctive thinly coursed stone facing with deeper levelling courses was used. To both main elevations, the projections flanking the arch were poorly tied in to the main wall faces; it was not possible to determine with any certainty whether these projections were buttresses or former returns.

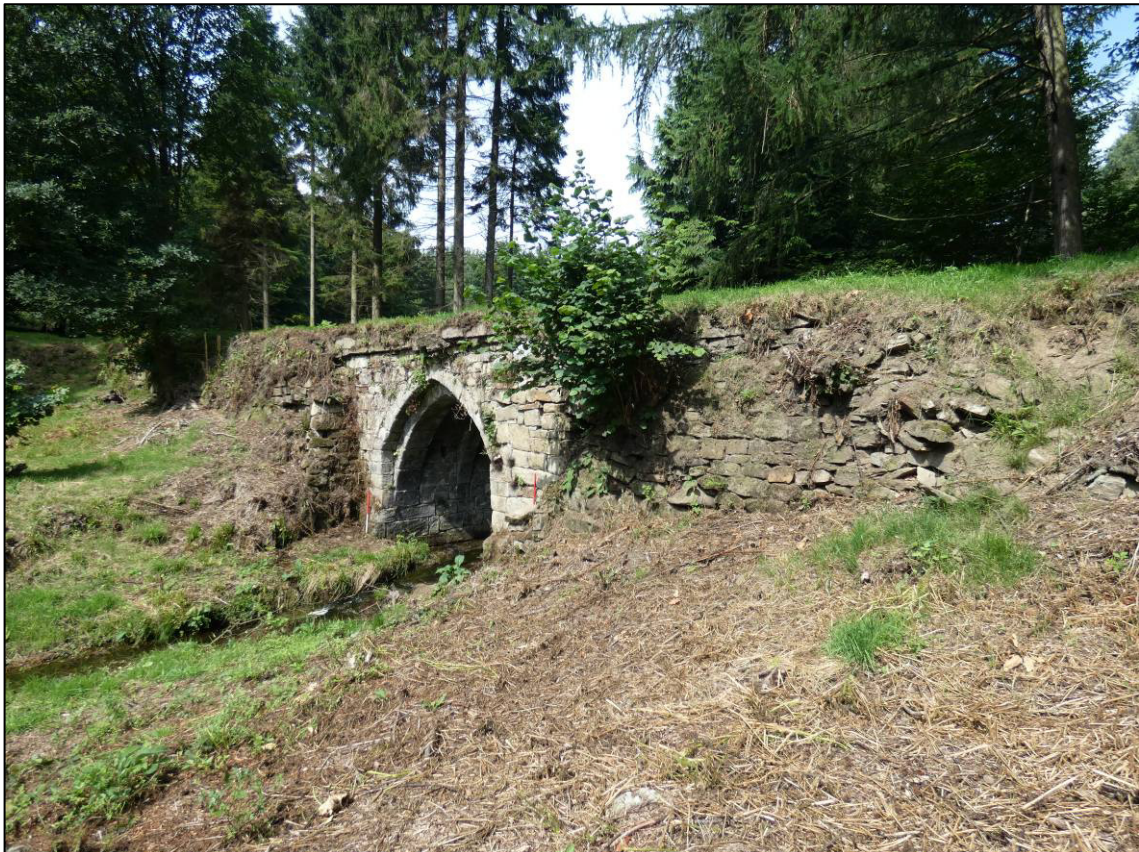
Plate 7: View of south elevation and east abutment, prior to repairs, looking NW (photo 1/885).

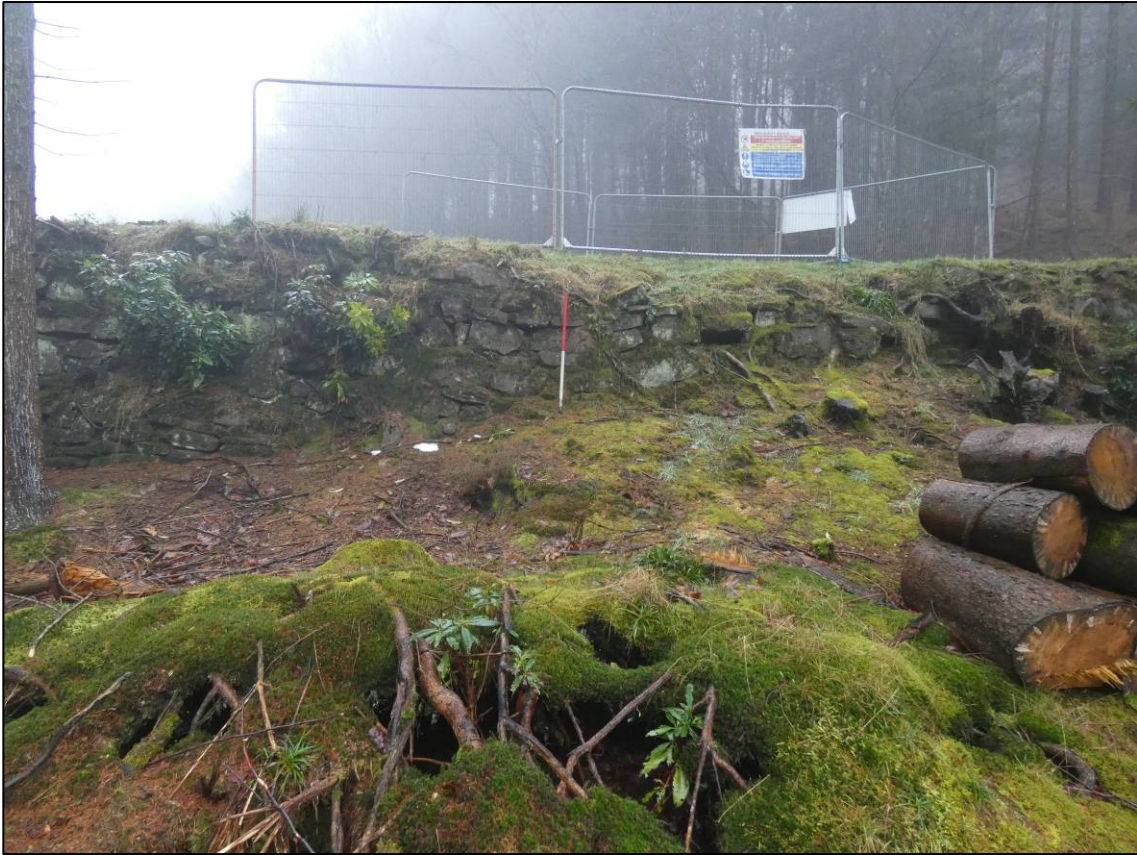
Plate 12: North elevation, west abutment, looking S (photo 7/064).

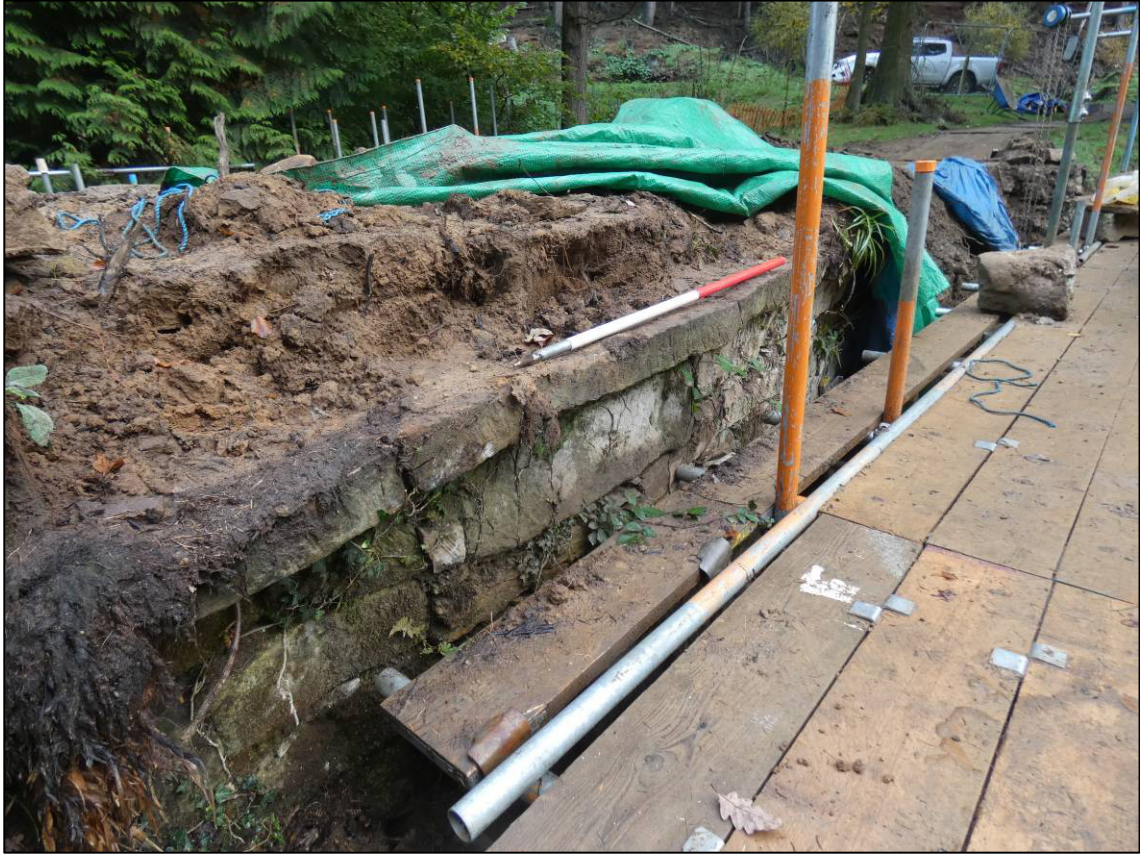
Plate 14: South elevation under repair, showing exposed stringcourse, looking NE (photo 3/290).

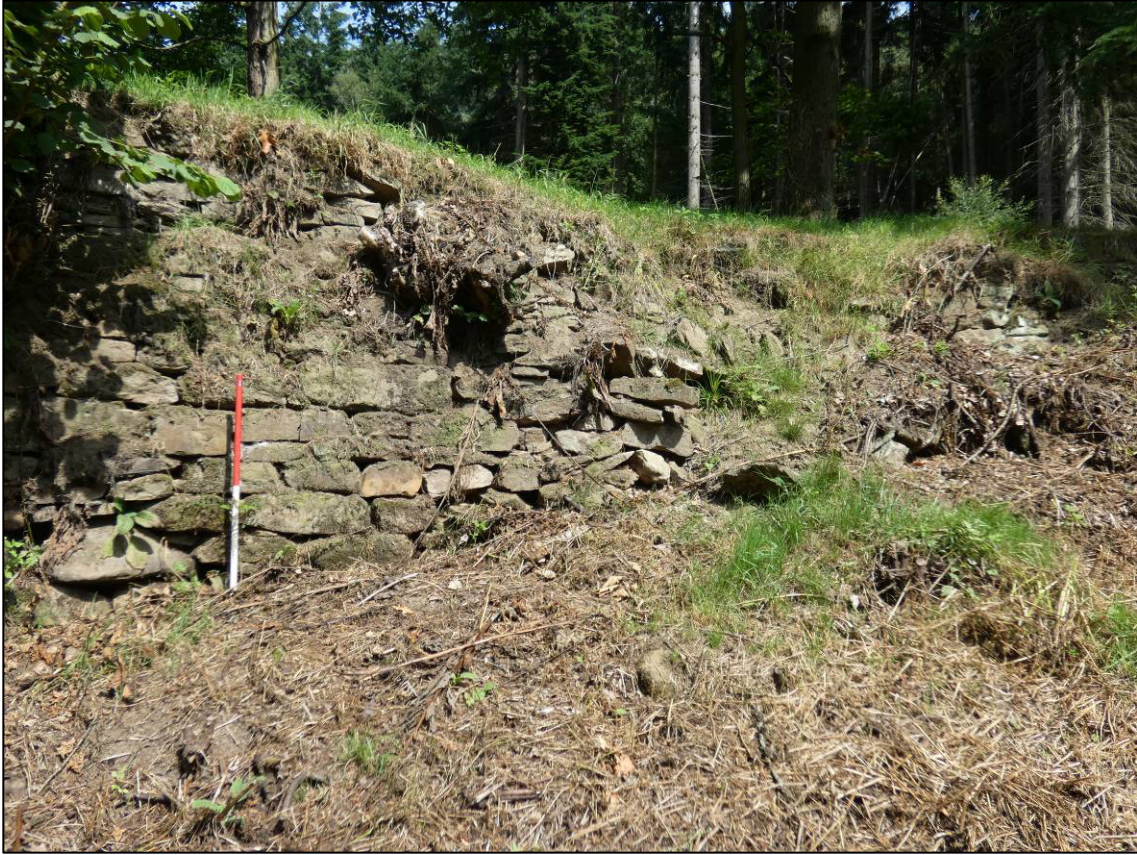
Plate 17: South elevation, east abutment, looking E (photo 1/905).

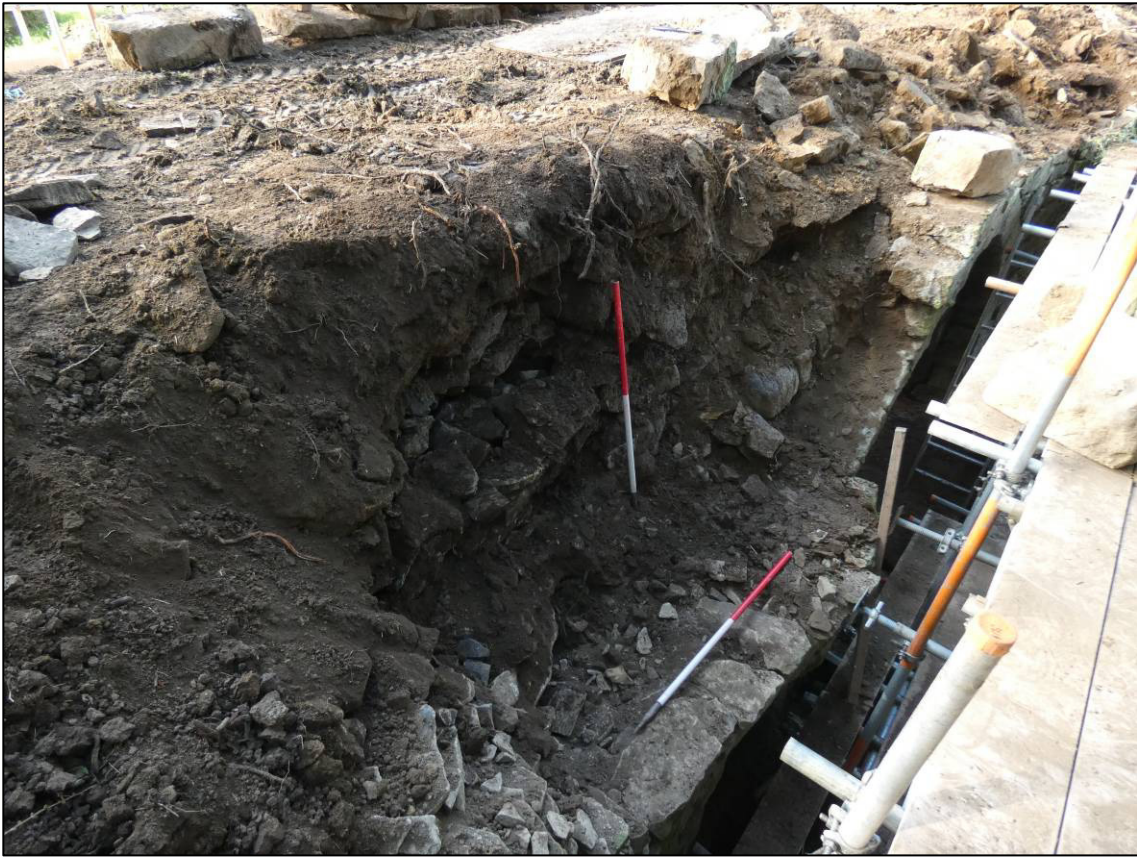
- 5.3 In total, a c.5.30m long section of the facing stone of the north elevation, to the east side of the arch, was removed to an average height of 2.30m below the reduced causeway ground surface. The core behind was then cut back for an average depth of c.1.5m from the former wall face and any collapsed core was consolidated and secured with lime mortar grout. This operation showed that the facing stones had an average depth of 0.40m back from the wall face [2/115] (see plate 21). Behind the facing stones, close to the arch, the remains of a crude relieving arch formed from rubble voussoirs were exposed [2/118] (see plate 22). This relieving arch was only visible for a length of c.0.70m and the upper surface was set 0.20m lower than the apex of the bridge arch itself. Around the relieving arch, and in the western part of the exposed section generally, behind the facing stone, the body of the abutment was formed from loose rubble that appeared to

Plate 21: North elevation, area east of arch during clearance, looking W (photo 2/115).

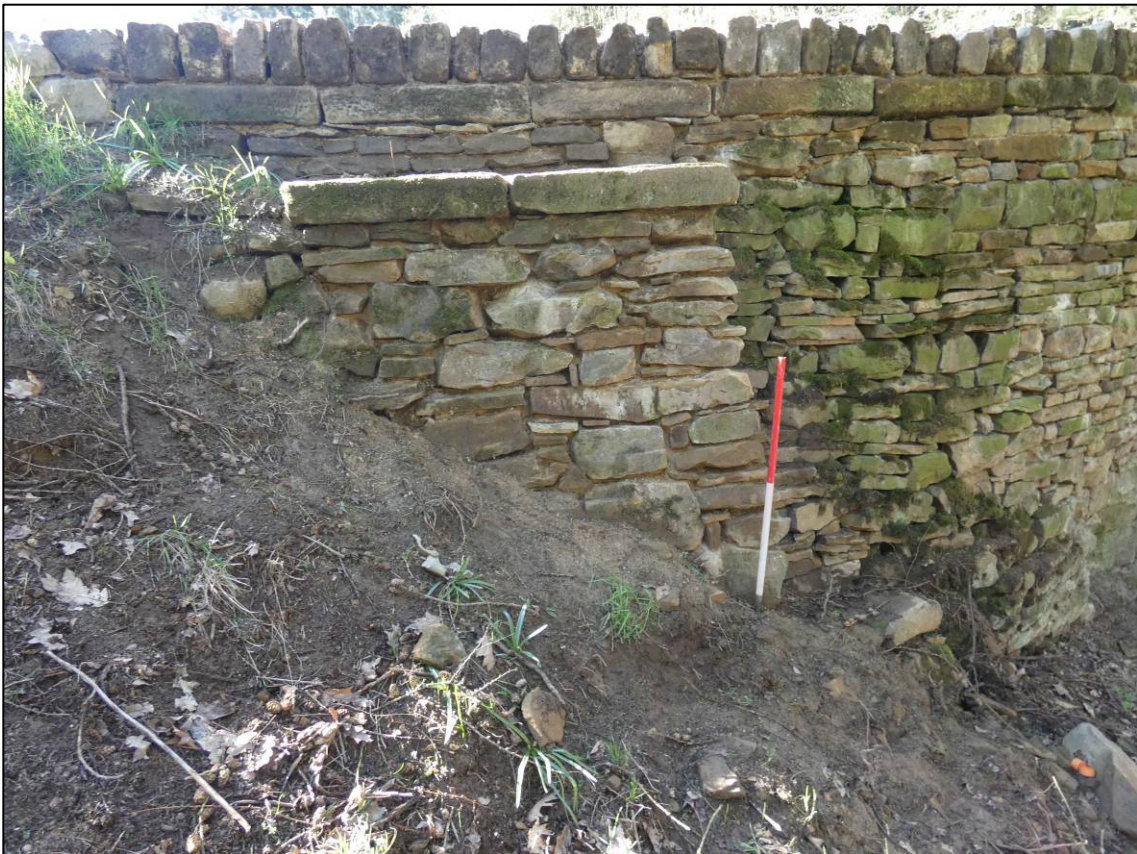
Plate 24: North elevation, east buttress/return after repairs, looking S (photo 8/587).

- 5.5 As part of the consolidation works, the largest stones taken down from the wall face were reset back in the same positions wherever possible. The new facing was not pointed, but the mortar recessed deeply, so that the appearance of a drystone construction was maintained. The buttresses either side of the arch were rebuilt using original and salvaged stone, and the tops capped with flat stones [7/067, 7/068, 7/070; 8/587] (see plates 23 and 24). A number of record photographs were taken of the north elevation while consolidation work was in progress [3/305, 3/308, 3/309, 3/311, 3/312; 7/066, 7/071-7/073, 7/075].

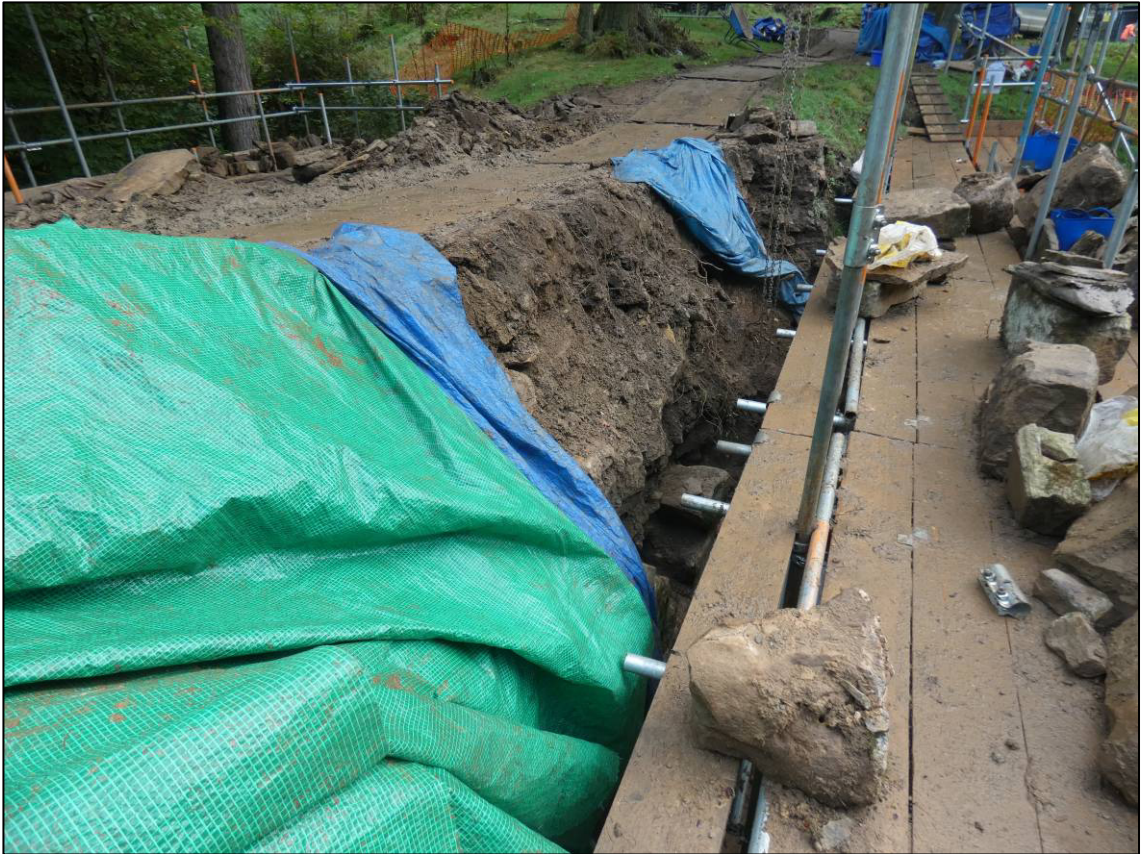
- 5.9 In addition to those parts of the south elevation which were dismantled, a 0.50m high section of the reduced ground surface along the top of the elevation was graded back from the outer face for a width of 1m [3/288, 3/289, 3/295] (see plate 27). As before, no evidence for any former surfaces or artefactual dating evidence was exposed.

Plate 27: South elevation, under repair, looking E (photo 3/288).

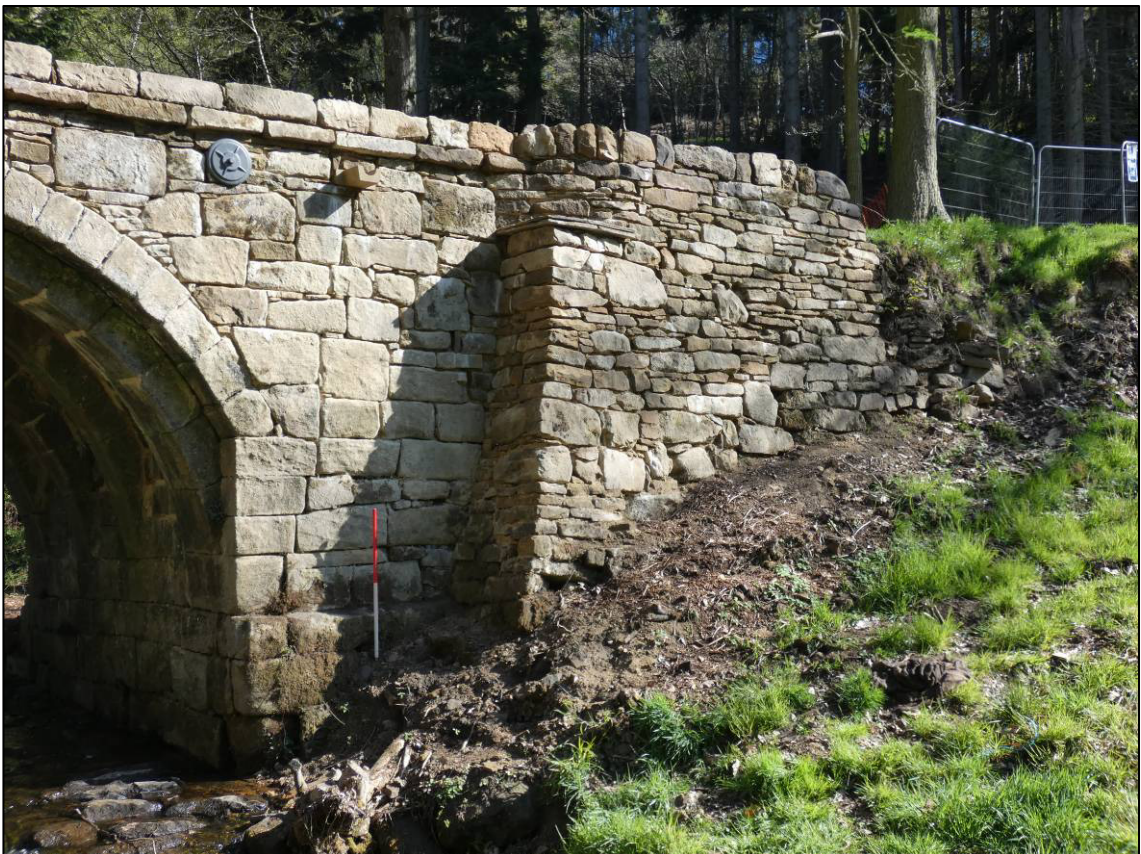
Plate 28: South elevation, east abutment and buttress/return, repairs complete, looking NE (photo 8/572).

- 5.10 Once again, as part of the consolidation works, the largest stones taken down from the wall facing were reset in the same positions as in the original elevation. The new facing was not pointed, but the mortar recessed deeply, so that the appearance of a drystone construction was maintained. The buttresses/returns either side of the arch were rebuilt using original and salvaged stone, and the tops capped with flat stones [7/049, 7/052; 8/570, 8/568] (see plates 28 and 29); both buttresses were rebuilt with a slightly curving parapet face above [5/633, 5/634; 8/570, 8/572] (see plate 30). Some repointing work was also done to the inside of the bridge vault [7/058; 8/590-8/592]. Once again, a number of photographs were taken of the south elevation while consolidation work was in progress [5/629, 5/631; 7/048, 7/050, 7/051].

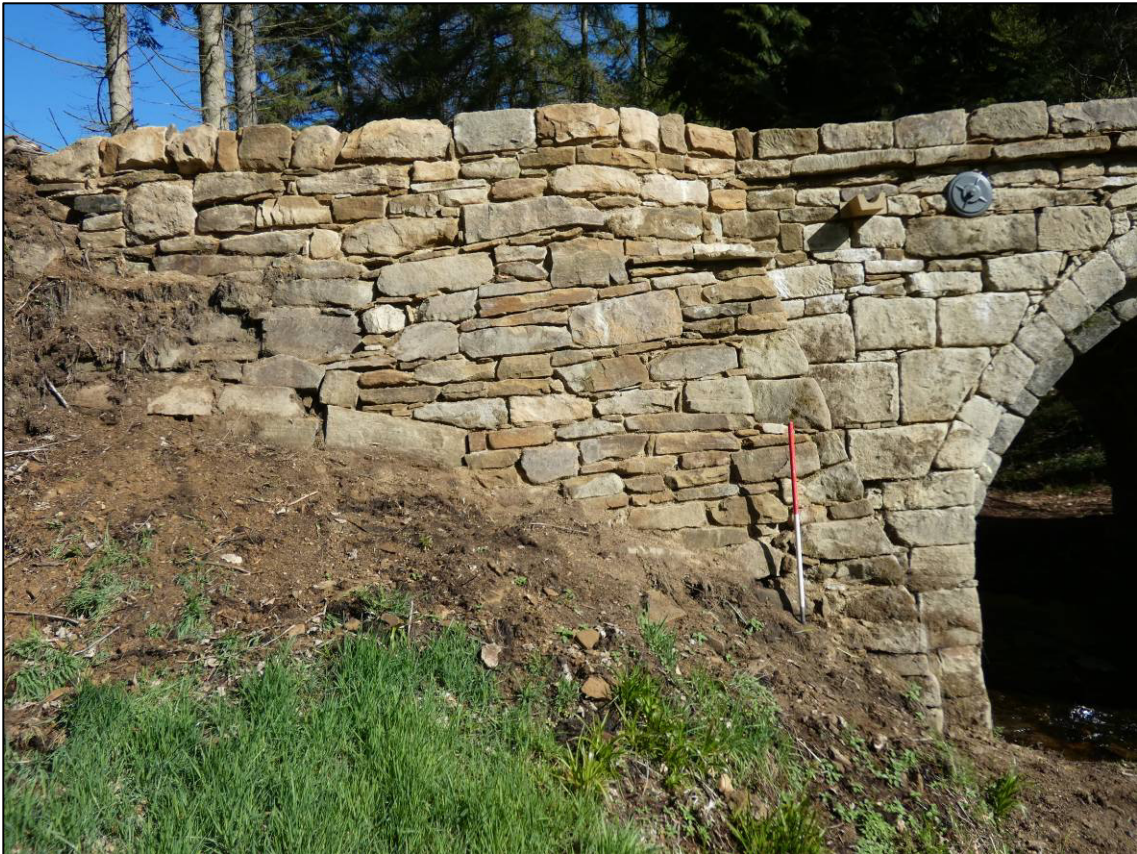
Plate 29: South elevation, west abutment and buttress/return, repairs complete, looking N (photo 8/570).

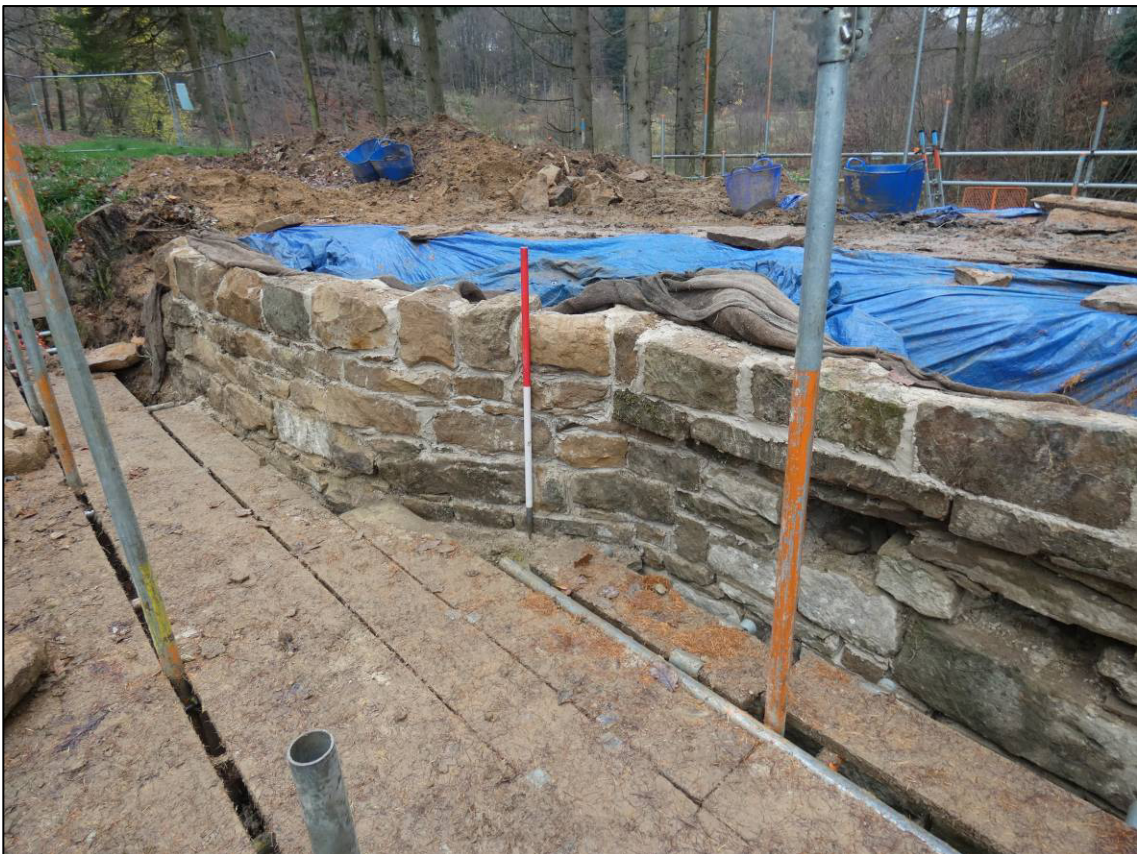
Plate 30 South elevation, rebuilt parapet to west of arch, looking NW (photo 5/633).

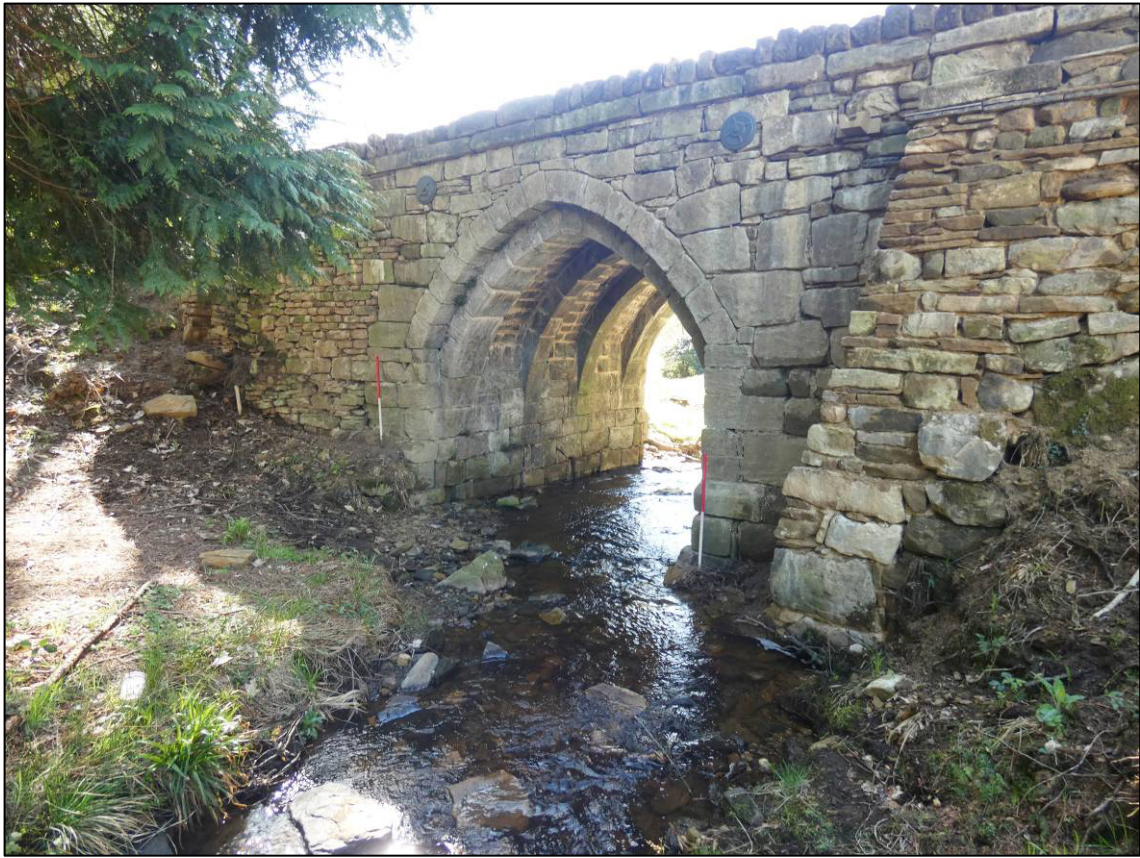
Plate 33: North elevation, repairs complete, looking SE (photo 8/593).

- 5.15 A final visit was made to the bridge on 5th May 2021, to record the structure in its completed state. Both elevations were photographed (north elevation [8/583, 8/584, 8/589, 8/593-8/595]; south elevation [8/565-8/567, 8/569, 8/571, 8/581]), as well as the top of the bridge [8/562, 8/563] (see plates 33 to 36).

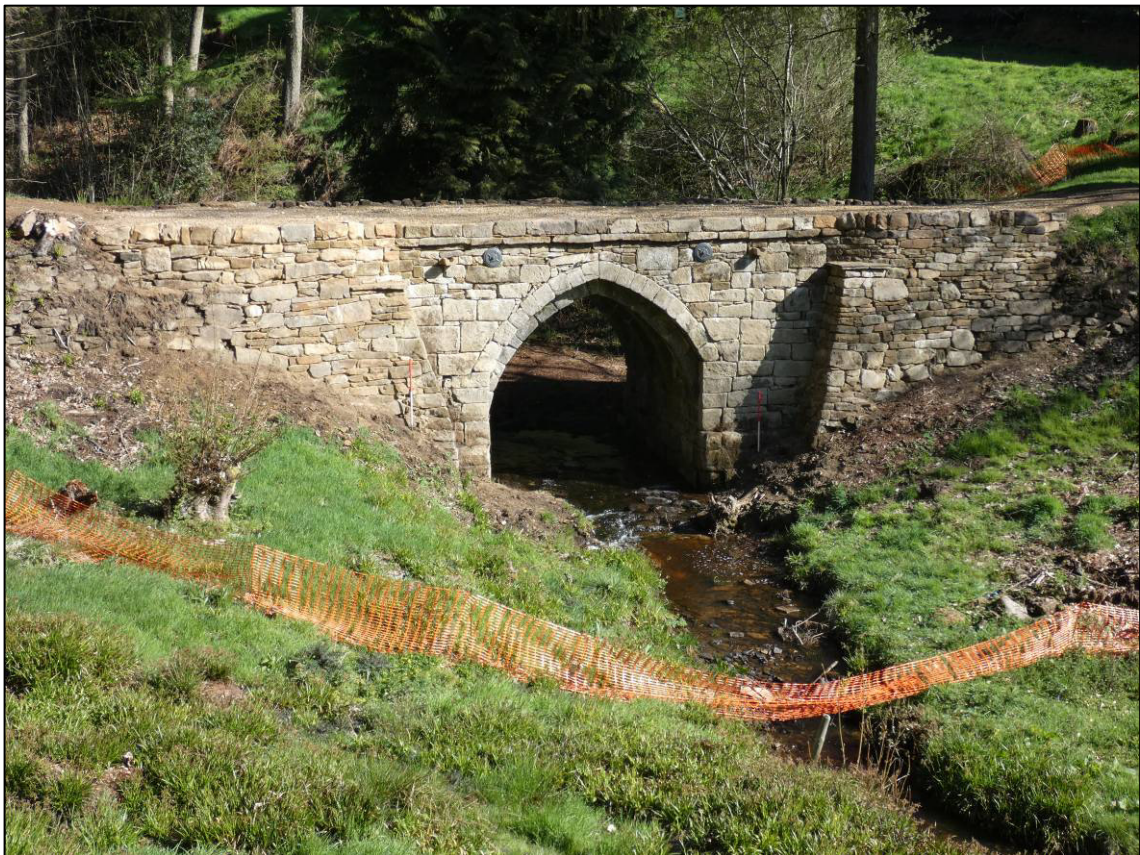
Plate 34: South elevation, repairs complete, looking N (photo 8/566).

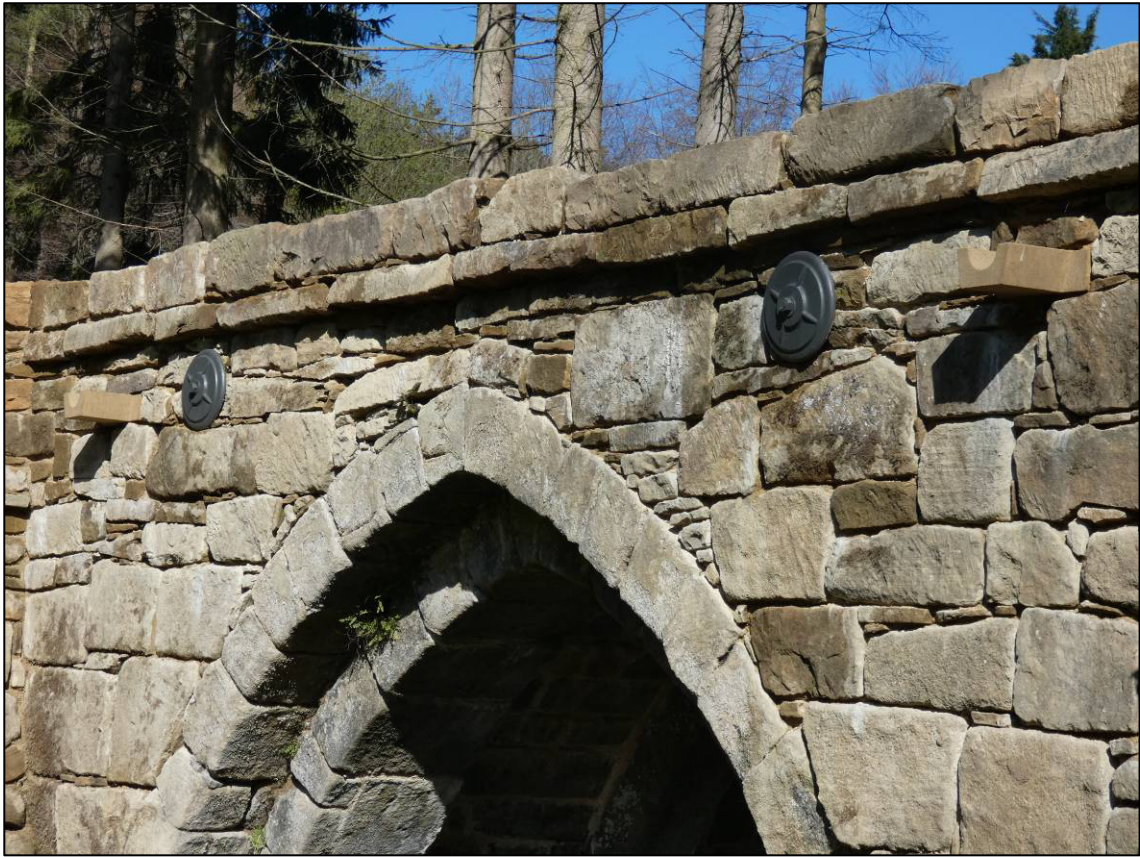
Plate 35: South elevation, details, of drains and ties, looking NW (photo 8/582).

- 5.14 The tie-bars and drains were laid into the two excavated trenches [6/777] (see plate 32) which were then backfilled. Chutes were also placed into the parapet walls to allow water to be shed from the wall faces below [5/635; 7/053; 8/582, 8/585, 8/586]. The top of the causeway was re-surfaced with road stone and topsoil, and then re-sown with grass seed, restoring the ground surface to approximately the same level it had been prior to the start of the works [7/069].

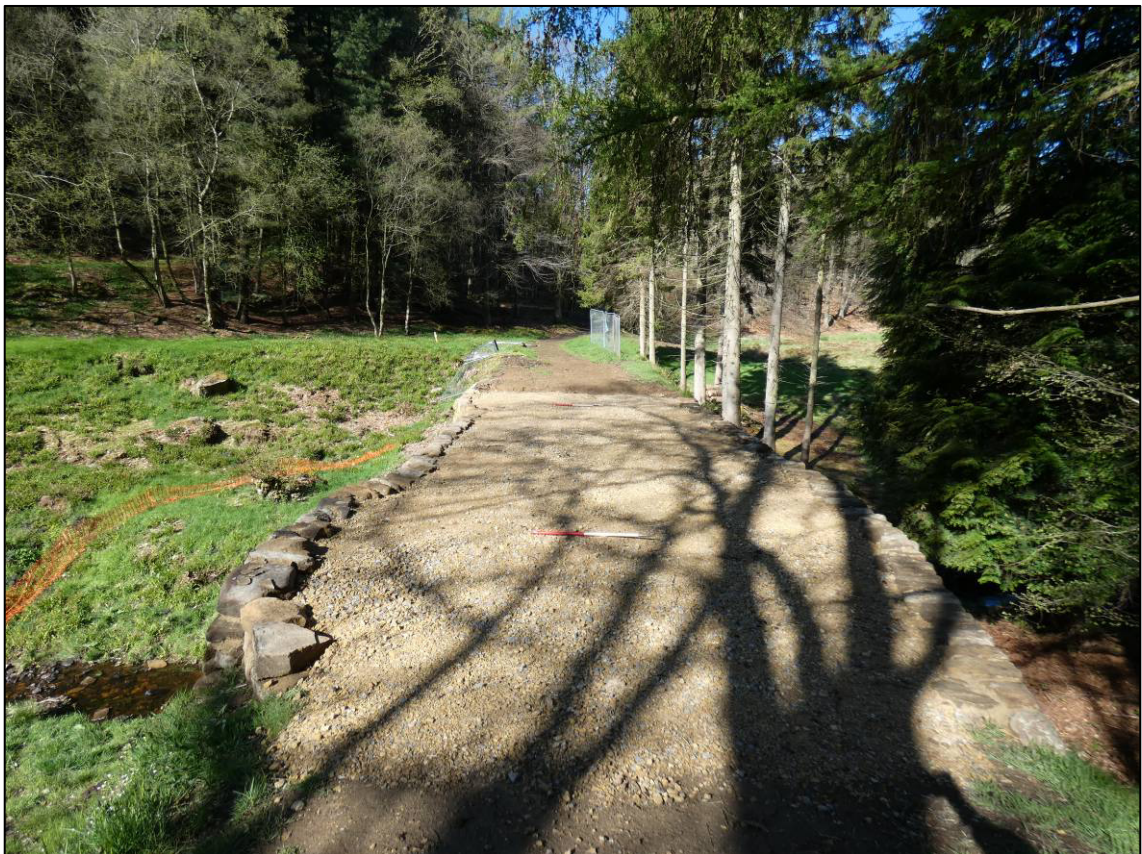
Plate 36: Top of bridge, repairs complete, grass to be sown, looking E (photo 8/562).
