FABRIC REPAIRS TO JERVAULX ABBEY,
EAST WITTON, NORTH YORKSHIRE

ARCHAEOLOGICAL OBSERVATION,
INVESTIGATION AND RECORDING

Report no: 2018/570.R01
Version: Final
Date: February 2021
Author: Ed Dennison & Shaun Richardson

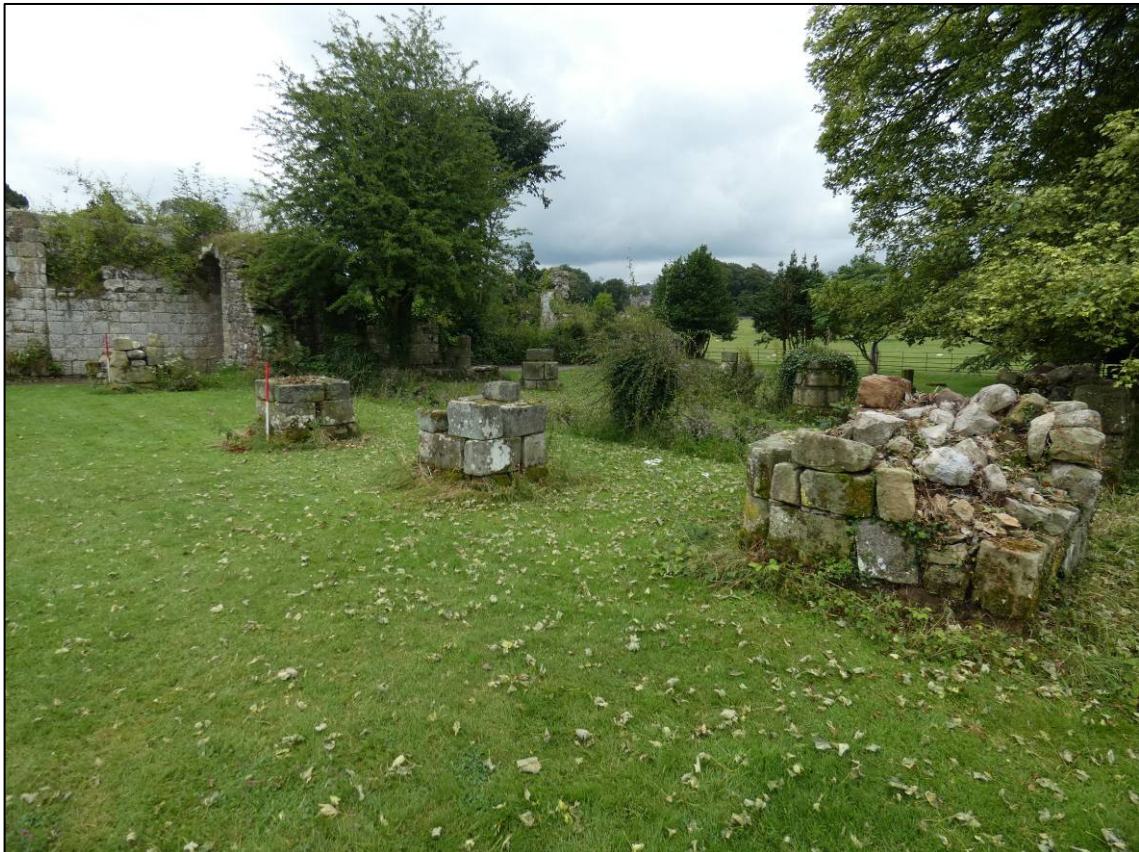
Plate 5: Area 2: Lay brothers' rear-dorter, north external elevation, piers and east return of west wall, looking SE (photo 2/465).

- 5.8 The four arches on the north side of the rere-dorter were originally supported on the returns of the east and west walls and three intermediate piers, although the eastern pier is now not visible above ground [2/464, 2/465] (see plate 5). The return to the west wall end is c.1.50m square. Its north (external) side is built from large, roughly squared stones, and there were loose stones piled on the top [2/457]. The east side had loose stones stacked against it, and there is a chamfered jamb to the south-east corner, rebated to the north side [2/458]. The south side is inset approximately half way along its length, which represents the internal angle of the return [2/459]. The western of the three piers in the north wall is c.1m square, and rises from a chamfered plinth. It is built from large pieces of ashlar, but had some *ex situ* fragments placed on top, including what might be a small piscina [2/460, 2/461] (see plate 6). The central pier is similar although without the *ex situ* stones on top [2/462]. The north end of the east wall has a chamfered plinth visible to the base of the east side, but otherwise appears to have been much rebuilt and had loose stone stacked against it [2/463] (see plate 7).

- 5.9 The walls and piers were repaired by resetting any dislodged stones, with minor rebuilding to the corners, repointing with well recessed mortar, and filling voids with soil to support new soft cappings so that they could re-vegetate [3/574-3/579; 6/664-6/666] (see plates 8 and 9).

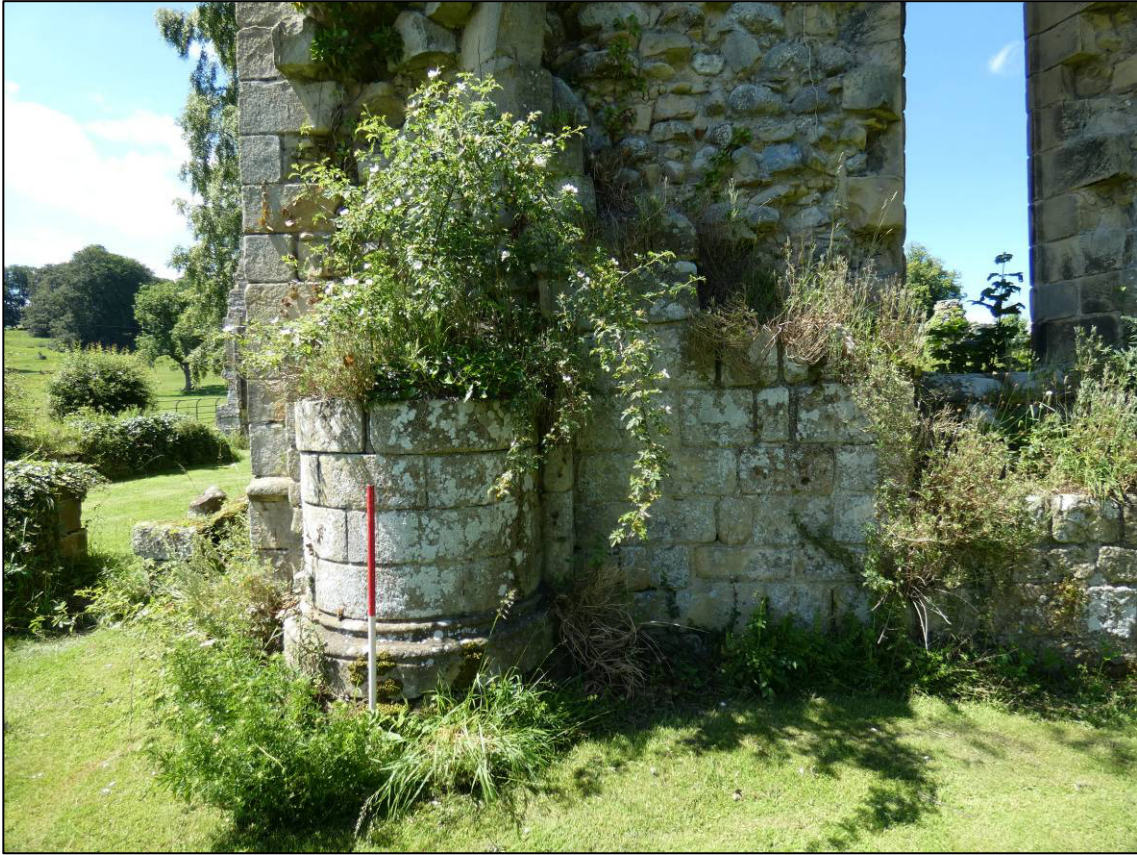
Plate 30: Area 9: Monks' dorter, pier at south end of east internal elevation of west wall, looking W (photo 1/307).

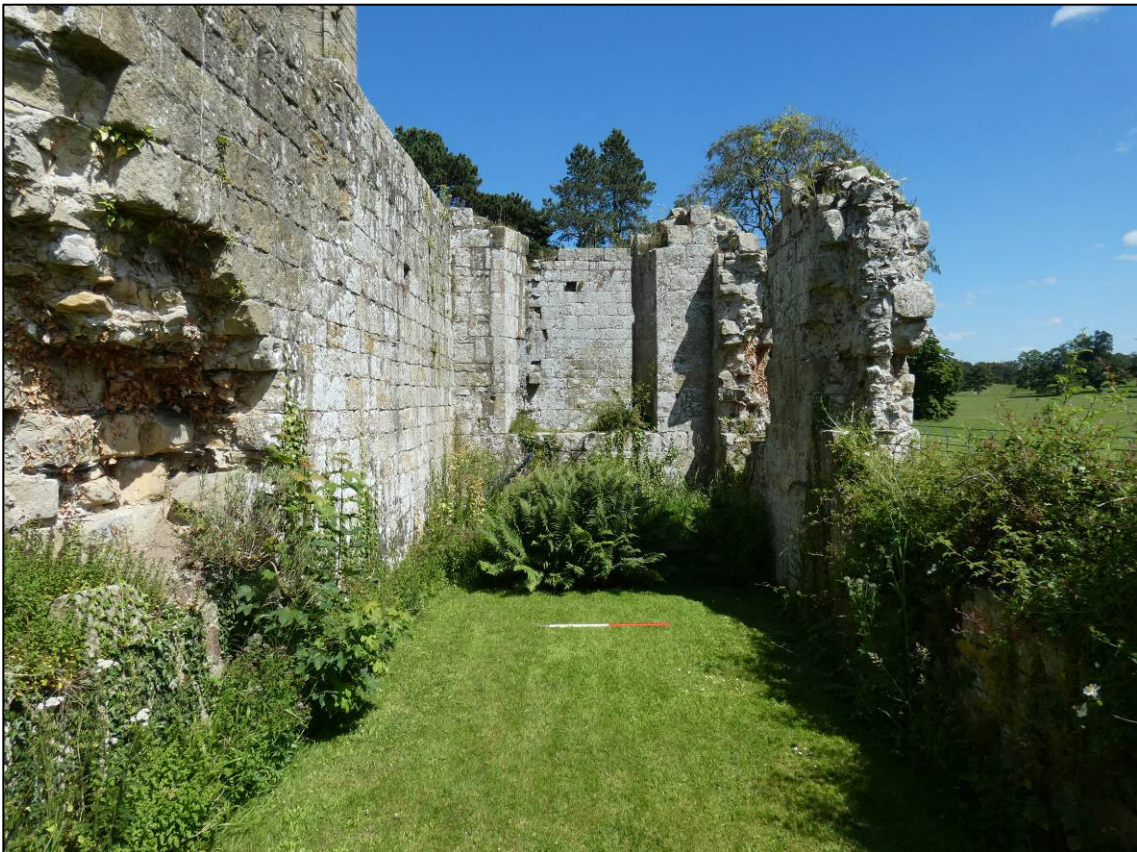
Plate 31: Area 10: Chapel interior, looking E (photo 1/359).

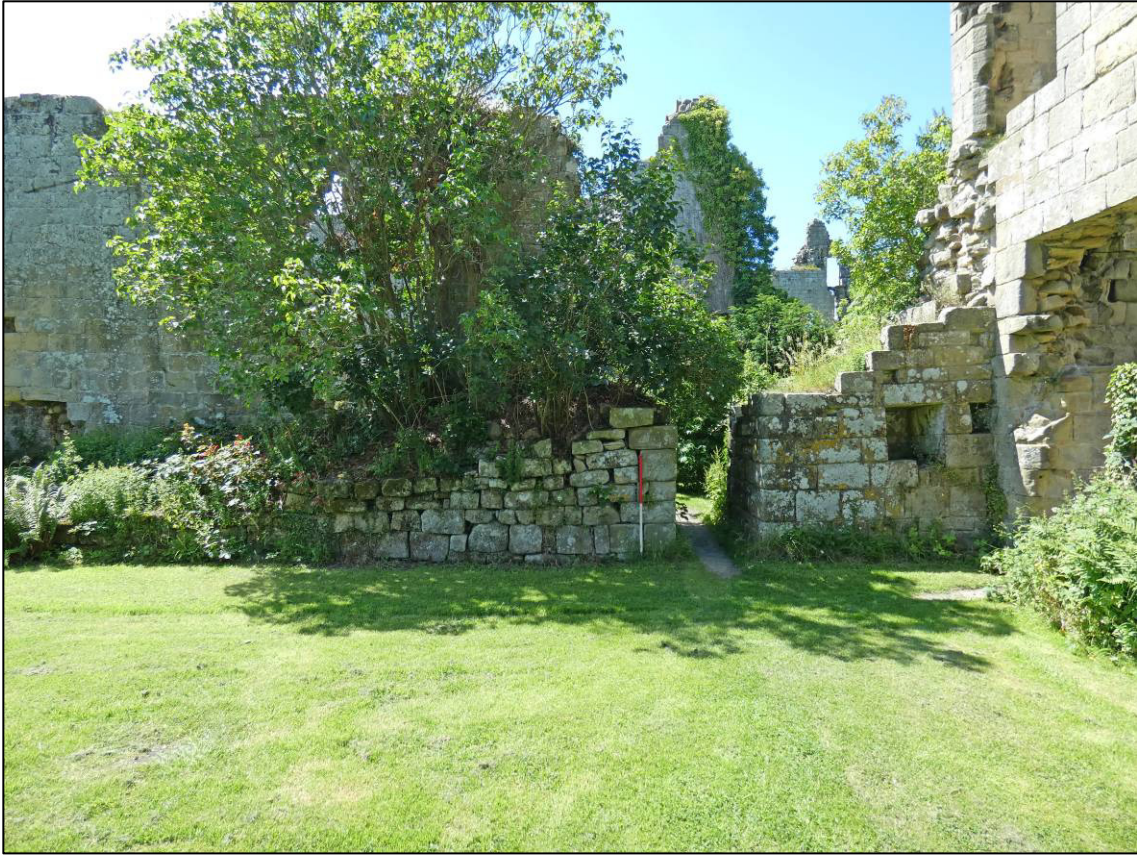
Plate 32: Area 11: Abbots' lodging, east internal elevation of west wall (north end), showing doorway into garderobe, looking W (photo 1/342).

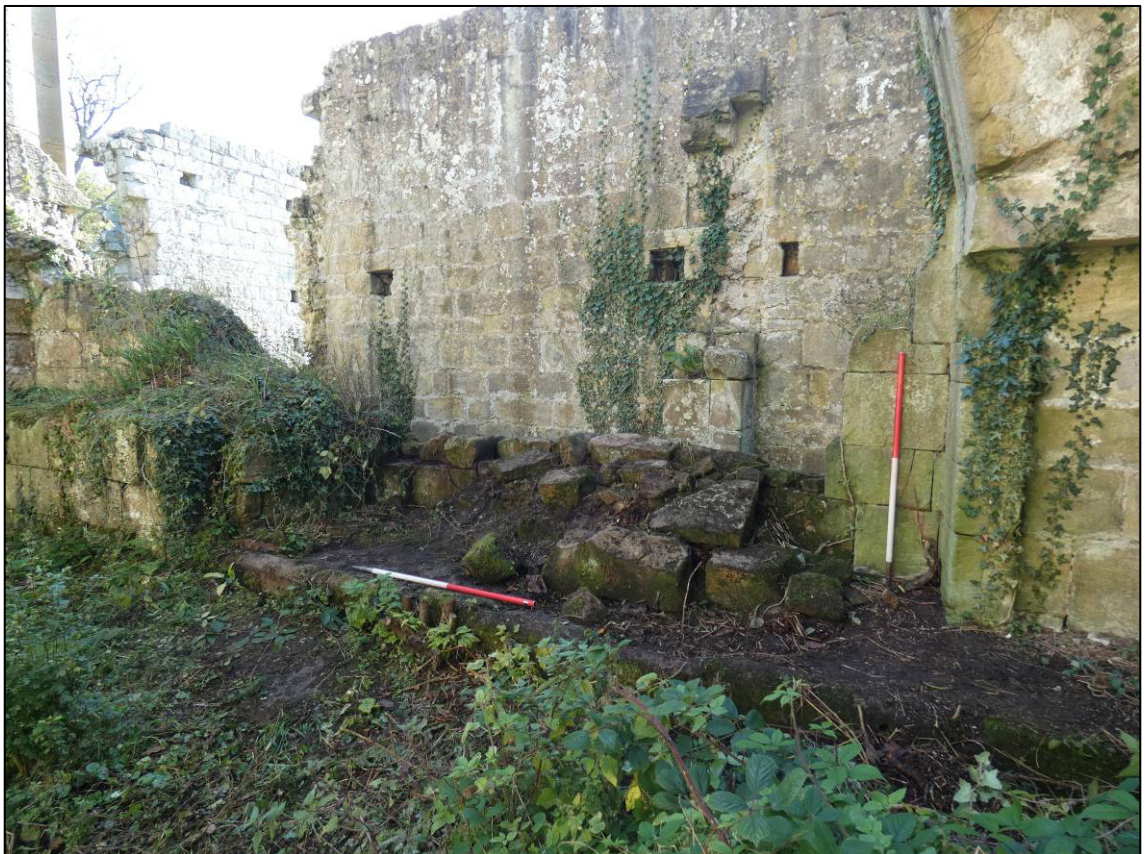
Plate 37: Area 13: Meat kitchen, north internal elevation of south wall, showing fireplace, looking SE (photo 4/176).

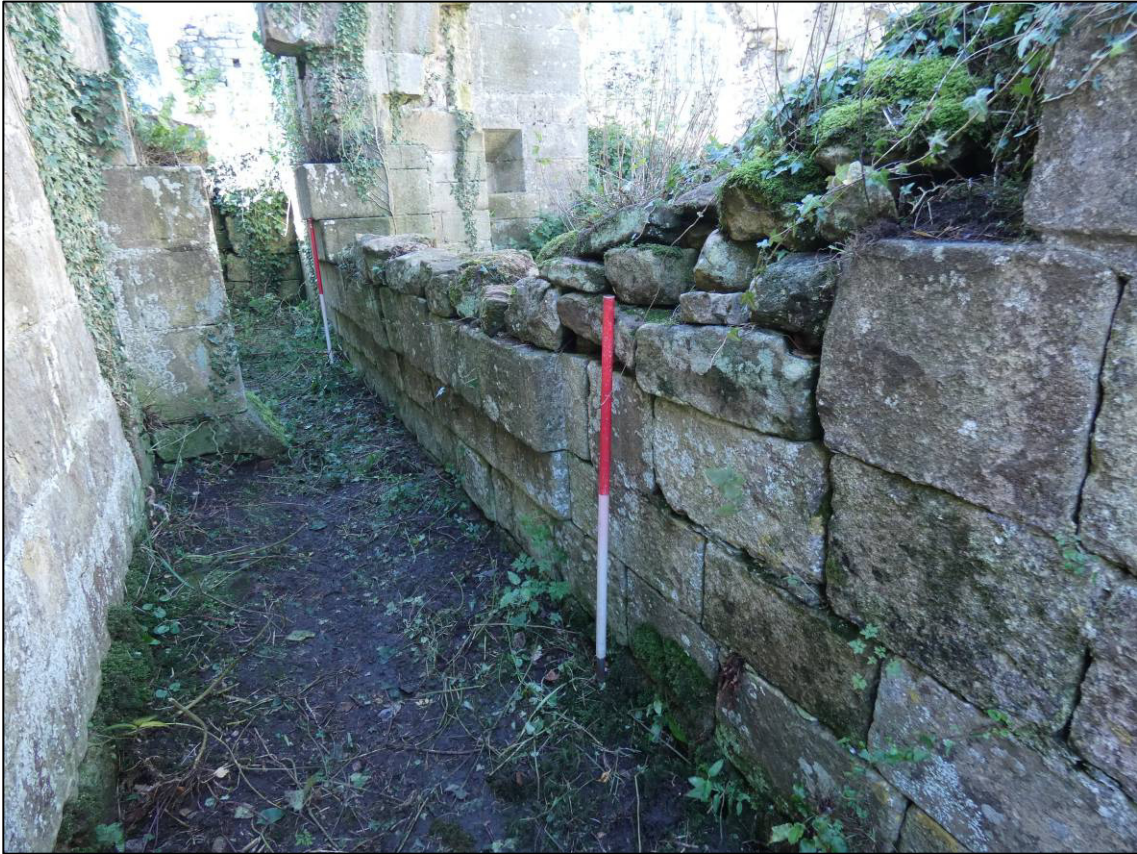
Plate 38: Area 13: Meat kitchen, south external elevation of south wall, showing corbelling for fireplace, looking W (photo 4/179).

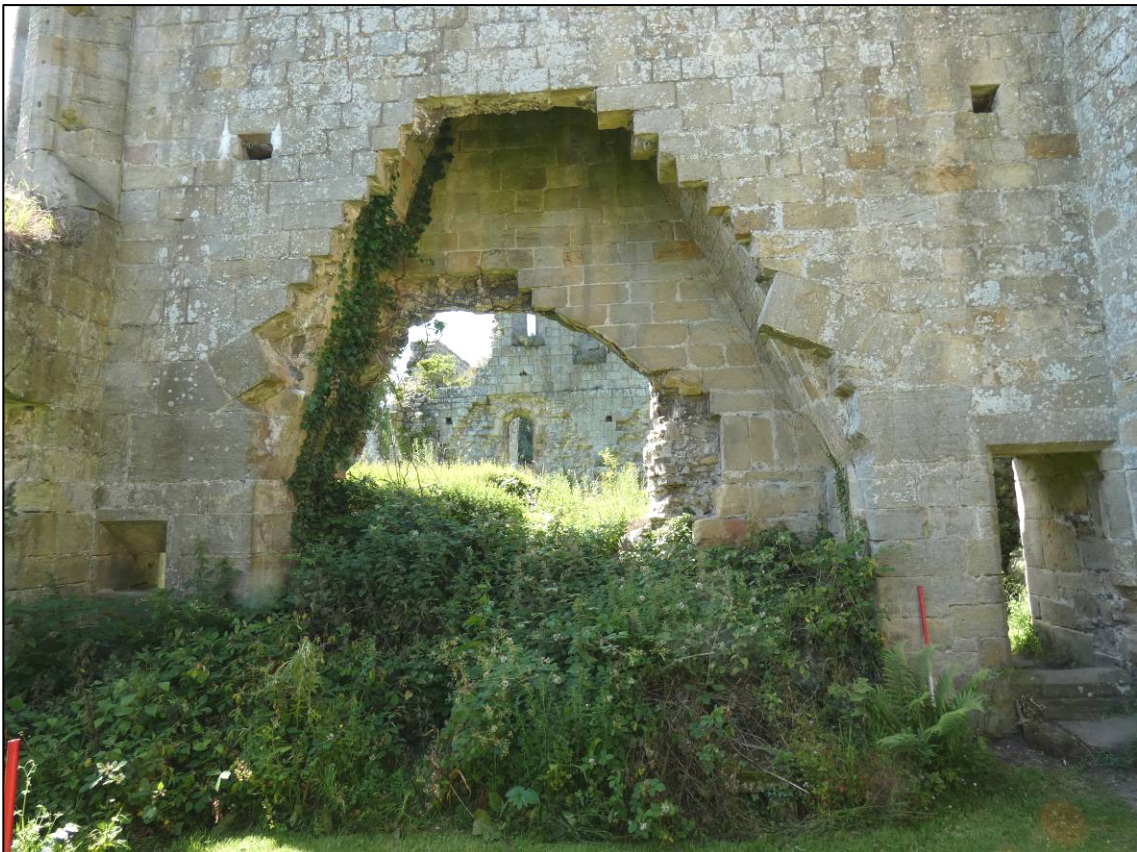
Plate 39: Area 13: Meat kitchen, east internal elevation of west wall, before clearance, looking W (photo 1/336).

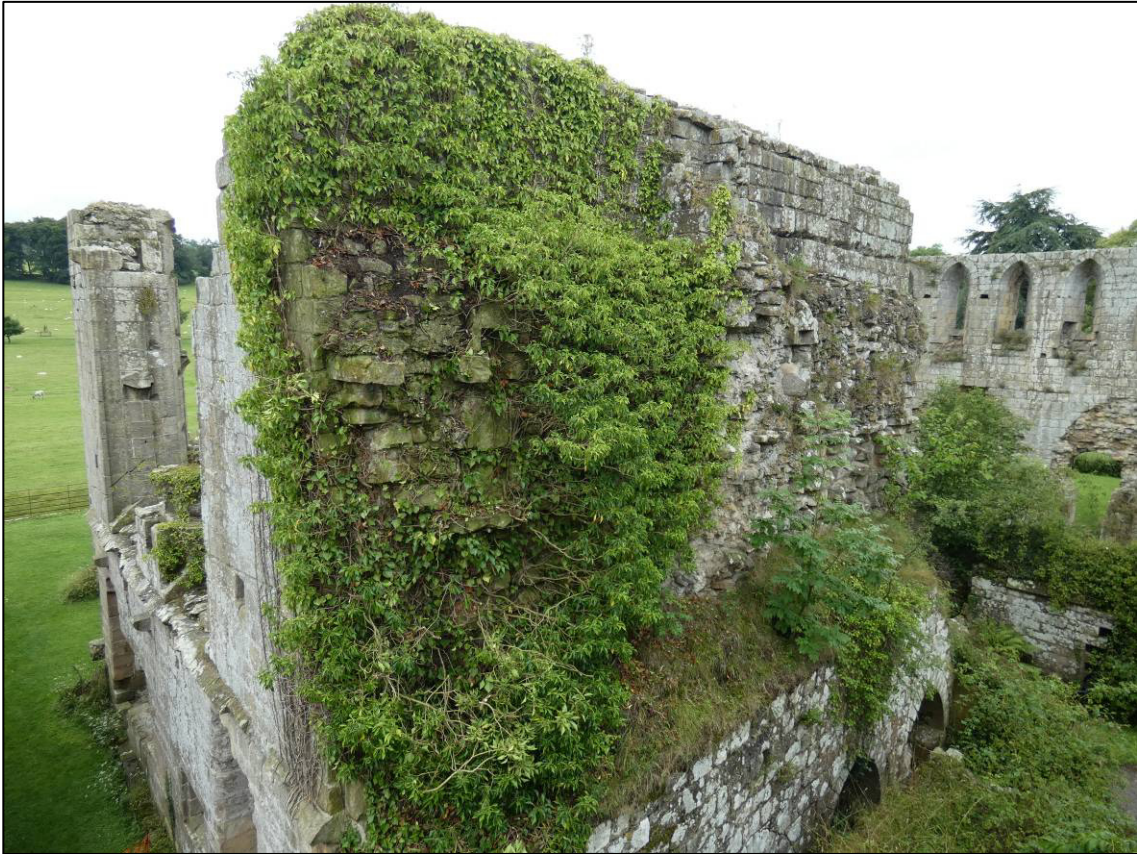
Plate 40: Area 14: Monks' rere-dorter, north internal elevation of south wall (upper level), during clearance, looking SW (photo 2/491).

- 5.45 Prior to the start of the conservation works, the north side of the monks' rere-dorter south wall had a covering of ivy to the upper part of the north-east corner [1/327, 1/328; 2/489, 2/491, 2/499] (see plate 40). As this was removed, using a hoist, a number of photographs were taken of the upper part of the wall from the hoist, although the drain below meant that it was not possible to get close enough to the wall face to take any detailed measurements. As a result, it was not possible to enhance or add to the previous survey of this part of the wall produced by English Heritage in May 1994 (scan 24) (see figure 11 top). The highest part of the wall, effectively the south side of the north wall of the adjacent meat kitchen, was seen to be faced with coursed squared stone; a projection to the centre forms the chimney flue from the fireplace in the north wall of the meat kitchen [2/493-2/496] (see plate 41). To the west of the chimney, a large stone is set within the squared stones, interrupting the coursing; its purpose is unclear. Below the larger stone, a horizontal cut line where the former leaded roof of the rere-dorter has been removed is visible; this continues across the elevation either side of the chimney flue. Below this cut line, the rest of the upper part of the wall comprises exposed core, as shown on the previous survey drawing [3/565]. To the east side, there is what appears to be a rectangular socket framed by dressed stones set within the core work [2/492]. There is a similar feature to the west, just beyond the centre of the wall, although this one appears more like a small former window rather than a socket; both features have been blocked internally [2/501; 3/563, 3/564] (see plate 42). Hope and Brakspear (1911, 324) note that these two features are 'two little lancets'. Further to the west again, there is a possible larger blocked window opening.

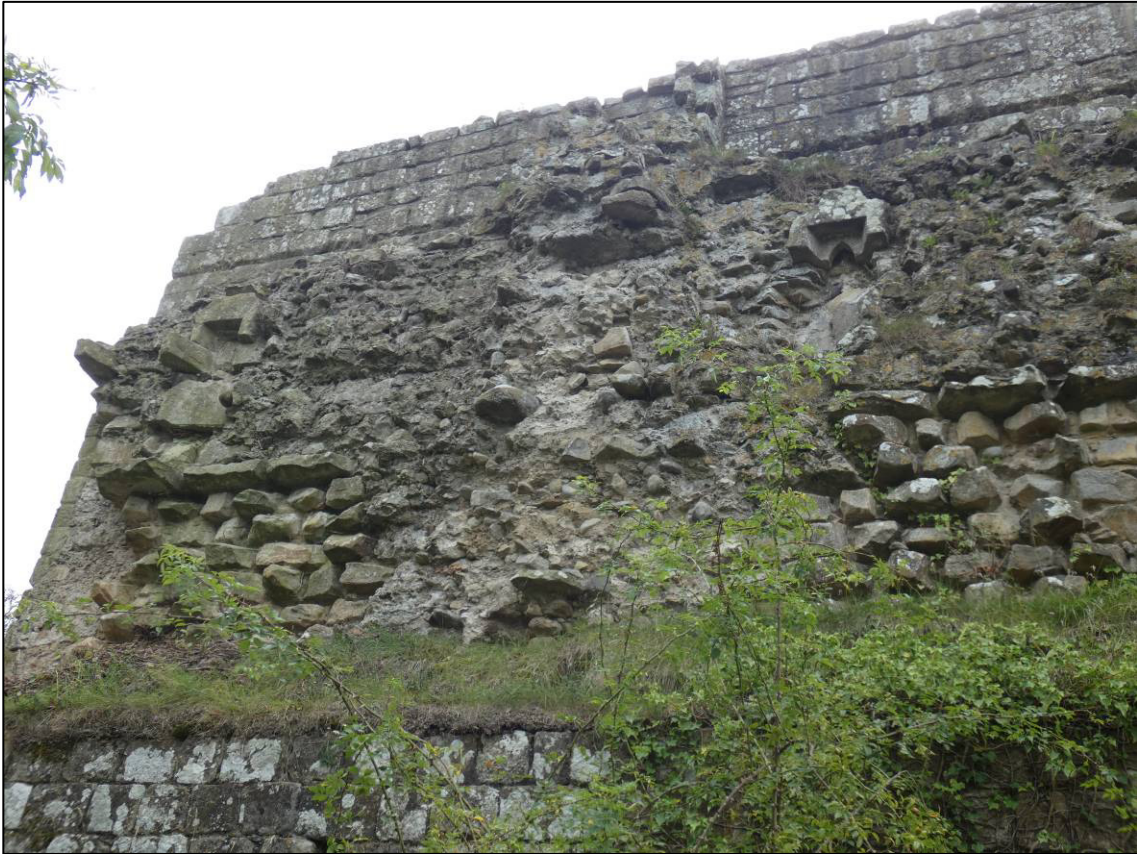
Plate 42: Area 14: Monks' rere-dorter, north internal elevation of south wall (upper level), after clearance, showing possible lancet windows either side of chimney and cut line of former rere-dorter roof, looking S (photo 3/563).

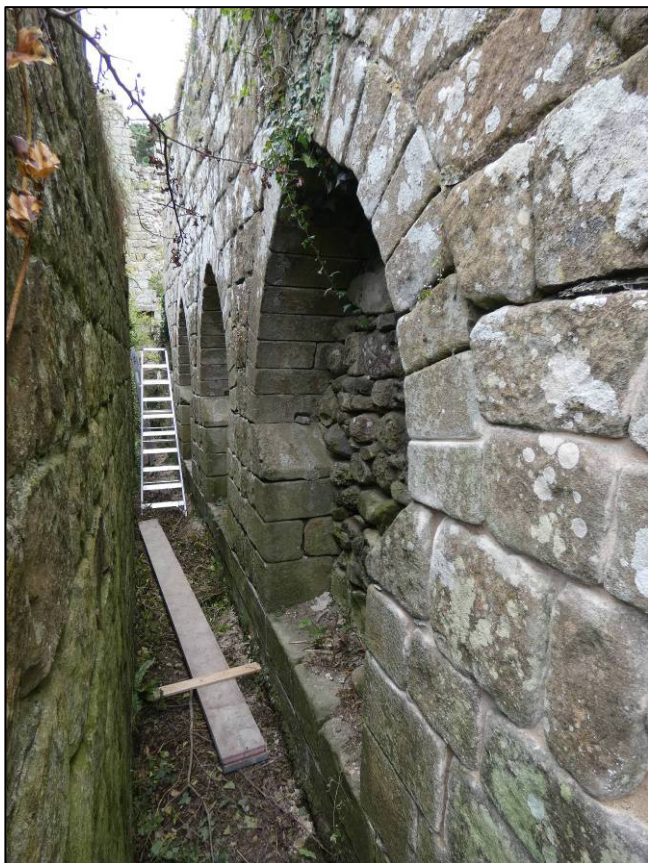
- 5.47 The wall contains five two-centred arched recesses, the western four blocked internally by the adjacent meat kitchen to the south, with the partial blocking of the eastern arch brought forward due to the steps to the south (see Area 12 above); there were once seven arches in total, although the easternmost two examples have largely collapsed. The recesses are set at c.3m centres, and the base of each is set 0.50m above the bottom of the drain; where the drain was cleared, it was seen to comprise large, neatly-cut flagstones. The sides of each recess rise vertically for 0.80m to meet chamfered springers for the arch, which is built of squared voussoirs; the apex of each arch is set c.2.30m above the recess. A number of simple masons' marks survive to the voussoirs of the arches. The remainder of the wall is built of neatly squared and coursed masonry, set with a lime mortar [3/567] (see plate 44). No evidence could be seen for the row of wooden seats over the arches, and Hope and Brakspear note that any remaining evidence is confined to the east wall, as noted above. The narrow width of the drain meant that it was not possible to get any detailed photographs of individual arches, apart from the westernmost one [3/566; 7/619] (see plate 45). The arches and the wall face generally were subject to minor re-pointing using recessed mortar.

Plate 44: Area 14: Monks' rere-dorter, south internal elevation of drain, looking E (photo 3/567).

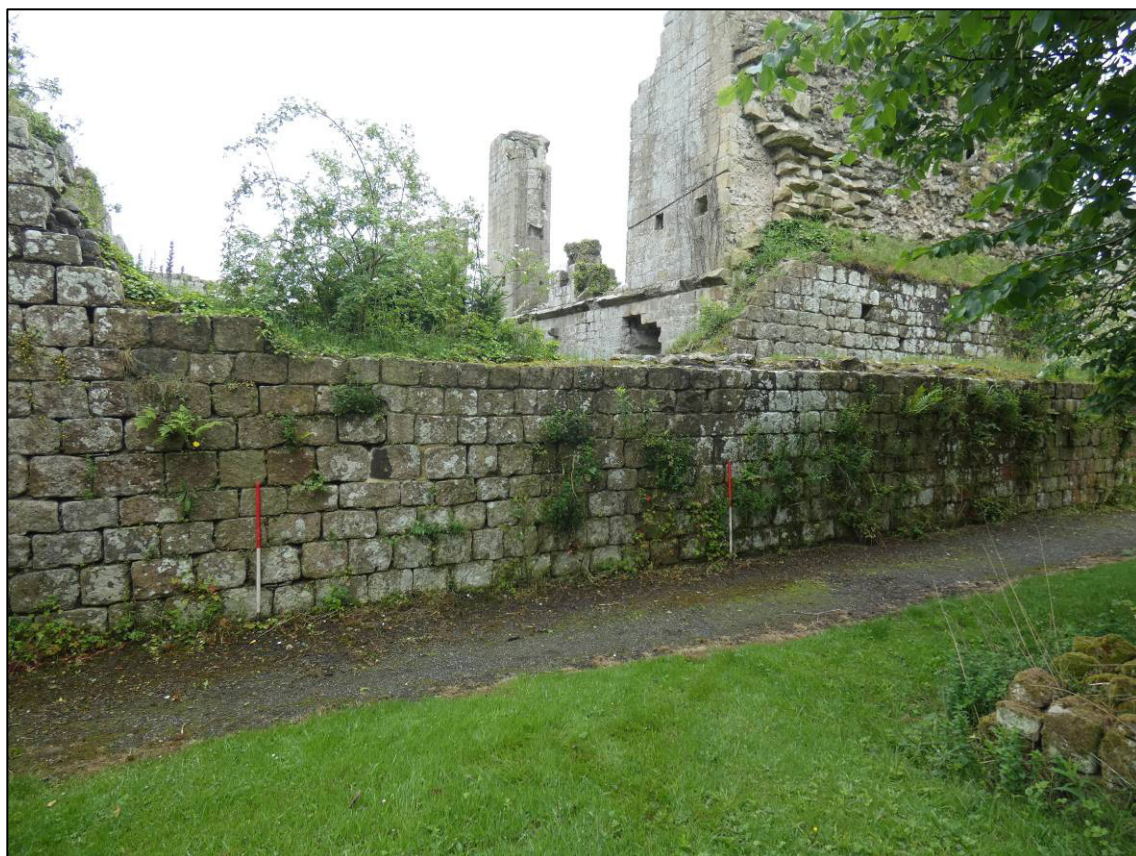
- 5.48 Prior to the start of the conservation works, the north elevation of the drain's north wall was obscured by vegetation at a lower level [1/347, 1/348, 1/372; 6/649, 6/650] (see plate 46), as were the exposed sections of the north side of the rere-dorter's north wall [1/373, 1/374]. In the event, no vegetation clearance or subsequent conservation works was undertaken in these areas.

Plate 46: Area 14: Monks' rere-dorter, north external elevation of drain, looking SW (photo 6/650).

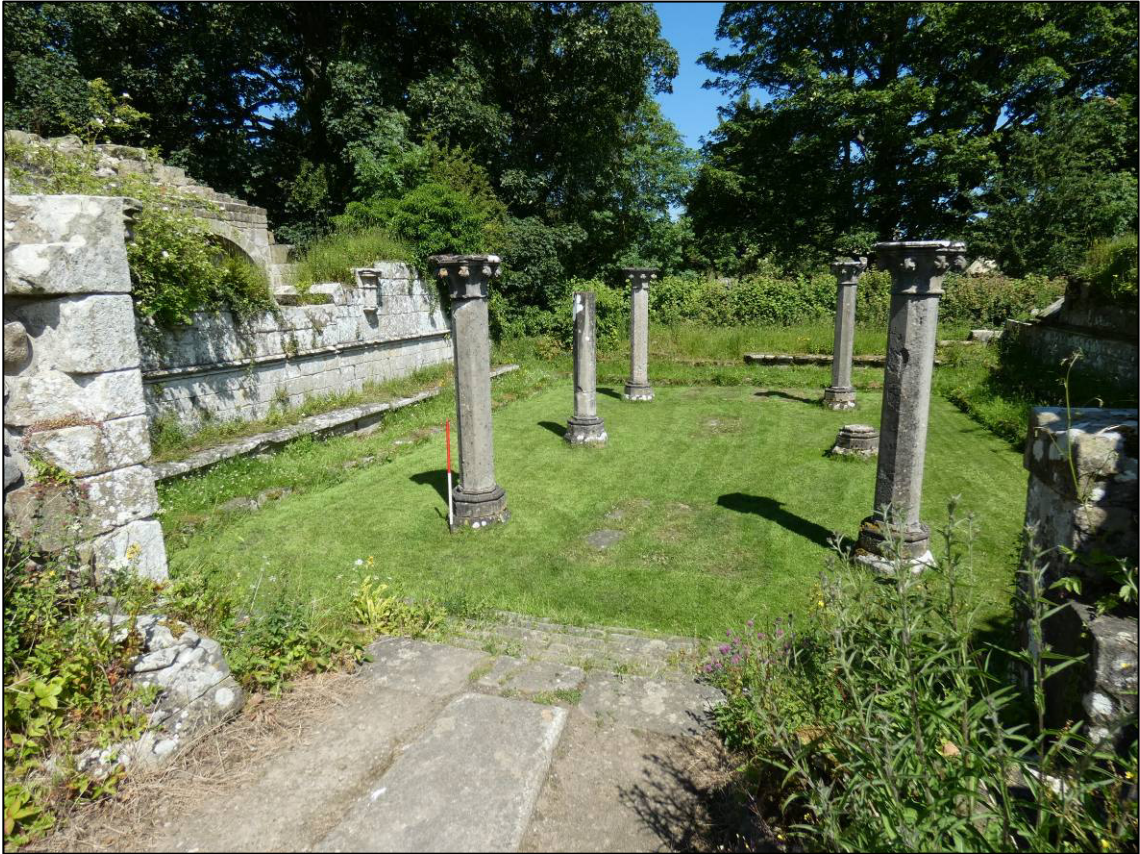
complex. It measures 14.6m long by 10.9m wide and the interior lies lower than the external ground level, and the monks would have sat on the stone benches placed around the walls. The vaulted roof is divided into four bays divided into three aisles by two rows of three octagonal columns (five remaining), each cut from a single block of stone. At the east end are five grave slabs of former abbots, with a further three slabs at the entrance (Hope & Brakspear 1911, 317-319; Davies no date, 14-15). Both elevations of the north and south walls were surveyed in 1986 (contractor unknown) to produce stone-by-stone drawings (scans 7 and 27). Prior to the start of the conservation works, the internal walls were partly covered with vegetation [1/381-1/389] (see plate 51). They were due to be investigated, followed by minor repointing as necessary in addition to some repairs to a fractured column. In the event, no clearance or subsequent conservation works were undertaken.

Plate 51: Area 16: Chapter house, interior, looking E (photo 1/381).

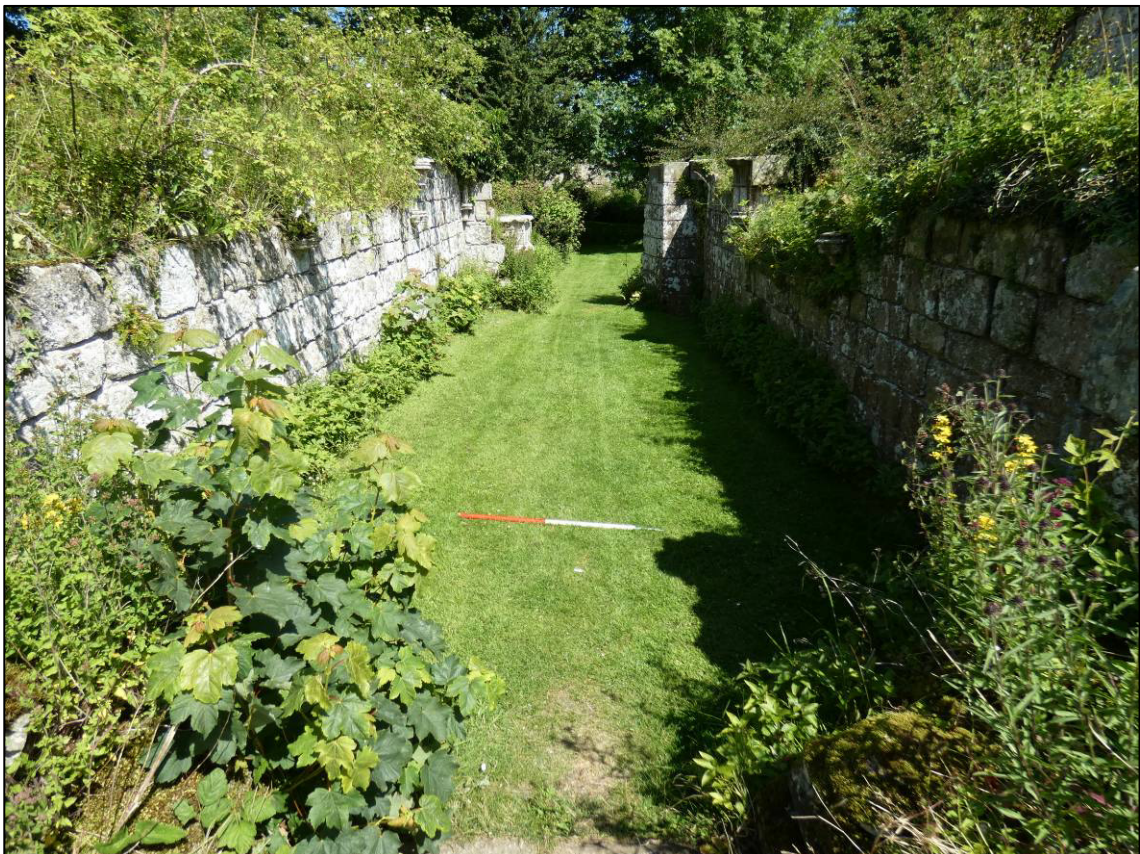
- 5.55 The parlour lies to the south. It is also predominately of early 13th century date, and measures 9.4m long by 3.8m wide, divided into three bays (Hope & Brakspear 1911, 320). The internal elevations of the south, east and west walls were surveyed by York Archaeological Trust (date unknown) (scan 28), and the north wall by English Heritage in July 1984 (scan 29). Prior to the start of the conservation works, the tops of the walls were partly covered with vegetation [1/312, 1/313, 1/375-1/380] (see plate 52). The walls were due to be investigated and followed by minor repointing as necessary, but in the event no repairs or conservation work was undertaken.

Plate 52: Area 16: Parlour, interior, looking E (photo 1/380).

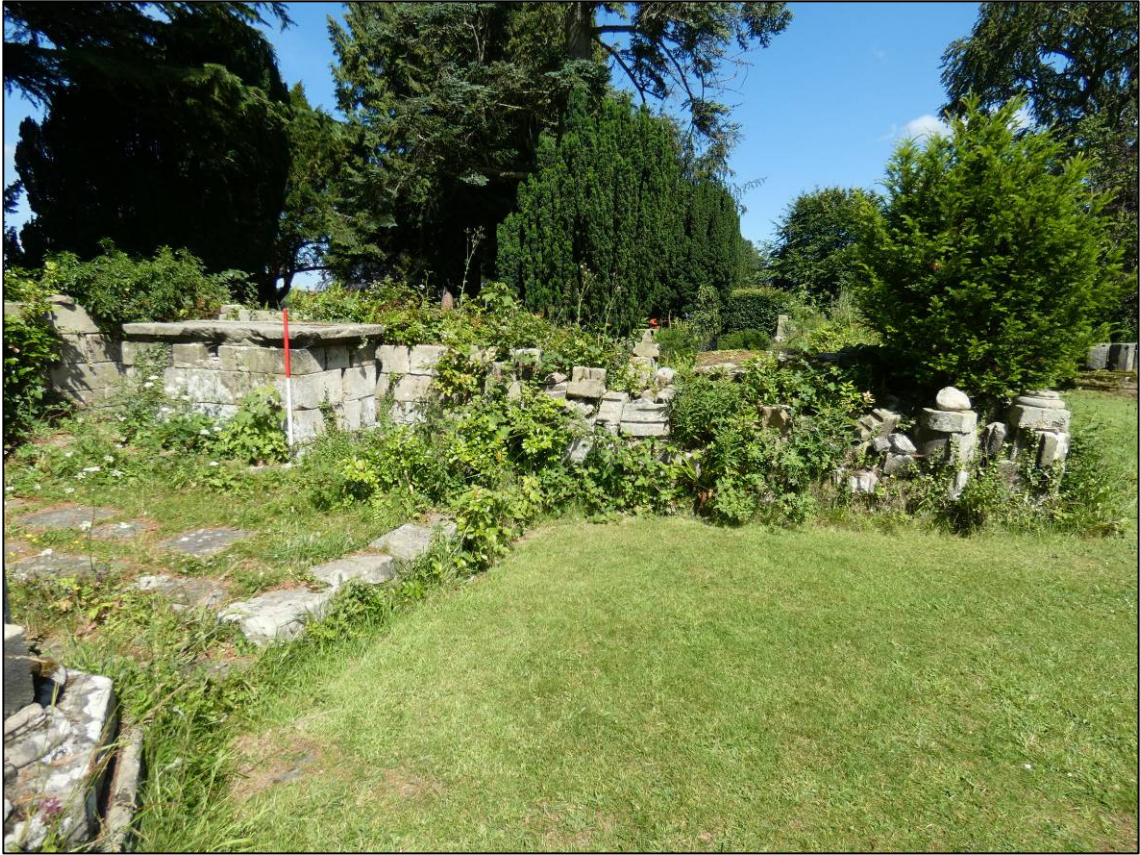
- 5.61 The north and south walls of the presbytery, and the east wall of south transept, were covered with vegetation, and clearly had quantities of *ex situ* fragments stacked against them [1/393-1/396; 4/186] (see plate 59). Loose stones along the south wall of the presbytery and a portion of the east wall of the south transept were reset and remortared [6/635, 6/636], and the repairs were photographed on completion [7/612, 7/614, 7/615, 7/621] (see plate 62).

Plate 59: Area 19: Abbey church, north transept, west internal elevation of east wall, looking E (photo 1/394).

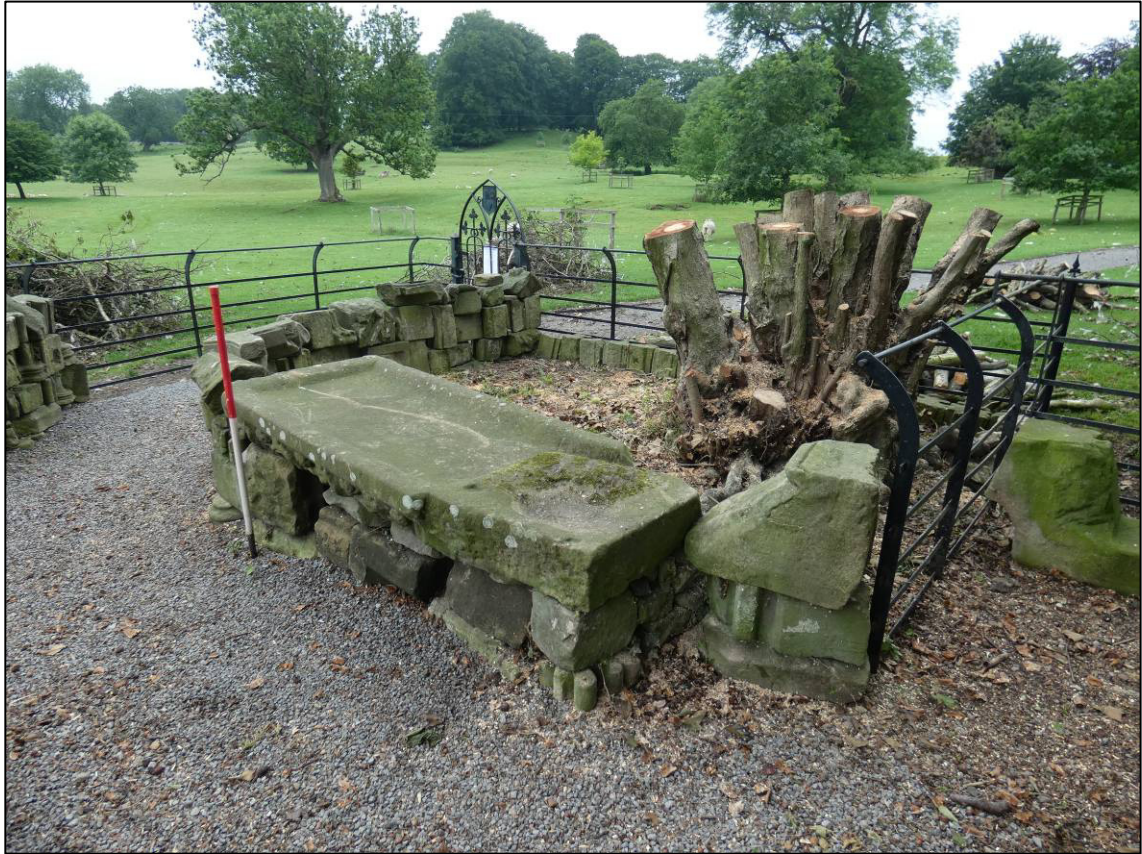
- 5.62 Two trees at the south-west corner of the current entrance into the abbey complex, near the south side of the lay brothers' infirmary, were completely cut back, thus making the very large number of *ex situ* architectural fragments here, including the embalming slab, more visible and recognisable [6/668-6/672] (see plate 63).

Plate 63: Site entrance, ex situ stonework and embalming slab, after tree clearance, looking SW (photo 6/670).

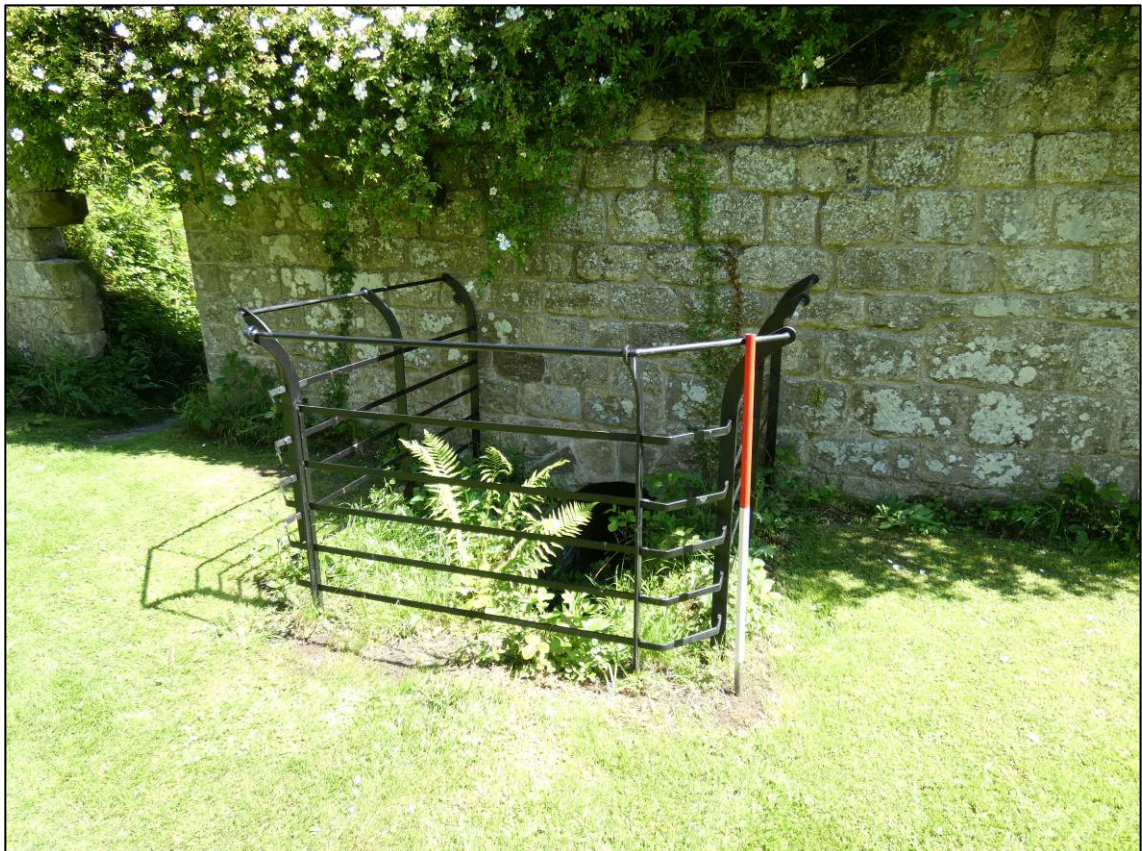
Plate 64: Area 9: Monks' dorter, fenced culvert against west internal elevation of east wall, looking E (photo 1/318).

- 5.63 The fencing which protects the open sections of the main east-west drain running through the abbey complex was either renewed or strengthened before or during the current phase of repairs. In many cases, the drain was culverted under the buildings, although an open channel runs through the lay brothers' rere-dorter (Area 2). New fencing had been erected against the west internal elevation of the lay brothers' quarters east wall (Area 4) [1/291], and against the east internal elevation of the monks' dorter's east wall (Area 9) [1/318], in advance of the main phase of work (see plate 64). Similar fencing had also been erected around the open drain at the west end of the monks' rere-dorter (Area 14) [1/350], and there is some older-style fencing just to the west [1/349] (see plates 65 and 66). New grills had previously been installed over the drain as it passed through the infirmary range (Area 15) [1/364] (see plate 67), and also against the east internal elevation of the monks' frater (Area 6) [1/358].

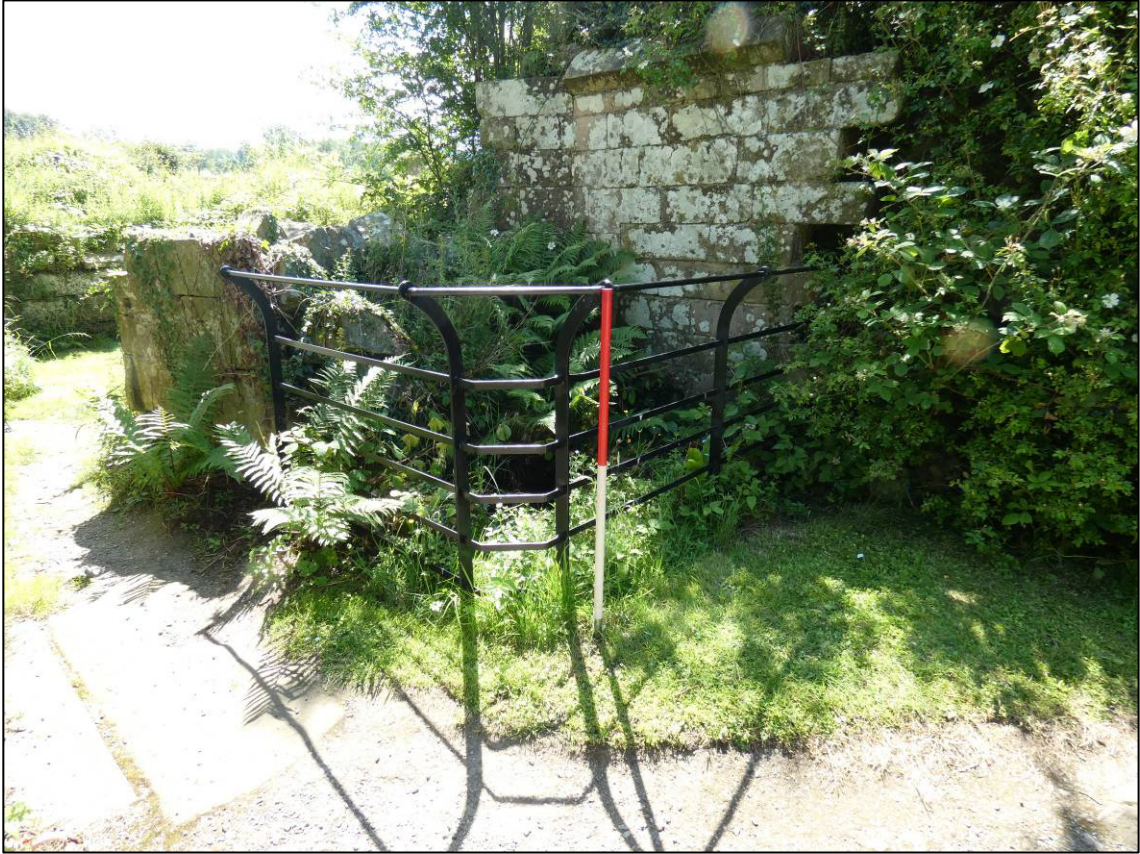
Plate 65: Area 14: Monks' rere-dorter, west end of drain showing new fencing, looking SE (photo 1/350).

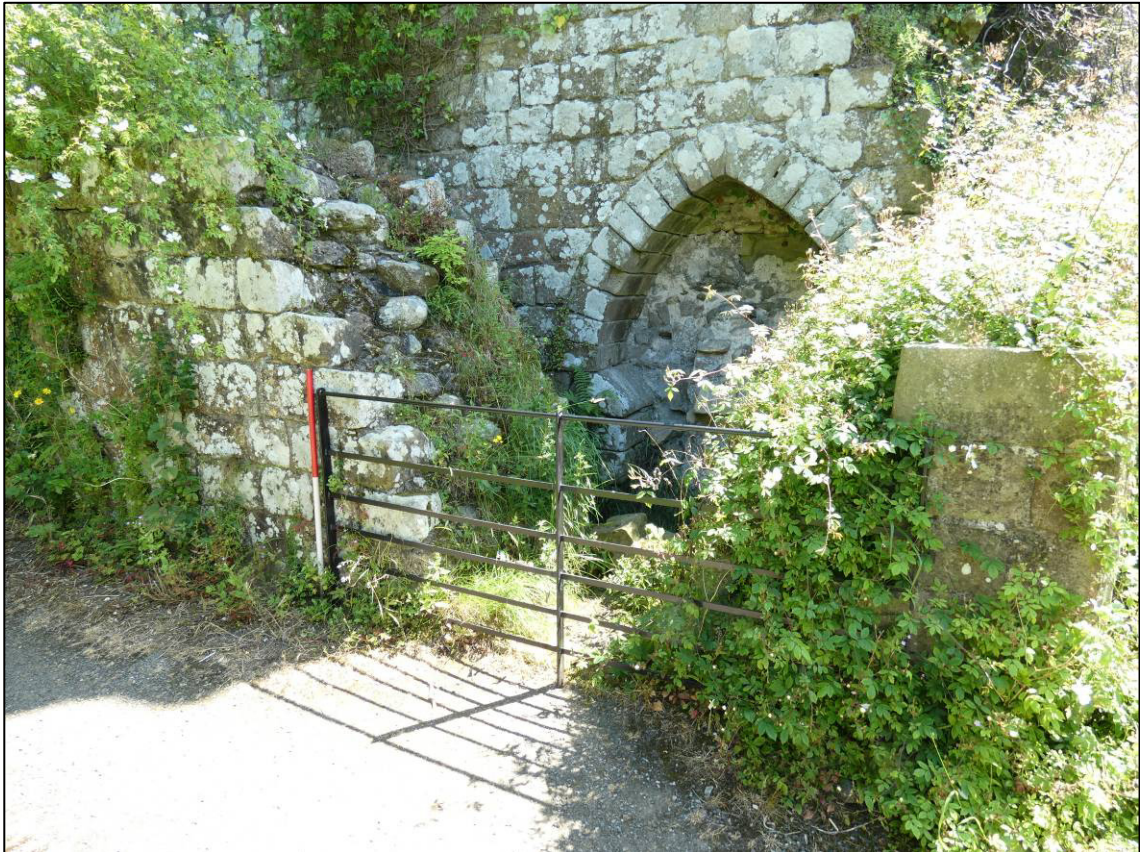
Plate 66: Area 14: Monks' rere-dorter, west end of drain showing older-type fencing, looking SE (photo 1/349).

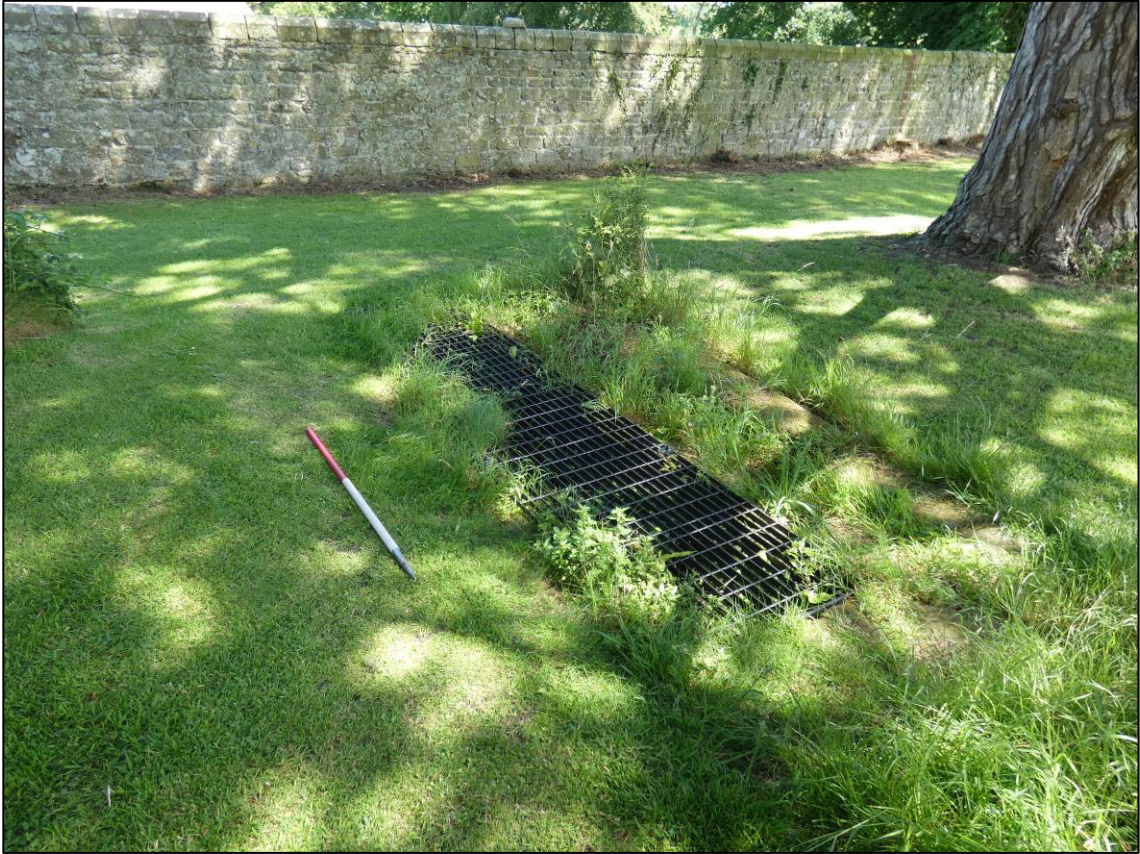
Plate 67: Area 15: Monks' infirmary, grills over open culvert of east-west drain, looking SE (photo 1/364).

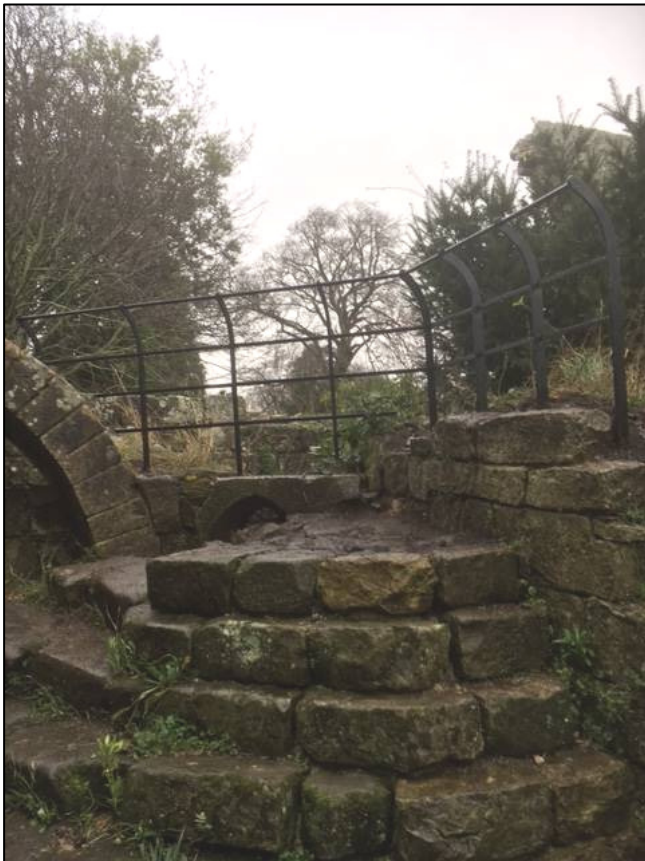
Plate 68: Area 12: Stairs between abbots' lodging and monks' rere-dorter, new fencing to top over drain, looking N (photograph courtesy Historic Property Restoration).

- 5.64 Once the stairs between the abbots' lodging and the monks' rere-dorter had been stabilised, new fencing was also erected around the top to prevent unauthorised access into and across the drain immediately to the north (see plate 68). Finally, a

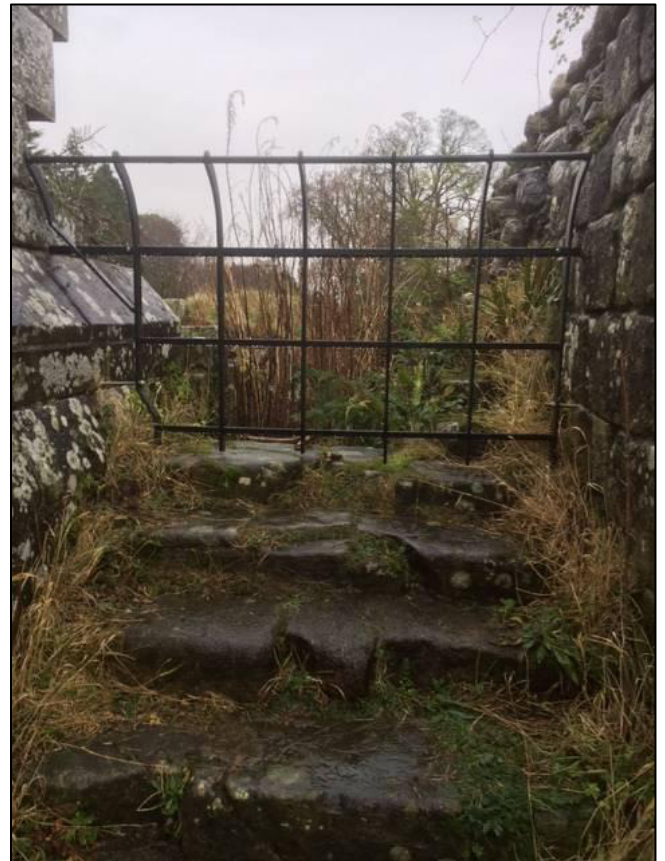
Plate 69: Area 4: Lay brothers' dorter, dorter stairs to north external elevation, new fencing, looking E (photograph courtesy Historic Property Restoration).

single metal tie-rod over the steps of the lay brothers' dorter stairs (Area 4), placed to deter public access up the steps [7/624], was replaced with a more robust structure (see plate 69).
