THE OLD VICARAGE, STONEGATE,  
THORNE, DONCASTER DN8 5NP

HISTORIC BUILDING RECORDING  
AND ARCHAEOLOGICAL INVESTIGATION,  
OBSERVATION AND RECORDING

Report no: 2020/614.R01  
Version: Final  
Date: July 2022  
Author: Shaun Richardson & Ed Dennison

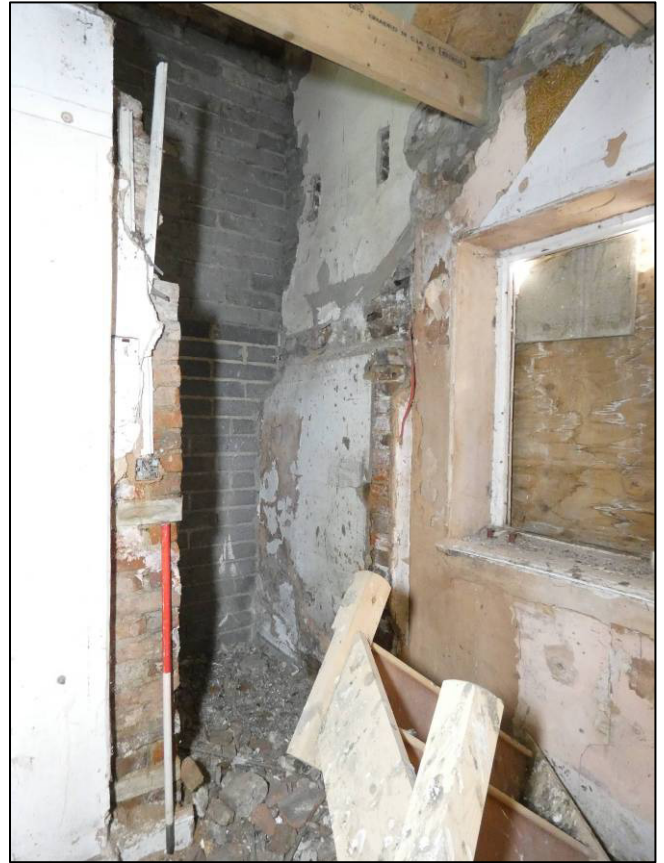
- 4.26 The main feature to the eastern space (**GF6**) [2/121, 2/122, 2/127] is the large projecting chimney breast to the east wall, which almost certainly once housed a large cooking range [2/116, 1/120] (see plate 39). It is flanked by large recesses

Plate 39: Rear wing ground floor, east room (GF6), fireplace to east wall, looking SE (photo 2/116).

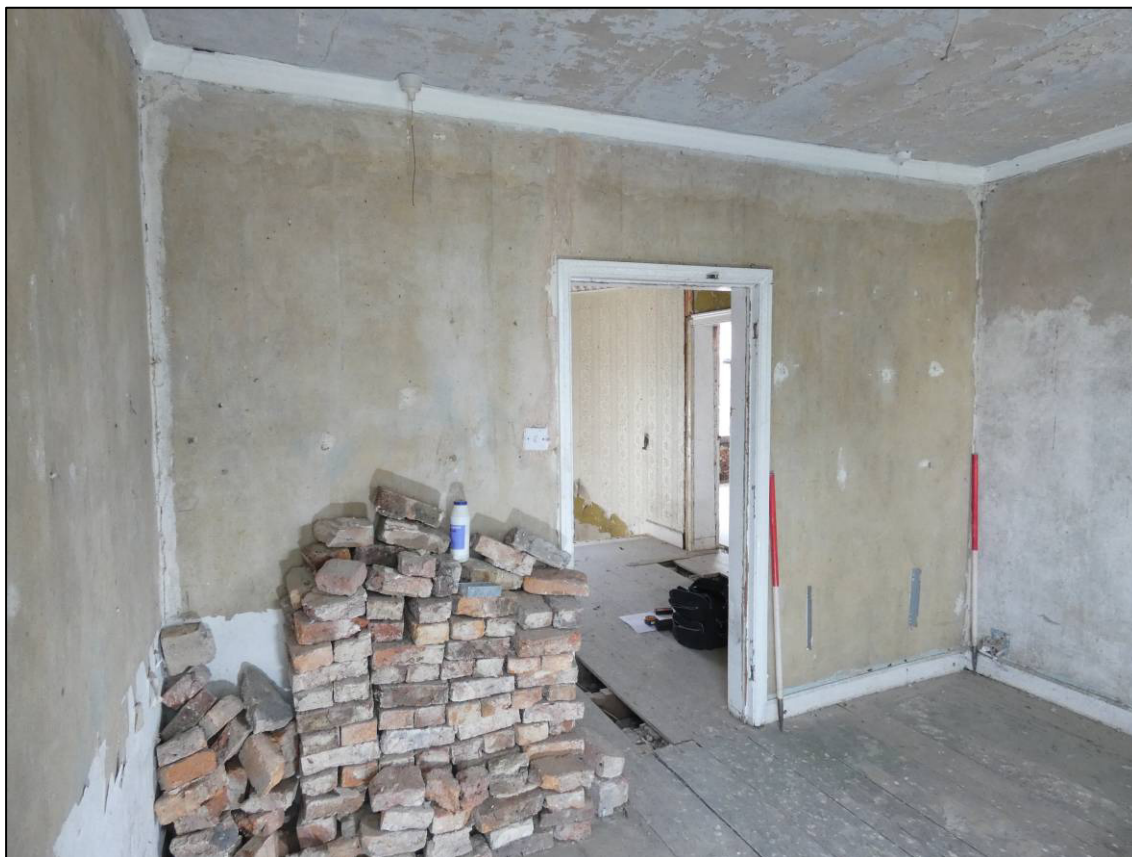
Plate 51: First floor south-west room (1F3), north wall showing inserted door to left, looking N (photo 2/283).

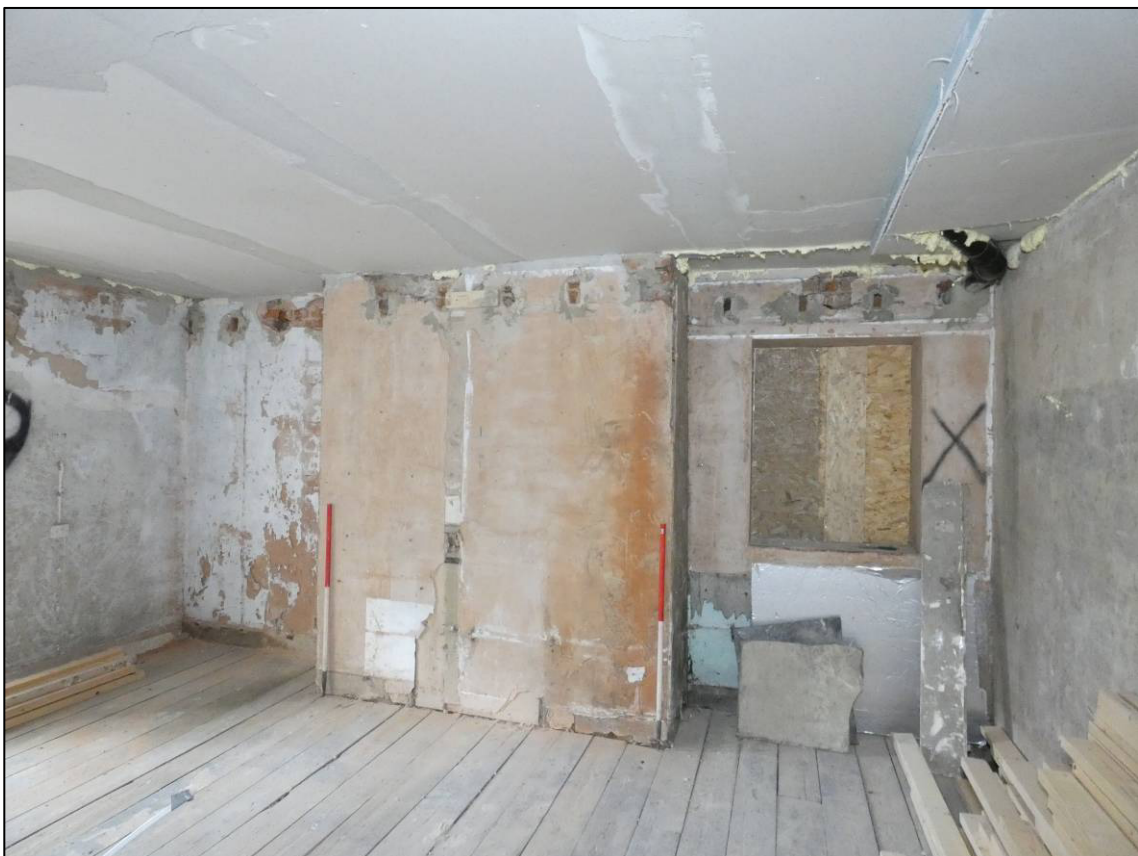
Plate 55: First floor front north room (1F5), butt joint to east wall, looking E (photo 2/303).

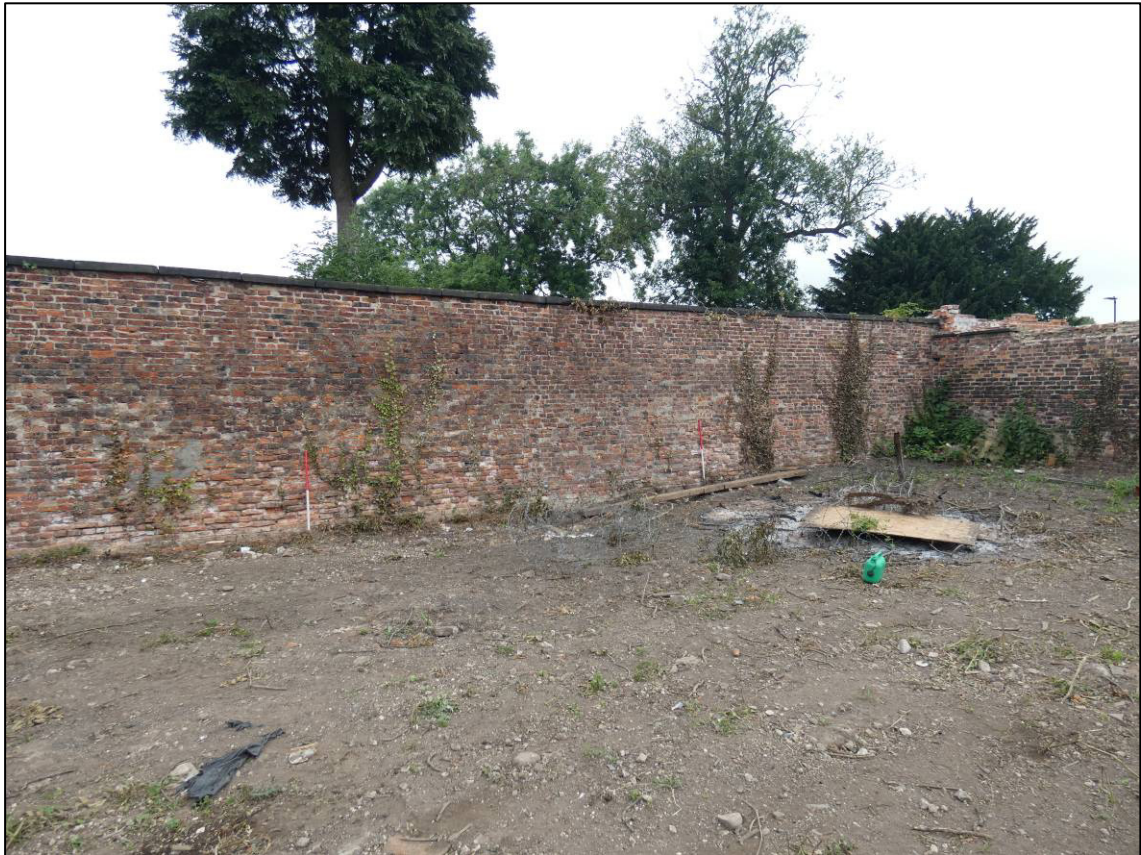
Plate 68: Rear yard, central part of north boundary wall, showing areas of blocking and repair, looking N (photo 1/965).

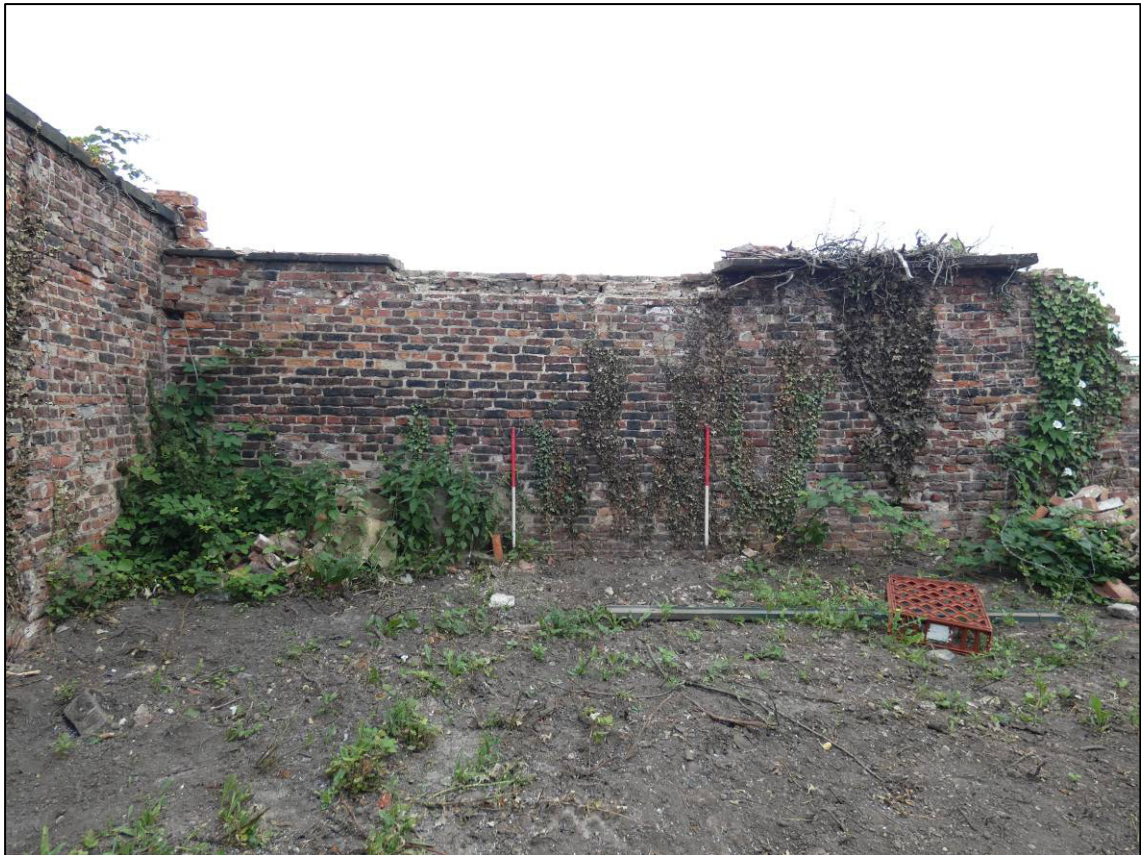
- 5.3 The main body of the north boundary wall appears to have been built in two phases, perhaps because it retains the higher church yard ground to the north [1/962, 1/963] (see plates 69 and 70). The lower section, c.1.90m high, has a slightly battered profile and is built of light red handmade bricks (average dimensions 230mm by 110mm by 60mm) laid in an approximate English Garden Wall bond. The upper part of the wall (to a height of 3.06m above ground level) is

built of brownish-red handmade bricks (average dimensions 230mm by 110mm by 55mm, but with much variety), many of which are over-fired, with up to five stretcher courses to each header course. It has a flat sandstone coping. Towards its east end, the north boundary wall is butted by a cross-wall, running on an angled north-east/south-west alignment across the plot and with a significant gap, 3.80m wide, to the centre; this gap has been widened to allow access for the contractors, and it is not known how wide it might have been, or even if it was present, originally. This cross-wall stands up to 2.47m high with flat sandstone coping [1/960, 1/961, 1/964] (see plate 71). It is built of dark brown-red handmade bricks (average dimensions 230mm by 110mm by 55mm), laid with between three to eleven stretcher courses to each header course, and set with a lime mortar. Excavation of footing trenches adjacent to the wall showed that it had only shallow footings. The section of cross-wall to the south of the gap contains a blocked flat-headed doorway opening with a timber lintel.

Plate 70: Rear yard, east part of north boundary wall, showing changes in build, looking N (photo 1/963).

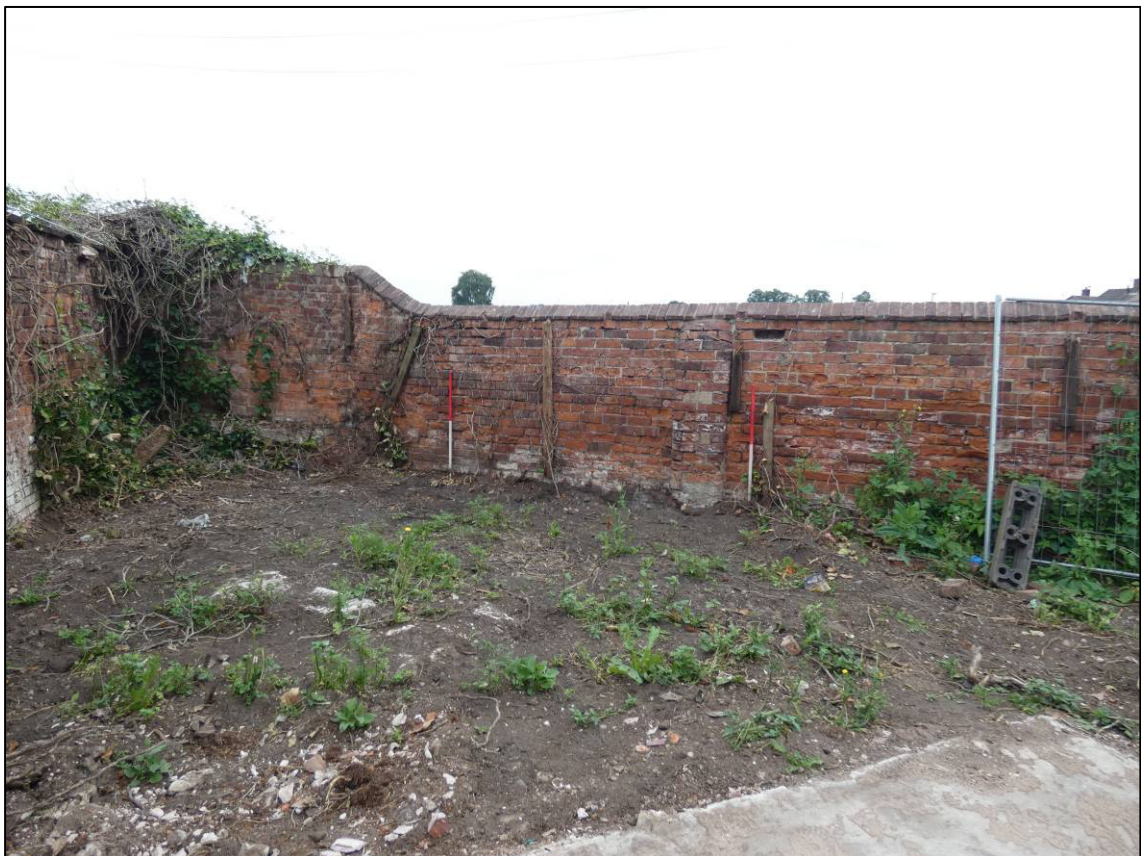
- 5.4 To the east of a small coach house/stable building (see below), the north boundary wall of the plot is similar to the form described west of the cross-wall, although slightly lower [1/958] (see plate 72). Again, it appears to be of two phases. The lower 1.30m has a top which slopes downwards from west to east. It is built of orange-red handmade bricks (average dimensions 210mm by 110mm by 60mm) laid in English Garden Wall bond (three stretcher courses to each header course) and set with a lime mortar. This was used as a base for the upper part, which rises to 2.08m in height and has stone coping. It is built of orange-red handmade bricks (average dimensions 230mm by 110mm by 70mm), mostly laid in stretcher bond.

Plate 72: Rear yard, east end of north boundary wall, looking N (photo 1/958).

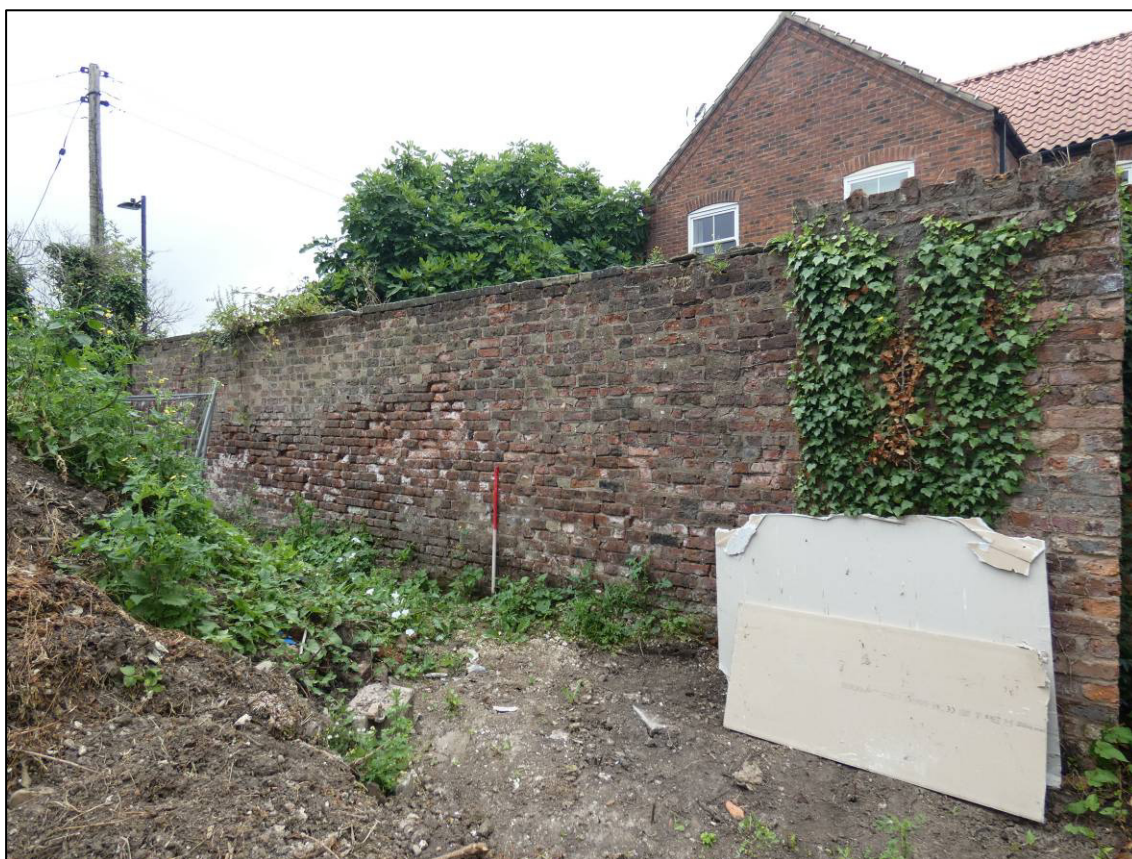
- 5.5 The wall fronting onto Back Lane is built of similar brickwork to the upper part of the wall just described, but is more neatly laid; the wall is also much lower at c.1.50m in height and has triangular brick coping and a central internal buttress [1/959] (see plate 73). The southern part of this wall had been largely demolished at the time of the EDAS survey [1/957].

Plate 73: Rear yard, north end of east boundary wall to Back Lane, looking E (photo 1/959).

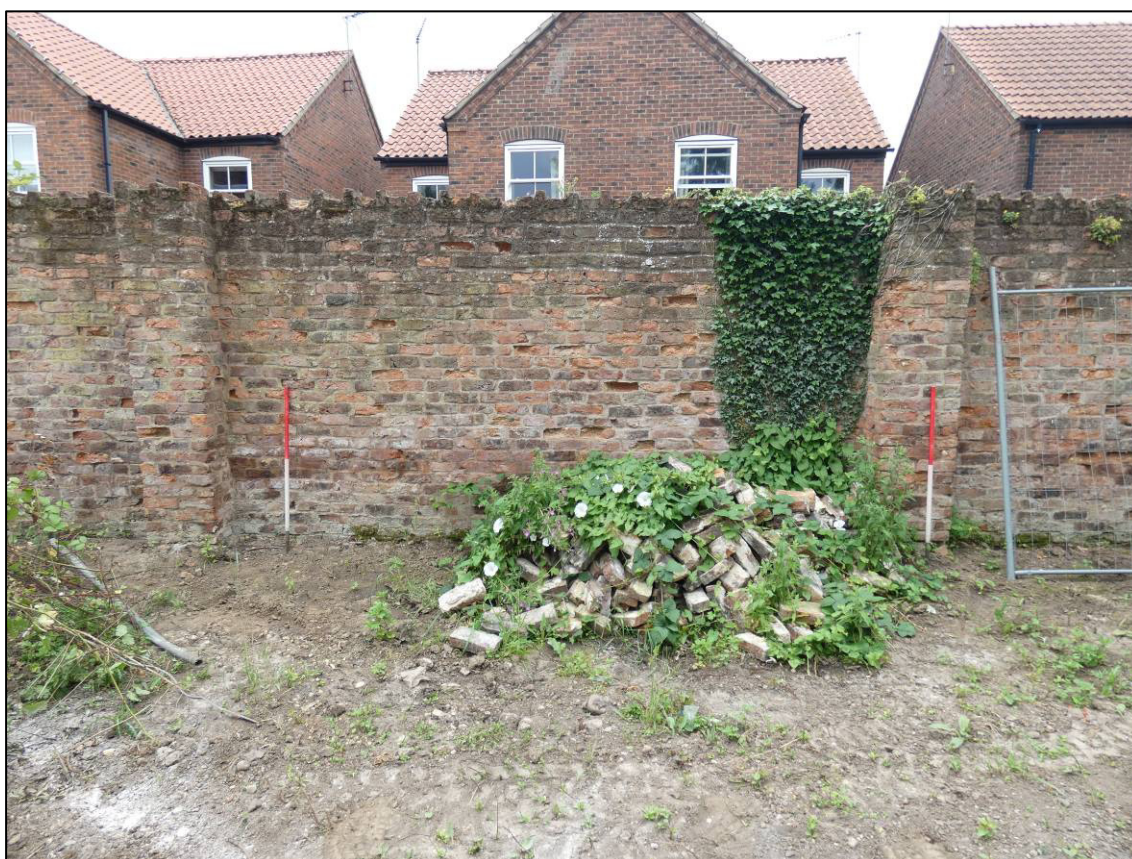
- 5.6 Turning to the south boundary wall of the garden, the eastern c.11m section stands up to 2.66m high with stone coping [1/969] (see plate 74). It is built of dark brown-red handmade bricks (average dimensions 230mm by 110mm by 55mm), laid without a clear bonding pattern and set with a lime mortar. The remainder of the boundary wall is modern, and has been built from reused bricks set with a cement mortar; it was presumably rebuilt following a recent housing development in the plot to the south (Rainbow Close). The wall stands up to 2.64m in height with a crenellated top, and incorporates a number of regularly spaced piers [1/970-1/972] (see plate 75).

Plate 74: Rear yard, east part of south boundary wall, looking SE (photo 1/969).

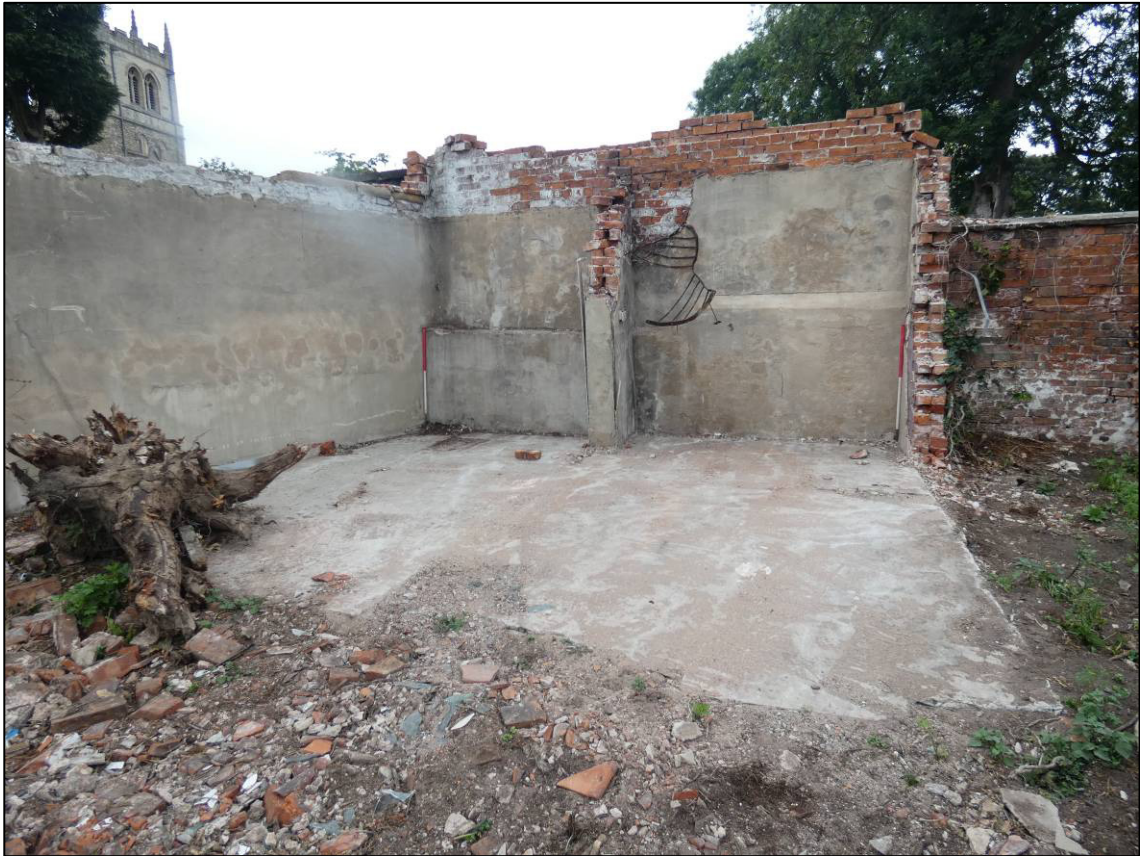
Plate 75: Rear yard, central part of south boundary wall, looking S (photo 1/971).

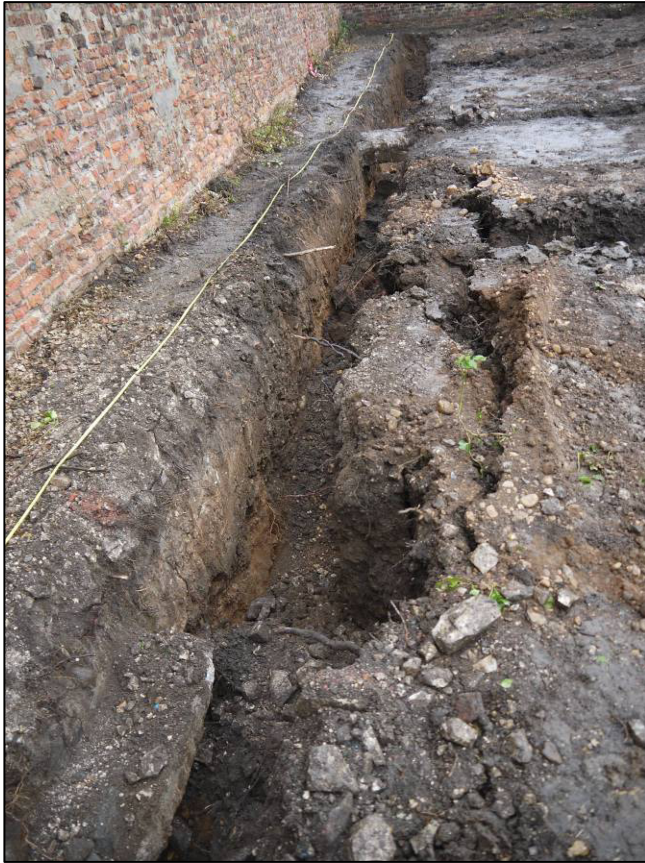
- 6.2 As noted in Chapter 2 above, prior to the start of the archaeological watching brief, any loose vegetation or construction debris was removed from the site using a mechanical excavator, although no ground reduction was carried out; the ground surface was set at an average height of c.8.90m AOD. All excavations were then undertaken by a mechanical excavator using a toothed bucket. The weather conditions (heavy rain) and depth of the excavated foundation trenches restricted safe access, making site recording difficult, and in some areas the sides of the trenches were unstable, resulting in some partial collapse (see plates 78 and 79). The watching brief took place between 6th and 10th August 2021.

Plate 78: Collapse to south side of Trench 1, looking E.

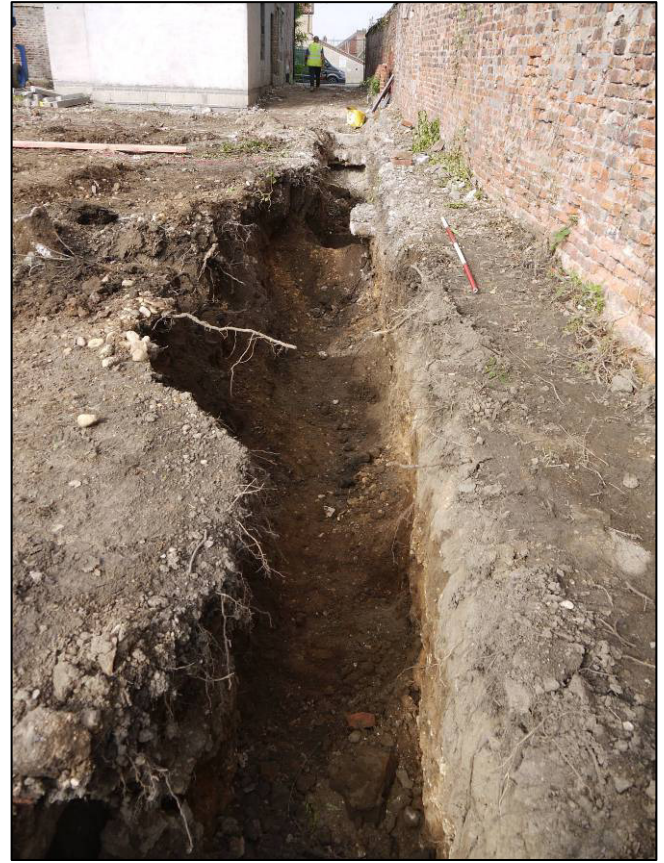
Plate 79: Collapse to south side of Trench 1, looking W.

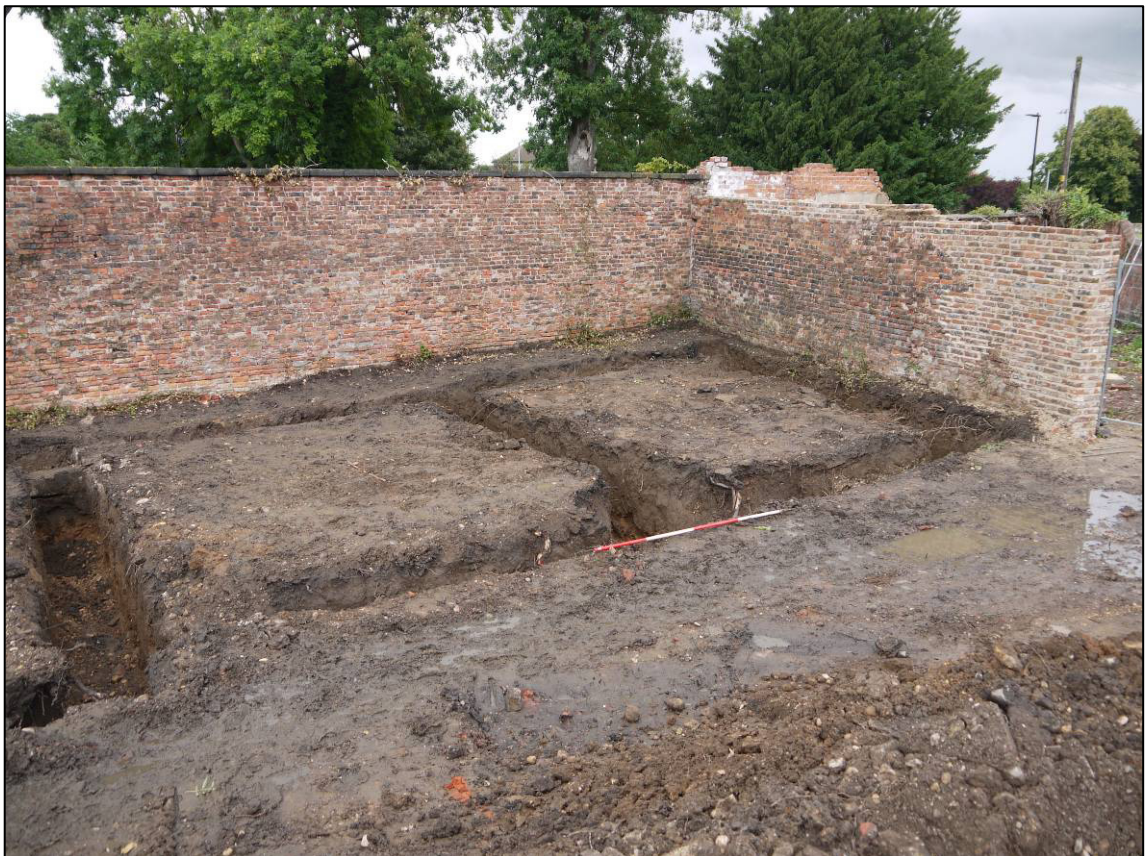
Plate 80: Excavated trenches for east end of new building, looking NE.

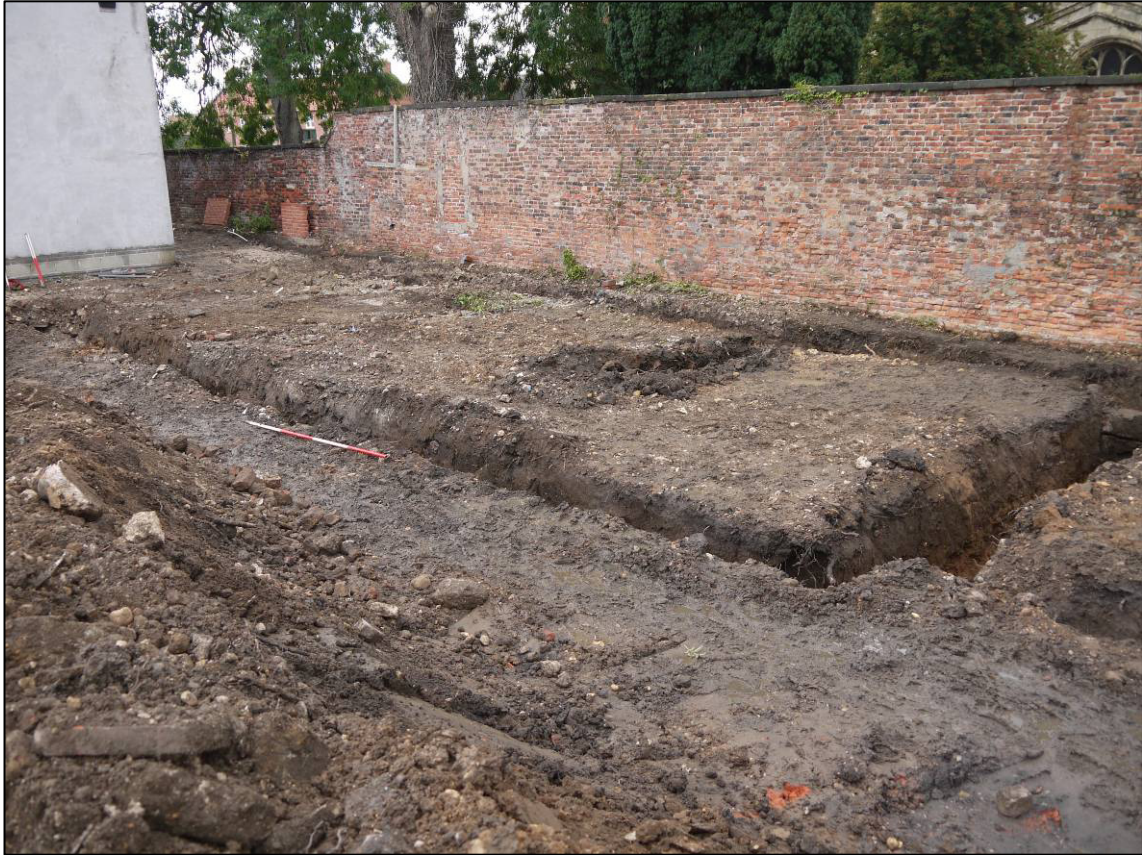
Plate 81: Trenches undergoing excavation for west end of new building, looking NW.

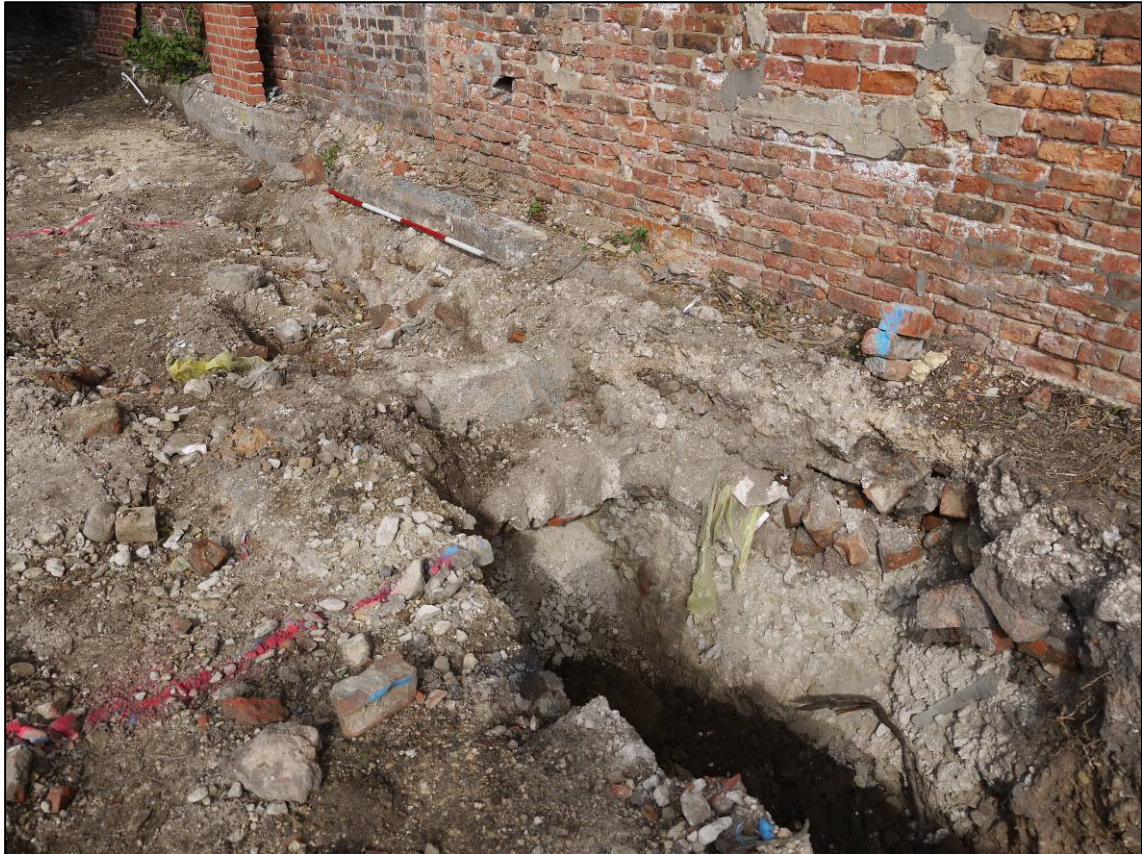
Plate 82: Concrete and brick footings (101) at west end of Trench 1, with brick and stone rubble to east (115/116), looking NW.

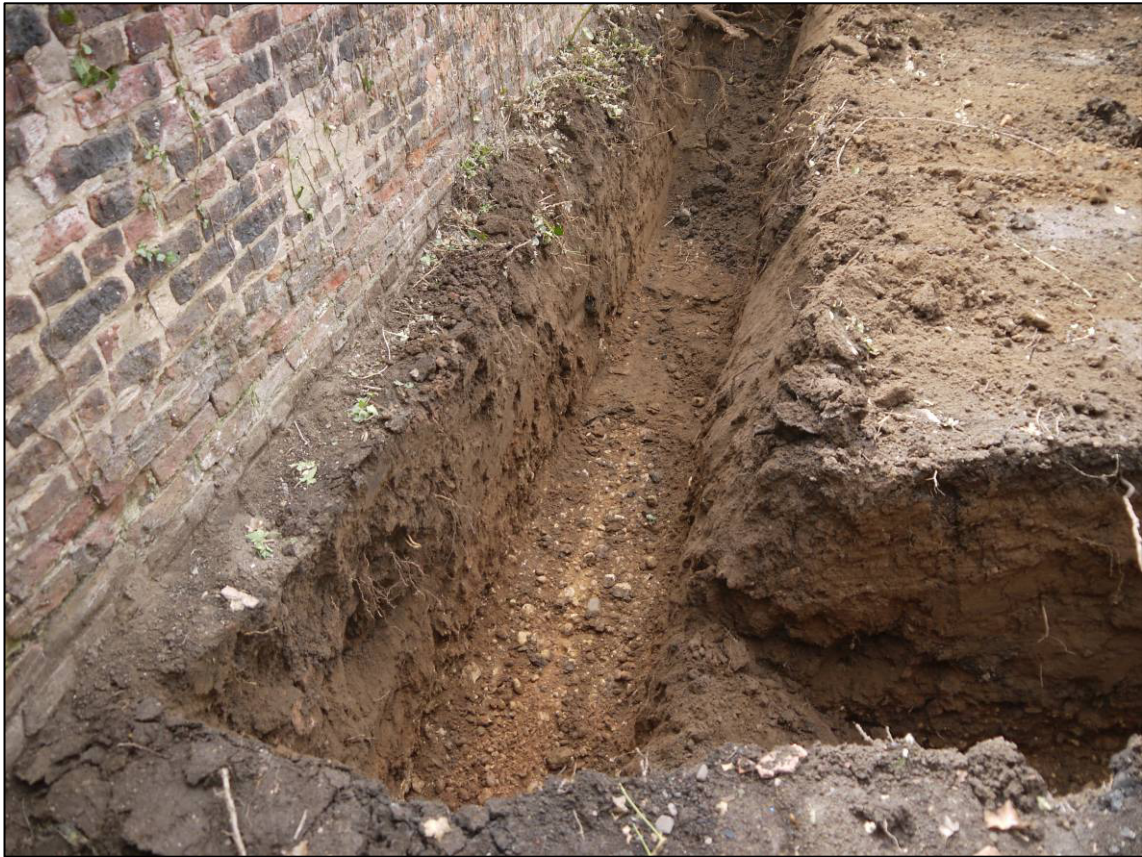
- 6.11 The lowest deposit exposed within the excavated trenches, extending across all areas and cut or overlain by all other contexts, was a thick natural fractured sandstone (108), almost gravel-like in parts. This was at least 0.86m thick and extended below the base of all the monitored trenches [3/10] (see plate 87).

Plate 87: Natural fractured gravel-like sandstone (108), exposed in base of north end of Trench 3, looking S.

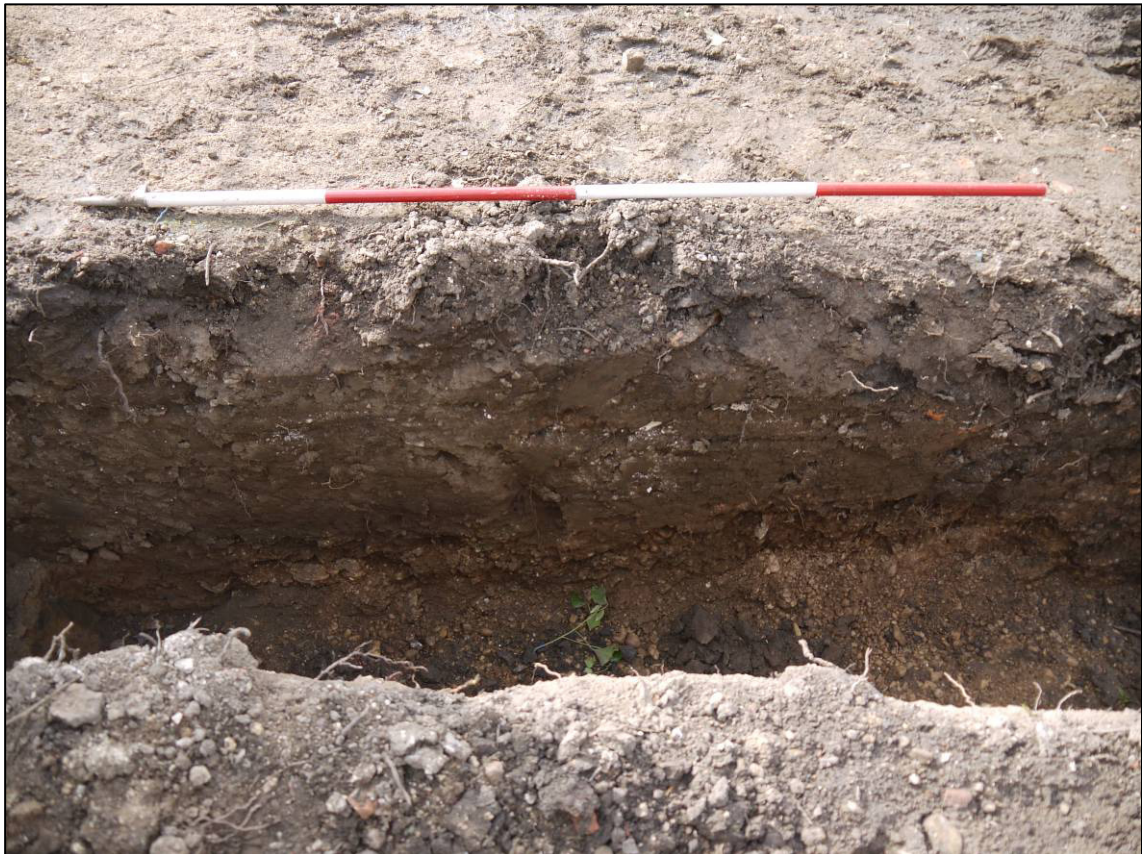
mid-dark grey sandy silt 'topsoil' (104), 0.28m thick, which overlay the silty sand and clay subsoil (105), here 0.70m thick (see plate 88). This in turn overlay the natural fractured sandstone (108) which extended beyond the depth of excavation.

Plate 88: Representative Section 2, east end of south side of Trench 2, looking S.
