**LINHAY AT LICKHAM BOTTOM,
HEMYOCK, DEVON**

HISTORIC BUILDING RECORDING

Project LBL262

HISTORIC BUILDING RECORDING OF A LINHAY AT LICKHAM BOTTOM, HEMYOCK, DEVON

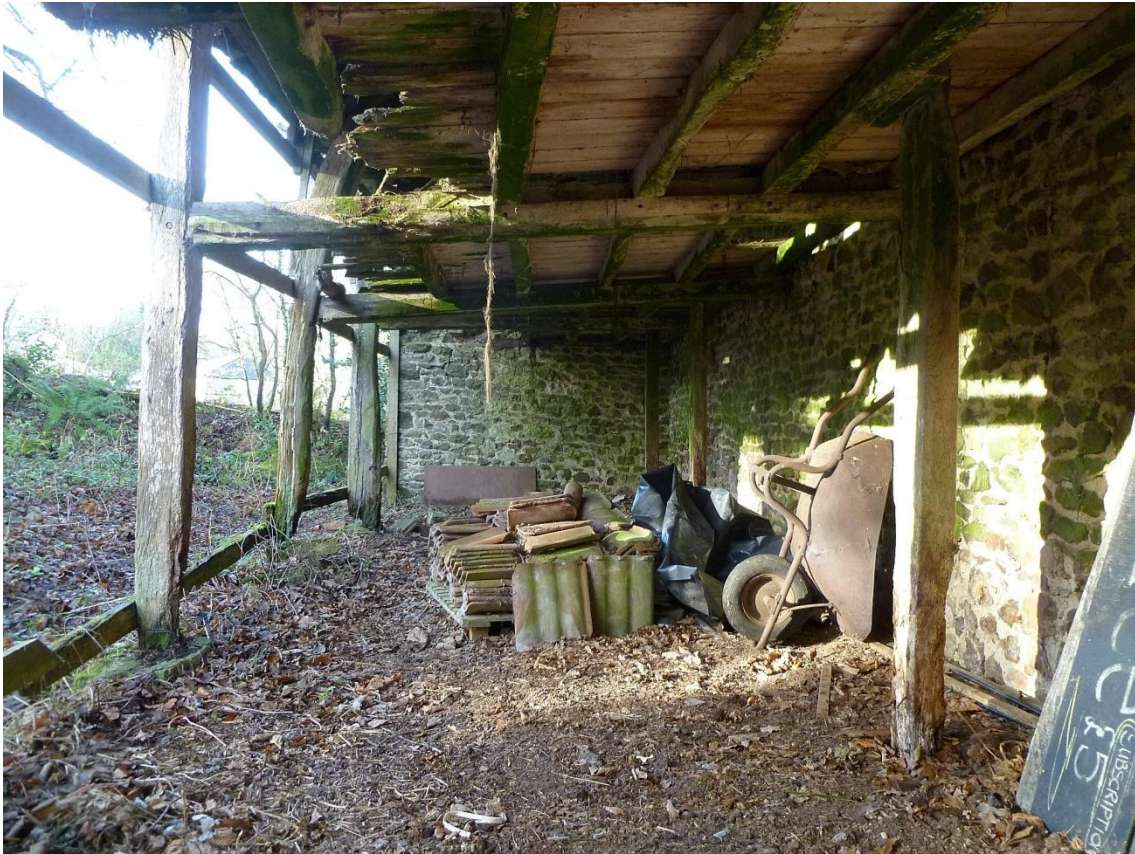
The tallet floor, which was not readily accessible due to decay and some fodder still being in place at the east end, is formed of 16cm by 2.5cm square edged softwood boards. The south front of the floor is very weathered and decayed. There is no evidence of a fixed ladder up to the loft, a feed slot in the tallet floor, or a fixed manger or feed trough along the inside of the rear wall.

Ground floor interior, looking west, showing tallet floor structure

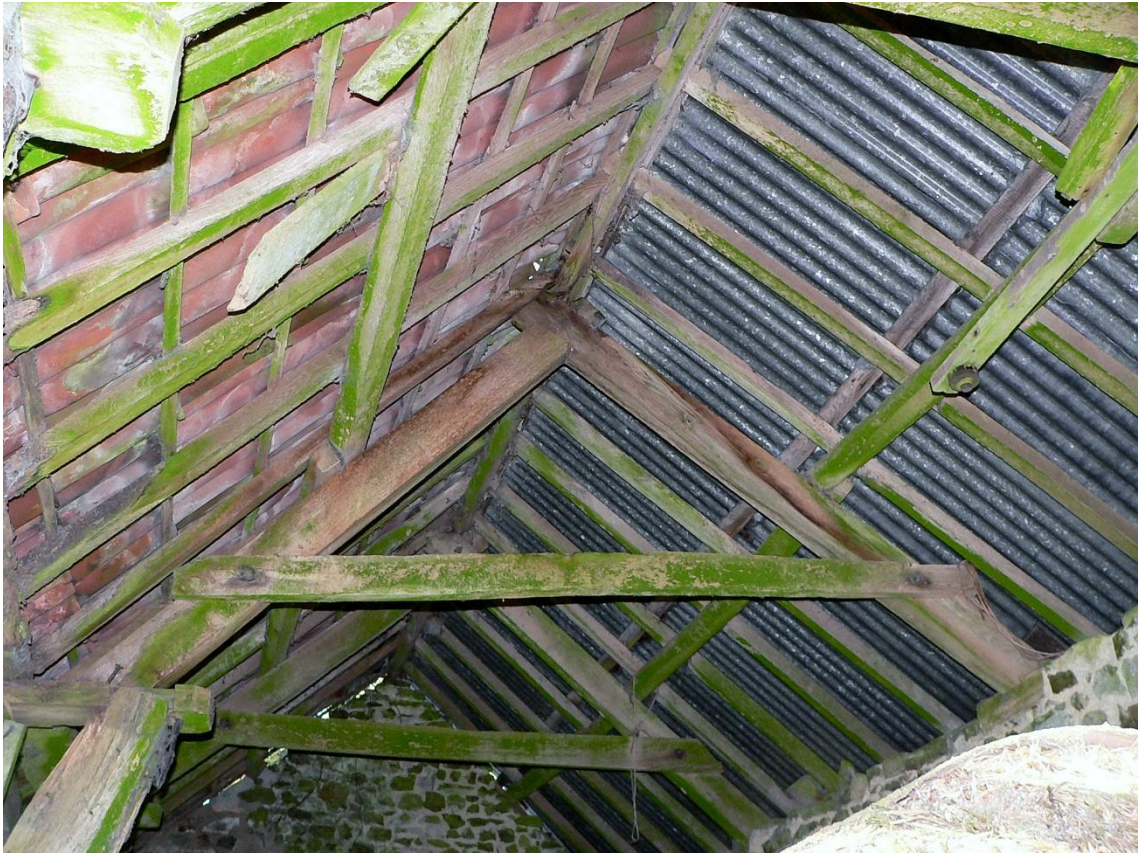
Roof structure, looking west

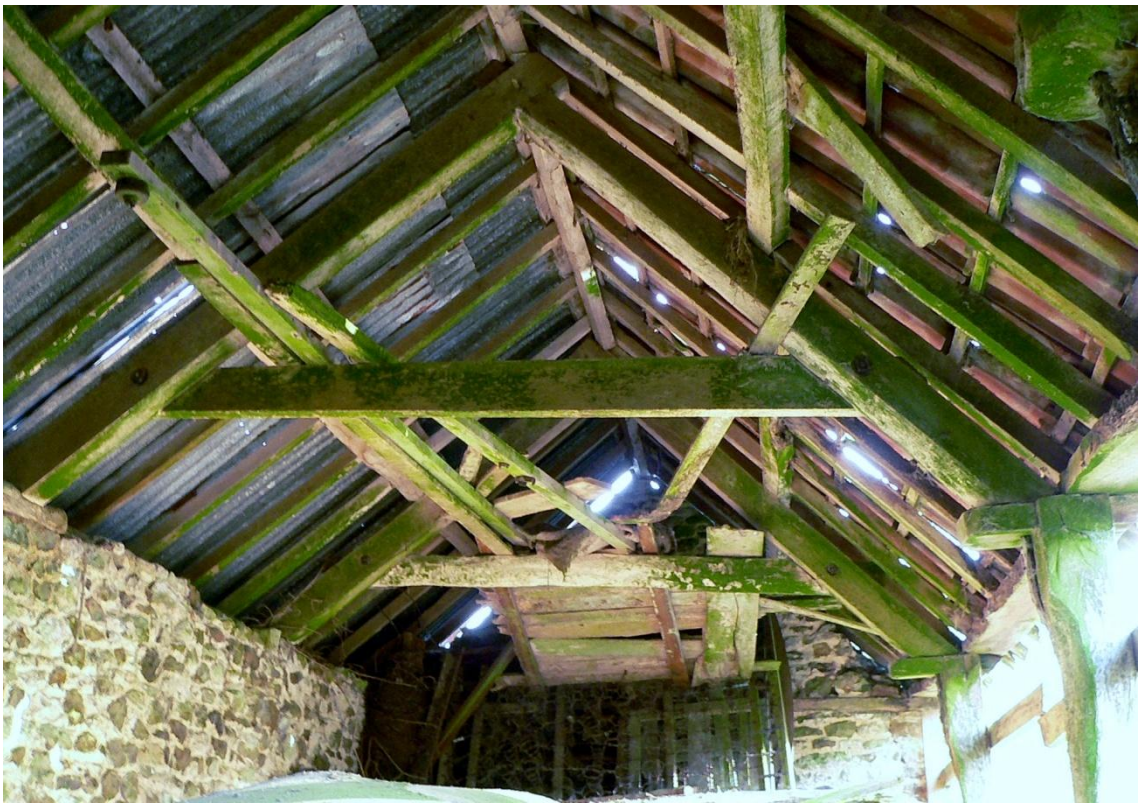
Tallet and roof looking east

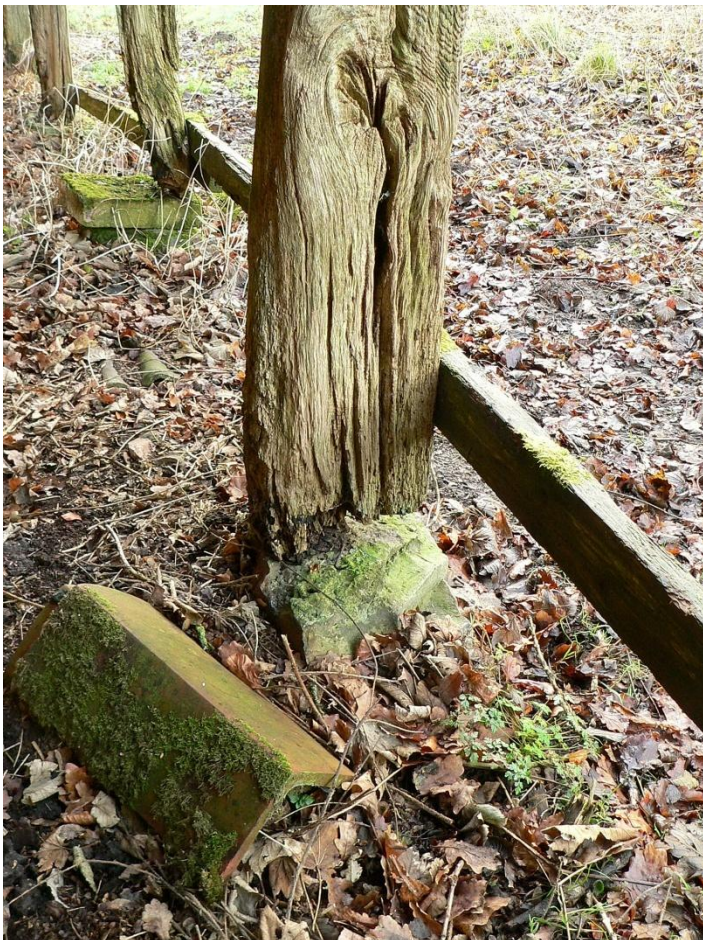
The four front posts sit on roughly shaped stone bases. Numbering from west to east, P1 and P2 are squared oak timbers which both have a natural curve inwards towards their tops. P3 is a squared timber with a slightly jowled top and P4 a straight squared timber. All of the posts are weathered and there is no clear evidence that any of them have been re-used; they are probably 'as found' timbers, sparingly converted from locally sourced trees. All four posts have a short, north-south aligned, timber plates notched into/over their heads. A single iron spike has been driven down through each pad on the of north side of the post head, presumably to stop it from moving outwards (see photograph).

Stone bases under feet of posts
