**REPORT
TO
SCOTTISH & SOUTHERN
ELECTRICITY NETWORKS AND
HISTORIC ENVIRONMENT SCOTLAND**

**EXCAVATIONS AT
DEMOLISHED STRUCTURE
AT CRAIGNAVAR TOWNSHIP,
GLEN ALMOND, PERTHSHIRE**

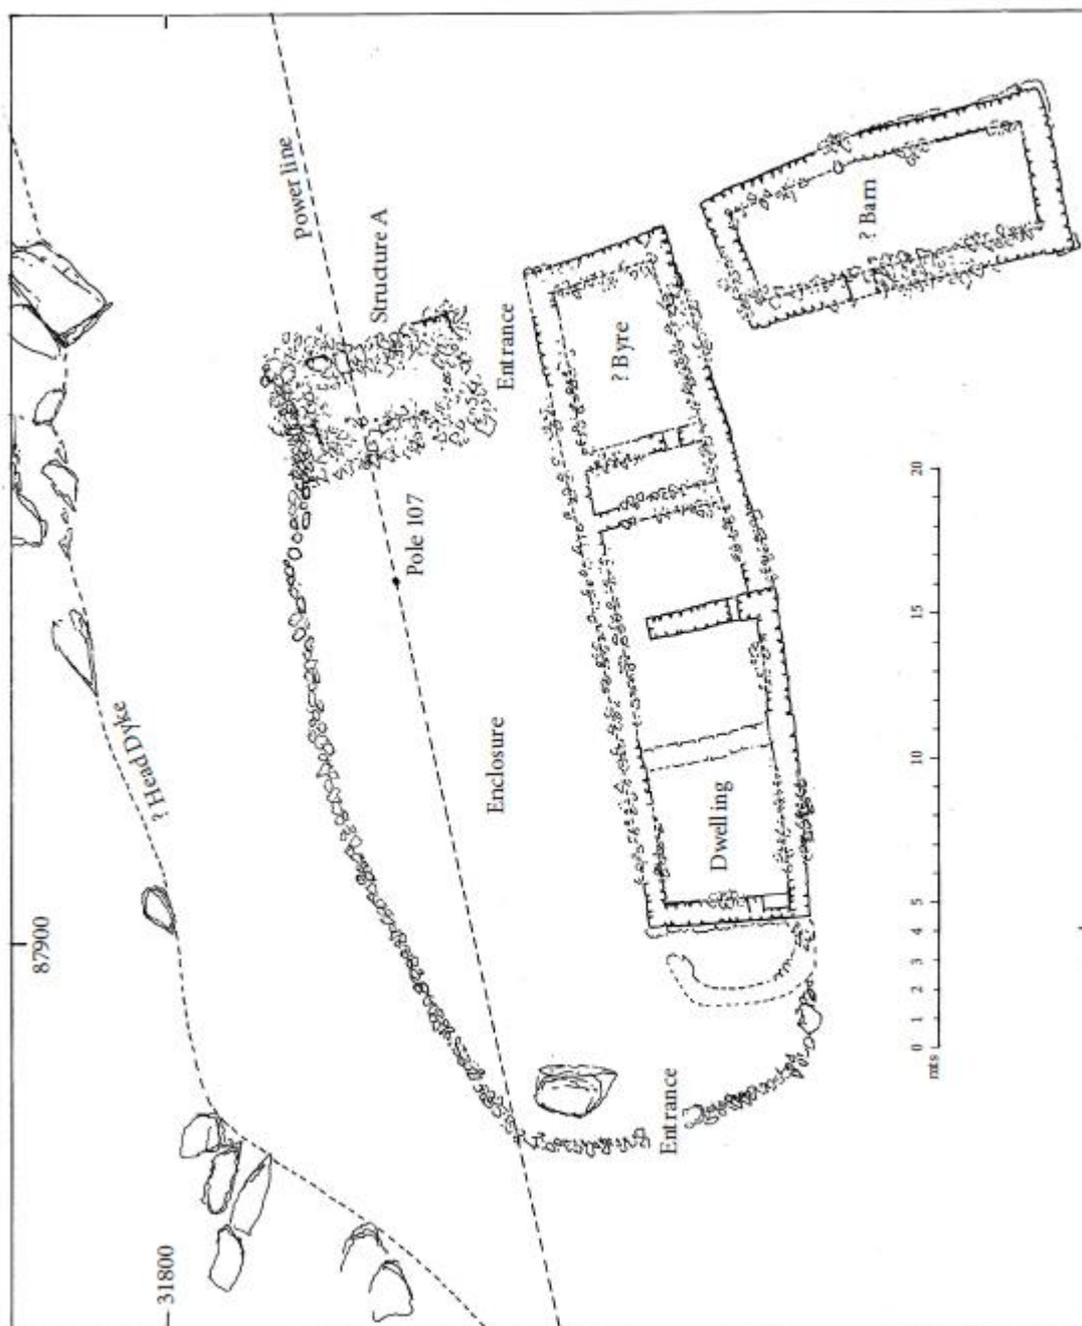
Structure A was centred on NN 87921 31793 and measured 4.6m north/south by 1.9m wide internally within walls built of random rubble of local origin. Its east and west walls were 0.7m thick while its gables were more substantial at 0.9m thick. The building was sunk some 0.2-0.3m into the ground, the lower courses of the west wall functioning effectively as a

Structure A and associated buildings

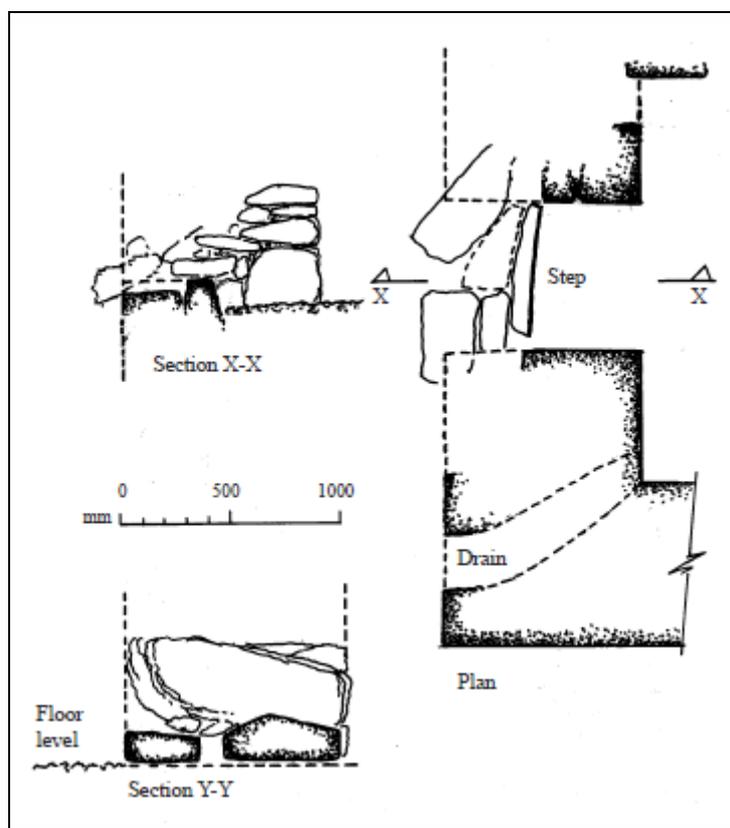
There was an opening, 0.7m wide, in the south wall that had been blocked at some stage. This doorway, with a step midway through it, gave access to a passage leading into the east side of the enclosure. It is not obvious why the opening was blocked.

Plan of doorway in south wall and sections X-X and Y-Y

In addition, HES requested that the blocking in the south wall opening should be replaced. Following these operations, SSEN will remove any remaining spoil from the site.
