# THE RABBIT 1-3 HIGH STREET WEST BISHOPWEARMOUTH SUNDERLAND

#### HISTORIC BUILDINGS RECORDING

### THE RABBIT, 1-3 HIGH STREET WEST, BISHOPWEARMOUTH, SUNDERLAND SR1 3EX

Report title:	The Rabbit, 1-3 High Street West, Bishopwearmouth, Sunderland.
	Historic Buildings Recording.
Stage:	Final
Project code:	AP 21/32
Compiled by:	Richard Carlton, Peter Ryder & Marc Johnstone
Control:	Alan Rushworth
OASIS ID:	thearcha2-511292
Date issued:	07/09/2022
Planning application:	N/A
Grid reference:	NZ 39246 57012 (approximate centre)
Client:	Sunderland City Council

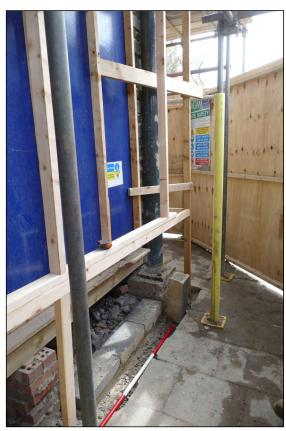
Photo 05. Ground floor exterior, view looking SE at detail of south-westernmost cast-iron column, supporting the 'shop-frontage'.

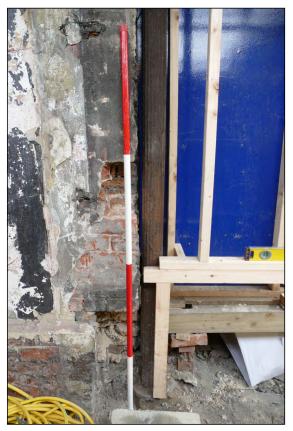
Photo 04. Ground floor exterior, view looking ENE at detail of north-westernmost cast-iron column, supporting the 'shop-frontage'.

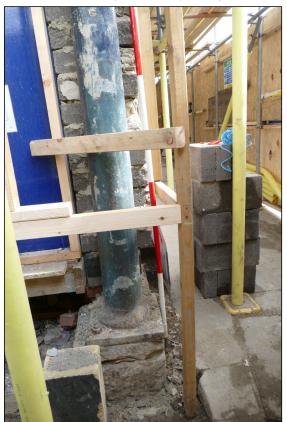
Photo 06. Ground floor exterior, view looking ENE at detail of south-westernmost cast-iron column, supporting the 'shop-frontage'.

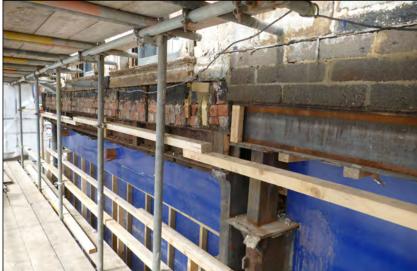
Photo 09. Interface between ground and first floors, view looking NW across the south wall, with detail of iron girder and column where High Street West No. 1 extends from No. 2.

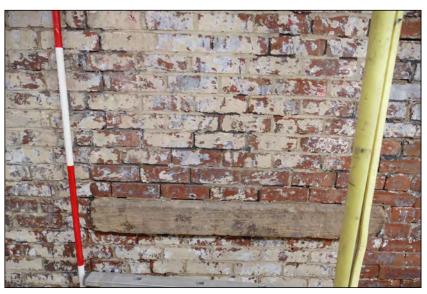
Photo 08. Ground floor exterior, view looking ENE at timber lintel in the west wall.

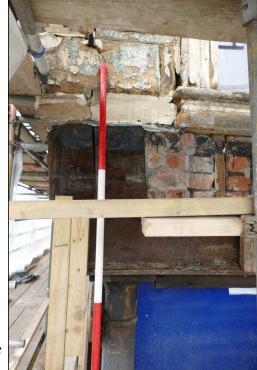
Photo 13. Interface between ground and first floors, view looking NNW at SW corner of south wall, showing detail of iron girder and column for the 'shop-front' facade.

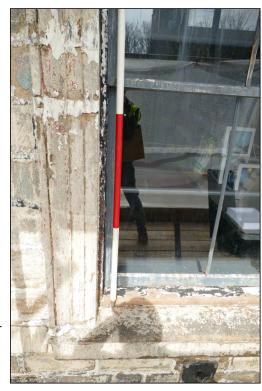
Photo 15. First floor exterior, view looking NNW at detail of easternmost window in south wall of High Street West No. 2.

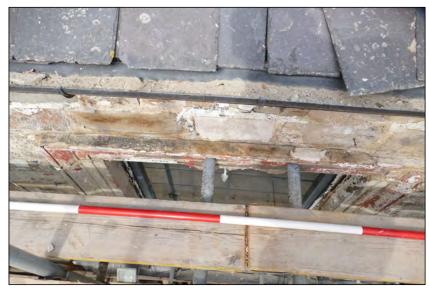
Photo 17. Interface of first floor exterior and roof, view looking NNW at detail of upper portion of central window in High Street West No. 2.

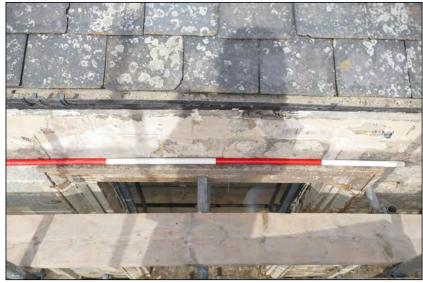
Photo 21. Interface of first floor exterior and roof, view looking NNW at detail of upper portion of westernmost window in High Street West No. 1.
