LEVEL 2 HISTORIC BUILDING SURVEY

Agricultural Buildings at Stonton Road, Church Langton, Leicestershire [Grid Reference: SP728943]

Report Date: September 2010

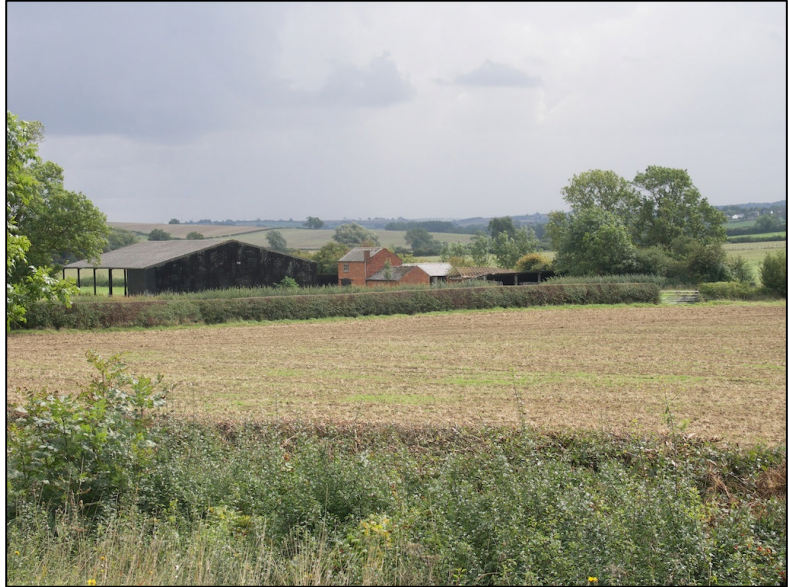
Plate 1:

- 4.1 These redundant farm buildings stand within undulating open countryside on the western slopes of the River Welland valley [Plate 1] about 1.5 km (1 miles) to the north of Church Langton on the east side of Stonton Road close to its junction with Cranoe Road [NGR SP728943] (see Figure 1).

- 4.4 To the north of this group of traditional farm buildings is a large, modern Dutch barn [Plate 1].

View looking south-east across the Welland valley showing the farm buildings within the wider landscape
