Mill Hall, Dunnings Lane,
Pulham Market
Norfolk

Historic Buildings Recording

OA East Report No: 1057

Historic Building Survey

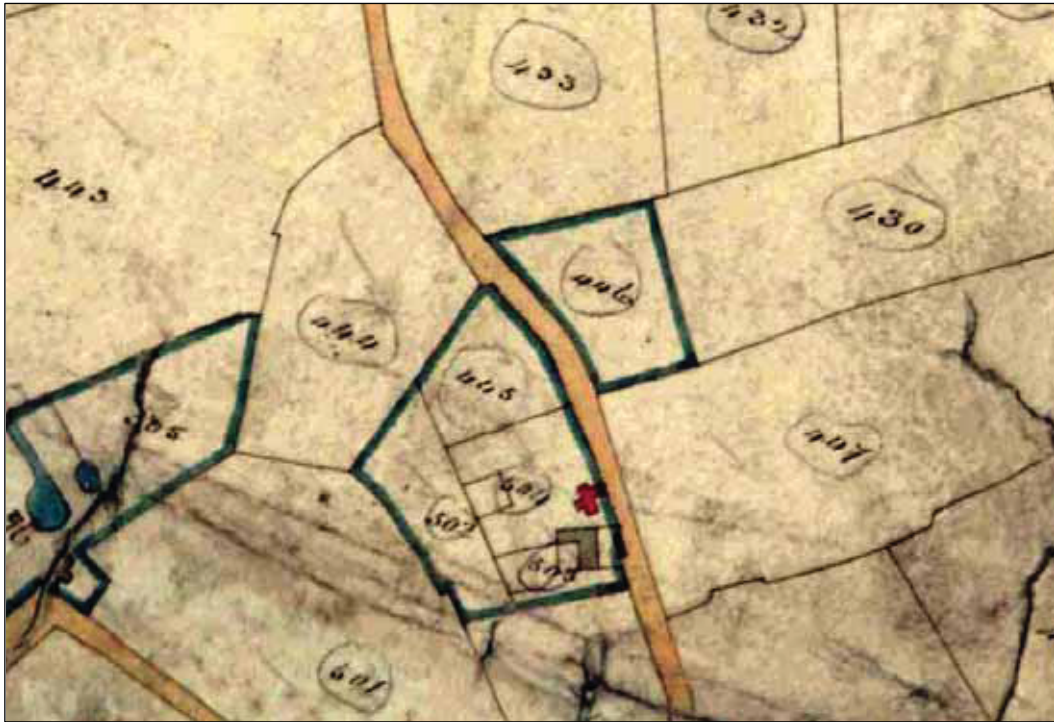
Figure 2: Tithe Map (1838) showing Mill Hall

- 3.1.1 The earliest primary source available for consultation was the tithe map (1838) (Figure 2).
- 3.1.2 A tithe map was drawn up for almost all rural parishes in Norfolk between 1836 and 1850. This was necessary because the Tithe Commutation Act of 1836 asked that payments of tithe in the form of farm produce should be replaced by a money payment. Tithe was a tax, which was paid to the local church.

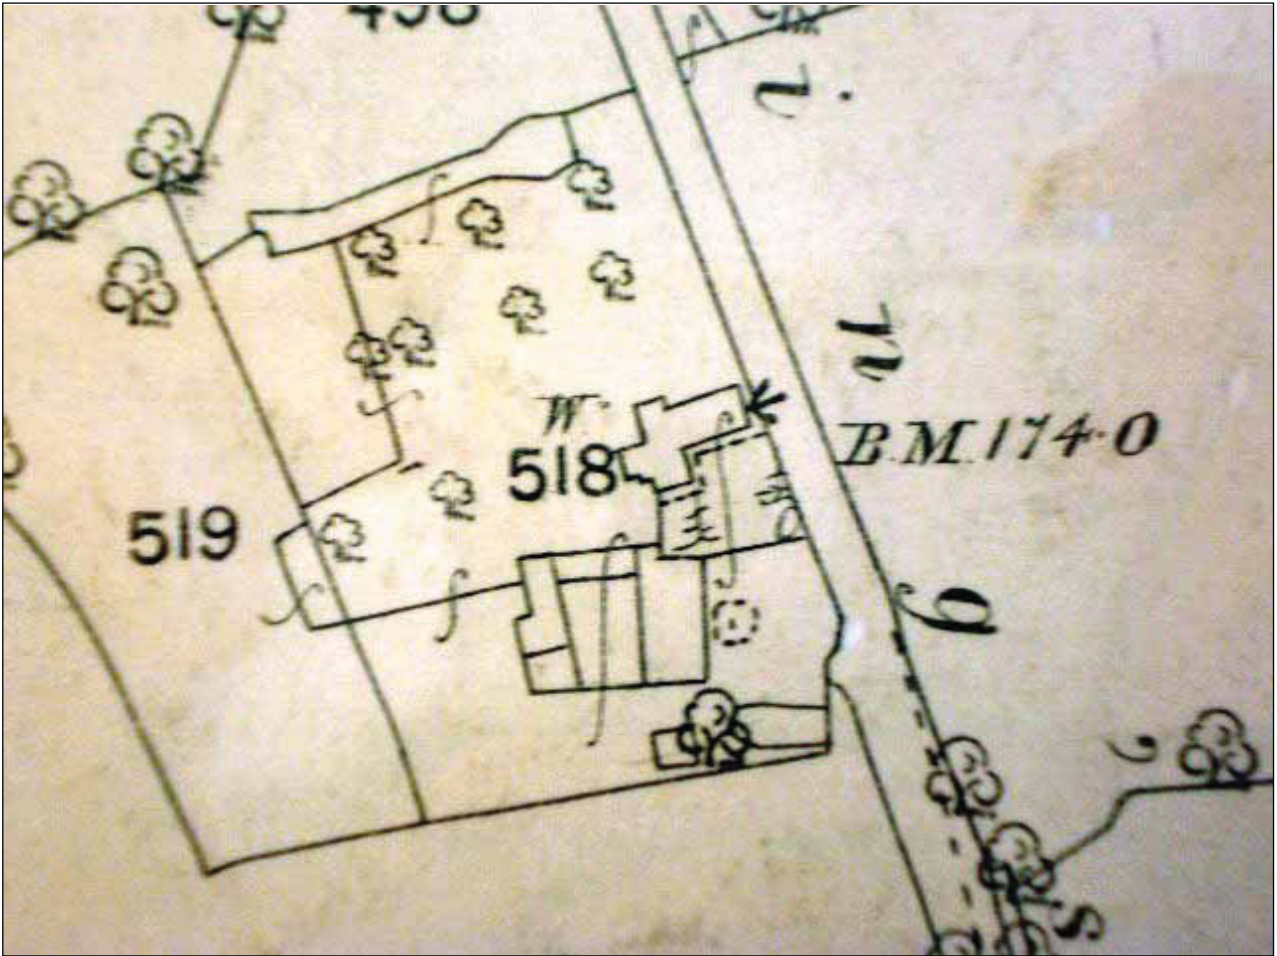
Figure 3: Ordnance Survey, 1st Edition (1885) (1:2500)

3.2.1 The Ordnance Survey map from 1885 (Figure 3) provides a more detailed and reliable plan of Mill Hall than the tithe map .

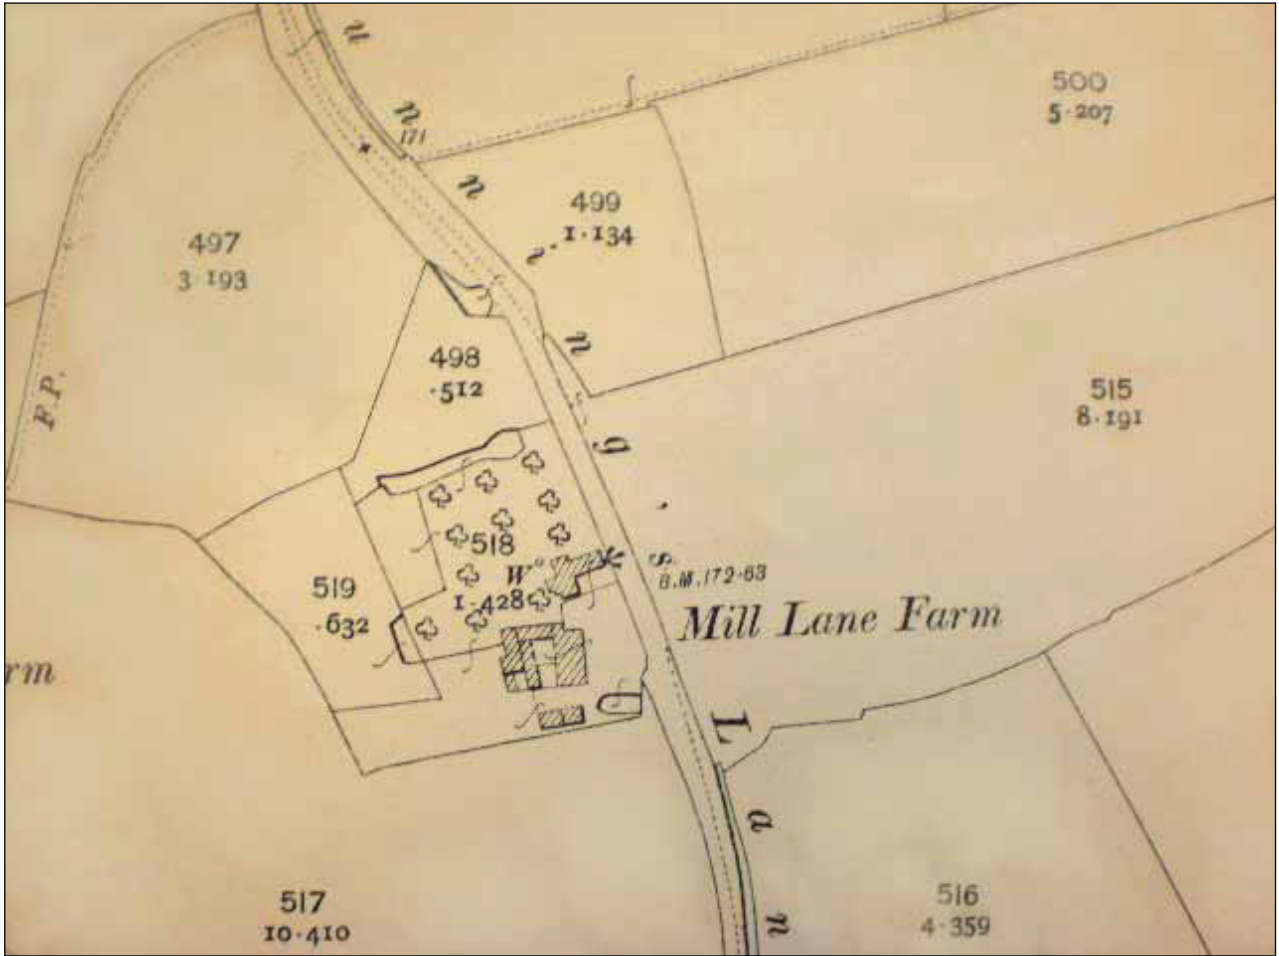
Figure 4: Ordnance Survey, 2nd Edition (1905) (1:2500)

3.3.1 By 1905, the group of buildings on the map is labelled as "Mill Lane Farm" (Figure 4).

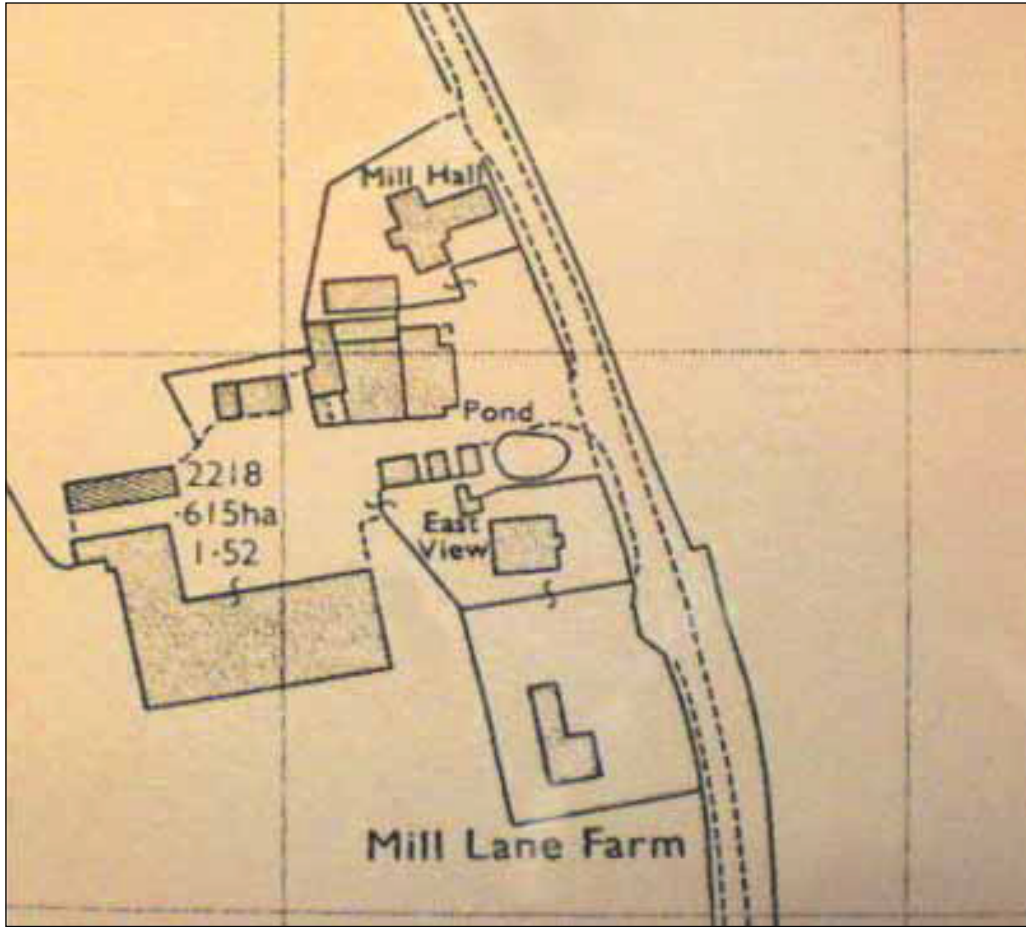
Figure 5: Ordnance Survey, 1981 showing Mill Hall (1:2500)

- 3.4.1 The next available map for consultation was the 1981 edition of the Ordnance Survey (Figure 5).
- 3.4.2 By 1981, it appears that the main building of Mill Hall has undergone renovations and alterations to make the layout proportions resemble exactly how it appears today. The modern extension appears for the first time, however, still not as extensive as it is today.
- 3.4.3 The outbuildings still resemble the layout shown on the previous Ordnance Survey map of 1905, still with no evidence of the outbuilding surveyed in its current layout.
- 3.4.4 This map indicates for the first time that the building under investigation may be separate to the group to the south, now labelled Mill Lane Farm, and the main house is now Mill Hall.

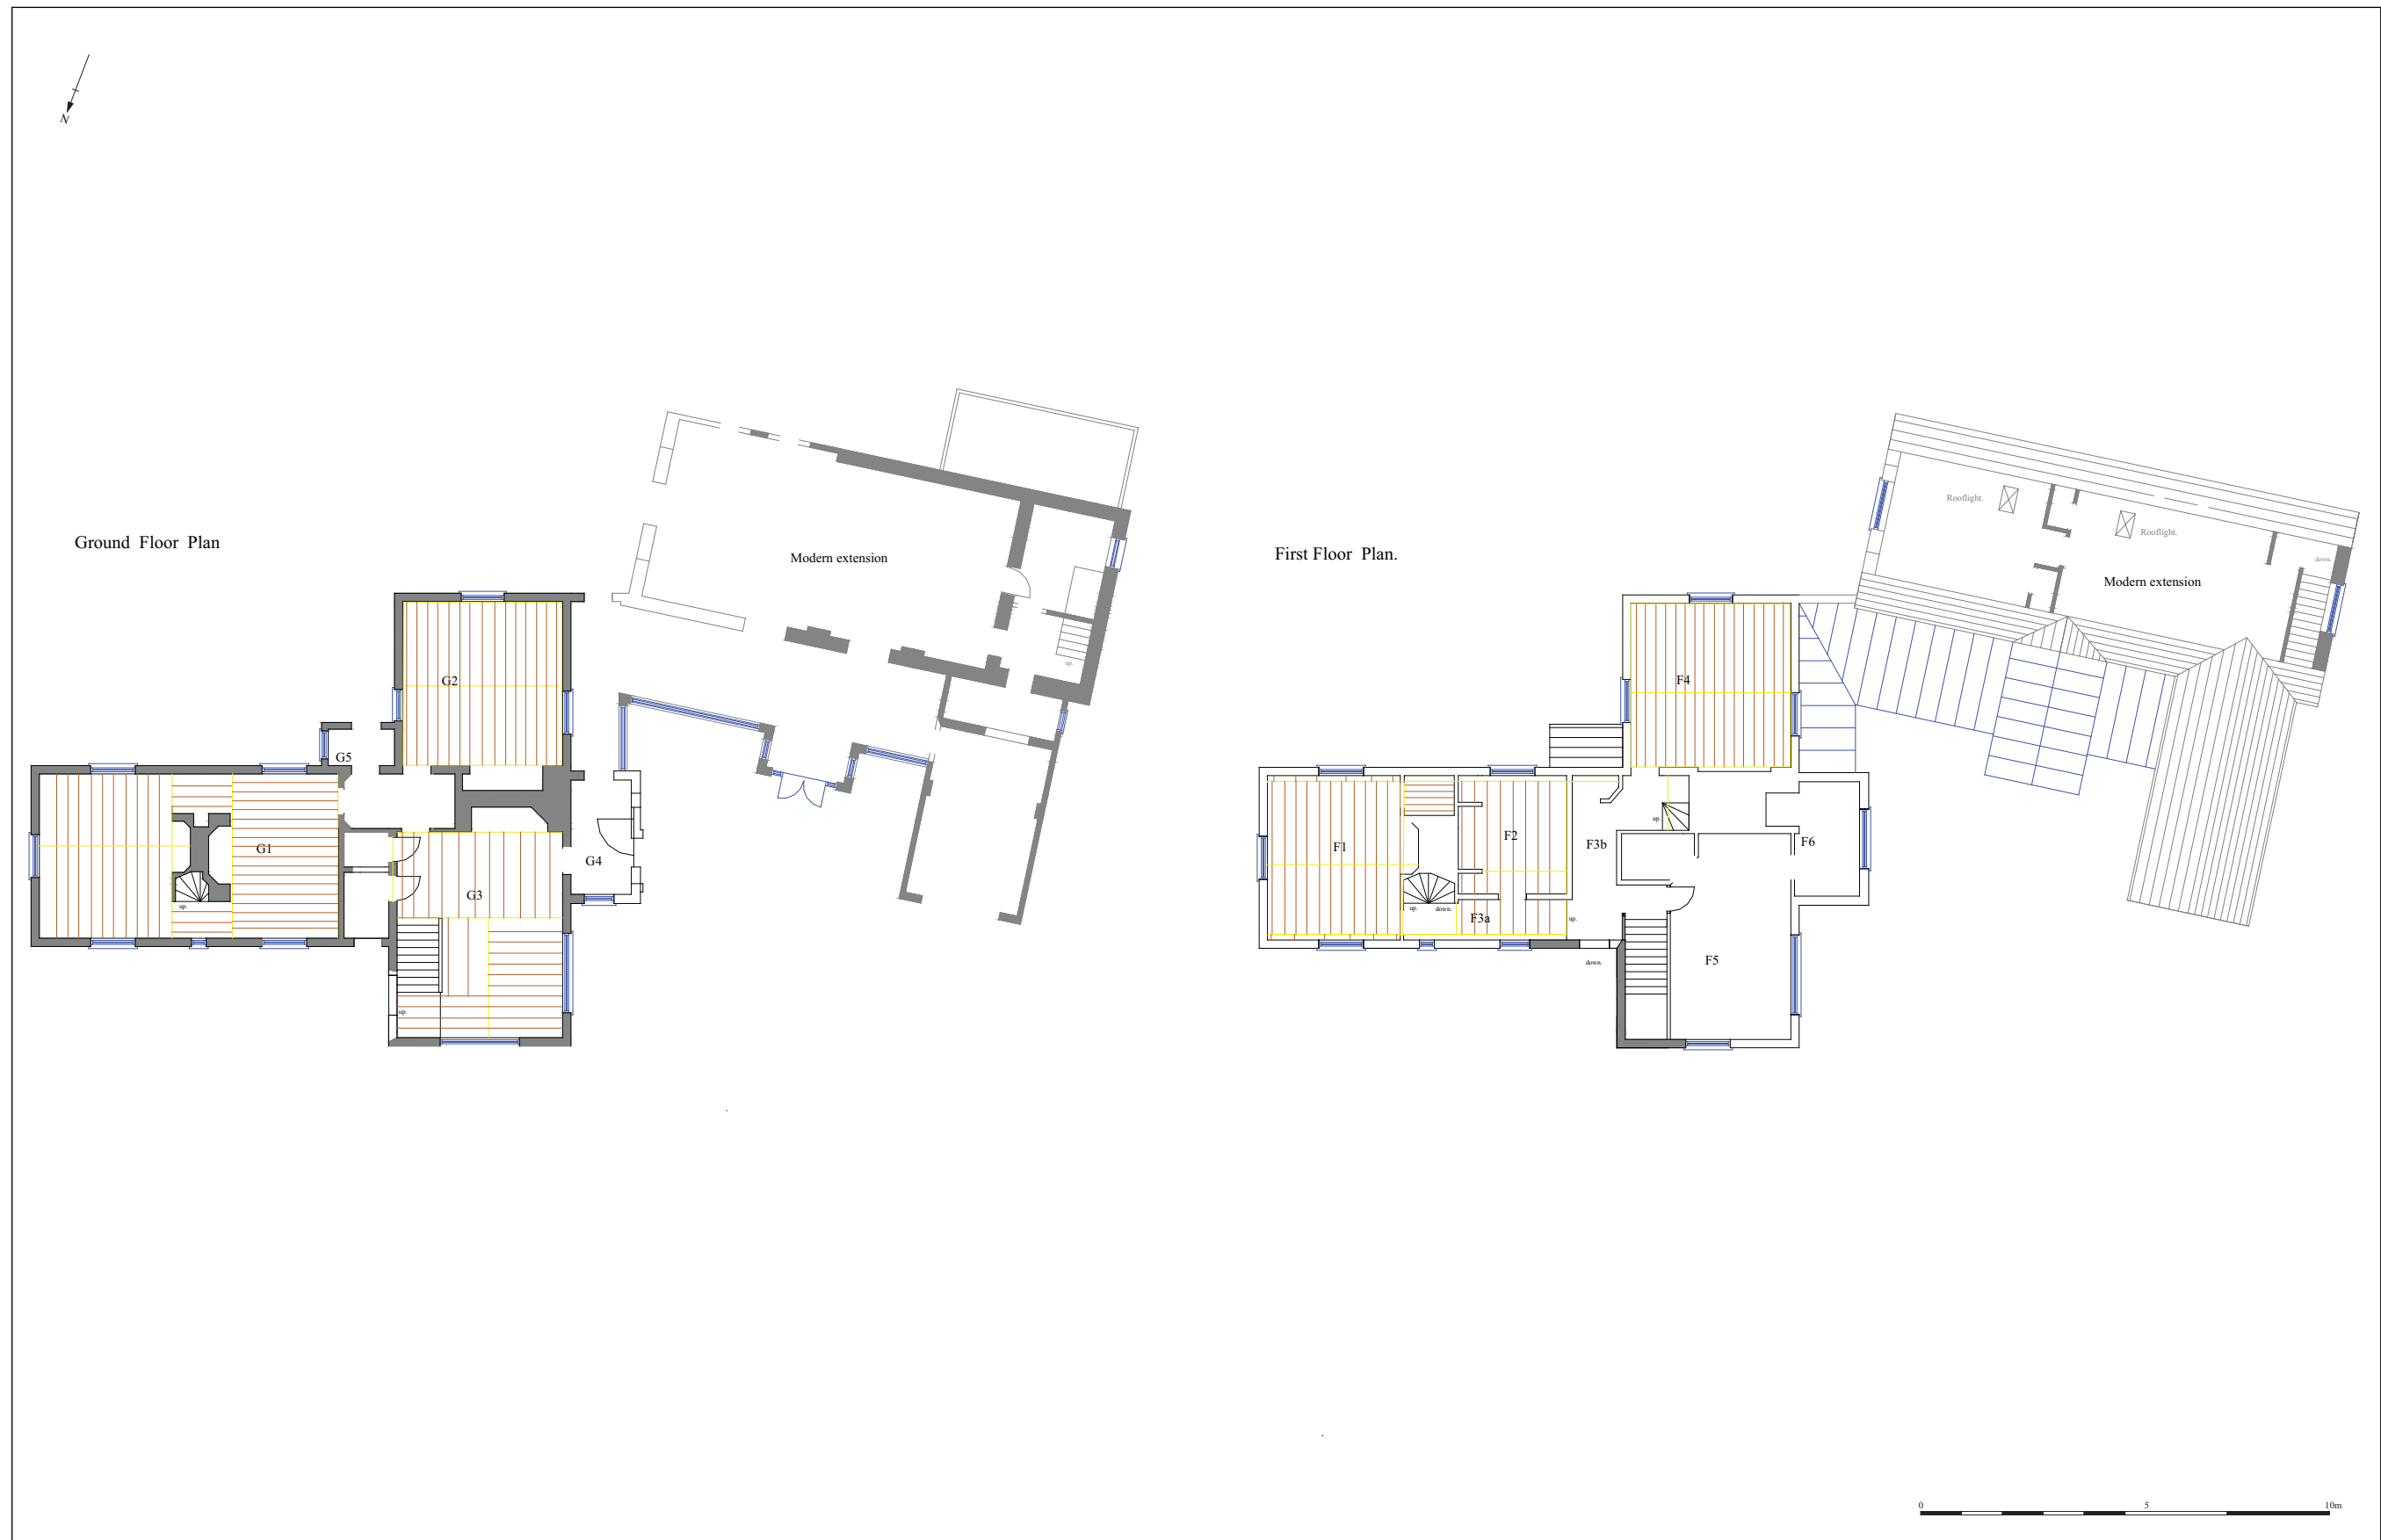
Figure 10: Plan showing orientation of overhead beams and joists (brown)

- 4.4.5 The ceiling joists in this room run in several different directions (Figure 10). They are quite decorative and comprise of three different moulded designs (Figure 12). The first, (Figure 12a) stylistically is very similar to an example of a moulded ceiling beam recorded in Kent dated to 1507 (Hall, 2007). The second type (Figure 12b). The third type (Figure 12c) was a very plain and less decorative type. These three types are used alternately in one part of the room and then the plainer types b and c used for the rest (plate 15). These moulded ceiling joists appear to be too decorative and large to fit into a room of this size. They appear to be more like moulded ceiling beams like those dated and recorded by Hall and therefore may have come from another building. Although they appear to fit within the ceiling beams, each one seems to have been repaired or filled for a better fit (plate 16) which would suggest they have been re-used and reconstructed. The joists were all chamfered at the ends with straight cut step stops, therefore if they were re-used for a smaller room, they were shortened at the ceiling beam ends and re-fitted and filled.
