**First White Cloth Hall  
Kirkgate, Leeds  
West Yorkshire**

Archaeological Watching Brief  
and Structural Watching Brief

Report no. 3460  
October 2020

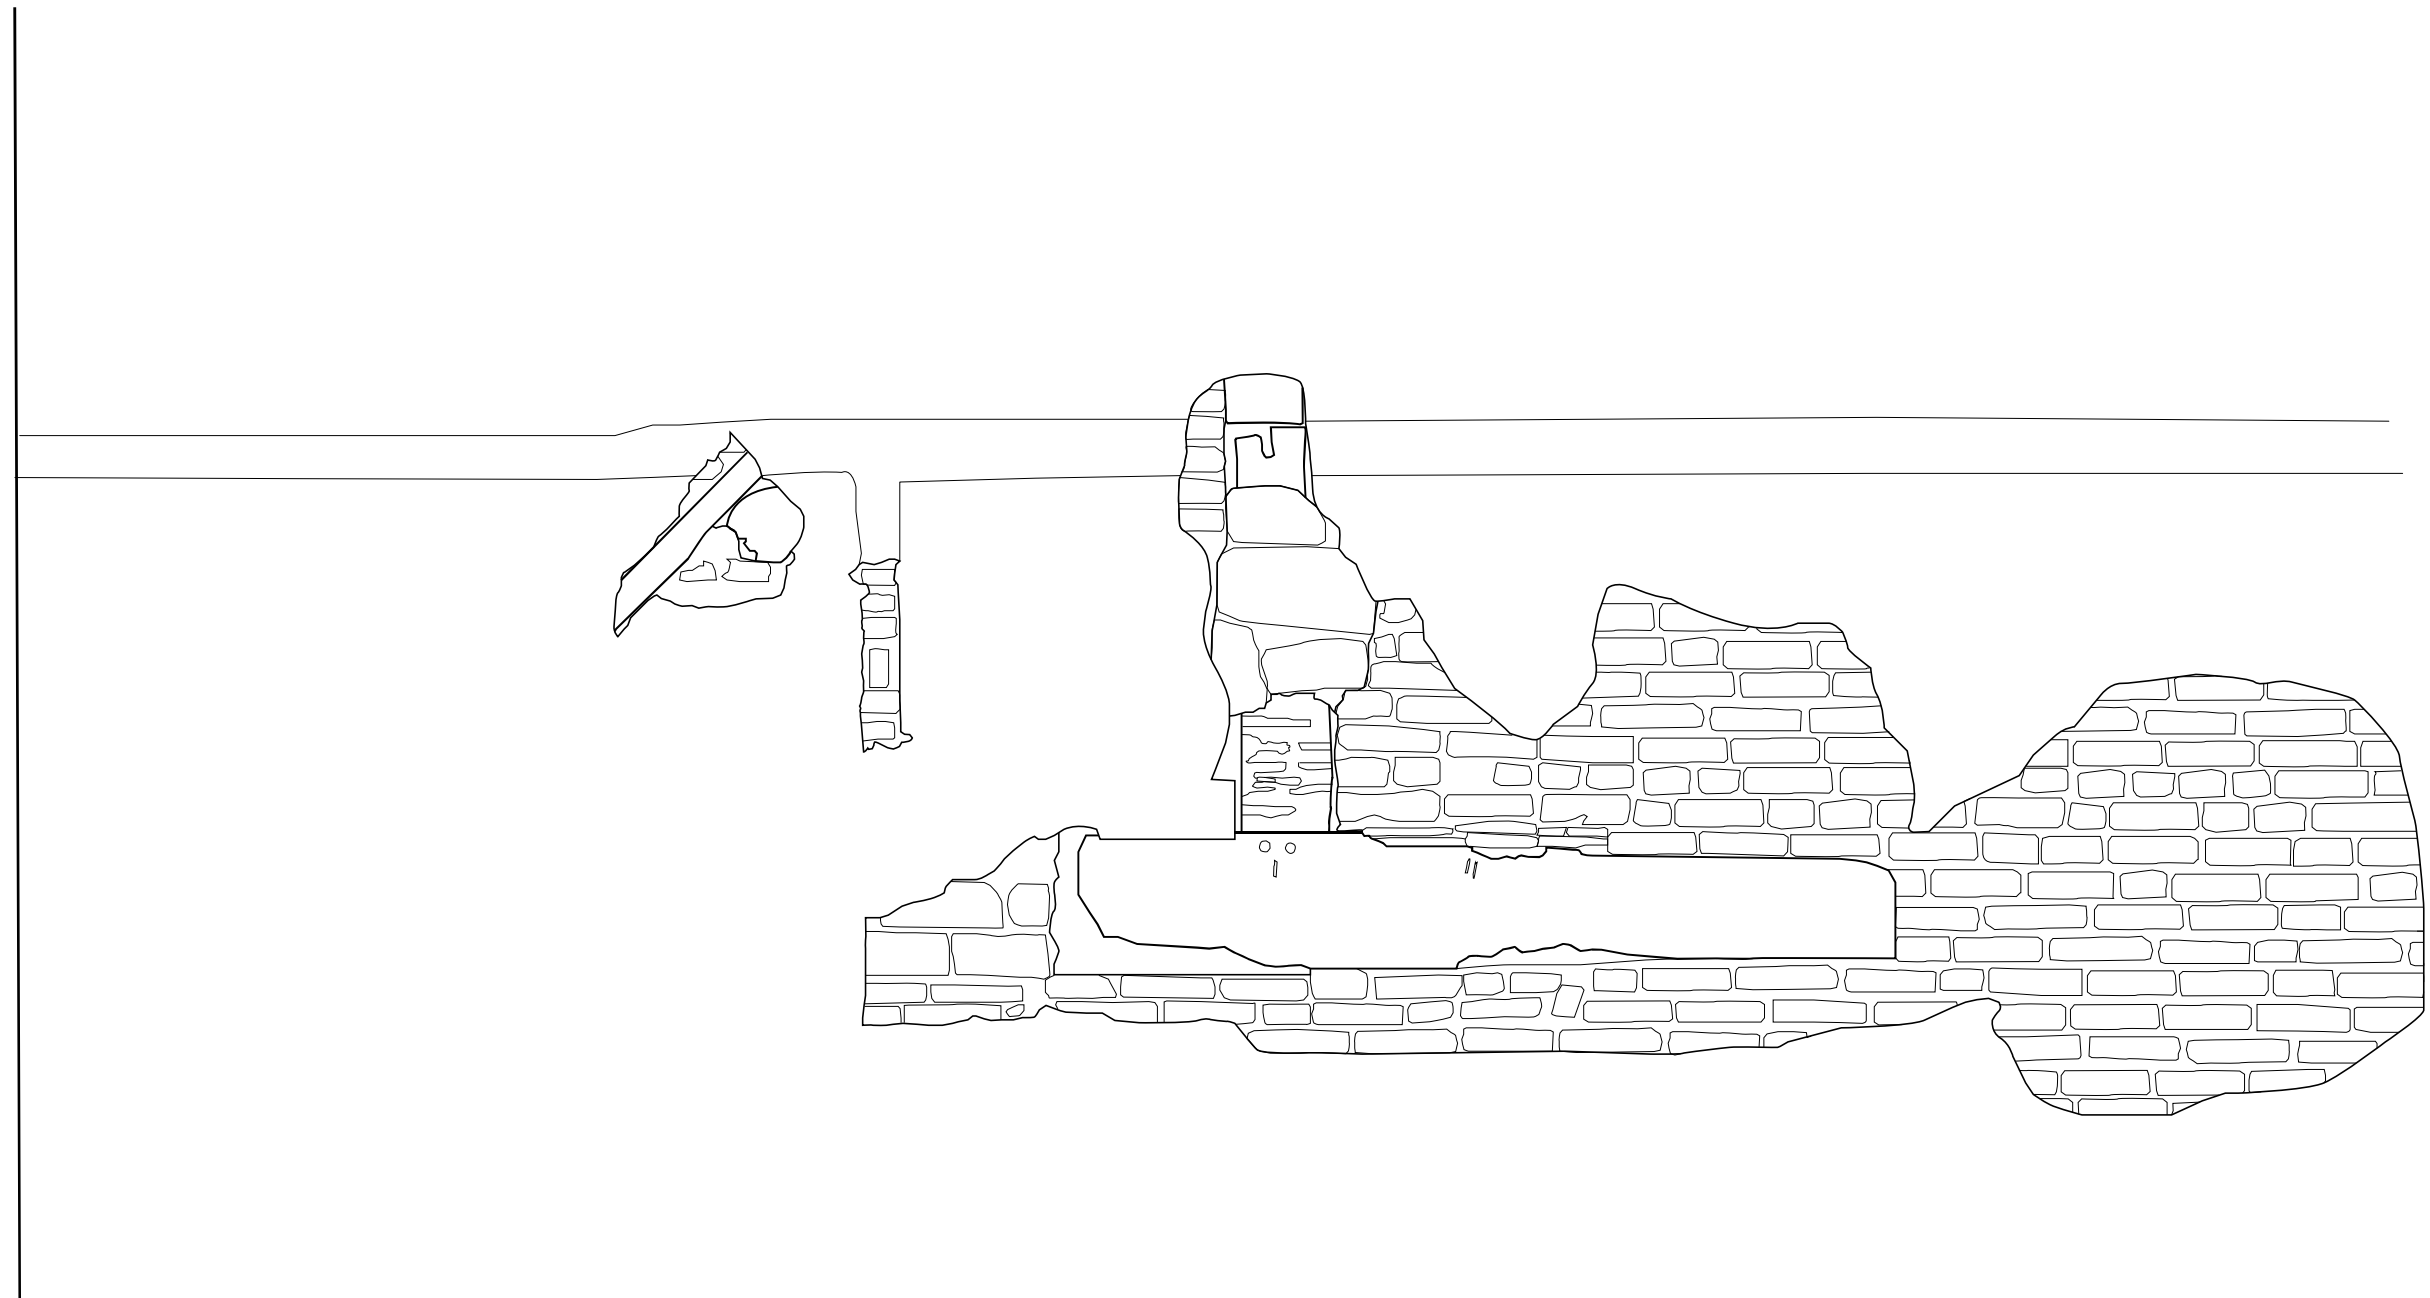
At the north end of the elevation, at first floor level, earlier timbers were identified (Fig. 10; Plates 62 to 65). The timbers were not fully exposed, as they were not beneath the plaster but encased within the east wall, sealed by a skin of brickwork and mortar associated with the construction of the FWCH. The timbers appear to be a part of a former King-post truss rather than a timber framed building. A possible purlin was also identified supporting a rafter. The purlin was only seen in section but appeared to be a roughly shaped tree trunk. The presumed King-post had a pegged mortise and tenon joint with the presumed tie-beam, both had been carved with the Roman numeral I. The Roman numeral II was also identified on the tie-beam. Towards the upper section of the King-post there appeared to be a mortise slot for a strut. Evidence for lathe and plaster was also observed on the king-post.

Fig. 10. Detail of timbers encased in the east wall of the east range (scale 1:20 @ A3)

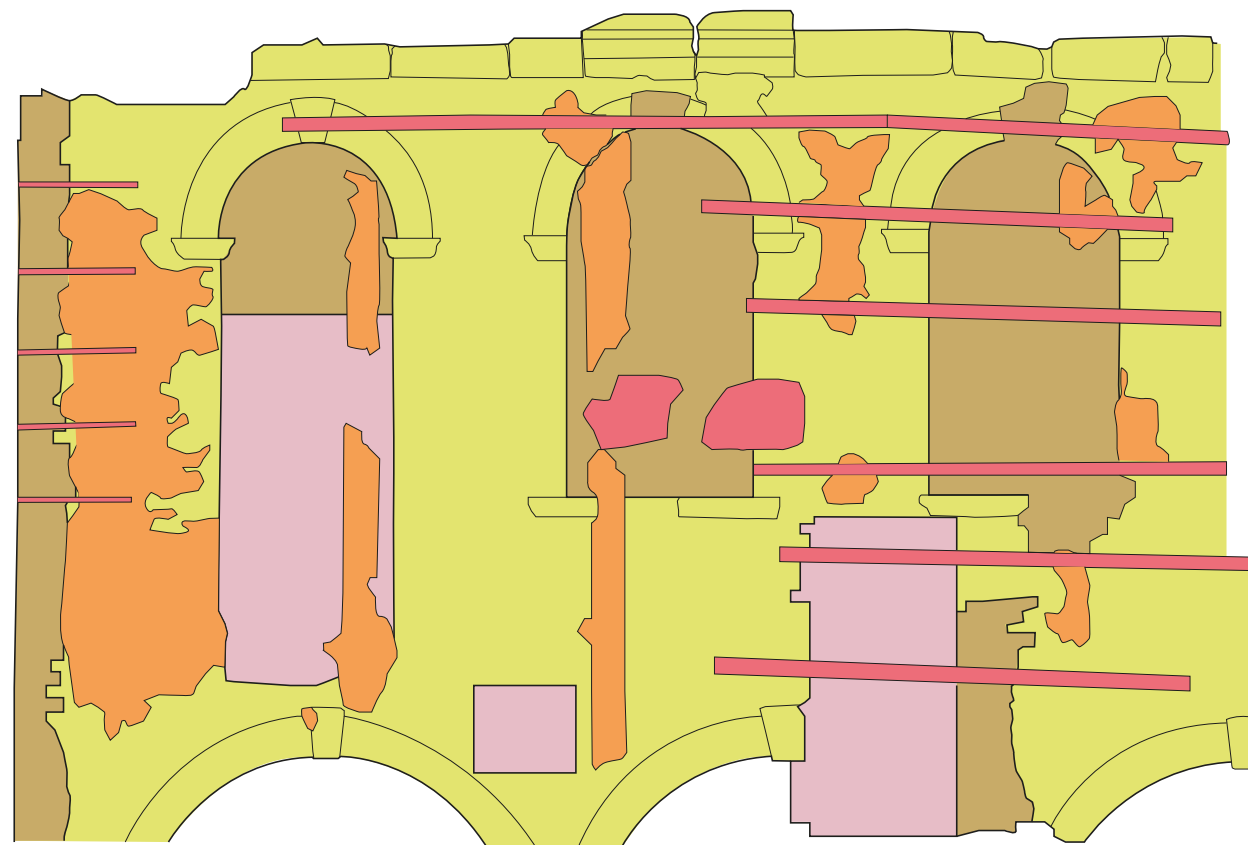
function. The sandstone sill remains are fragmented (Plates 69 and 70), two pieces remain in situ for the second window from the north end, and one piece is in situ for the third window. Figure 11 illustrates their location. The ends of the sills appear to have a slight cyma reversa ogee profile and taper in at the base. The fragments are 0.13m thick, with the positioning of the pieces indicating the sills would have had a length of *c.* 1.70m.

Fig. 11. External west elevation of the east range, showing the detail of the three windows at the north end of the first floor (1:50 @ A3)

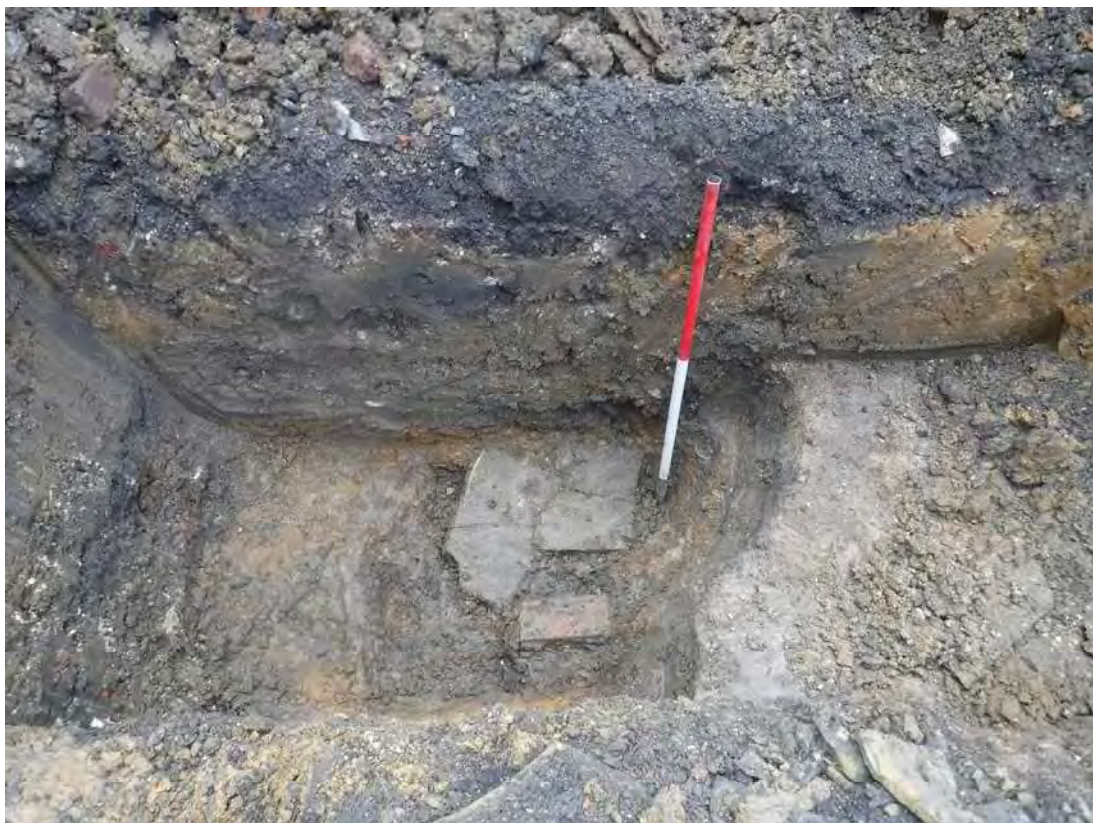
Plate 2  
Test Pit 4, southwest facing section of feature 109, 110 and 104

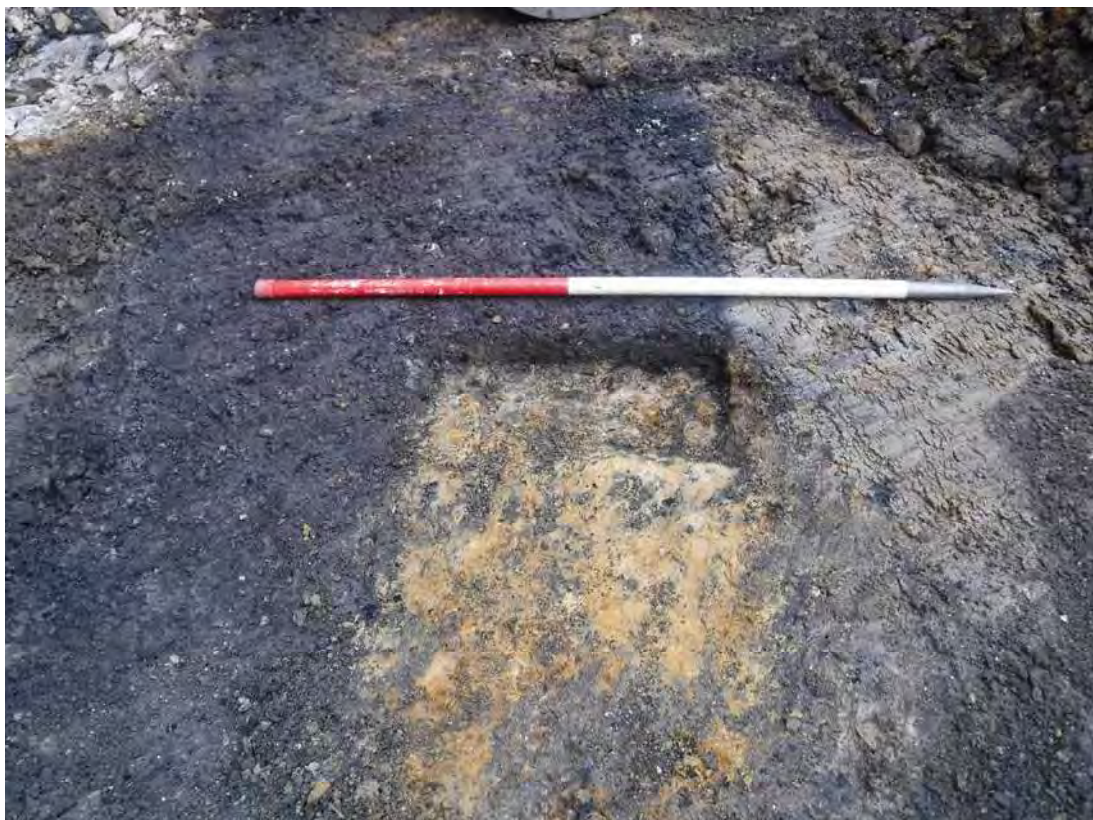
Plate 6

Pit 119

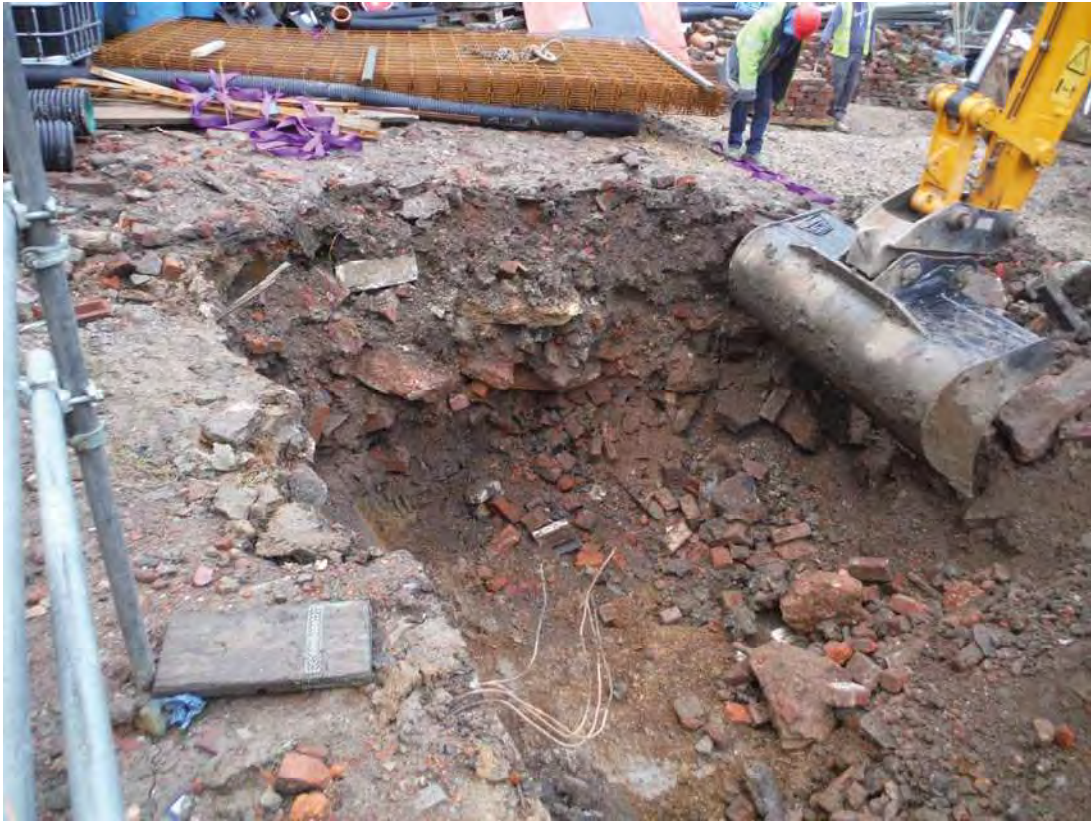
Plate 7

Working shot of ground level reduction in the west corner of site, showing demolition debris 140

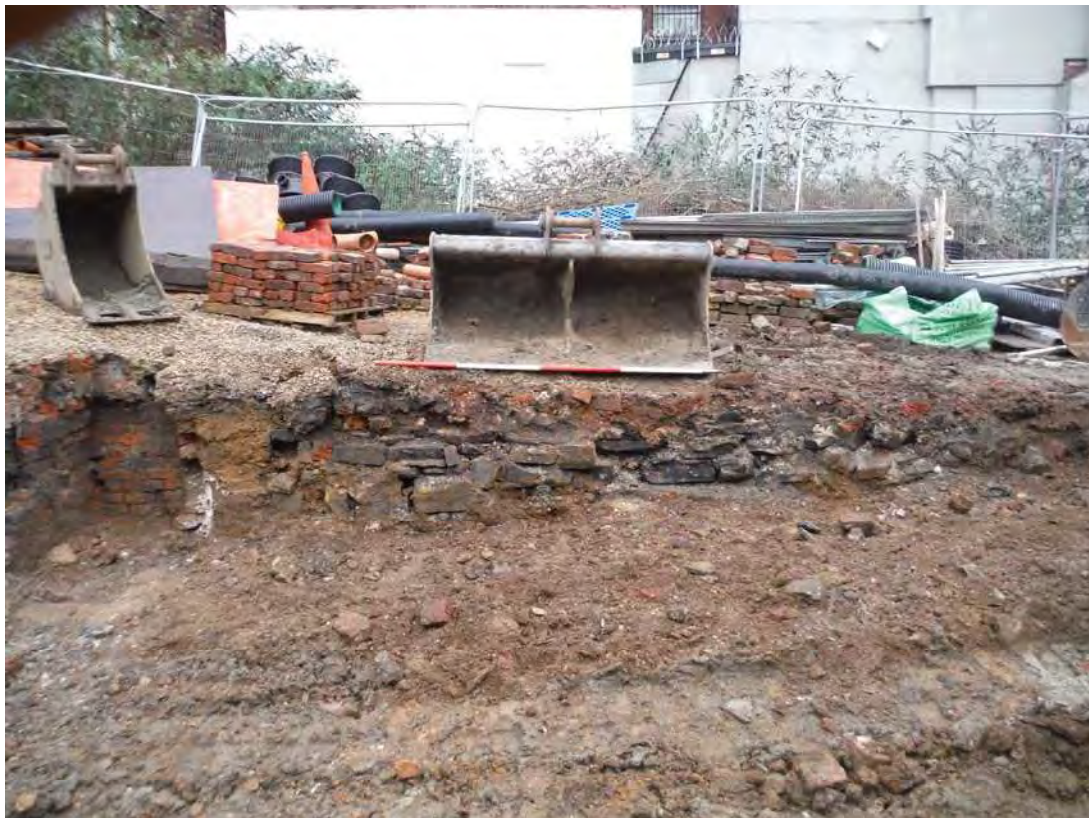
Plate 10

In the west corner of site amongst the demolition debris (140), the remains of a cellar were encountered, the cellar was located at the west end of the south range, and the foundations of the west wall of the west range were also observed. The foundations (137; Fig. 6, S. 06; Plate 10) survived to a maximum height of 0.95m and length of 4.30m, and were constructed of random rubble stone, bonded with a pale grey lime mortar. Signs of burning to the wall were observed. At the south end, the foundations had been cut by the construction cut (138) for the later built cellar at the west end of the south range, which was likely constructed when the south range south wall was re-built in the late 19th/early 20th century. The void between the construction cut (138) and cellar wall 136 was filled by deposit 139, a yellow-brown silty clay.

East facing elevation of the foundations of the west wall of the west wing of the FWCH

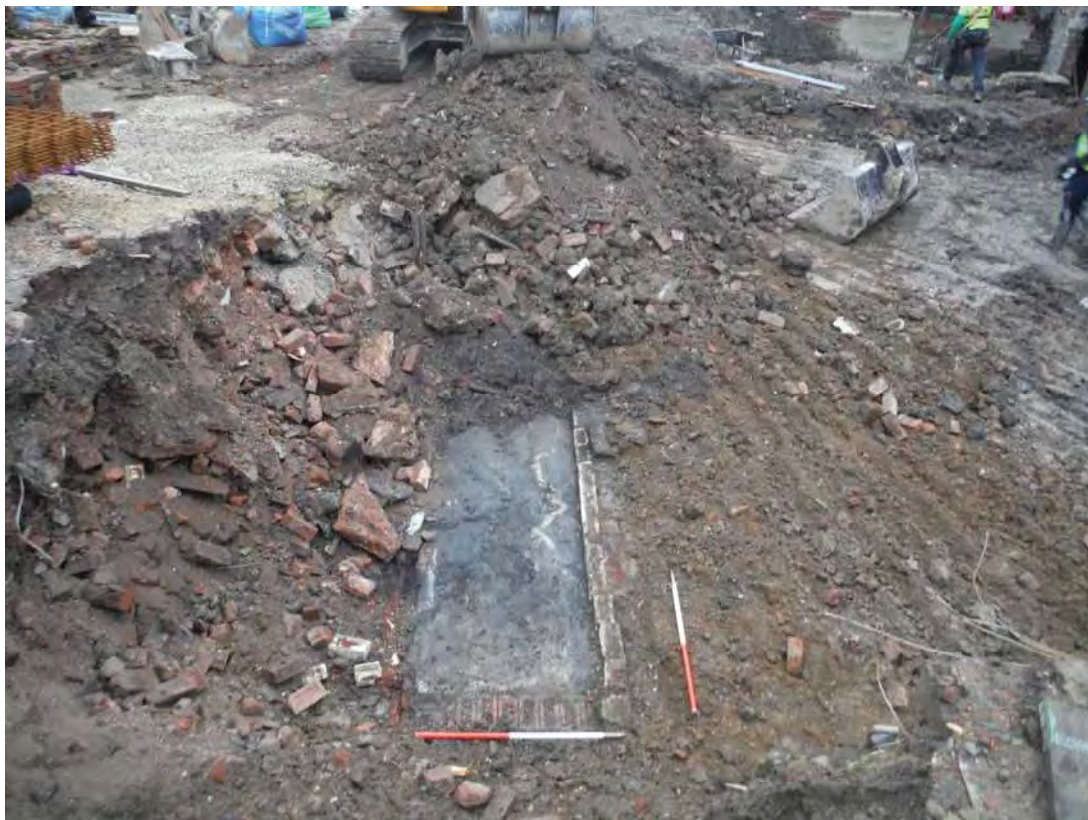
Plate 11

The cellar (Fig. 6, S. 06; Plate 11) encountered comprised a wall forming the partial remains of a square room. The wall (125) was constructed of bricks two skins wide, the outer skin was constructed of handmade bricks and the inner skin was constructed of early to mid-20th-century machine made frogged bricks which were stamped with 'LFC°L<sup>D</sup>'. The internal side of the bricks had a white glaze finish. A concrete surface (126; 31.00m aOD) was encountered along the internal east side of the cellar, and it extended to the west for 1m. The internal base of the cellar was not reached, and the level of the concrete surface (126) was much higher suggesting a possible half landing or perhaps the cellar floor was later raised in the late 20th century.

Cellar at the west end of the south range

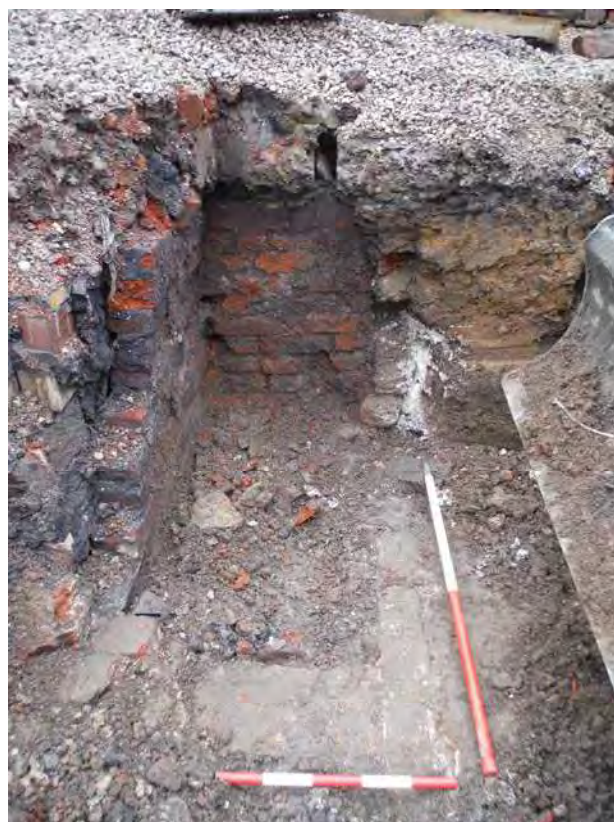
Plate 12

Against the external north side of wall 125 a small rectangular brick feature (Fig. 6, S. 06; Plate 12) composed of brick walls 134, 135 and 136 was encountered. The feature was 1.11m long, by 0.68m wide and survived to a maximum height 1.16m. The walls were constructed of handmade bricks and appeared contemporary with the outer skin of wall 125. It was not clear what the rectangular brick feature was, but it possibly related to staircase access into the cellar.

Brick feature abutting the north side of the possible cellar

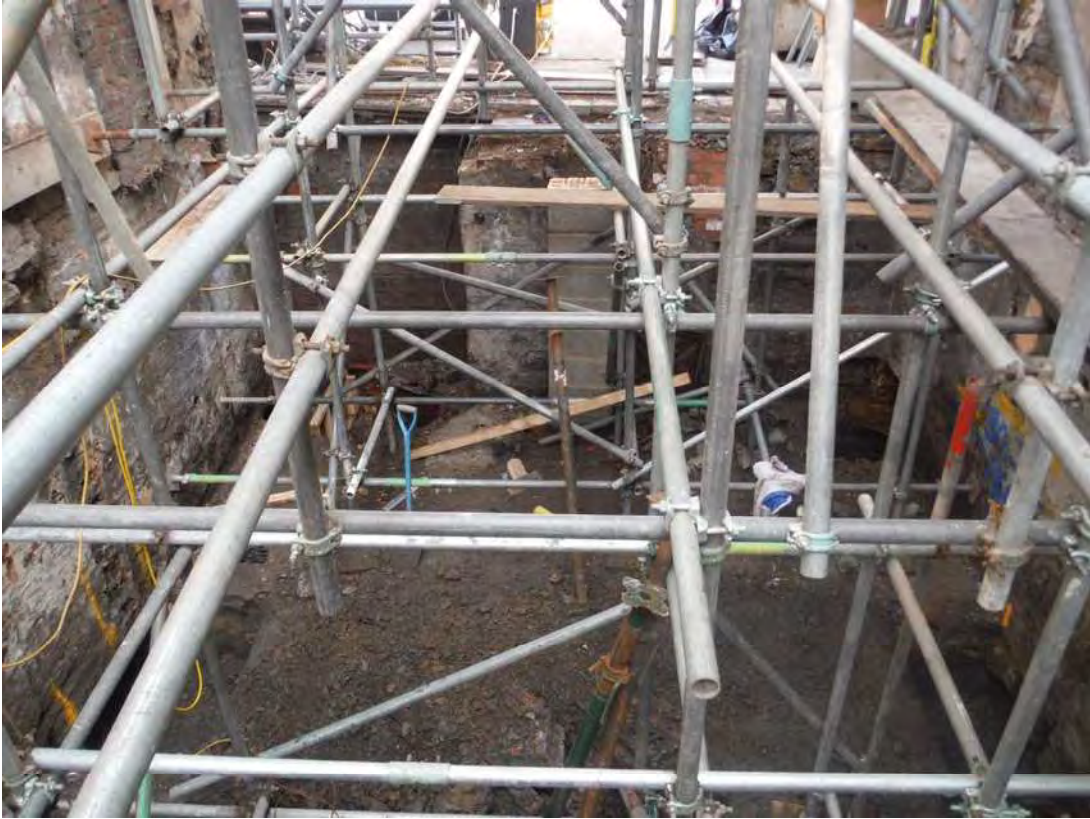
Plate 13

Pile Pad pits 1 to 7 (Plate 13) were excavated within the cellar at the north end of the east range. PP2 and PP5 utilised and extended TP1 and TP2 to a length of 1m. A sequence of

View into the cellar showing the pile pad pits

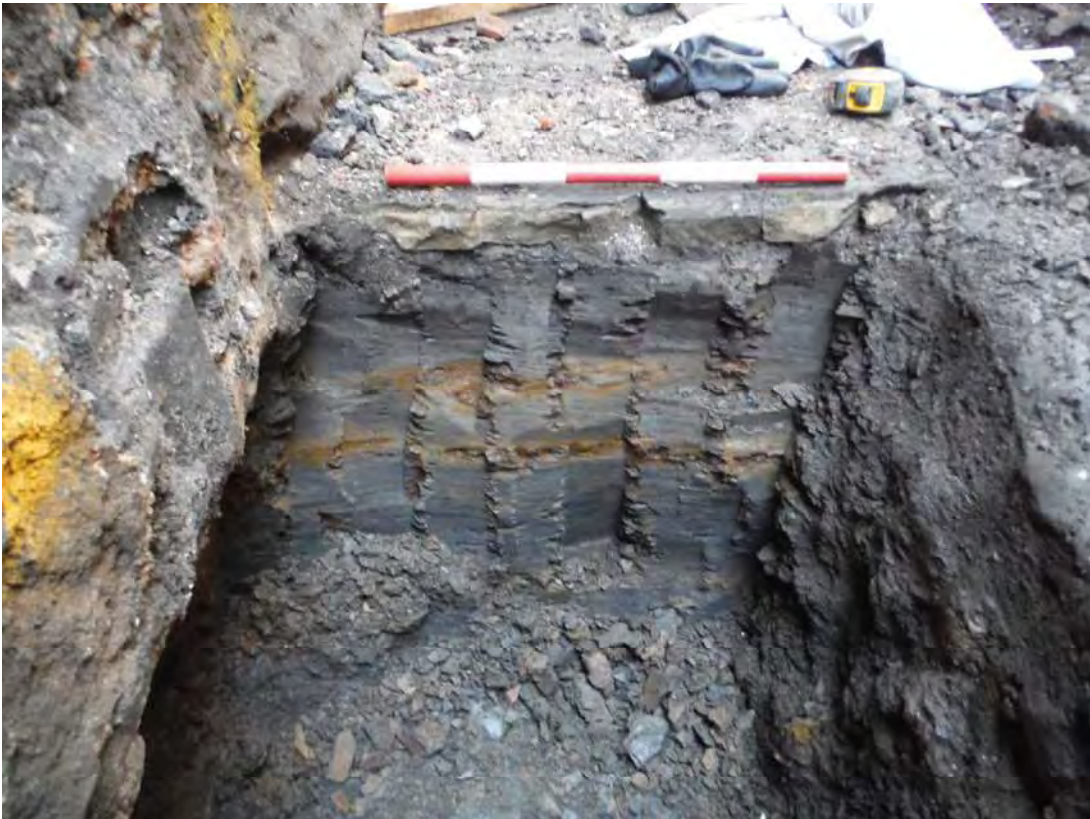
Plate 14

levelling deposits (Fig. 8, S. 09; Plate 14) were encountered underlying the early 19th-century flagstone surface of the cellar. Natural geology (115) was reached at a depth of *c.* 0.46m (*c.* 29.10m aOD), which was overlain by 0.24m of a pale grey silty clay with lenses of mid-yellow-brown silty clay (116) and appeared to be re-deposited natural. Deposit 116 was overlain by 117, a 0.22m thick made ground levelling deposit composed of dark grey clay containing charcoal flecking and fragments of brick, which was sealed by the cellar flagstone surface. Prior to the excavation of PP7, the passageway which led to the original staircase access into the cellar was cleared of building debris (Plate 15). At the south end of the passage a large sloping stone slab was encountered in situ and was determined to be the base riser for the staircase. No further evidence for the construction of the staircase was encountered on the east and west elevation of the passageway, possibly suggesting the remaining steps were constructed of a free standing timber structure. Within PP7, a northeast to southwest aligned ceramic drain was encountered, underlying the flagstone floor, and in the north corner of the cellar where PP6 was located, there was a drain access point (Plate 16), which appeared Victorian in date.

Southeast facing section of PP5

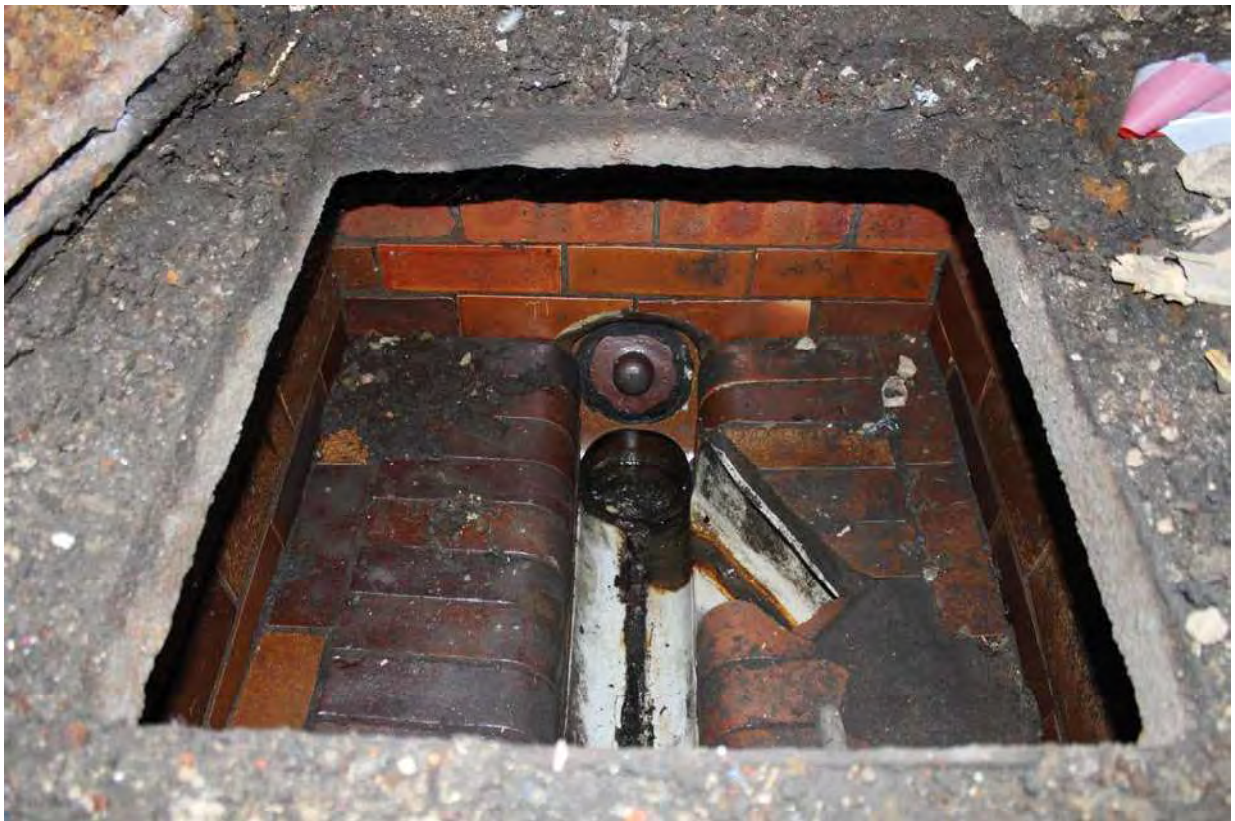
Plate 16  
Drain access point in north corner of cellar

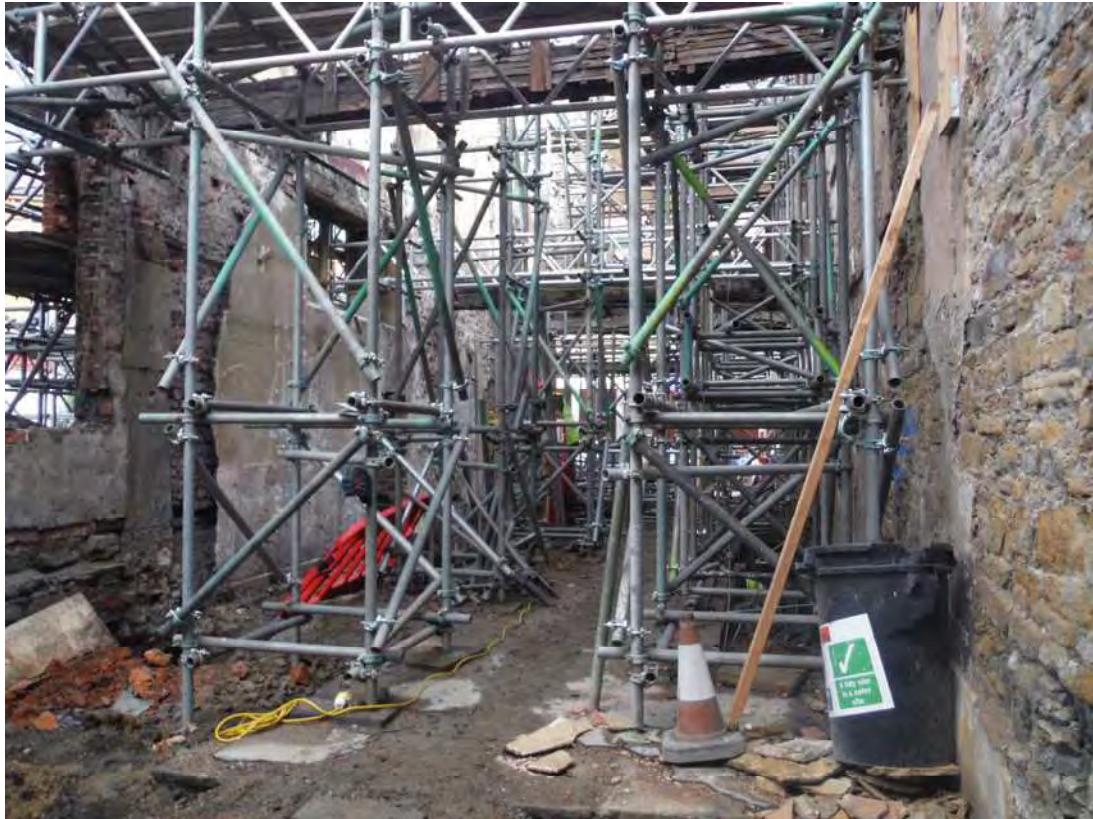
Plate 17

Pile Pad pits 8, 19 and 20 were located centrally within the east range at ground floor level (31.75m aOD; Plate 17). The extant floor surface in this area comprised modern concrete, which was removed in the areas of the pile pad pits prior to their hand excavation. PP19 utilised TP3 and PP20 was 1m in length. PP8 (Fig. 8, S. 10; Plates 18 and 19) was positioned along the east wall of the east range, undercutting the wall by 0.12m. Earlier deposits underlying the wall were encountered, so too was the sequence of deposits within the building which were consistent with PP19 and PP20. The northwest facing elevation showed that natural (141) underlying the east wall was at a depth of 0.29m. This was overlain by made ground deposit 118, which comprised a re-deposited natural, which in turn was overlain by 0.10m of mid-grey-brown clayey silt levelling deposit (142). Overlying the levelling layer was the stone section of the east wall of the FWCH. On the northwest facing section, visible for 0.15m in width on the north side and extending beyond the base of PP8, is the brick built cellar wall (111) of the east range. The wall is early 19th century in date, and was constructed underpinning the masonry of the east wall. No construction cut for the cellar wall was visible, indicating the wall was constructed flush against its cut.

View of central area of east range during the excavation of the pile pad pits

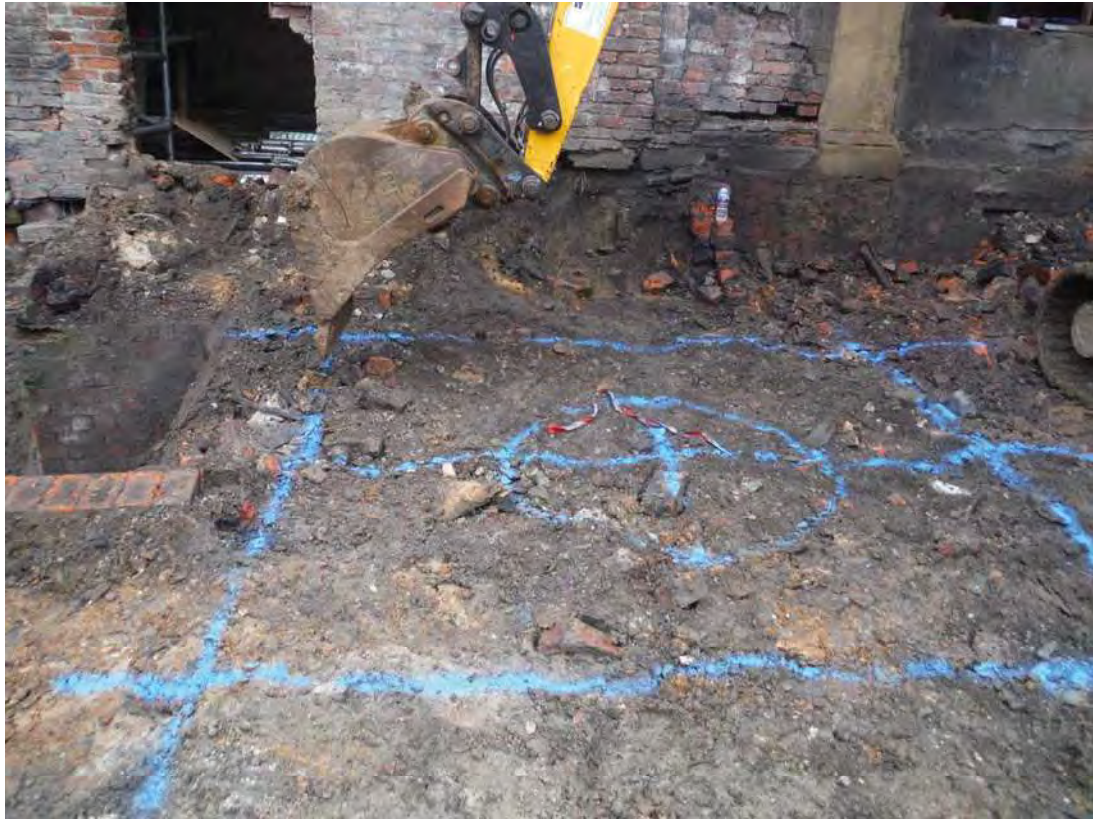
Plate 25

The Pipe Trench was located along the west side of the west wall of the east range. It was *c.* 9.50m long by *c.* 0.70m wide and opened out into a larger area at the north end *c.* 2.50m by *c.* 2.50m (Plate 25). During the ground level reduction in preparation for the machine excavation of the Pipe Trench, the remains of wall 124 (Plates 26 and 27) was encountered. Wall 124 had a northeast to southwest alignment and was constructed of handmade bricks bonded with a lime mortar. The wall was two skins wide and was the foundation for the west side passageway wall, which was constructed in the early 19th-century through the south range. On the east side of the wall, infilling the passageway area, was a 1.10m thick deposit of dark grey-brown clay silt with frequent rubble debris. At the base of the deposit, a ceramic drain was visible and likely related to the drain identified above PP13. To the west side of wall 124 was made ground deposit 123.

View of area at north end of pipe trench, prior to excavation

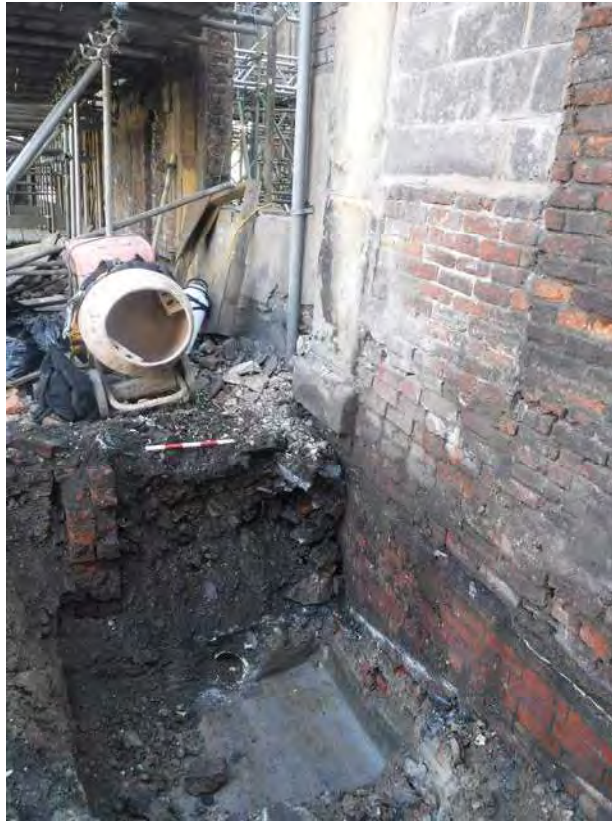
Plate 27  
Southwest facing section showing wall 124

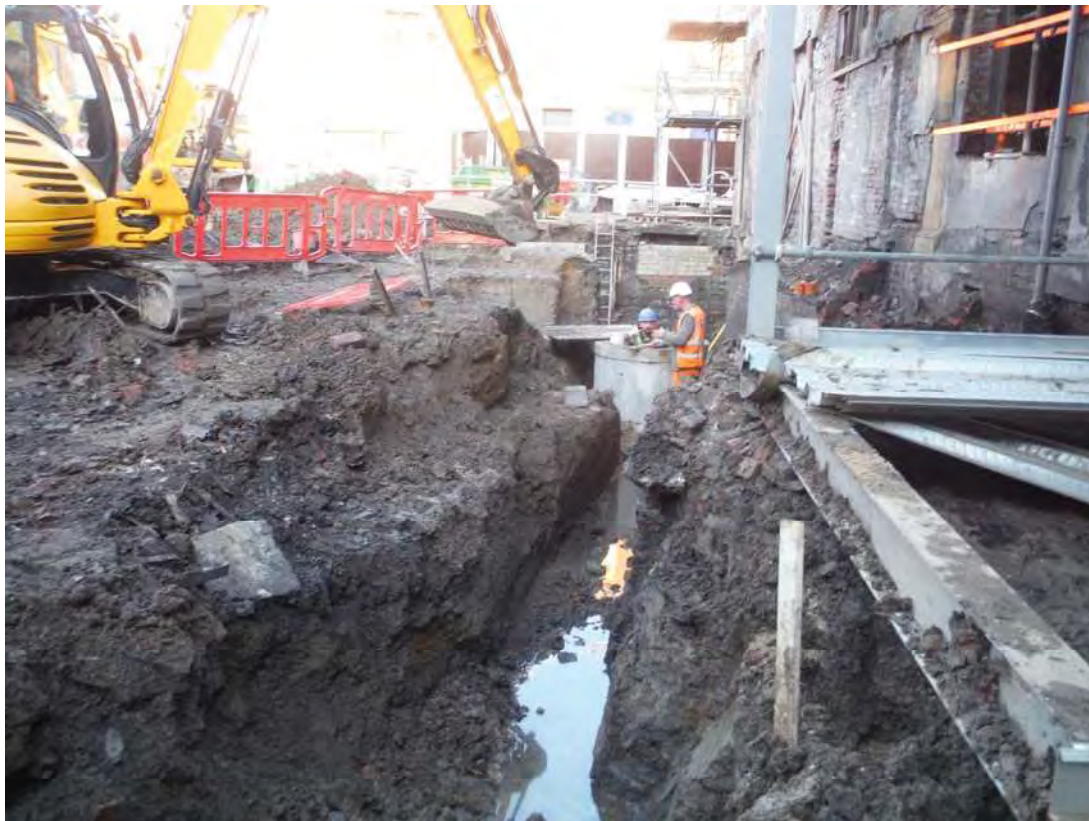
During the excavation of the Pipe Trench, the area directly to the north side of the passageway was found to comprise 0.52m of made ground deposit 123 overlying made ground deposit 113 (Plate 28). At a later date, at the south end of the Pipe Trench, a perpendicular trench was excavated on a northwest to southeast alignment, 0.60m wide and

Plate 28  
Installation of drain at the north end of the Pipe Trench

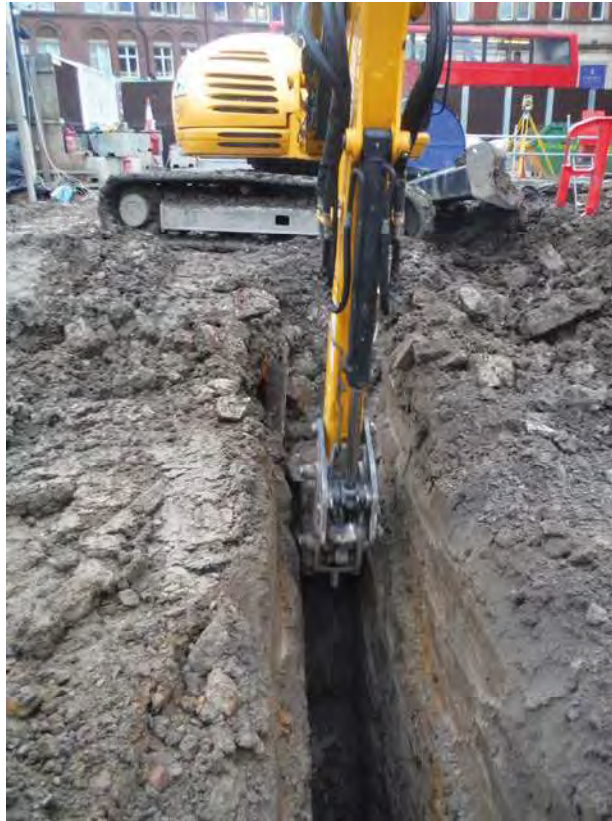
Plate 29

The Foundation Trench (Plates 29 to 31) measured *c.* 15m long and was excavated by machine to a depth of 2.40m. The south 5m of the trench was *c.* 0.60m wide and the remaining length was *c.* 0.40m wide. Natural geology was reached at a depth of 0.40m (*c.* 30.60m aOD) and was overlain by made ground deposit 123. As made ground deposit 113 and 114 were not encountered overlying the natural here, it was determined that made ground deposits 113 and 114 were localised to the south range area of the building.

Working shot of the excavation of the Foundation Trench

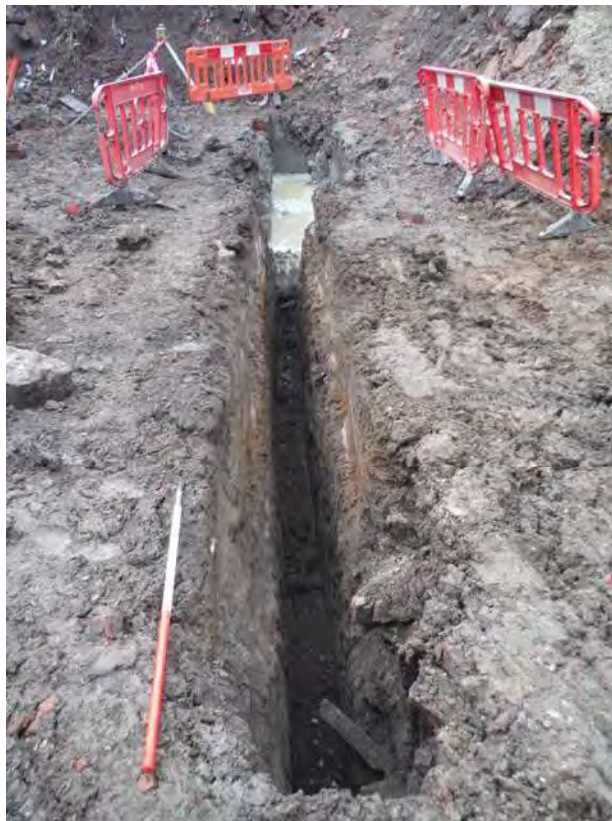
Plate 30

View along the Foundation Trench

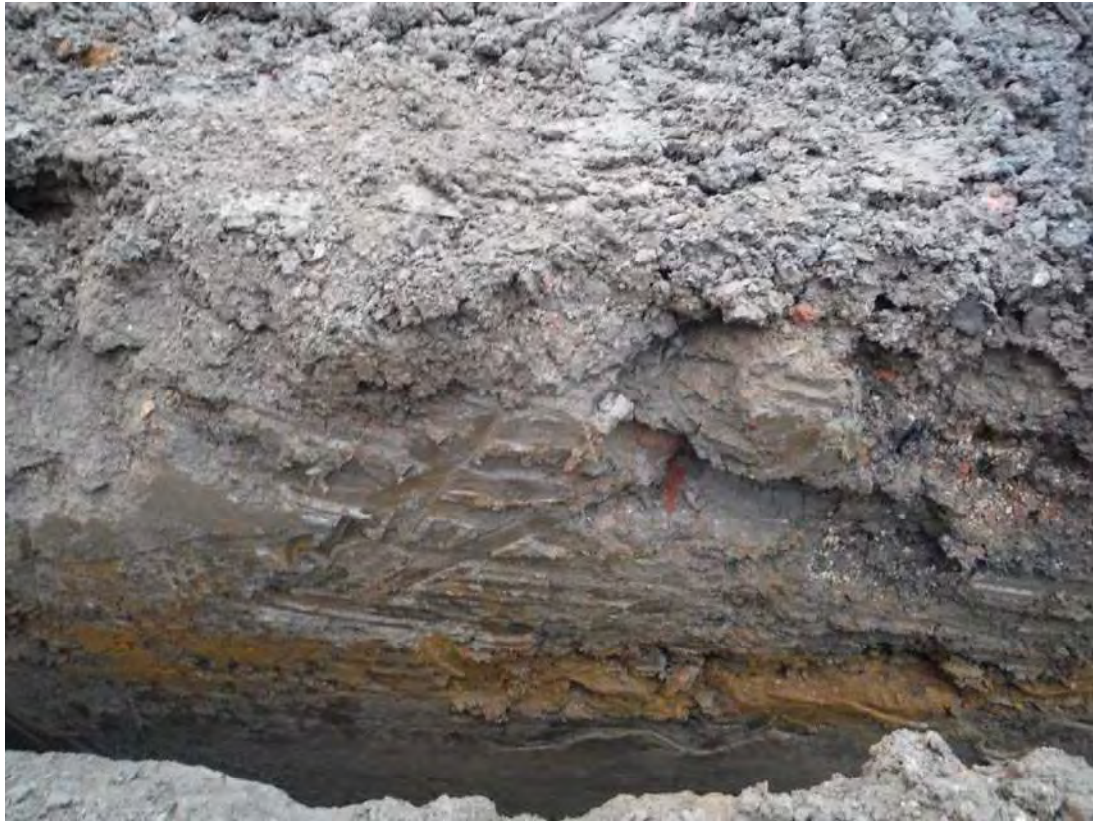
Plate 31

Northwest facing section of the Foundation Trench at the north end

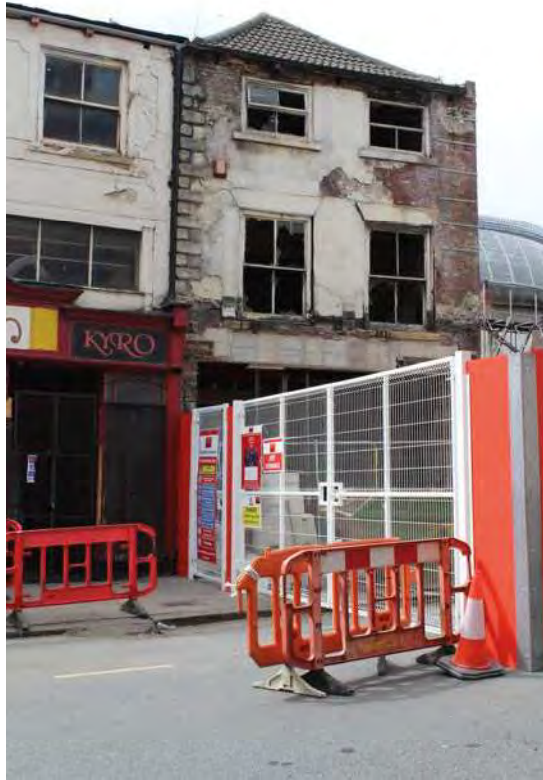
The exterior north elevation (Plate 49) of the east range is brick-built and had been finished with 20th-century render. The lower part of the original elevation had been removed (Plate 50) to make way for a late 19th-century shop frontage. Surviving on the east side, formerly only visible at first floor level, are side alternate chamfered stone quoins (Plates 51 and 52).

Plate 49  
North exterior elevation of the east range

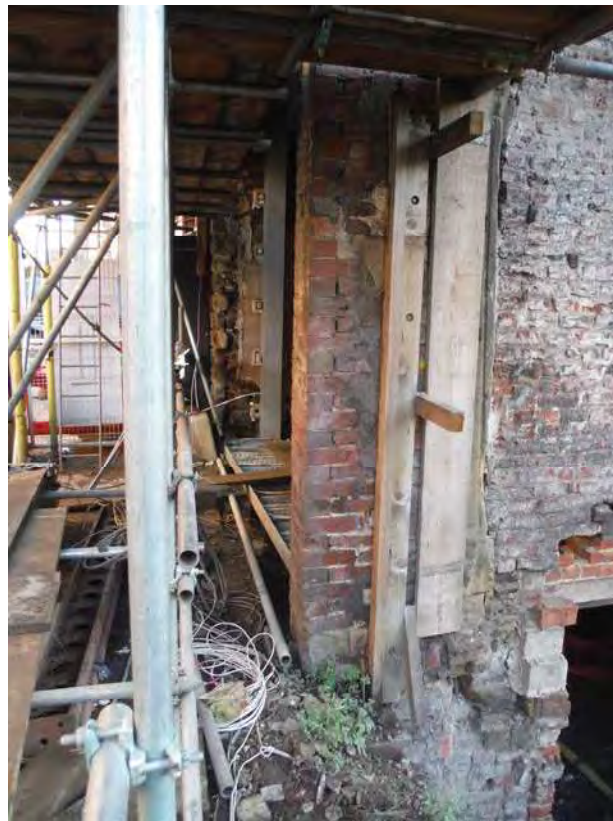
Plate 50  
Ground floor level of the north elevation of the east range

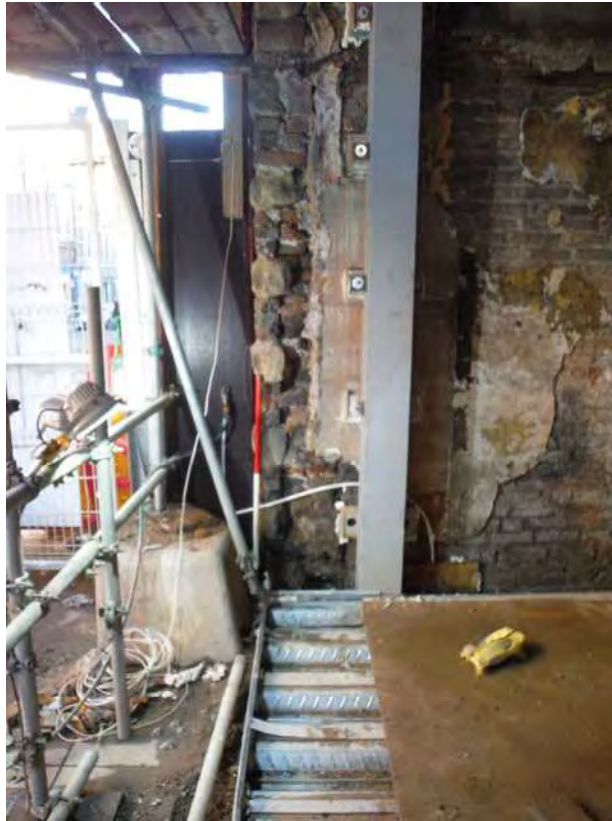
Plate 51

East side, ground floor level of the north elevation of the east range

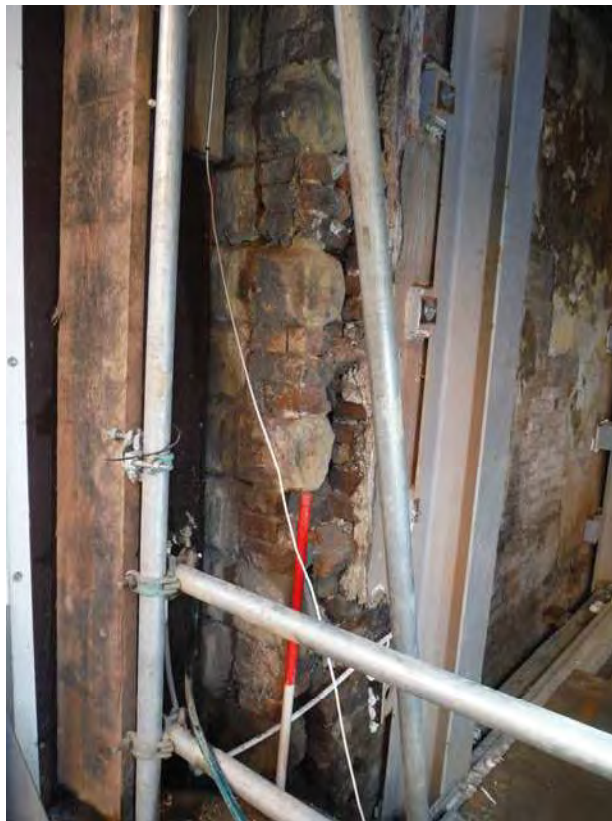
Plate 52

Detail of east side quoins of the north elevation

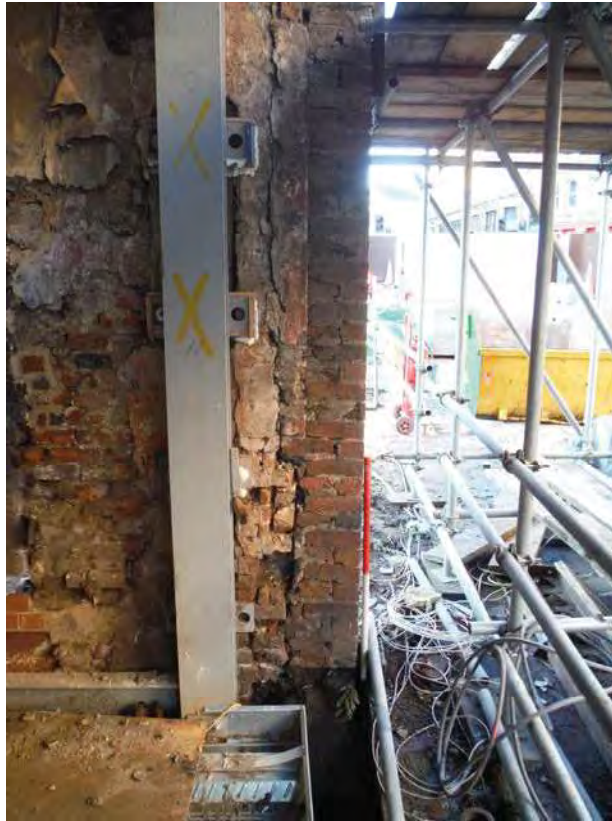
Plate 53

The west side of the ground floor and the first and second floor level of the elevation is constructed of machine made bricks with fairly thin mortar joints, laid to a five course Common bond. This phase of brickwork does not appear to have been tied into the west elevation of the range (Plate 53) and has subsequently pulled away from the structure slightly, with modern ties used at the upper level of the elevation to hold the wall in place. This secondary phase of brickwork likely dates to when the range was converted into a house by James Boyne in the early 19th century, which correlates well with the bricks and brick bond type used.

West side, ground floor of the north elevation of the east range
