**First White Cloth Hall  
Kirkgate, Leeds  
West Yorkshire**

Archaeological Watching Brief  
and Structural Watching Brief

Report no. 3460  
October 2020

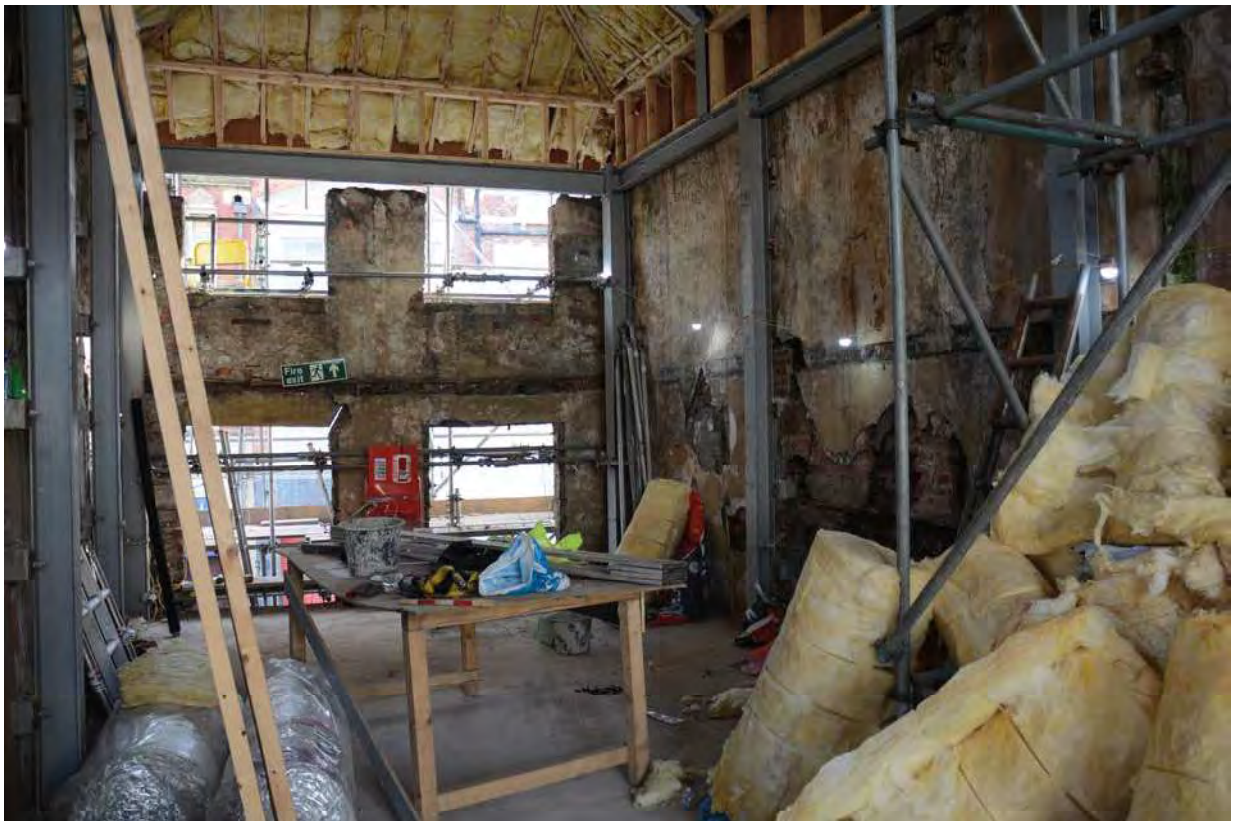
Plate 54

Internally much of the elevation retained its 19th-century plaster, however small areas of brickwork exposed appeared consistent with the external interpretation of the elevation (Plate 54).

Interior first and second floor of the north elevation of the east range

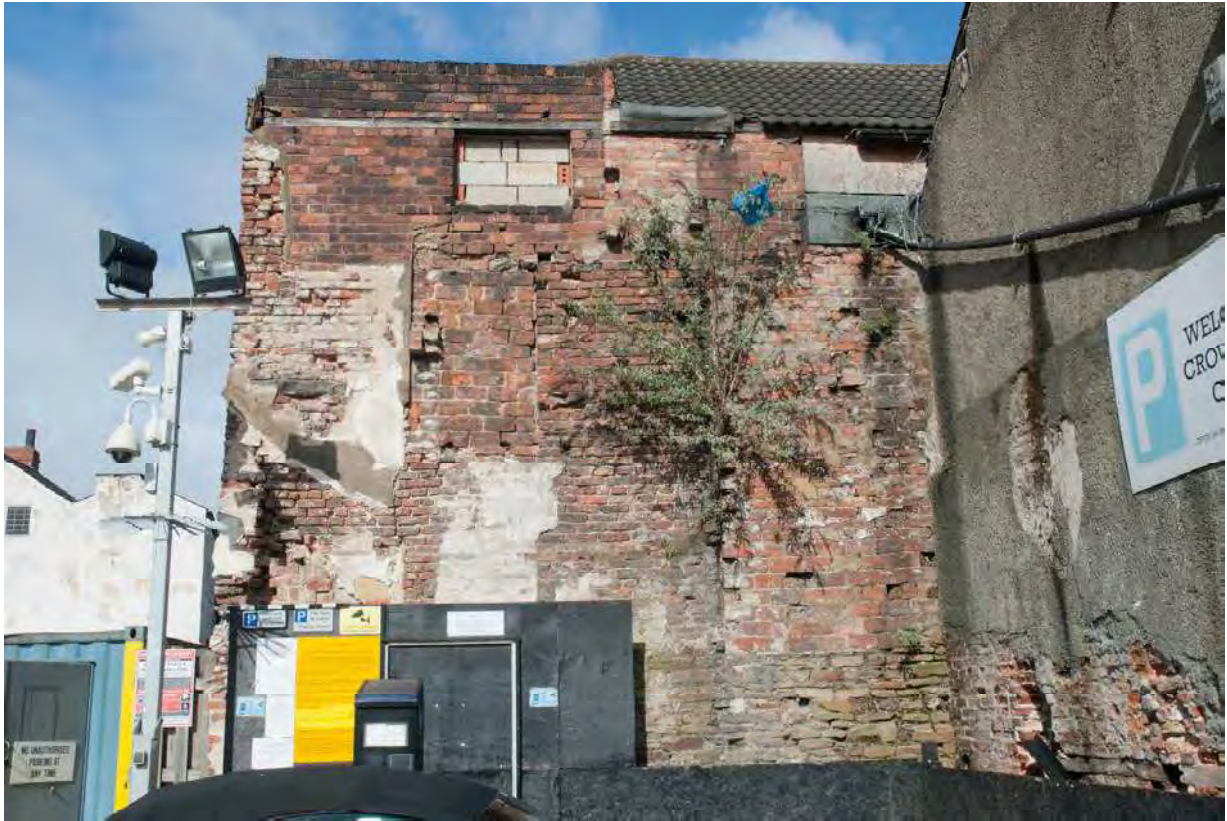
Plate 55

Externally only the east gable end of the south range is visible from the east side (Plate 55). The remainder of the building abuts No. 97 Kirkgate. The ground floor level of the elevation is constructed of roughly coursed stonework, which is overlain by brickwork associated with the construction of the FWCH in 1711. Overlying this, is mid to late 20th-century brickwork laid to a three course Common bond, which extends above the original height of the eaves. There are two inserted high-level windows and two brick blocked first-floor windows. Formerly attached to the elevation there was a fireplace and chimney flue, which have been recorded previously. Additional features were identified internally and are discussed below.

East exterior elevation of south range

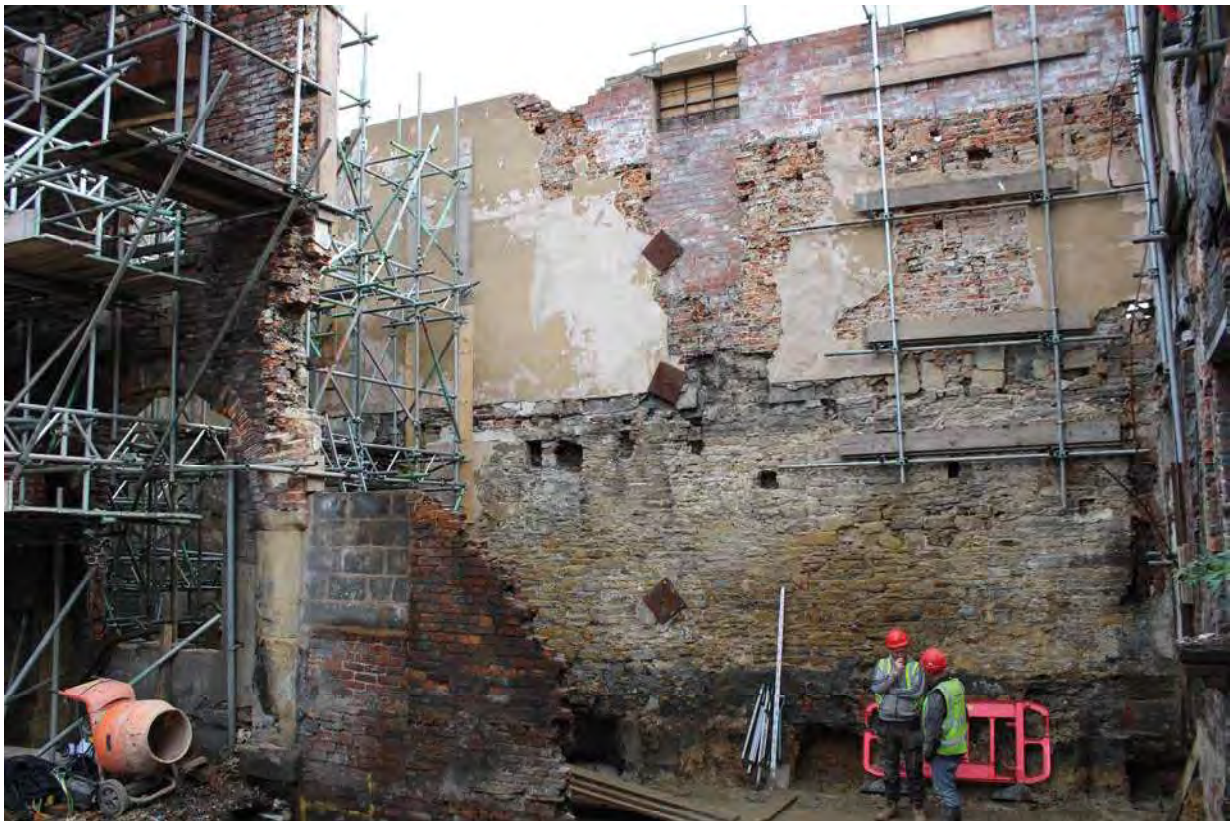
Plate 56

Internally (Plate 56 to 58) the stonework visible externally was seen to survive to a maximum height of 4.80m. The masonry (Plates 59 and 60) is present for roughly half the length of the elevation. Roughly centrally located along the elevation there is a vertical join with brickwork associated with the construction of the FWCH. Here the stonework continues to the north acting as a plinth for the first phase brickwork. At the north end the plinth has been underpinned by early 19th-century brickwork associated with the construction of the cellar at the north end of the range.

East wall of east range and east wall of south range, south end

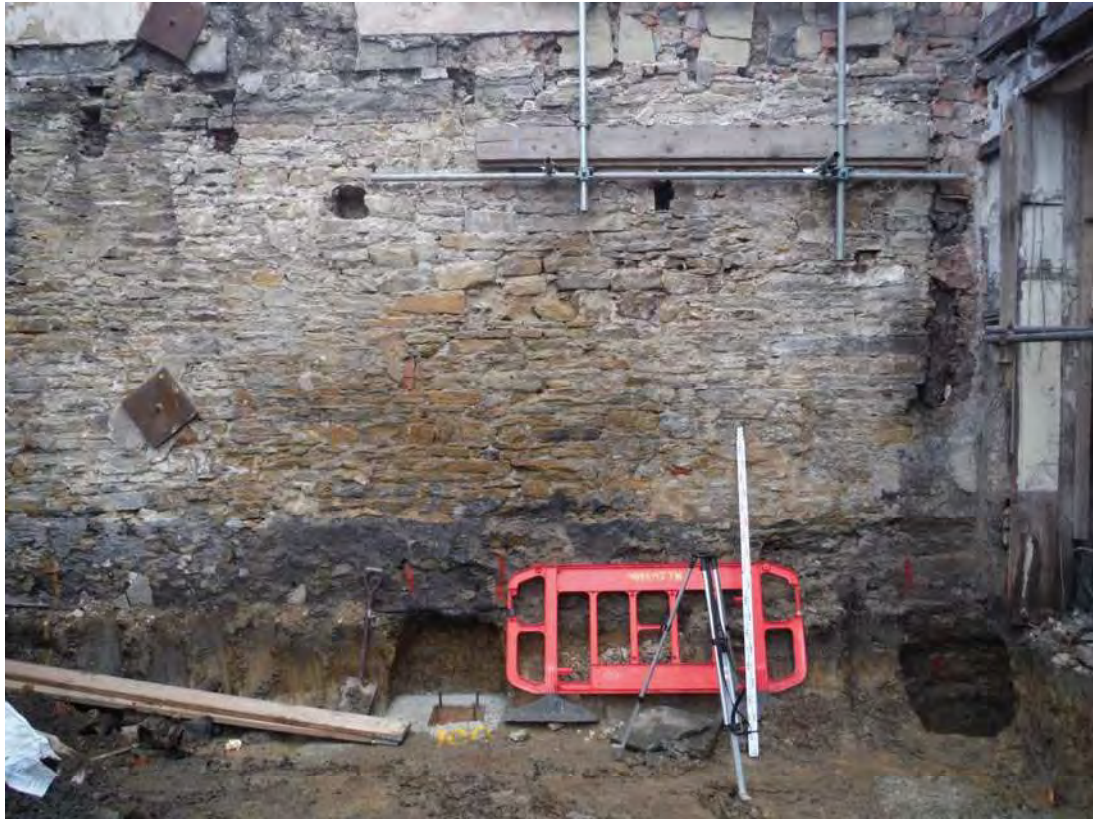
Plate 59

Masonry at south end of east wall of east range

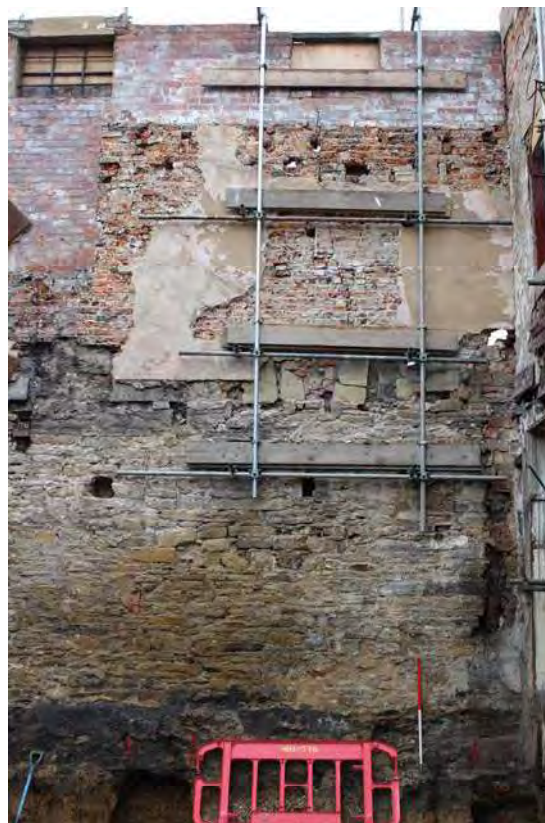
Plate 60

Masonry at south end of east wall of east range

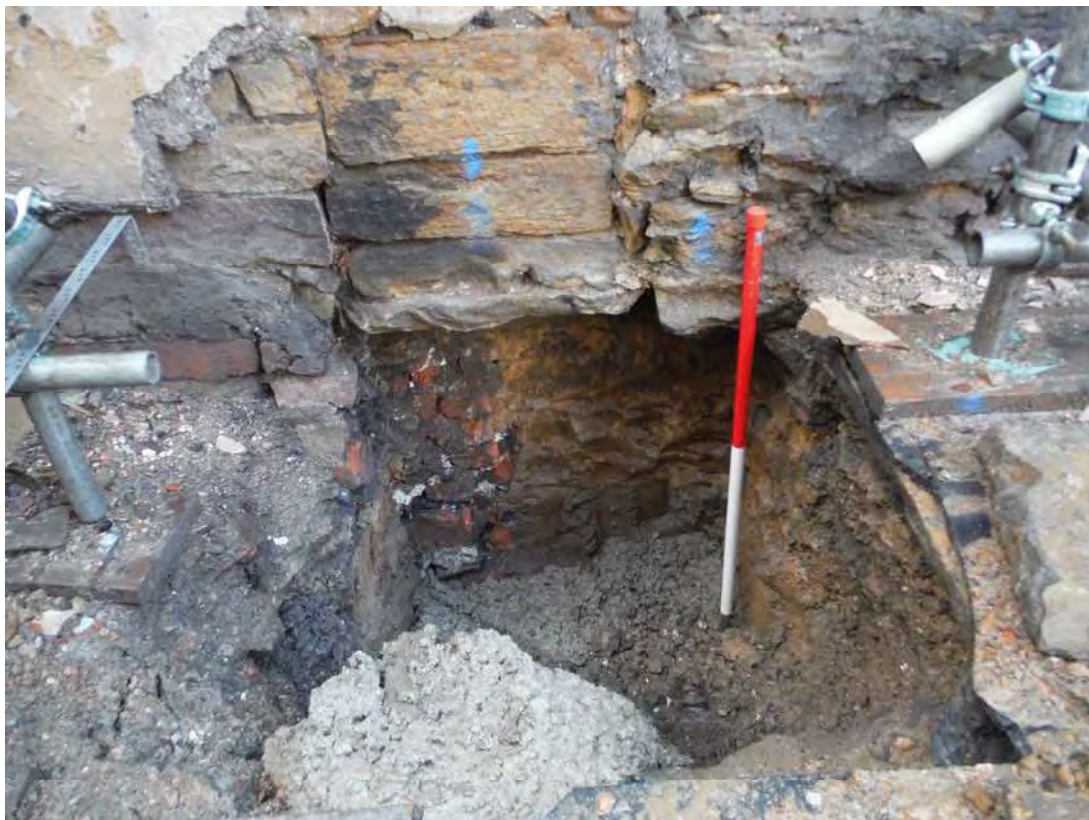
Plate 61

Directly below the vertical join between the masonry and brickwork there is what appears to be a former corner of an earlier building (Plate 61). Here the masonry is more evenly coursed and the stone is dressed. This suggests that the stonework belongs to an earlier stone built

Possible rear corner of earlier building

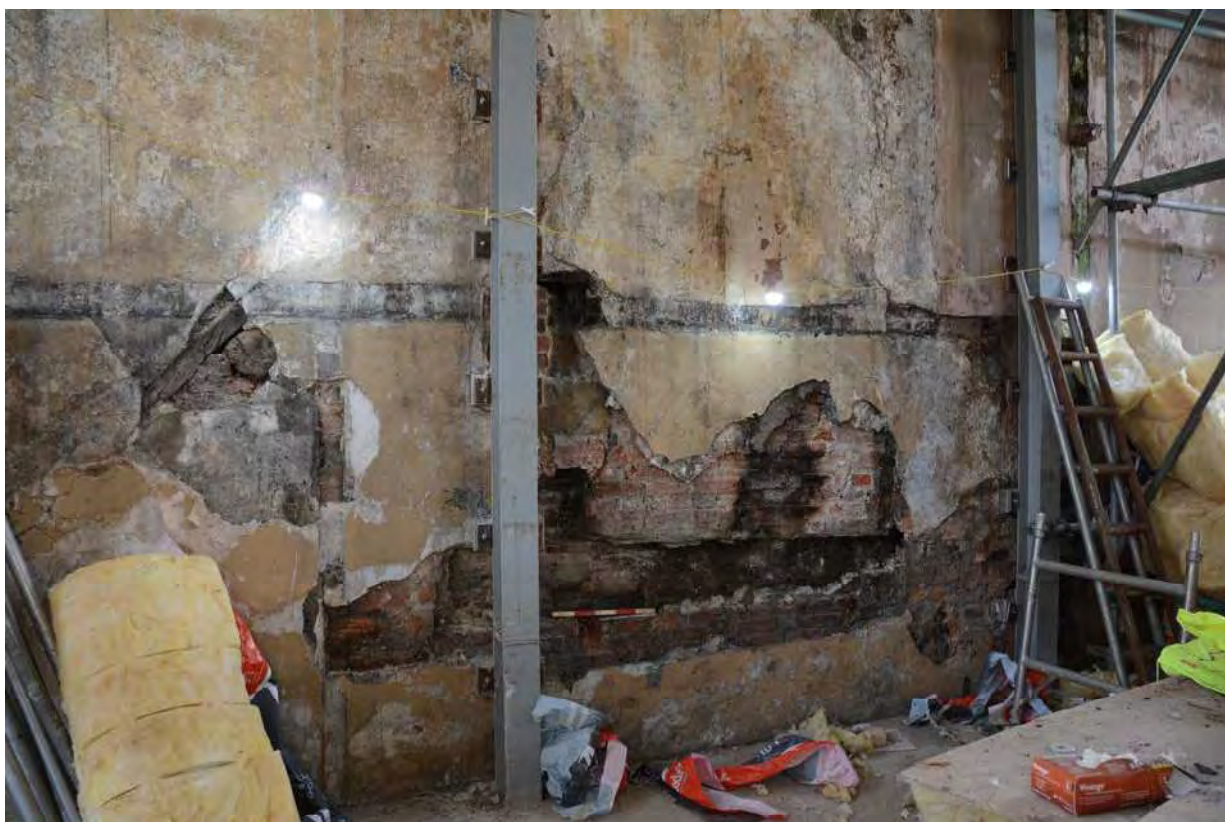
Plate 62

At the north end of the elevation, at first floor level, earlier timbers were identified (Fig. 10; Plates 62 to 65). The timbers were not fully exposed, as they were not beneath the plaster but encased within the east wall, sealed by a skin of brickwork and mortar associated with the construction of the FWCH. The timbers appear to be a part of a former King-post truss rather than a timber framed building. A possible purlin was also identified supporting a rafter. The purlin was only seen in section but appeared to be a roughly shaped tree trunk. The presumed King-post had a pegged mortise and tenon joint with the presumed tie-beam, both had been carved with the Roman numeral I. The Roman numeral II was also identified on the tie-beam. Towards the upper section of the King-post there appeared to be a mortise slot for a strut. Evidence for lathe and plaster was also observed on the king-post.

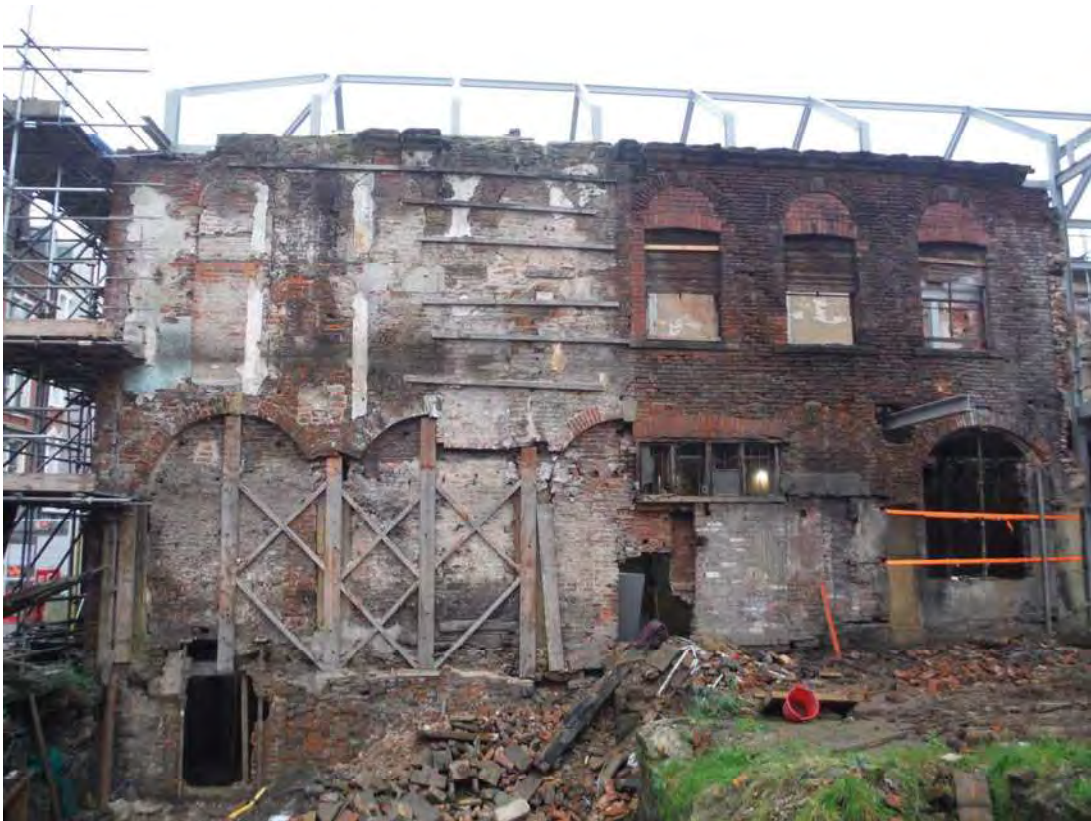
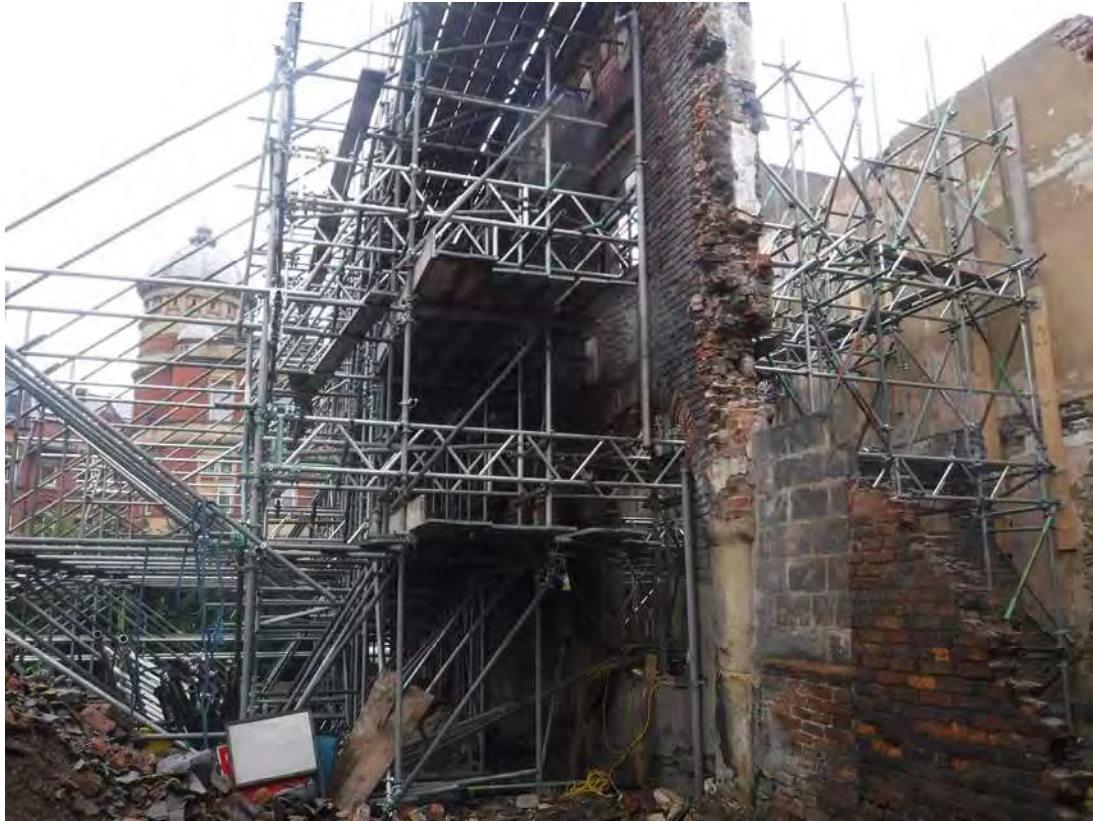
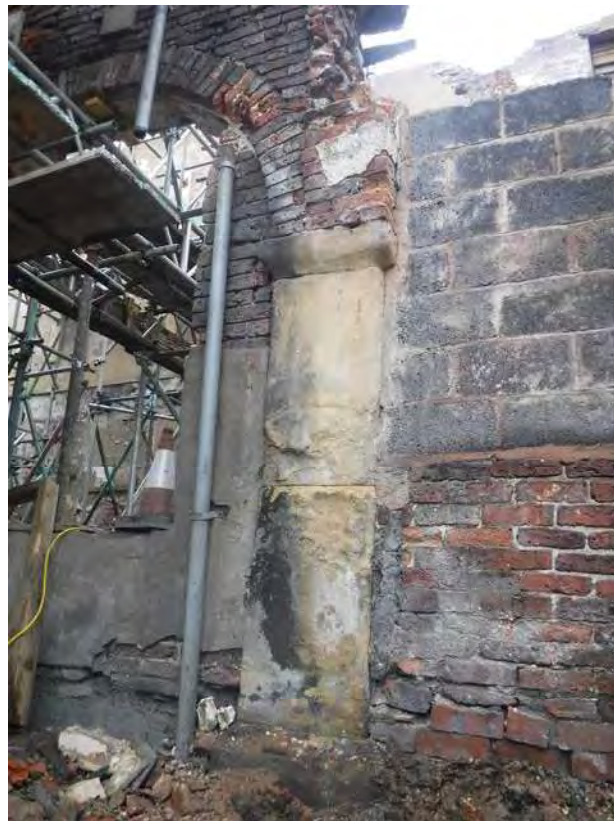
The external west elevation (Plate 66) of the building at ground floor level comprises a colonnade of five blocked arches (Plates 67 and 68). It has been previously suggested that the colonnade was blocked in the 18th century, possibly at the time when the south range was converted into an assembly room. At first floor level there are six round-arched windows, they have brick voussoirs, formed from alternate courses of headers and stretchers, and have a central projecting sandstone keystone. The three windows at the north end retain their original chamfered stone springers. Partial remains of the sandstone window sills are present for the second and third window from the north end. The level of these stones indicates that the sills of the three windows at the south end of the elevation have been lowered.

West exterior elevation of east range

View along west exterior elevation of the east range

Detail of arch at south end of the west exterior elevation of the east range

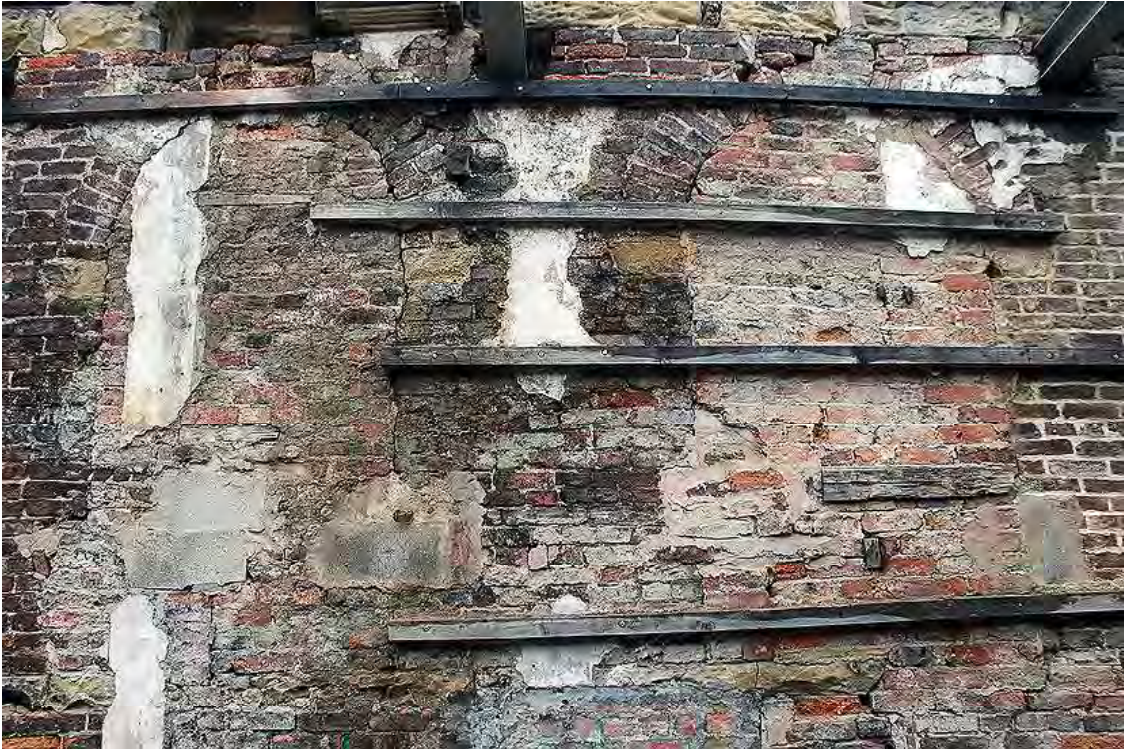
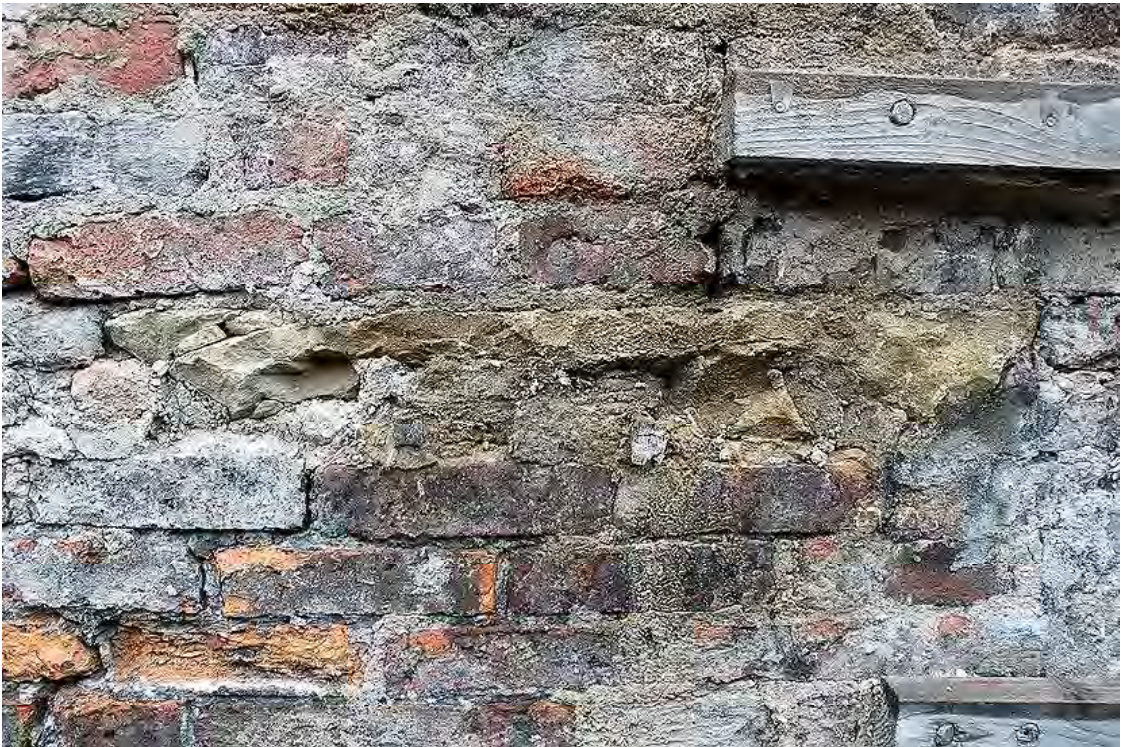
function. The sandstone sill remains are fragmented (Plates 69 and 70), two pieces remain in situ for the second window from the north end, and one piece is in situ for the third window. Figure 11 illustrates their location. The ends of the sills appear to have a slight cyma reversa ogee profile and taper in at the base. The fragments are 0.13m thick, with the positioning of the pieces indicating the sills would have had a length of *c.* 1.70m.

The second and third window from the north end of the west exterior elevation of the east range

Close-up detail of the south side sill fragment of the first floor second window from the north end

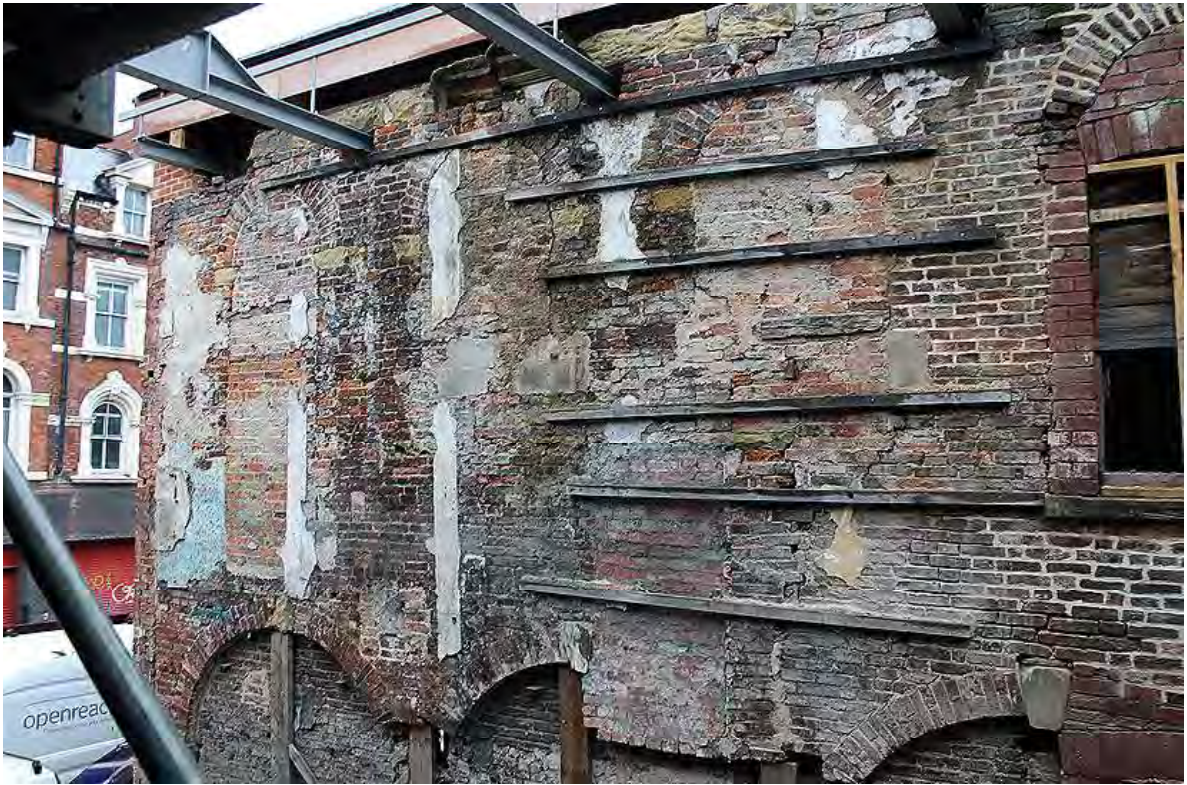
Plate 71

The removal of the plaster, which formerly obscured the north end of the first floor (Plate 71), has revealed two blocked doorways. The north end window had been altered to form a doorway, with the level of the base of the blocked doorway suggesting it was made prior to the lowering of the first floor level of the building. The doorway would have provided access into the north range, which was constructed in the early 19th-century, suggesting that the lowering of the first floor of the east range did not happen at the same time as the construction of the north range, but perhaps later in the late 19th century. At this time the doorway would then have been blocked. The second doorway is located between the second and third window from the north end, at the lowered first floor level, suggesting it was made when the north end of the east range was remodeled. The brick infill of the opening suggests it was blocked in the early 20th-century.

The north end windows of the first floor of the west exterior elevation of the east range

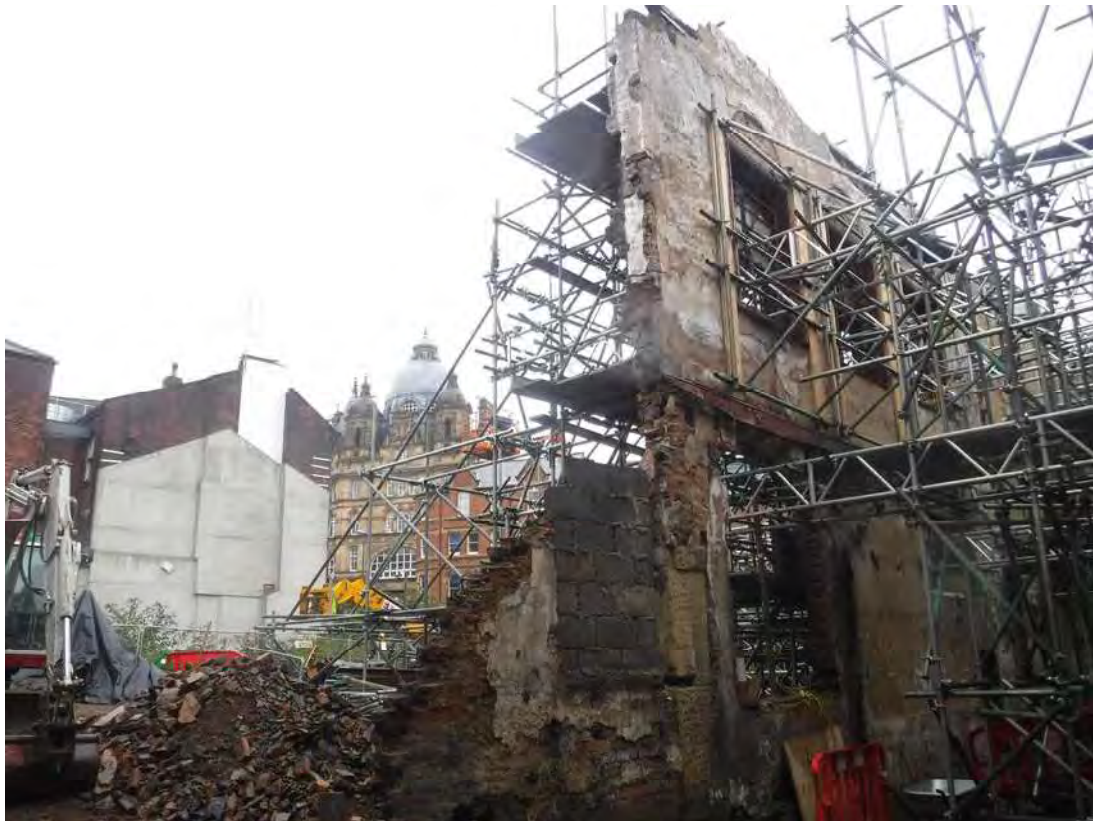
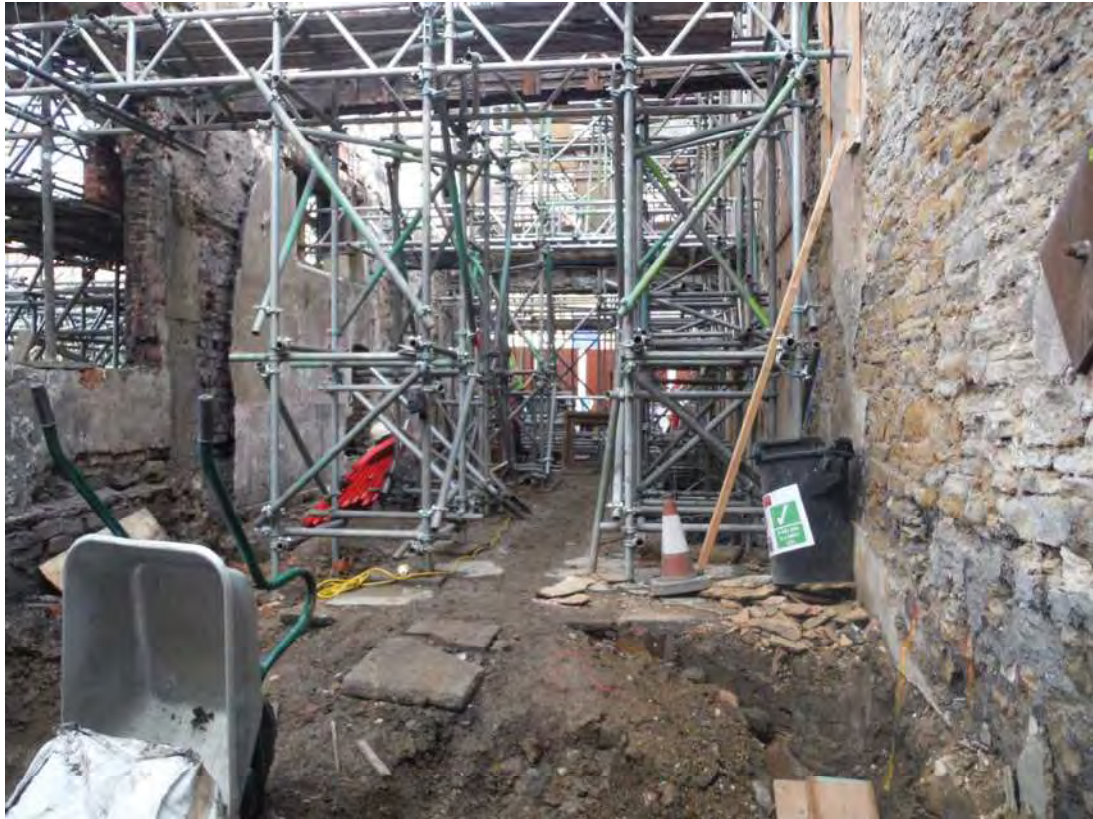
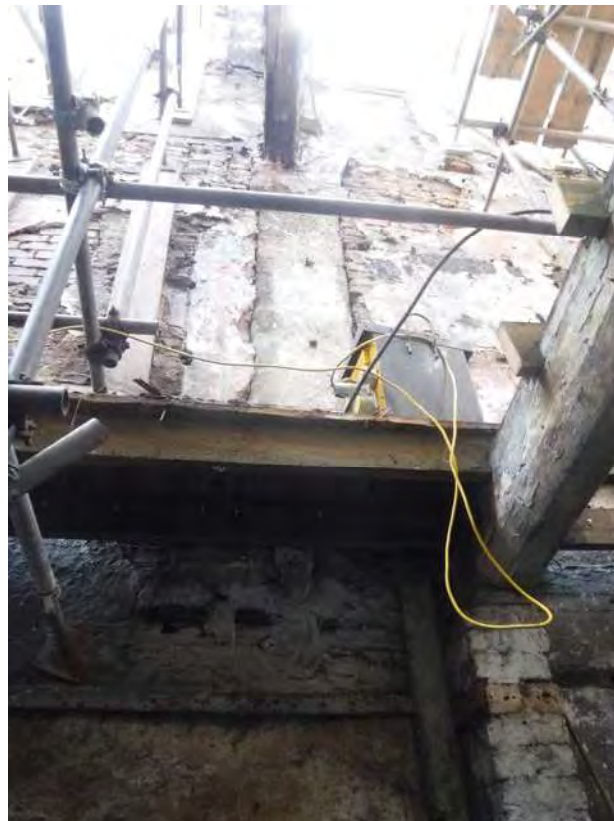
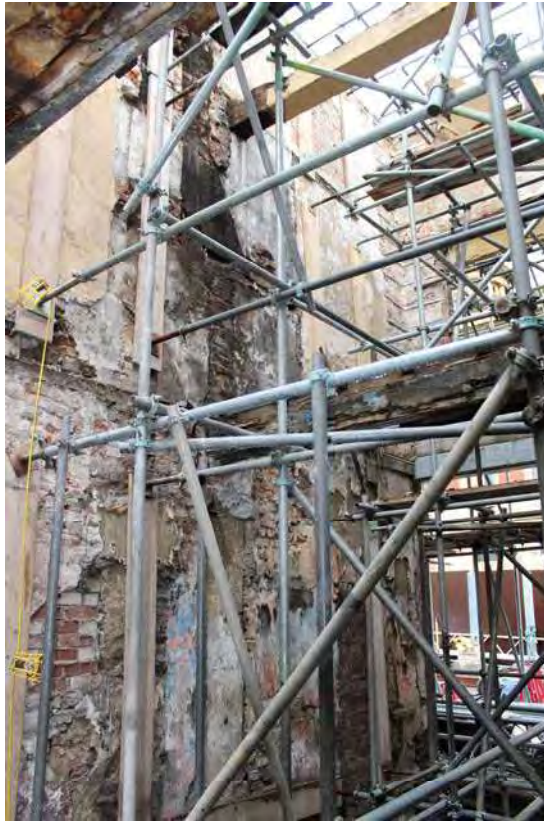
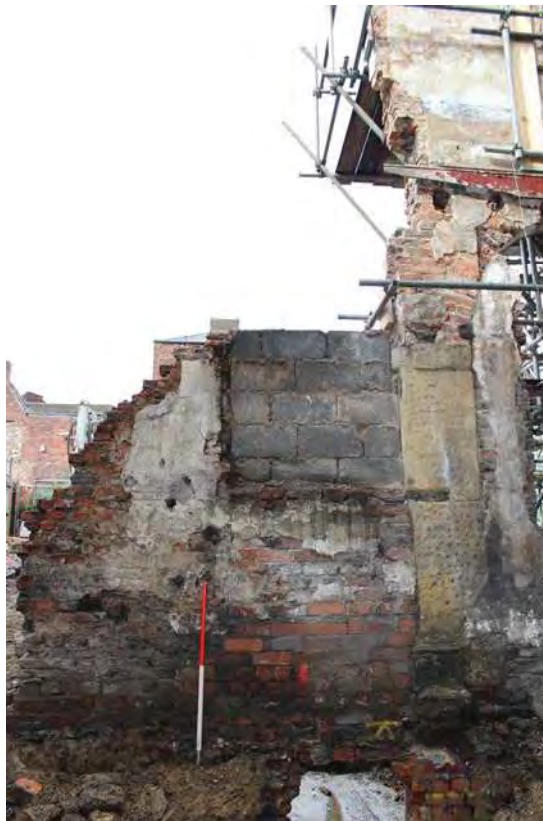
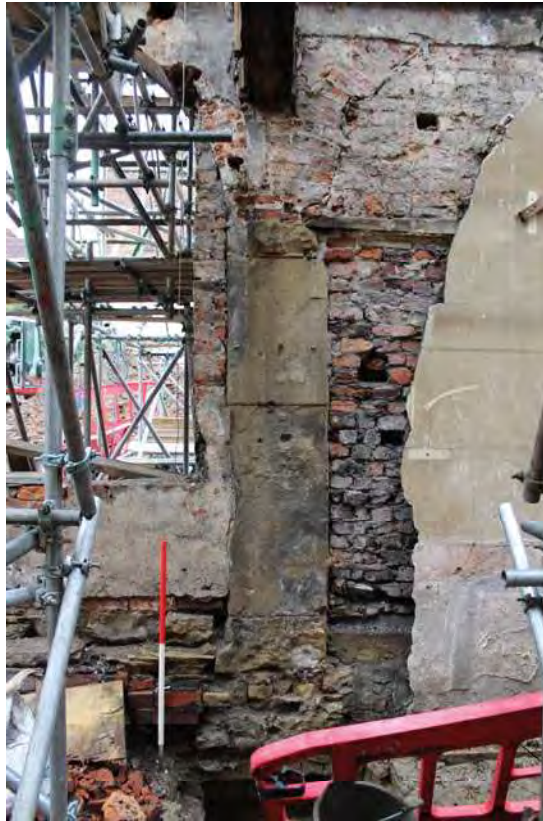
Internally the removal of plaster from the west elevation at ground floor level revealed parts of the colonnade of five blocked arches (Plates 72 to 77). At first and second floor level very little of the plaster was removed from the west elevation (Plates 78 to 81). The later inserted brick built fireplace at first floor level and the chimney breast at second floor level had been removed (Plate 82). Here the brickwork was soot stained. Where brickwork was revealed, it appeared consistent with that identified externally.

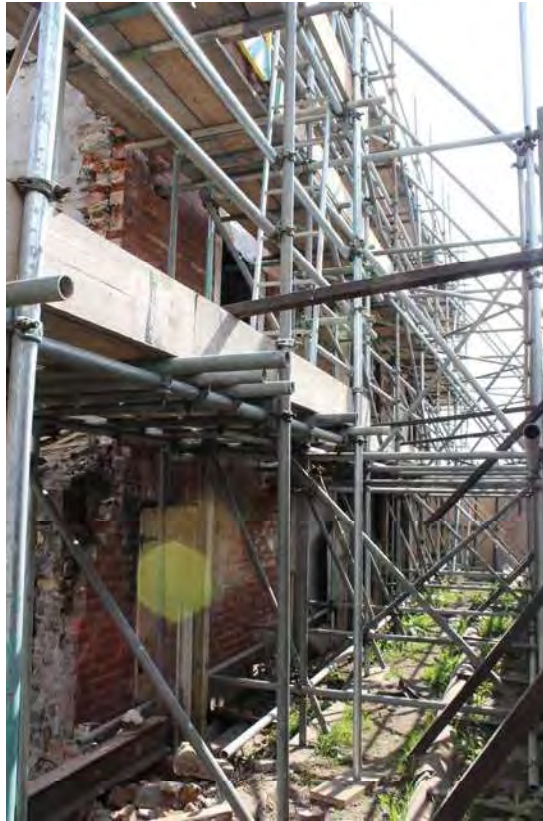
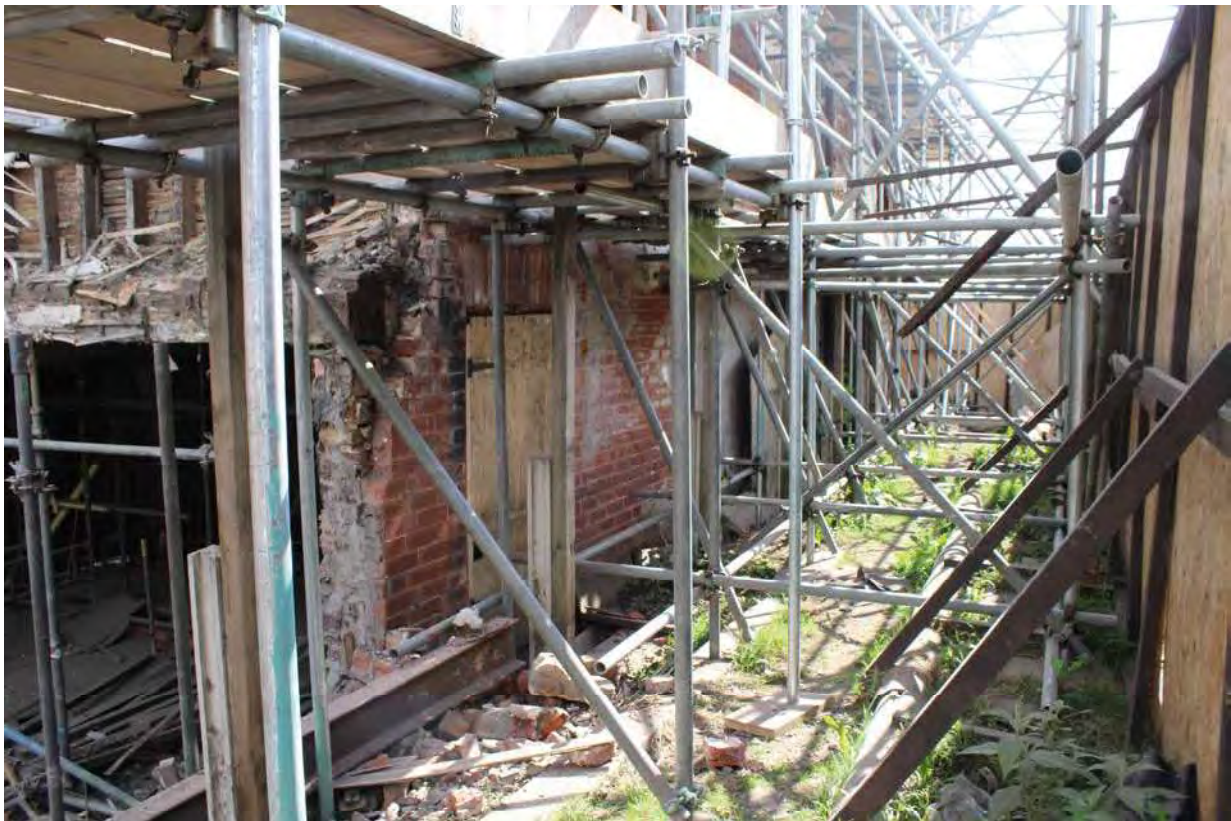
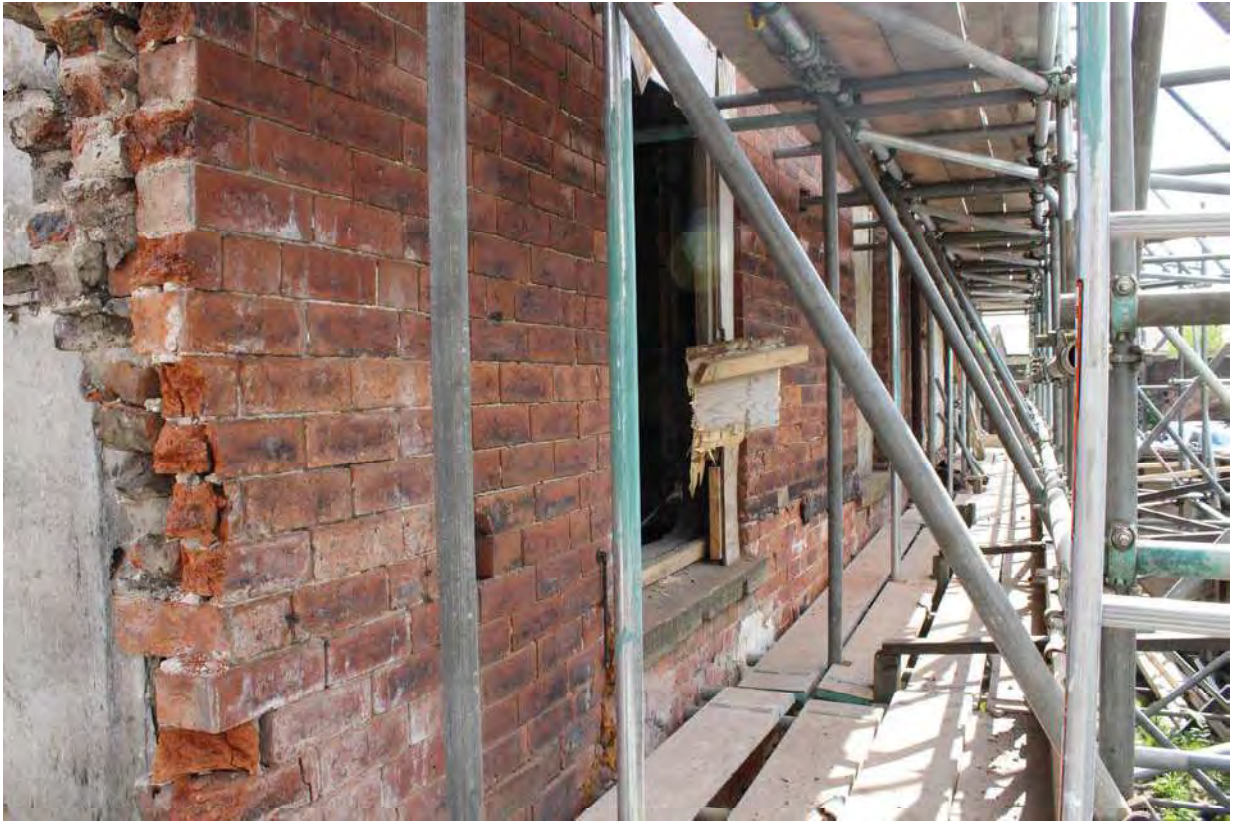
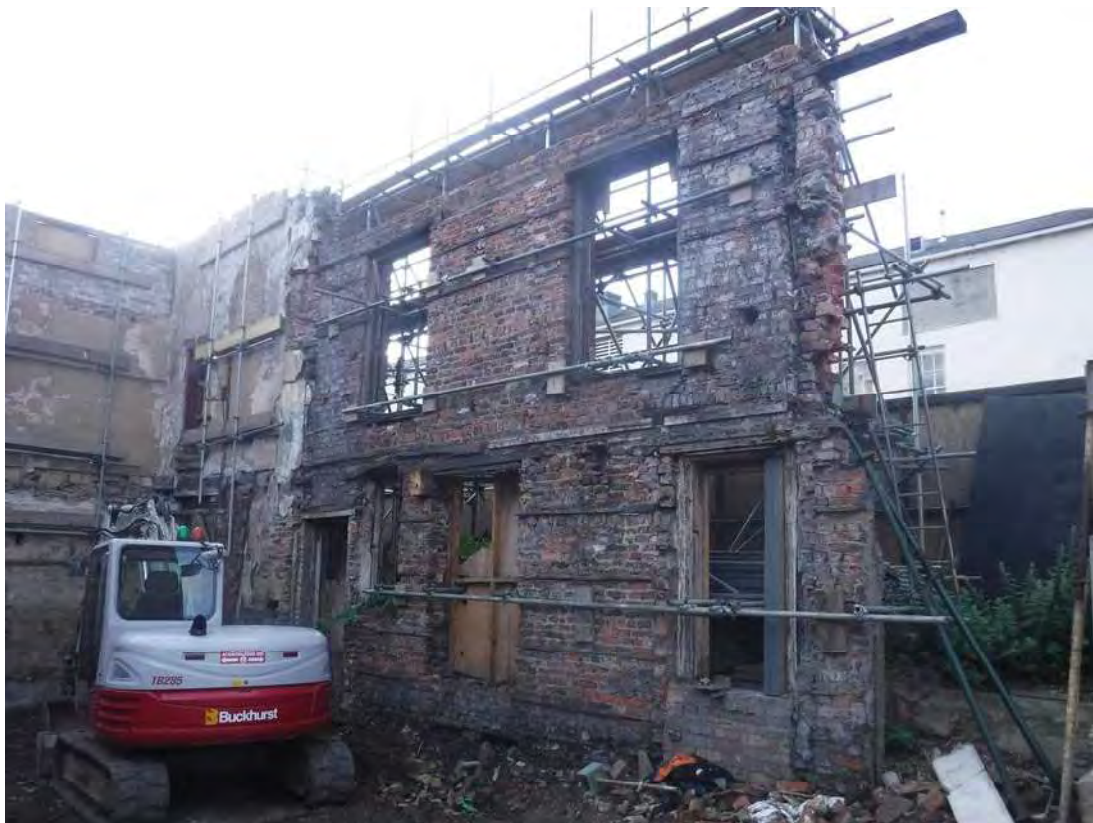
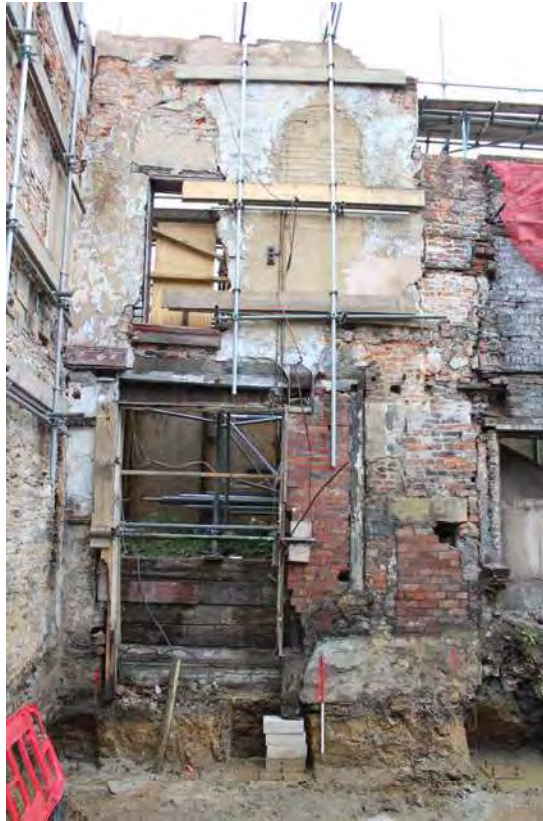
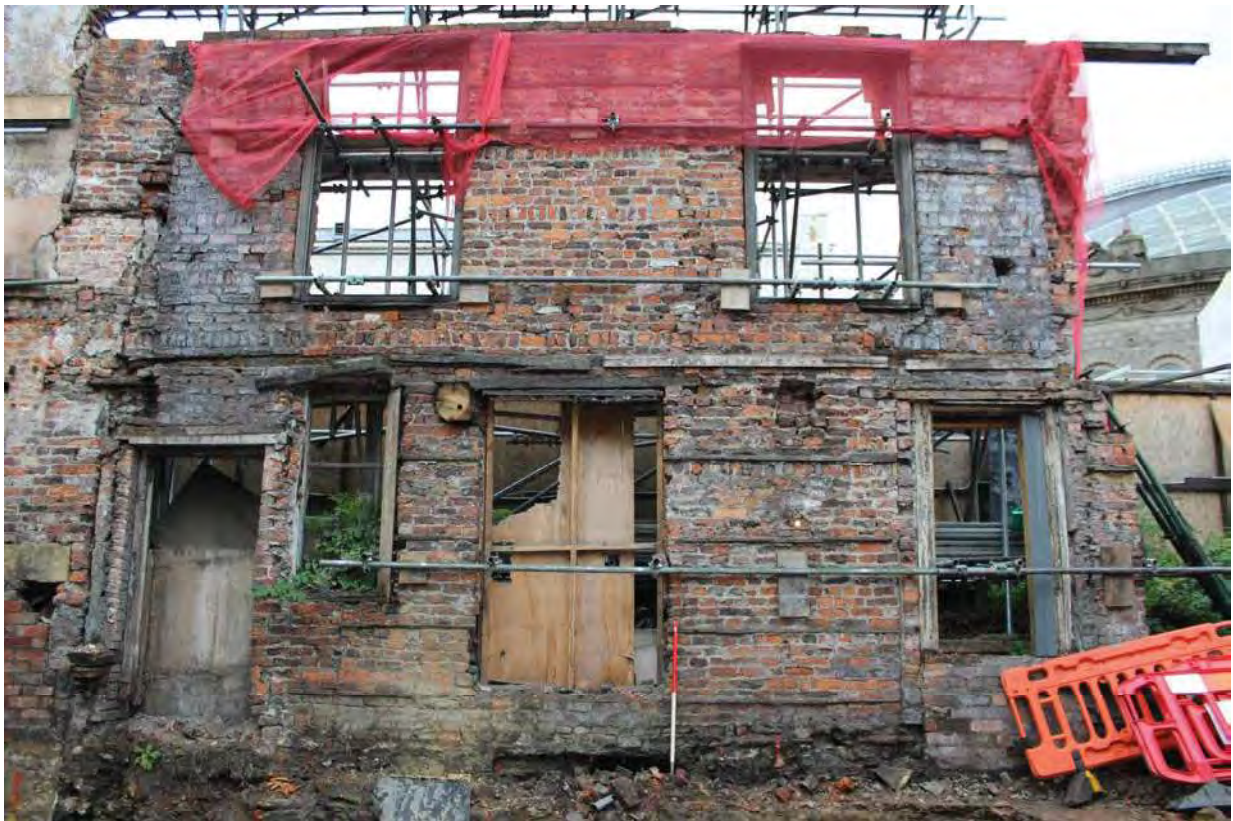
Four phases were identified on the south elevation of the south range (Plates 89 to 94). The first phase related to the construction of the FWCH, the second to the blocking of openings and the construction of the cross-passage, the third related to the late 19th/early 20th-century re-building of much of the wall, and the fourth to mid to late 20th-century alterations.
