**First White Cloth Hall  
Kirkgate, Leeds  
West Yorkshire**

Archaeological Watching Brief  
and Structural Watching Brief

Report no. 3460  
October 2020

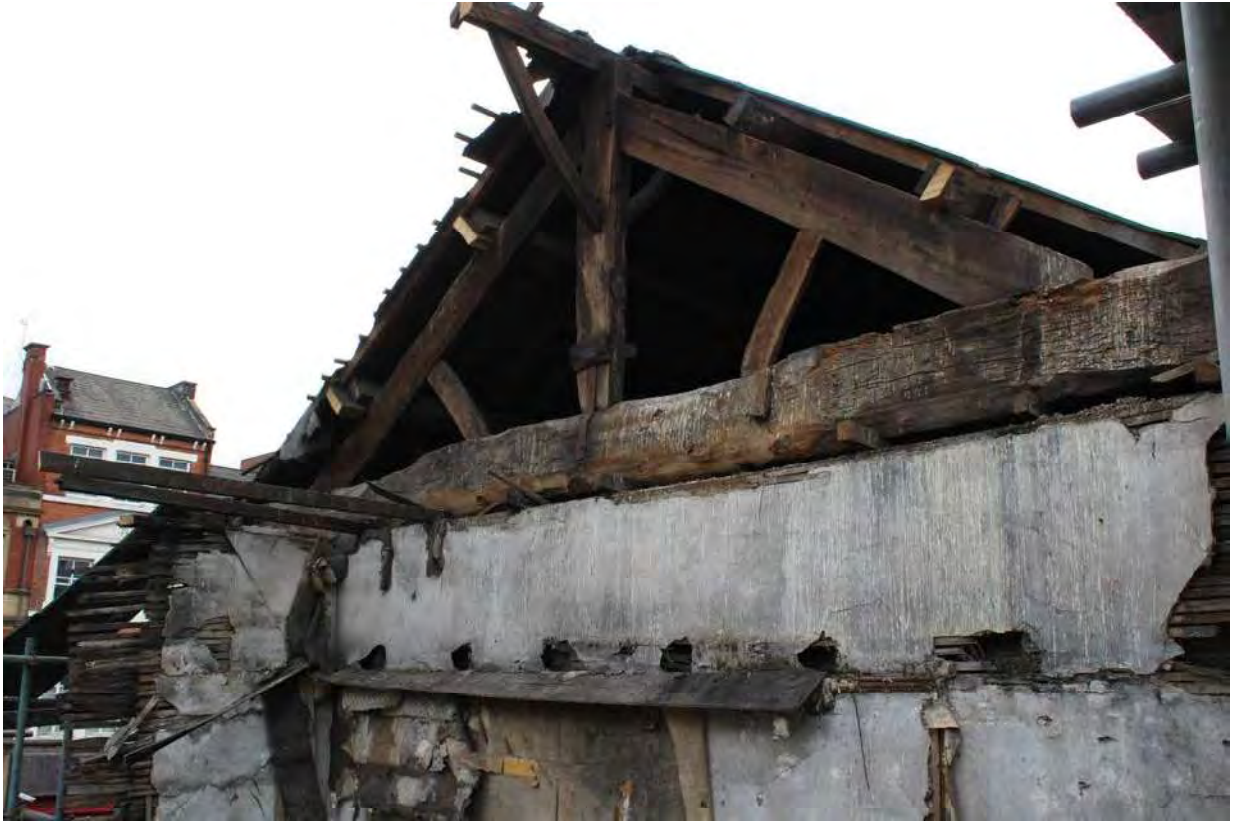
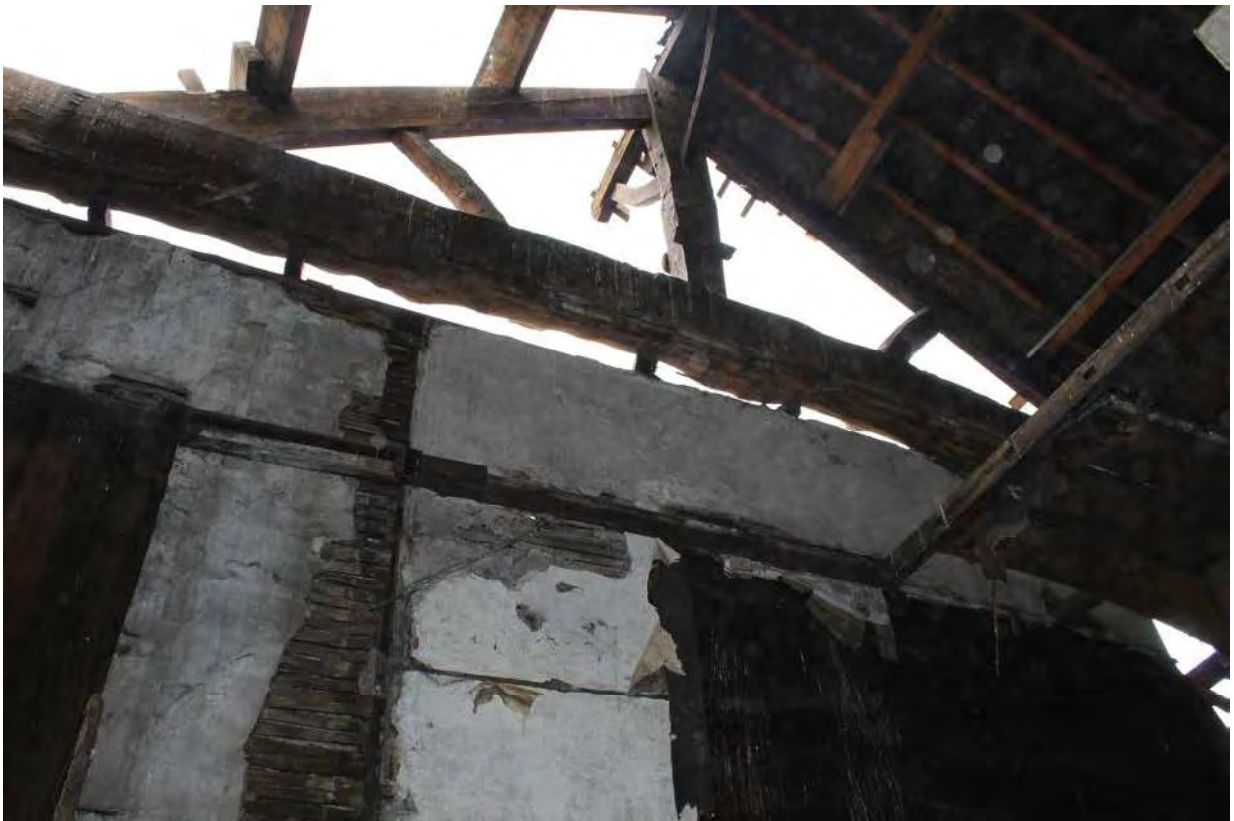
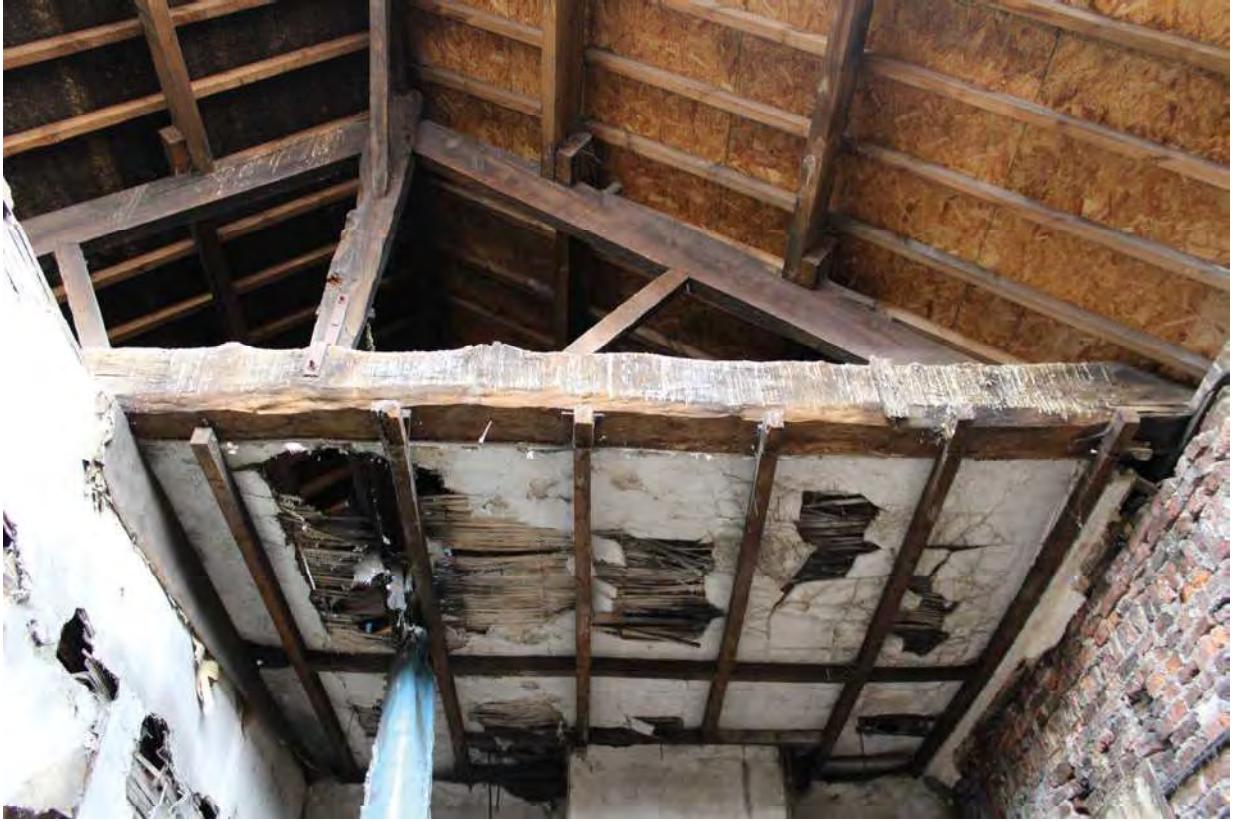
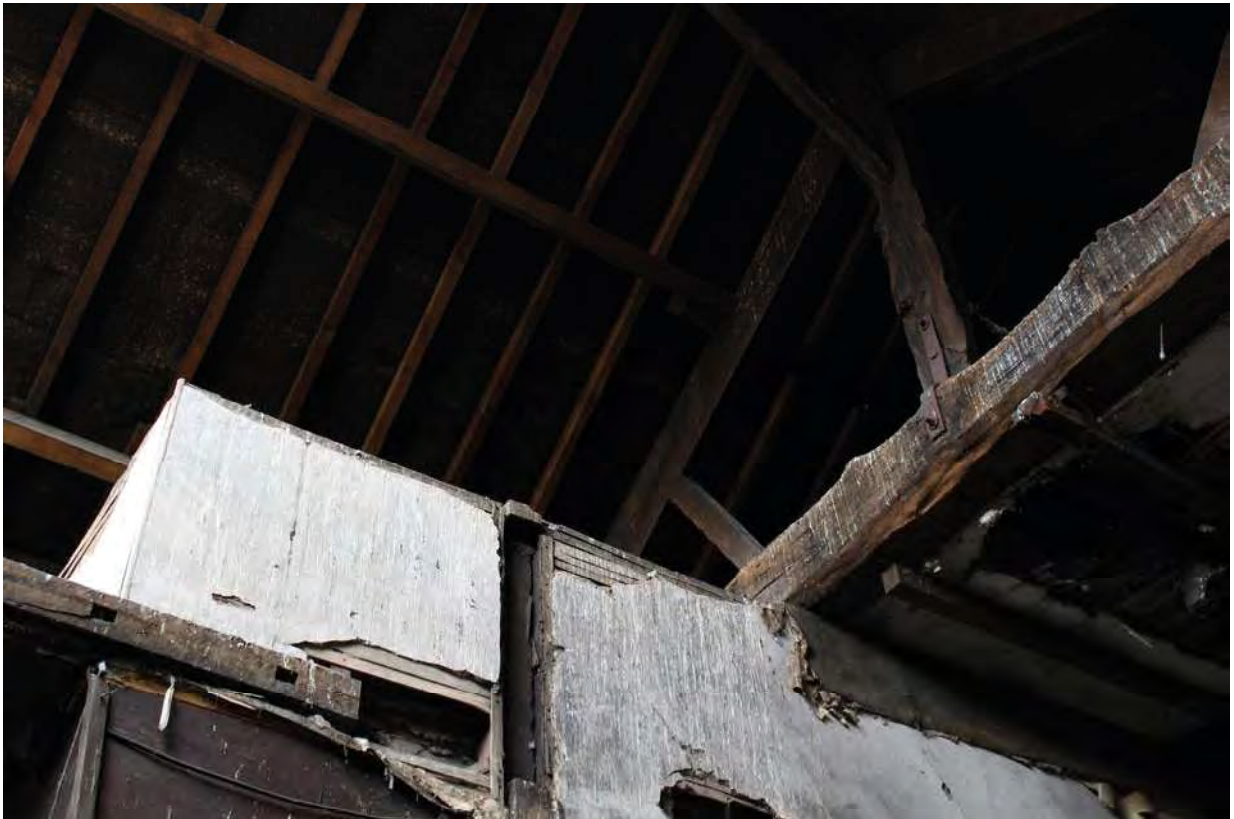
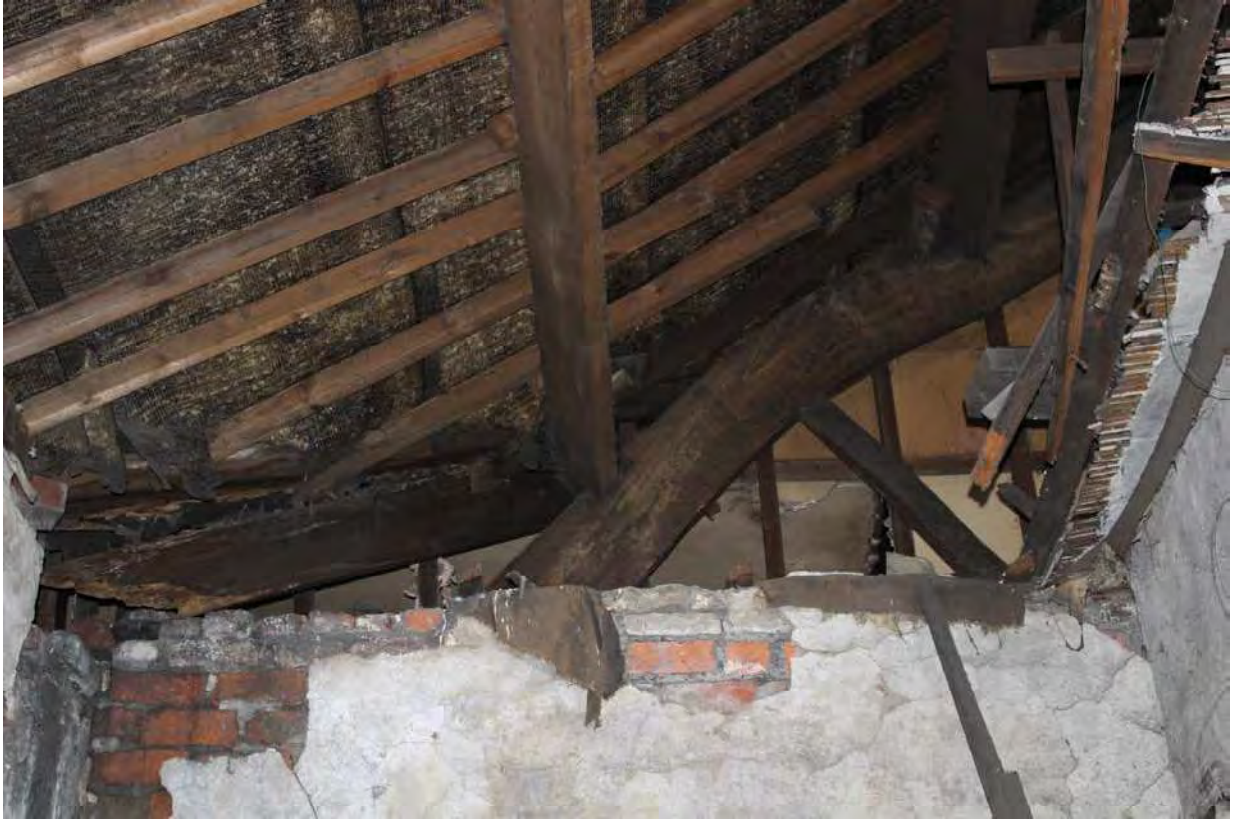
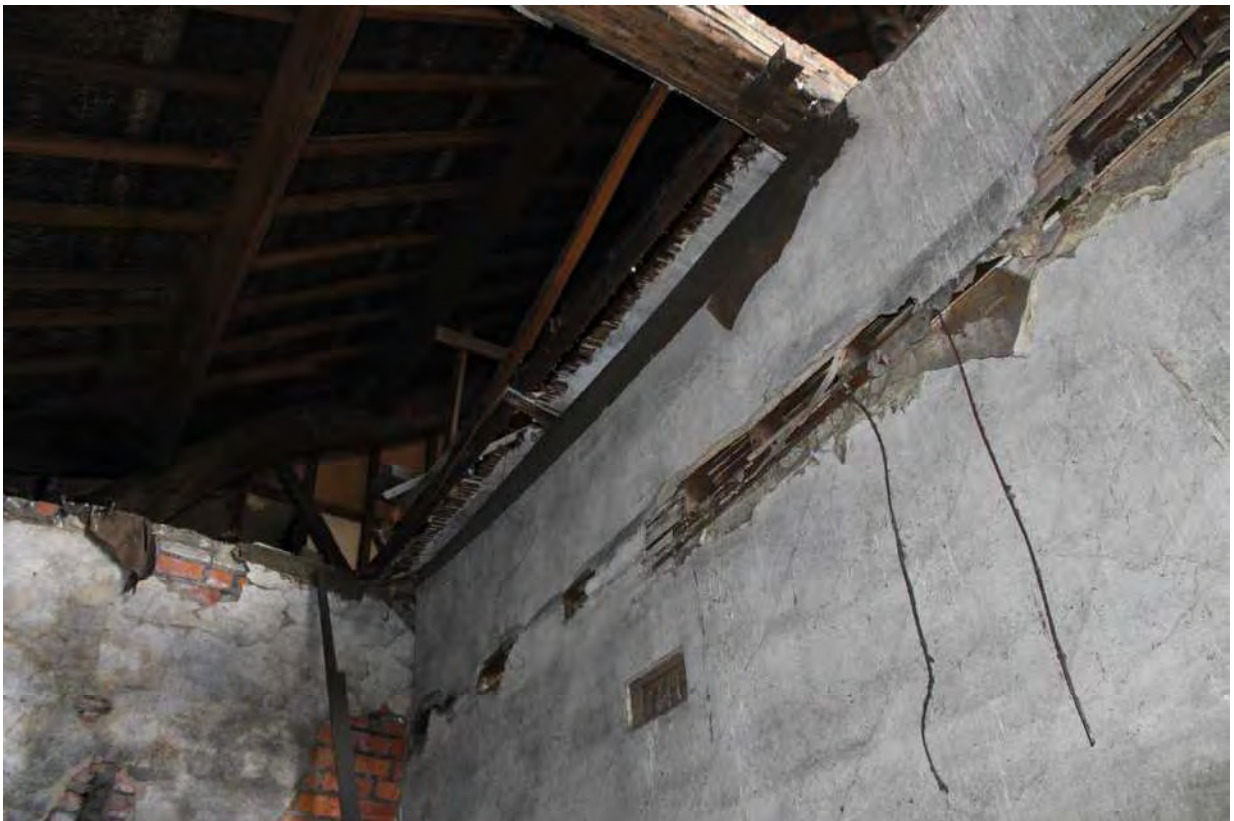
During the archaeological works no structural evidence was encountered for the existence or position of a cupola on the roof (Plates 95 to 101).

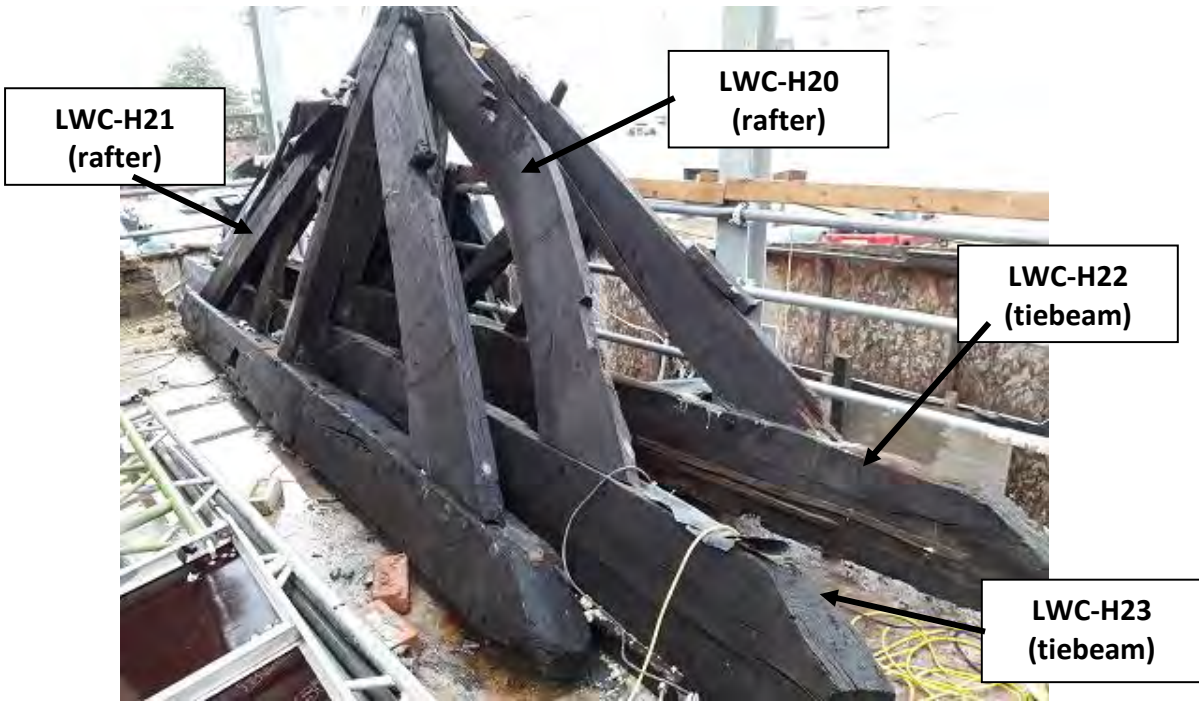
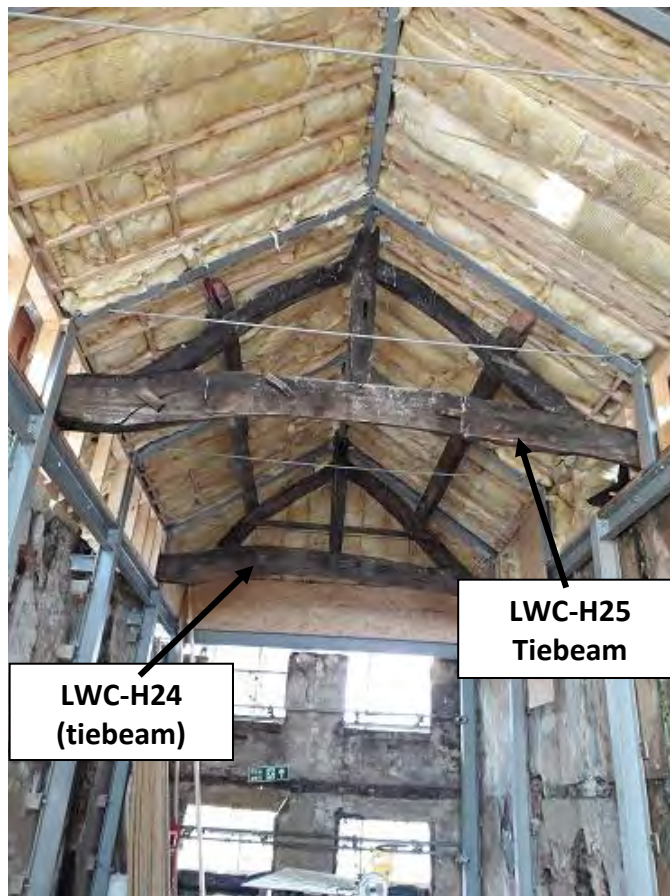
Figure 5a/b: Annotated photograph to help locate sampled timbers (see Table 1)

Sample LWC-H22 has a last ring date of 1460, this last ring being at the heartwood/sapwood boundary. This means that although all the sapwood rings have been lost from the sample, it is *only* the sapwood that is missing. Given that most oak trees have between a minimum of 15 sapwood rings and a maximum of 40, this would suggest that the source tree was felled at some point between 1475 at the earliest and 1500 at the latest. Given that all the other timbers used for these trusses have already been dated in the first programme of tree-ring dating as having been felled in the mid-1470s, it is more likely than not that this timber, and those represented by samples LWC-H21 and H23, were also felled at about this time.

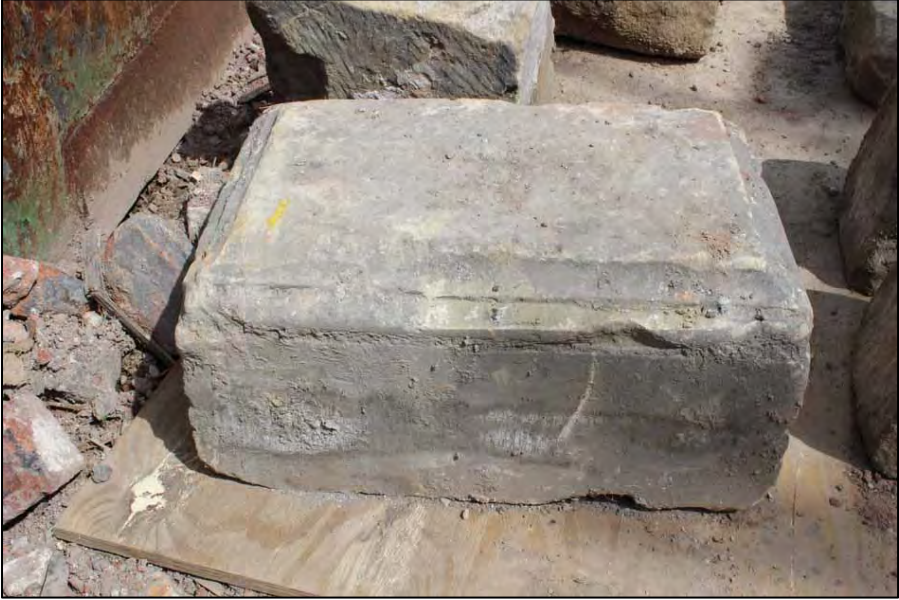
STONE 1

<b>Condition</b>	GOOD
<b>Measurement</b>	L:600mm W:400mm D:300mm
<b>Description</b>	Base stone - possible pillar plinth
STONE 2

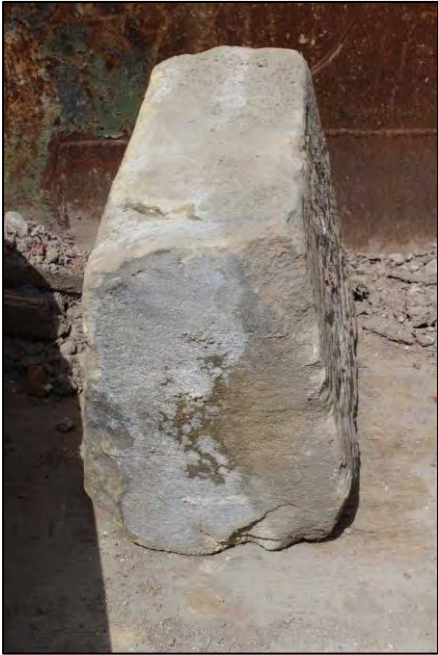
<b>Condition</b>	MODERATE
<b>Measurement</b>	L:400mm W:340mm D:280mm
<b>Description</b>	Keystone piece

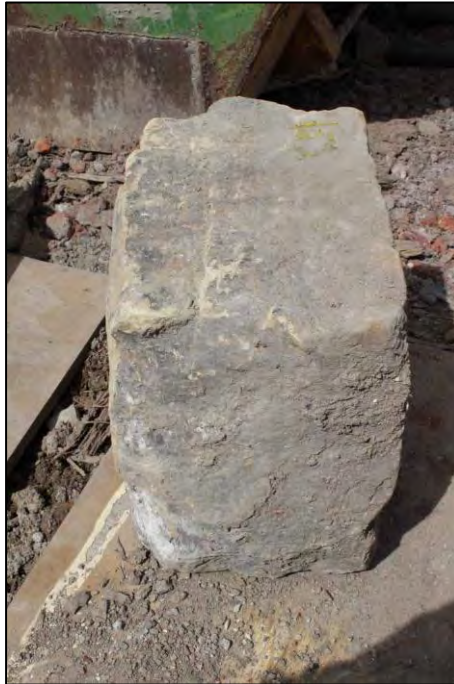
**STONE 5**

<b>Condition</b>	GOOD
<b>Measurement</b>	L:200mm W:300mm D:300mm
<b>Description</b>	Unidentifiable

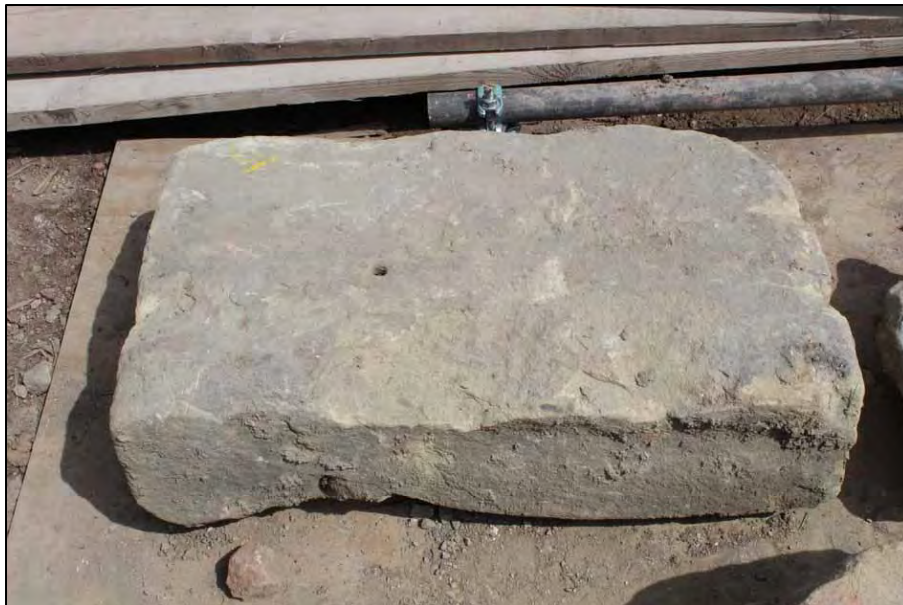
**STONE 6**

<b>Condition</b>	GOOD
<b>Measurement</b>	L:800mm W:500mm D:250mm
<b>Description</b>	Unidentifiable - possible upright stone, with perforated circular hole, and ledge to one corner (perhaps for joist)

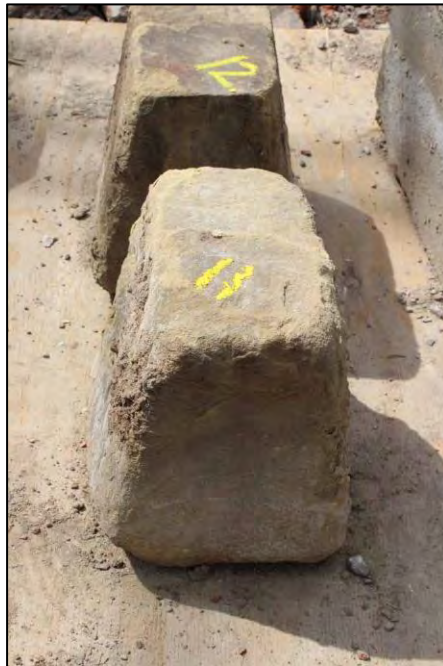
**STONE 11**

<b>Condition</b>	GOOD
<b>Measurement</b>	L:250mm W:190mm D:230mm
<b>Description</b>	Keystone piece - stepped, possibly for timber frame

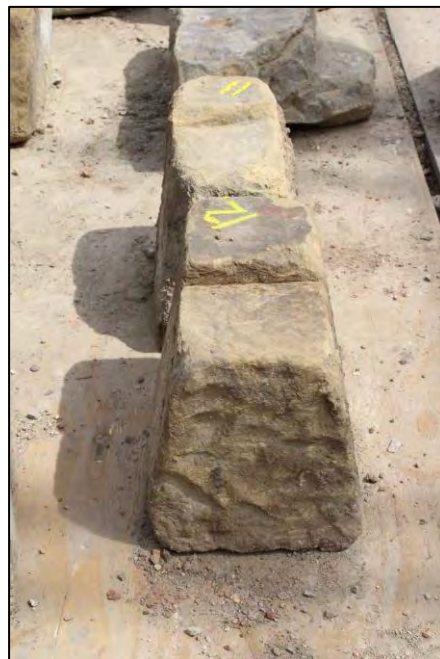
**STONE 12**

<b>Condition</b>	GOOD
<b>Measurement</b>	L:250mm W:190mm D:230mm
<b>Description</b>	Keystone piece - stepped, possibly for timber frame

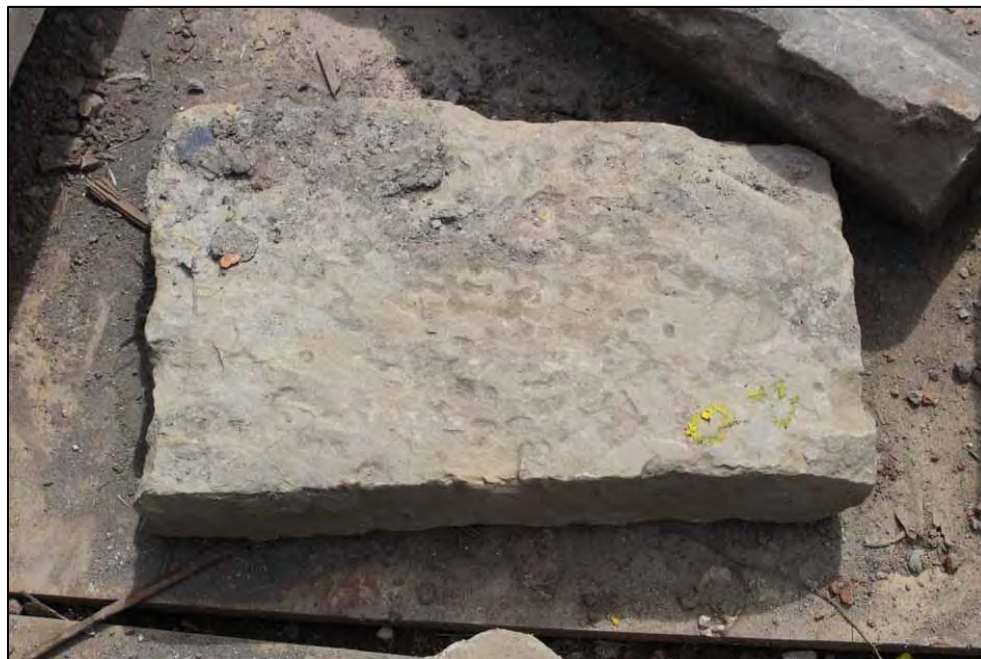
**STONE 20**

<b>Condition</b>	GOOD
<b>Measurement</b>	L:420mm W:280mm D:100mm
<b>Description</b>	Possible window sill piece

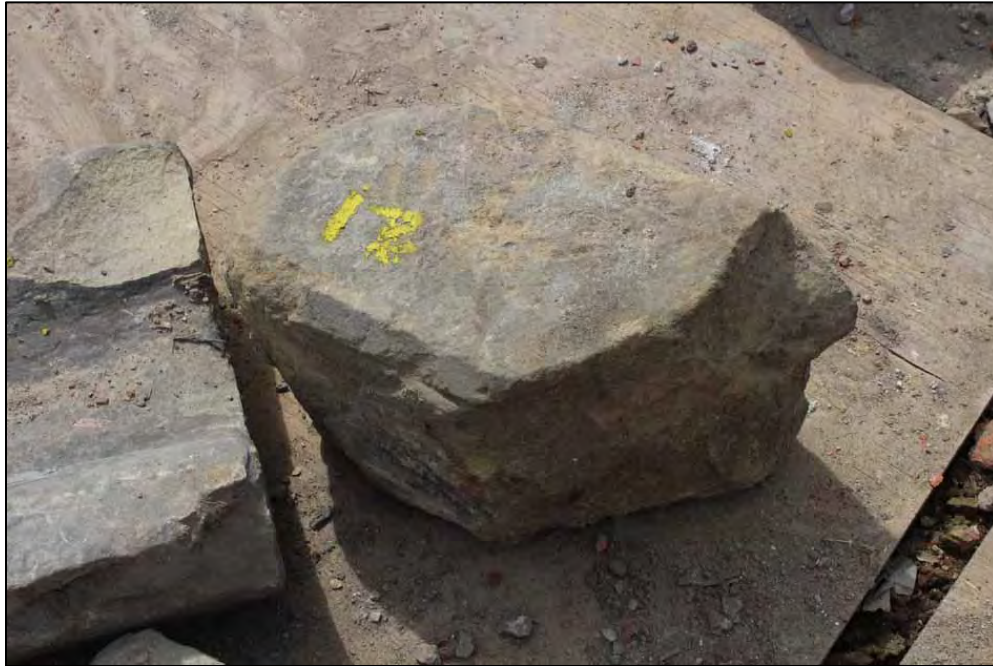
**STONE 21**

<b>Condition</b>	POOR
<b>Measurement</b>	L:300mm W:150mm D:200mm
<b>Description</b>	Unidentifiable - has a bevelled edge

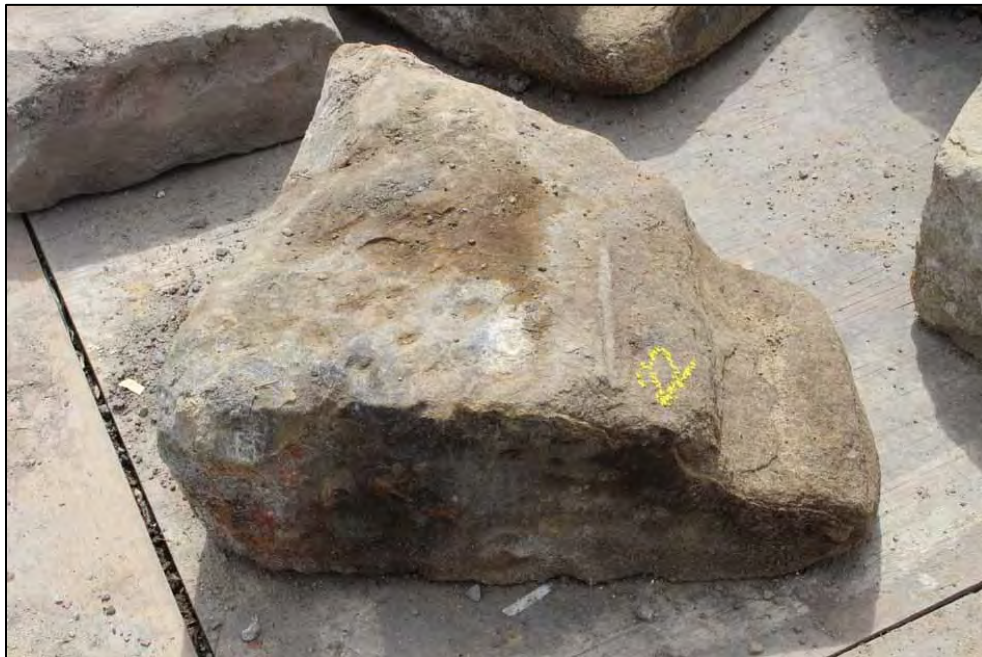
**STONE 22**

<b>Condition</b>	POOR
<b>Measurement</b>	L:600mm W:500mm D:240mm
<b>Description</b>	Probable cornice piece

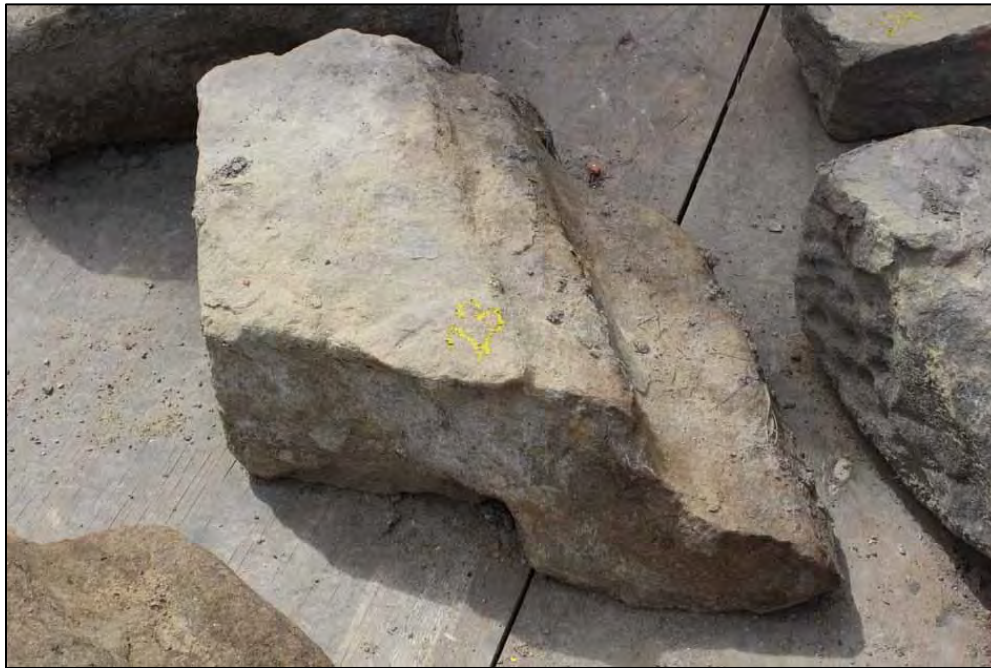
**STONE 23**

<b>Condition</b>	MODERATE
<b>Measurement</b>	L:500mm W:600mm D:250mm
<b>Description</b>	Probable cornice piece

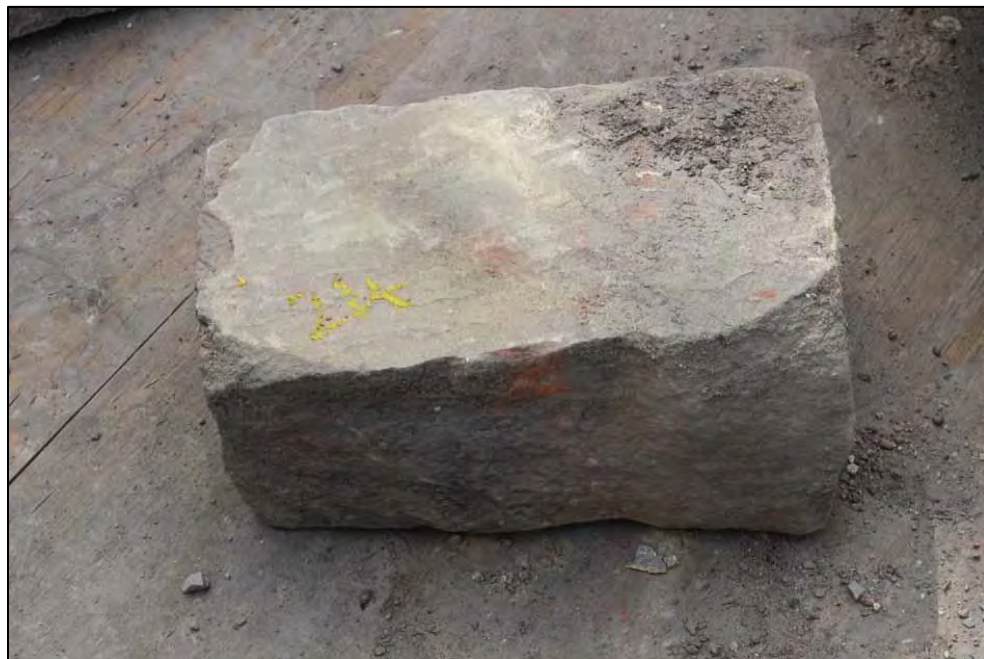
**STONE 24**

<b>Condition</b>	GOOD
<b>Measurement</b>	L:340mm W:200mm D:140mm
<b>Description</b>	Unidentifiable - rectangular block piece

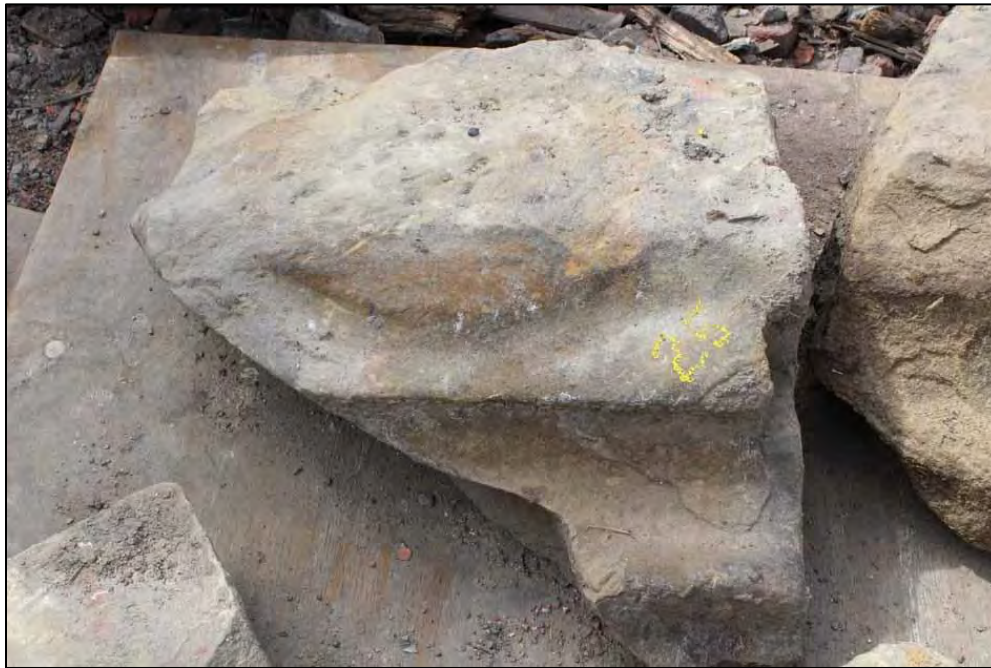
**STONE 25**

<b>Condition</b>	POOR
<b>Measurement</b>	L:600mm W:500mm D:250mm
<b>Description</b>	Probable cornice piece

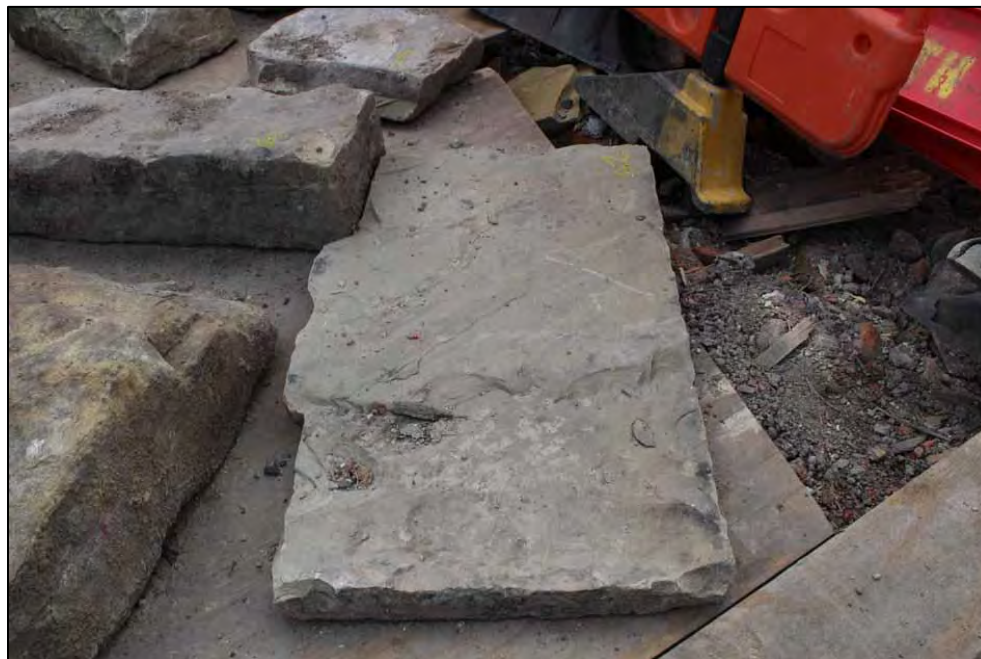
**STONE 26**

<b>Condition</b>	GOOD
<b>Measurement</b>	L:850mm W:500mm D:60mm
<b>Description</b>	Possible threshold flagstone or sill

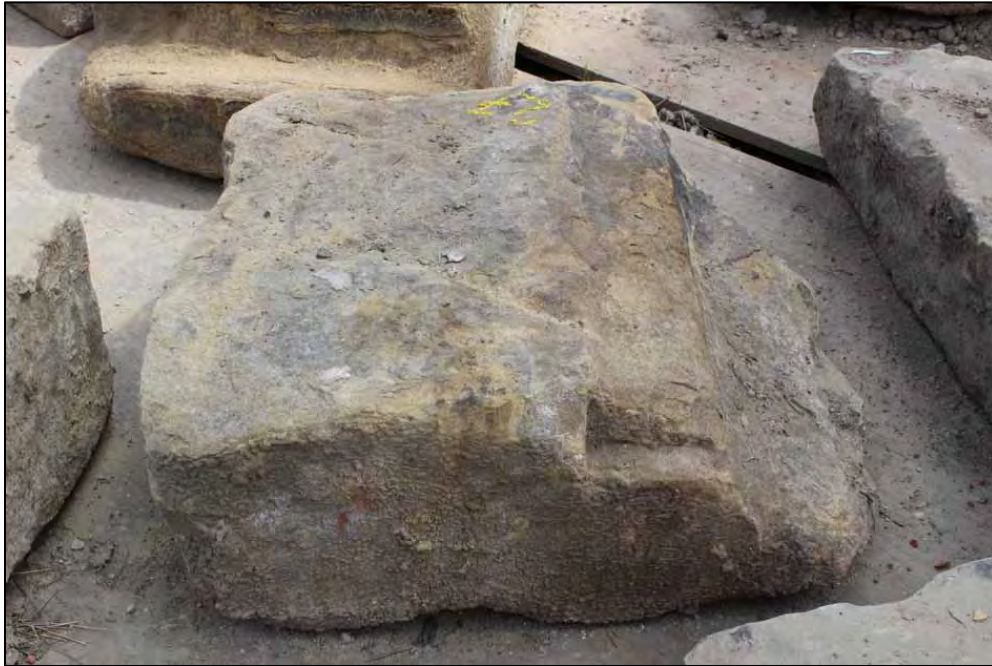
**STONE 27**

<b>Condition</b>	MODERATE
<b>Measurement</b>	L:600mm W:600mm D:250mm
<b>Description</b>	Possible base/corner piece

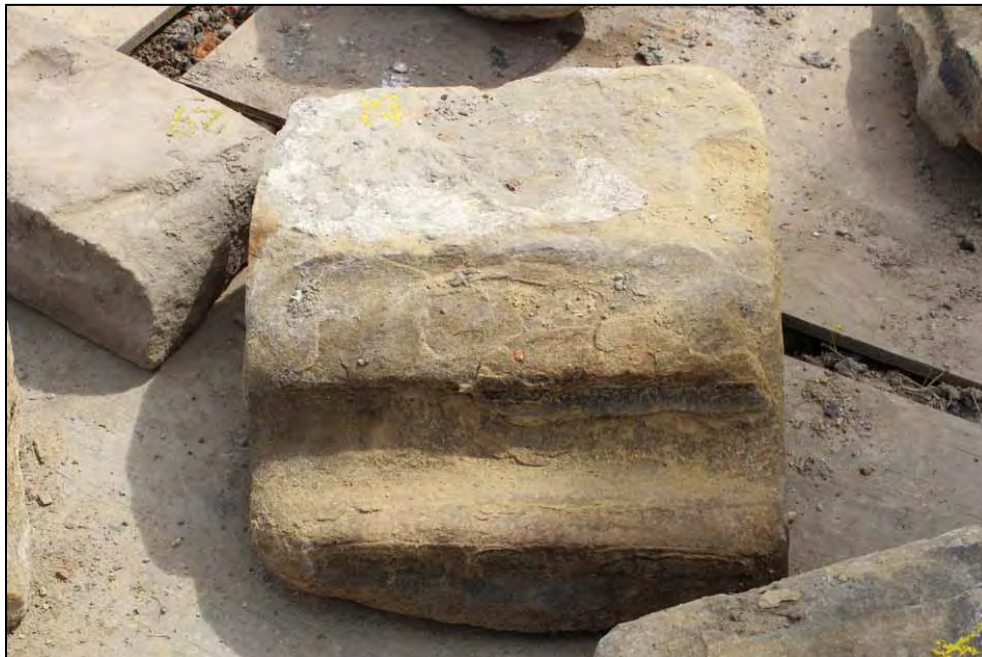
**STONE 28**

<b>Condition</b>	GOOD
<b>Measurement</b>	L:500mm W:550mm D:250mm
<b>Description</b>	Cornice piece

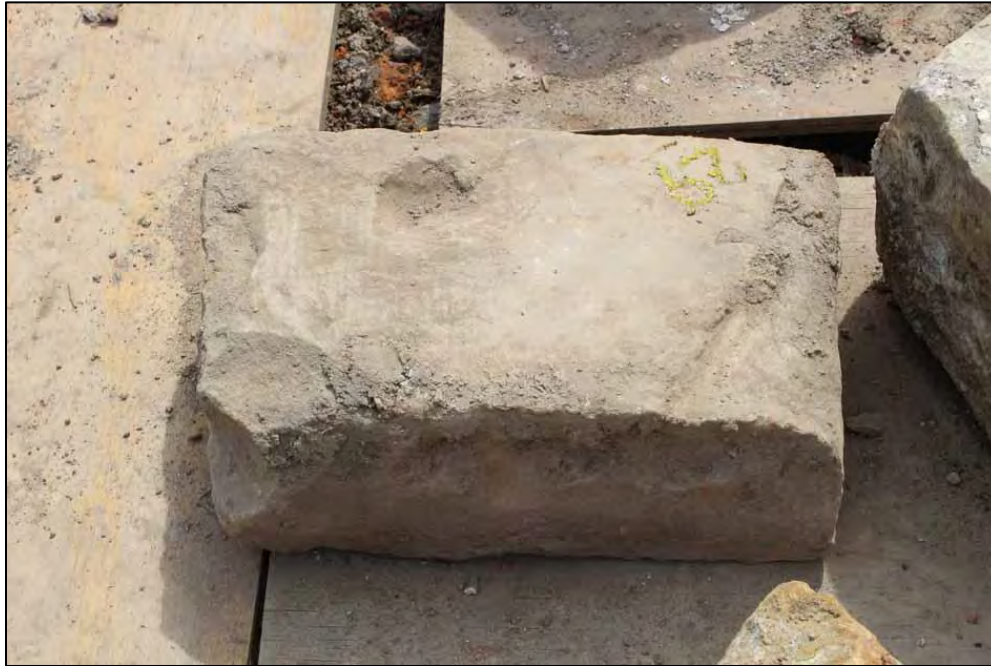
**STONE 29**

<b>Condition</b>	GOOD
<b>Measurement</b>	L:450mm W:260mm D:180mm
<b>Description</b>	Unidentifiable - rough rectangular block

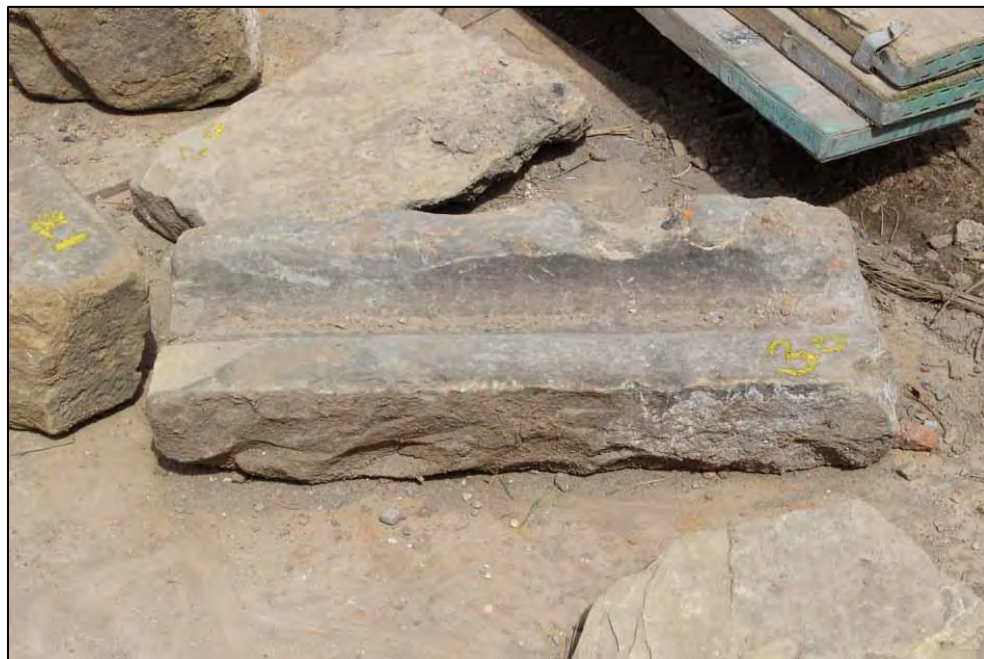
**STONE 30**

<b>Condition</b>	MODERATE
<b>Measurement</b>	L:700mm W:300mm D:150mm
<b>Description</b>	Possible guttering

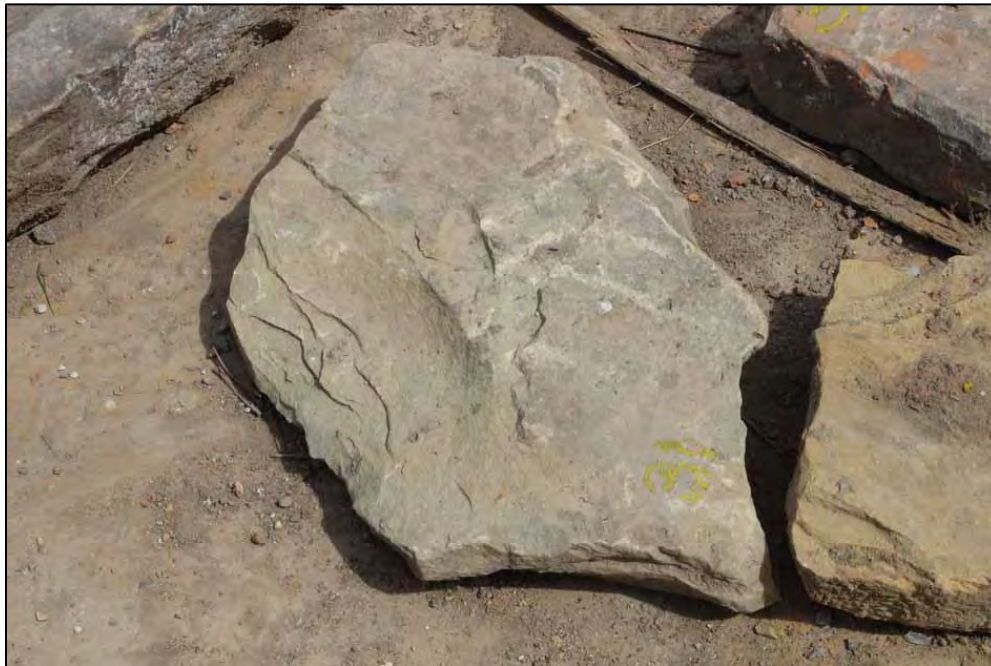
**STONE 31**

<b>Condition</b>	POOR
<b>Measurement</b>	L:550mm W:350mm D:60mm
<b>Description</b>	Irregular slab with shaped pointed end

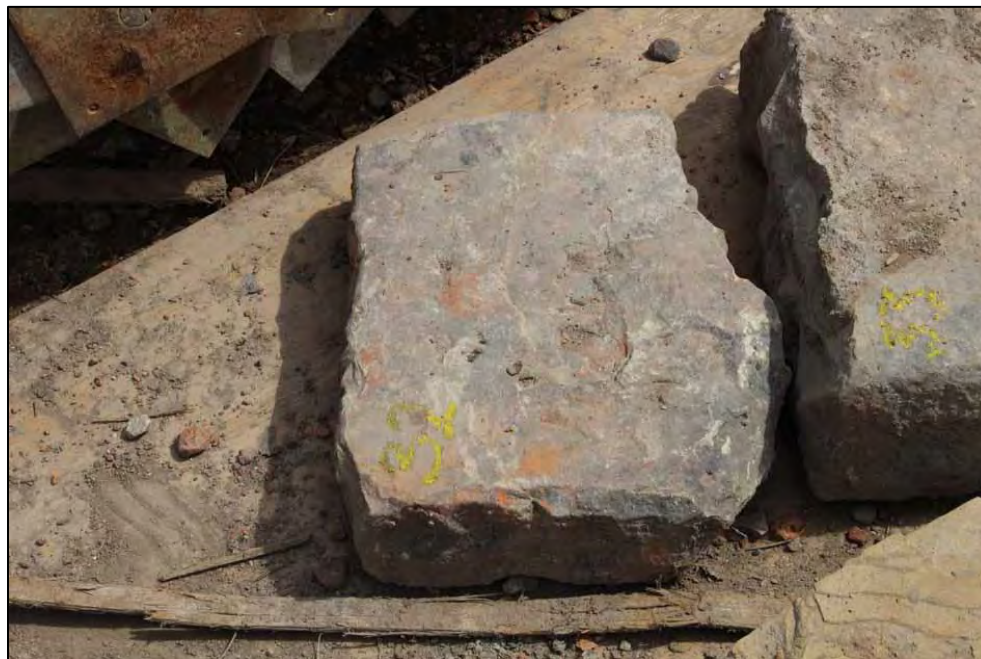
**STONE 32**

<b>Condition</b>	MODERATE
<b>Measurement</b>	L:380mm W:300mm D:100mm
<b>Description</b>	Unidentifiable - slab piece

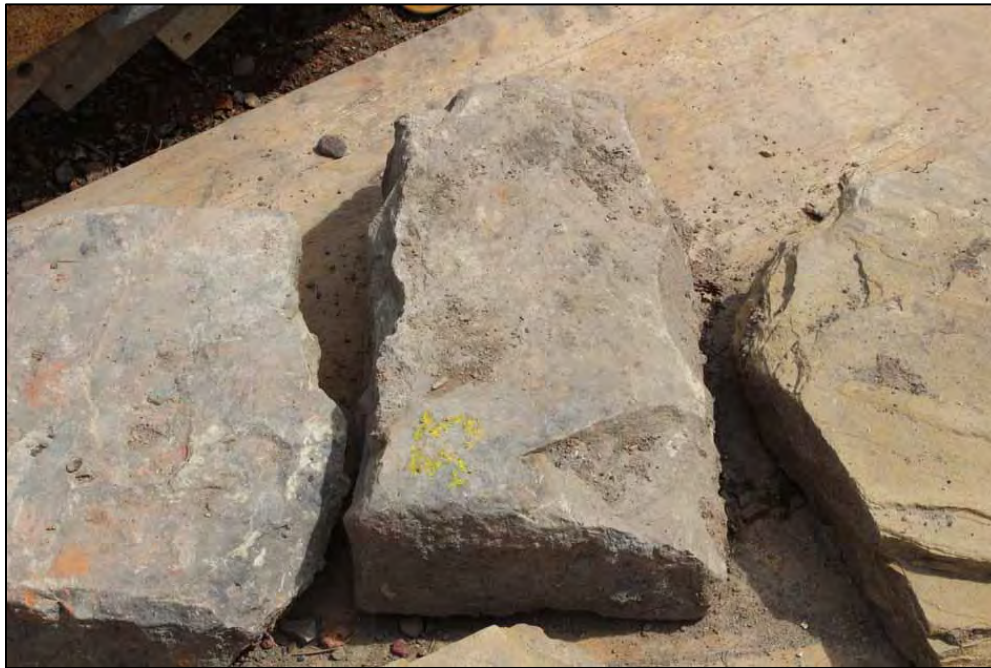
**STONE 33**

<b>Condition</b>	<b>POOR</b>
<b>Measurement</b>	L:450mm W:300mm D:150mm
<b>Description</b>	Unidentifiable - irregular block piece

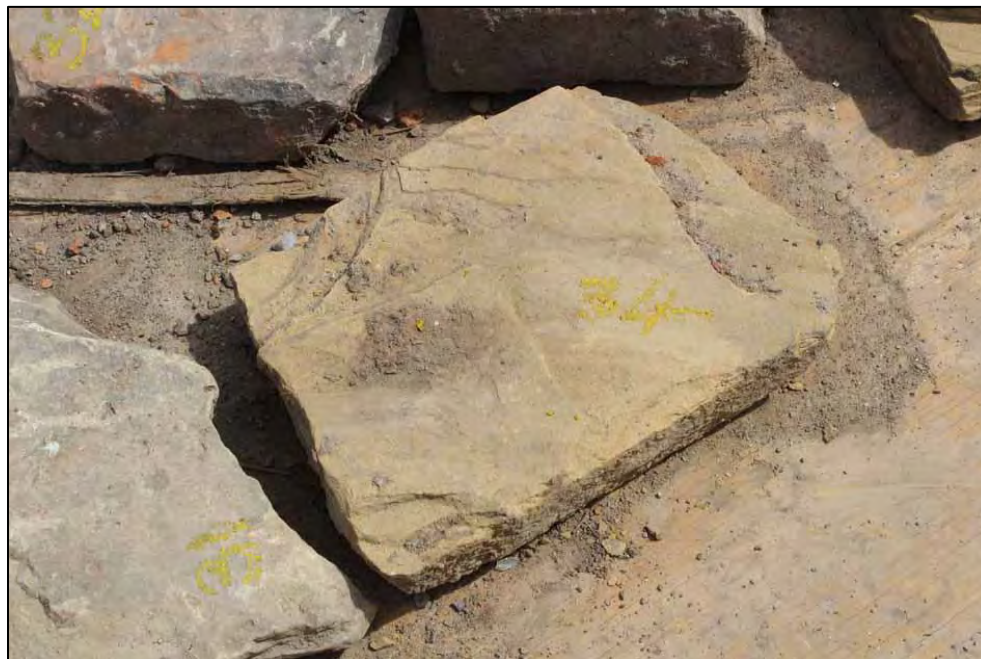
**STONE 34**

<b>Condition</b>	<b>POOR</b>
<b>Measurement</b>	L:380mm W:300mm D:100mm
<b>Description</b>	Unidentifiable - slab piece

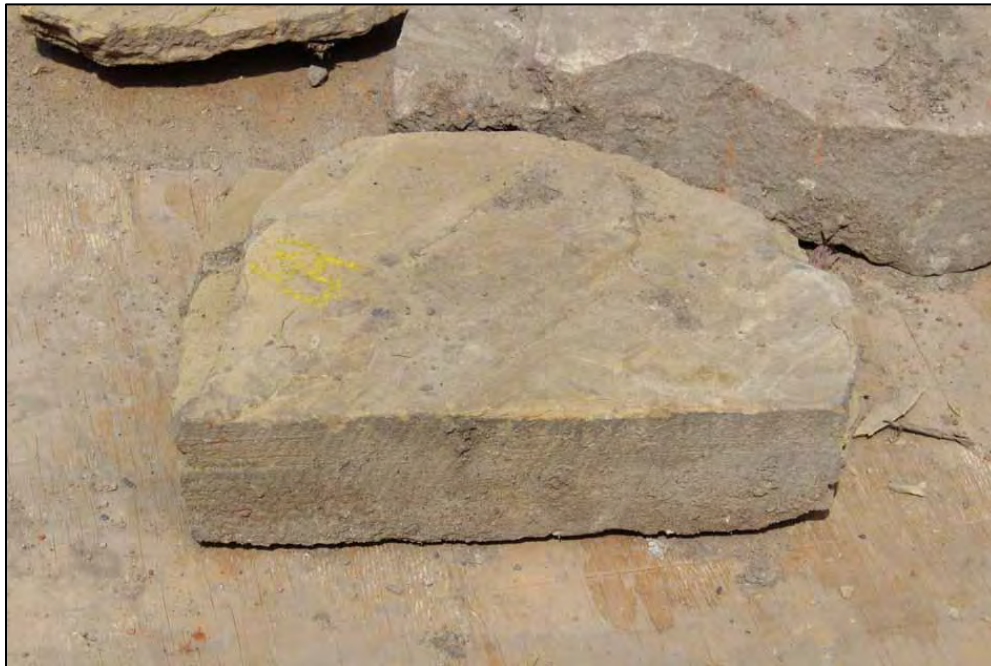
**STONE 35**

<b>Condition</b>	MODERATE
<b>Measurement</b>	L:380mm W:360mm D:100mm
<b>Description</b>	Unidentifiable - slab piece

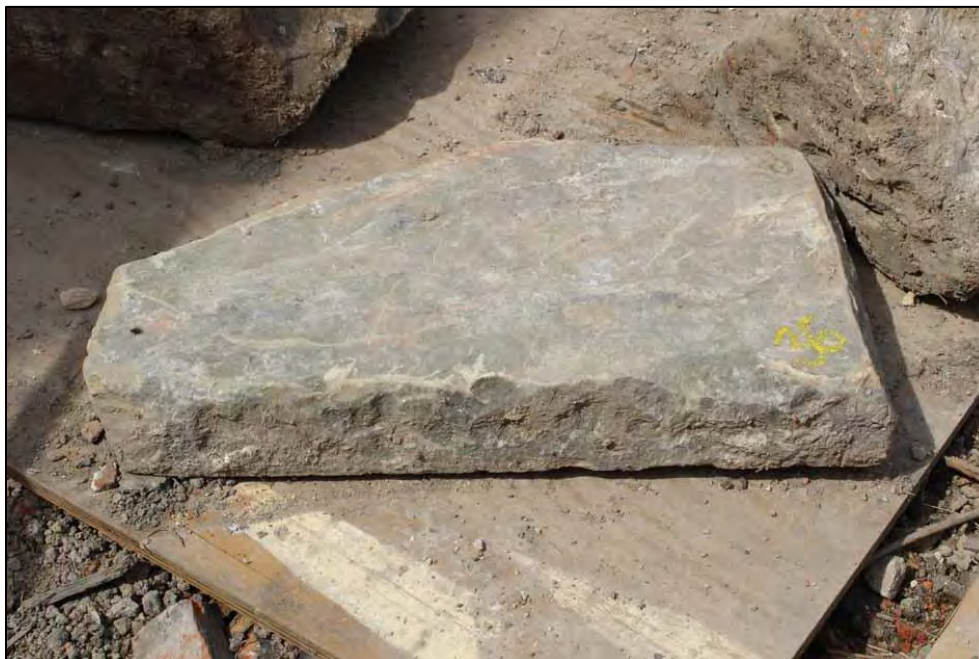
**STONE 36**

<b>Condition</b>	GOOD
<b>Measurement</b>	L:700mm W:390mm D:120mm
<b>Description</b>	Probable threshold or sill

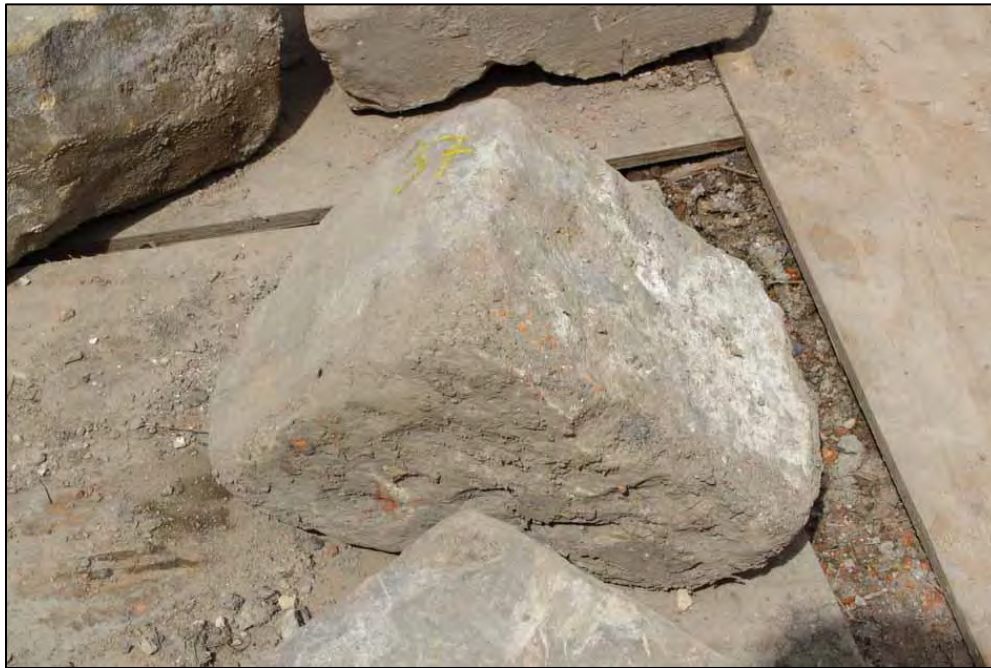
**STONE 37**

<b>Condition</b>	GOOD
<b>Measurement</b>	L:350mm W:250mm D:380mm
<b>Description</b>	Keystone piece
