**First White Cloth Hall  
Kirkgate, Leeds  
West Yorkshire**

Archaeological Watching Brief  
and Structural Watching Brief

Report no. 3460  
October 2020

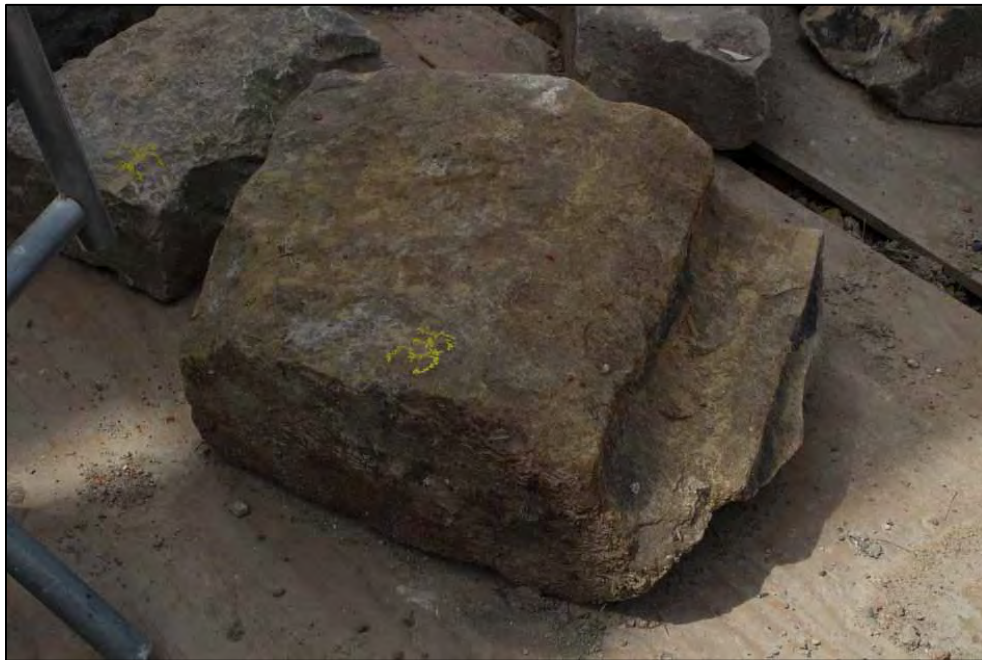
**STONE 38**

<b>Condition</b>	MODERATE
<b>Measurement</b>	L:500mm W:600mm D:300mm
<b>Description</b>	Cornice piece

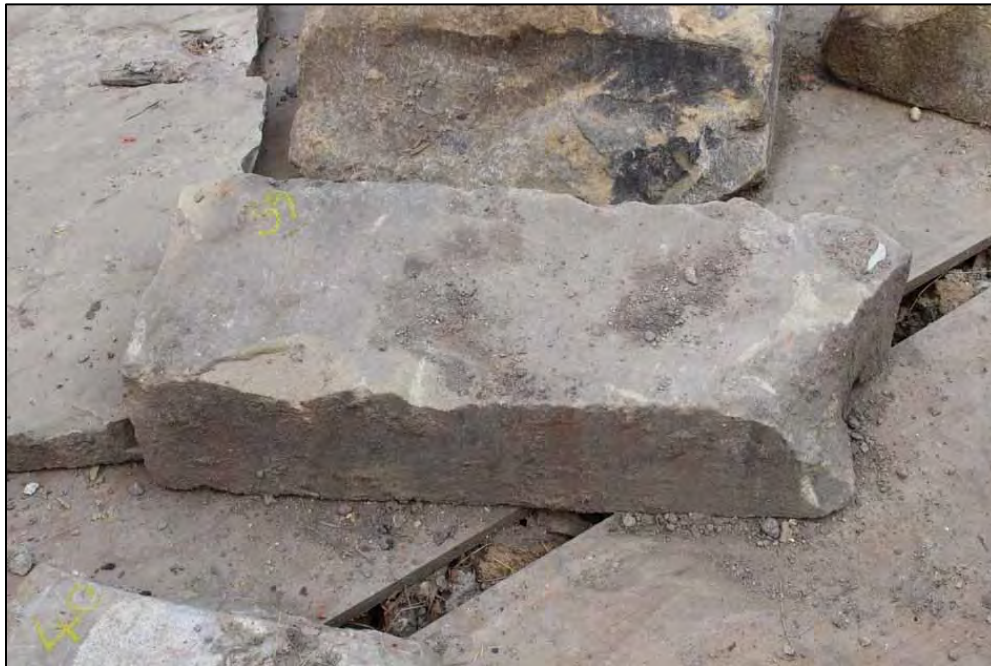
**STONE 39**

<b>Condition</b>	MODERATE
<b>Measurement</b>	L:750mm W:280mm D:200mm
<b>Description</b>	Possible column/pillar piece

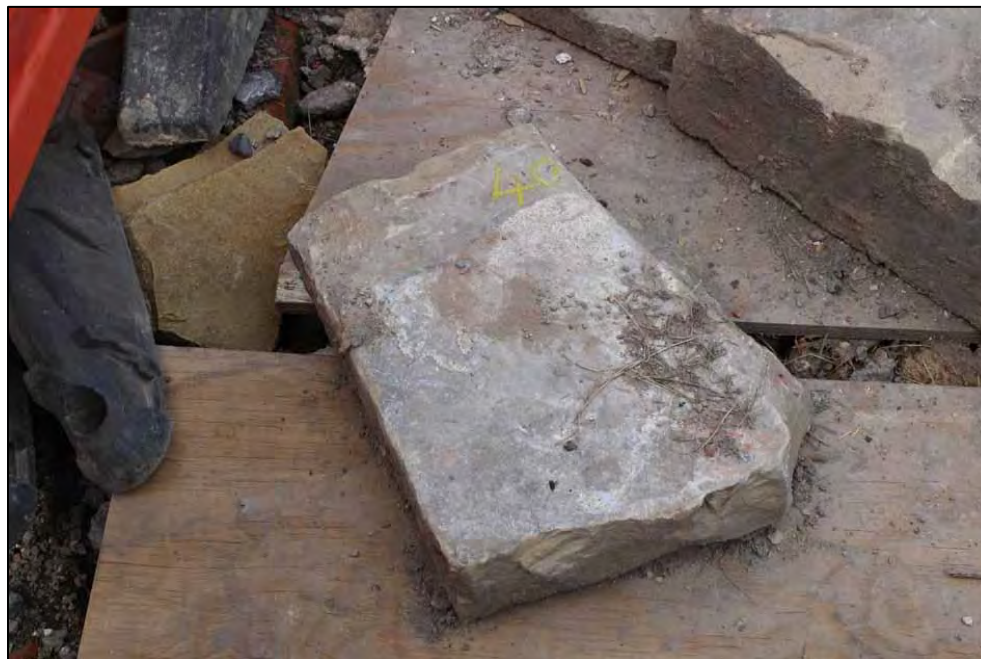
**STONE 40**

<b>Condition</b>	GOOD
<b>Measurement</b>	L:400mm W:350mm D:100mm
<b>Description</b>	Unidentifiable - slab piece

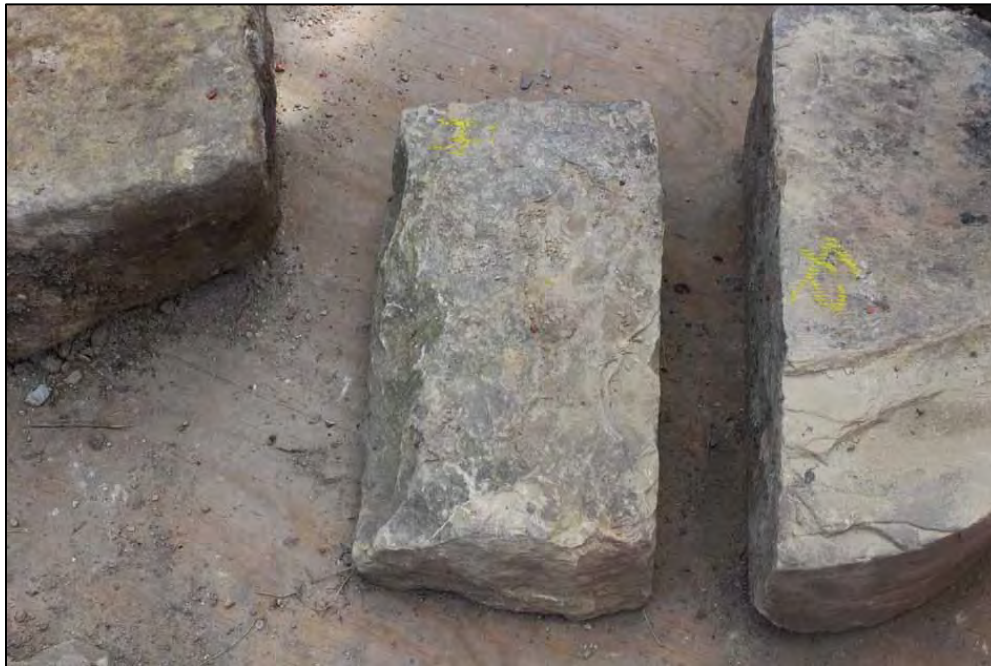
**STONE 41**

<b>Condition</b>	MODERATE
<b>Measurement</b>	L:500mm W:300mm D:150mm
<b>Description</b>	Possible column/pillar piece

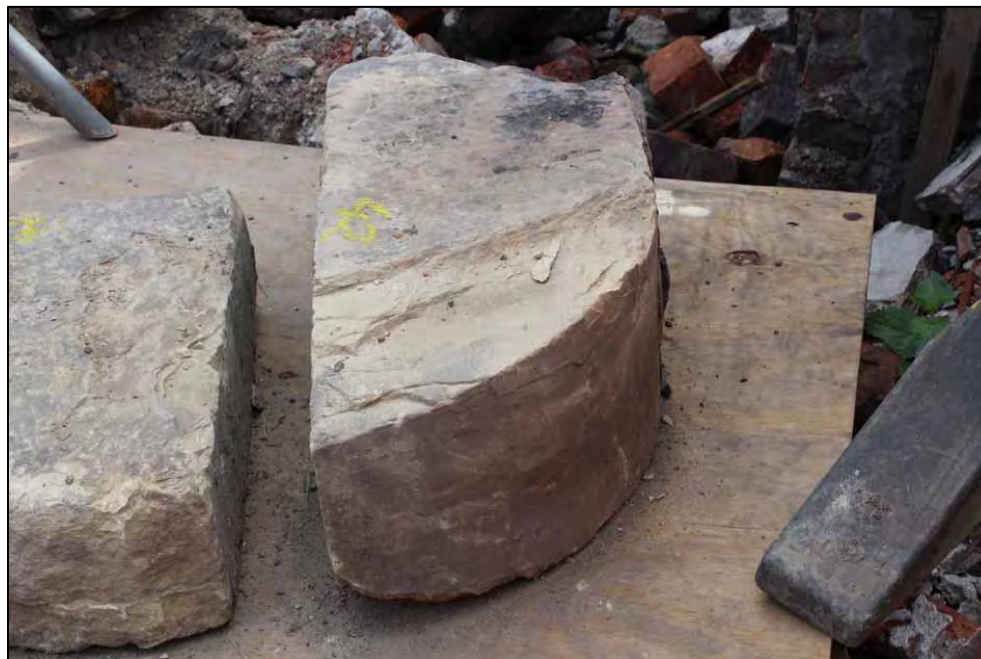
**STONE 42**

<b>Condition</b>	GOOD
<b>Measurement</b>	L:650mm W:300mm D:250mm
<b>Description</b>	Possible corbel

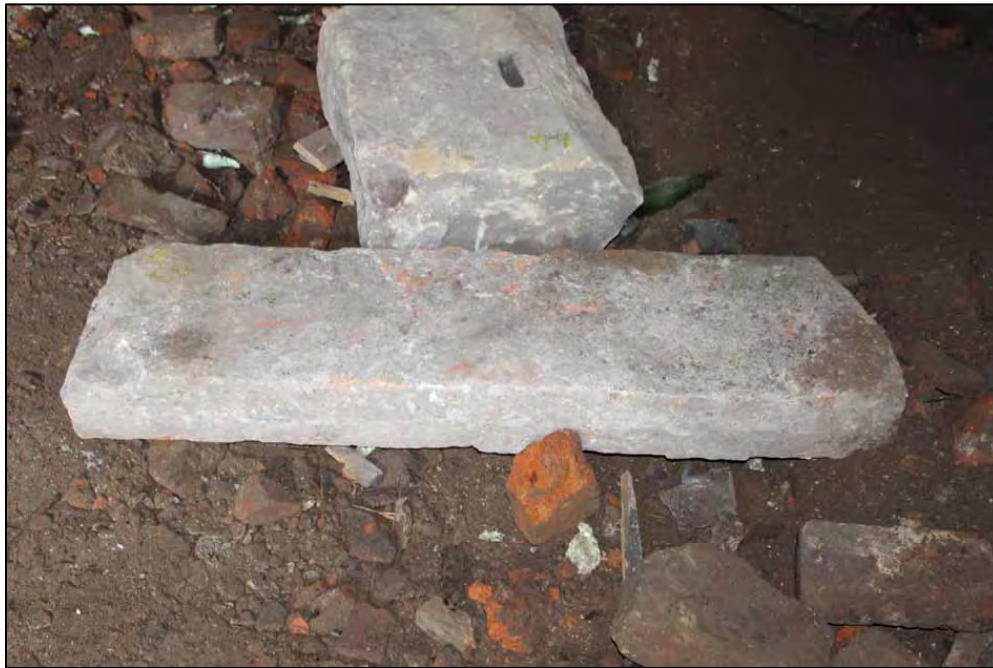
**STONE 43**

<b>Condition</b>	GOOD
<b>Measurement</b>	L:1200mm W:300m D:150mm
<b>Description</b>	Unidentifiable

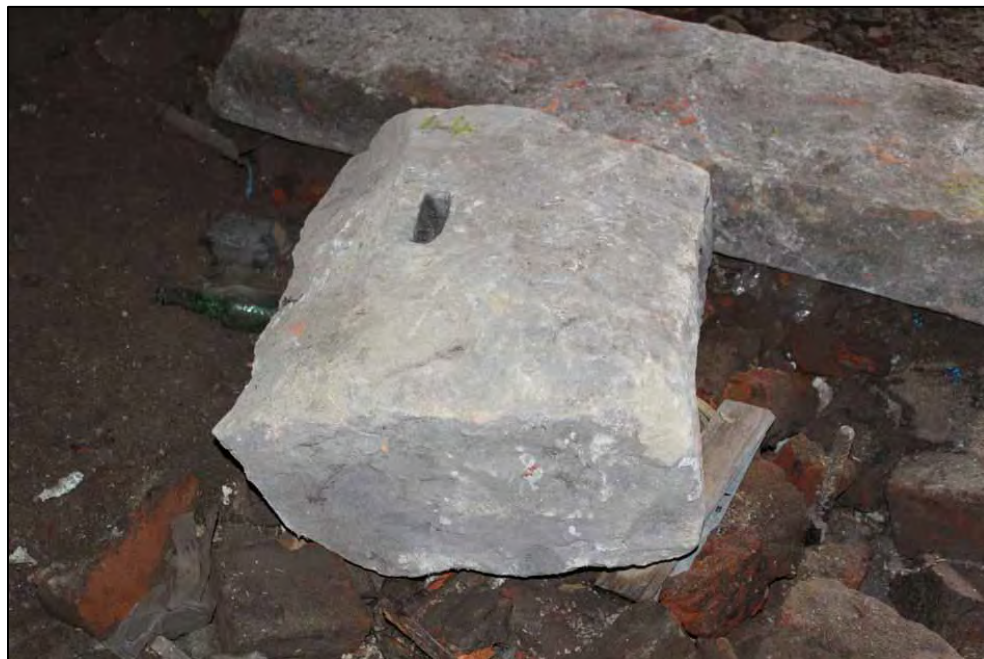
**STONE 44**

<b>Condition</b>	MODERATE
<b>Measurement</b>	L:340mm W:460mm D:250mm
<b>Description</b>	Possible capital

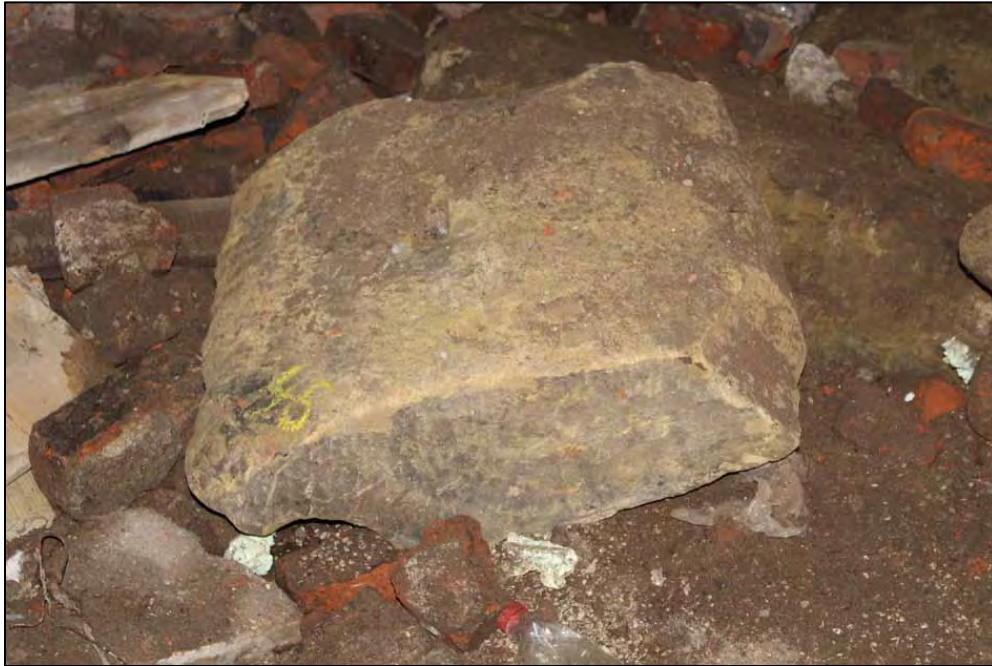
**STONE 45**

<b>Condition</b>	POOR
<b>Measurement</b>	L:600mm W:500mm D:250mm
<b>Description</b>	Cornice piece

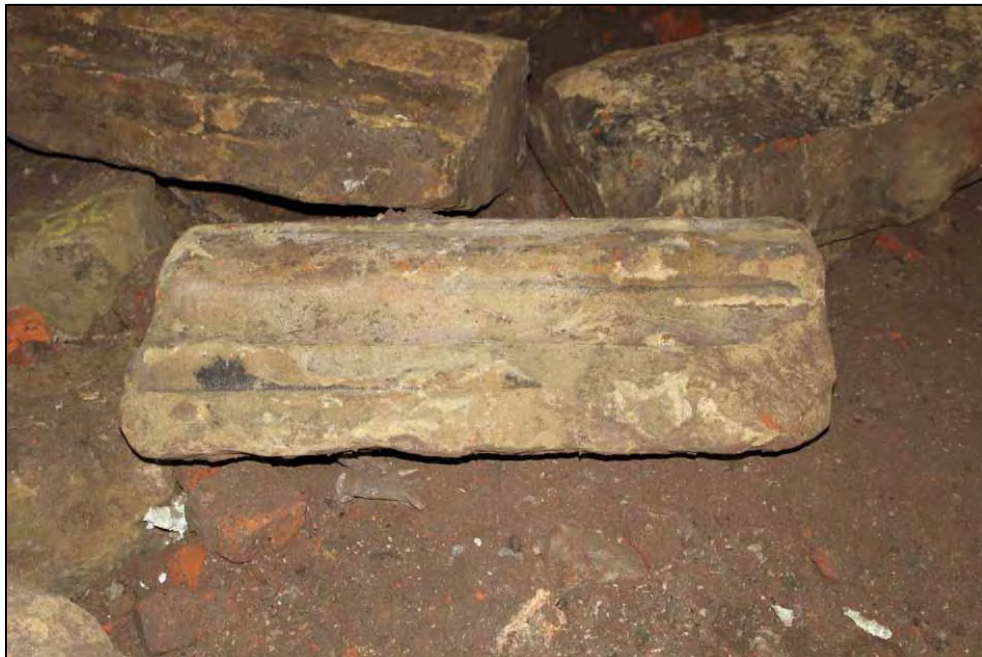
**STONE 46**

<b>Condition</b>	POOR
<b>Measurement</b>	L:900mm W:600mm D:250mm
<b>Description</b>	Cornice piece

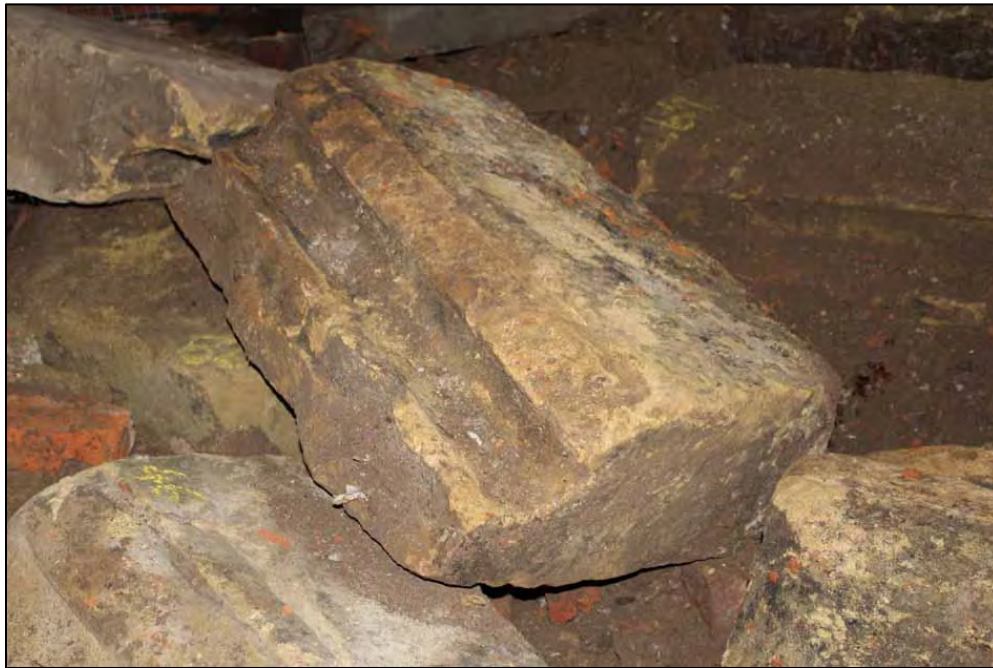
**STONE 47**

<b>Condition</b>	MODERATE
<b>Measurement</b>	L:900mm W:600mm D:250mm
<b>Description</b>	Cornice piece

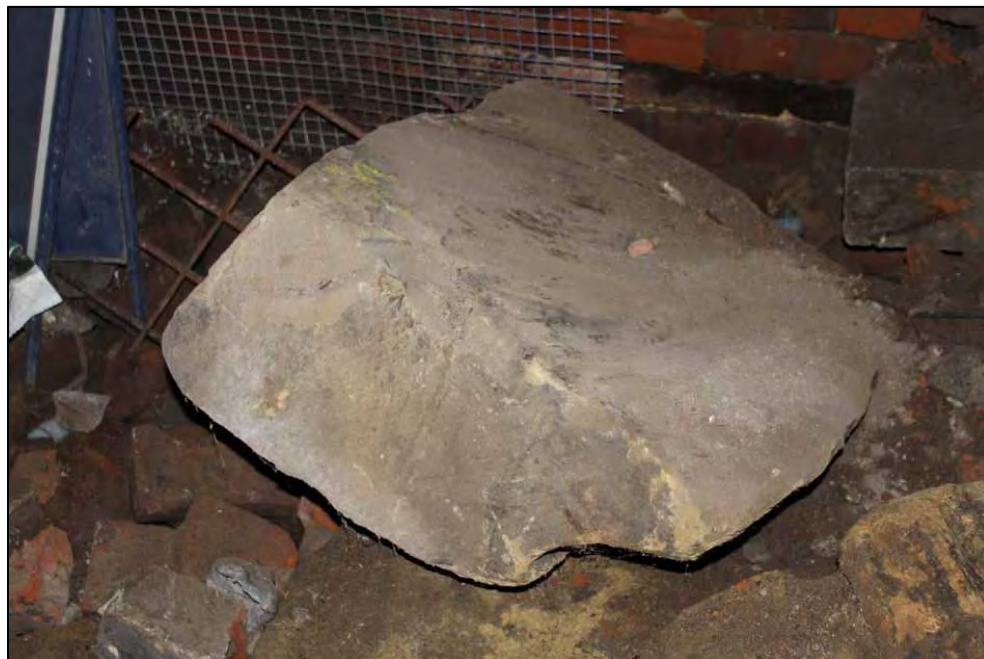
**STONE 48**

<b>Condition</b>	MODERATE
<b>Measurement</b>	L:900mm W:600mm D:250mm
<b>Description</b>	Cornice piece

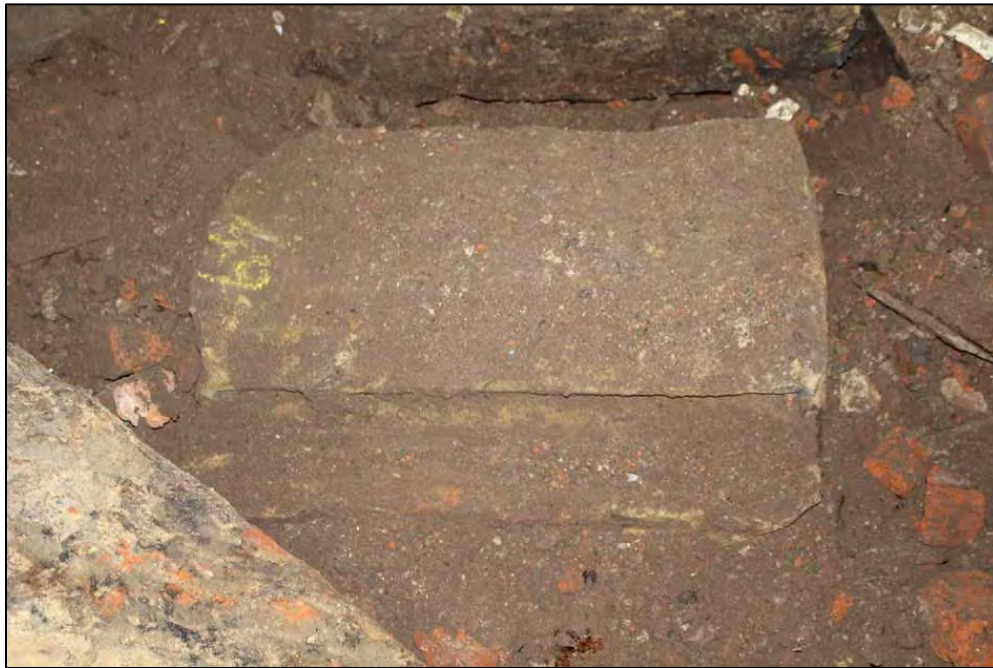
**STONE 49**

<b>Condition</b>	GOOD
<b>Measurement</b>	L:7320mm W:470mm D:250mm
<b>Description</b>	Cornice piece

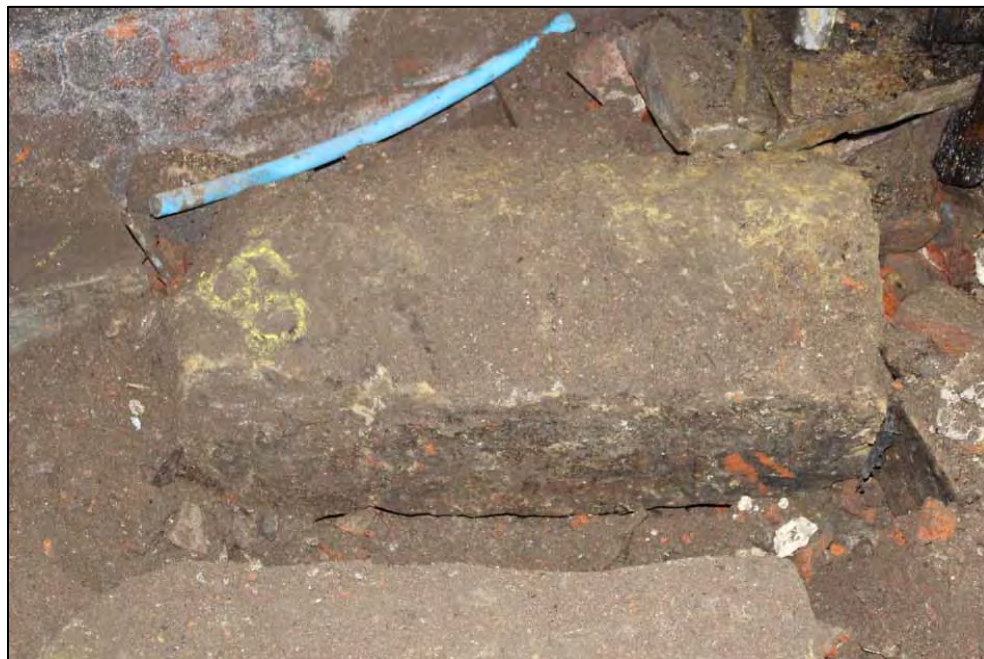
**STONE 50**

<b>Condition</b>	POOR
<b>Measurement</b>	L:720mm W:420mm D:250mm
<b>Description</b>	Probable cornice piece

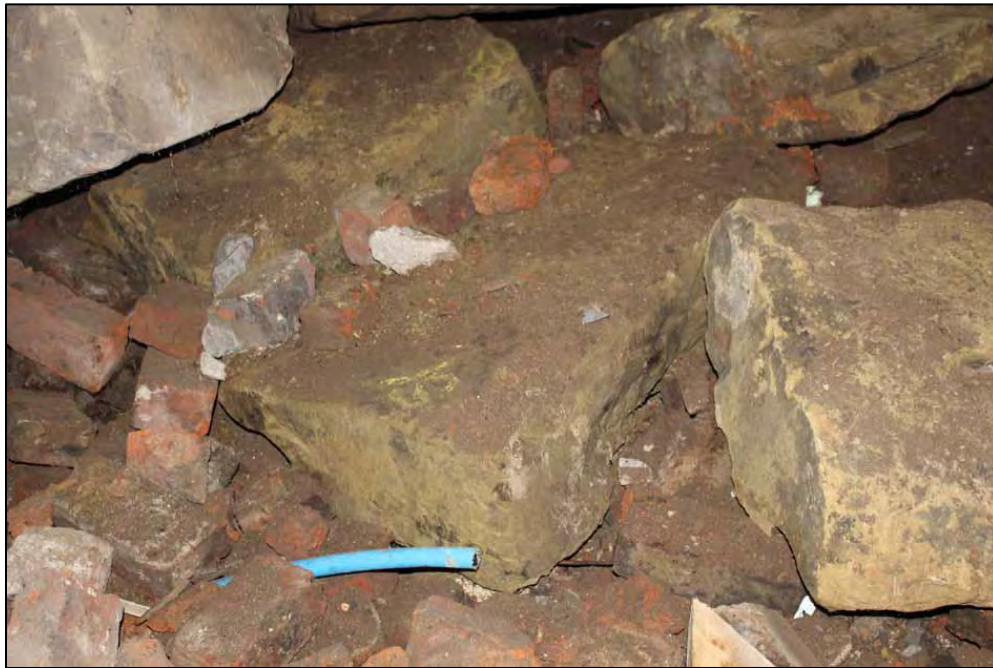
**STONE 51**

<b>Condition</b>	MODERATE
<b>Measurement</b>	L:900mm W:600mm D:280mm
<b>Description</b>	Cornice piece

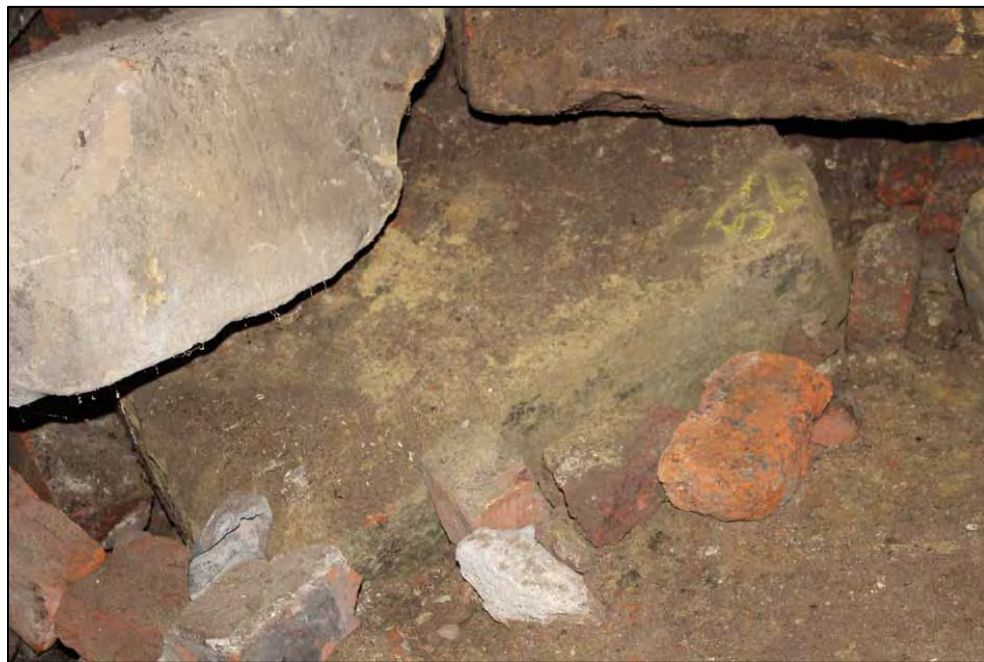
**STONE 52**

<b>Condition</b>	MODERATE
<b>Measurement</b>	L:750mm W:450mm D:300mm
<b>Description</b>	Probable cornice piece

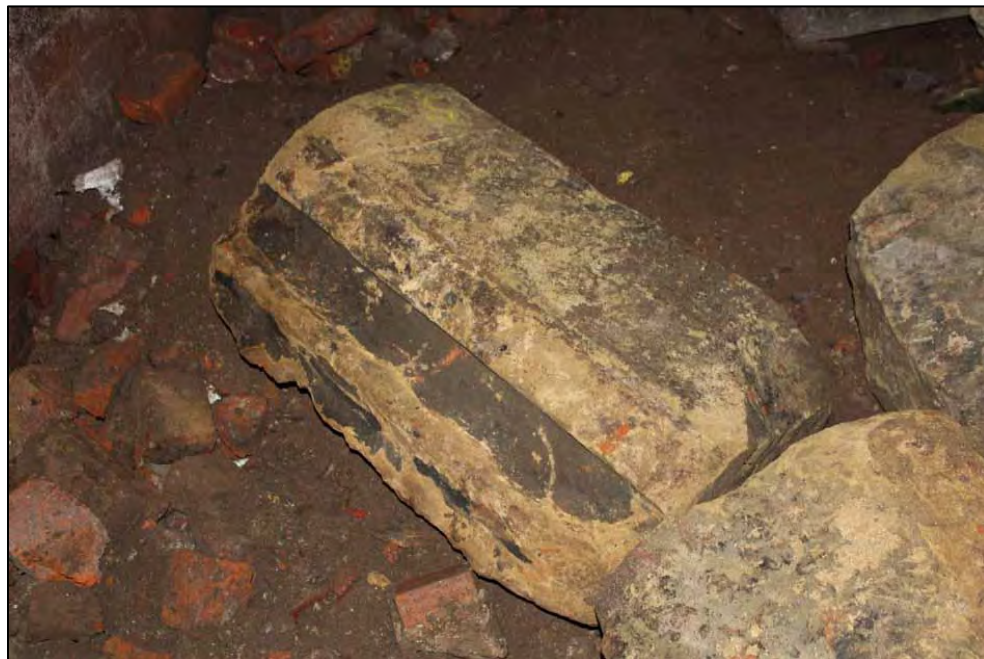
**STONE 53**

<b>Condition</b>	<b>POOR</b>
<b>Measurement</b>	L:900mm W:500mm D:300mm
<b>Description</b>	Cornice piece
<b>STONE 54</b>	
<b>VOID</b>

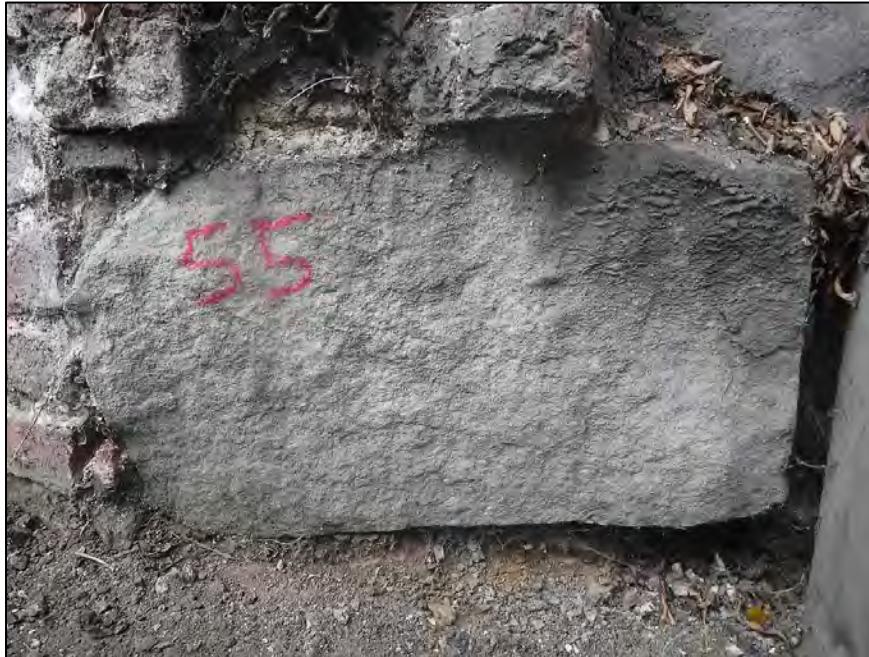
**STONE 55**

<b>Condition</b>	GOOD
<b>Measurement</b>	L:530mm W:300mm
<b>Description</b>	Unidentifiable - block piece

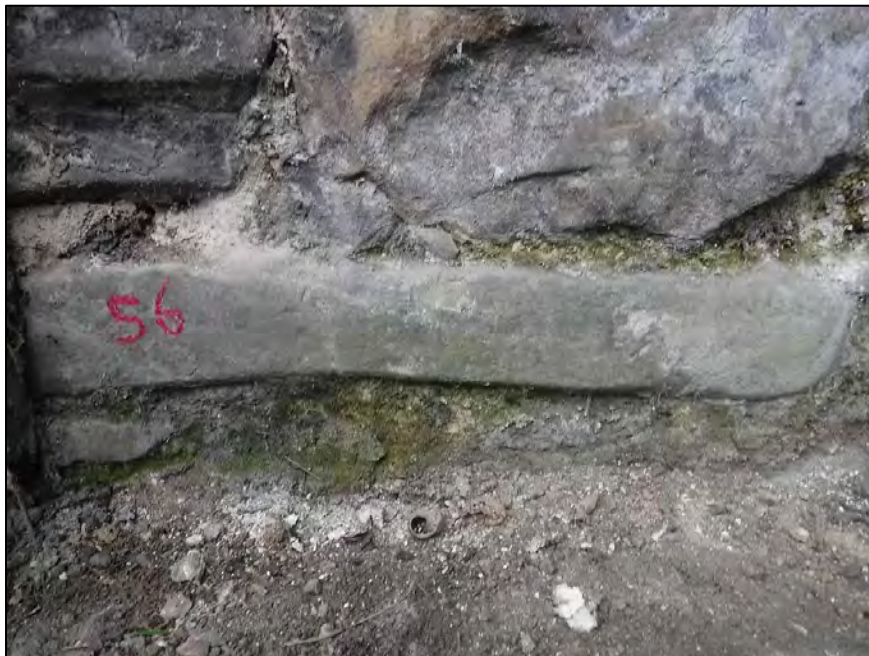
**STONE 56**

<b>Condition</b>	GOOD
<b>Measurement</b>	L:920mm W:130mm
<b>Description</b>	Possible threshold (worn centrally on its underside)

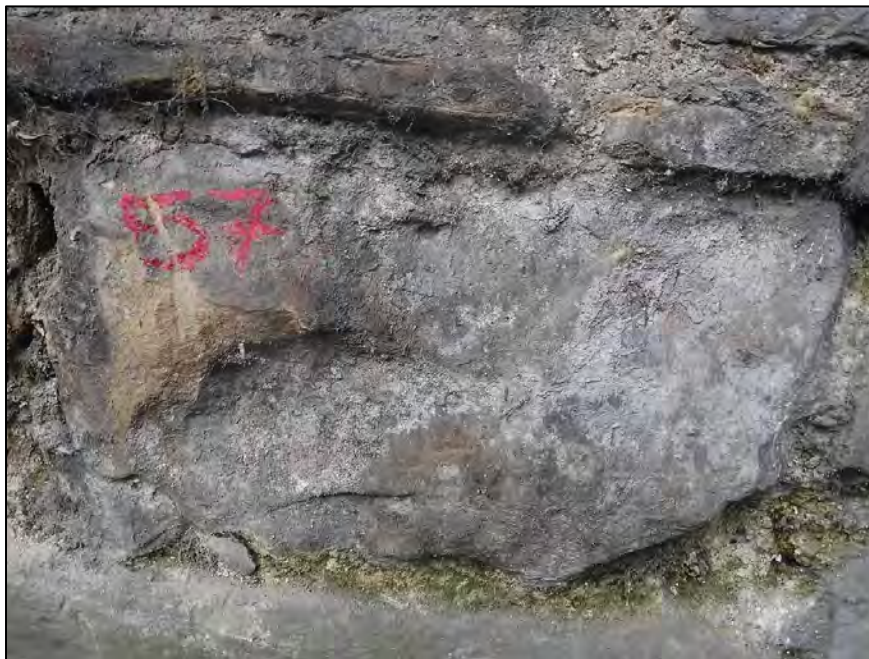
**STONE 57**

<b>Condition</b>	MODERATE
<b>Measurement</b>	L:470mm W:280mm
<b>Description</b>	Unidentifiable - irregular block piece

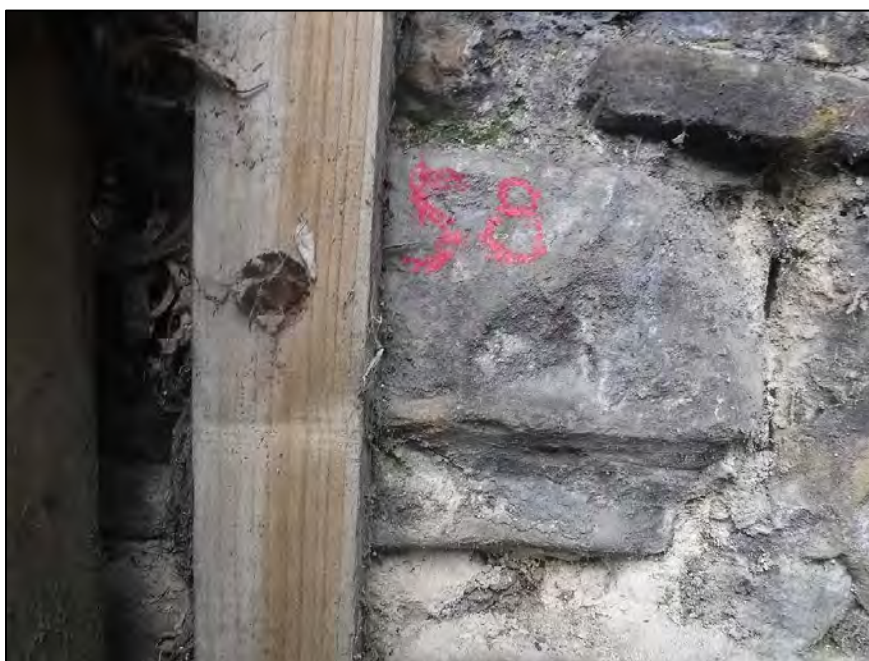
**STONE 58**

<b>Condition</b>	MODERATE
<b>Measurement</b>	L:440mm W:230mm
<b>Description</b>	Possible cornice fragment - block piece with concave groove

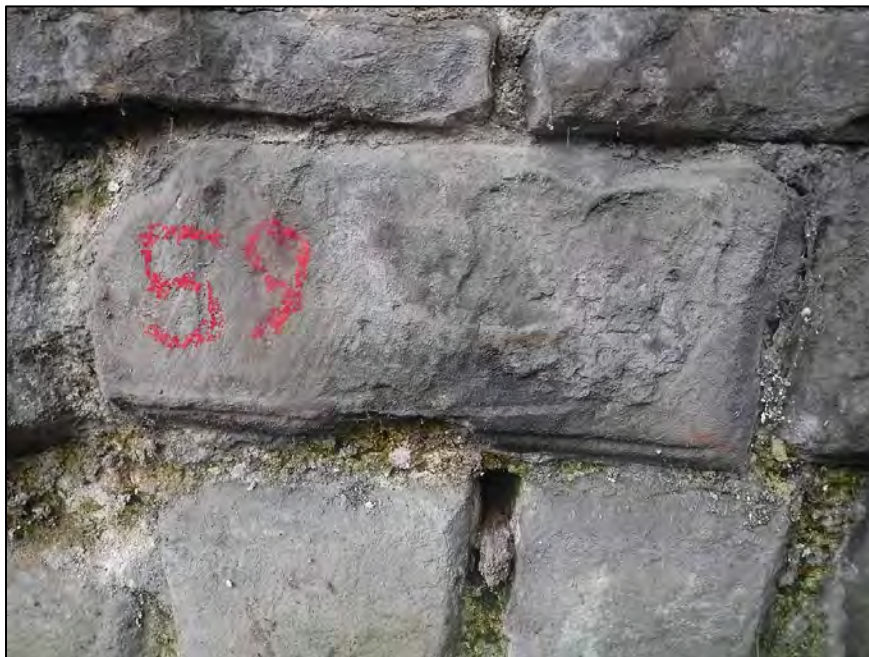
**STONE 59**

<b>Condition</b>	MODERATE
<b>Measurement</b>	L:410mm W:210mm
<b>Description</b>	Possible base stone or pillar plinth fragment

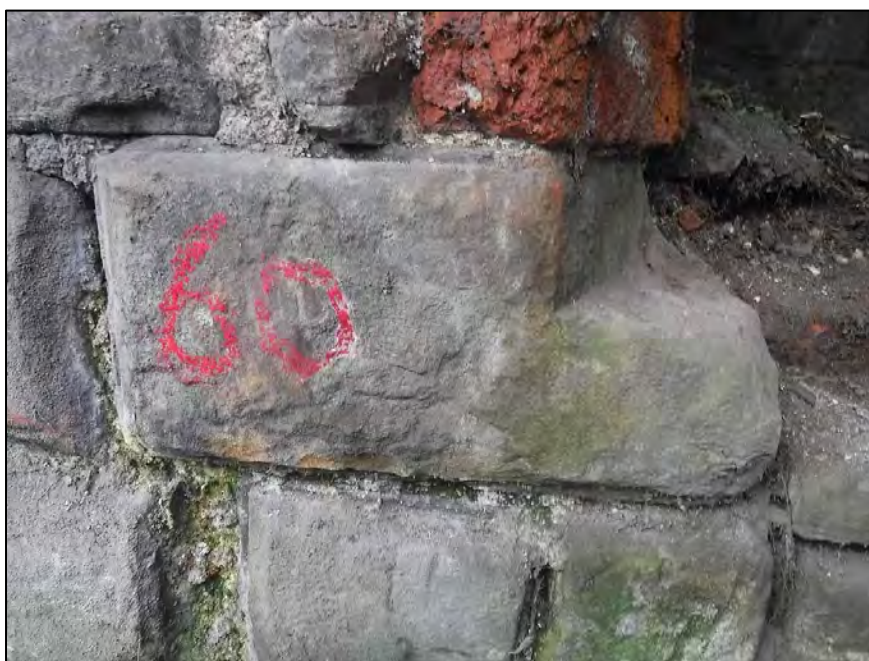
**STONE 60**

<b>Condition</b>	GOOD
<b>Measurement</b>	L:420mm W:200mm D:200mm
<b>Description</b>	Possible base stone or pillar plinth fragment – the notched corner looks to be a later alteration

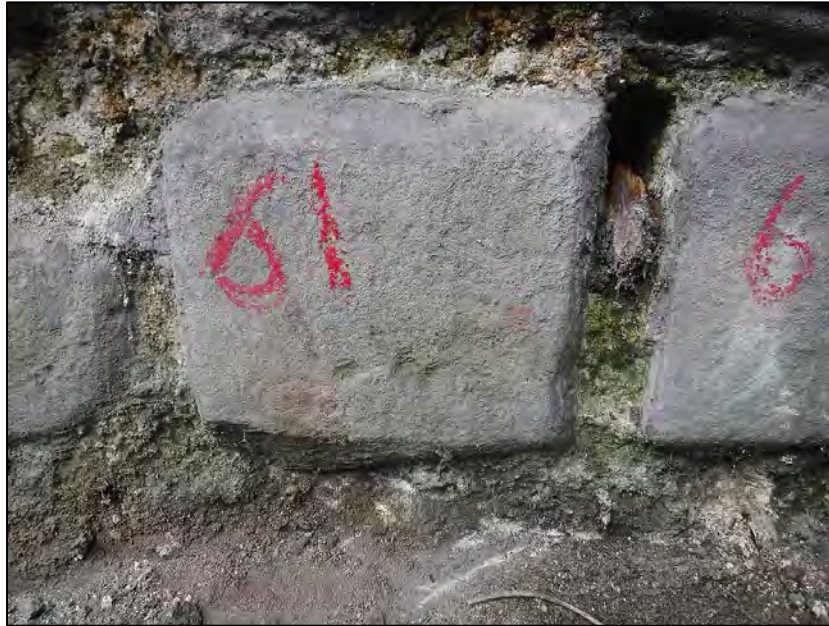
**STONE 61**

<b>Condition</b>	MODERATE
<b>Measurement</b>	L:200mm W:190mm
<b>Description</b>	Unidentifiable – block piece fragment, possibly formerly joined Stone 62

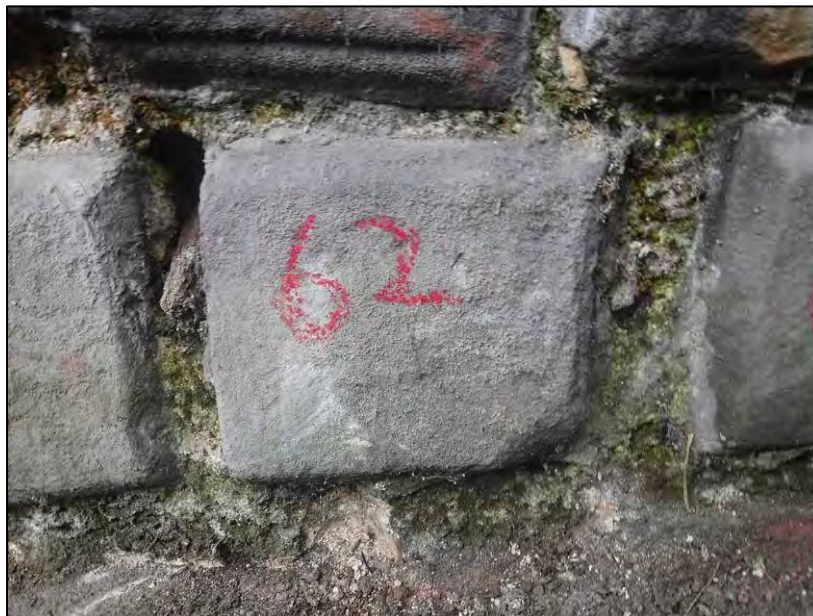
**STONE 62**

<b>Condition</b>	MODERATE
<b>Measurement</b>	L:190mm W:190mm
<b>Description</b>	Unidentifiable – block piece fragment, possibly formerly joined Stone 61

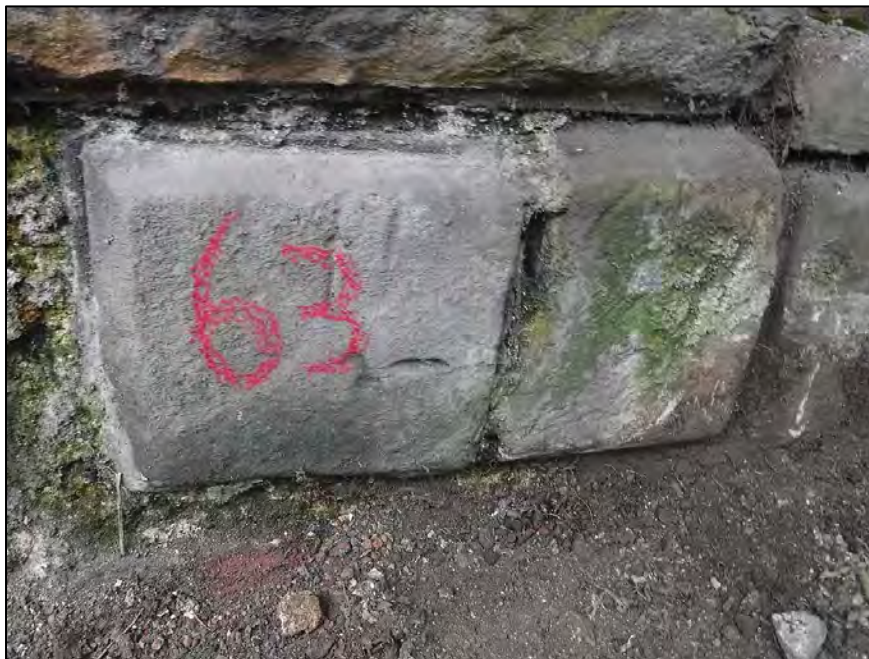
**STONE 63**

<b>Condition</b>	<b>POOR</b>
<b>Measurement</b>	L:370mm W:210mm
<b>Description</b>	Unidentifiable – fragmented block piece

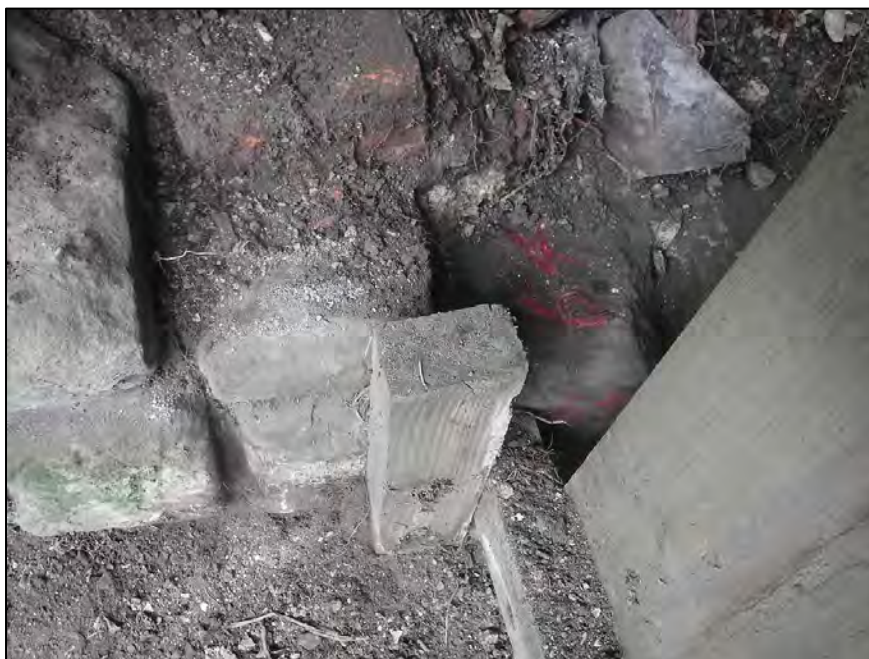
**STONE 64**

<b>Condition</b>	<b>MODERATE</b>
<b>Measurement</b>	L:410mm W:190mm
<b>Description</b>	Unidentifiable – block piece

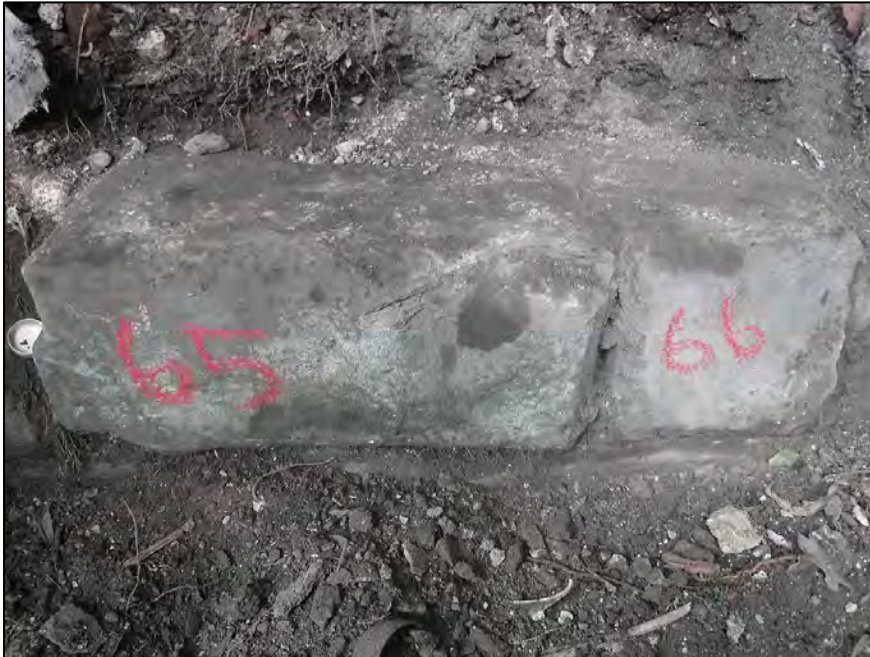
**STONE 65**

<b>Condition</b>	MODERATE
<b>Measurement</b>	L:410mm W:190mm D:200mm
<b>Description</b>	Unidentifiable – block piece

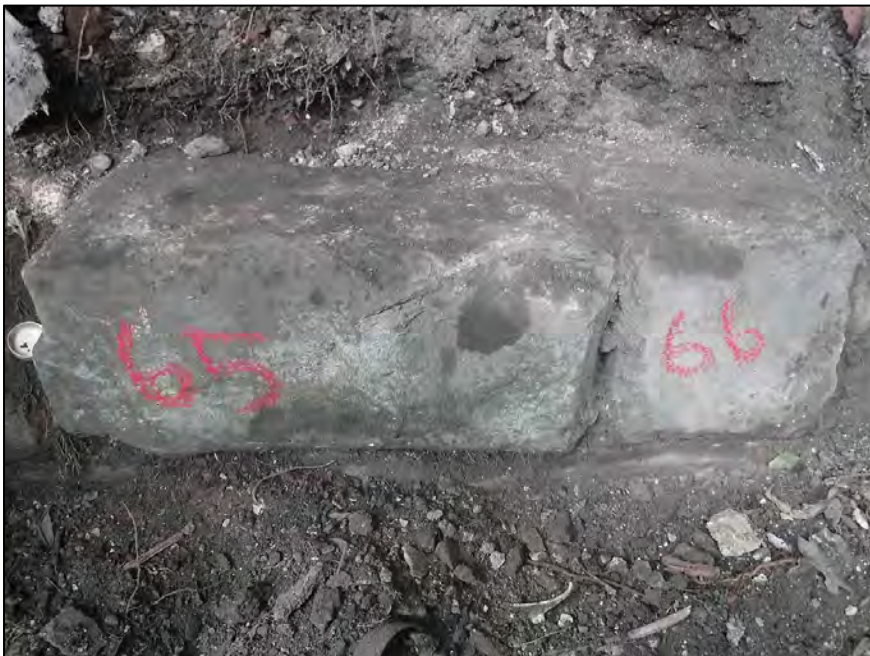
**STONE 66**

<b>Condition</b>	POOR
<b>Measurement</b>	L:200mm W:190mm
<b>Description</b>	Unidentifiable – block piece

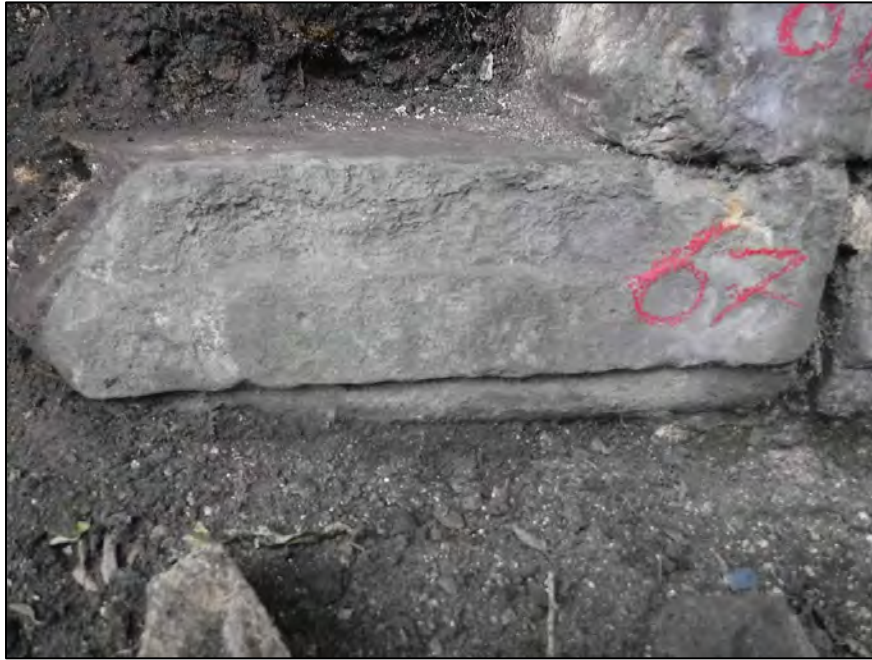
**STONE 67**

<b>Condition</b>	MODERATE
<b>Measurement</b>	L:560mm W:190mm
<b>Description</b>	Possible base or plinth piece

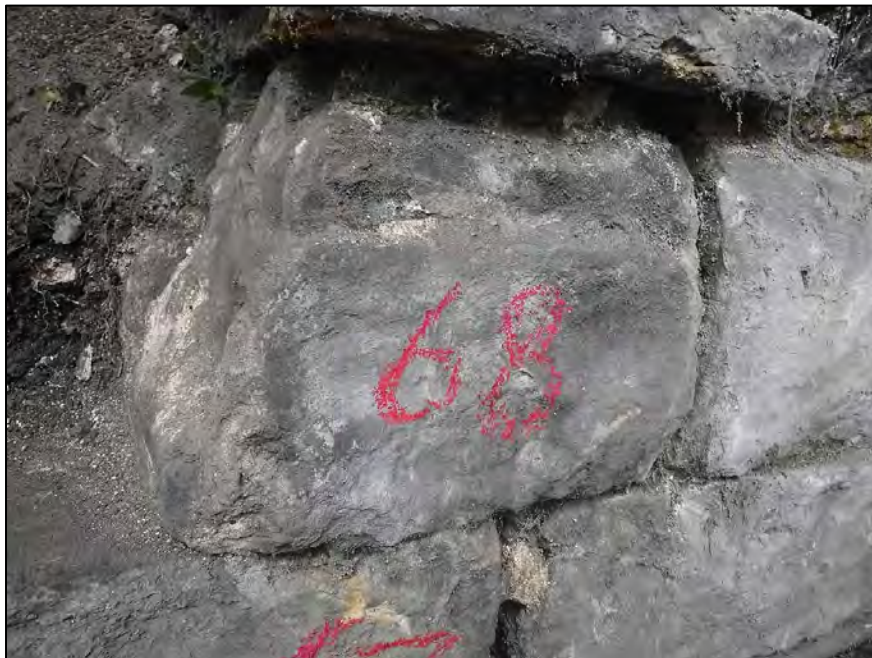
**STONE 68**

<b>Condition</b>	POOR
<b>Measurement</b>	L:260mm W:200mm
<b>Description</b>	Unidentifiable - irregular block piece

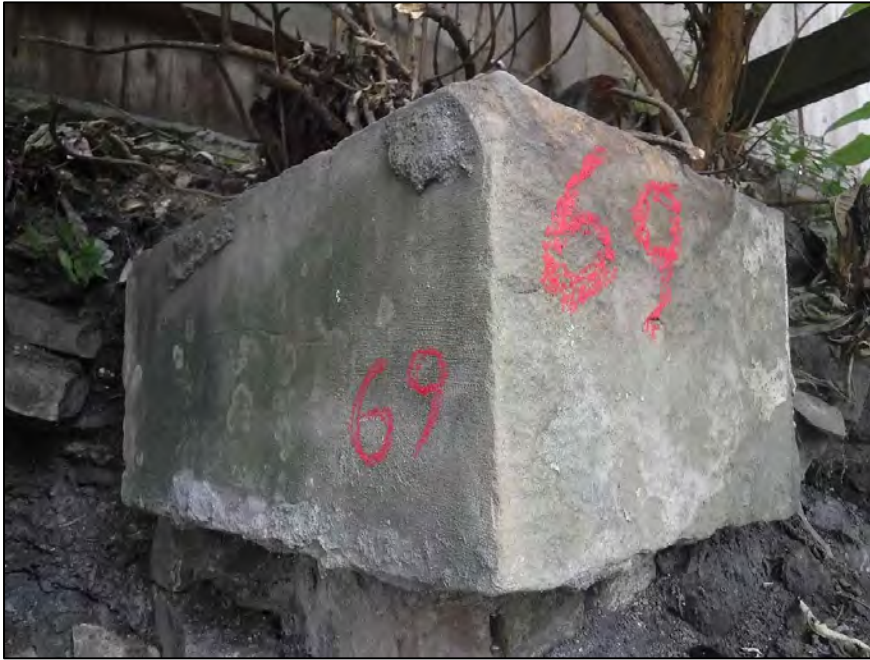
**STONE 69**

<b>Condition</b>	GOOD
<b>Measurement</b>	L:490mm W:220mm D:330mm
<b>Description</b>	Possible corner stone or pillar piece

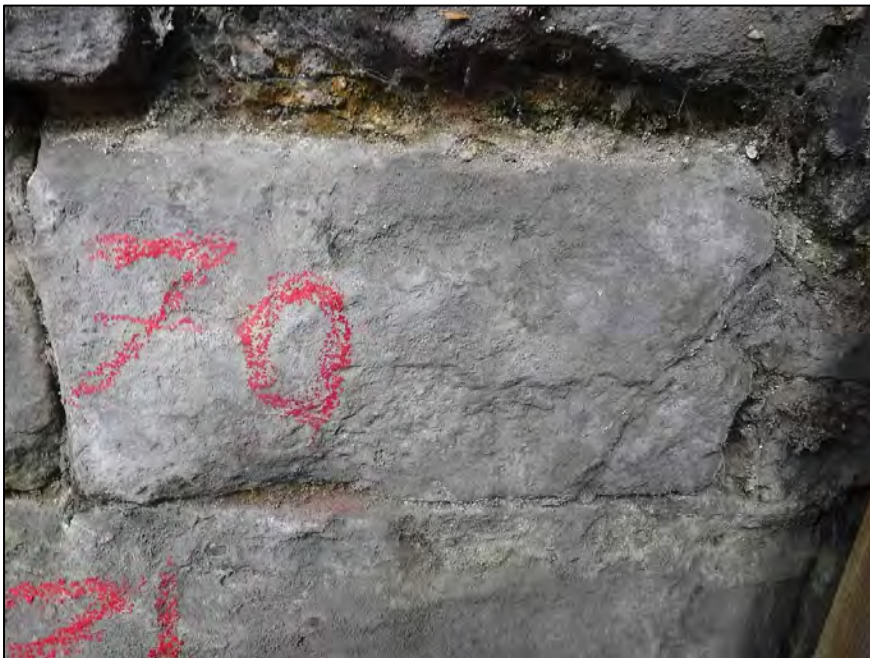
**STONE 70**

<b>Condition</b>	MODERATE
<b>Measurement</b>	L:390mm W:210mm
<b>Description</b>	Unidentifiable - block piece

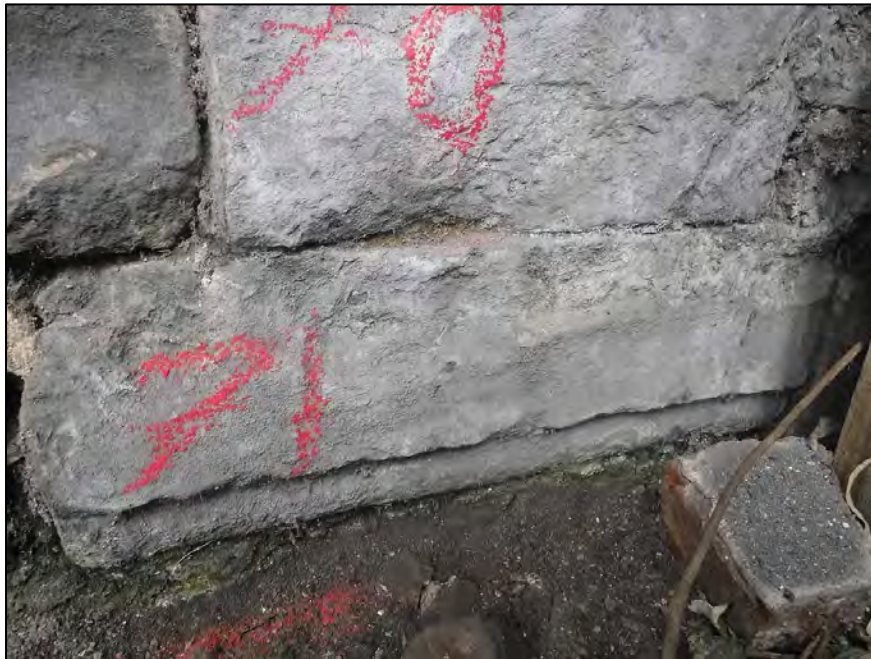
**STONE 71**

<b>Condition</b>	GOOD
<b>Measurement</b>	L:550mm W:200mm
<b>Description</b>	Possible base or plinth piece

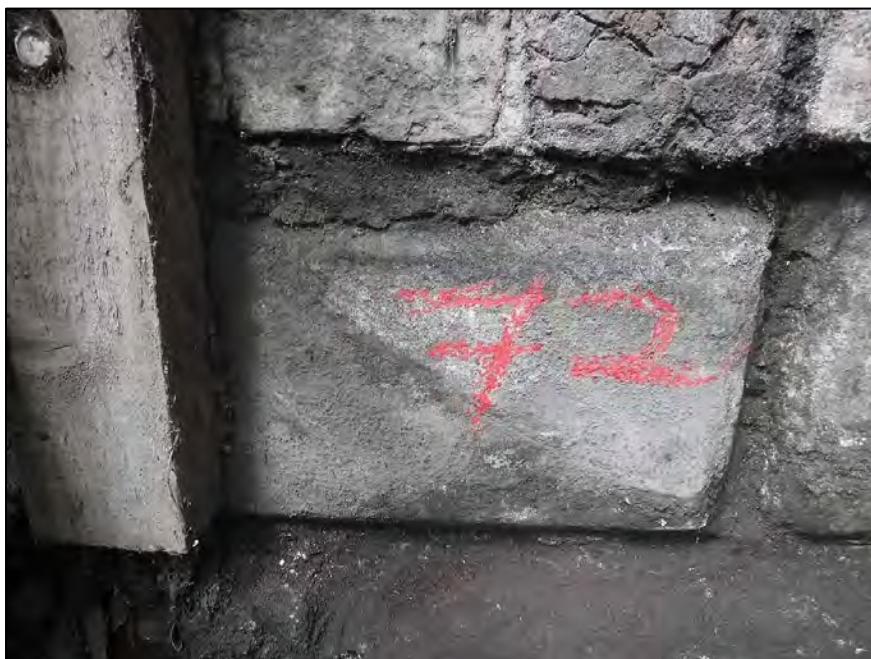
**STONE 72**

<b>Condition</b>	GOOD
<b>Measurement</b>	L:390mm W:190mm
<b>Description</b>	Unidentifiable - block piece

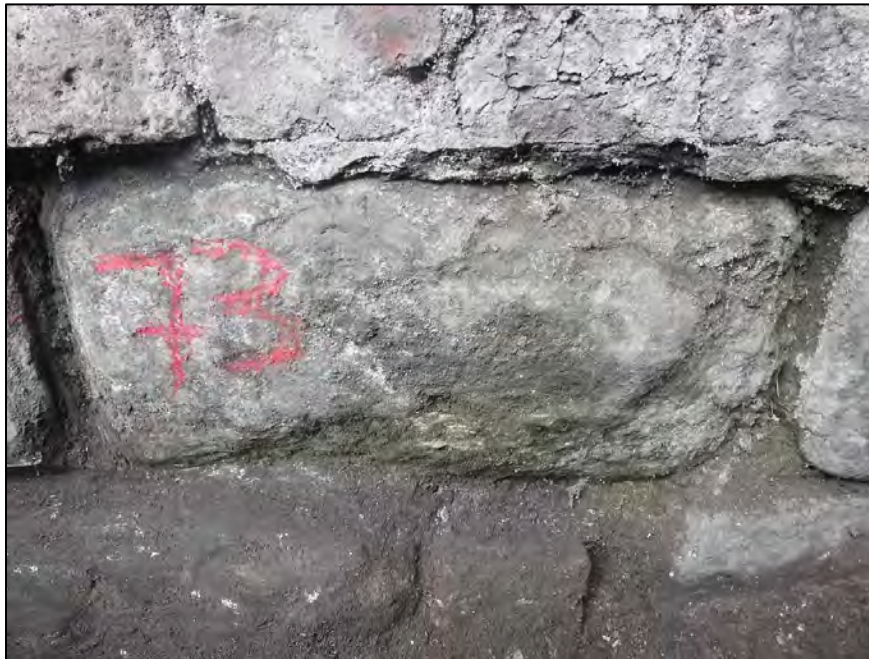
**STONE 73**

<b>Condition</b>	MODERATE
<b>Measurement</b>	L:400mm W:200mm
<b>Description</b>	Unidentifiable - block piece

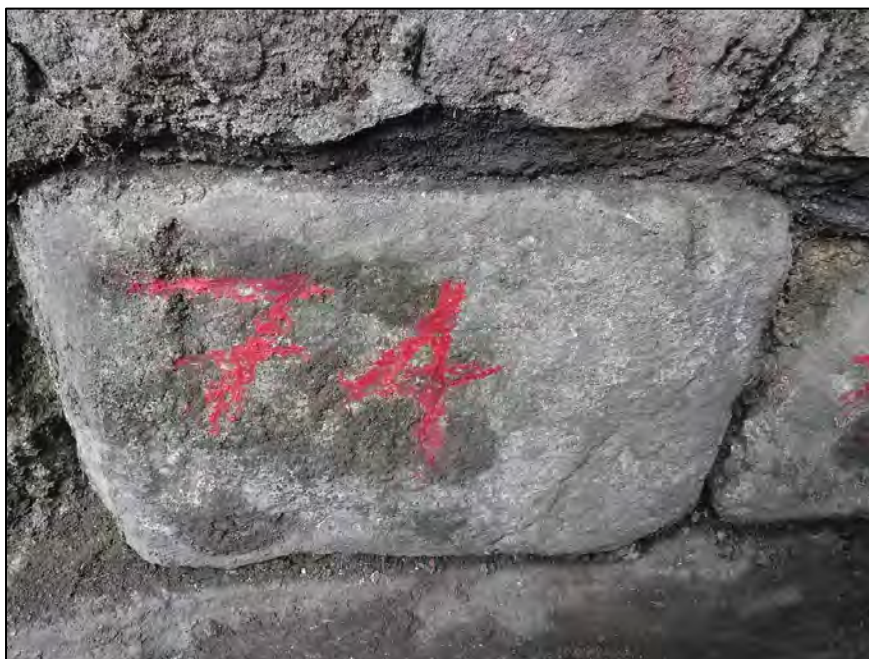
**STONE 74**

<b>Condition</b>	GOOD
<b>Measurement</b>	L:280mm W:190mm
<b>Description</b>	Unidentifiable - block piece
