**First White Cloth Hall  
Kirkgate, Leeds  
West Yorkshire**

Archaeological Watching Brief  
and Structural Watching Brief

Report no. 3460  
October 2020

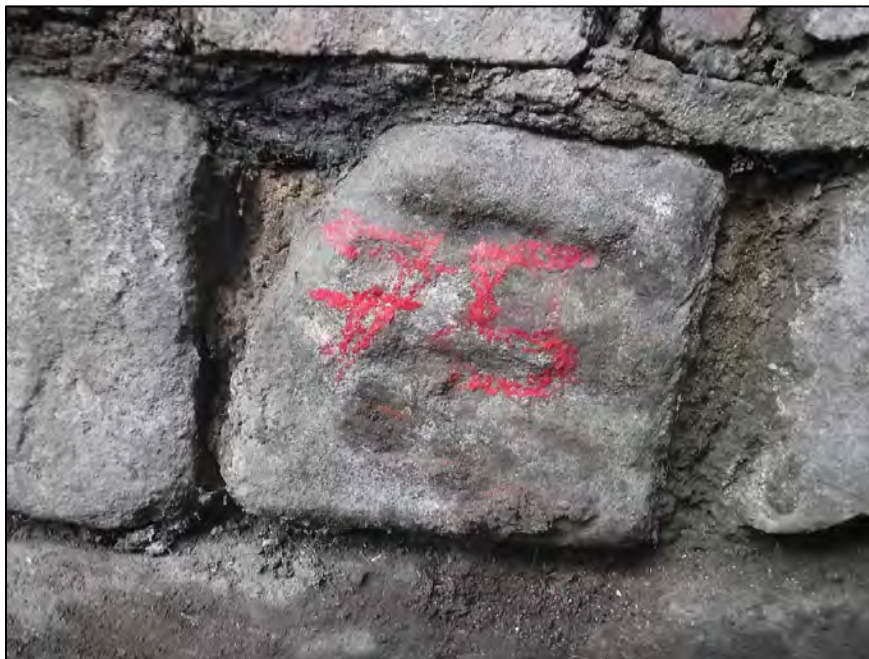
**STONE 75**

<b>Condition</b>	<b>POOR</b>
<b>Measurement</b>	L:190mm W:190mm
<b>Description</b>	Unidentifiable - irregular block piece

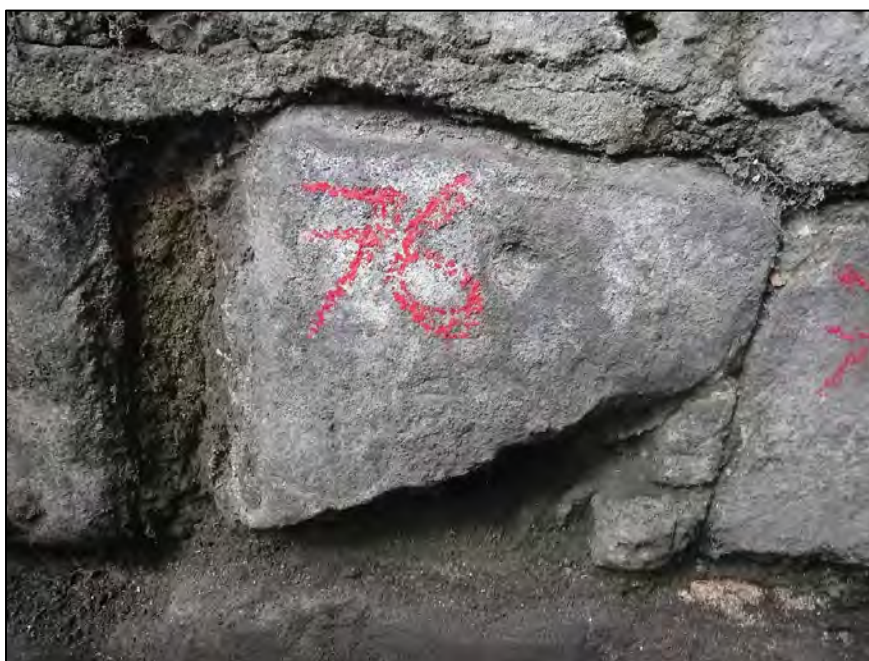
**STONE 76**

<b>Condition</b>	<b>POOR</b>
<b>Measurement</b>	L:210mm W:180mm
<b>Description</b>	Unidentifiable - irregular block piece

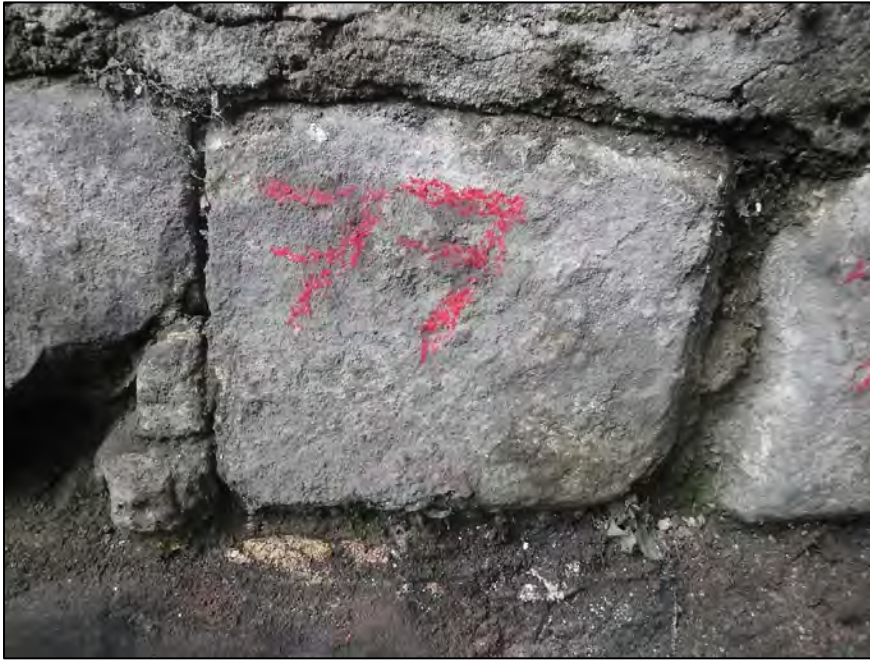
**STONE 77**

<b>Condition</b>	MODERATE
<b>Measurement</b>	L:180mm W:160mm
<b>Description</b>	Unidentifiable - block piece

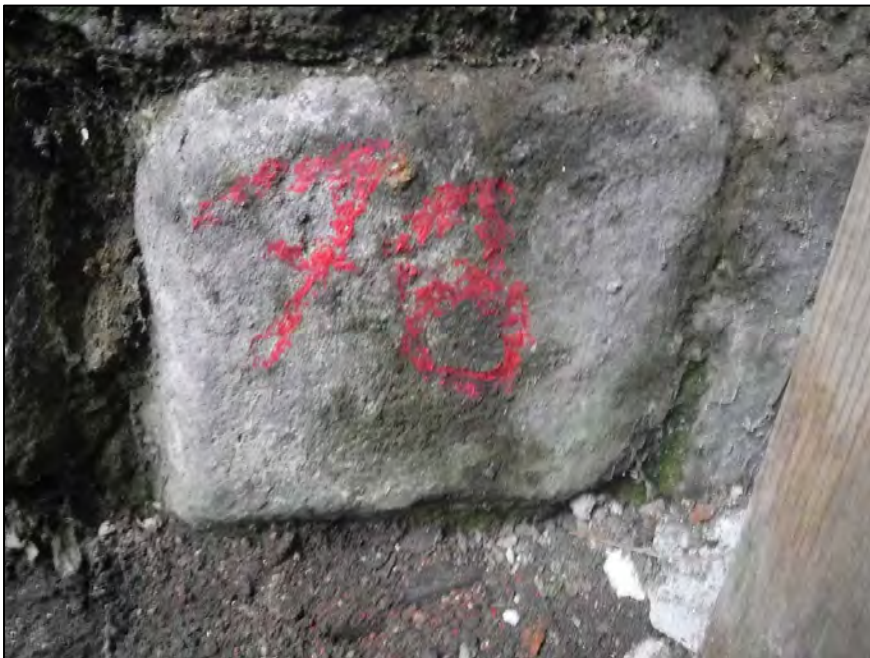
**STONE 78**

<b>Condition</b>	MODERATE
<b>Measurement</b>	L:200mm W:190mm
<b>Description</b>	Unidentifiable - block piece

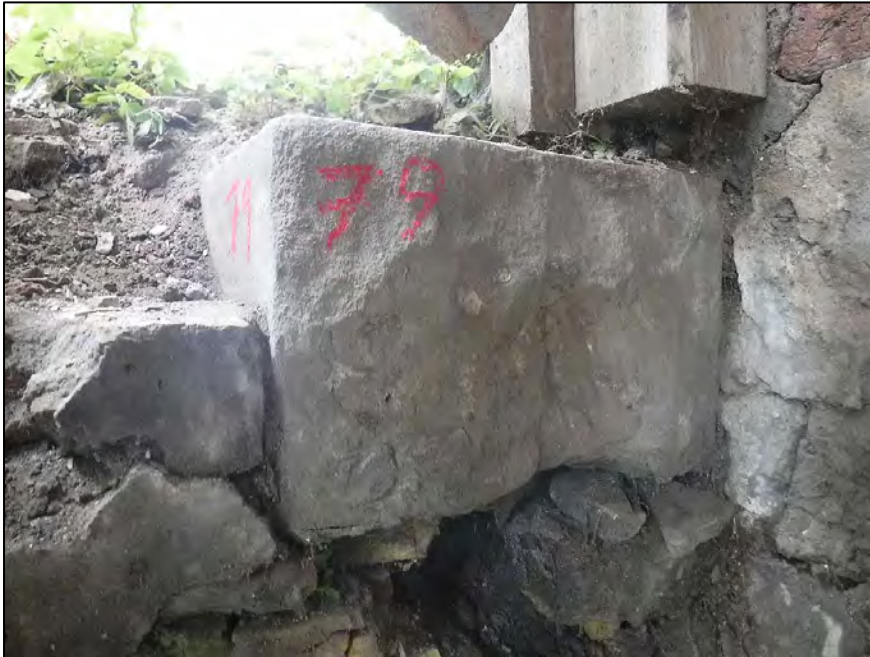
**STONE 79**

<b>Condition</b>	GOOD
<b>Measurement</b>	L:310mm W:200mm D:>330mm
<b>Description</b>	Unidentifiable - block piece, possible quoin stone

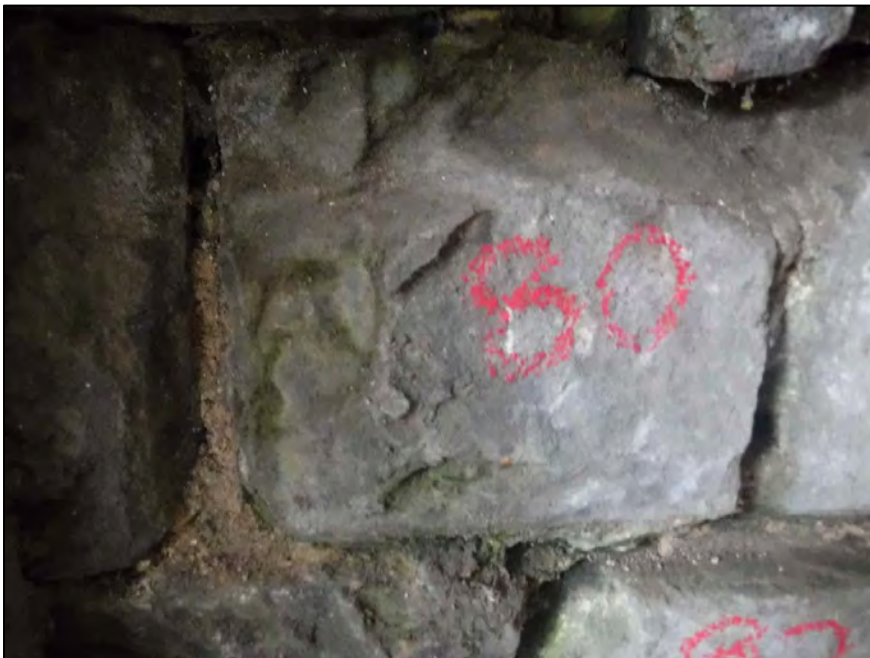
**STONE 80**

<b>Condition</b>	MODERATE
<b>Measurement</b>	L:190mm W:210mm
<b>Description</b>	Unidentifiable - irregular block piece

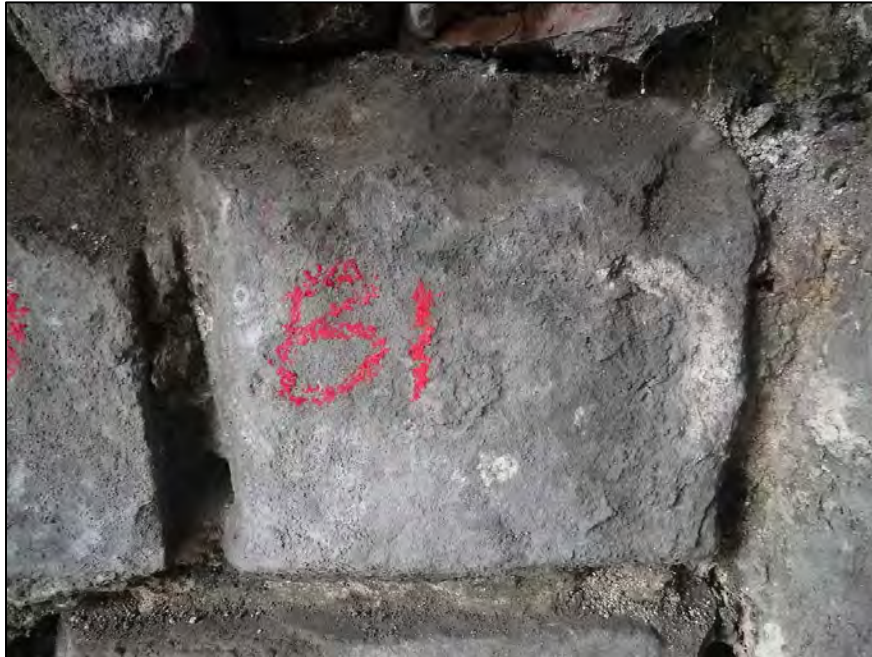
**STONE 81**

<b>Condition</b>	MODERATE
<b>Measurement</b>	L:190mm W:210mm
<b>Description</b>	Unidentifiable - irregular block piece

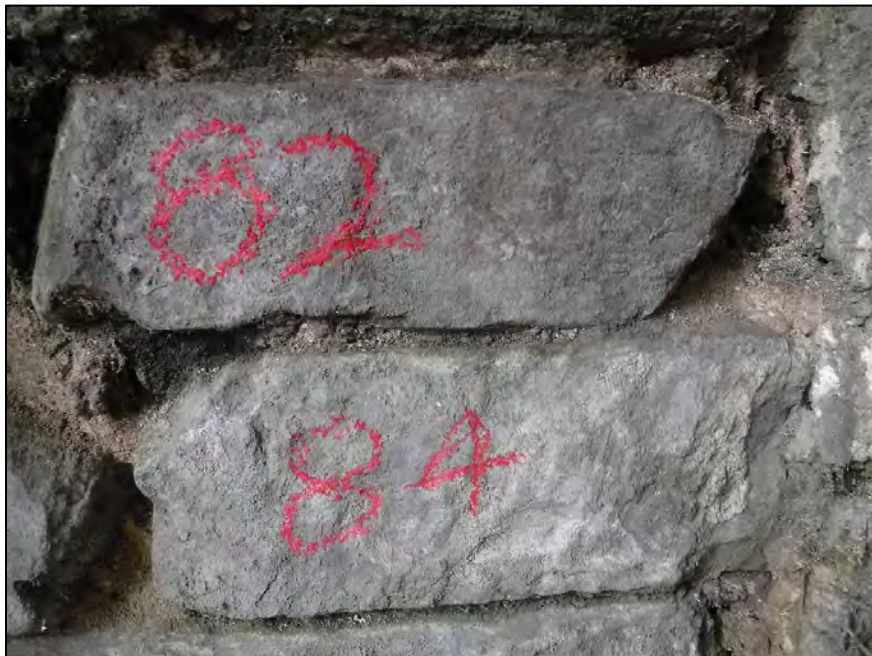
**STONE 82**

<b>Condition</b>	MODERATE
<b>Measurement</b>	L:290mm W:90mm
<b>Description</b>	Unidentifiable - irregular block piece

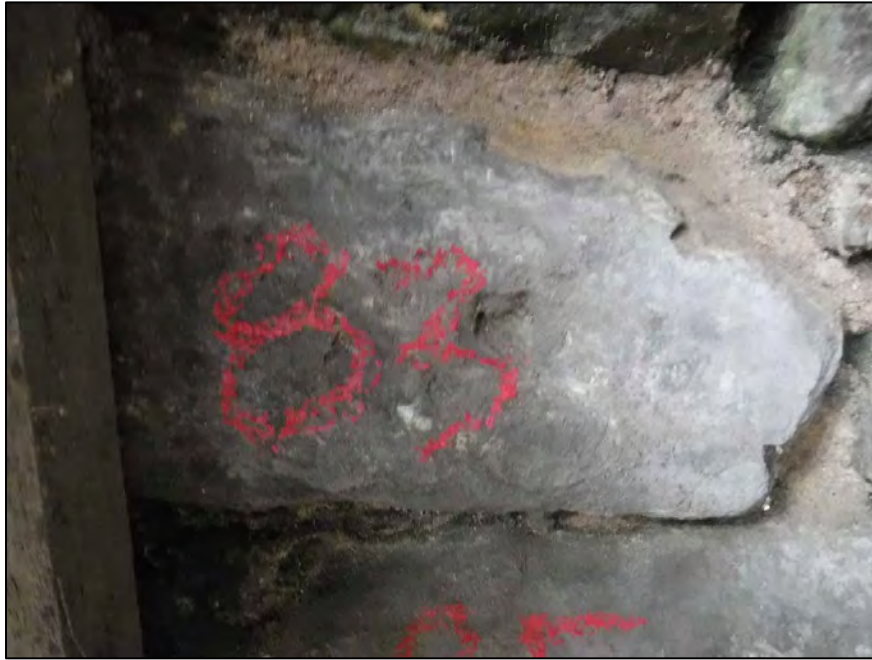
**STONE 83**

<b>Condition</b>	MODERATE
<b>Measurement</b>	L:380mm W:150mm
<b>Description</b>	Unidentifiable - irregular block piece

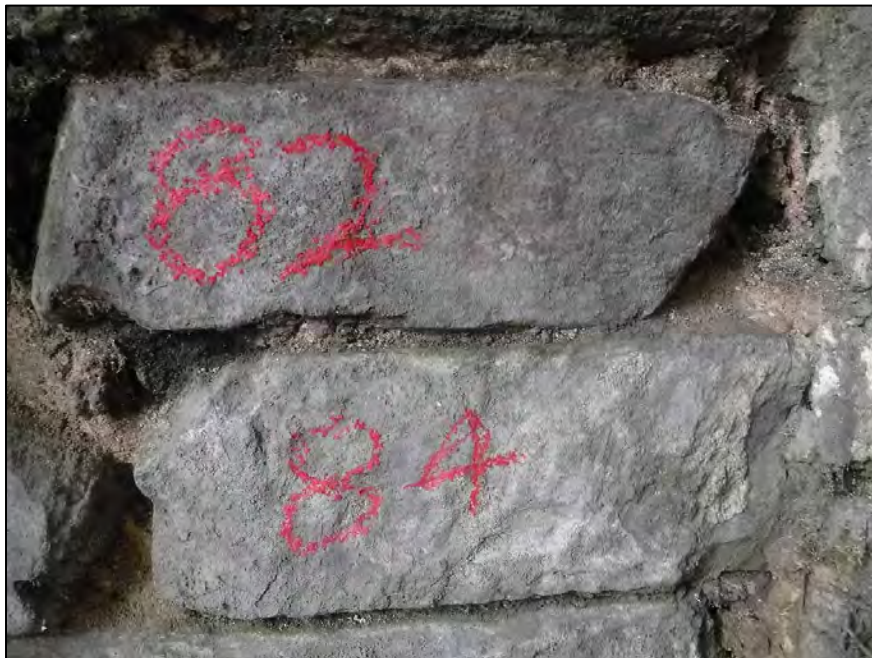
**STONE 84**

<b>Condition</b>	MODERATE
<b>Measurement</b>	L:280mm W:120mm
<b>Description</b>	Unidentifiable - irregular block piece

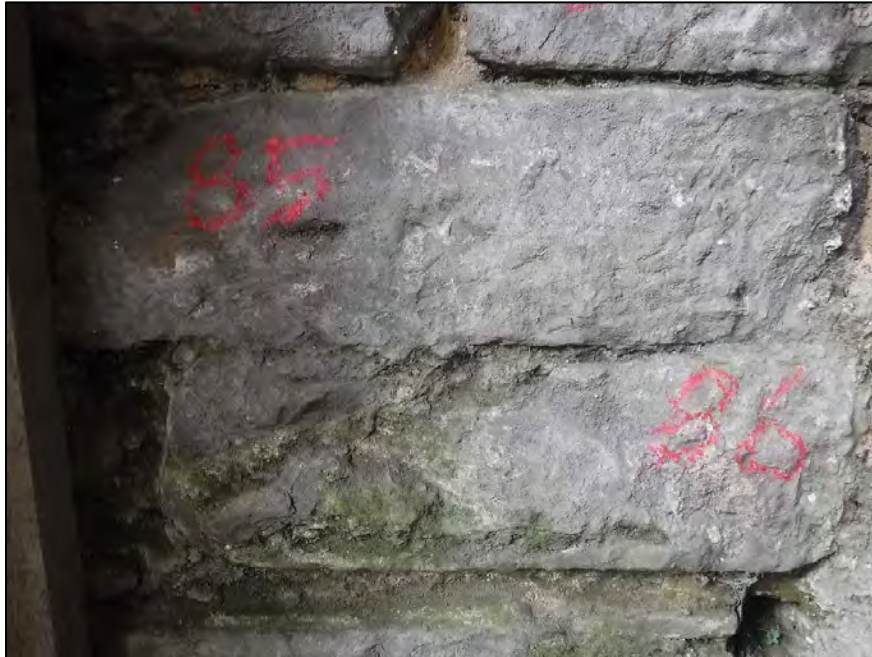
**STONE 85**

<b>Condition</b>	GOOD
<b>Measurement</b>	L:520mm W:170mm
<b>Description</b>	Unidentifiable - block piece

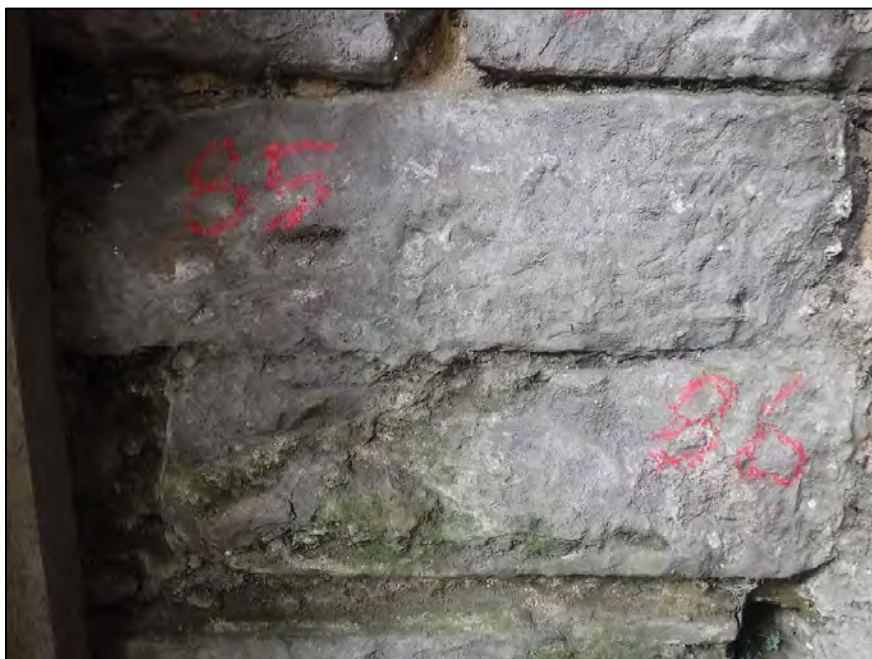
**STONE 86**

<b>Condition</b>	MODERATE
<b>Measurement</b>	L:470mm W:160mm
<b>Description</b>	Unidentifiable - block piece

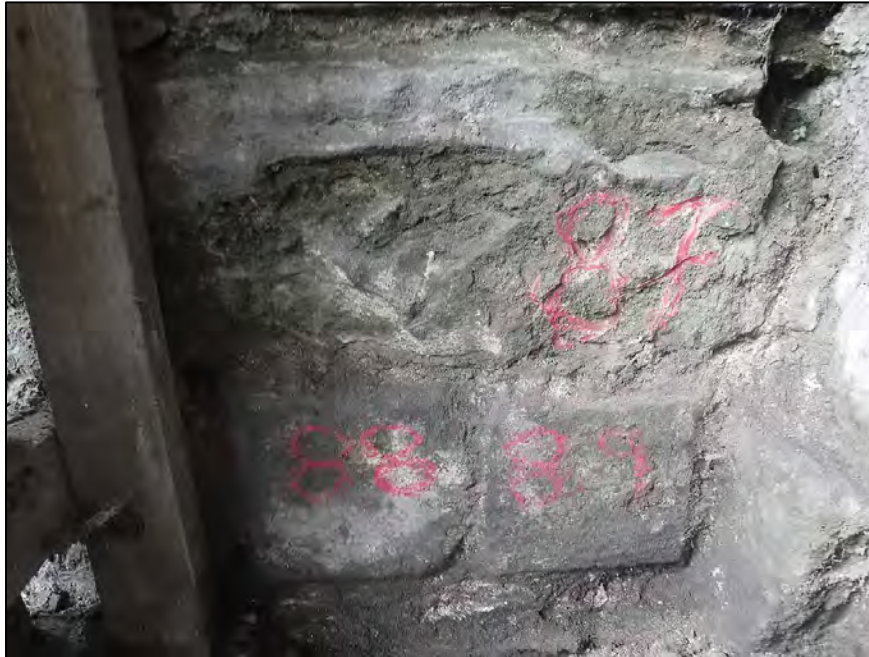
**STONE 87**

<b>Condition</b>	POOR
<b>Measurement</b>	L:5670mm W:280mm
<b>Description</b>	Unidentifiable - irregular block piece

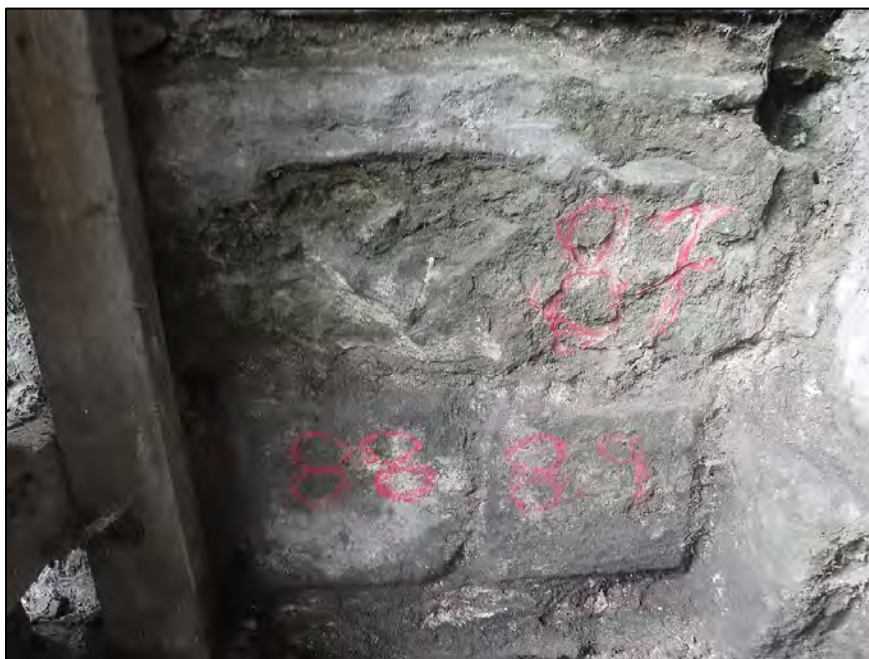
**STONE 88**

<b>Condition</b>	MODERATE
<b>Measurement</b>	L:200mm W:200mm
<b>Description</b>	Unidentifiable - block piece

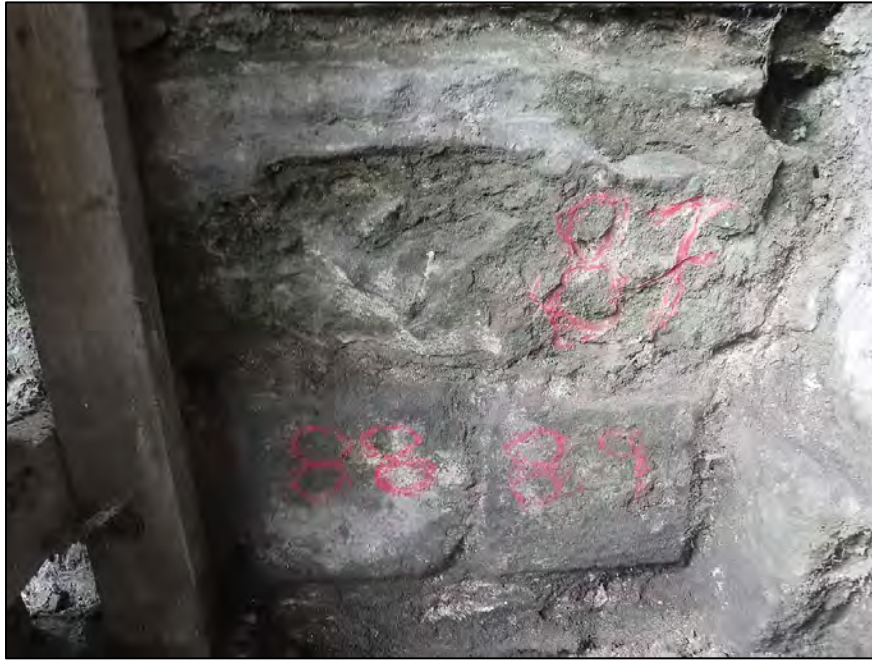
**STONE 89**

<b>Condition</b>	MODERATE
<b>Measurement</b>	L:200mm W:190mm
<b>Description</b>	Unidentifiable - block piece

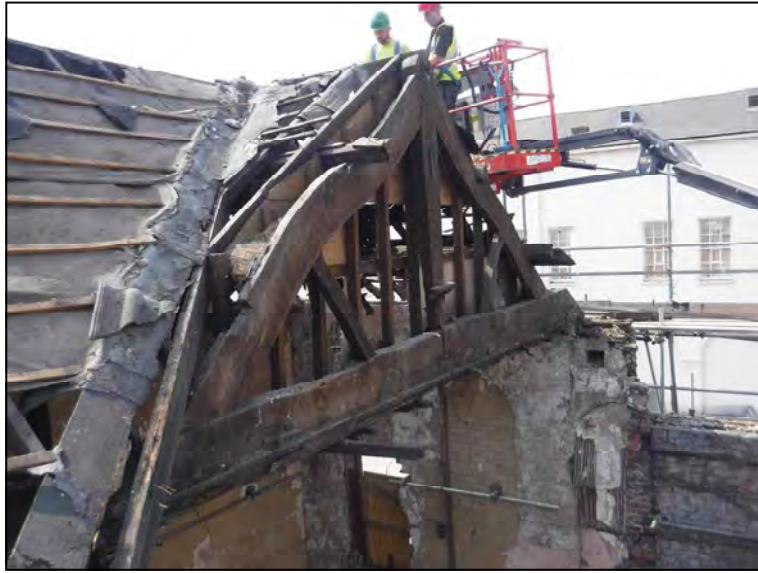
*Plate 1. Truss 1, general view, looking south-east*

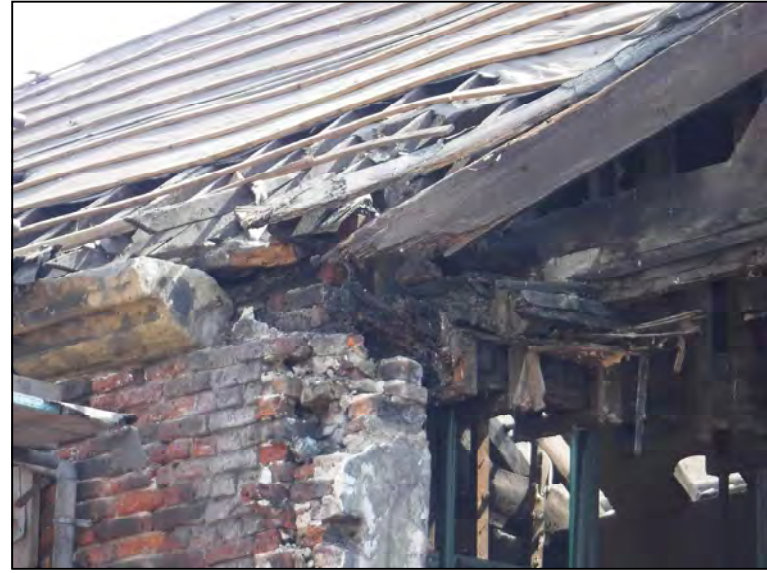
side, the upper purlin had clearly been replaced and the lower was absent at the time of recording. Trusses 1 and 2 were constructed as a single joined piece. The tie beam of Truss 1 lay above that of Truss 2 and the below the principal rafter of Truss 2. This area of both trusses was heavily decayed (Plate 4).

*Plate 4. Advanced decay in timbers at join of Trusses 1 and 2, looking north-east*

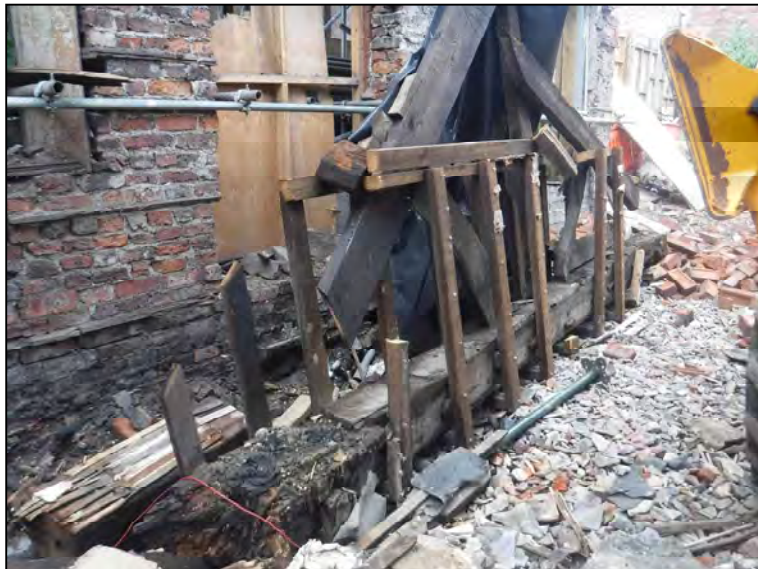
*Plate 7. Truss 2 following removal*

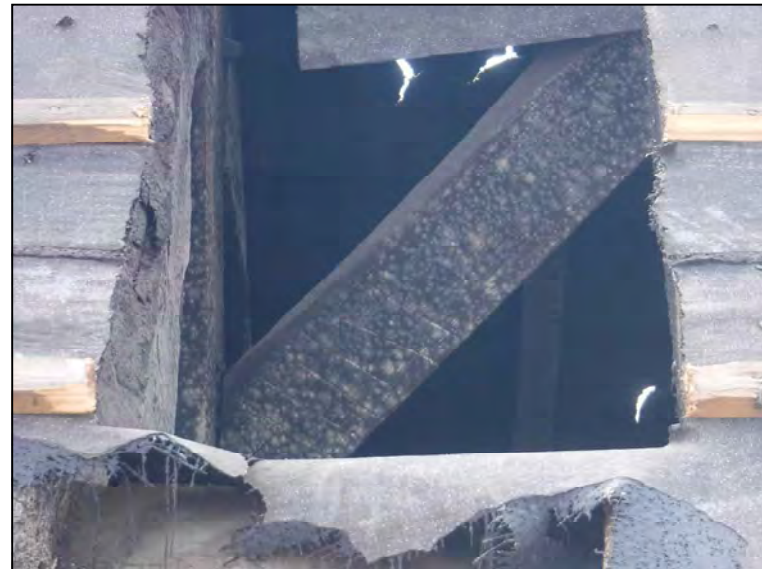
Two carpenter's marks were visible – a 'IIII' mark at the base of the king-post and a 'II' near the base of the western principal rafter. The diagonal brace extending southwards from the king-post to the ridge beam was marked 'IIIII' on its west-facing side (Plate 8). The condition of the truss appeared to be relatively good.

*Plate 8. Diagonal brace with carpenter's mark on the southern side of Truss 3, looking east*

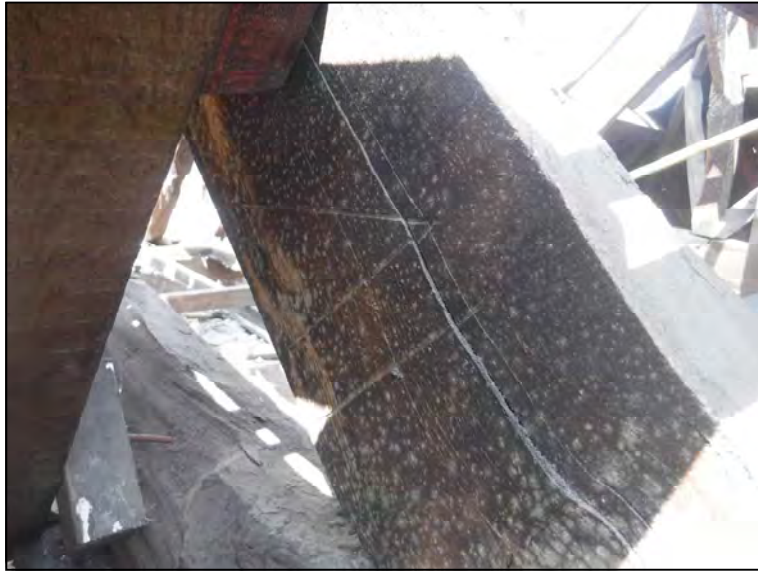
Only one carpenter's mark was noted on Truss 2 – an 'IV' near the base of one of its eastern principal rafter (Plate 9). The condition of the truss appeared to be relatively good.

*Plate 9. Truss 4 carpenter's mark, looking north-west*

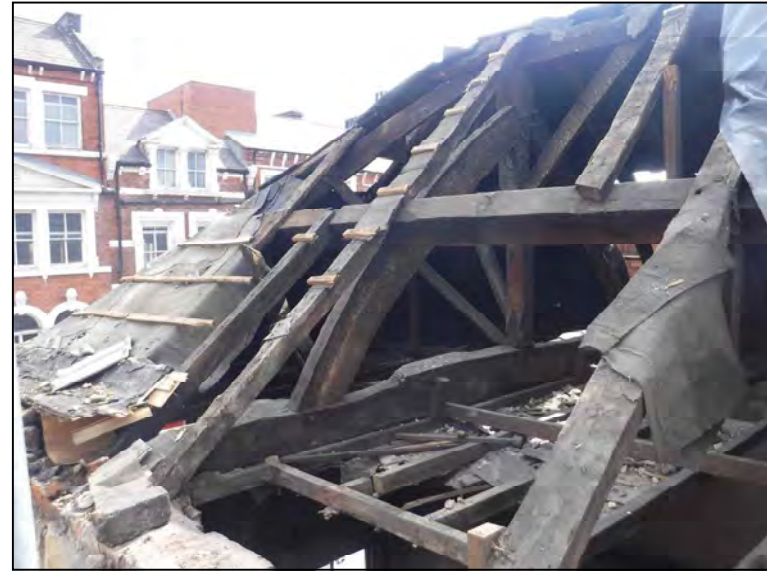
*Plate 10. Truss 5, looking north-east*

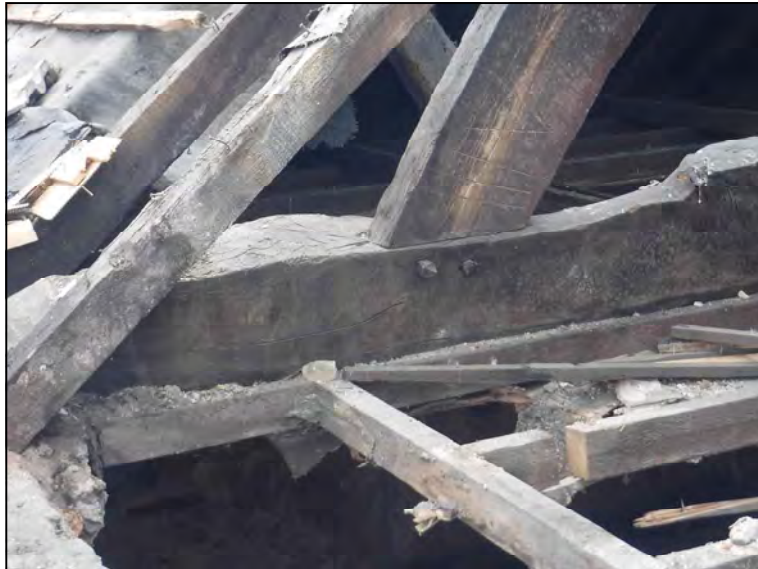
Four carpenter's marks were visible. These include 'IIIV' marking the base of its western principal rafter, a corresponding 'IIIV' on the tie beam (Plate 11), 'IIV' marked at the base of the king post and 'IIIIV' at the base of the eastern principal rafter. The condition of the truss appeared to be relatively good.

*Plate 11. Truss 5 carpenter's marks, looking north-east*

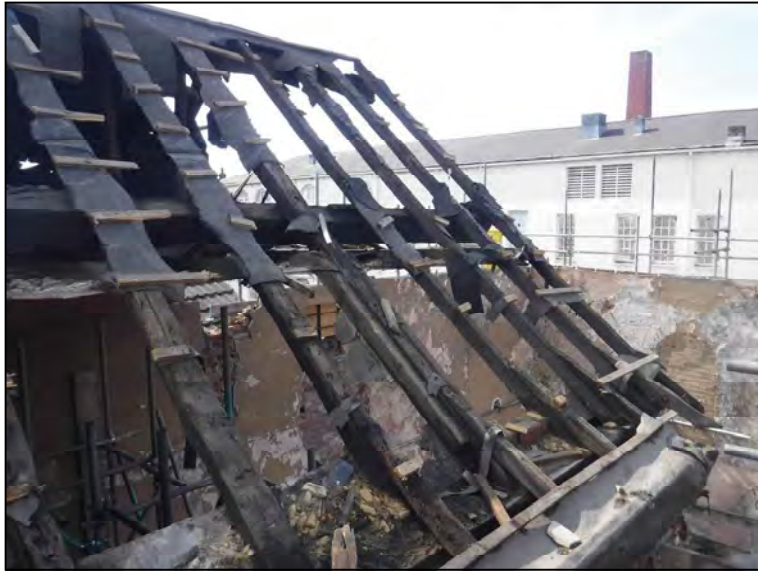
*Plate 13. Original and replacement rafters, looking south-east*
