ASHCOMBE FARM, STOODLEIGH, TIVERTON, DEVON

RAPID HISTORIC BUILDING APPRAISAL

Stewart Brown Associates

February 2018

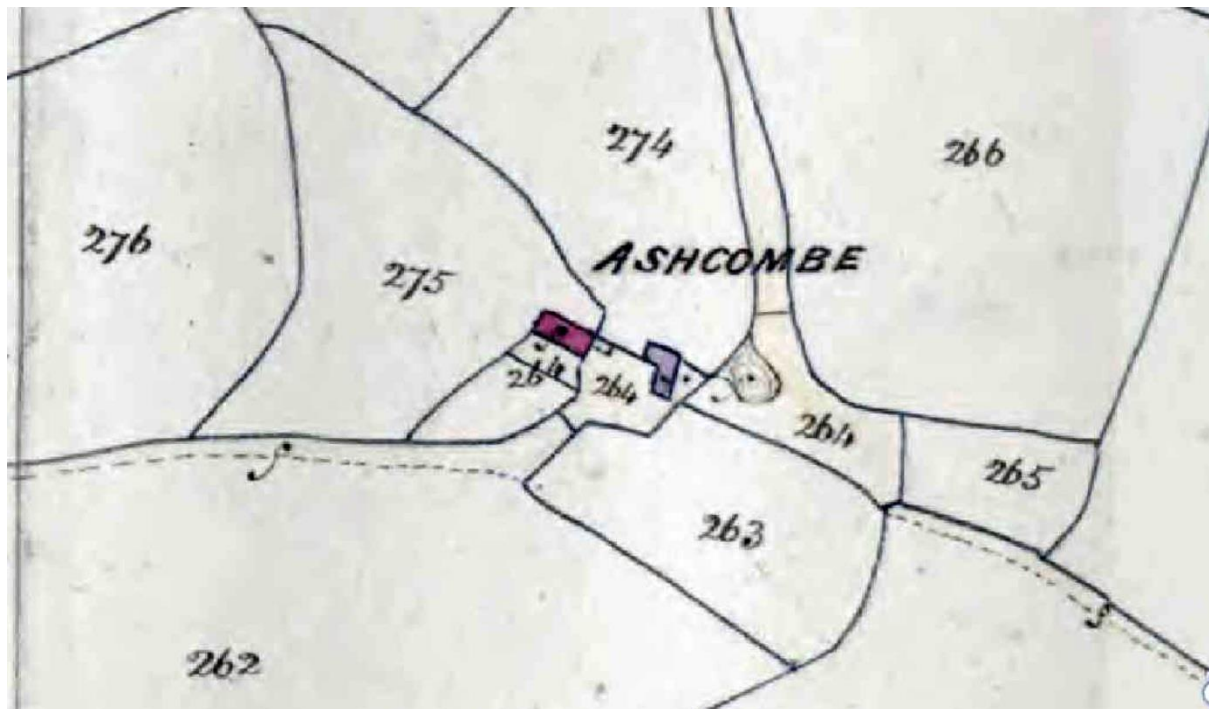
The farmhouse appears on the tithe map of 1841 (Fig. 1), so was already in existence by then.

Fig. 1 Ashcombe Farm as it appears on the tithe map of 1841.

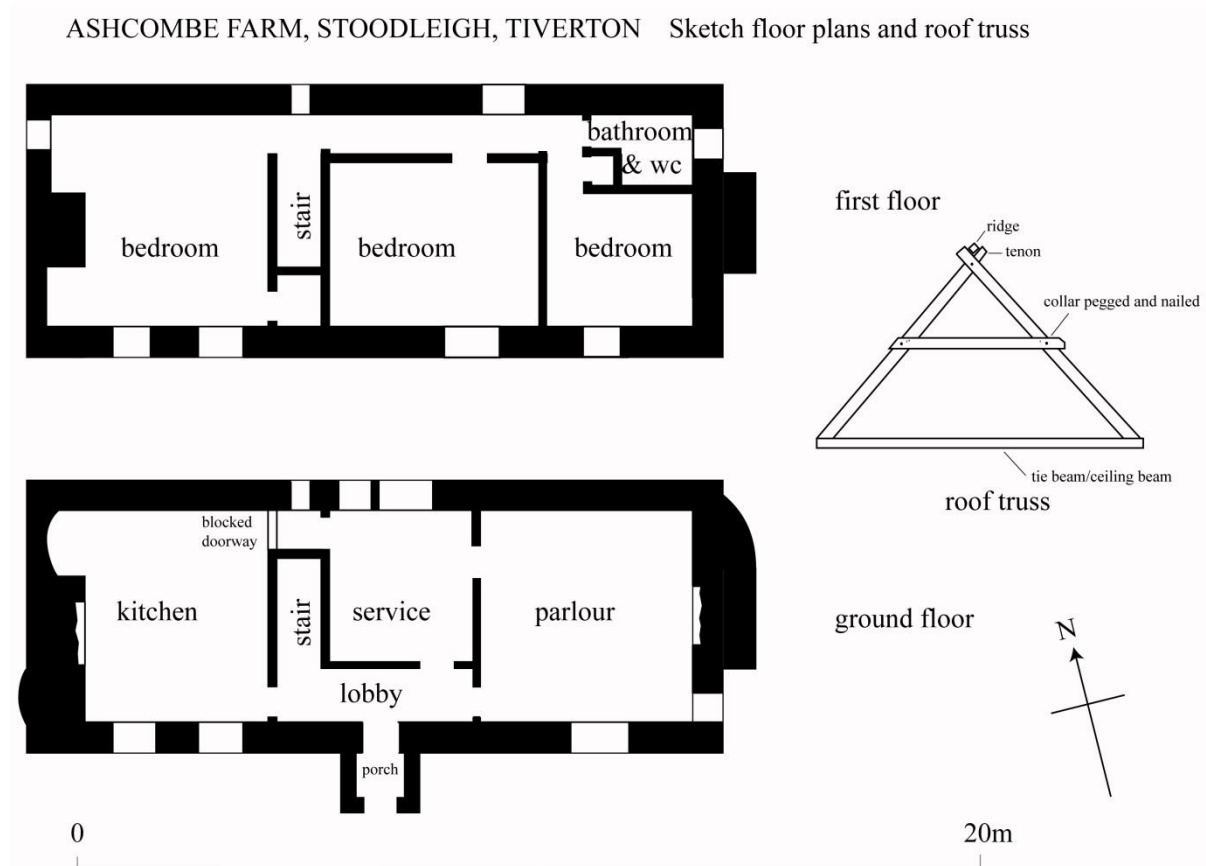
The present internal layout (Fig. 2) probably reflects the 18th-century one closely, since the 20th-century refurbishment appears to have simply rebuilt the internal partitions rather than changing the plan.

Fig. 2 Sketch floor plans and roof truss of Ashcombe Farmhouse.

The layout comprises three rooms on each floor. The ground floor comprises a kitchen/living room, central unheated service room, and parlour, with a central entrance opening into a lobby which leads to all three rooms and the stair. This post-dates the typical medieval and early post-medieval through passage plan. The first floor contains three bedrooms, all accessible from a landing at the head of the stair, and a bathroom and wc plus airing cupboard which were introduced in the 20th-century refurbishment.
