BERRY POMEROY GATEHOUSE ROOF 1998

ARCHAEOLOGICAL RECORDING

BERRY POMEROY GATEHOUSE ROOF;
BERRY POMEROY CASTLE
ARCHAEOLOGICAL RECORDING
1998

By Stewart Brown and Aidan Matthews

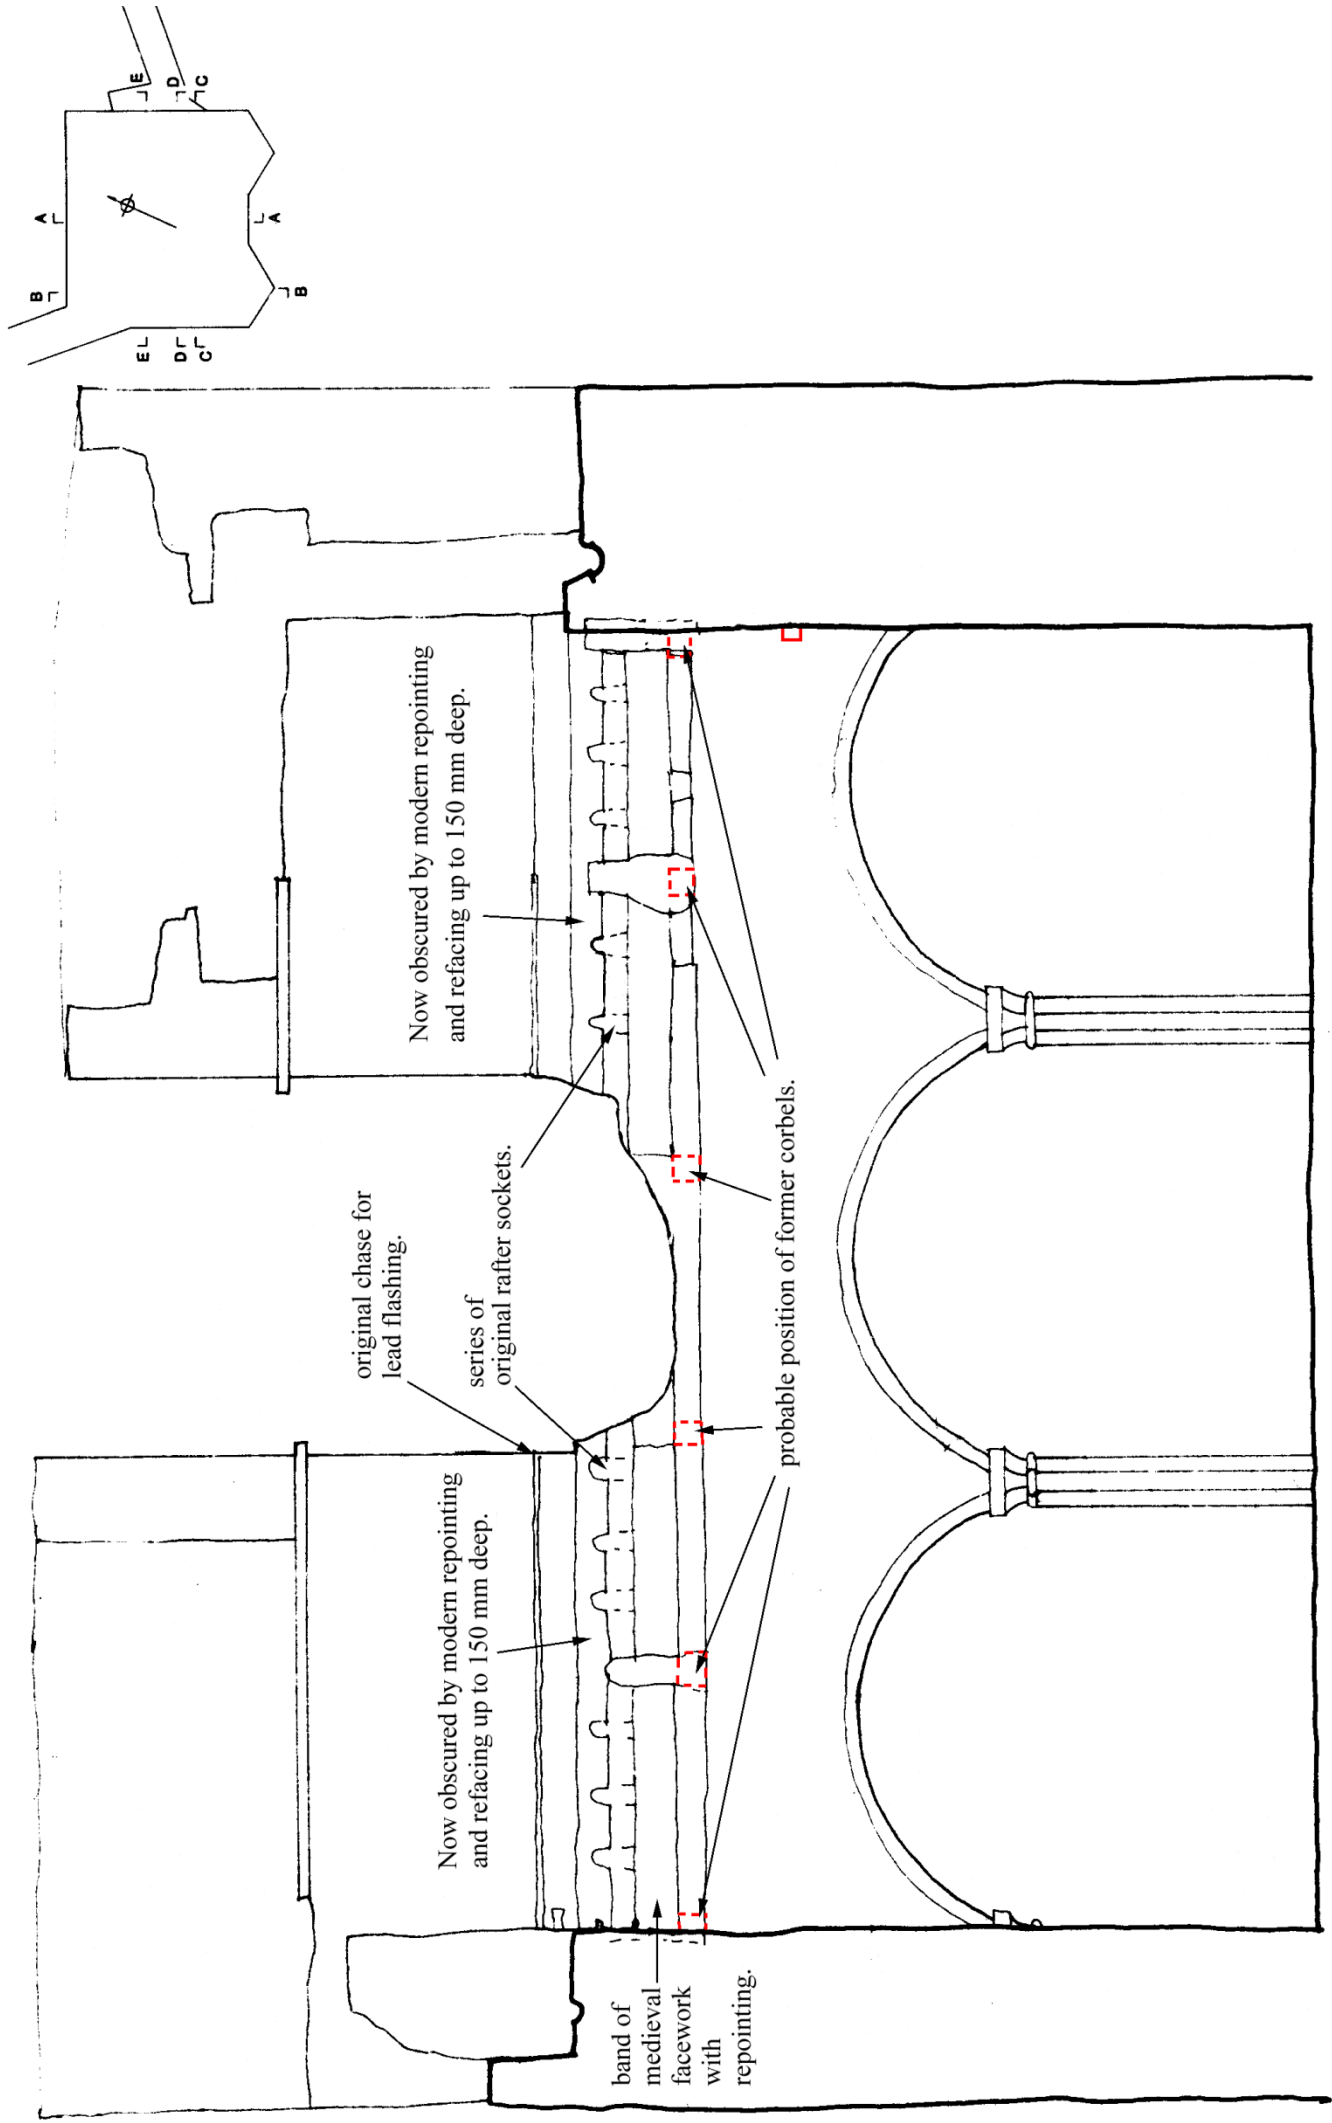
Fig 6 Arcade wall, north face, elevation DD.

Original survey by E.H. 1981, shown here with amendments and additions 1998 (in red).
