BERRY POMEROY CASTLE
ARCHAEOLOGICAL EXCAVATION AND RECORDING
DURING CONDITION SURVEY WORK

STEWART BROWN ASSOCIATES FEBRUARY 2008

BERRY POMEROY CASTLE, DEVON
ARCHAEOLOGICAL EXCAVATION AND RECORDING IN ASSOCIATION WITH
CONDITION SURVEY WORK

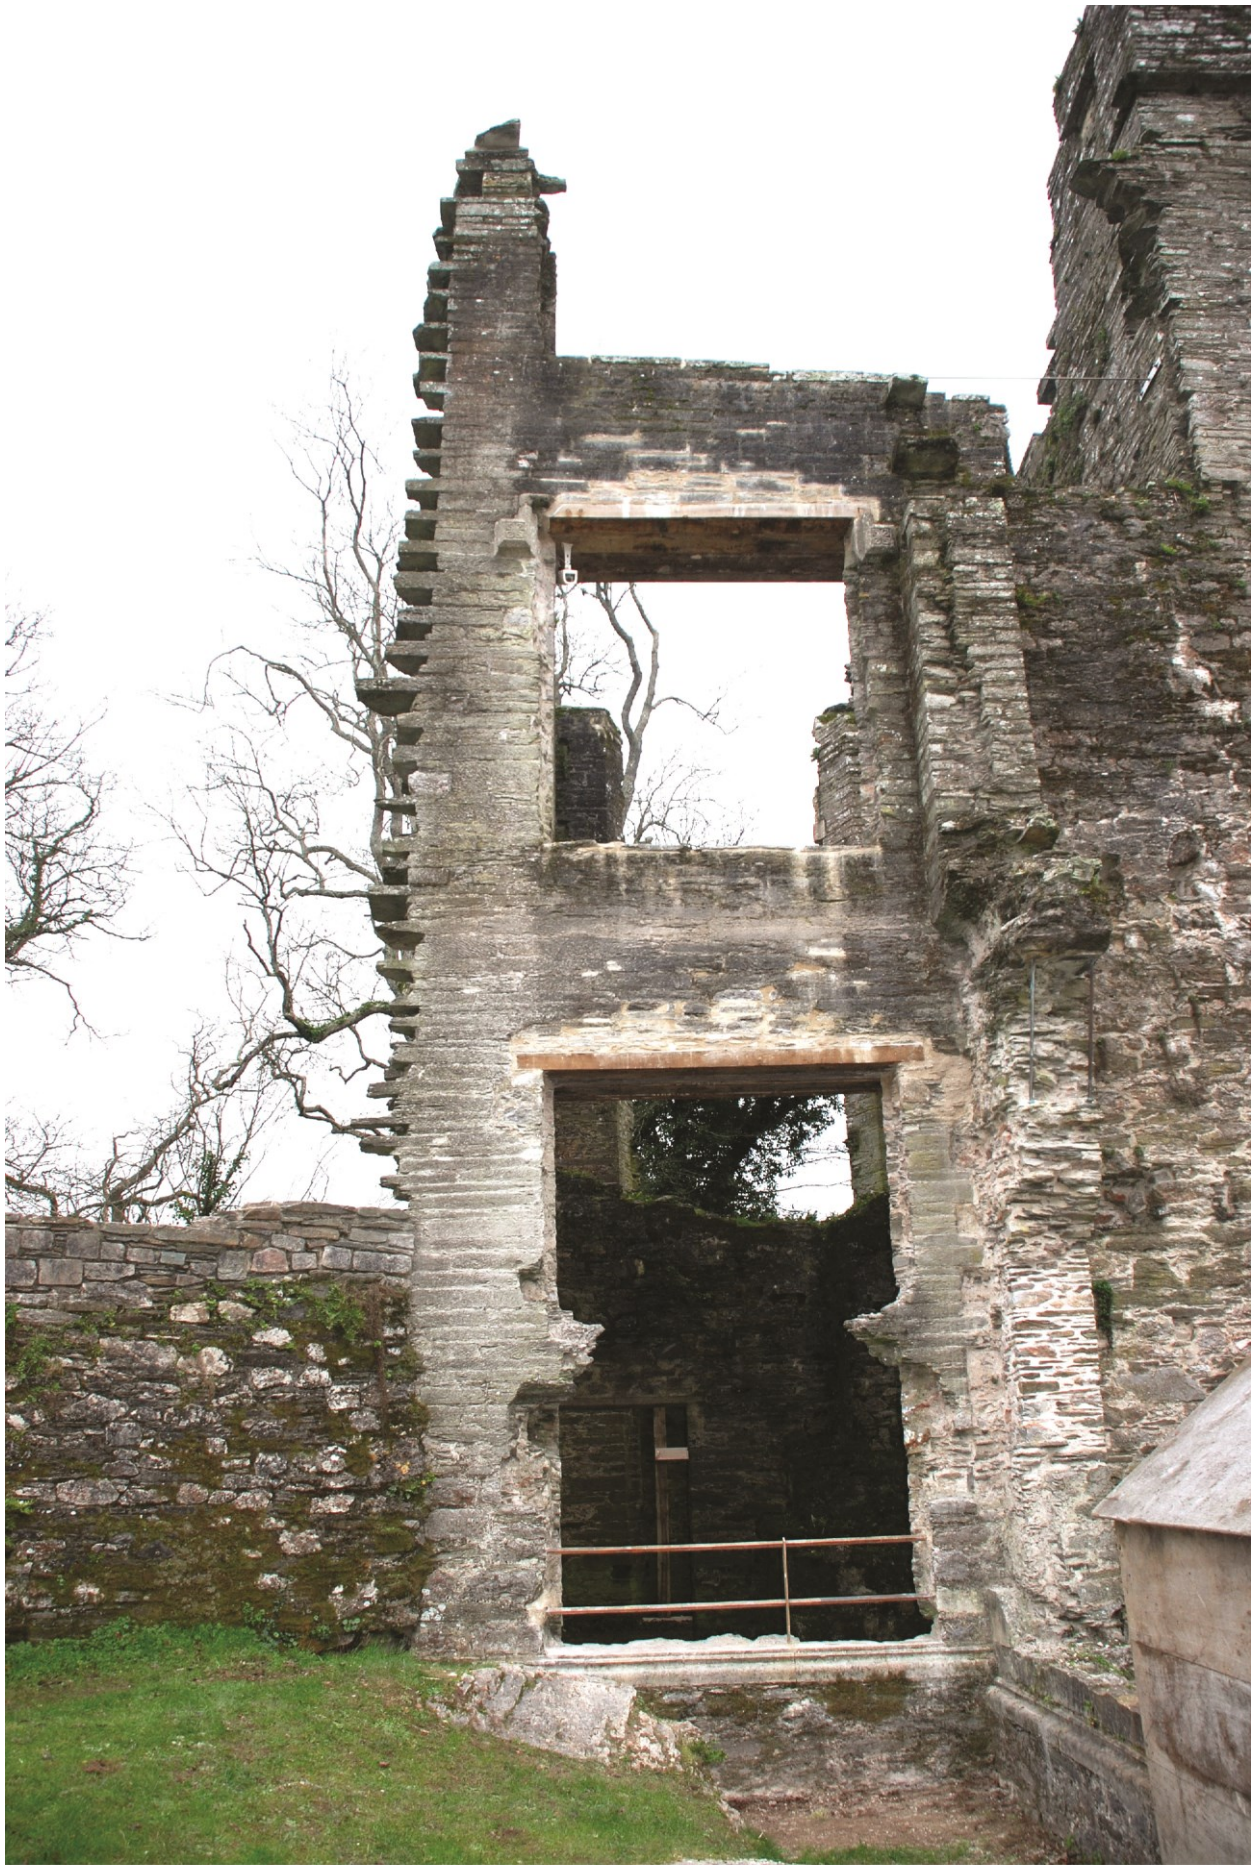
Consolidation of the window sill and wall capping uncovered no previously unrecorded archaeological features. The new railing was inserted into existing masonry joints so none of the original stonework was disturbed. Plates 13 and 14 show the window sill after conservation work and the new railing. Plate 15 shows the northeast elevation of the kitchen quarter after conservation work.

Plate 15 The kitchen quarter after conservation work, looking southwest.

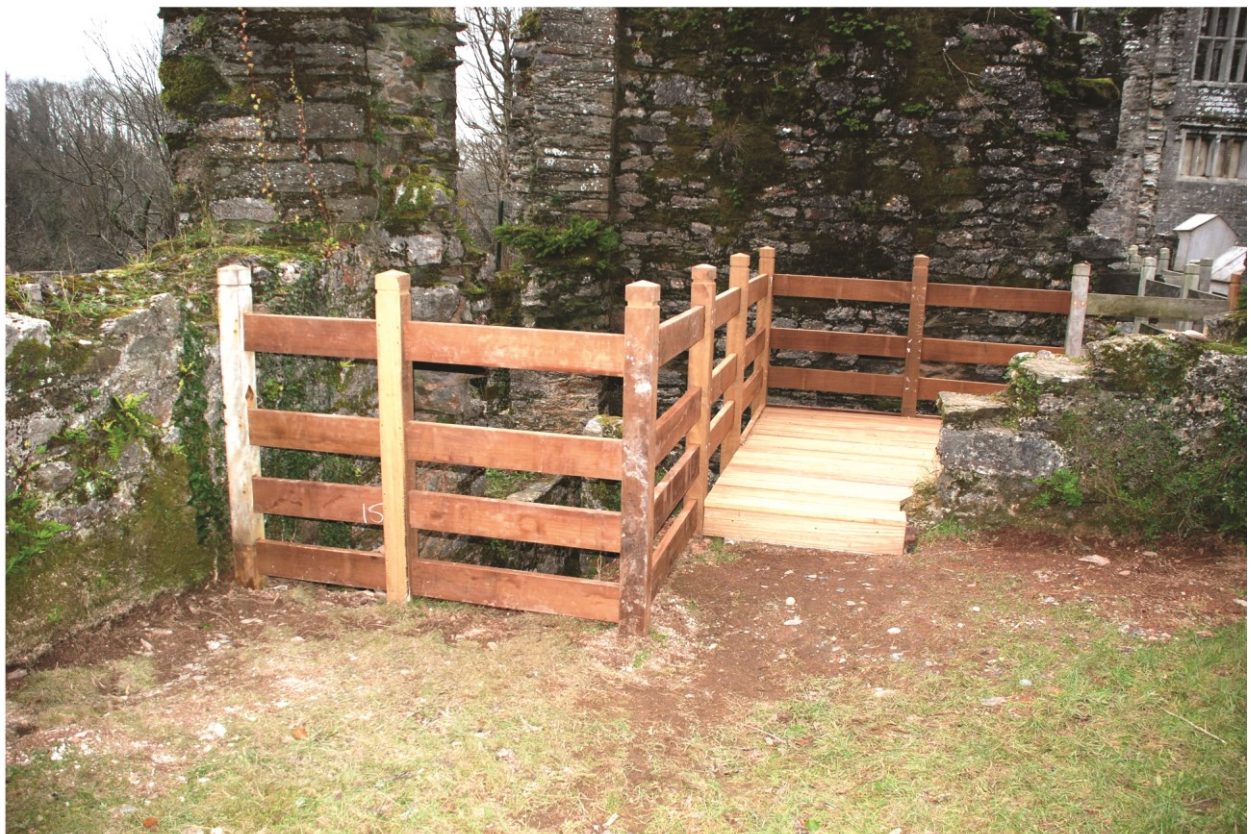
Plate 19 The new timber railings at the northern angle of the kitchen, looking north.
