**Historic building recording
at Chisnell Lift Bridge
(Bridge 193),
near Deddington,
Oxford Canal,
Oxfordshire**

Martin Cook BA MCIfA
and Suzanne MacLeod BA

6th February 2017
Revised 24th February 2017

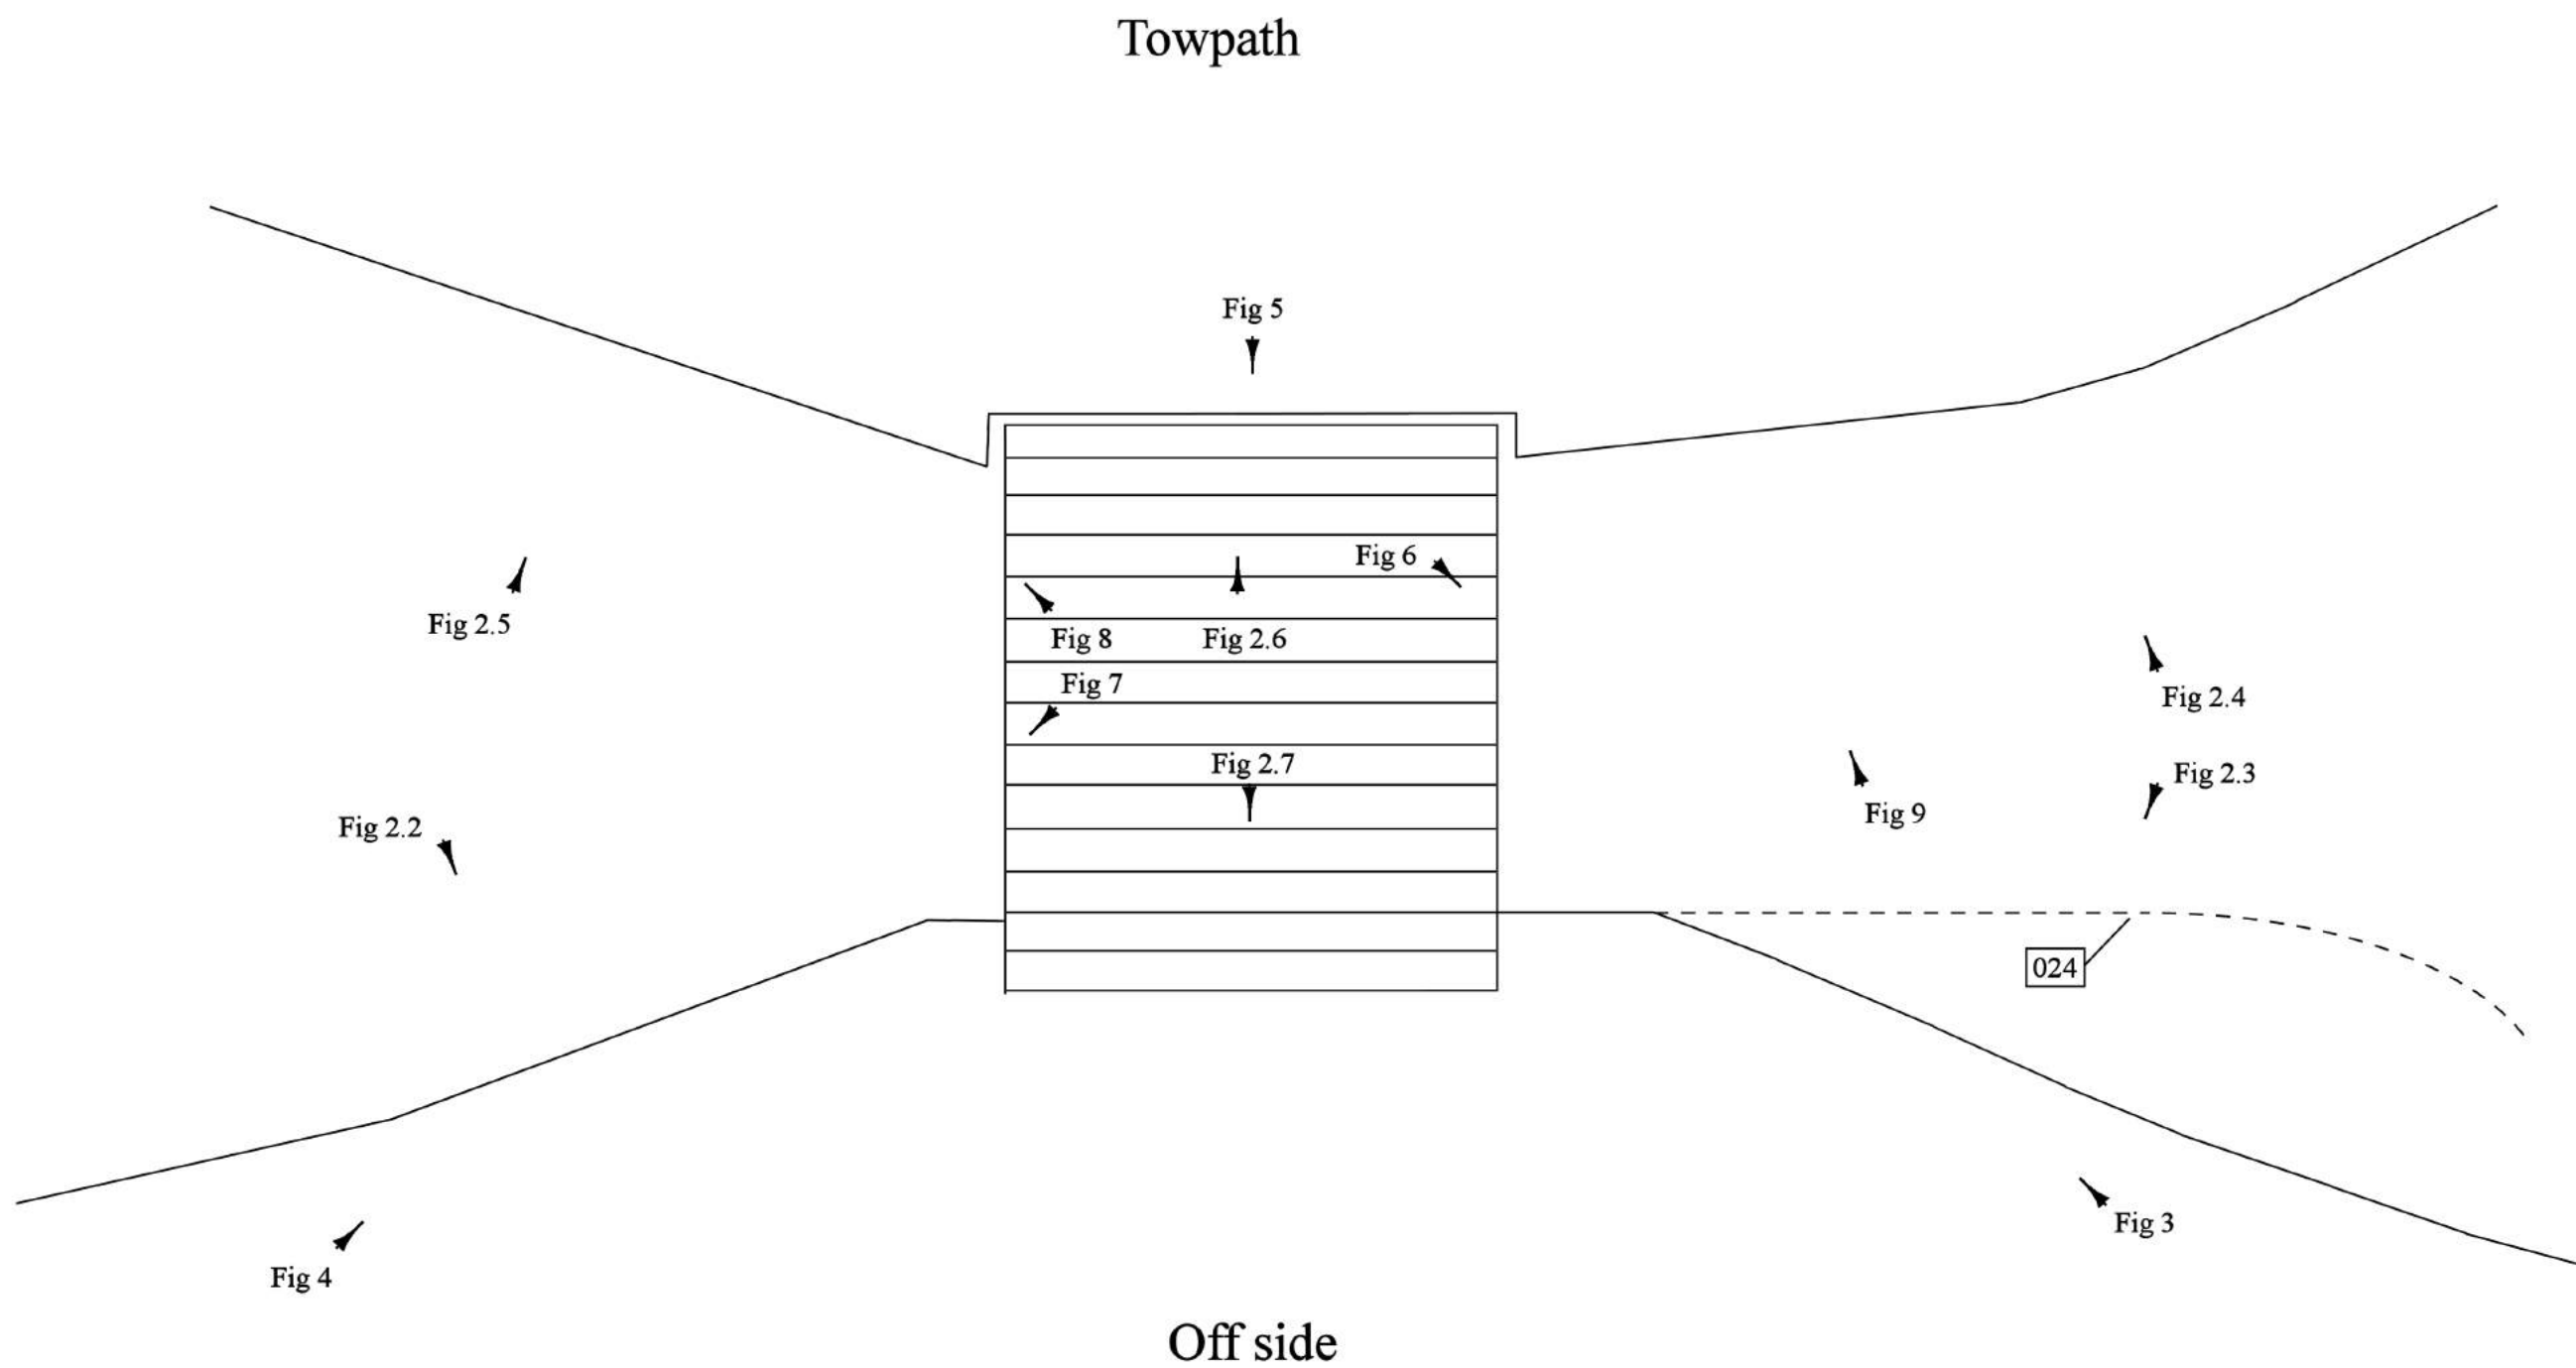
Fig 2.1: Plan of bridge showing deck, locations of elevations and other photographs

When clearance of the collapsed stonework of the south-east wing wall was complete, the original line of the wing wall (context 024; Figs 2.1 and 6) was identified and recorded.
