Archaeological building investigation and recording at 1 New Street, Childswickham, Worcestershire, WR12 7HQ

Martin Cook BA MCIfA

25th September 2019

The project was undertaken to level two standard, in advance of demolition of the property.

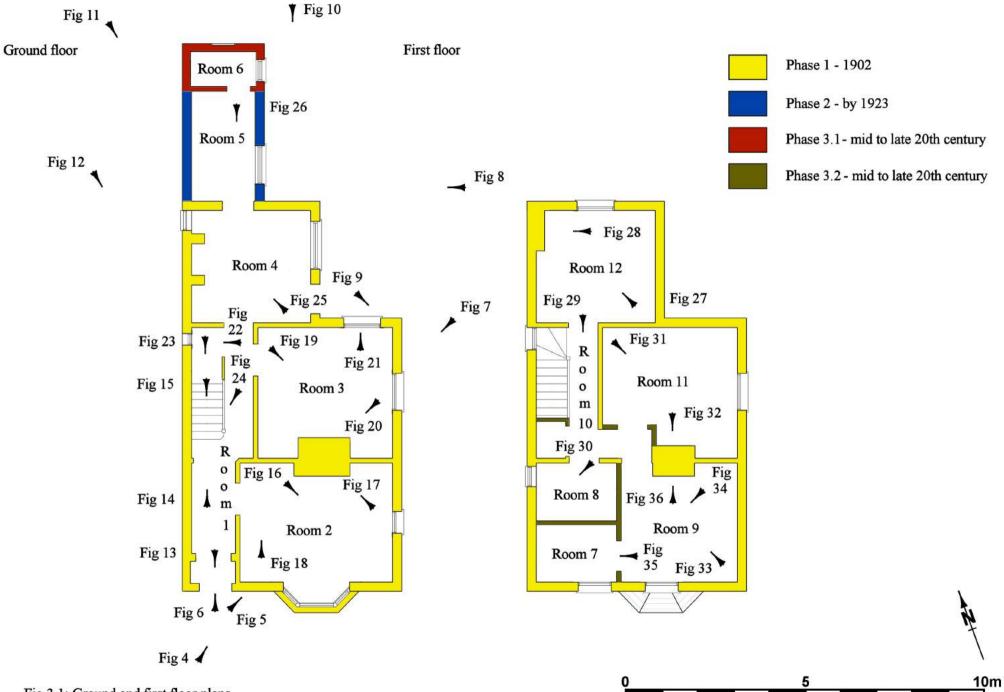
Fig 3.1: Ground and first floor plans

An 'L' shaped dwelling comprising, at ground floor level, a sitting room and a dining room, built around a back-to-back fireplace, with a side passage and a kitchen with its own fireplace, was surmounted by a first floor of three rooms and a landing (Fig 3.1). It is thought that a range was provided in the kitchen, which was also used as a temporary bathroom and that lavatory arrangements were a privy at the end of the garden.

The first bedroom was subdivided with stud partitions to provide a bathroom and toilet, accessible from the first floor passage, and an *en suite* (Figs 3.1 30 and 35).

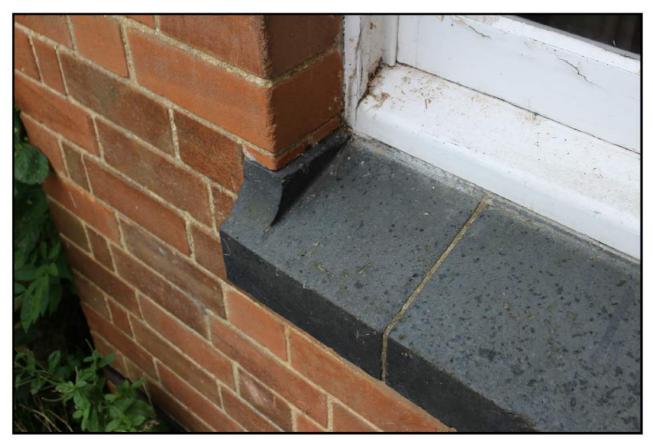
Fig 9: North elevation; detail of mouded blue brick cill

The other elevations (Figs 3.2 - east and west elevations, 3.3 - north elevation and Figs 6, 7, 8, 10, 11 and 12) were somewhat plainer. These were built in a version of Flemish bond (header/three stretchers/header in courses). The openings, where original, have single brick arches and blue brick moulded cills (Fig 9). The blue brick damp proof course continued around all three elevations.

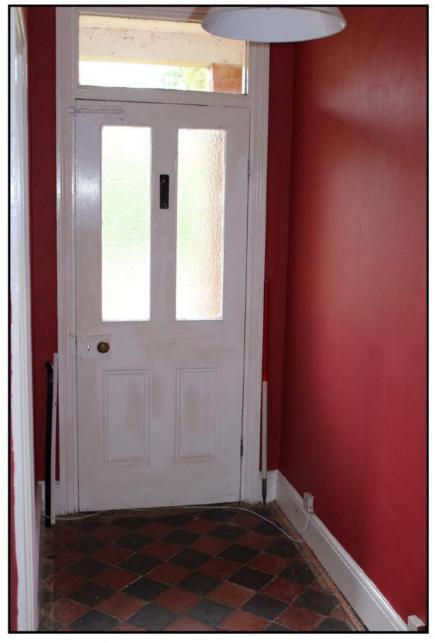
Fig 13: Room 1; hall

The interior has been redecorated over the years and only a few features may be assigned to the original construction of the house. These are the tiled floor in the hall (Figs 13, 14 and 15) the fireplaces on the first floor (Figs 28, 32 and 36) and the banister rail, spindles, the top and bottom newal posts and their caps. It is possible that the stair itself is also original but this could not be determined. The building retains sash windows in many of its openings but it is unlikely that these are original. The catches (Fig 21) may be.

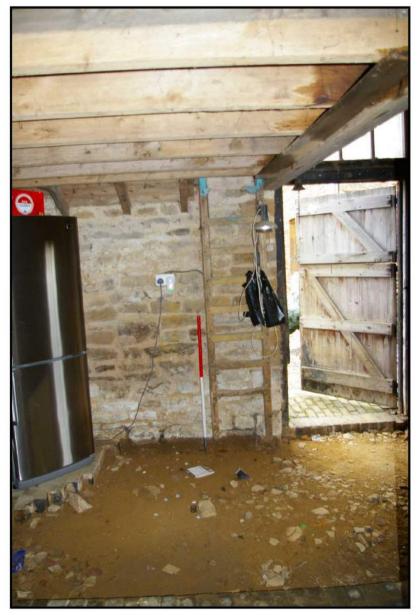
Fig 38.2: Hayloft ladder, stable, Woodford Halse, Northamptonshire - early to mid 18th century

been a vertical ladder, attached to one of the walls. Such ladders can still be seen providing access to hay lofts in stables dating from the early to mid 18th century (eg Fig 38.2; loft ladder Woodford Halse). There appears to have been a hearth against the southern wall from an early date and, presumably, such cooking as was undertaken took place over the open fire.
