Archaeological Building Recording at 1a Coffee Yard, York

Ben Savine

YAT Building Recording Report 2018/145 December 2018

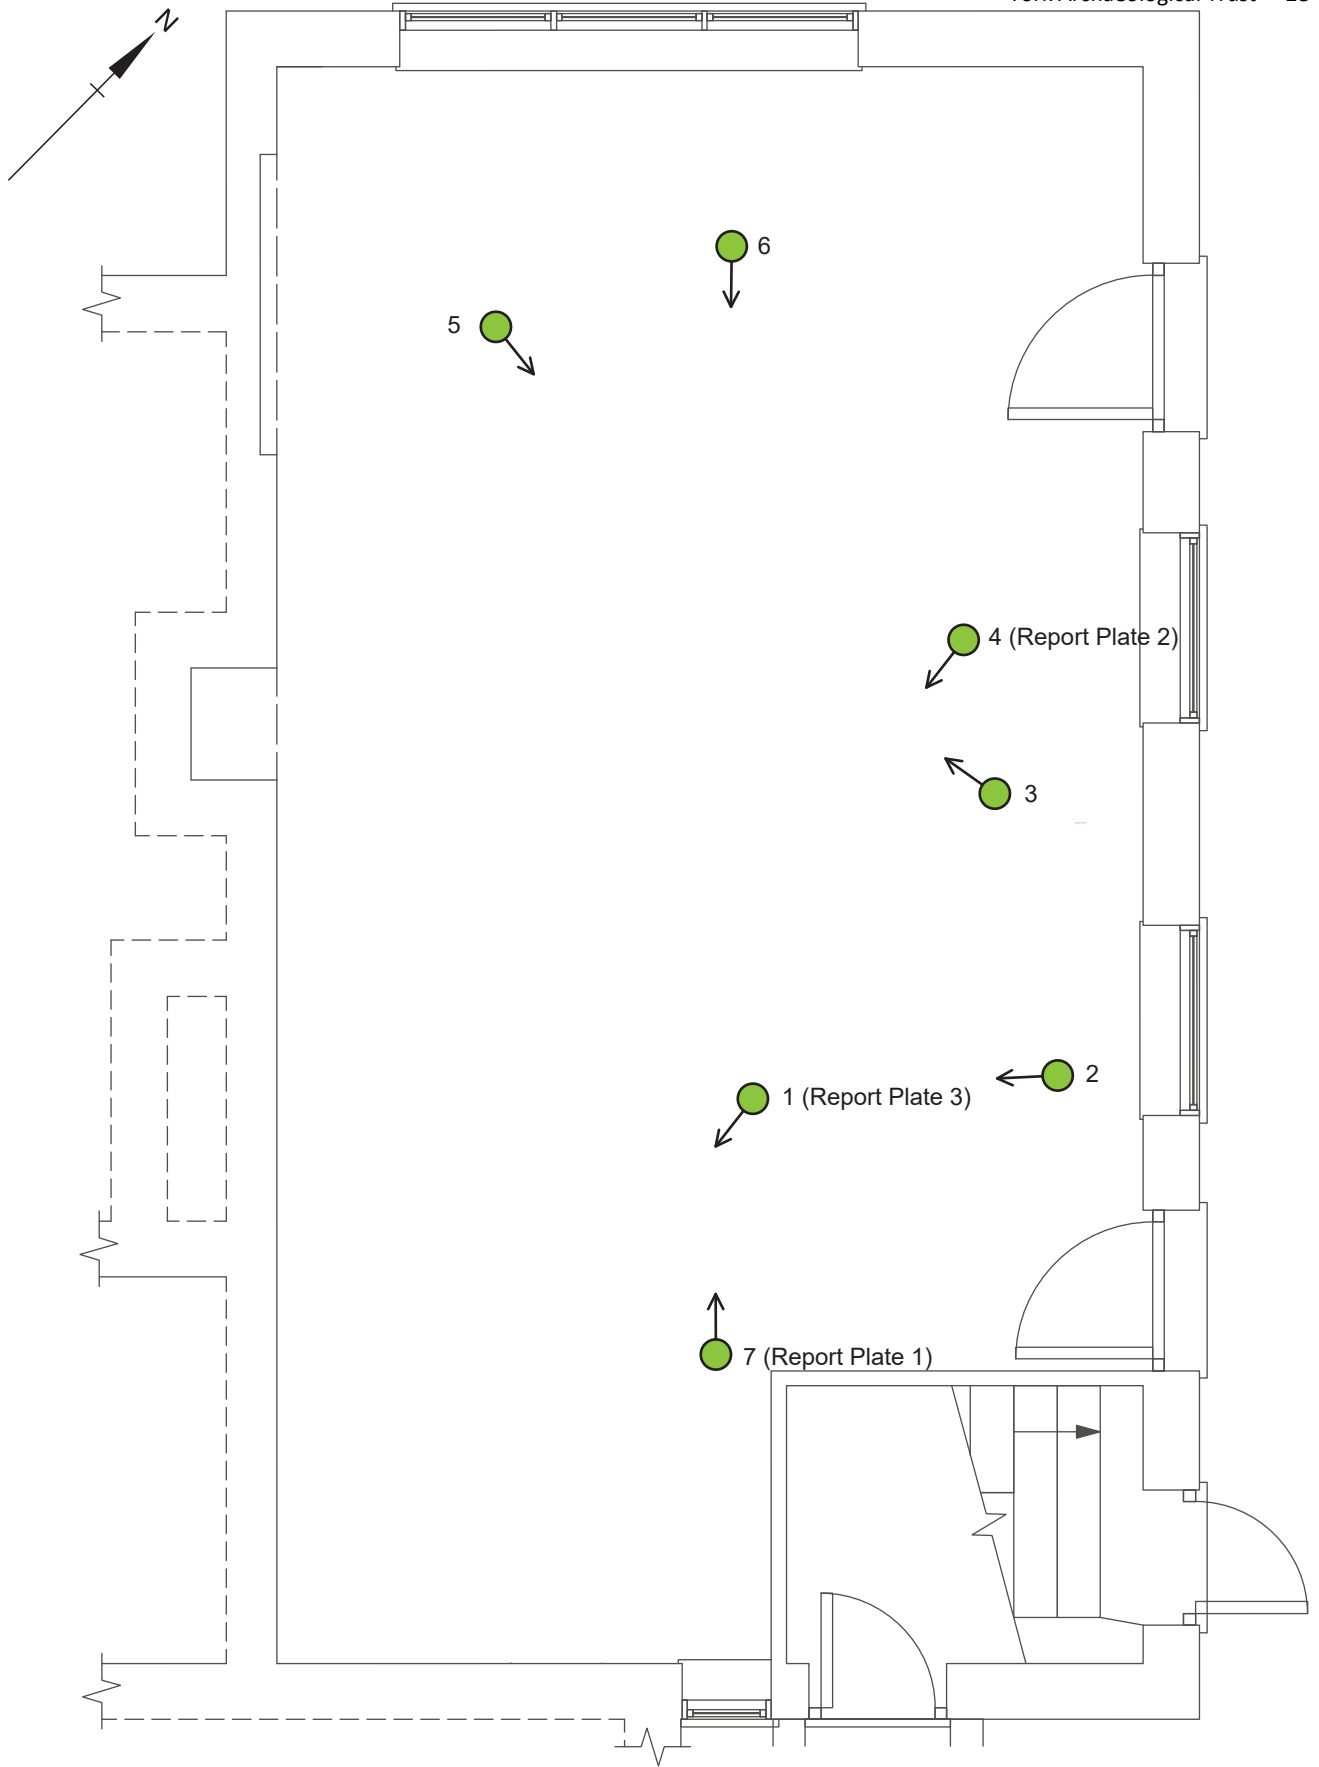
Fig. 3 Ground floor ceiling prior to works 1:50 (After Native Architects, Drawing 305)

Directly above both fire places and the 19th century 'false' ceiling were found small brick vaults presumably providing support for first floor fire places (Figure 3, Plates 17 and 18). Whether these are original features or later additions is not clear, however where brick work was exposed it appears similar to those bricks used in the wall below.
