## Building Recording at Duttons for Buttons, 32 Coppergate, York

YAT Building Report 2019/157 October 2019

On 10<sup>th</sup> October 2019 York Archaeological Trust undertook a course of Building Recording at Duttons for Buttons, 32 Coppergate, York, YO1 9NR (NGR SE 60444 51728). The works involved a Level 2 recording of external timbers exposed during improving and repair of the façade.

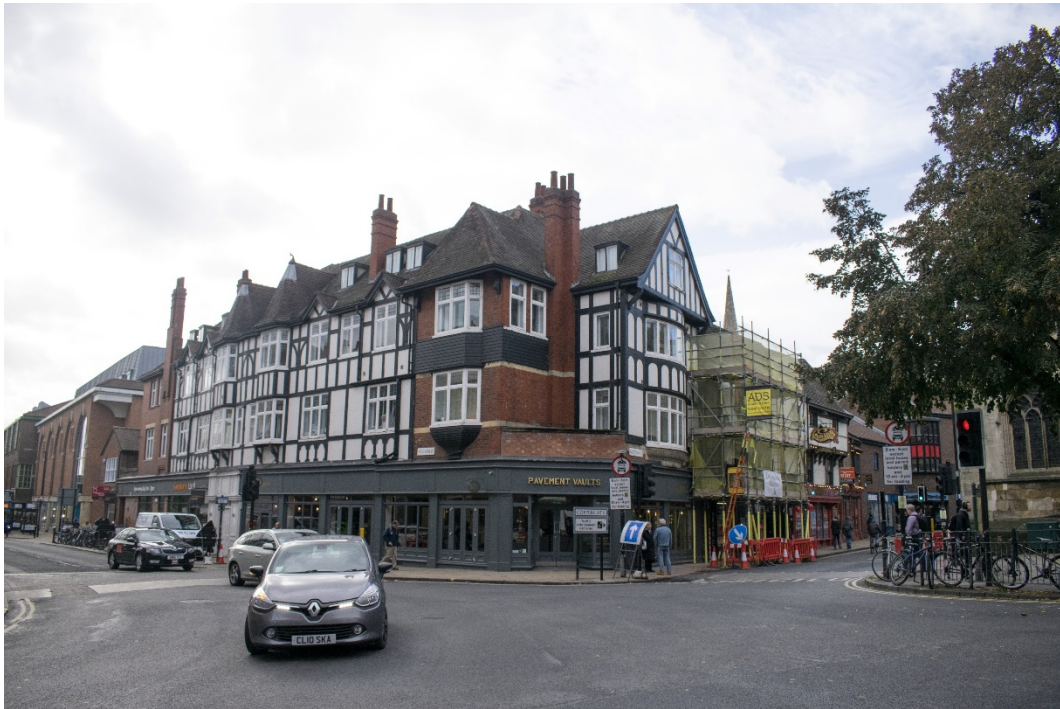
**Plate 1** View of 32 Coppergate from north-east side of Pavement, including Piccadilly.

32 Coppergate is a three-storey terrace property comprising two parallel ranges which fronts onto Coppergate (Plate 1). It is part of a larger Grade II\* Listed building with 28 and 30 Coppergate to the west. It has been attached to 2 Piccadilly, an early 20<sup>th</sup> century timber imitation building on its east side. The building features two parallel pitched roofs that encompass 28 to 32 Coppergate comprised of grey slate tiles. The first floor features a deep jetty.
