# CONDITION ASSESSMENT OF THE SHIRE DITCH, THE MALVERN HILLS, HEREFORDSHIRE AND WORCESTERSHIRE

Tom Vaughan

6<sup>th</sup> February 2006  
revised 22<sup>nd</sup> February 2006

INVESTOR IN PEOPLE  
Project 2817  
Report 1384  
WSM 34769  
/HSM 43068

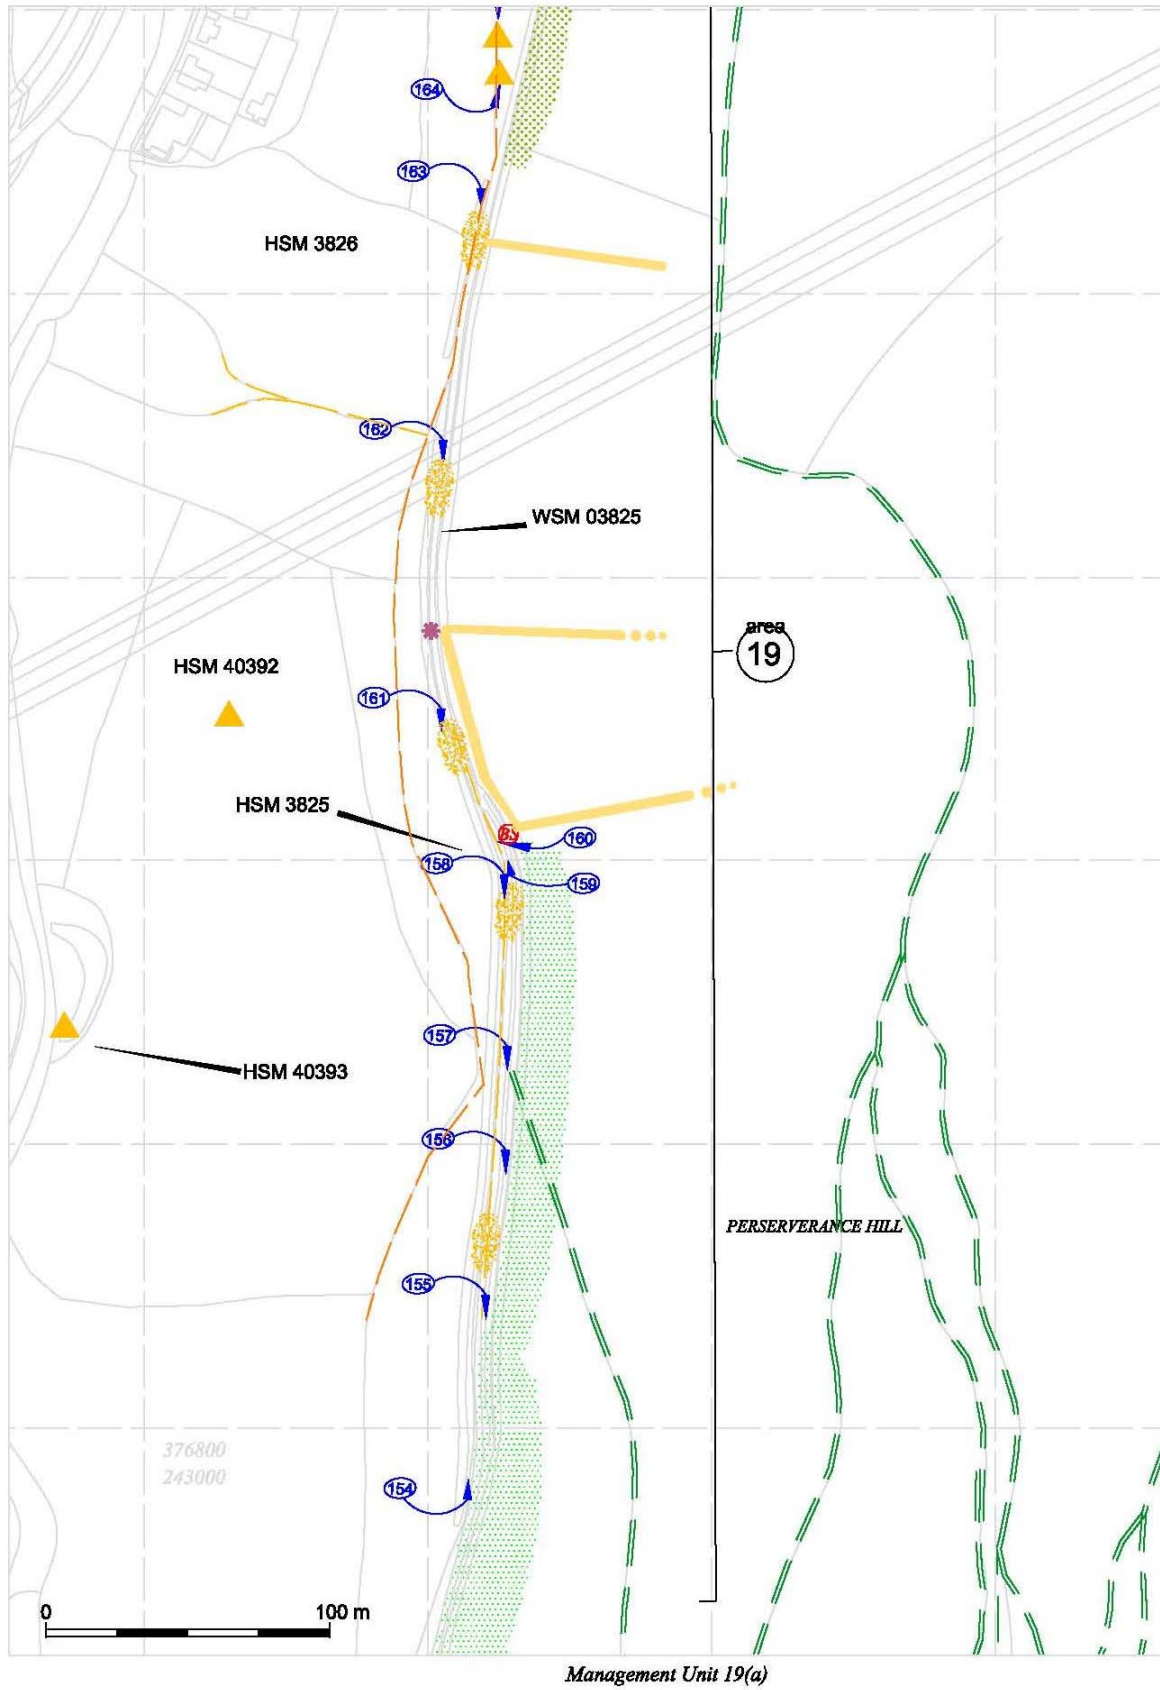
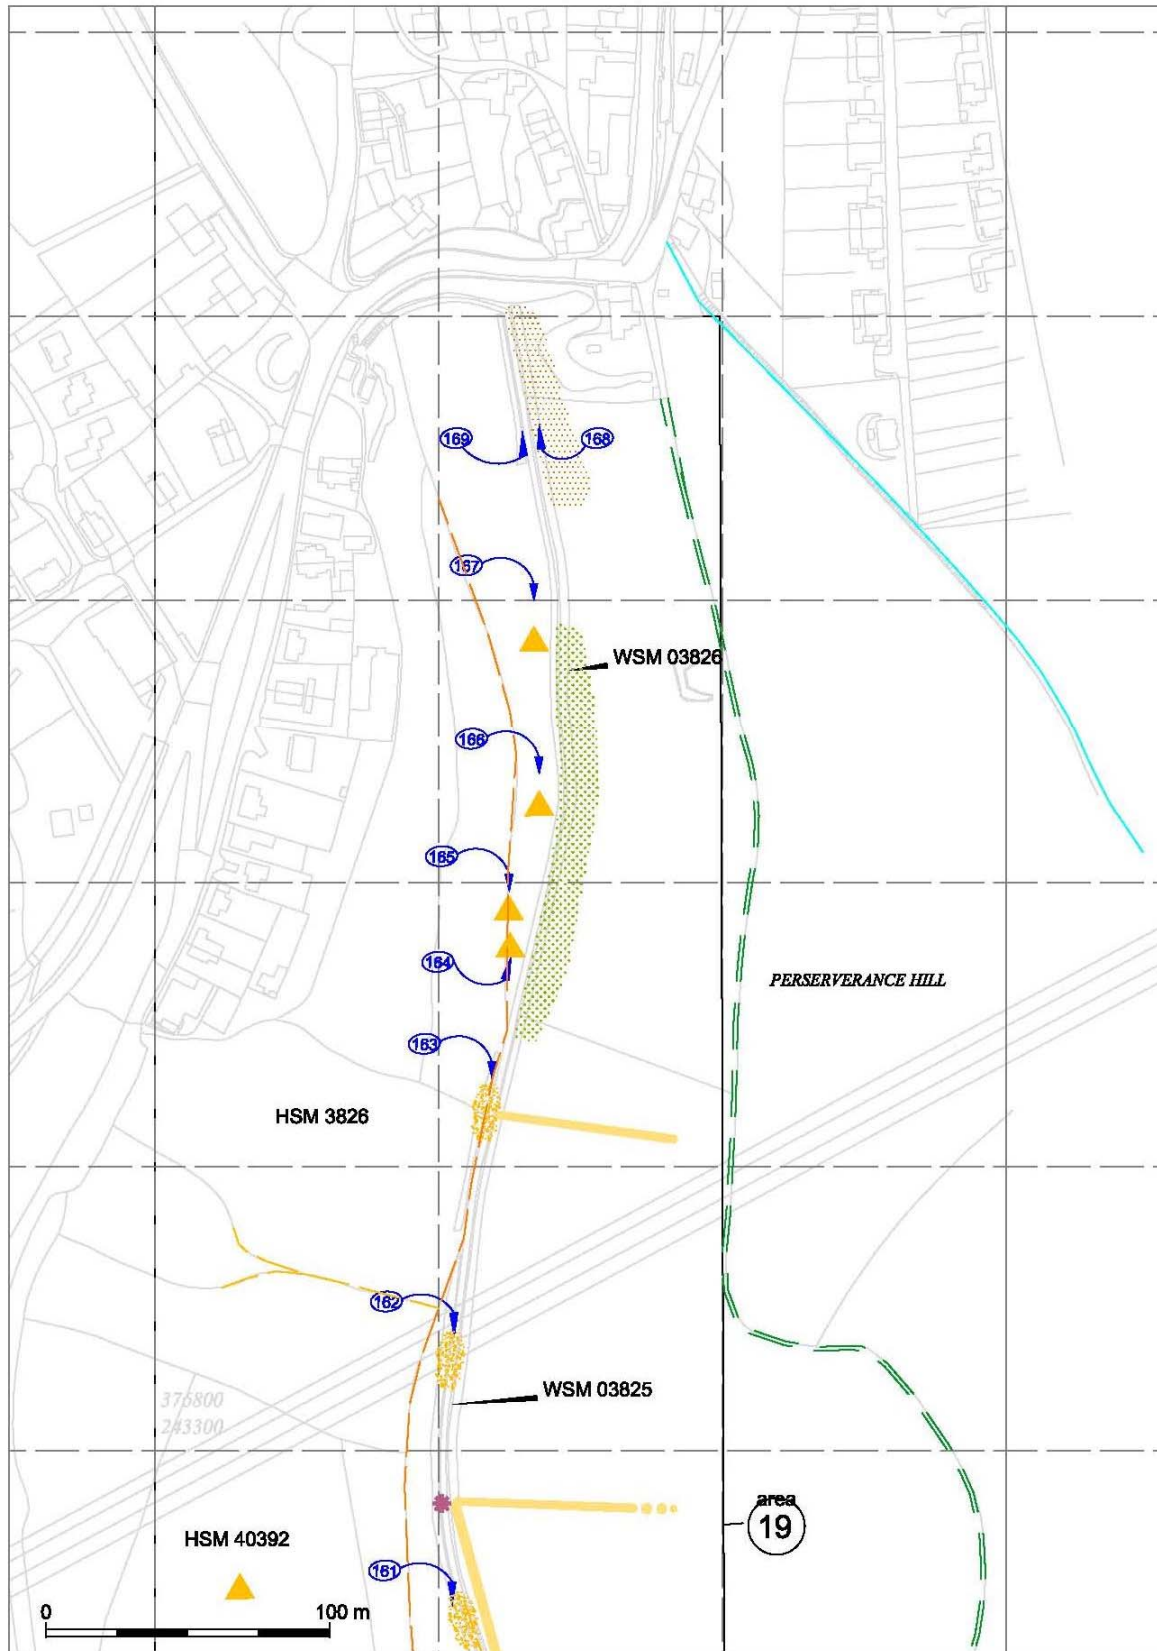
Management Unit 19(b)

<b>Management Unit:</b> Perserverence Hill		<b>NGR (from - to)</b> SO 76916 42941 - 76925 43702	<b>Number</b> 19
<b>Site Owner</b> Malvern Hills Conservators		<b>HER/SMR ref.</b> WSM 03825 and 03826 / HSM 3825 and 3826	
<p><b>Description</b>                  From the peak of Perserverence Hill to the Wyche Cutting.                  Main path along bank on east side of ridge, worn flat down to bare earth, gravel and rock with extensive water erosion along much of length up to SO 76905 43329.                  To north, bank forms minor path, under grass with only occasional minor erosion.                  Ridge to west is under moss and grass, frequently eroded and weathered to bare rock, with occasional rabbit burrows.                  Ditch removed by path to south-east at SO 76929 43129                  Ditch largely inaccessible under bracken and scrub with occasional trees south of bisecting field boundary at SO 76929 43207.                  Boundary stone in ditch at this point.                  Between this field boundary and another at SO 76904 43282 to north there is no defined ditch and bank appears modified.                  South of adjoining field boundary at SO 76921 43413 ditch is not evident around rock outcrop.                  Four small quarry pits along ridge between SO 76927 43479 and 76936 43589                  Minor path or animal track from north-east bisects ditch at SO 76938 43507; no erosion.                  North of SO 76938 43527 ditch is irregular and winding along east side of ridge - disturbed by adj. quarrying?                  North of SO 76941 43595 ditch is under bracken                  Ephemeral ditch reappears at SO 76942 43661, under long grass and scrub bushes, fenced off for quarry on south-east side of the Wyche Cutting.</p>

<b>Survival Visible components</b>	Medium		
<b>Condition % affected</b>	Medium/poor		
<p><b>Vulnerability</b>                  Weathering and water erosion                  Minor rabbit activity                  Footpath erosion</p>			
<b>Significance Within the monument</b>	Medium		
<b>Risk to significance</b>	Medium/High		
<b>Priority Based on factors above</b>	Medium/High		
<b>Remediation</b>	Clear scrub from ditch - S3 Discourage use of bank path - R3 Reinstate and reseed eroded path on bank - RE1-4 Reinstate weathered bank - RE1 and RE2 Monitor - M3		
<b>Figure</b>			
<b>Plates</b> -	<b>Photos</b> 154-169

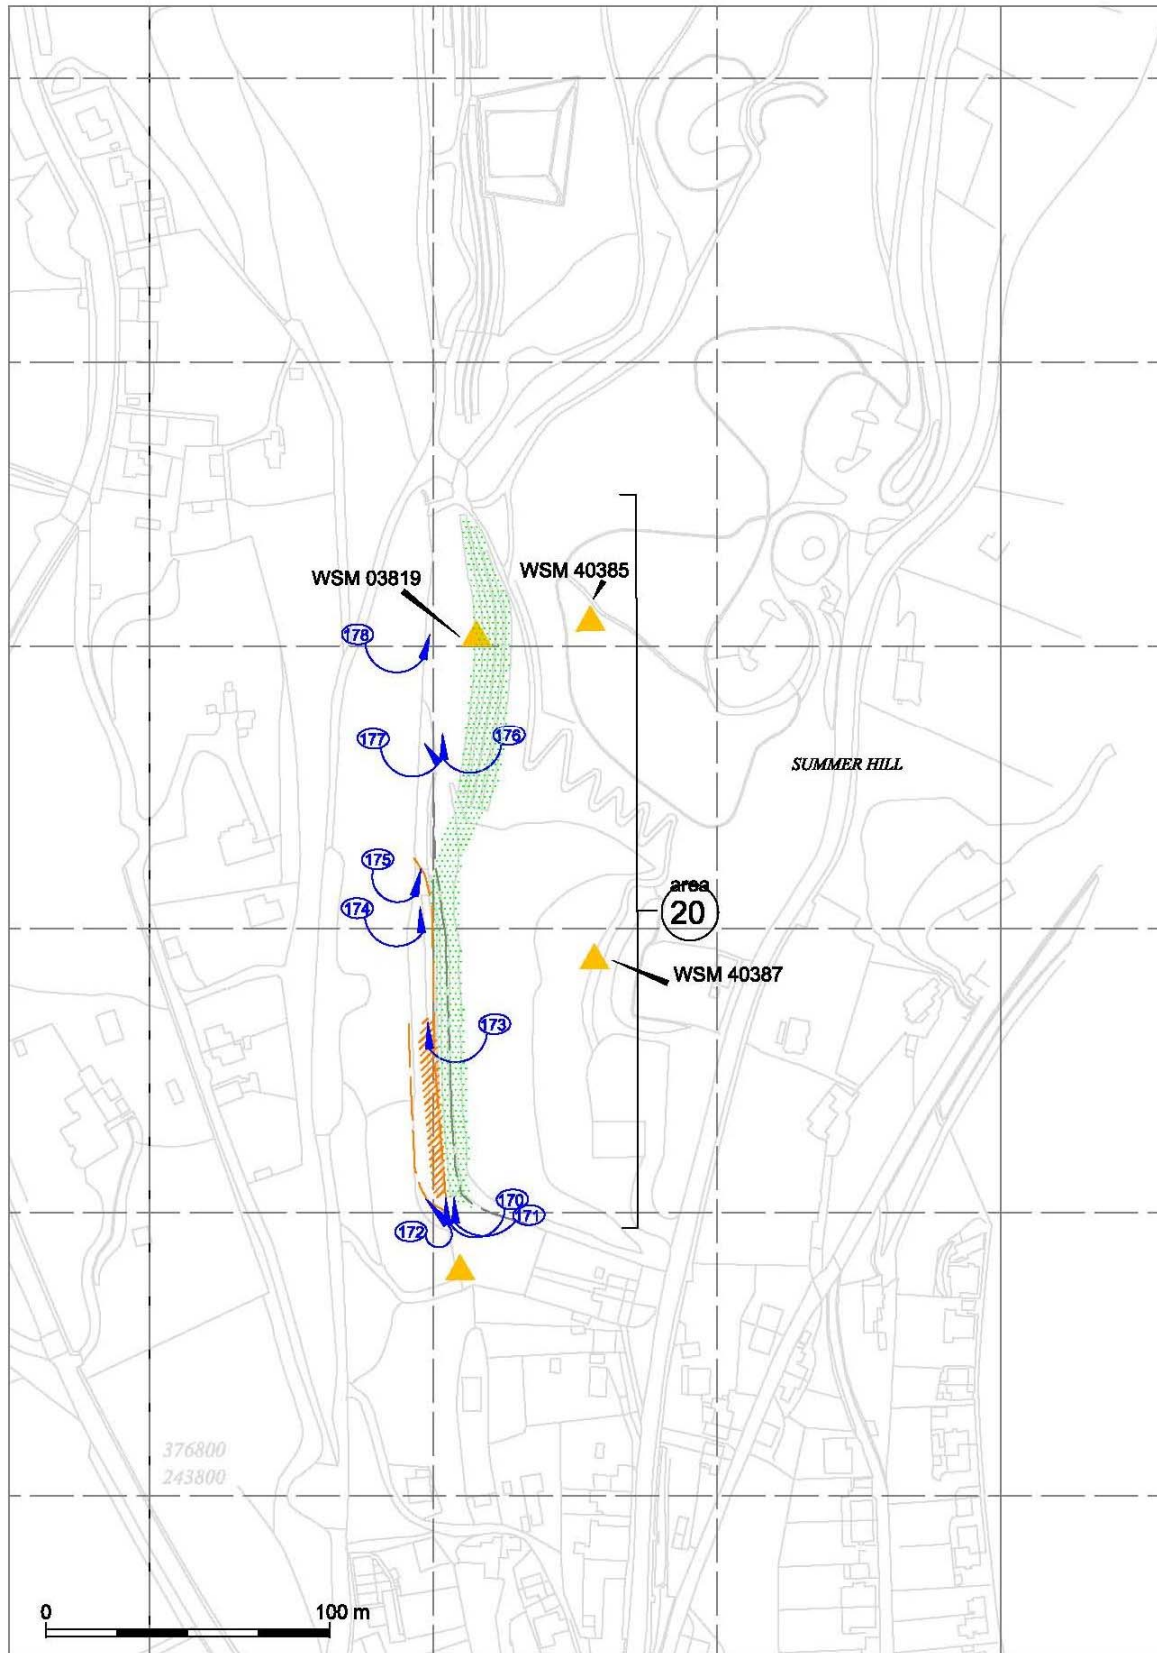
Management Unit 20

<b>Management Unit:</b> Wyche Cutting to the Gold Mine		<b>NGR (from - to)</b> SO 76906 43894 - 76914 44120	<b>Number</b> 20
<b>Site Owner</b> Malvern Hills Conservators		<b>HER/SMR ref.</b> WSM 03819 / HSM 3819	
<b>Description</b> North of houses to the north of the Wyche Cutting, up to the Gold Mine saddle, west of Upper Wyche and Wyche Quarry. West bank is footpath, worn flat to bare rock, gravel and soil. West side of ridge under gorse, with occasional irregular paths up to main ridge worn to bare earth and gravel with water erosion, e.g. SO 76901 43900. Ditch to east under open woodland of trees, occasional scrub and leaf mold. Concrete wall within ditch at south end, from SO 76910 43906 to 76899 44059; bisects ditch and bank path at SO 76900 44018; main path joins summit path. Quarry appears to have entirely removed ditches between SO 76899 44059 and 76912 44043 At north end, possible multiple ditches inaccessible under dense gorse & grass northwards, but appear well-defined from saddle. Short deep trench on ridge toward north end, west of main monument is probably quarry related. Area terminates south of saddle where all earthworks have been removed by quarrying and later footpaths and bridleways.

<b>Survival Visible components</b>	Medium/Good		
<b>Condition % affected</b>	Medium/Good		
<b>Vulnerability</b> Minor weathering and water erosion to bank Erosion in footpath ditch Silt and root disturbance to east and multiple ditches			
<b>Significance Within the monument</b>	Medium		
<b>Risk to significance</b>	Medium/Low		
<b>Priority Based on factors above</b>	Medium		
<b>Remediation</b>	Encourage access away from bank path and reroute along ridge - R3 Deter access across bank - R1 Reseed and reinstate bank path - RE1-4 Clear dense scrub and trees within east and multiple ditches to north - S2 Monitor - M3		
<b>Figure</b>			
<b>Plates</b> -	<b>Photos</b> 170-178

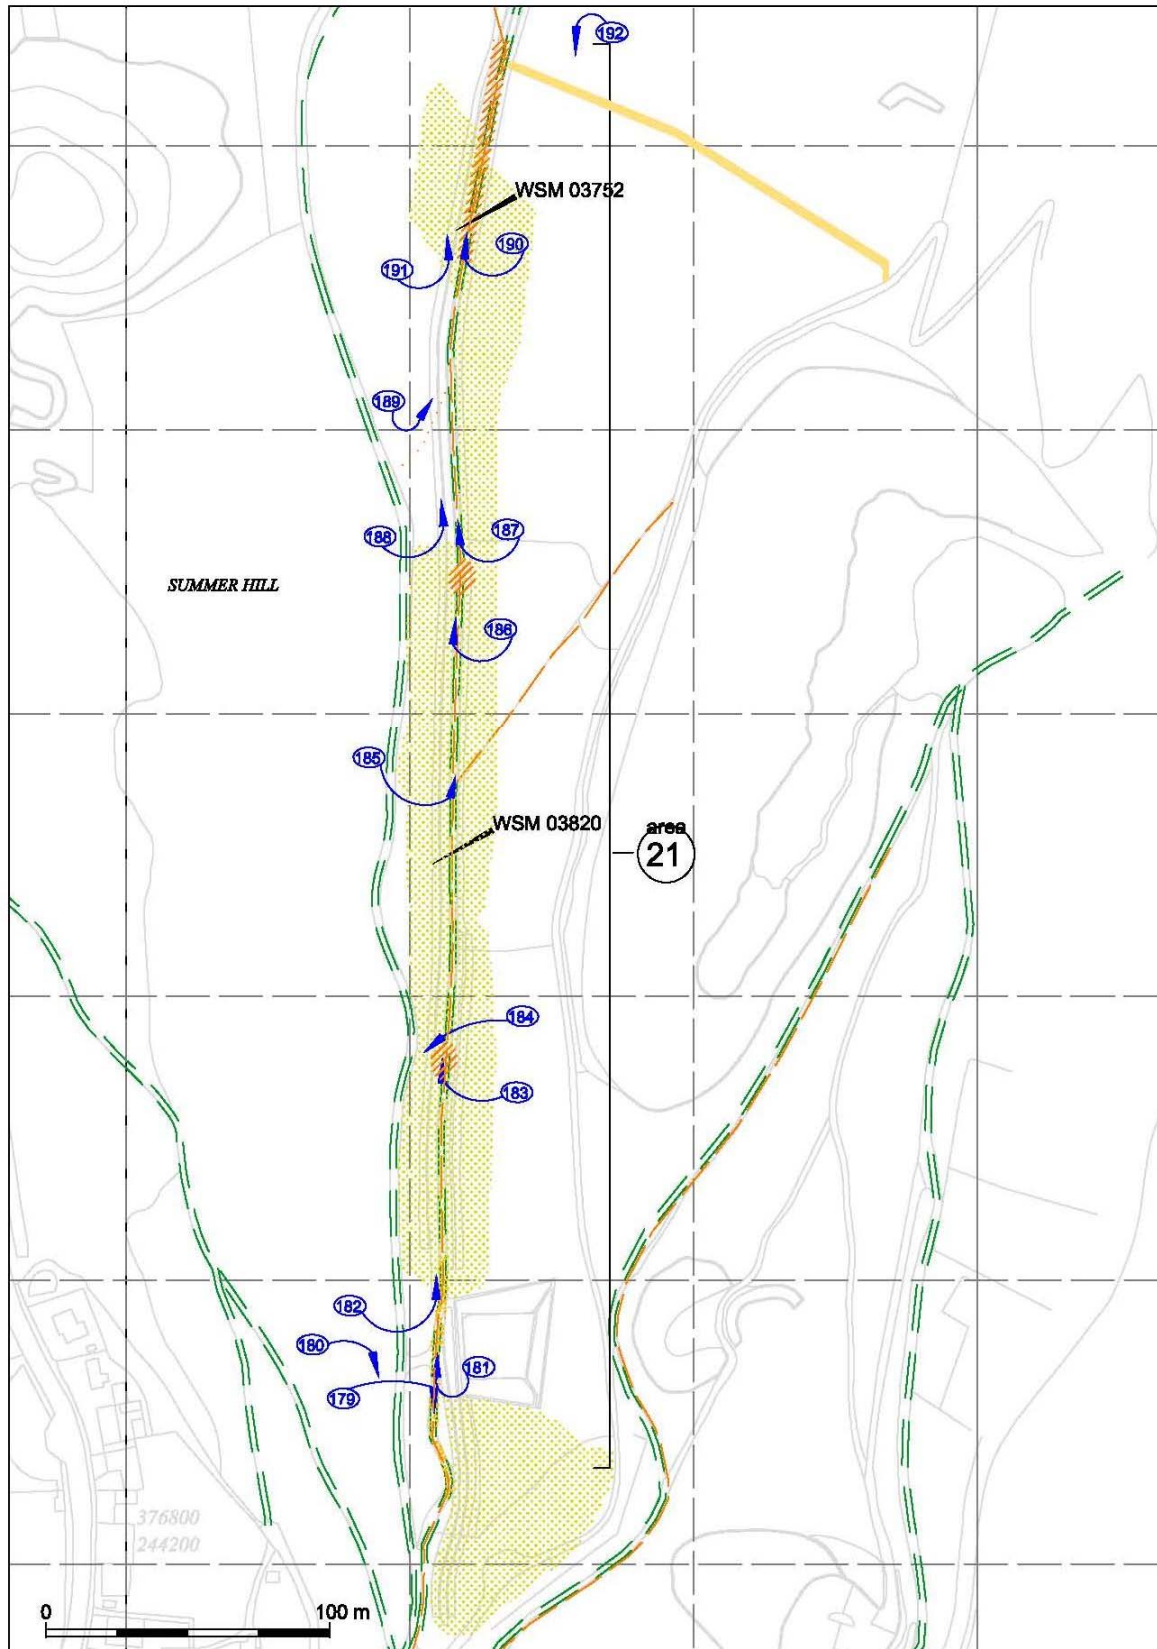
Management Unit 21

<b>Management Unit:</b> Summer Hill		<b>NGR (from - to)</b> SO 76911 44237 - 76934 44741	<b>Number</b> 21
<b>Site Owner</b> Malvern Hills Conservators		<b>HER/SMR ref.</b> WSM 03820 and 03752 / HSM 3821	
<b>Description</b> From the Gold Mine saddle, up the south side of Summer Hill to the peak; east of Earnslaw Quarry, Malvern Common and The Firs. No defined ditches due north of saddle - area inaccessible under gorse and scrub. Bridleway along bank, worn flat to bare earth and soil. Water plant has truncated ditch to east between SO 76918 44258 and 76916 44303. Bank and ditches truncated by path to water plant at SO 76904 44272 with imported gravel. Unclear if there is a ditch north of water plant; inaccessible under gorse and trees. Bank variously under grass, gorse and scrub; bridleway along ridge to west. Extensive water erosion within bridleway at SO 76915 44406, 76915 44457, 76916 444505 and to north summit. Irregular paths across bank at SO 76913 444386 and 76913 44482 worn to bare earth and gravel. Minor path from north-east cut through possible east ditch at SO 76915 44473; bare rock in west ditch adj. Possible west ditch northwards from SO 76911 44551, generally grassed with occasional gorse; weathered north of SO 76904 44604. Minor path/animal track across bank and west ditch at SO 76904 44604, worn to bare earth and stone. Field boundary from south-east adjoins ditch at SO 76934 44728. Area terminates north of peak where worn path on bank turns north-west across west ditch and onto ridge (continued as Area 22).

<b>Survival</b> Visible components	Medium/poor		
<b>Condition</b> % affected	Medium/poor		
<b>Vulnerability</b> Weathering of bank on summit Footpath erosion Water erosion			
<b>Significance</b> <b>Within the monument</b>	Medium		
<b>Risk</b> <b>to significance</b>	Medium/High		
<b>Priority</b> <b>Based on factors above</b>	Medium/High		
<b>Remediation</b>	Deter access across bank - R1 Deter access along bank path and reroute along ridge - R3 Reinstate water eroded sections - RE4 Clear gorse and scrub to south end - S2 or S3 Monitor - M3		
<b>Figure</b>			
<b>Plates</b>  10	<b>Photos</b>  179-192

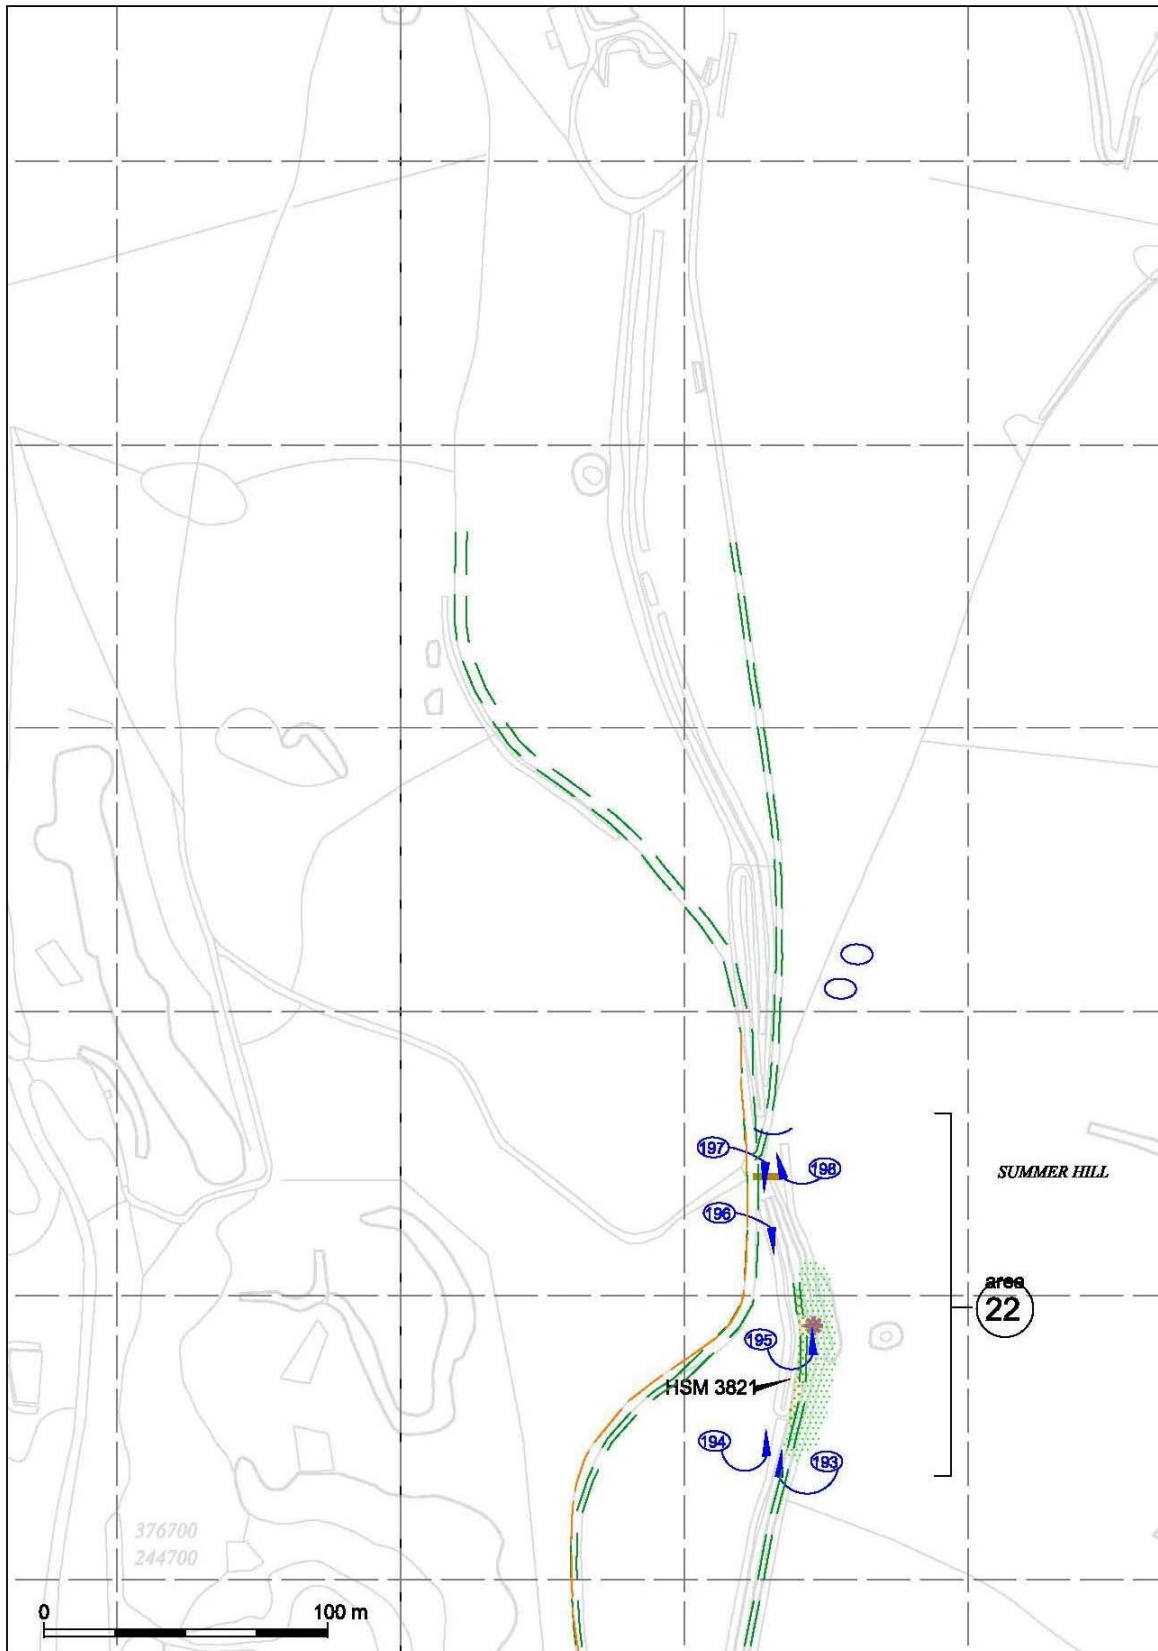
Management Unit 22

<b>Management Unit:</b> Summer Hill		<b>NGR (from - to)</b> SO 76934 44735 - 76931 44851	<b>Number</b> 22
<b>Site Owner</b> Malvern Hills Conservators		<b>HER/SMR ref.</b> WSM 03821 / HSM 3821	
<b>Description</b> From the peak of Summer Hill northwards to the saddle, south of Worcestershire Beacon. South end of area defined by change of alignment of path across ditches and onto ridge to west. Bank very silted and flat, under short grass; ditch to east lower on slope, under grass and occasional scrub. Possible mole hills on bank at SO 76938 44775. Rock outcrop in ditch at SO 76946 44789. Bank largely peters out at SO 76932 44821 and becomes very ephemeral Bank ill-defined on ridge, eroded? Bench cut into bank at SO 76930 44845. Temporary water bowser located south of bench, for water trough to east down slope. Footpath follows ridge, worn to bare earth and gravel along full length. Area terminates to north at the intersection of three Bridleways and a path on the ridge, obliterating all earthworks.

<b>Survival Visible components</b>	Medium		
<b>Condition % affected</b>	Medium/poor		
<b>Vulnerability</b> Minor animal activity Minor weathering Siltting			
<b>Significance Within the monument</b>	Medium		
<b>Risk to significance</b>	Low		
<b>Priority Based on factors above</b>	Low		
<b>Remediation</b>	Resite temporary fencing and bowser away from ditch - G2 Clear ditch - S2 or G3 Reinstate eroded sections - RE3 or RE4 Monitor - M3		
<b>Figure</b>			
<b>Plates</b> -	<b>Photos</b> 193-198

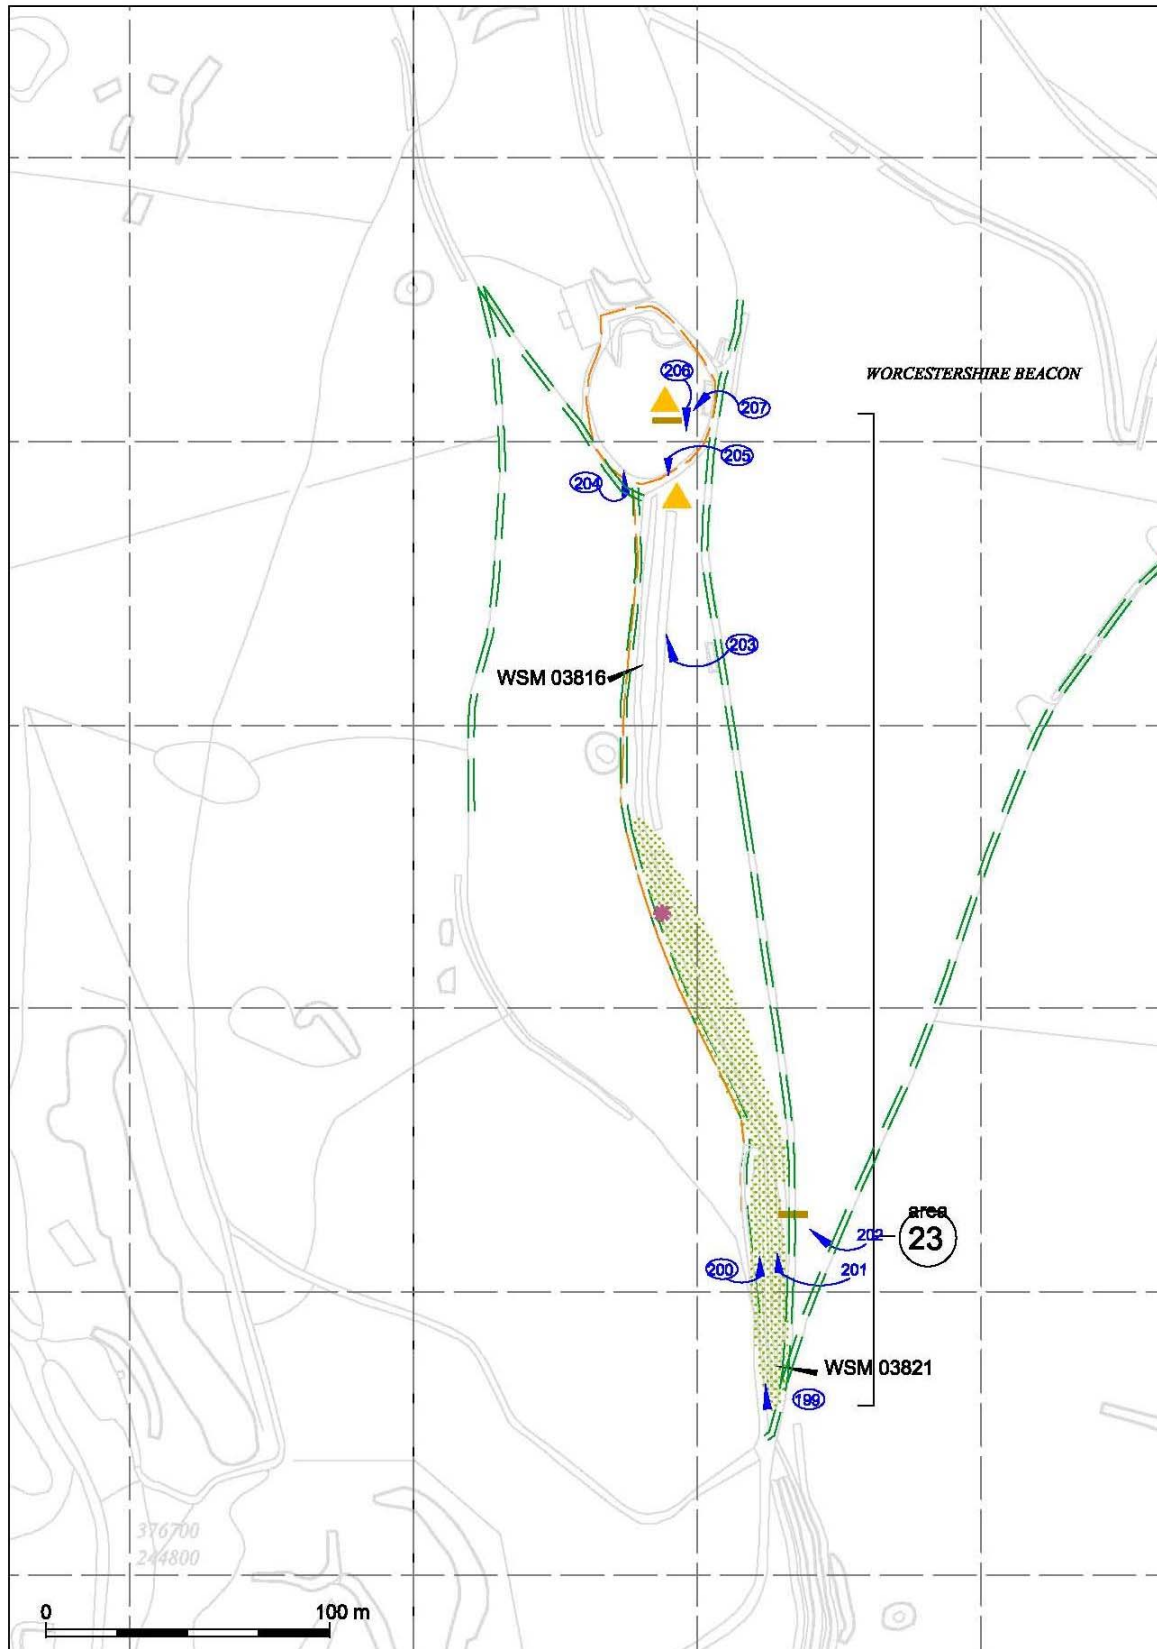
Management Unit 23

<b>Management Unit:</b> Worcestershire Beacon		<b>NGR (from - to)</b> SO 76926 44860 - 76895 45204	<b>Number</b> 23
<b>Site Owner</b> Malvern Hills Conservators		<b>HER/SMR ref.</b> WSM 03816 and 03821	
<b>Description</b> From the saddle north of Summer Hill, north up slope to peak of Worcestershire Beacon. The intersection of three Bridleways and a path joining on the ridge define the south end of this area, obliterating all earthworks. Main ridge path is a Bridleway to west of ditches. Two separate ditches at southern end, both are generally under long grass with occasional rabbit burrows to east. Ditches unify at SO 76920 44965, under long grass to summit. Bench cut into east ditch at SO 76930 44930 adj. to path, minor erosion to bare earth to east. Rock outcrop in ditch at SO 76888 45034. From SO 76882 45057 the gravel path on bank to west is eroding gravel into grassed flat ditch to east. Ditch bisected by path at SO 76890 45188, in-filling ditch and occasionally worn to bare soil and gravel. Possible quarry disturbance in ditch south of path, at c SO 76890 45180. Not possible to define ditch north of path where is a wide shallow quarry with a bench located to west side.

<b>Survival Visible components</b>	Medium/poor		
<b>Condition % affected</b>	Medium		
<b>Vulnerability</b> Minor weathering and erosion from path to west Minor rabbit activity Siltng			
<b>Significance Within the monument</b>	Medium		
<b>Risk to significance</b>	Medium/low		
<b>Priority Based on factors above</b>	Medium/low		
<b>Remediation</b>	Monitor rabbits and eroded section - M3		
<b>Figure</b>			
<b>Plates</b> -	<b>Photos</b> 199-207

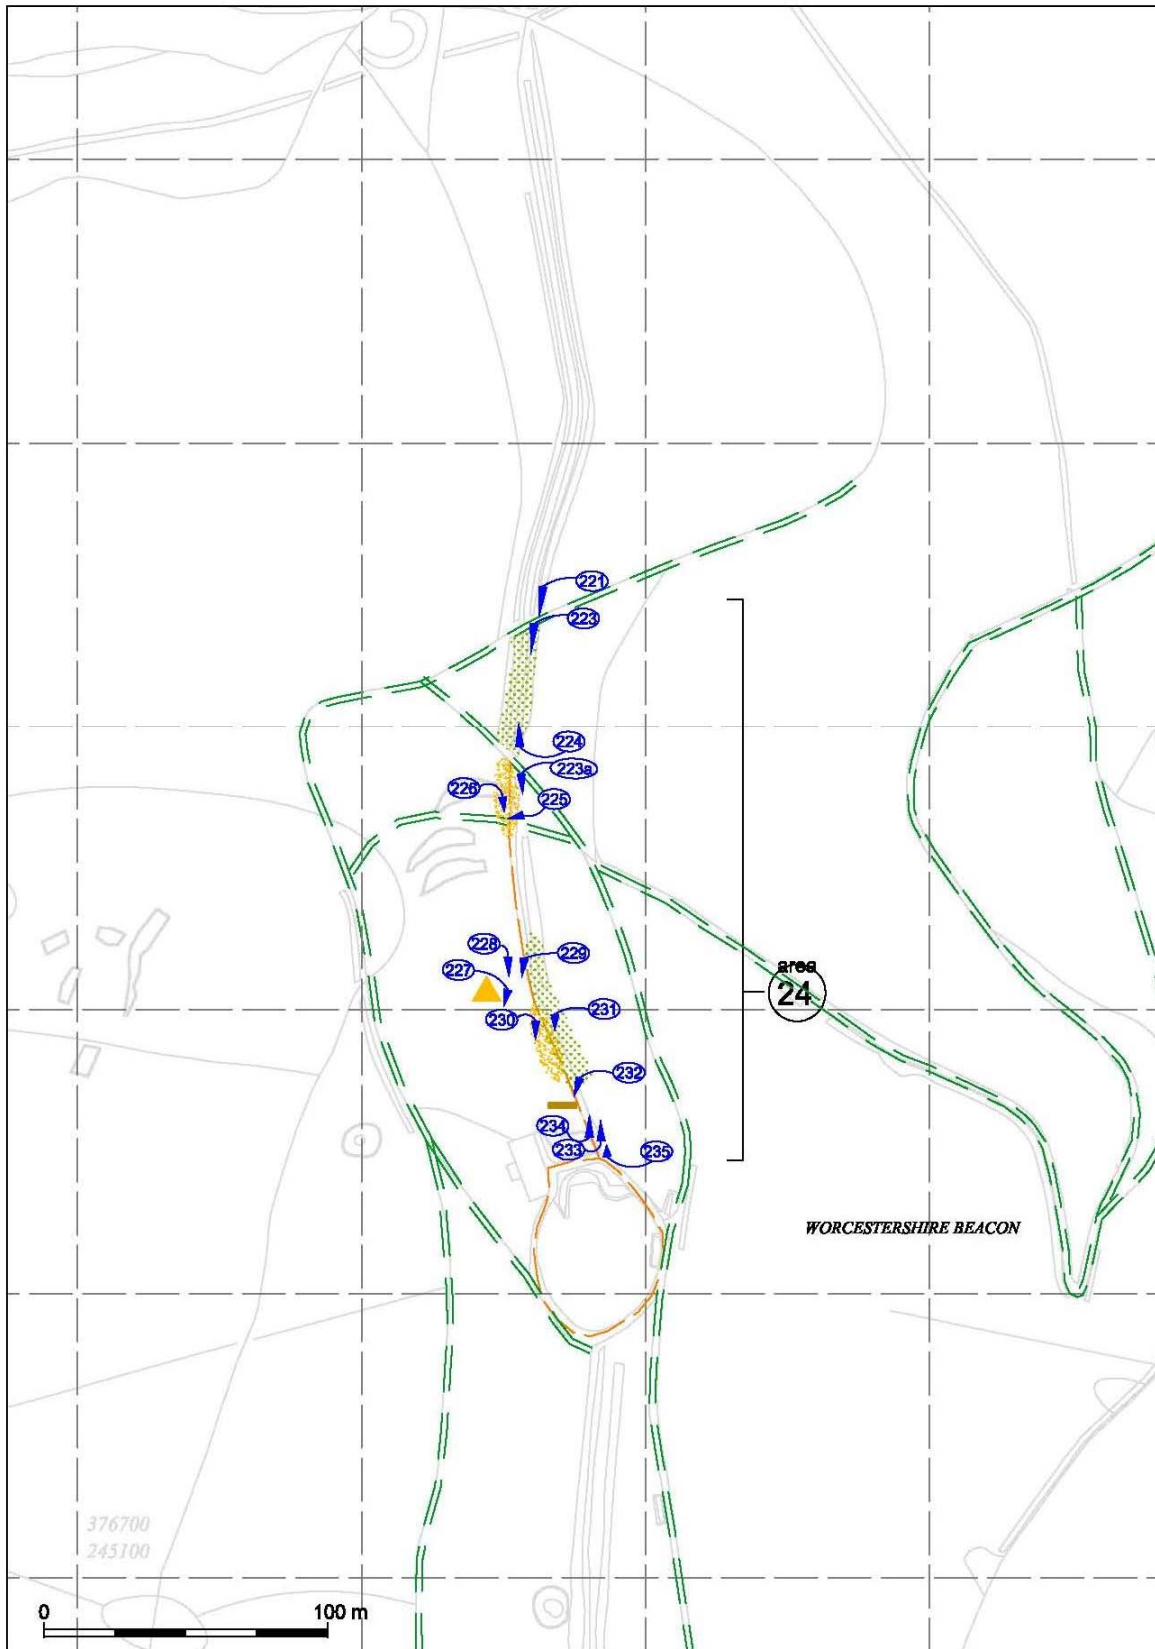
Management Unit 24

<b>Management Unit:</b> Worcestershire Beacon		<b>NGR (from - to)</b> SO 76885 45253 - 76861 45435	<b>Number</b> 24
<b>Site Owner</b> Malvern Hills Conservators		<b>HER/SMR ref.</b> WSM 03816	
<b>Description</b> From main path by rock outcrop at peak of Worcestershire Beacon down slope to north; separated from Area 25 by Bridleway. Possible double ditch below peak; west ditch (or worn bank?) is under path worn down to bare rock, gravel and soil, with water erosion down steeper gradient, e.g. SO 76865 45291; east ditch is under long grass. Bench at SO 76876 45260 cut into west bank Quarry in west ditch at SO 76854 45306 Single defined ditch only from SO 76856 45364 southwards. Ditch bisected by a rarely used Bridleway at SO 76856 45364 over a rock outcrop, where banks and ditch are eroded down to bare rock. At south end single ditch is generally under long grass with very occasional erosion to bare earth. Bank to west under grass worn to bare rock under minor path. Minor bank to east under grass with less bare rock Bisected by main Bridleway at SO 76858 45385, completely in-filling ditch and truncating banks

<b>Survival Visible components</b>	Poor		
<b>Condition % affected</b>	Poor/Medium		
<b>Vulnerability</b> Weathering and water erosion on path down steep gradient Footpath erosion			
<b>Significance Within the monument</b>	Medium		
<b>Risk to significance</b>	Medium/High		
<b>Priority Based on factors above</b>	Medium/High		
<b>Remediation</b>	Reseed and reinstate path and ditch - RE2-4 Deter access along bank path - R3 (within constraints of MHC Acts) Monitor erosion on Bridleways - M3		
<b>Figure</b>			
<b>Plates</b>  11 & 12	<b>Photos</b>  223-235

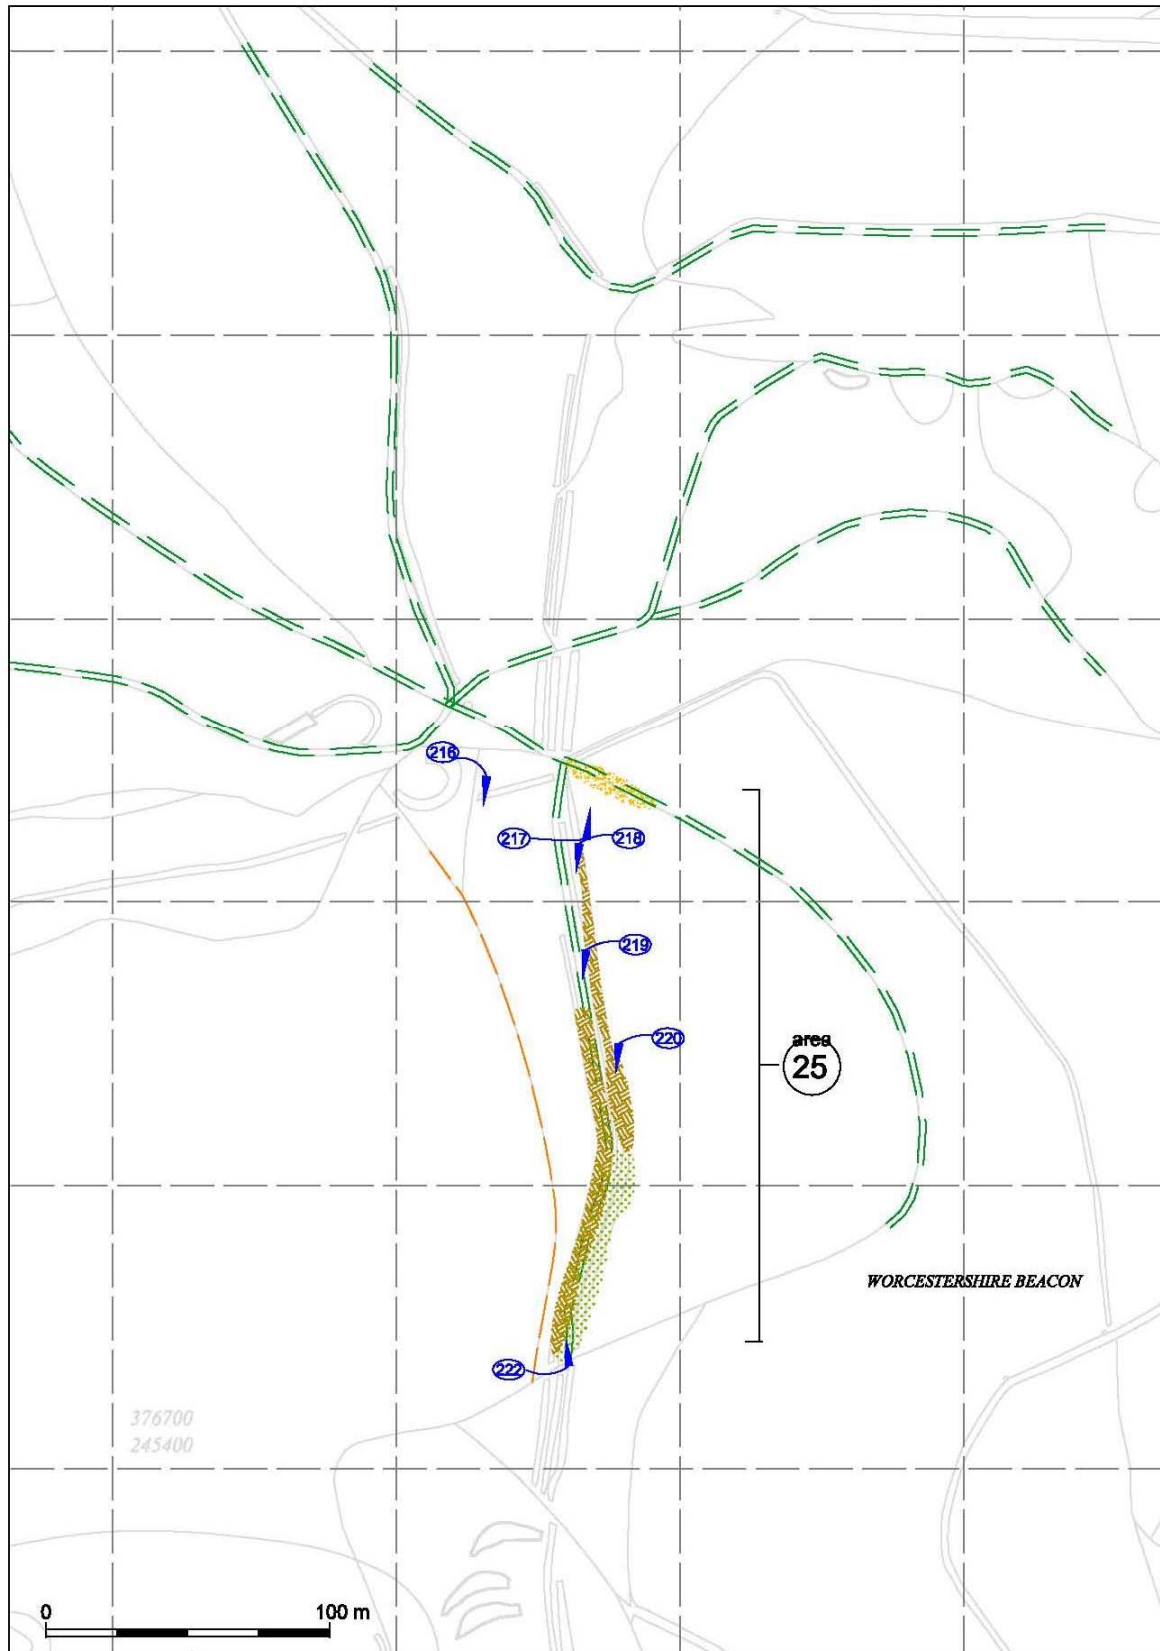
Management Unit 25

<b>Management Unit:</b> Worcestershire Beacon		<b>NGR (from - to)</b> SO 76860 45439 - 76862 45646	<b>Number</b> 25
<b>Site Owner</b> Malvern Hills Conservators		<b>HER/SMR ref.</b> WSM 03816	
<b>Description</b> North slope of Worcestershire Beacon north to saddle south-east of Sugarloaf Hill; separated from Areas 24 and 26 by Bridleways. Bridleway to south completely in-fills ditch and is worn to bare soil. Wide ditch generally under long grass, occasional bushes with very occasional erosion to bare earth. Banks either side, generally under short grass with minor paths with occasional ware to bare earth and water erosion, most severe at north end of east bank. Path on west bank is a Bridleway.			
<b>Survival Visible components</b>	Medium/Good		
<b>Condition % affected</b>	Good		
<b>Vulnerability</b> Erosion along paths and from main perpendicular Bridleway to south Siltling			
<b>Significance Within the monument</b>	Medium

<b>Risk to significance</b>	Medium/low		
<b>Priority Based on factors above</b>	Low/Medium		
<b>Remediation</b>	Reseed and reinstate path and ditch - RE2-3 Deter access along bank path - R3 Monitor erosion on Bridleways - M3 Clear ditch - S2 or S3		
<b>Figure</b>			
<b>Plates</b> -	<b>Photos</b> 216-222

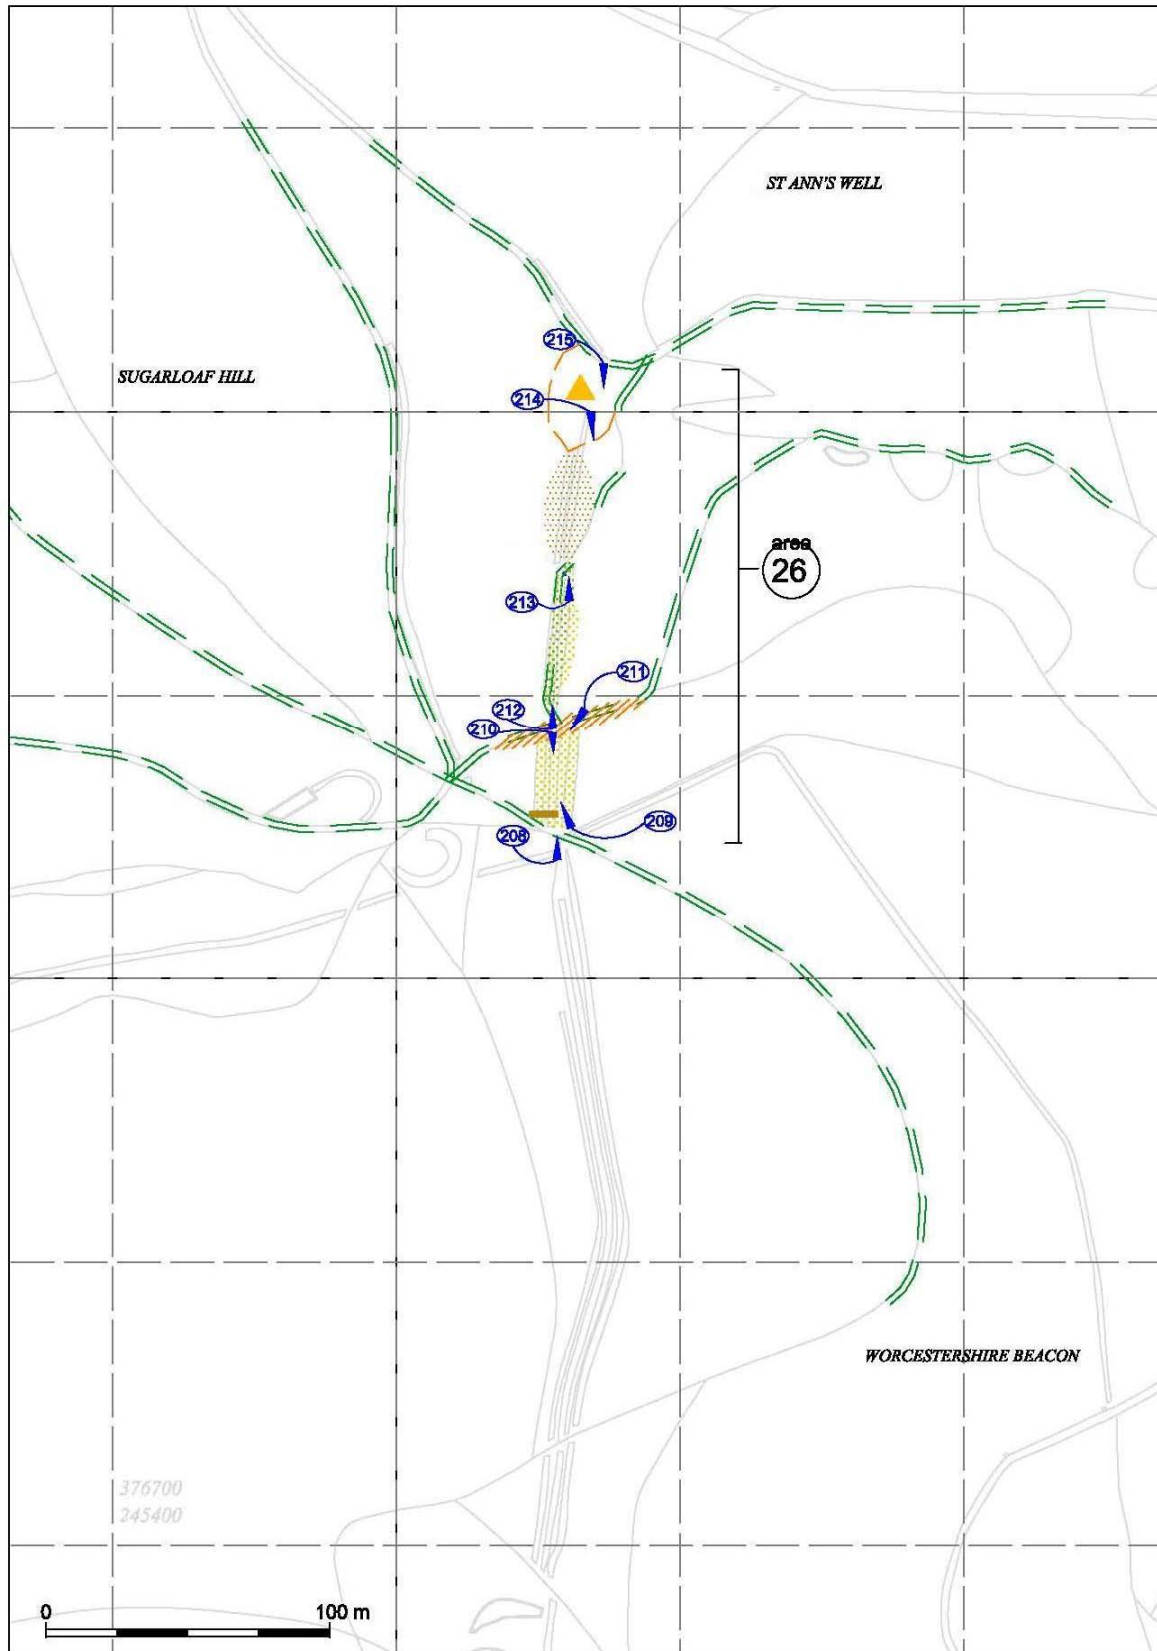
Management Unit 26

<b>Management Unit:</b> Sugarloaf Hill		<b>NGR (from - to)</b> SO 76858 45651 - 76896 45796	<b>Number</b> 26
<b>Site Owner</b> Malvern Hills Conservators		<b>HER/SMR ref.</b> WSM 03816	
<b>Description</b> From the saddle south-east of Sugarloaf Hill down to the south side of Happy Valley/Green Valley, west of St Ann's Well. Bridleway to south of area completely in-fills ditch and is worn to bare gravel and soil. Ditch with banks to either side, under long grass with frequent gorse bushes. Bench on west bank at SO 76853 45654 Bisected by perpendicular Bridleway at SO 76858 45686, worn to bare earth and rock Minor path up west side of ditch between two east-west paths, patches worn to bare earth. Minor Bridleway alongside west bank, cuts across ditch at SO 76862 45745, ditch silted and banks eroded but stable under grass and no present erosion. Ditch obscured by scrub and woodland north of minor path Area terminates where north end of ditch is truncated by quarry within woodland.

<b>Survival Visible components</b>	Medium/Good		
<b>Condition % affected</b>	Medium/Good		
<b>Vulnerability</b> Erosion across Bridleways Siltling			
<b>Significance Within the monument</b>	Medium		
<b>Risk to significance</b>	Low/medium		
<b>Priority Based on factors above</b>	Low		
<b>Remediation</b>	Monitor - M3 Clear gorse - S3 Thin out woodland - S3		
<b>Figure</b>			
<b>Plates</b> 13 & 14		<b>Photos</b> 208-215
